MOUNT POLLEY MINING CORPORATION
MOUNT POLLEY MINE

TAILINGS STORAGE FACILITY
REPORT ON 2010 ANNUAL INSPECTION

**TAILINGS STORAGE FACILITY
REPORT ON 2010 ANNUAL INSPECTION
(REF. NO. VA101-1/29-2)**

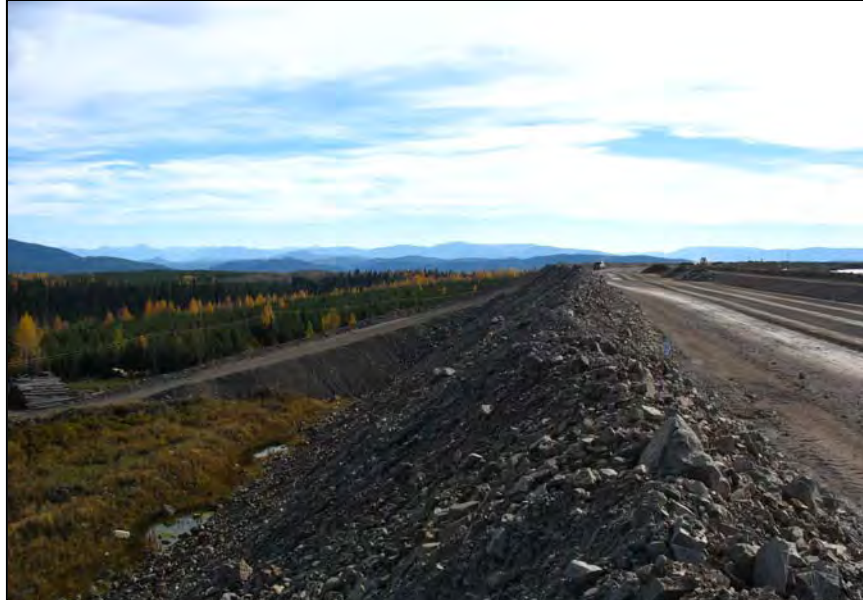
- A tension crack was observed at the Perimeter Embankment at an approximate chainage of 3+400. The tension crack is in the Zone C material at the downstream edge of the embankment crest. The tension crack was apparently identified two months earlier by the grader operator and was approximately 10 to 15 m long. The area has since been graded over but portions of the tension crack are still visible. The location of the tension crack in relation to the downstream slope is not an uncommon occurrence in rock slopes as the outer edge of the material typically receives less compaction effort. A tension crack does not necessarily indicate a plane of weakness in fill materials but it can't be ignored either. The tension crack is located on a section of the Perimeter Embankment located upstream of the Zone S borrow area.

PHOTO 5 – Tension Crack Location at the Perimeter Embankment.

It is recommended that a stability assessment be completed for this area to assess whether the borrow area configuration has any impact on the integrity of the current, and ultimate embankment section. It should also be noted that the identification of a tension crack, or any other abnormal observation at the tailings dam, should be reported to the design engineer immediately and prior to any remedial action being taken.

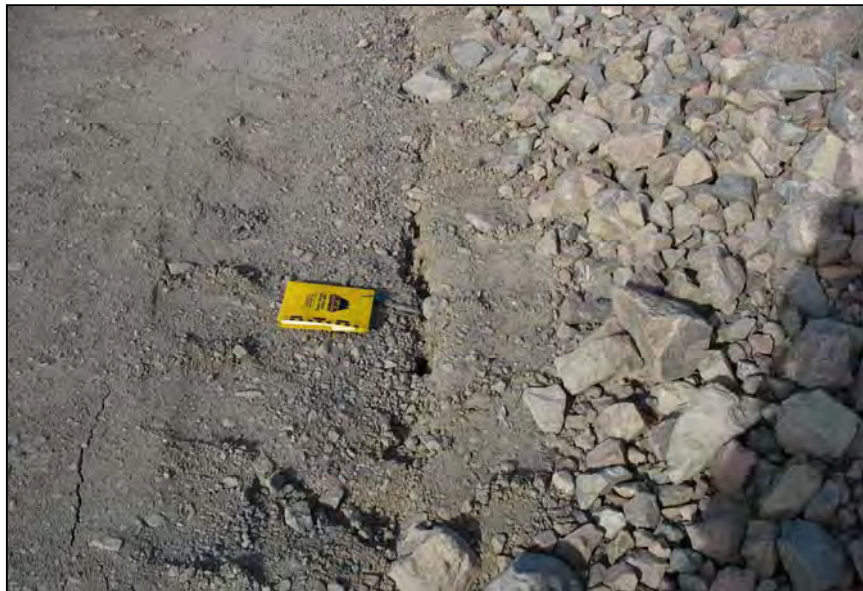
PHOTO 6 – Tension Crack at the Perimeter Embankment.

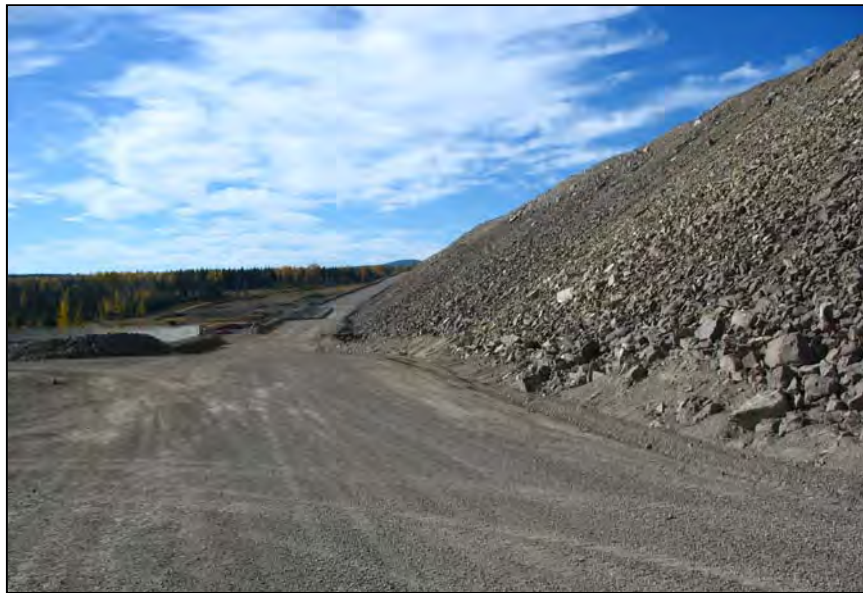
- Other than the tension crack mentioned above, no signs of distress were identified at the tailings embankments. The embankment slopes were approximately planar and there was no evidence of cracking, bulging or slumping in the embankment fill. The embankment crest appeared to be relatively level with no signs of differential settlement or distress. There was no evidence of animal burrowing.
- No major unexpected or uncontrolled seepage was observed from the embankments, including fill slope and foundations.
- The tailings embankments currently have a downstream slope of approximately 1.4H:1V. This was previously constructed as an interim slope to balance the construction material requirements with the waste production schedule for that particular year. This short term slope configuration still exists.

PHOTO 8 – Downstream Slope of Main Embankment.

It is recommended that the downstream slope of the Main Embankment be evaluated during the Stage 7 design phase to assess whether it requires flattening at this time.

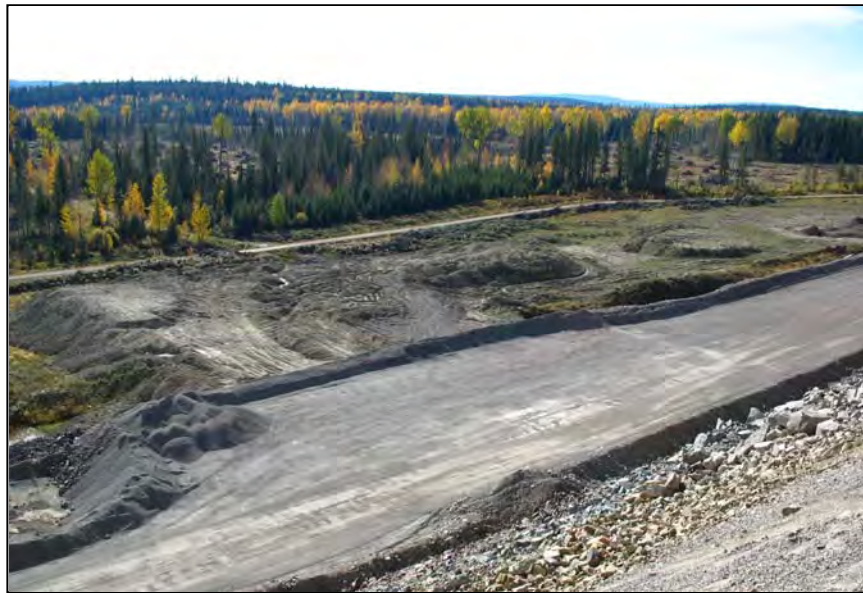
- Slight deviations measured in the lacustrine unit in Inclinator SI01-02 resulted in the recommendation for constructing a downstream buttress². The results of the stability assessment recommended a buttress be constructed downstream of the Main Embankment to an elevation of 920 m for a crest elevation of 958 m, the crest elevation for the Stage 6b embankment. The Stage 6b buttress footprint, which extends to both sides of the Main Embankment Seepage Collection and Recycle Pond, is shown on Drawing VA101-1/29-210. The letter also recommended that the buttress be constructed prior to the commencement of the Stage 6b construction program, which did not happen.

PHOTO 10 – Main Embankment Buttress.

It is recommended that the Main Embankment buttress requirements and timing be re-evaluated as part of the Stage 7 design of the TSF.

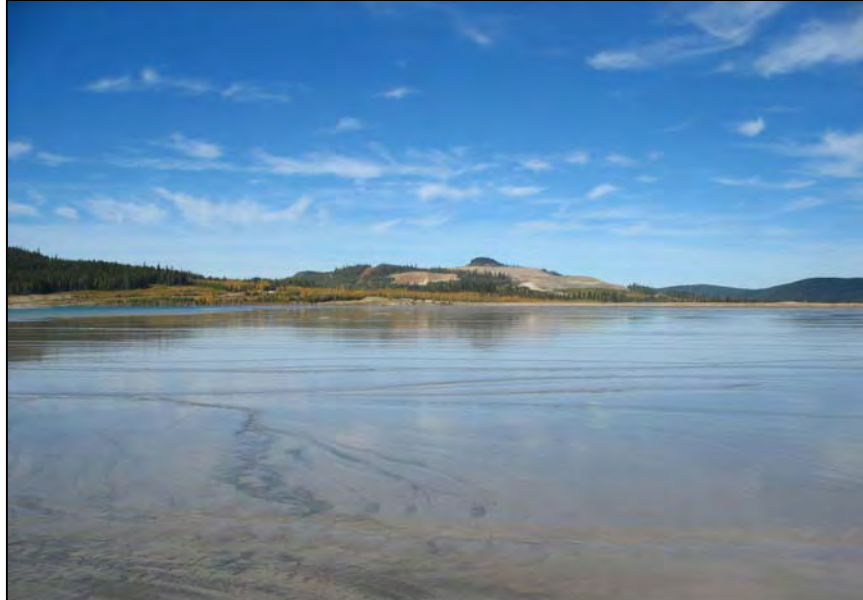
MPMC is currently single point discharging tailings near the northwest corner of the TSF. Prolonged discharge from this location has resulted in the supernatant pond migrating towards the Main and South Embankments where there is a lack of beach development. The beached tailings, when left to drain and consolidate, form the competent foundation required for the modified centerline construction embankment raises.

PHOTO 11 – Tailings Beach, From Main Embankment looking towards Perimeter Embankment.

It is recommended that MPMC adhere to the previous recommendations and develop a tailings management strategy that results in the MEMPR requirements for beach development along all of the embankments.

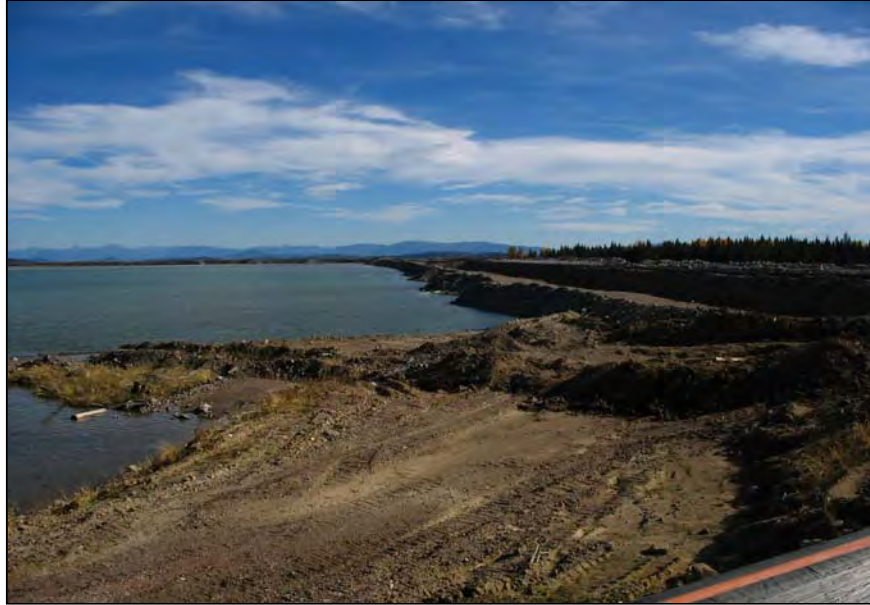
PHOTO 13 – South Embankment – Supernatant Pond adjacent to the dam
