MOUNT POLLEY MINING CORPORATION

MOUNT POLLEY MINE

TAILINGS STORAGE FACILITY 2012 ANNUAL REVIEW

PROJECT NO.: 1197001
DATE: April 8, 2013
DOCUMENT NO.: MP13-01

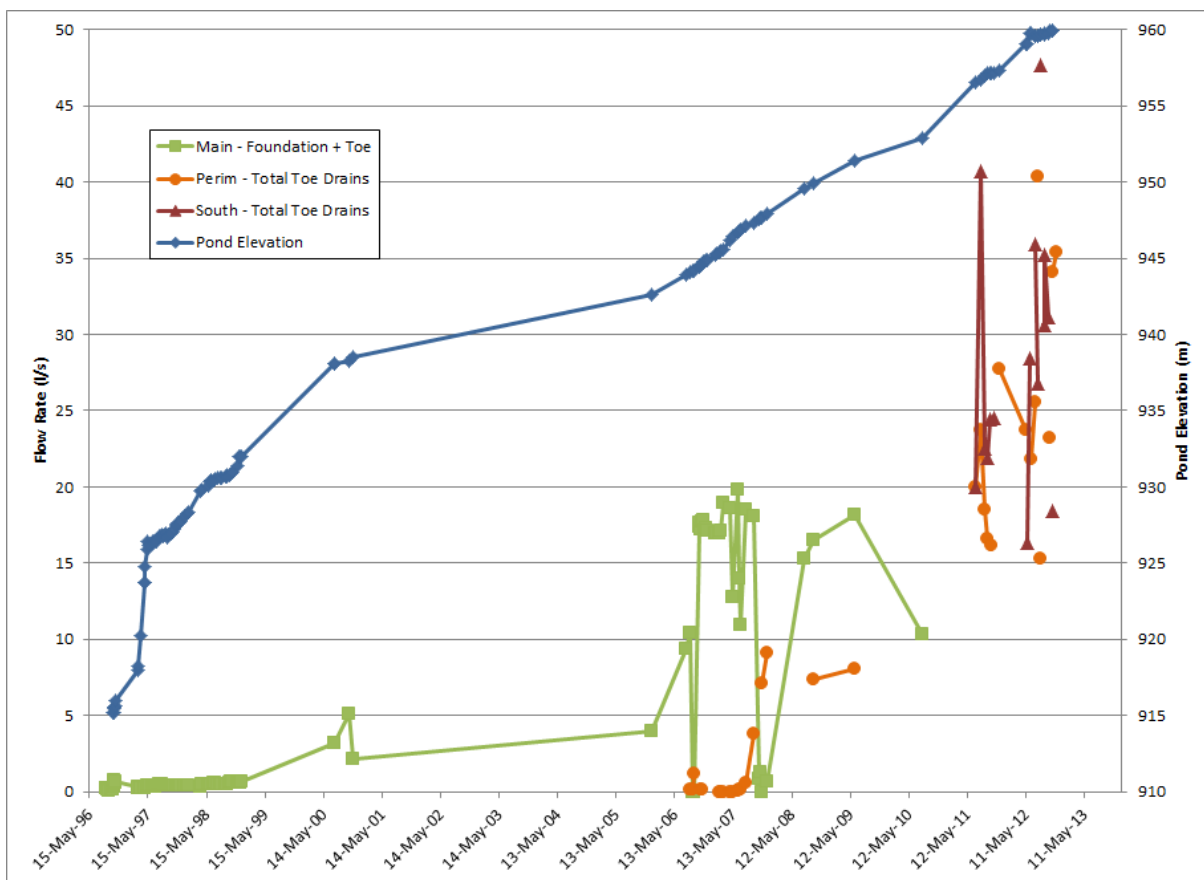
Figure 3-2. Drain Flow Readings.

widths, which are typically at a minimum immediately following the freshet, which is when spikes in drain flows are apparent. There appears to be a step increase in flow rate measured at the perimeter drain between 2009 and 2011, from approximately 8 l/s to ranging from 20 l/s to 50 l/s; this is likely in response to an increase in pond elevation.

There is no note of any turbidity observed in the drain water.

Measurement of drain flows into the Main Embankment seepage collection pond requires that the sediment control pond be pumped down to a low level to allow for safe entry into the sump. In 2011 and 2012, Main Embankment drain readings were not measured and MPMC was out of compliance with the OMS requirements. MPMC continues to work on revising the monitoring system in an attempt to capture drain flow readings in compliance with the OMS requirements. It is critical that this deficiency be rectified in 2013, as monitoring of drain flows is mandatory in terms of detecting changes in seepage conditions.

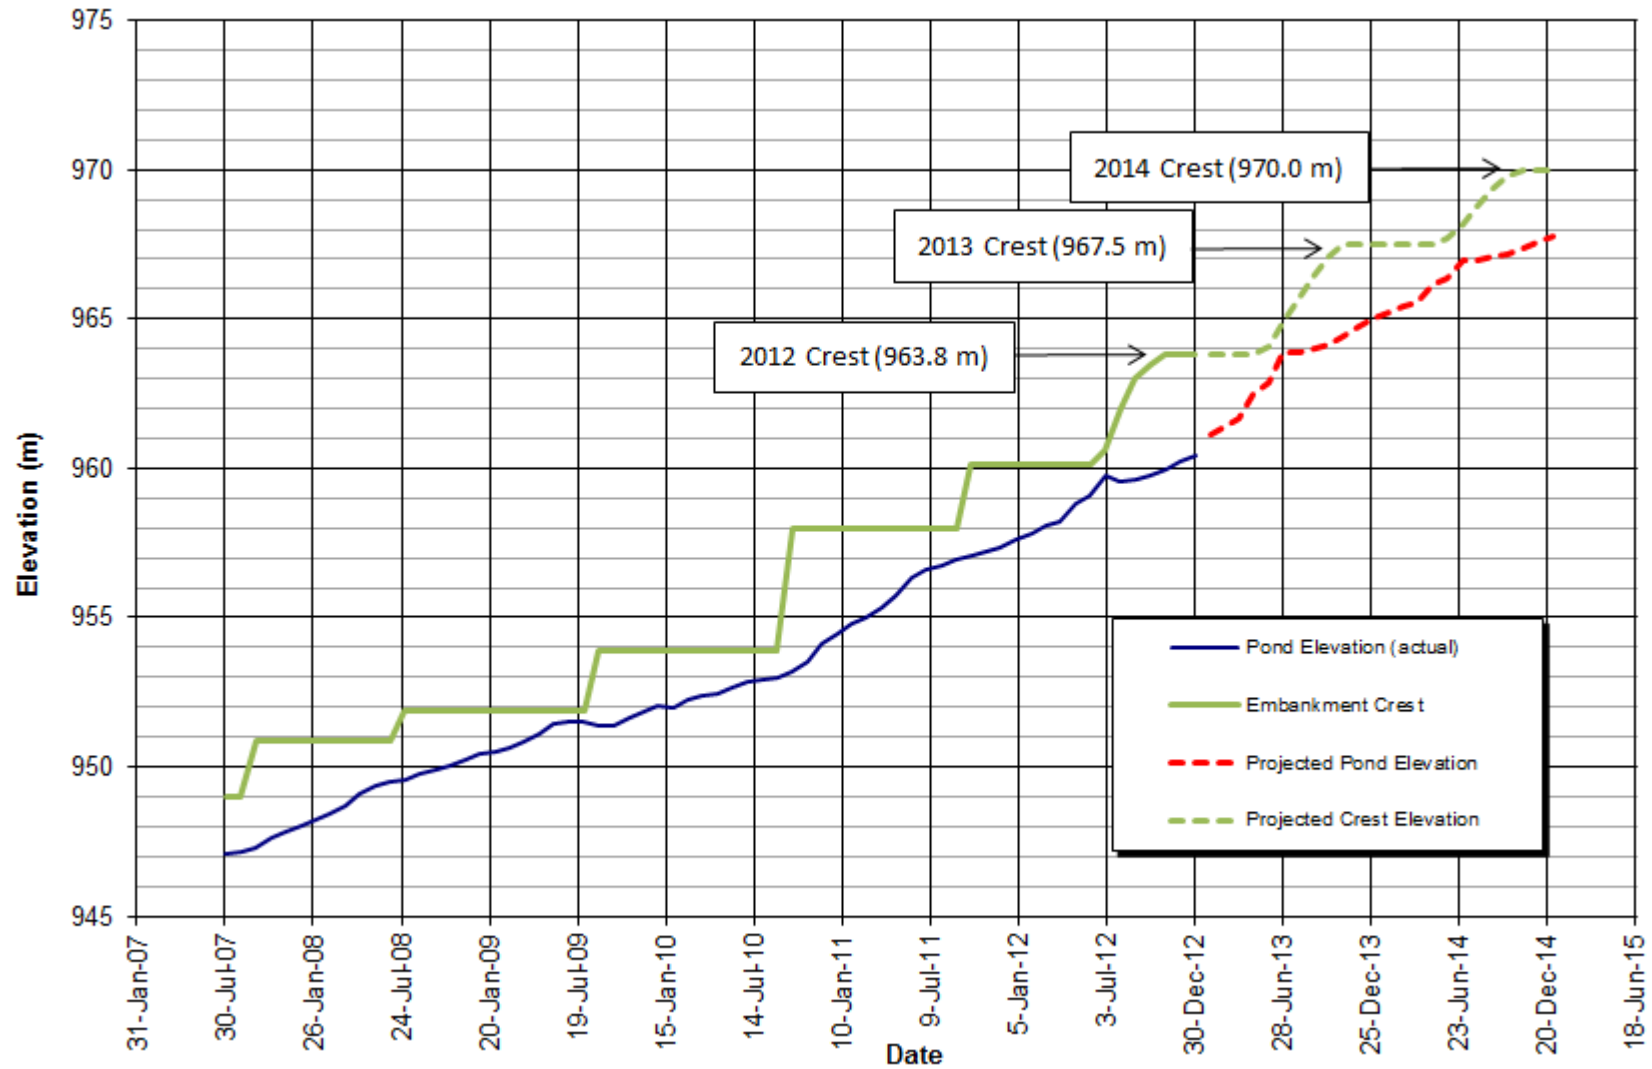
Figure 6-1. Impoundment Storage Elevation Curve.

The 2016 Mine Plan remains unchanged and forms the basis for future dam raises. The TSF embankment is reaching the final crest elevation (El. 970 m) considered in the original design. Should additional capacity be needed for future mine expansion, additional design will need to be completed to raise the impoundment beyond El. 970 m.

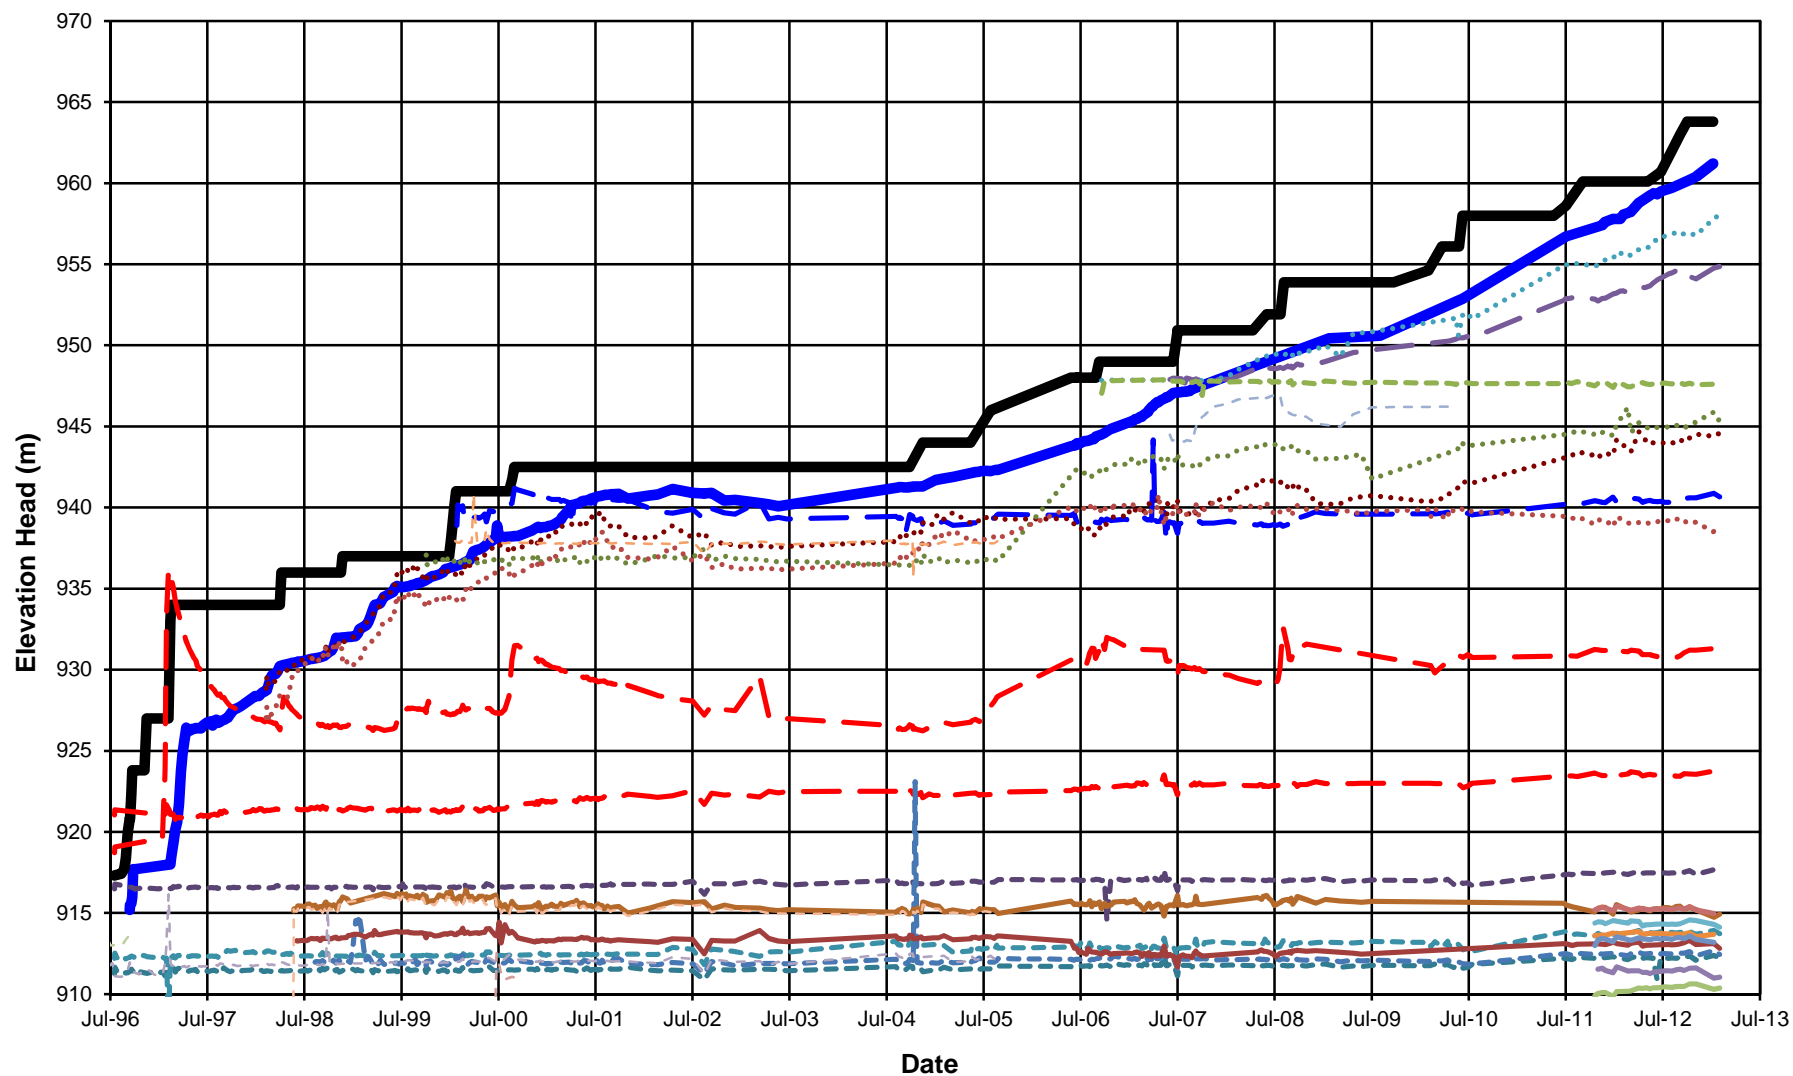
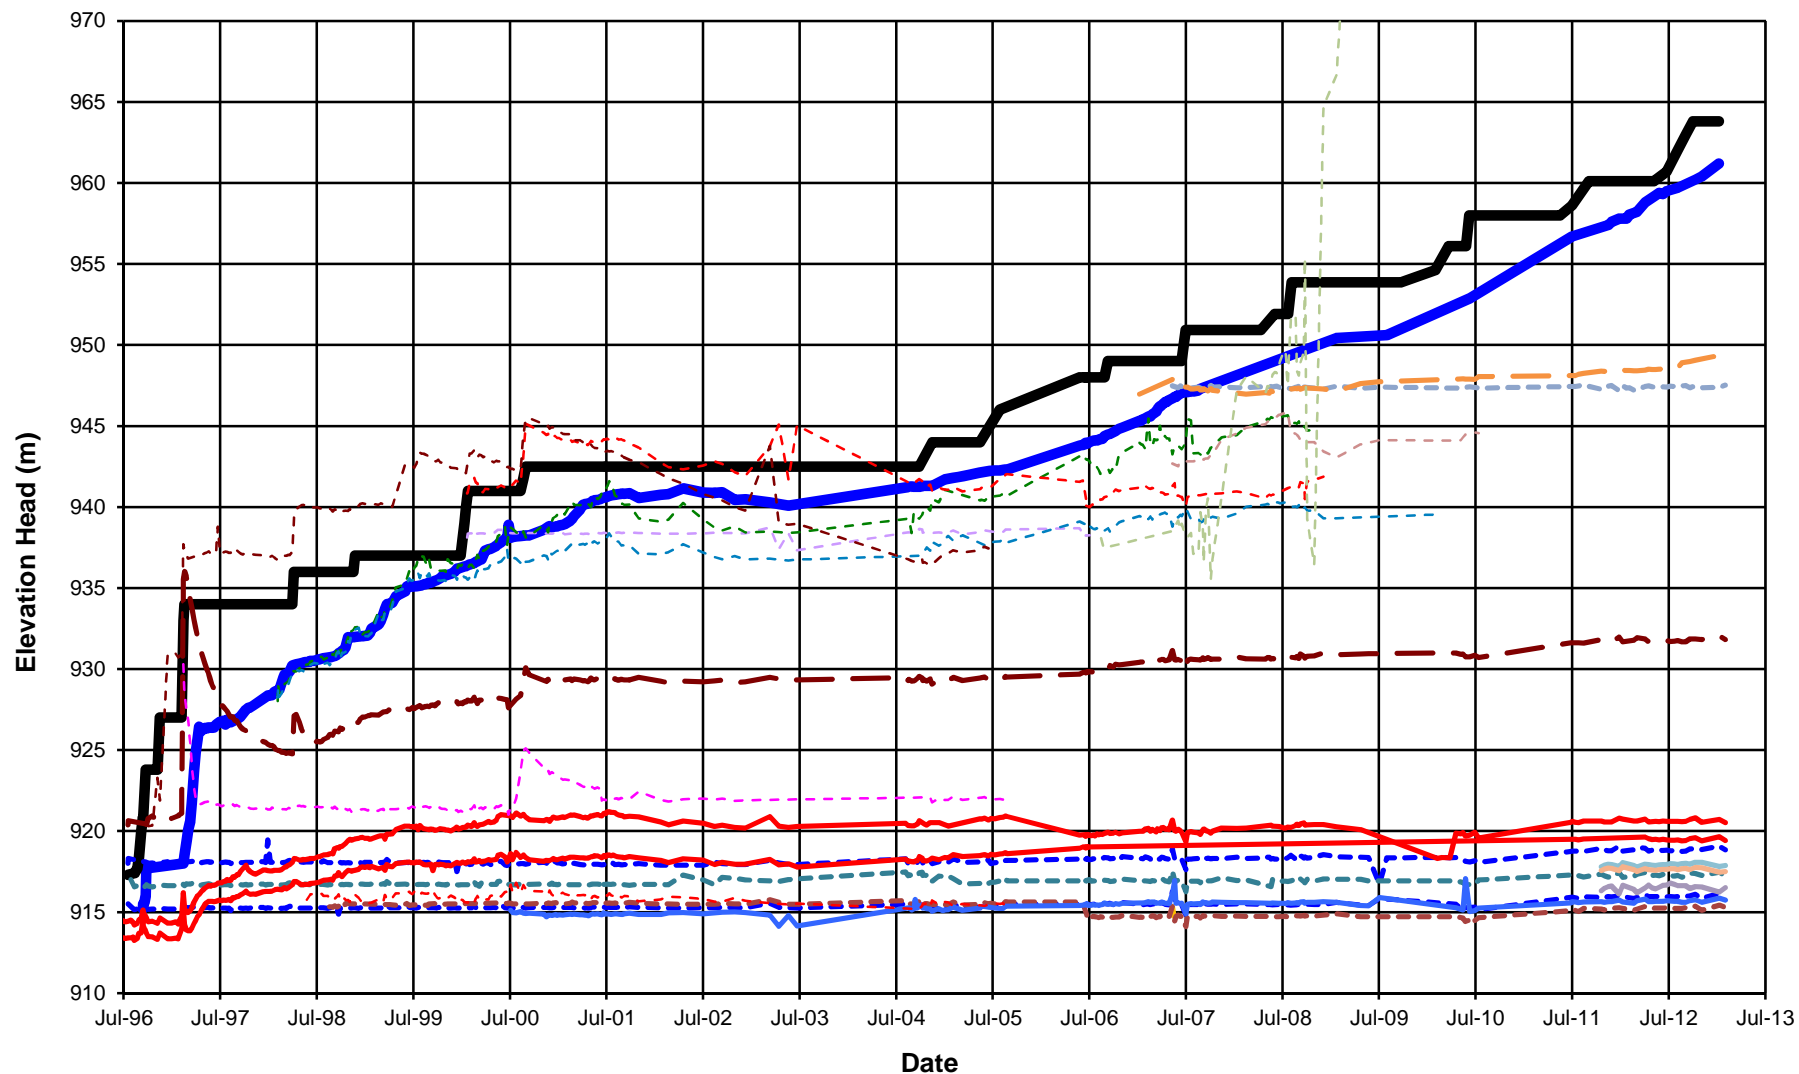
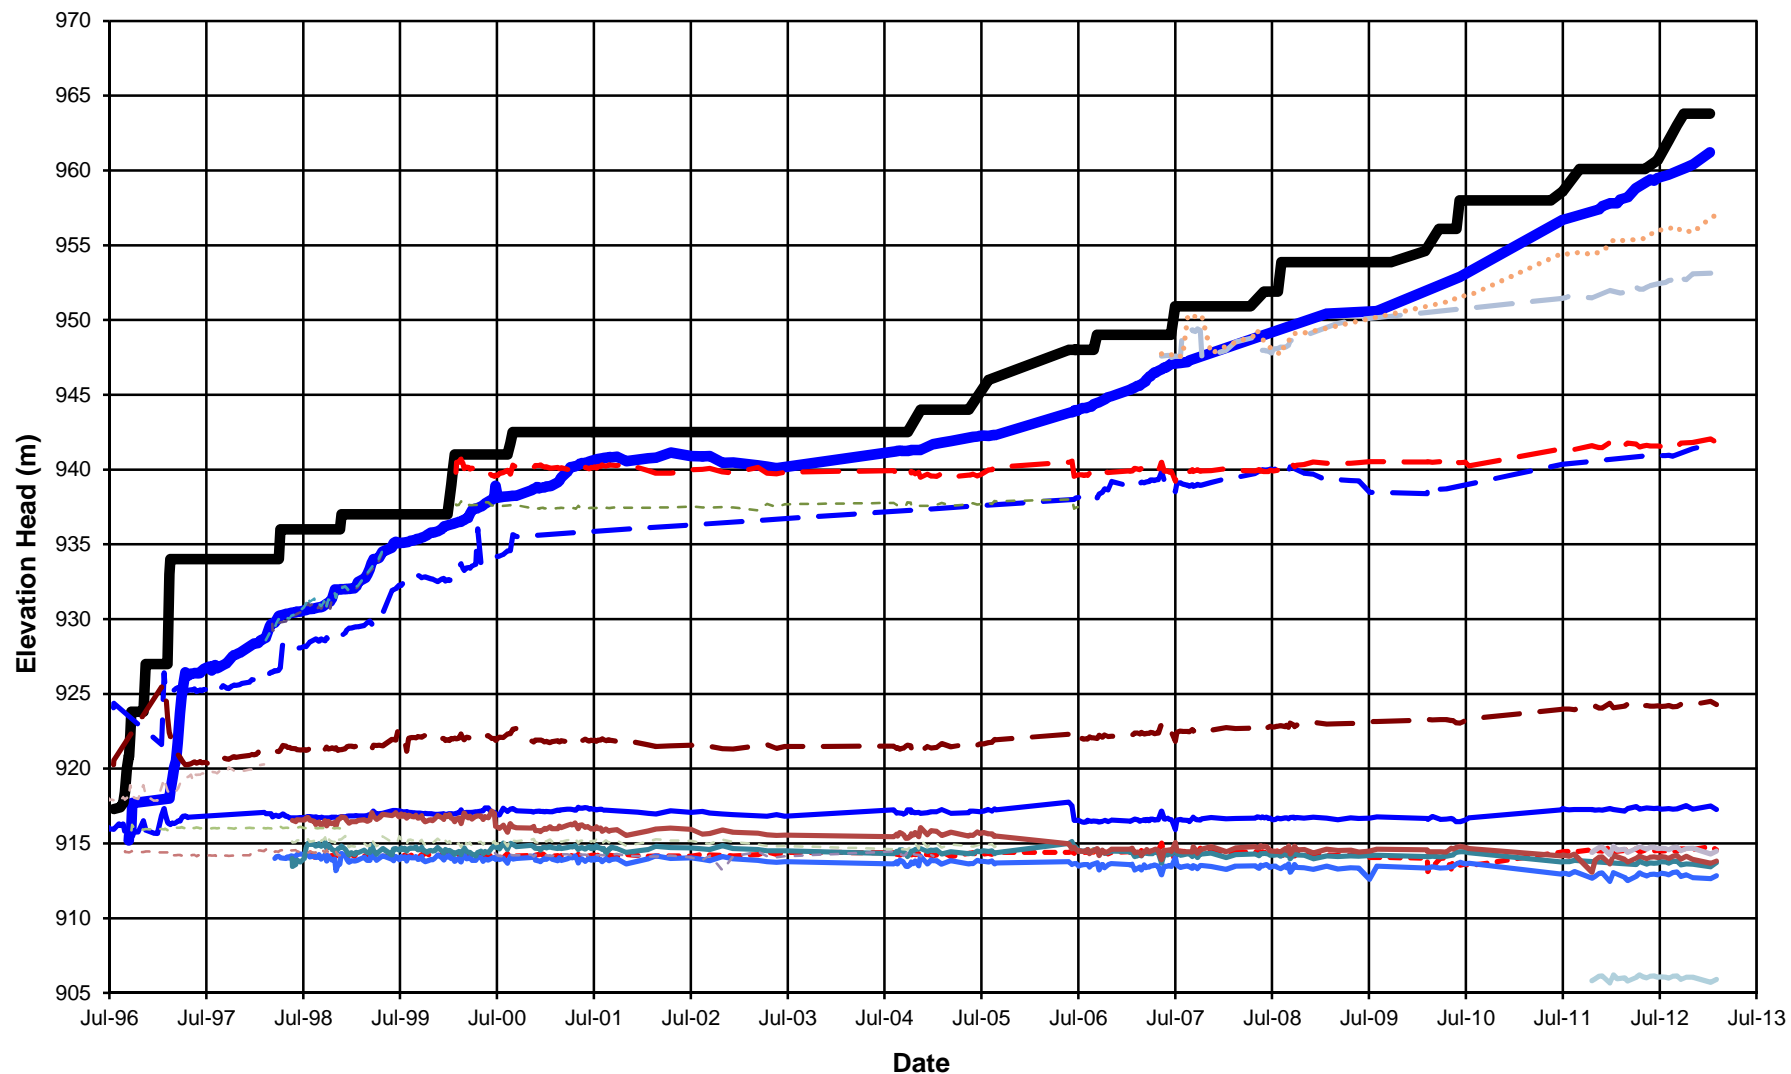
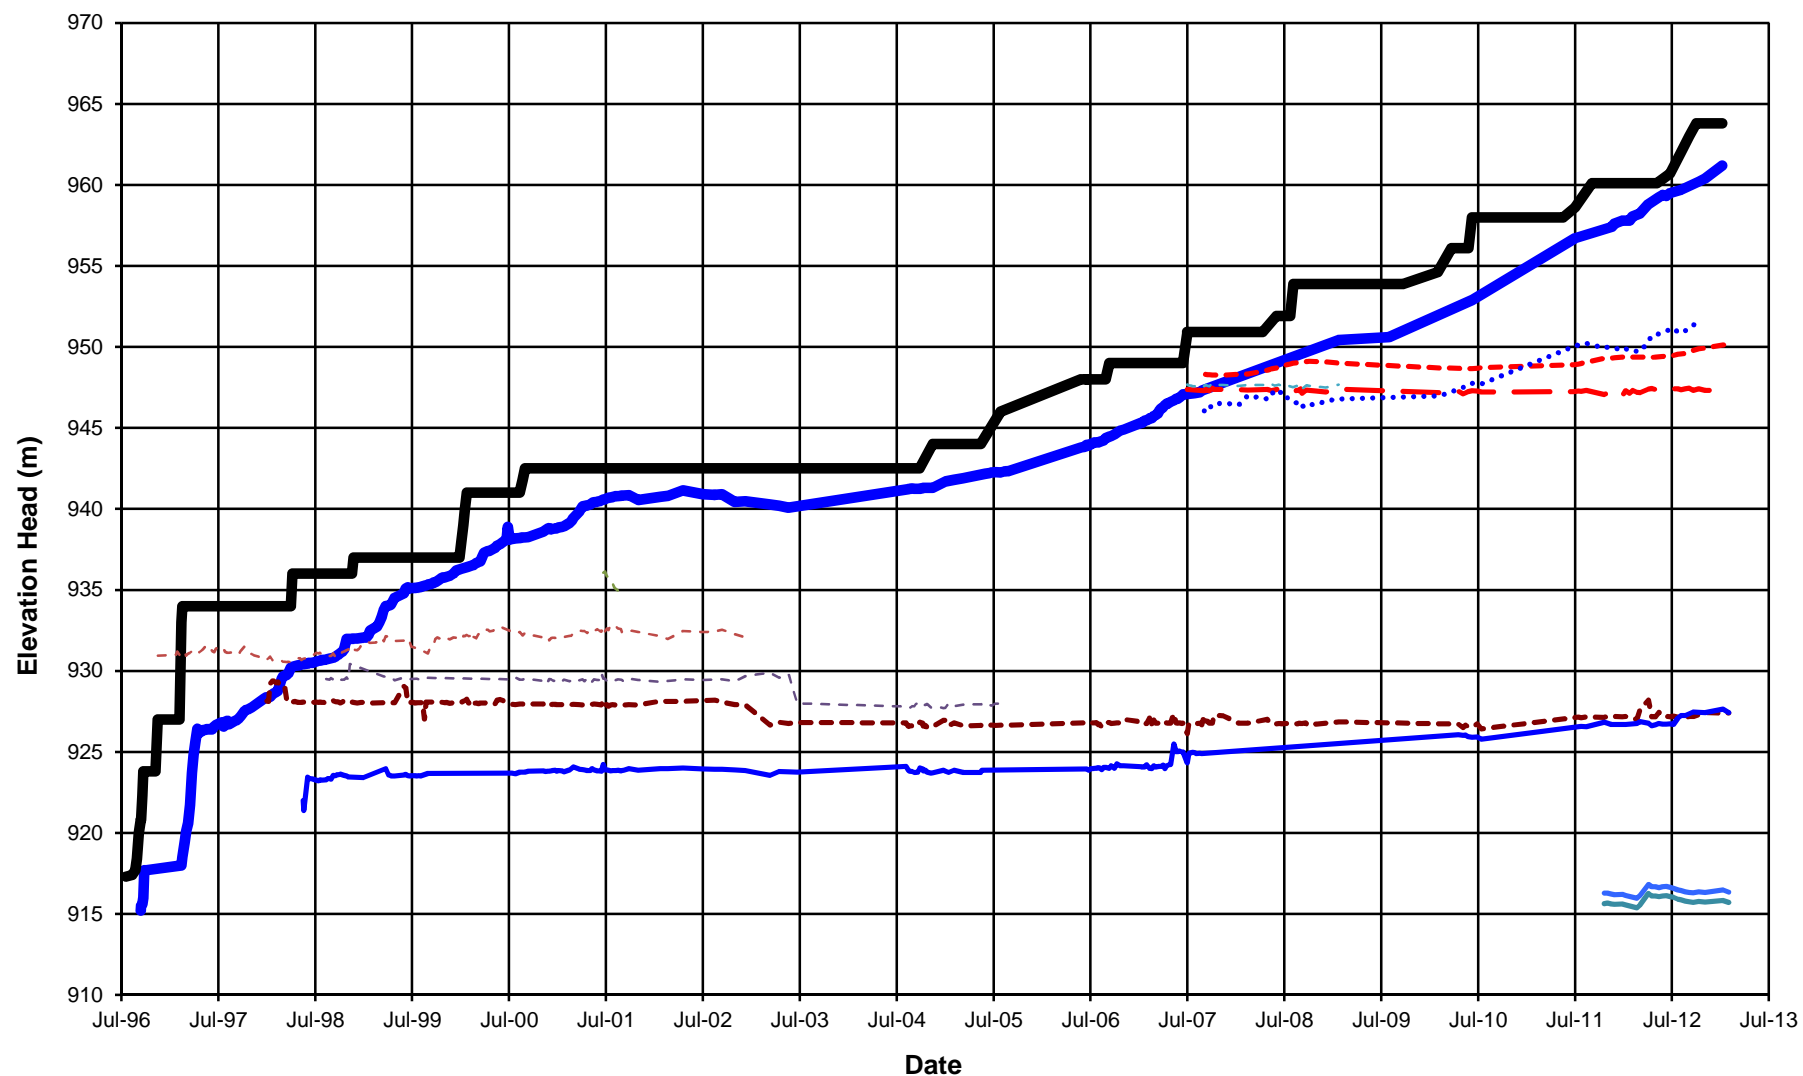
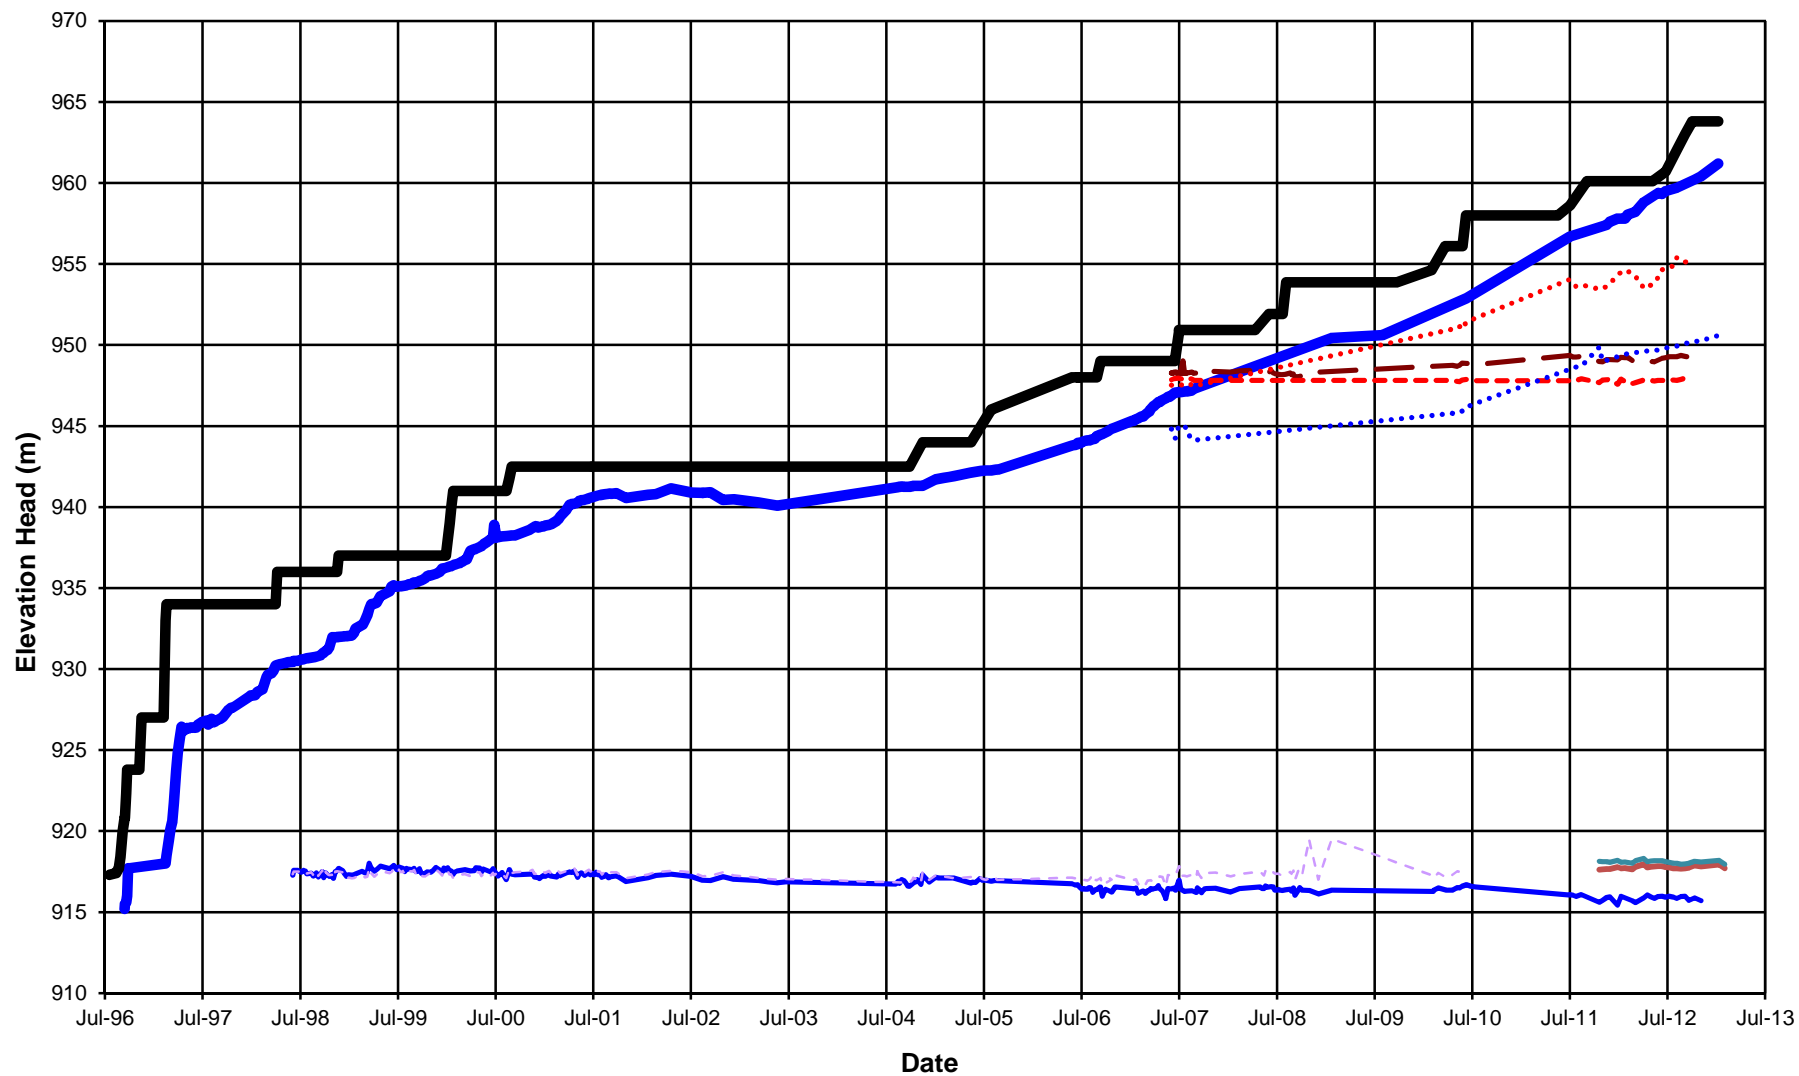
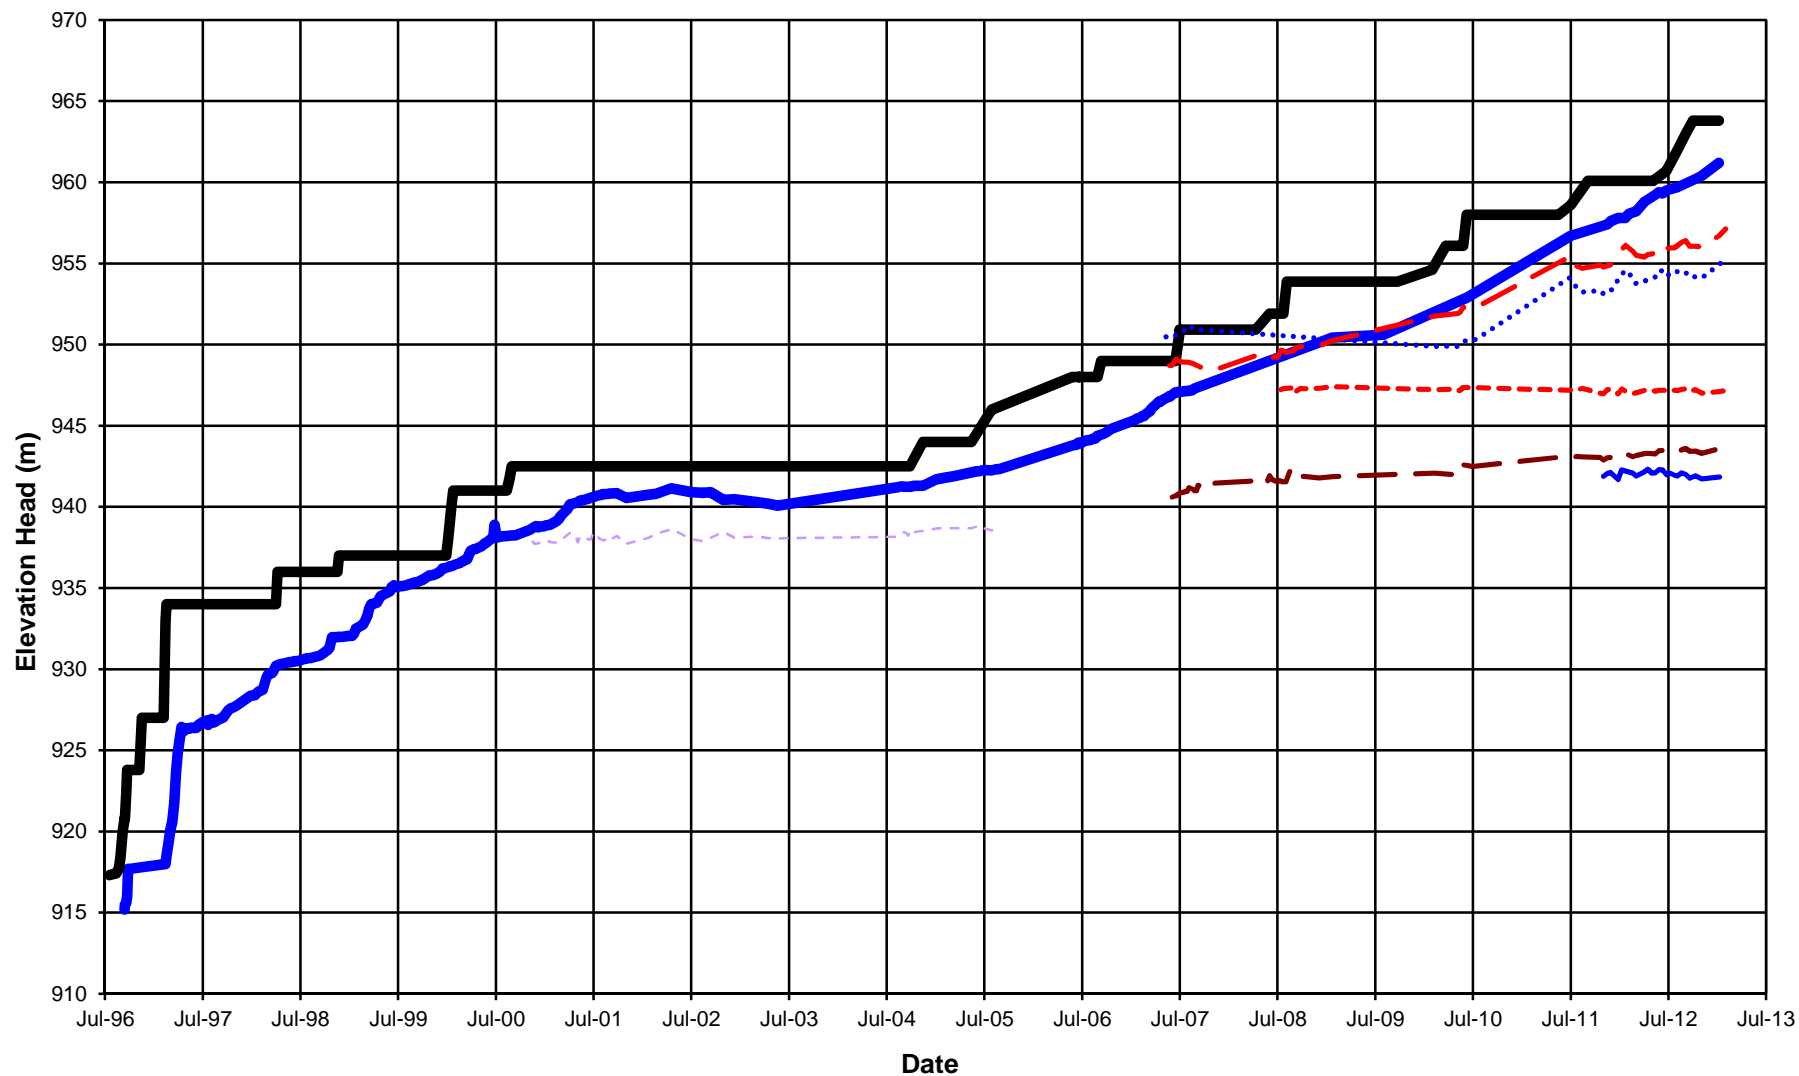
MOUNT POLLEY MINING CORPORATION		
MOUNT POLLEY MINE		
TAILINGS STORAGE FACILITY PLANE A PIEZOMETERS ELEVATION vs. TIME		
BGC ENGINEERING INC. AN APPLIED EARTH SCIENCES COMPANY	PROJECT NO. 1197-001	Date. MAR 2013
	REV. FIGURE D-1

All foundation piezometers remained within the "green" zone through 2012.

- Pore pressures in foundation soils in and around the TSF embankment were noted as stable with minor fluctuations. All foundation piezometric levels remained within the green limits given in Table 5-3.

- Pore pressures in the till core were found to be stable, with a slightly increasing trend in response to the rising pond level, and also possibly with some slight response to crest raising.
- Pore pressures in filter and drain zones remained unchanged throughout the year.
- Pore pressures in the tailings and upstream fill experienced an upward trend in response to the rising pond level. Piezometers installed at lower elevations within the upstream tailings experienced lower responses relative to the piezometers near the pond elevation, likely the result of proximity to the upstream under-drainage system, and indicative of continued downward gradients in the tailings as a result of the upstream drains.

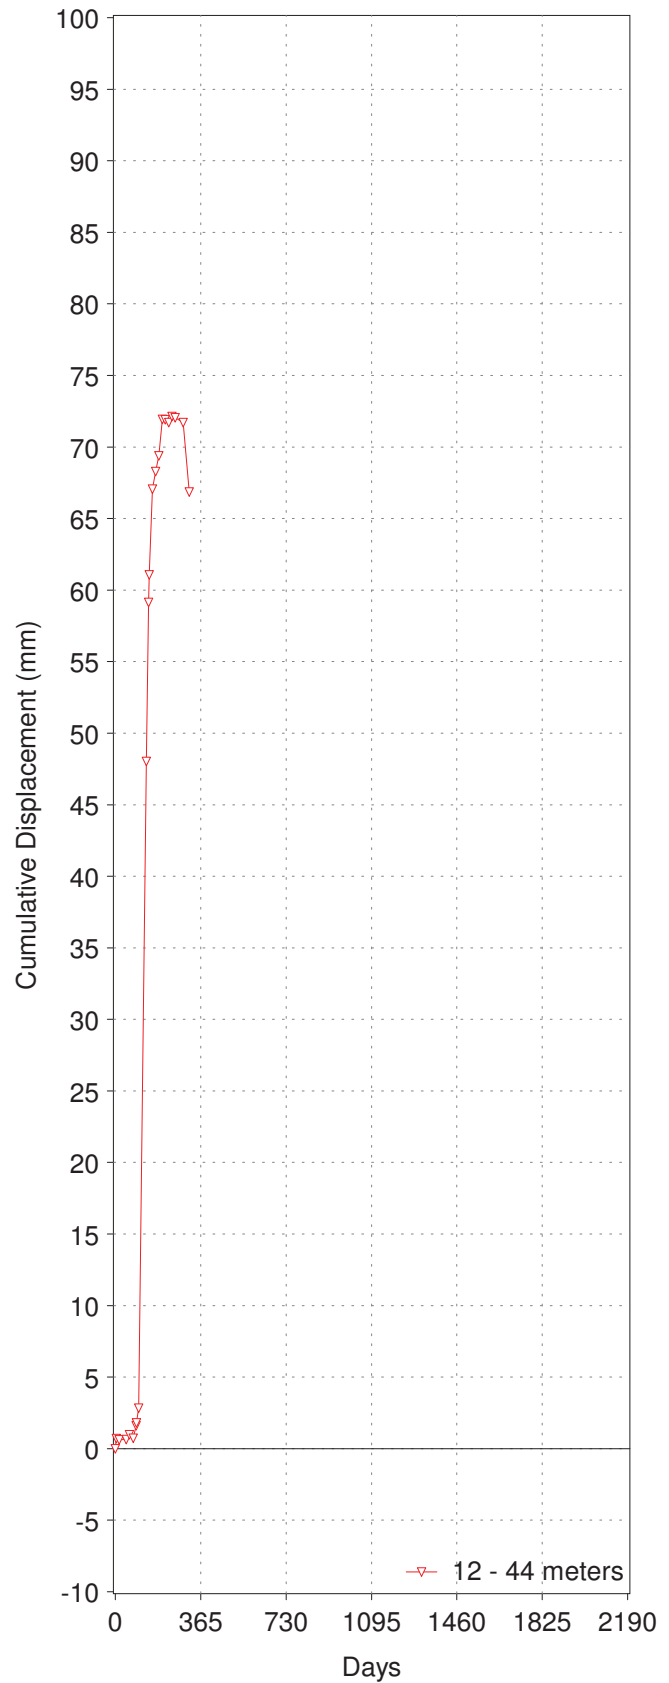
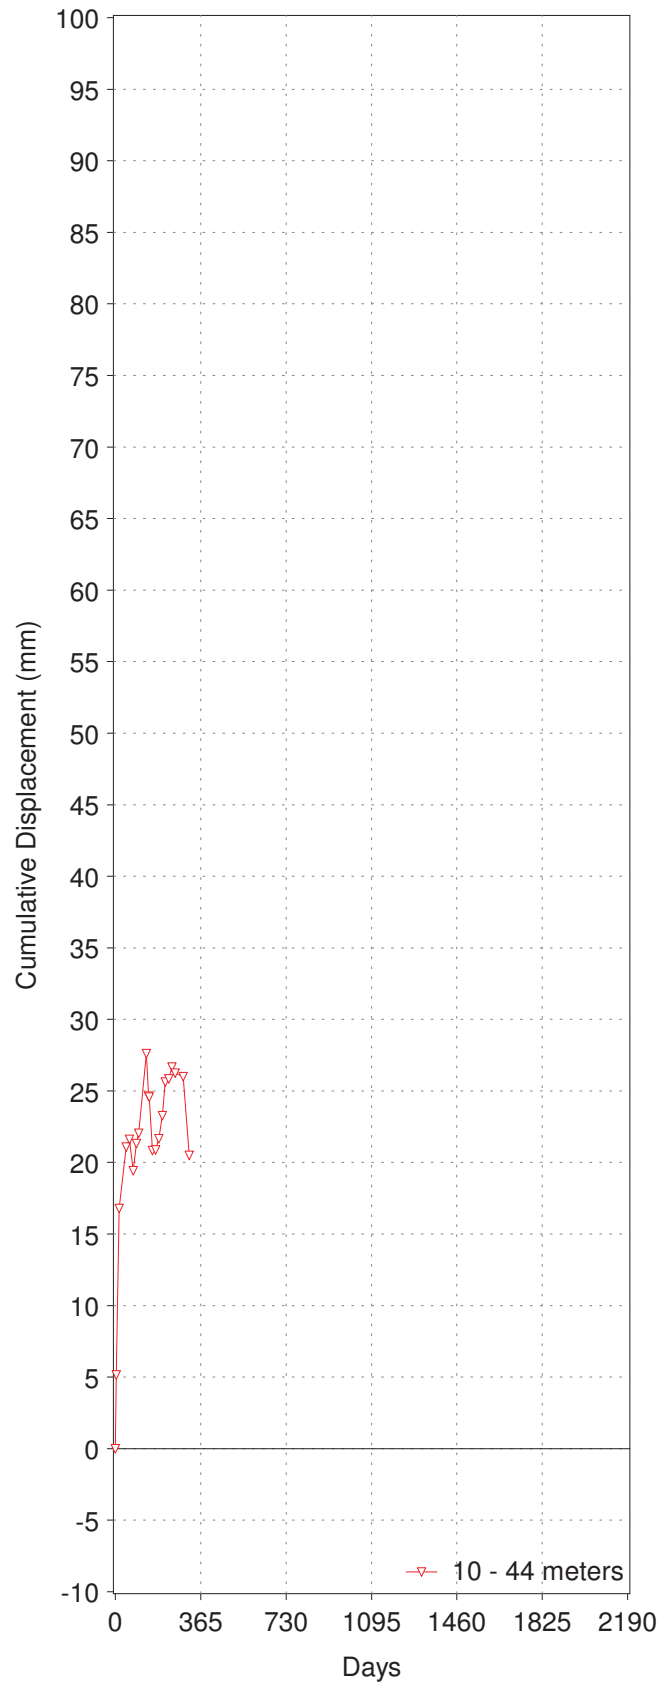
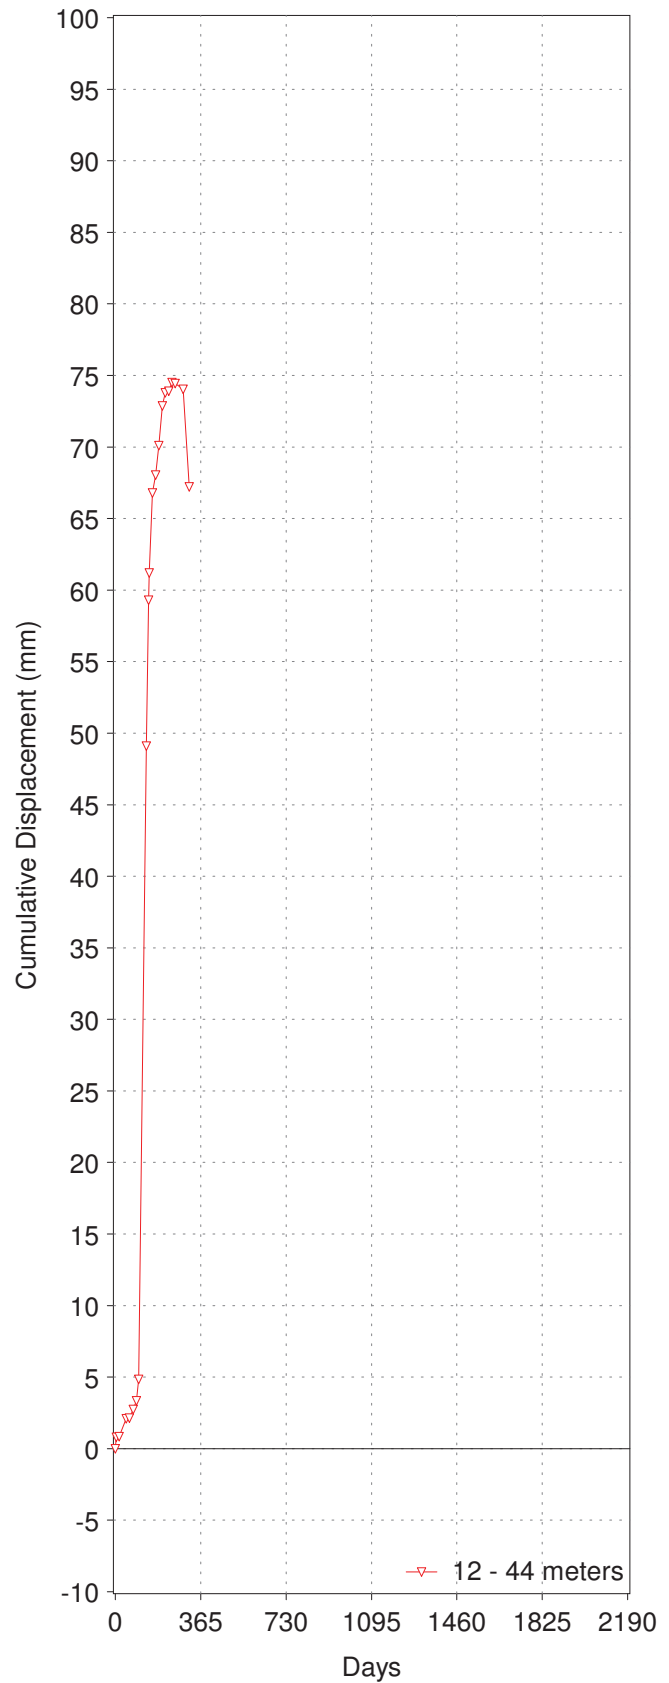
Mt. Polley
Cumulative & Time Displacement
SI11-04 A-Axis

SI11-04 has to date indicated an anomalous pattern of displacement suggestive of compression rather than net lateral displacement, although a faulty installation could be a contributor to the displacement pattern indicated. This slope inclinometer should be reinitialized when the compression displacement stabilizes. A replacement inclinometer was installed nearby in 2012, given concern that SI11-04 might soon become inoperative.
