Independent Expert Engineering Investigation and Review Panel

**Report on Mount Polley
Tailings Storage Facility Breach**

Appendix C: Surface Investigations

January 30, 2015

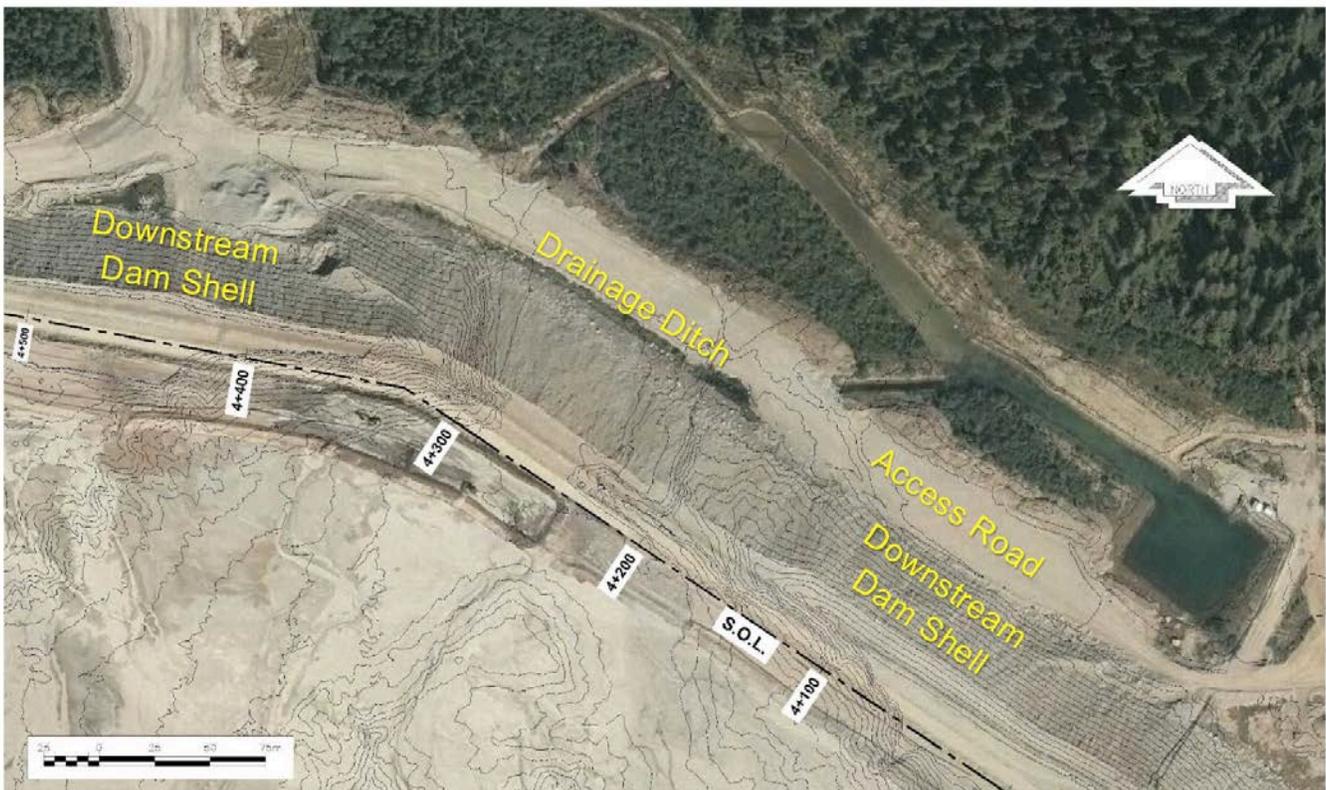
Figure C3.1.1 shows the pre-breach orthophoto taken on August 21, 2013 and the superimposed post-breach contour lines that identify the area of the breach. The S.O.L. line shown on the figure is the “Setting Out Line,” the reference line established for surveying and dimensioning of the dam. The chainage along the S.O.L. increases from east to west in the area of the breach. The till core of the dam is located near the S.O.L. A drainage ditch can be observed at the toe of the downstream shell of the dam.

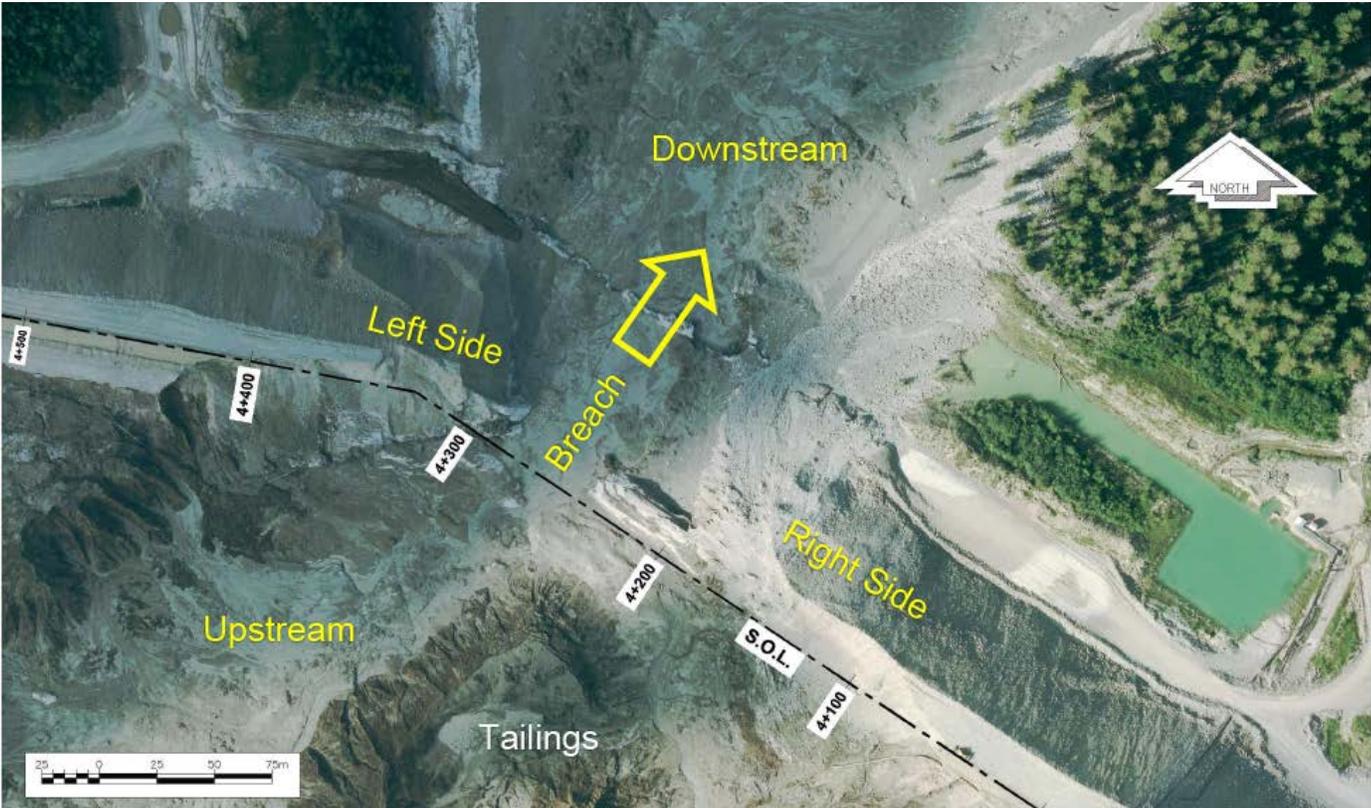
Figure C3.1.2 is a post-breach orthophoto showing the general configuration and conventions used in the breach area. This figure can be compared to Figure C3.1.1 to identify the areas impacted by the breach. The remaining sections of the dam on the left and right side are referred to as the respective “abutments” of the breach.

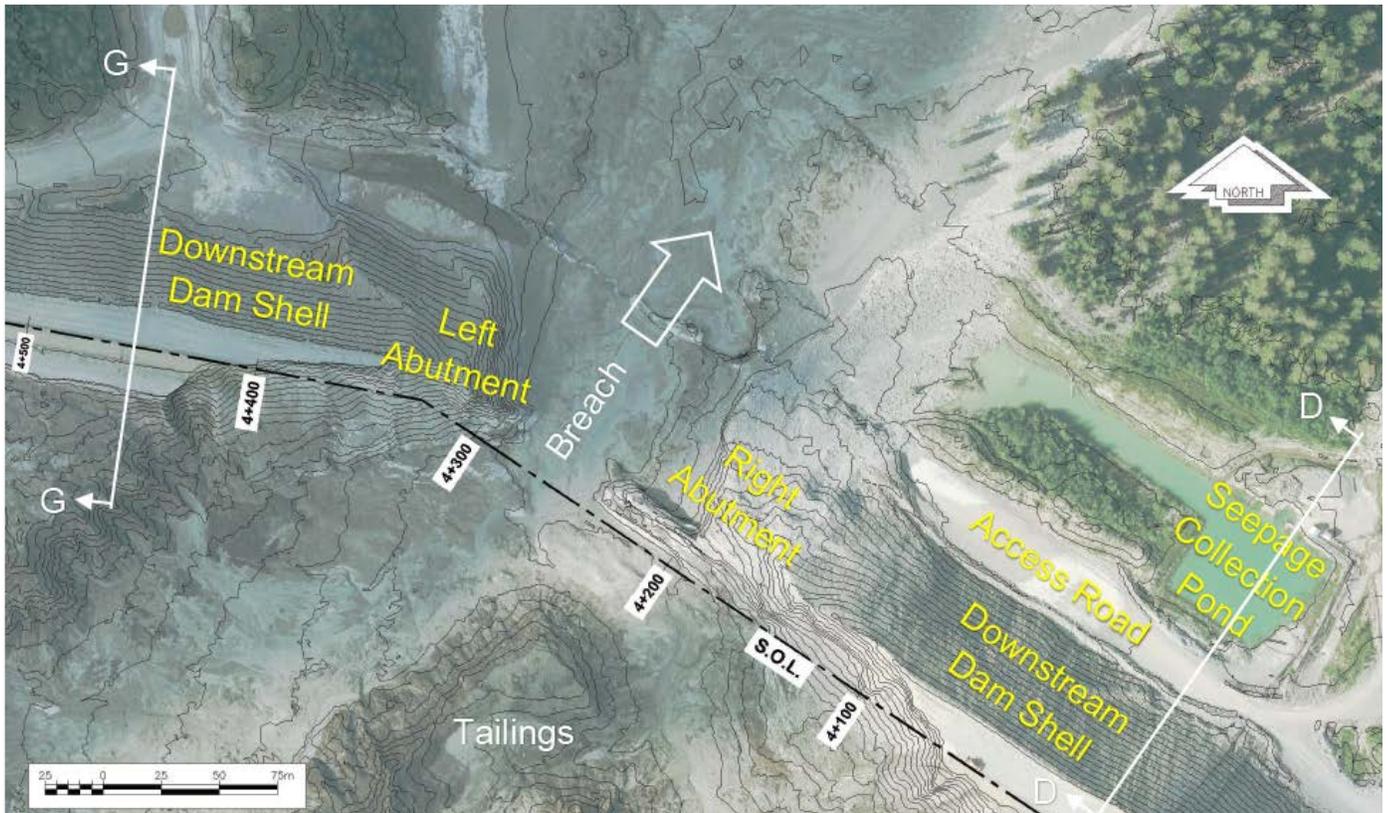
Figure C3.1.3 is a post-breach contour plan showing the topographical features of the breach area. The dam is about 40 m high on the downstream side adjacent to the breach. The Zone C rockfill downstream shell of the dam is indicated on the figure. The existing slope angle of the downstream shell is about 37°, or 1.3 horizontal to 1.0 vertical. Note that the dam alignment changes at the left abutment of the breach at the point known as “Corner 1”.

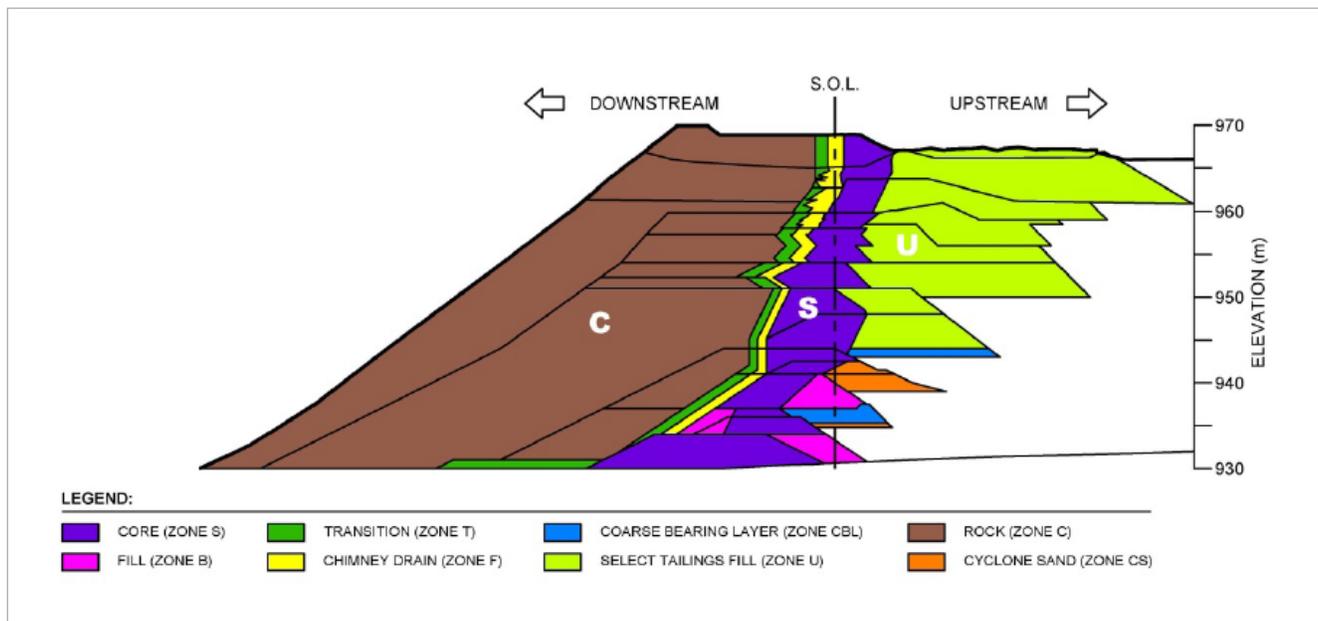
Figure C3.1.4 is an interpreted composite cross-section through the dam in the area of the breach. The black lines in the figure delineate the various stages of dam construction.

The figure combines the internal dam configurations at design Sections D and G to better represent conditions at the breach. At Section D, a downstream trial zone of cyclone sand was placed in the lower portion of the embankment during Stage 2C. This zone did not extend to the breach area. Accordingly, the composite section used as-built information from Section G for raises up to Stage 6B (approximate elevation 958 m), with as-built details above this elevation from Section D.

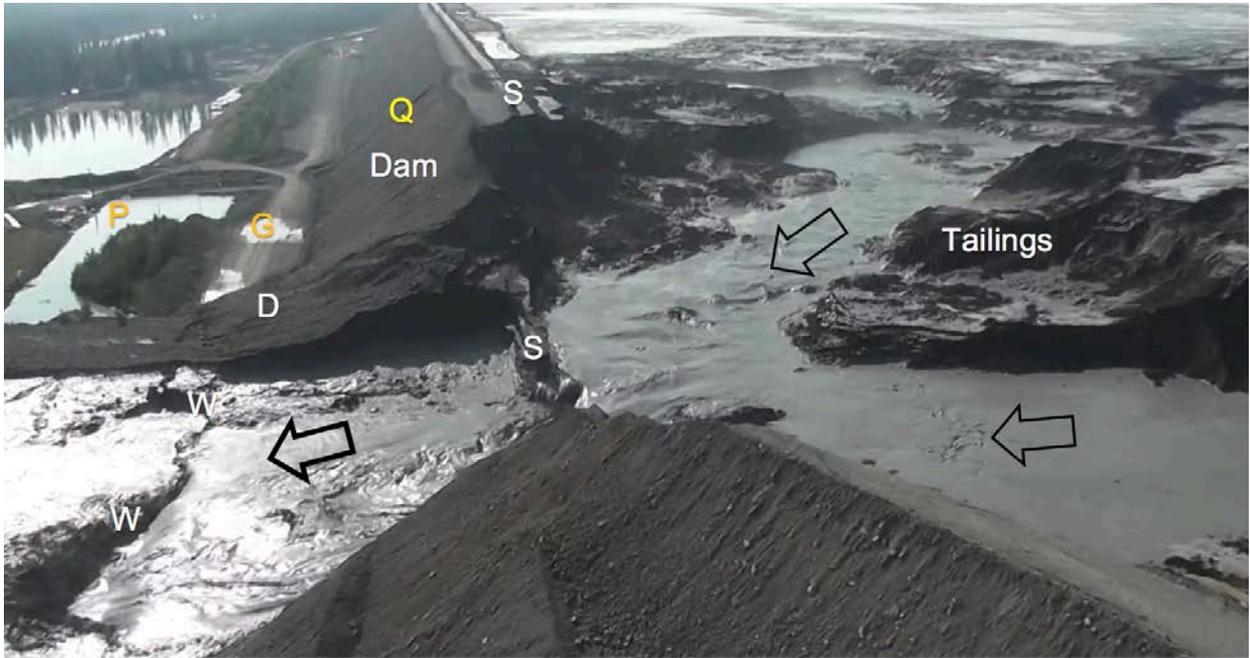
Figure C3.3.2 is a view looking across the breach at the right abutment. The photo shows a different perspective of the section of remnant core (S) that survived the breach, the displaced right embankment shell (D) and the linear whaleback (W). The photo also shows the Perimeter Embankment seepage collection pond (P) at center-left and its return-water pipeline (Q). Pounded water (G) in a low area on the access road at the toe of the dam was not present during later inspections and is believed to be from rainfall that preceded the breach. Also shown is the confluence of the two well-developed flow channels at the upstream entry to the breach.

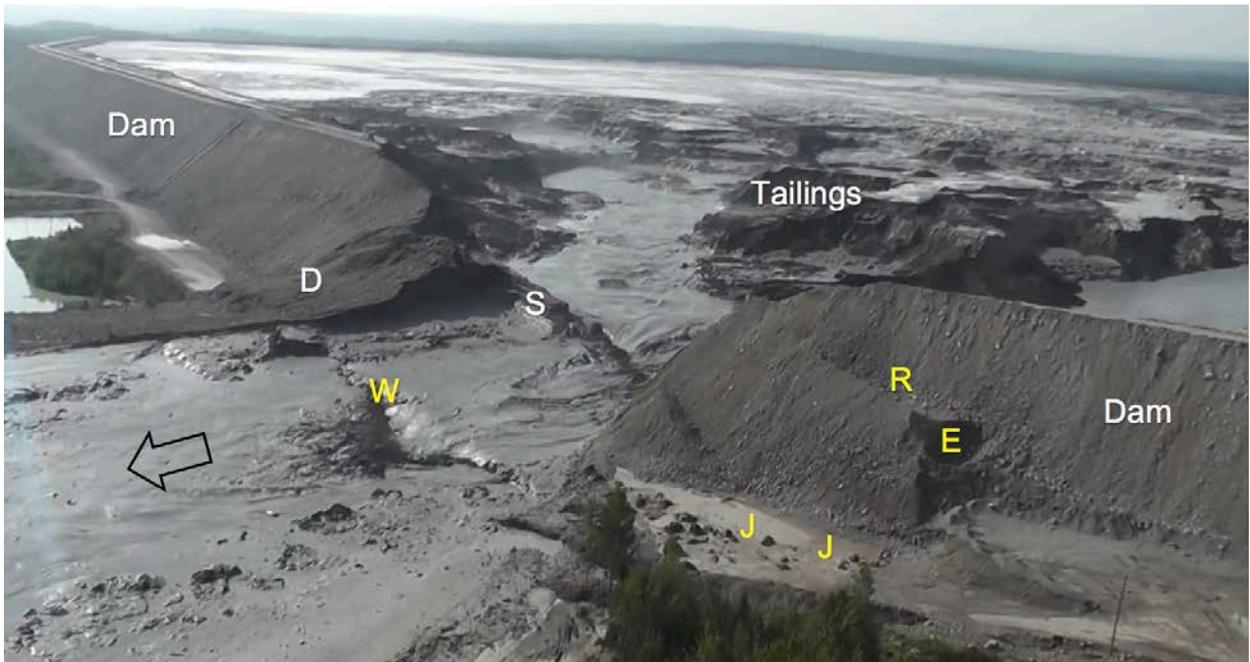
Figure C3.3.3 is an oblique view across the breach showing the flow of water and tailings. The whaleback (W) acts as the control section for downstream flow, with a visible hydraulic jump as water passes over it. A haul road ramp (R) was formerly used to gain access to the dam crest. Fill from this ramp had been salvaged for use elsewhere in dam construction, leaving the steep escarpment on the downstream slope and a circular excavated pit (E). Below this pit is a flat area where Zone F filter material had formerly been stockpiled. A series of large till blocks (J) believed to be pieces of eroded core material have been deposited on the access road during a period of higher breach flow.

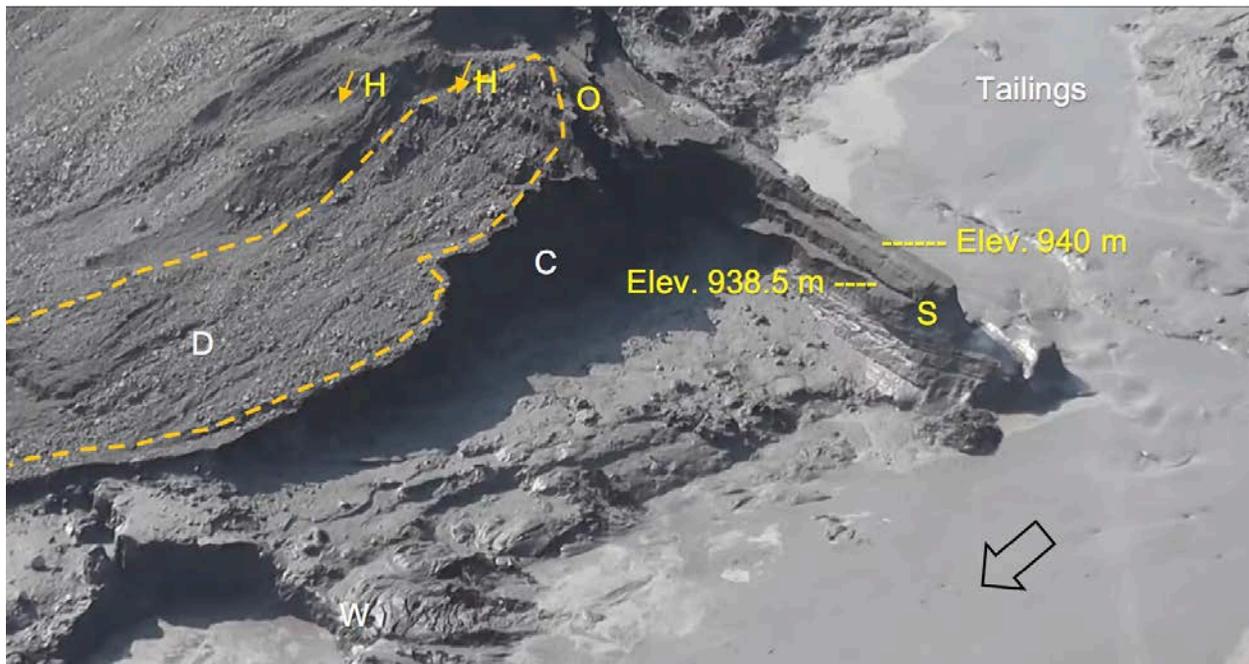
FIGURE C3.3.4: VIEW OF RIGHT ABUTMENT OF BREACH WITH SCARPS AND CRACKING (CARIBOO VIDEO AT 35:51)

Figure C3.3.4 shows the right abutment looking south and illustrates the sub-horizontal layering of the remnant till core (S). The crest of the remnant core is at about El. 940 m with a sub-horizontal bench on the downstream side at El. 938.5 m, corresponding approximately to the crest elevations of Stages 2C and 2B respectively. Another prominent sub-horizontal bench on the upstream side (not visible in the photo) is at approximate elevation El. 934 m corresponding to the crest of Stage 1B. A dip angle of 9° upstream was measured near the base of the remnant core. This section of remnant core was subsequently excavated and mapped and is described in section 3.7 of this Appendix.

The dashed line in **Figure C3.3.4** delineates an erosional surface produced by overflow on the displaced slope (D) during breach development. A layer of water-deposited tailings covers the relatively level bench at the base of the escarpment (C). A series of headscarps (H) were observed in the area of slide movement on the right abutment. Numerous open cracks can be observed at the crest of the slope in this area (O).

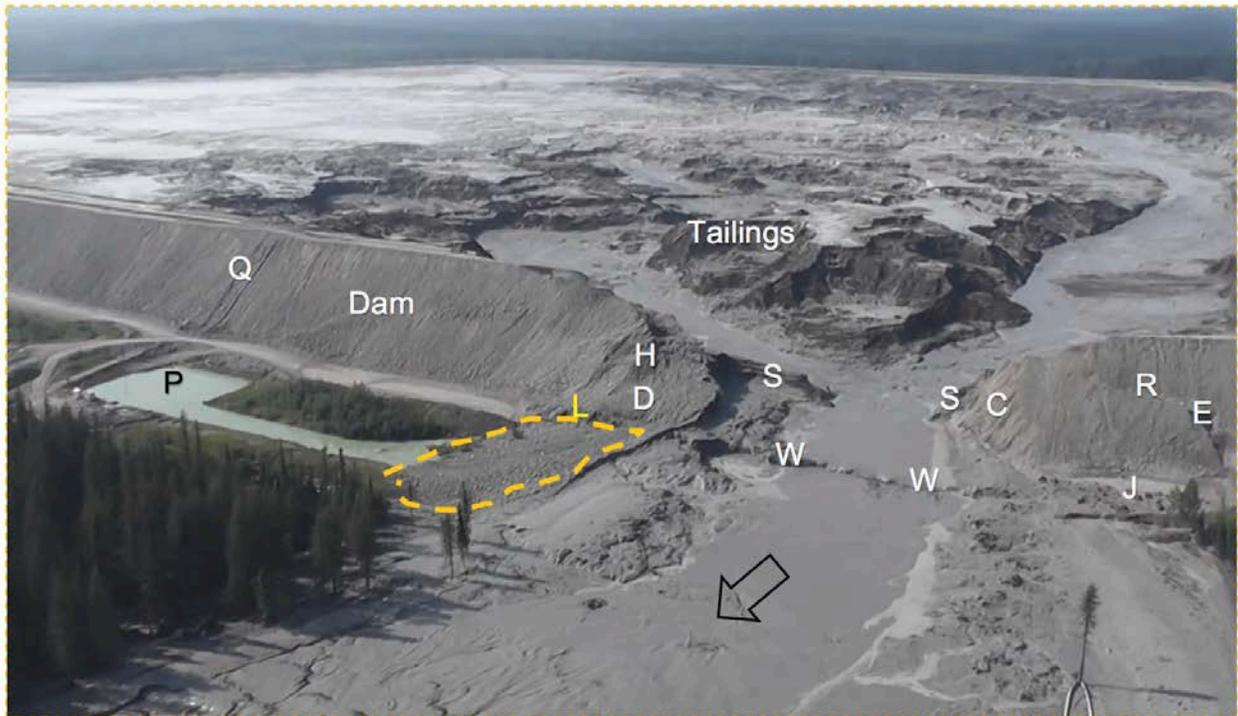
Figure C3.3.5 is a view looking upstream through the breach into the tailings facility. It shows toe bulging and translation displacement on the right abutment where rockfill material covers the access road. Large blocks of dense to compact, intact foundation till (up to 2.5 m high) containing organics and topsoil were observed at Location L. These blocks show evidence of having been upthrust into the displaced rockfill during the ground movement at the right abutment. The depositional area for eroded rockfill is indicated by the dashed line.

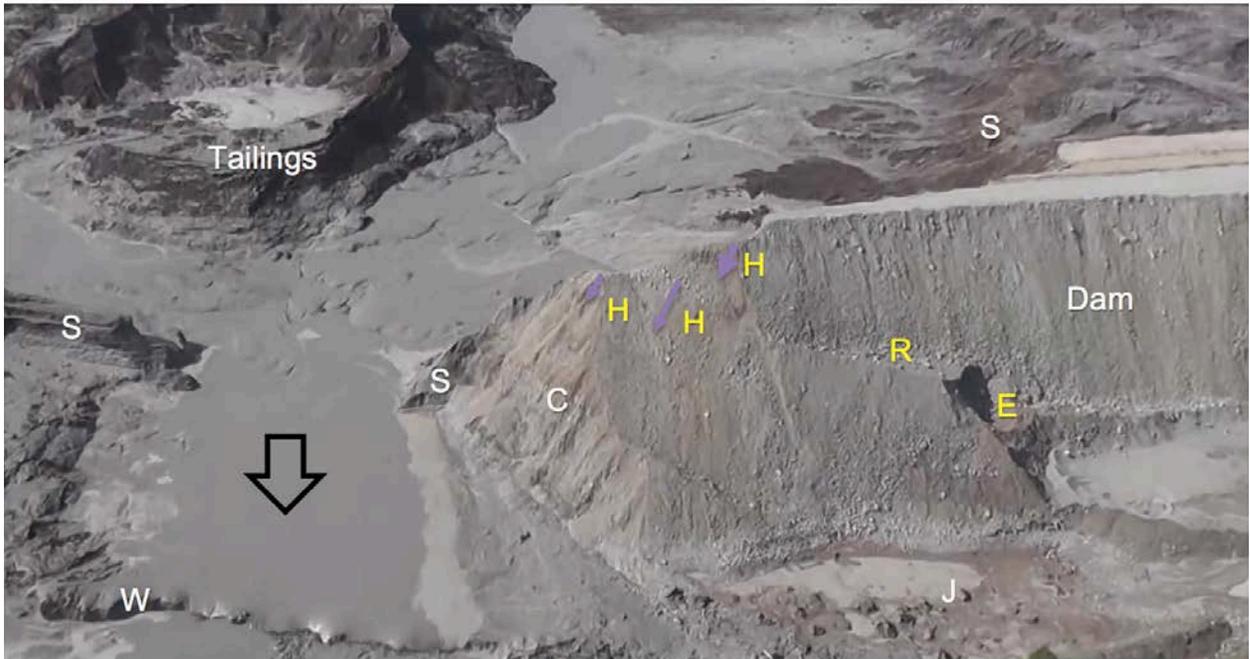
Figure C3.3.6 is a view of the left abutment looking upstream. The photo shows the sub-horizontal layering of the the left abutment rockfill shell at C, with beds dipping about 7° to 10° upstream. Also indicated are the circular excavated pit (E), the former haul road ramp (R), and the flat area below used for storing granular filter material.

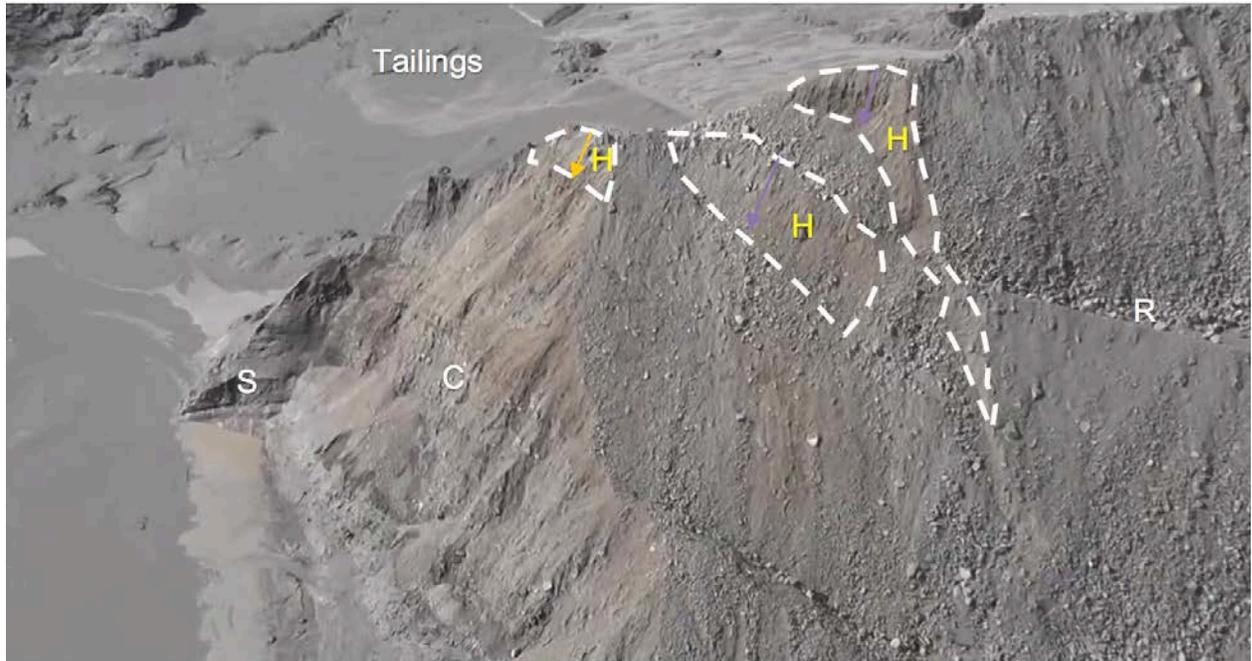
Figure C3.3.7 is a more detailed view of the left abutment en echelon scarps (H) and the dipping beds of the rock fill shell (C). The consistent measured bedding angles between 7° and 10° upstream indicate fairly uniform rotation of the left abutment prior to formation of the downdrop scarps.

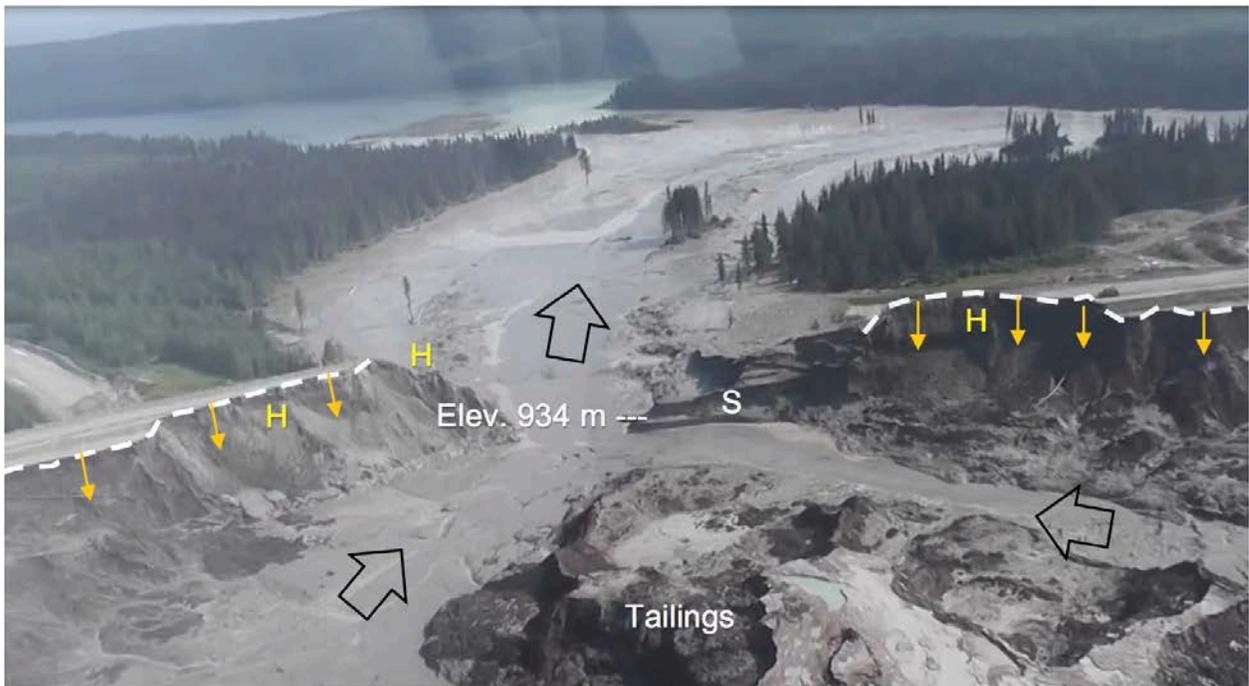
Figure C3.3.8, looking downstream through the breach area, shows the exposed upstream portion of the dam. It illustrates the large lateral extent of upstream collapse due to removal of tailings supporting the dam core. In some areas, the dashed line indicating the crest of the head scarps (H) extends downstream of the till core (S) and into the downstream slope.

The photo also shows the upstream sub-horizontal bench of till core located on the right abutment at approximate elevation El. 934 m. The en echelon scarps (H) located high on the left abutment indicating subsidiary movement into the eroded breach area can also be observed.

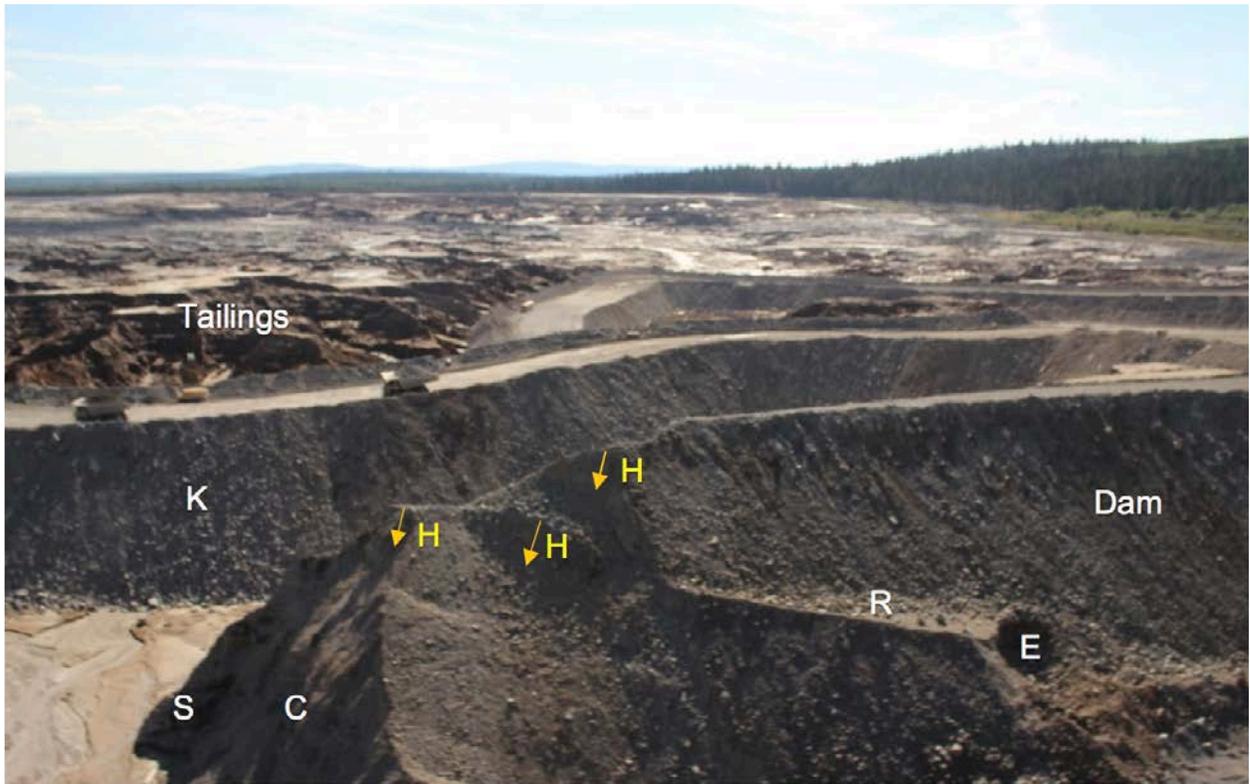
Figure C3.5.2 is a view looking upstream (south) across the left abutment of the breach. The photo shows the en echelon headscarps (H), the new rockfill dike (K), the former haul road access ramp (R,) and the excavated circular pit (E). This photo provides good definition of the large fill block bounded by the headscarps that dropped down into the breach subsequent to its rotation.

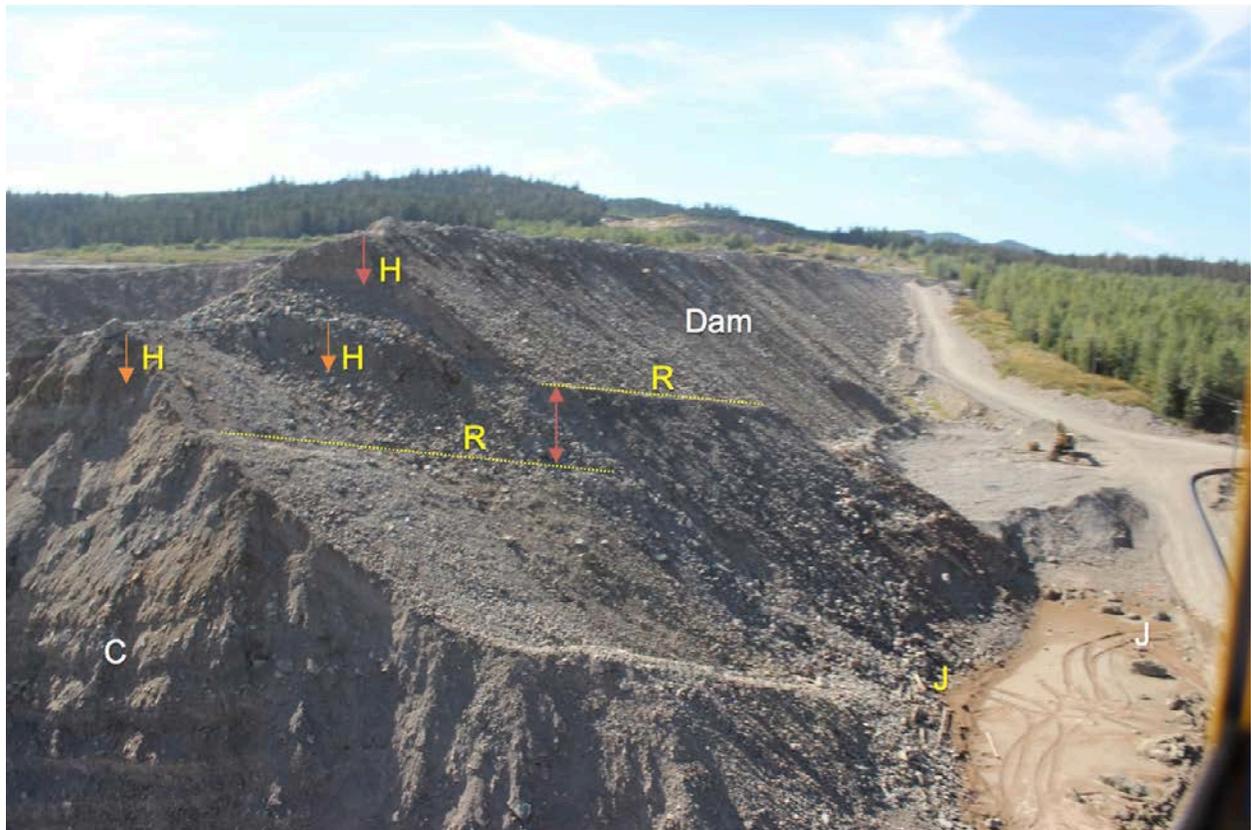
Figure C3.5.3 also shows the left abutment. The three en echelon scarps (H) which are about 3 m to 4 m high are clearly visible. The eroded till blocks (J) and pieces of organic drift wood can be seen at the downstream toe of the dam. The haul road ramp (R) is also visible along with the trace of its downdropped alignment. The estimated vertical displacement is about 5 m.

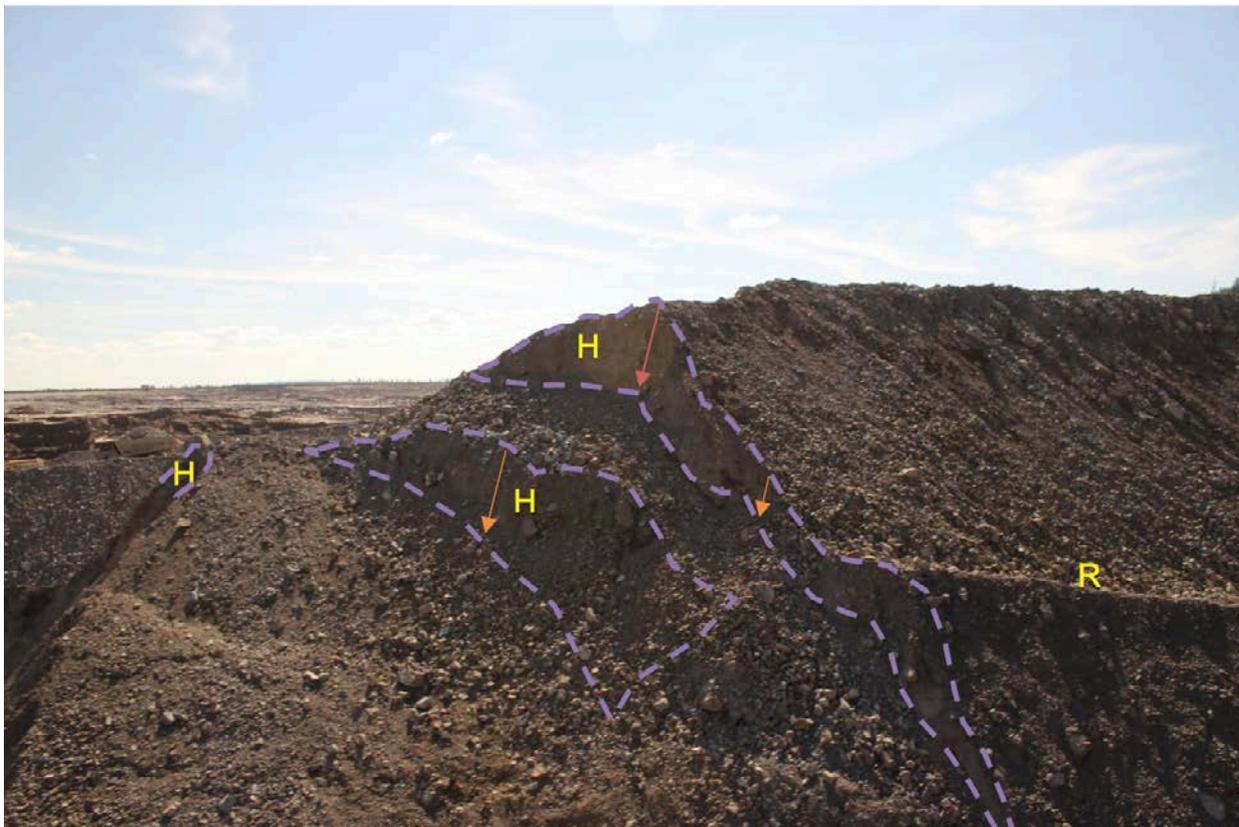
Figure C3.5.4 shows the upper portion of the left abutment with the three en echelon scarps (H) outlined. The maximum height of the upper two scarps is about 3 m to 4 m. The upper scarp cuts through the former haul road ramp (R). Below the scarps to the lower left is the upper surface of the downdropped fill block.

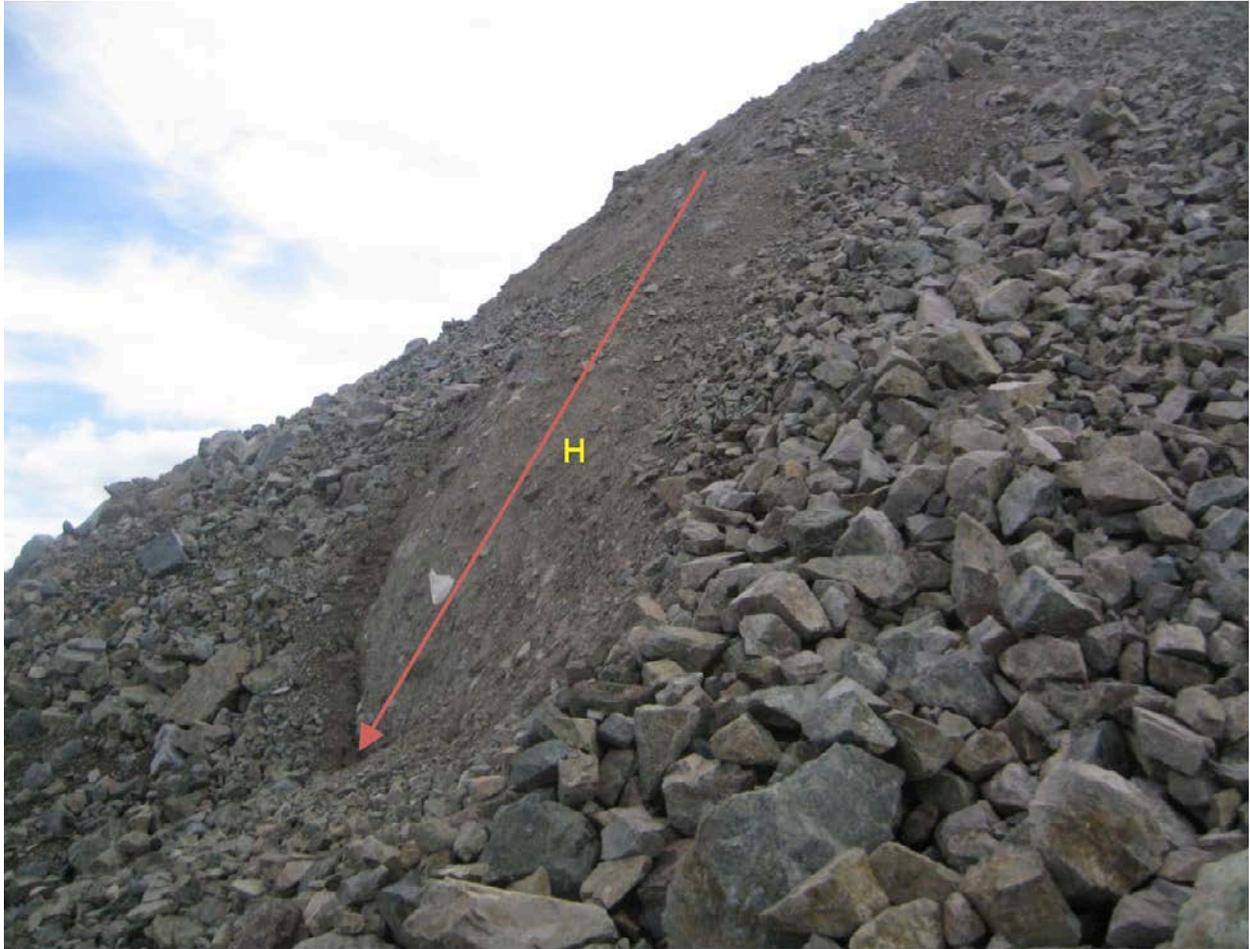
Figure C3.5.5 is a close-up of the upper scarp just above the remnant haul road. At this location, the scarp was measured as 1.7 m high.

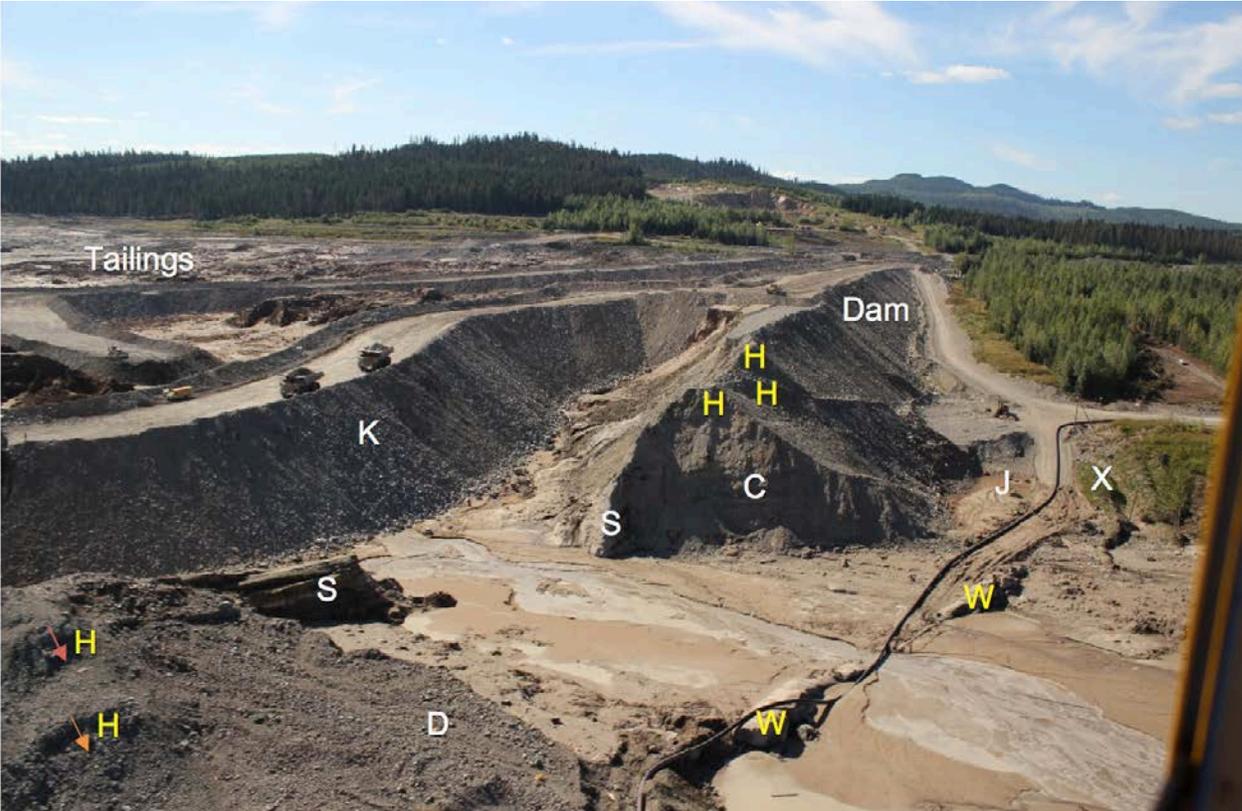
Figure C3.5.6 is an overall view looking west across the breach showing the linear whaleback (W), the head scarp on both abutments (H), and surface erosion rills on the displaced right abutment fill (D).

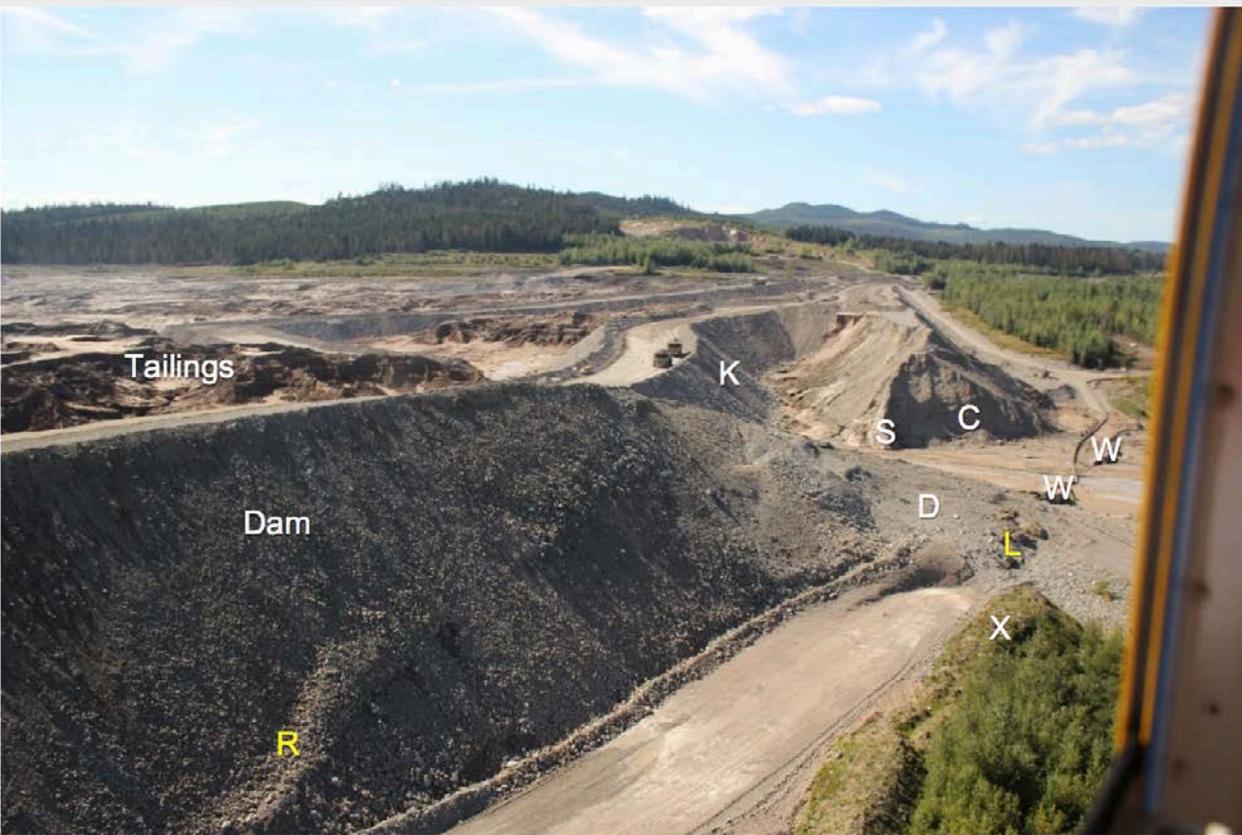
Figure C3.5.7 is a view looking west at the area to the right of the breach. The photo shows another former haul road (R) used to gain access to the crest. The low area on the access road below it that contained ponded water in the Cariboo video a month earlier is nearly dry. Toe bulging and lateral displacement of the right side of the breach can be seen in the area of L.

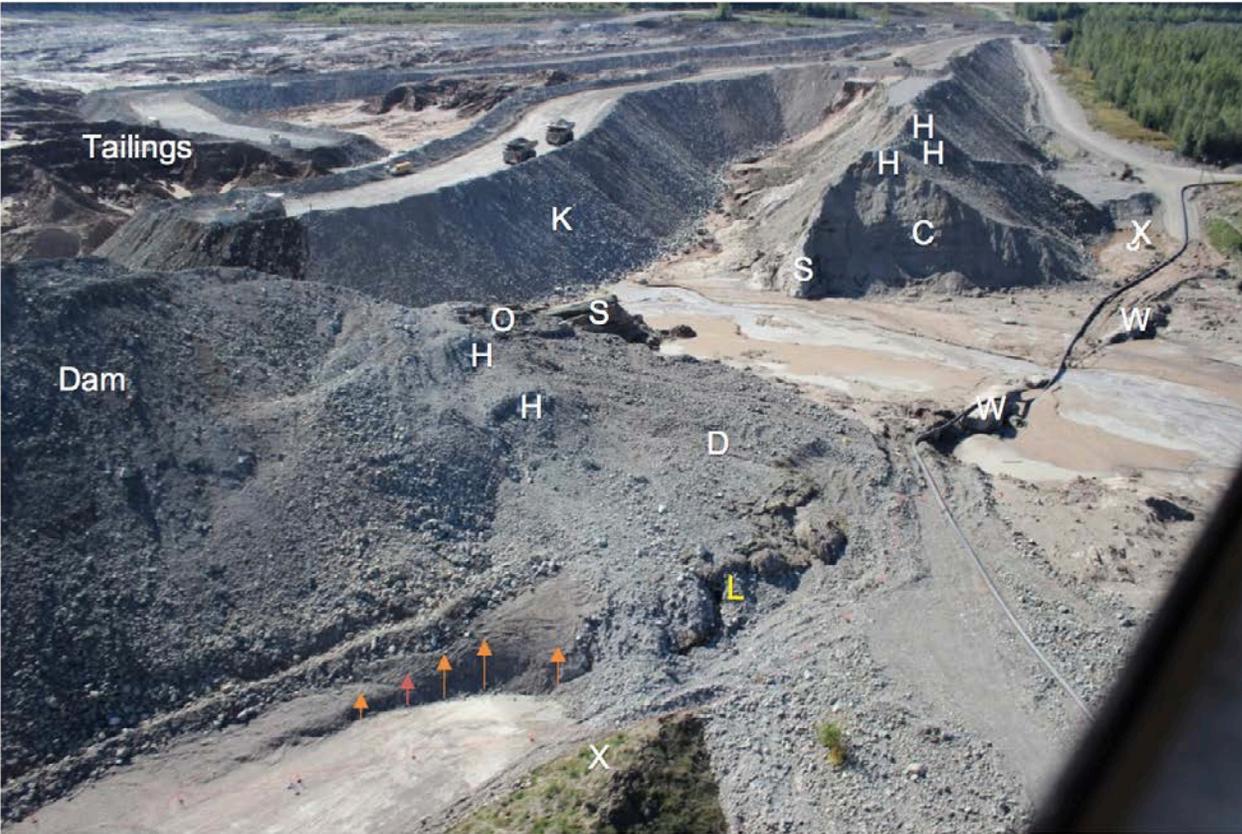
Figure C3.5.8 is a closer view looking west at the details of the right abutment. The toe bulging and lateral displacement of the right side of the breach can be seen at the toe of the slope near L. The orange arrows indicate the location and direction of upward thrusting. The estimated maximum vertical displacement at this location is about 3.5 m.

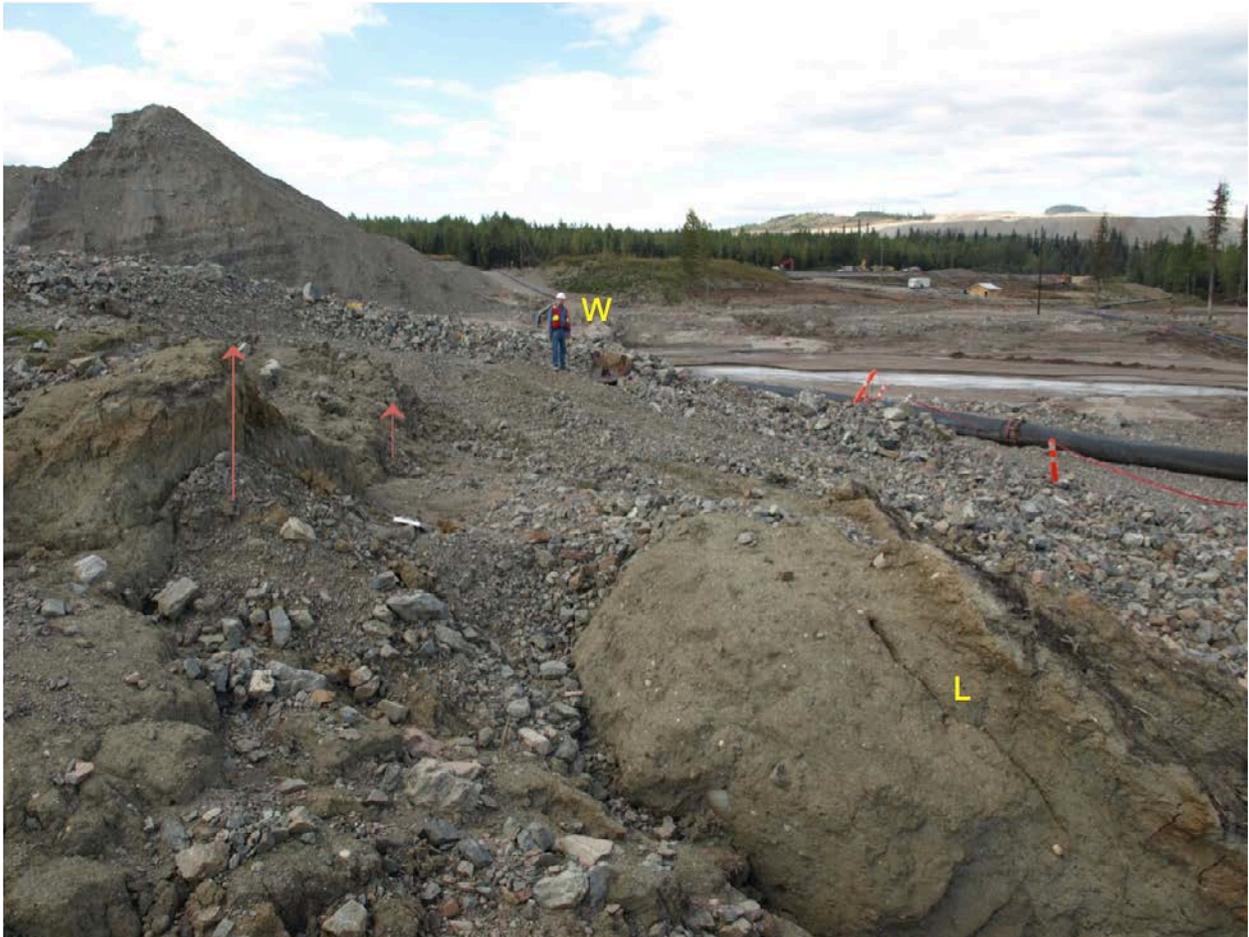
Figure C3.5.9 is a close-up of the upthrusted foundation till blocks and related scarps on the right side of the breach. The large till block (L) can be seen to contain layers of organic material, indicating its original orientation. Its current orientation is consistent with the outer limb of an anticlinal structure. The reverse dip of layering and lamination in the companion block (long arrow) shows it to be consistent with the inner anticlinal limb.

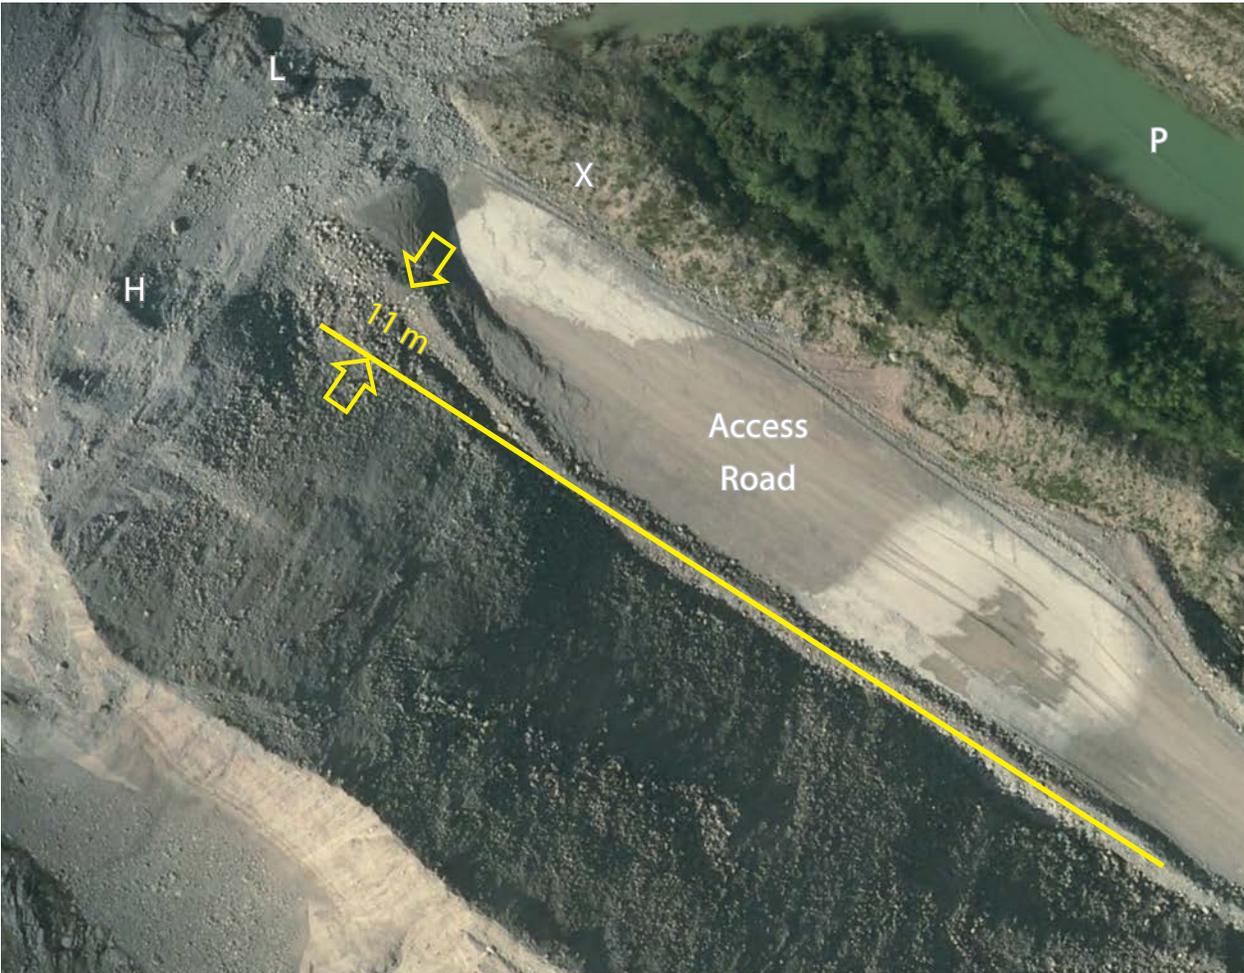
Figure C3.5.10 is a plan view of the right abutment that provides an estimate of the amount of lateral translation on the right side of the breach. Using the rockfill berm along the access road as a reference, an estimated translation of about 11 m has been measured from the figure.
