Independent Expert Engineering Investigation and Review Panel

**Report on Mount Polley
Tailings Storage Facility Breach**

Appendix C: Surface Investigations

January 30, 2015

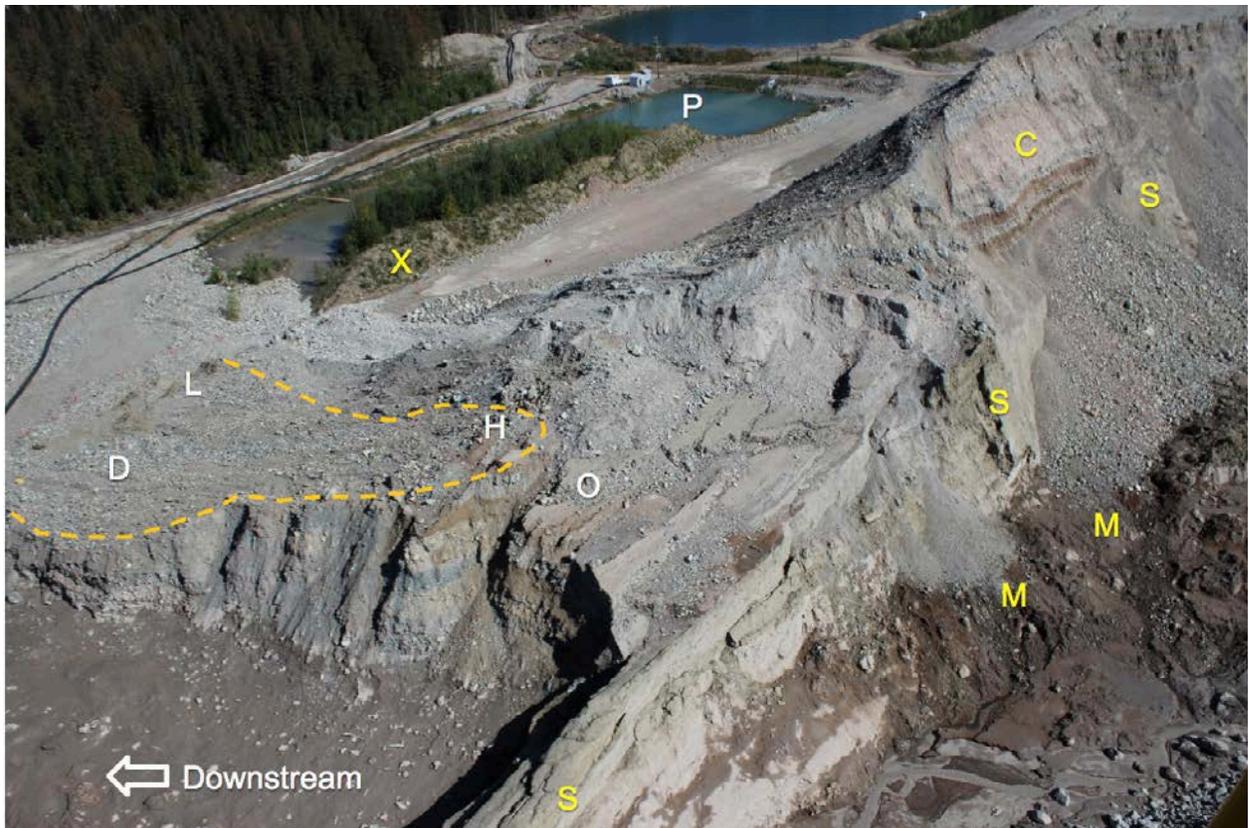
The photo of the upstream side of the right abutment in **Figure C3.5.11** shows the remnant till core (S) exposed at three locations and the sub-horizontal layering of the downstream rockfill shell (C). Two areas of observed seepage (M) near the base of the upstream side of the dam are also shown. These are thought to be from the upstream toe drain. The fill berm consisting of mixed till and organics (X) along the access road consists of materials stripped from the access road foundation.

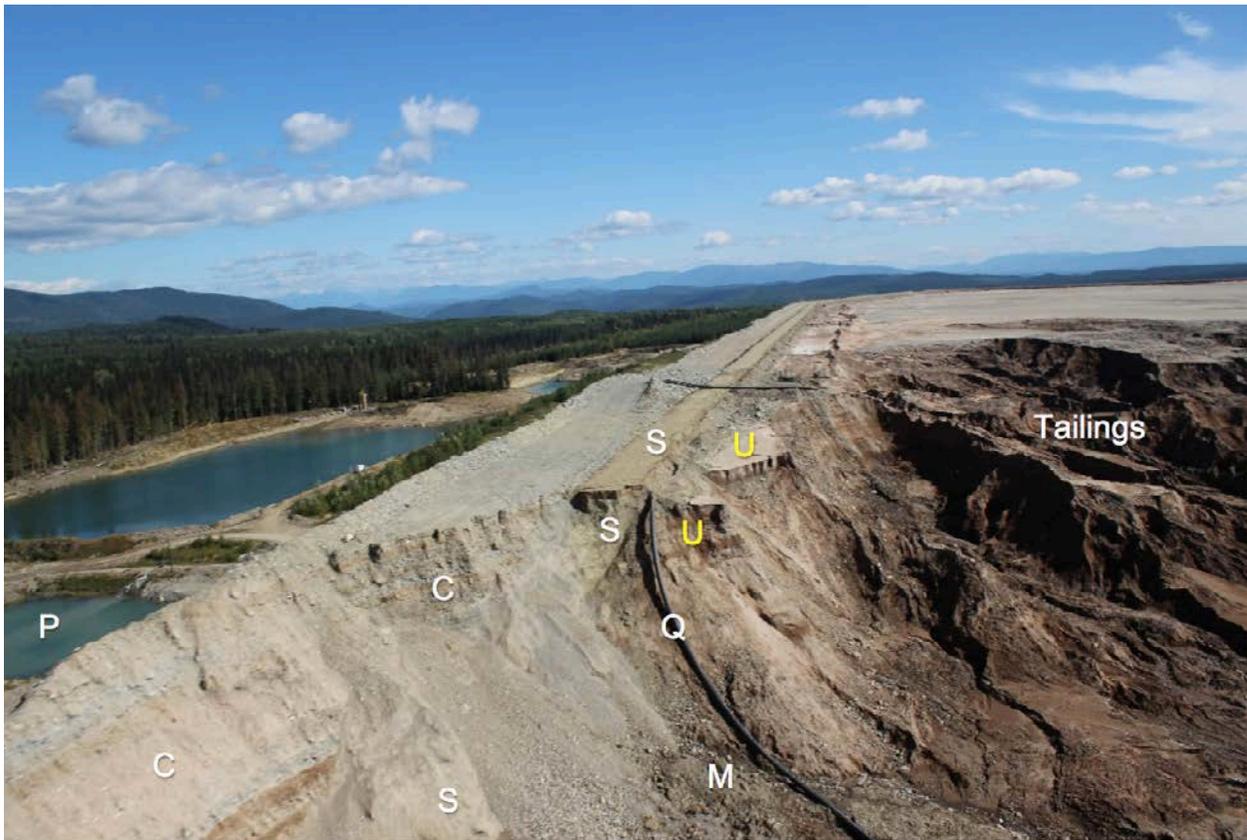
Figure C3.5.12 is a view of the upstream side of the dam to the right of the breach that shows the remnant till core (S), the sub-horizontal layering of the downstream rock fill shell (C) and the select upstream tailings fill (U). The location of the Perimeter Embankment seepage collection pond (P) is indicated, with its return-water pipeline crossing the crest in the distance. The tailings distribution pipeline (Q) originally extended along the upstream side of the crest and was not in service at the time of the breach. The area of upstream toe drain seepage is shown at M. The continuous scarps along the upstream crest of the dam are the result of slope failures caused by removal of supporting tailings during the breach.

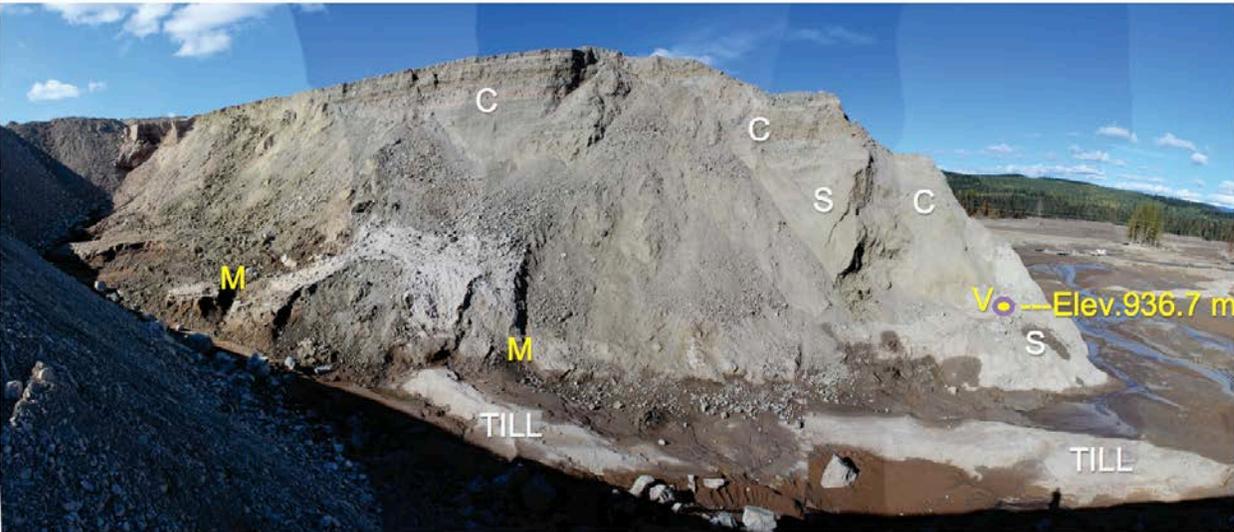
Figure C3.5.13 is a view of the upstream side of the left abutment that shows exposed native till at the base of the dam, the remaining remnant core (S), and the sub-horizontal bedding in the downstream rockfill shell (C). Zones of seepage were observed at M. A sub-horizontal void was observed within the remnant till core at Location V on the upstream side of the left abutment at El. 936.7 m corresponding to the crest of Stage 2B.

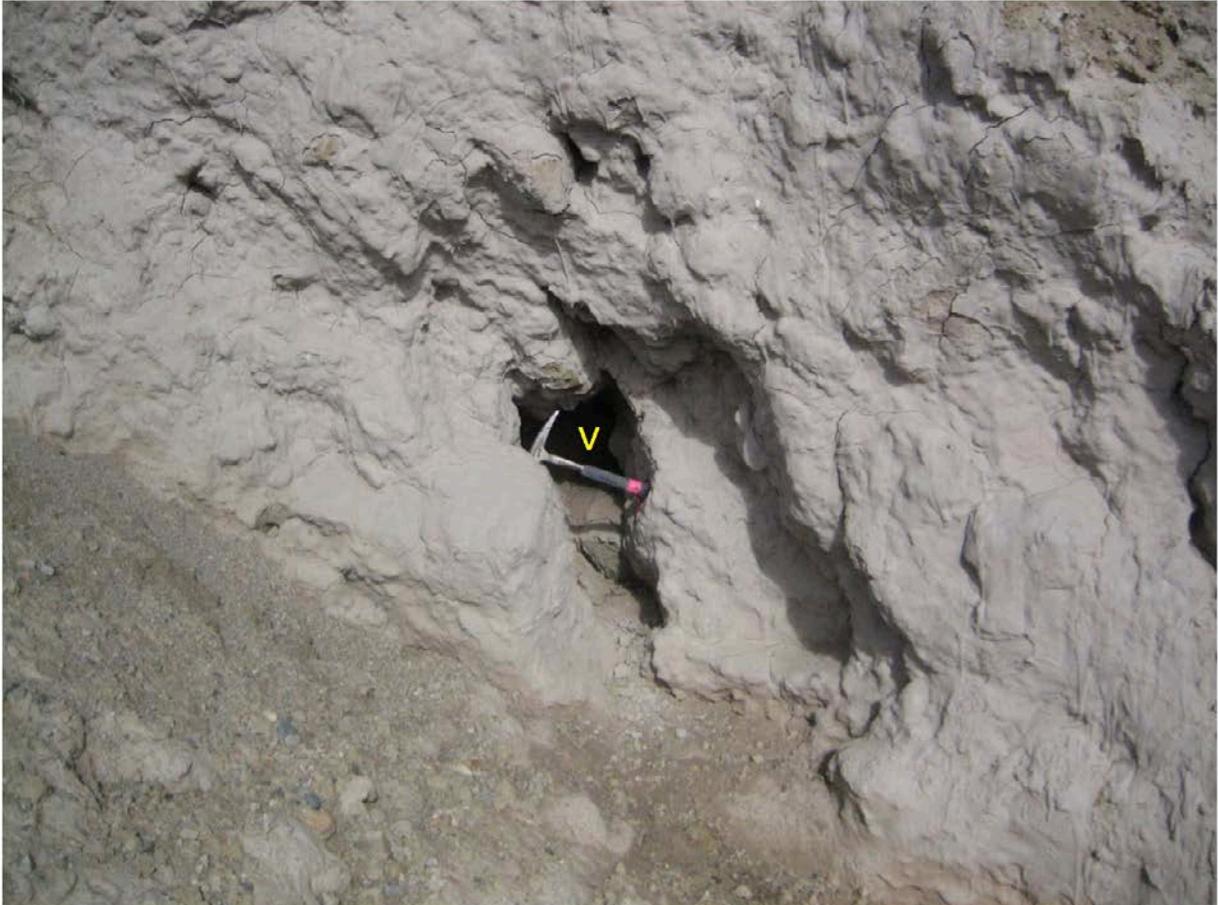
Figure C3.5.14 shows a closer view of the void. Its dimensions were measured at 0.7 m high, 0.3 m wide and 1.1 m deep. The inside surface was covered with a cake of fine sand tailings. The origin and implications of the void are further treated in section 4.3.

Several observed features and conditions relate to internal erosion processes. Firstly, a small void was observed at the left abutment (**Figures C3.5.13** and **C3.5.14**) measuring 0.7 m by 0.3 m and extending back 1.1 m into the Zone S core from the exposed face. The angularity and abrupt transitions of the void opening differ from the rounded surfaces and corners formed by surface erosion of the till as displayed, for example, on **Figures C3.5.17** and **C3.7.1**.

Additionally, gradation curves for the three samples of the Zone F filter material on the right abutment are provided in Attachment C1. The gradation data show that none of these samples met filter criteria (i.e., $D_{15} \leq 0.7\text{mm}$) that would have enabled them to prevent transport of fines from the till. Together, these factors suggest internal erosion as the likely cause of the left abutment void.

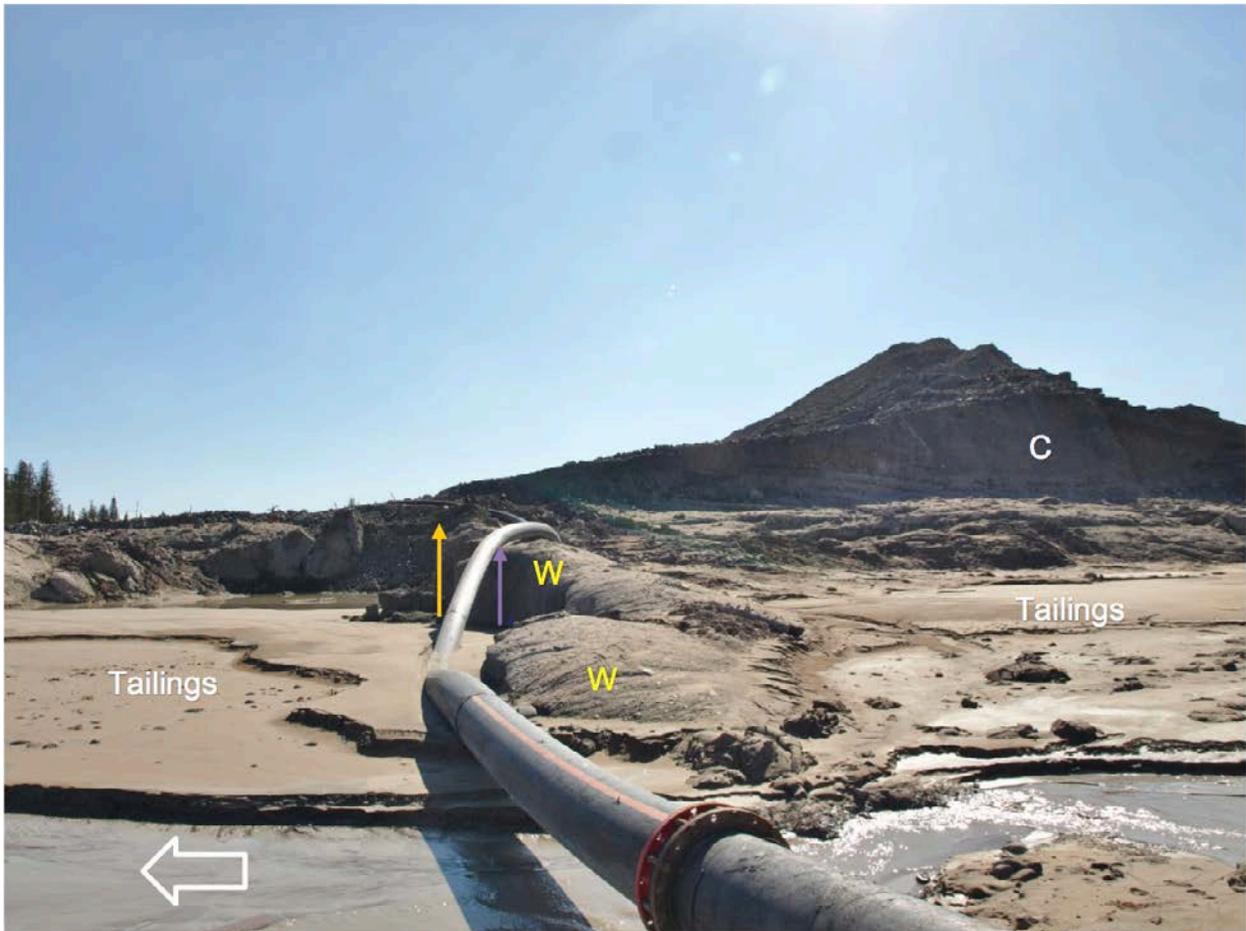
Figure C3.5.15 shows the linear, ridge-like whaleback feature (W) located near the downstream toe of the dam. It is comprised of dense native till and has a steep downstream face up to 2.8 m high with a shallowly-dipping upstream side. It is attributed to upthrusting (vertical arrows) of foundation till. The smooth and rounded surface of the whaleback is characteristic of both native and compacted till subjected to erosional breach flows throughout the area. Its signature appearance in this figure gives rise to the nomenclature used to describe it.

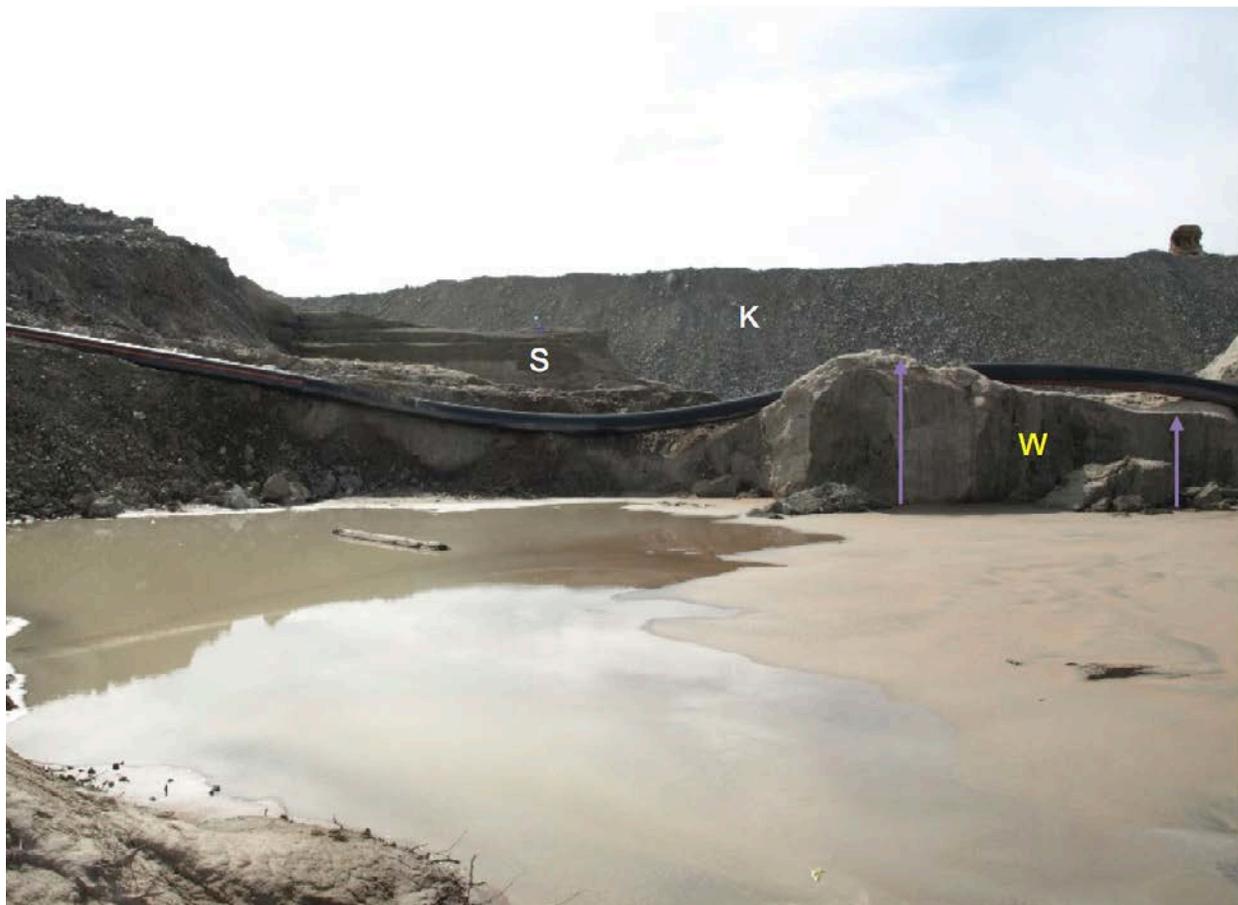
Figure C3.5.16 shows the whaleback (W) near the downstream toe of the right abutment. Here the arrows indicate upthrust of up to 2.8 m.

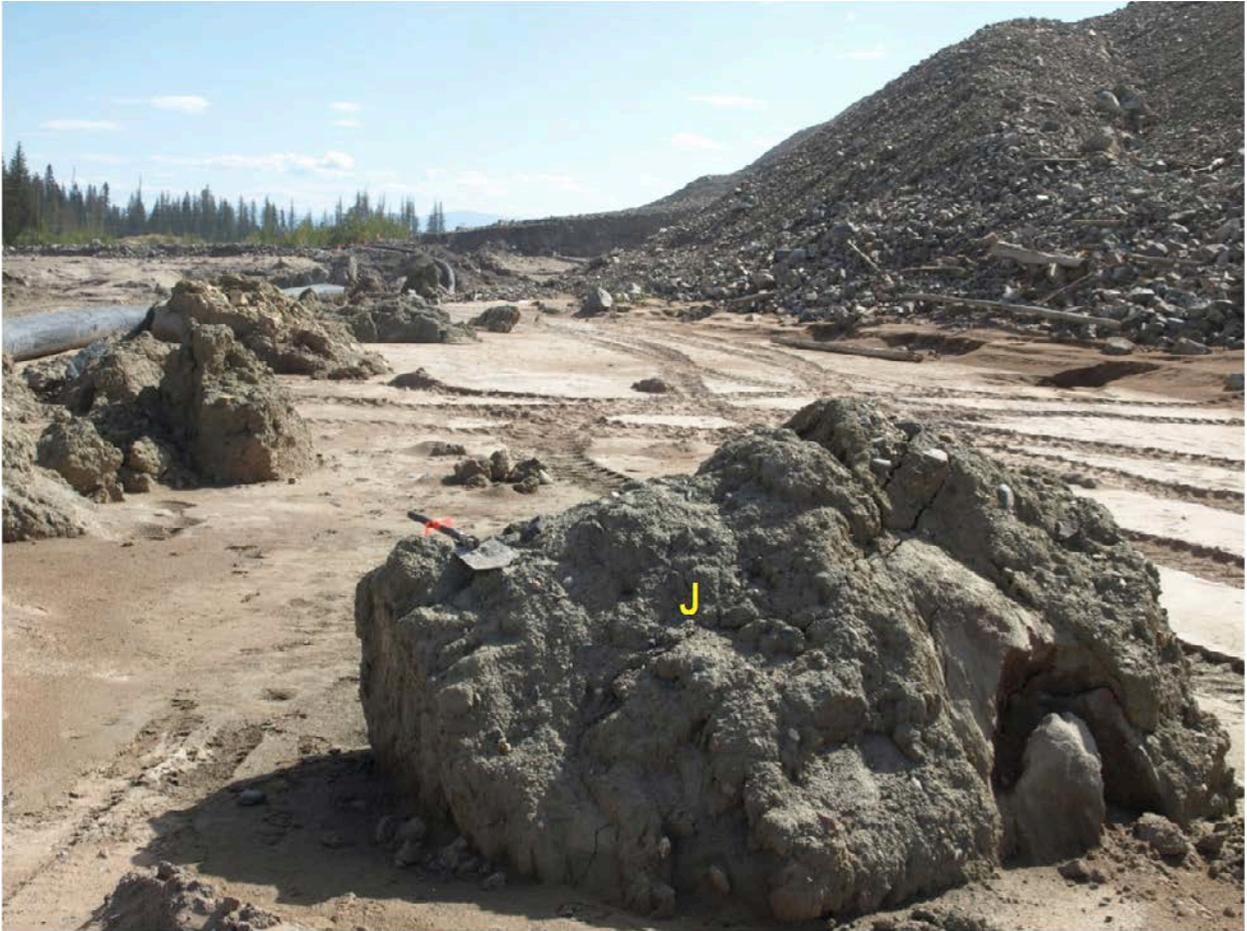
Figure C3.5.17 shows a close-up of one of the till blocks eroded from the dam core and deposited during the breach. The locations of these blocks can be seen on **Figure C3.5.1** (location J). Note the driftwood located on the toe of the dam slope that provides an indication of the water level during the breach. Transport of till blocks in motion can also be seen in the Cariboo video. Their mobility can be attributed in part to the buoyancy provided by the high-density mixture of fluid tailings and water that carried them.

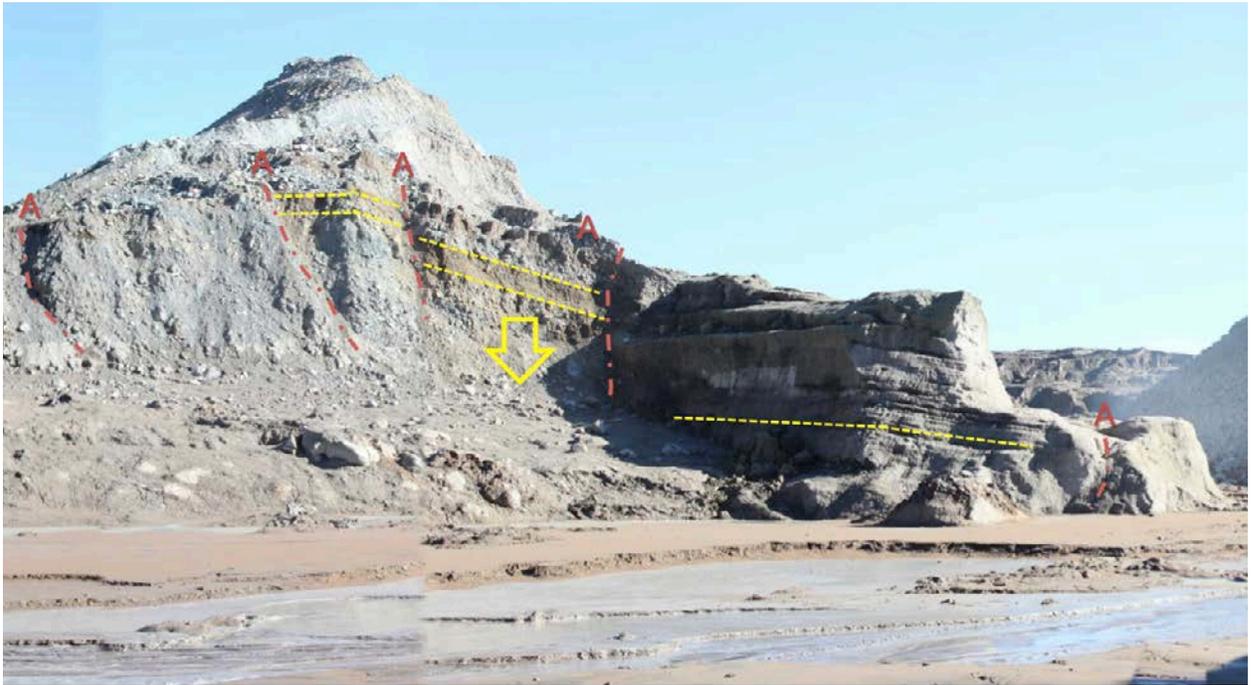
Figure C3.5.18 shows a more detailed view of the right abutment. The yellow dashed lines indicate selected traces of observed bedding from construction lift lines. The orange dashed lines (A) indicate shear features where bedding was offset. The yellow arrow indicates a downdropped graben associated with horizontal movements. Features in this area are described in more detail in section 3.6.

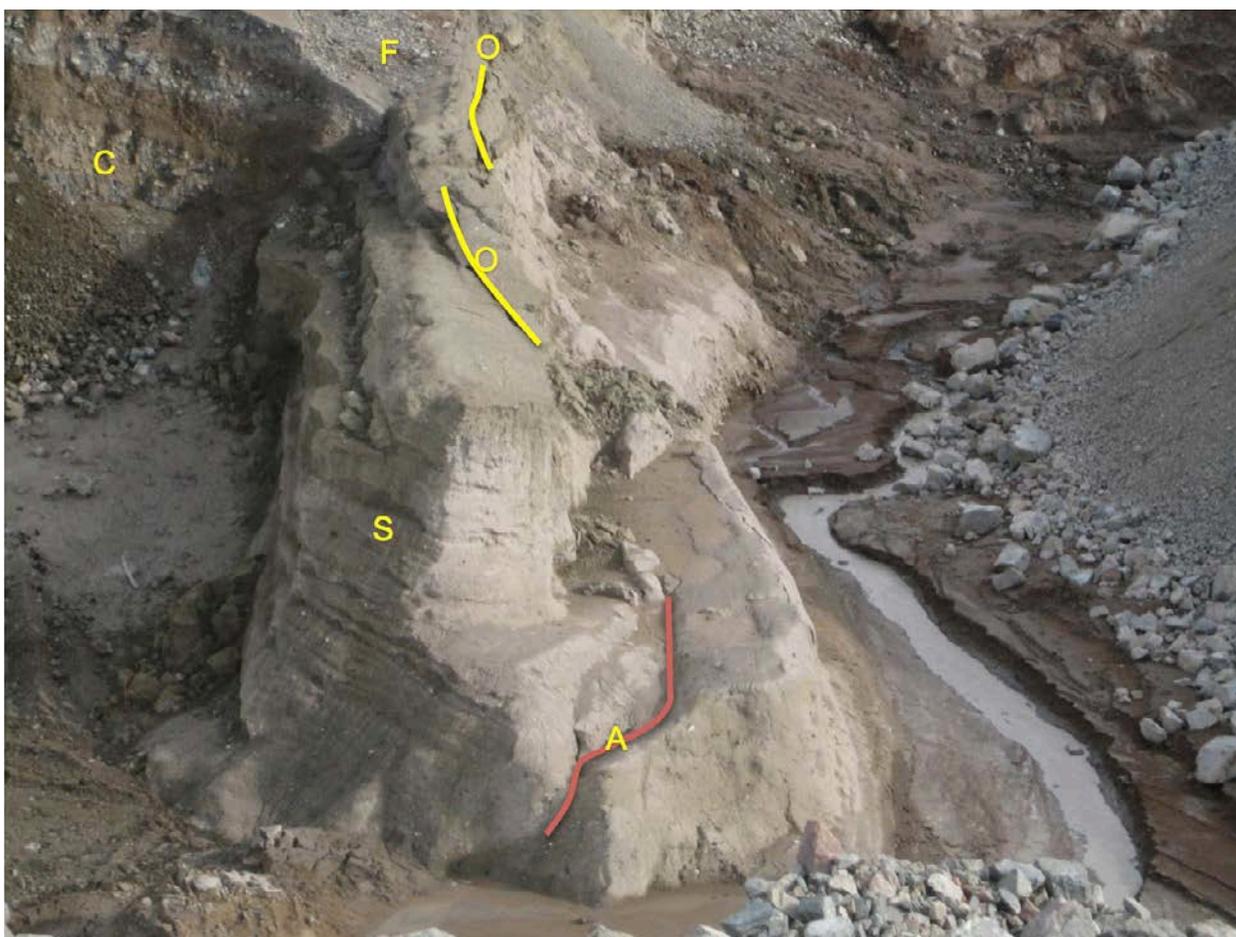
Figure C3.7.1 shows the remnant core on the right abutment prior to excavation. Indicated are the remnant till core (S), rockfill shell (C), filter (F), open cracks (O), and the surface expression of the shear surface (A). Zone B fill, described in the specifications as “glacial till, glaciolacustrine, or granular material,” may also be present on the downstream side of the core (left in photo), but could not be readily distinguished from Zone S in the field.

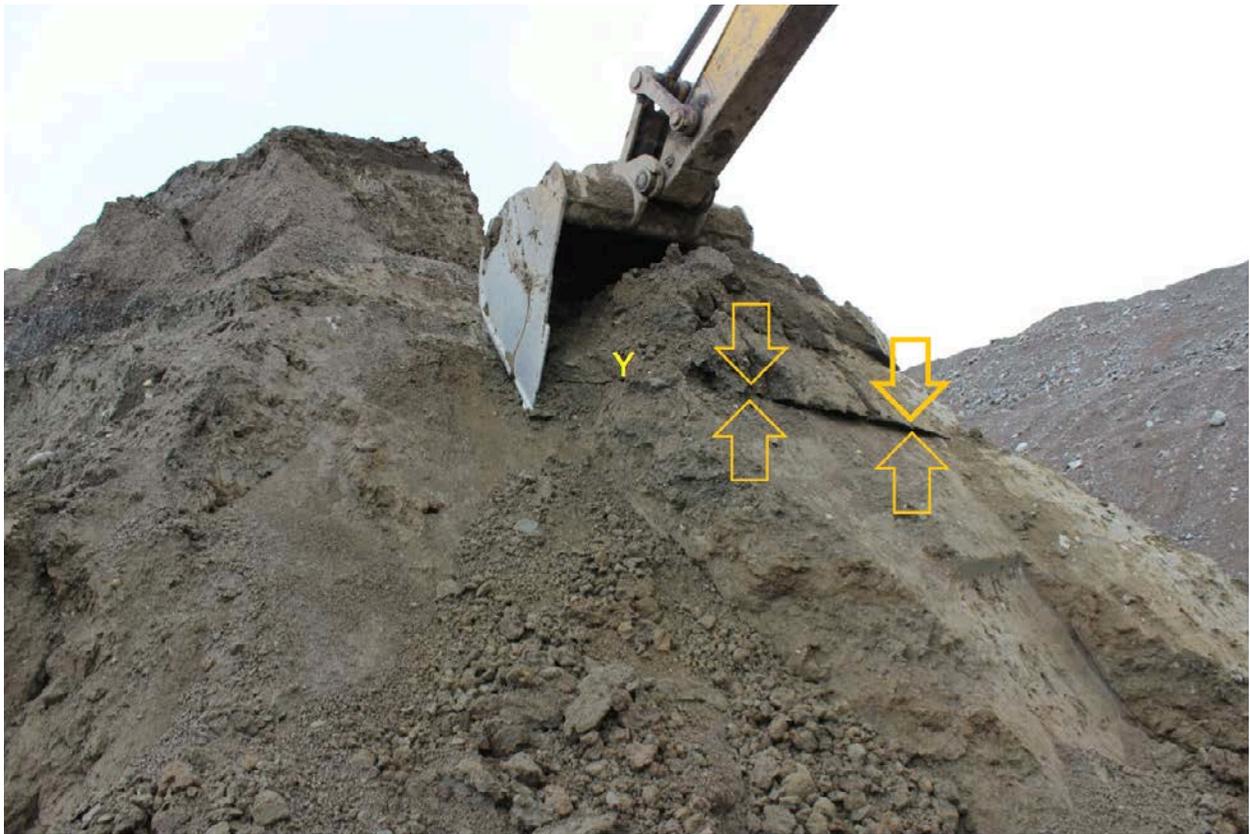
Figure C3.7.6 shows smooth planes (Y) associated with interfaces of fill lifts placed during construction. The surfaces were observed to dip upstream with an apparent dip of between about 5° to 20°. Where possible, the dip/dip direction was measured using a Brunton Geological Compass. The range of true dips is 6° to 25° and the range of dip directions is 197° to 300°. A total of 24 apparent dip measurements and 16 dip/dip direction measurements were collected. The average apparent dip is 15° and the average dip/dip direction is 16°/253°.

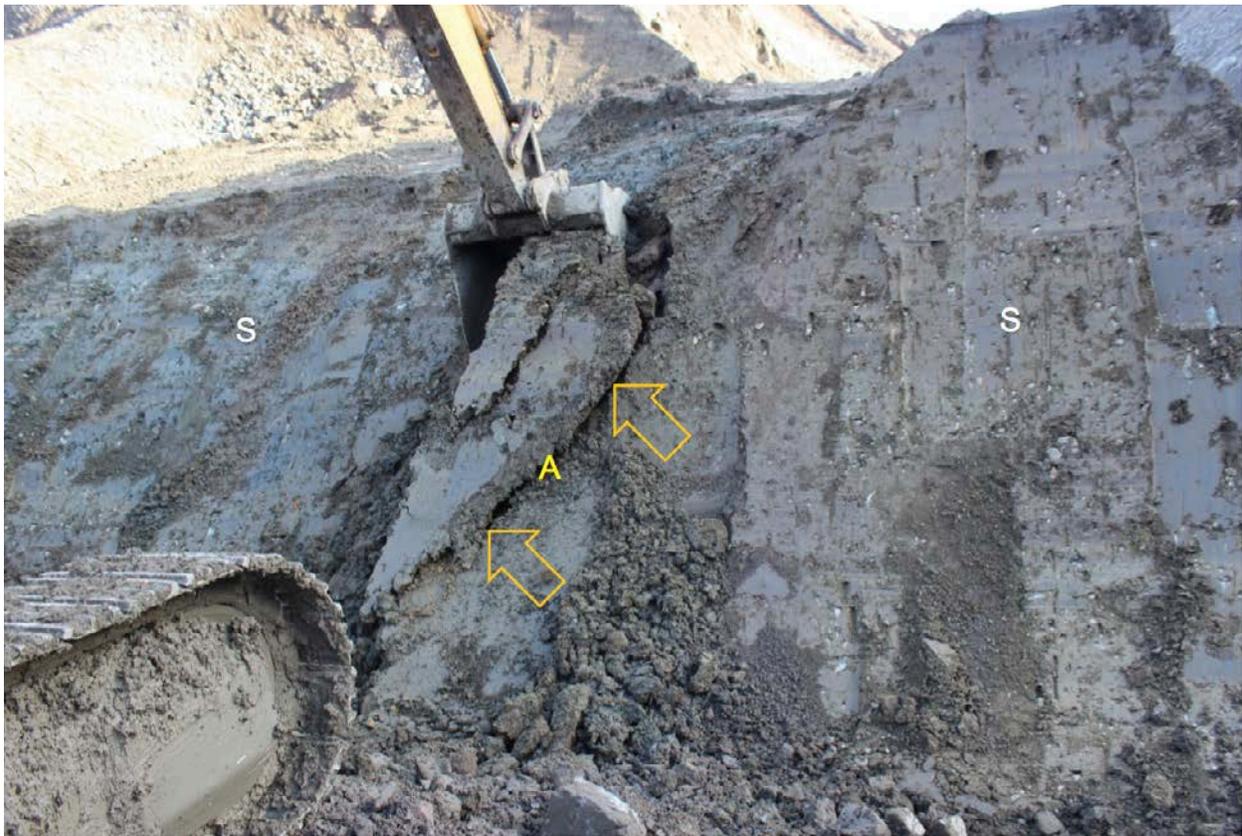
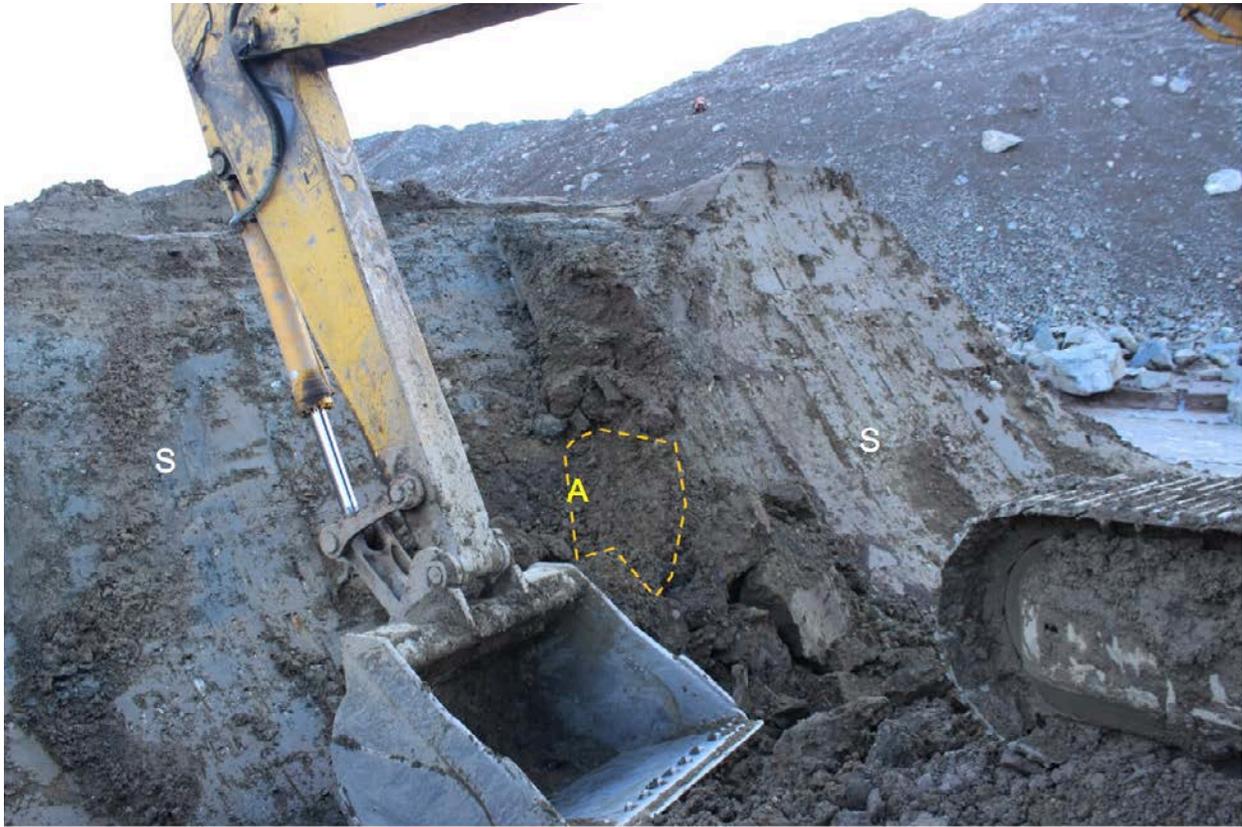
Figures C3.7.7 and C3.7.8 show Slice 25 where a block of material slid out along the shear surface (A) during removal.

The surface of the shear (A) in this location (Slice 25) was coated with reddish coloured uniformly-graded sand.

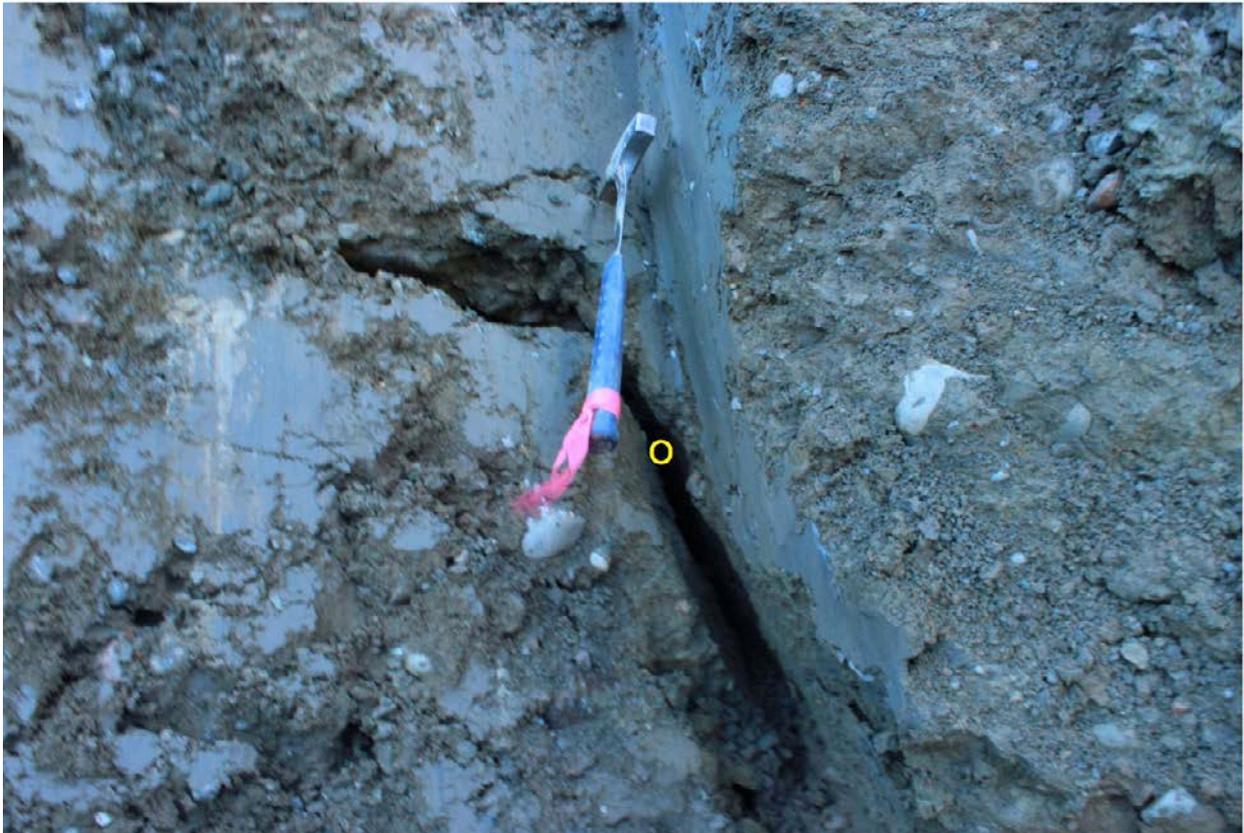
FIGURE C3.7.9: OPEN CRACK ENCOUNTERED DURING EXCAVATION OF SLICE 26

During the excavation of Slice 26 (lower phase) an open crack (O) that measured 700 mm long, 40 mm wide and 300 mm deep was encountered. **Figure C3.7.9** shows the crack during excavation. Upon the completion of the excavation, the crack was fully removed and not observed to continue in the remaining slices (27 to 41). The surfaces of this discontinuous crack were not softened or otherwise suggestive of hydraulic fracturing. It is believed to be a localized stress-relief feature induced by removal of supporting material during or after breach development.

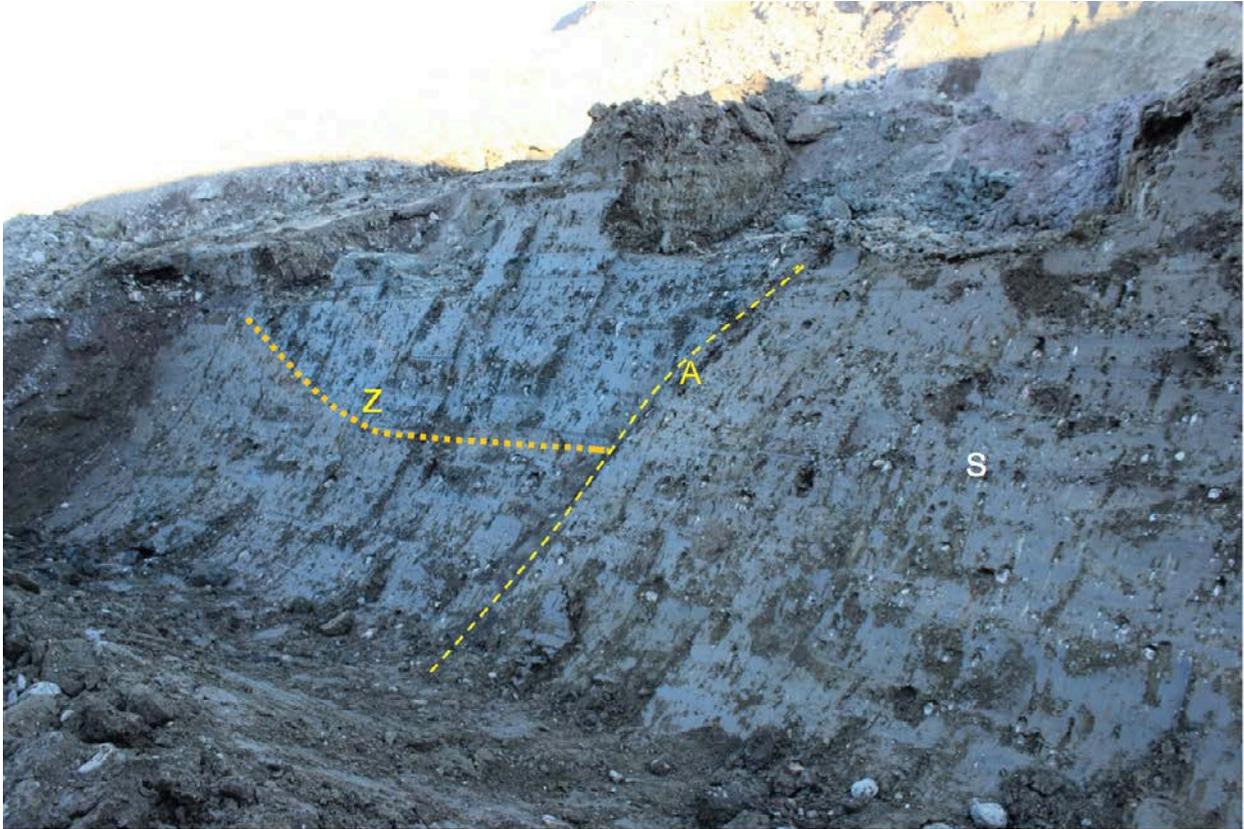
Figure C3.7.11 shows a marker bed (Z), the shear surface (A) and the till core (S). The marker bed was observed to be a dipping plane in Slices 23 to 30 and curved in Slices 31 to 41. Although the marker bed was clearly visible on the downstream side of the shear, no matching marker bed was observed on the upstream side. Accordingly, relative displacement across the shear is greater than 3.3 m from field measurements.

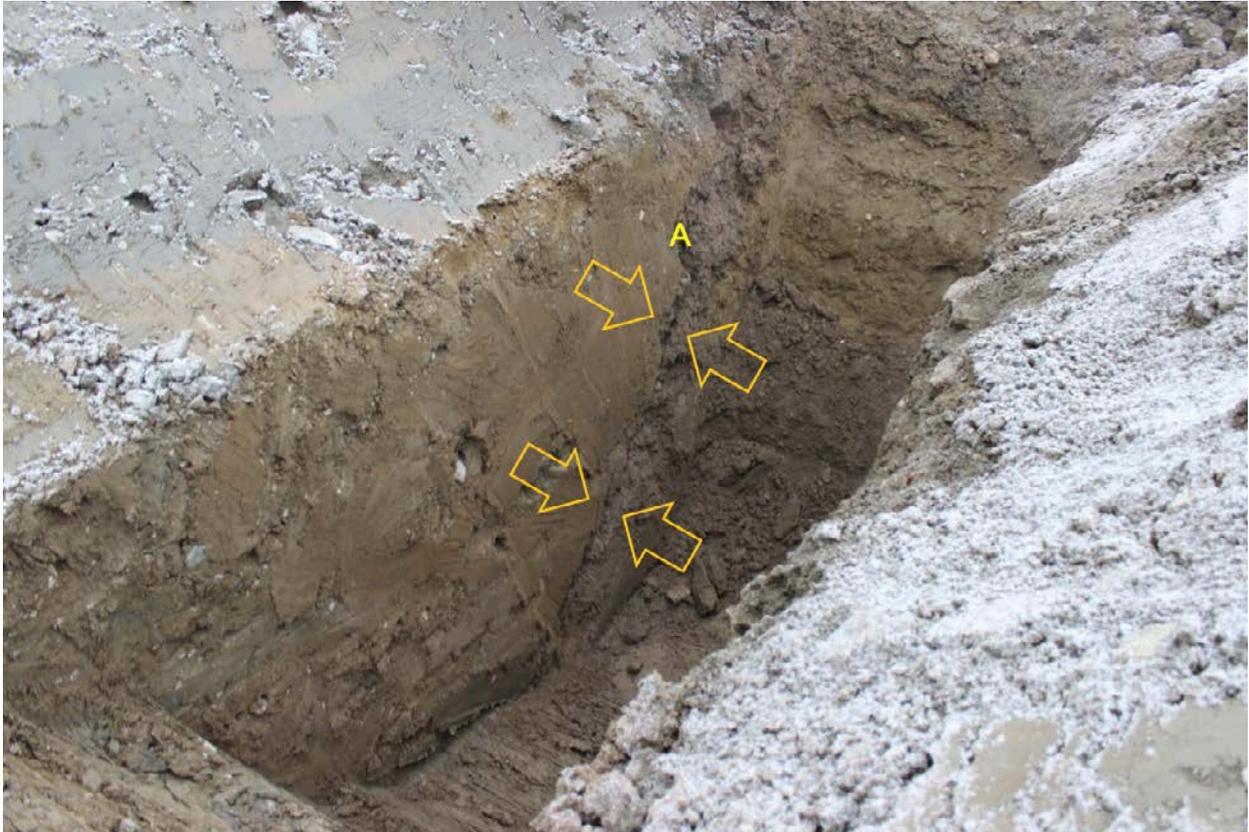
Figure C3.7.12 is a test pit excavated at the base of Slice 39. Shear (A) is expressed in the cut faces as a soft disturbed zone across the base of the excavation at approximately El. 925.5 m. The contact between the till core fill and the lower native till is difficult to definitively identify. The mottled colouring of the downstream (left) side of the shear suggests an origin as compacted core, with the more uniform upstream side better resembling native till. Observations on the upstream side of the shear indicate that the native till contact is likely in the range of El. 929.5 m to 930.5 m.

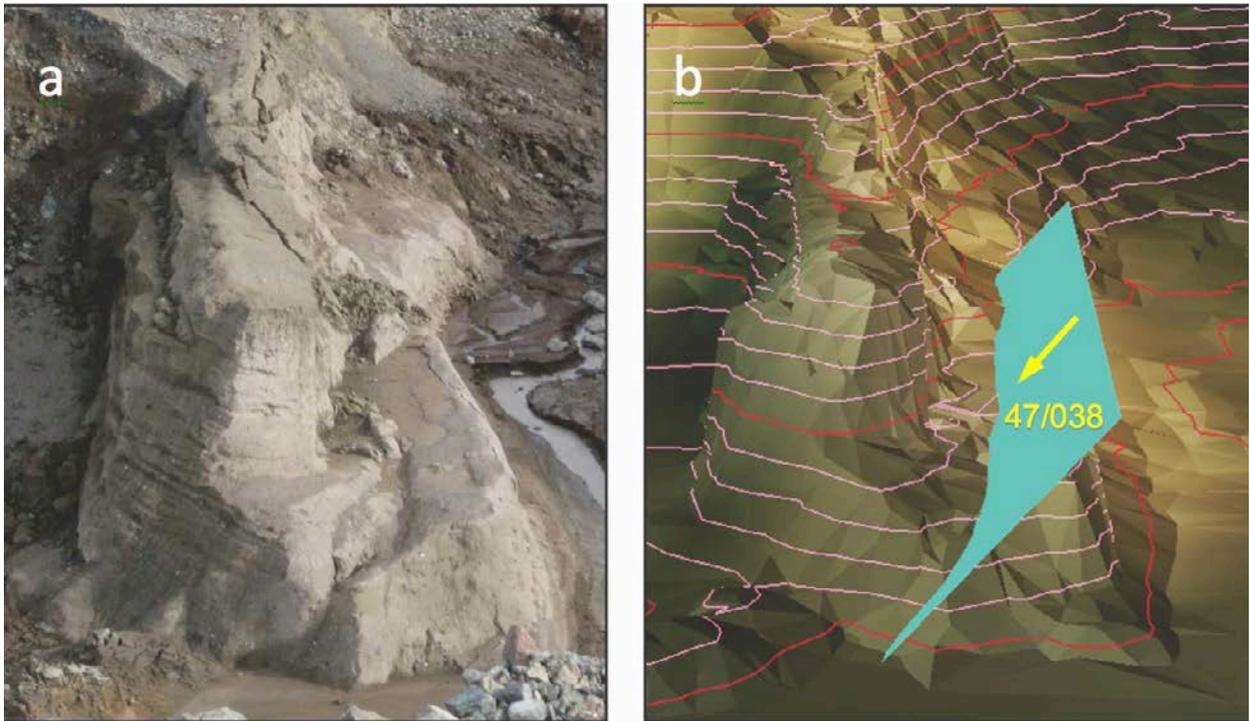
Figure C3.7.14a shows a photograph of the remnant till core of the right abutment. **C3.7.14b** is an isometric surface model with LiDAR-generated contours showing the three-dimensional orientation of the shear surface (47/038).

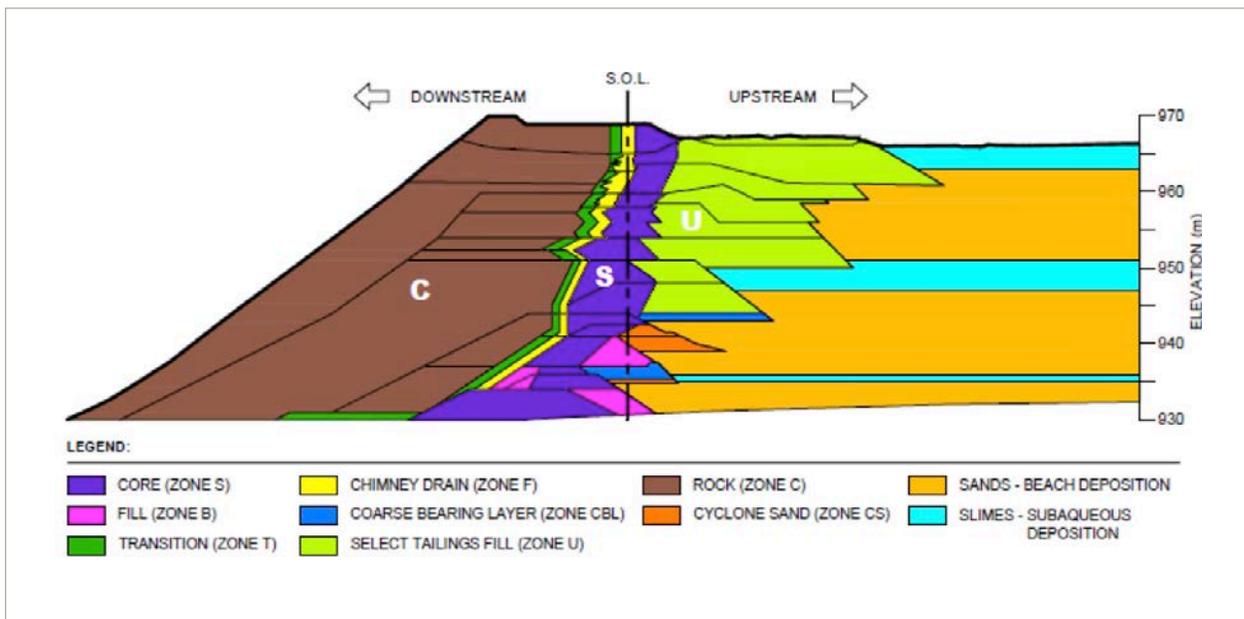
FIGURE C4.1.1: RECONSTRUCTED PRE-FAILURE TAILINGS PROFILE AT BREACH LOCATION

As shown in the figure, sand tailings likely predominated overall, with isolated layers of slimes in the lower, middle, and upper portions of the deposit. This is consistent with the prevailing location of tailings discharge, which was historically concentrated in the vicinity of Corner 1. Pre-failure strength and permeability characteristics typical of sand tailings are therefore likely to have predominated, except for the layers of slimes.

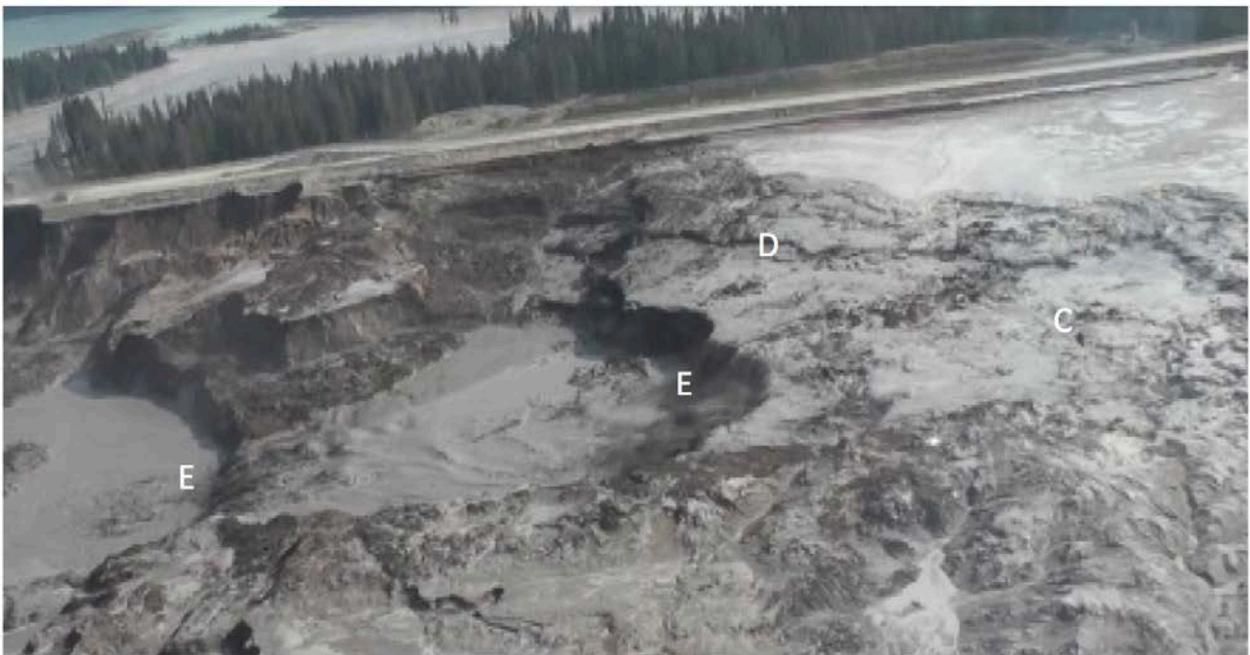
Figure C4.5.4 is a closer view of the same area that highlights the accompanying fluvial processes. A shallow surface depression on the right (C) is forming by sheet erosion of unconsolidated tailings, enhanced by downward displacement along the developing scarp (D). This depression has captured overland flows emanating from stored impoundment water farther to the right off the image. By the time they reach the semicircular knickpoints, these flows are concentrated into highly erosive cascades (E) that undercut the headscarp and further enhance knickpoint migration.
