# **Independent Expert Engineering Investigation and Review Panel**

## **Report on Mount Polley Tailings Storage Facility Breach**

#### **Attachment D6: Panel Boreholes and Sampling**

# Panel Borehole Logs

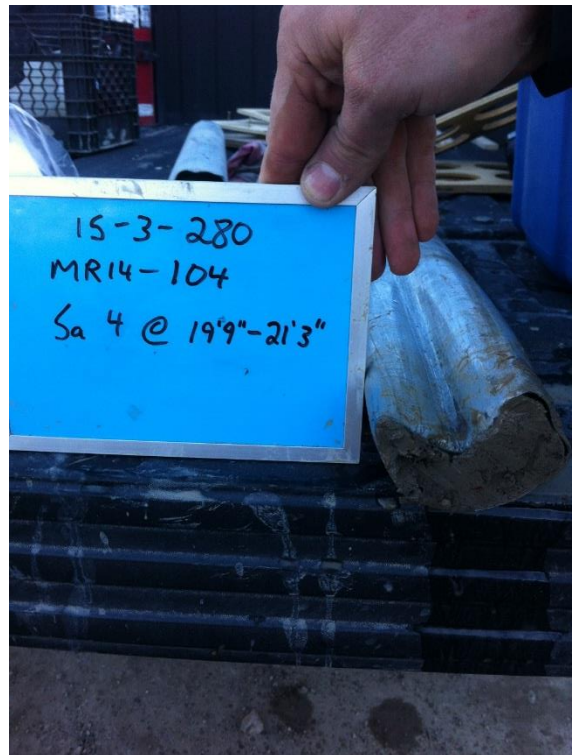
MR14-104 SAMPLE #2

**SEVERE DAMAGE –  
SAMPLE BAG REQUIRED**

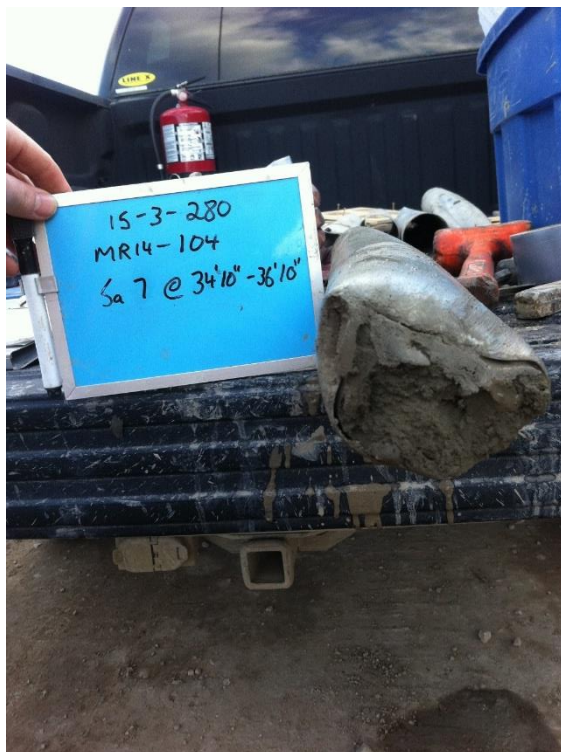
MR14-104 SAMPLE #5

## SEVERE DAMAGE – SAMPLE BAG REQUIRED

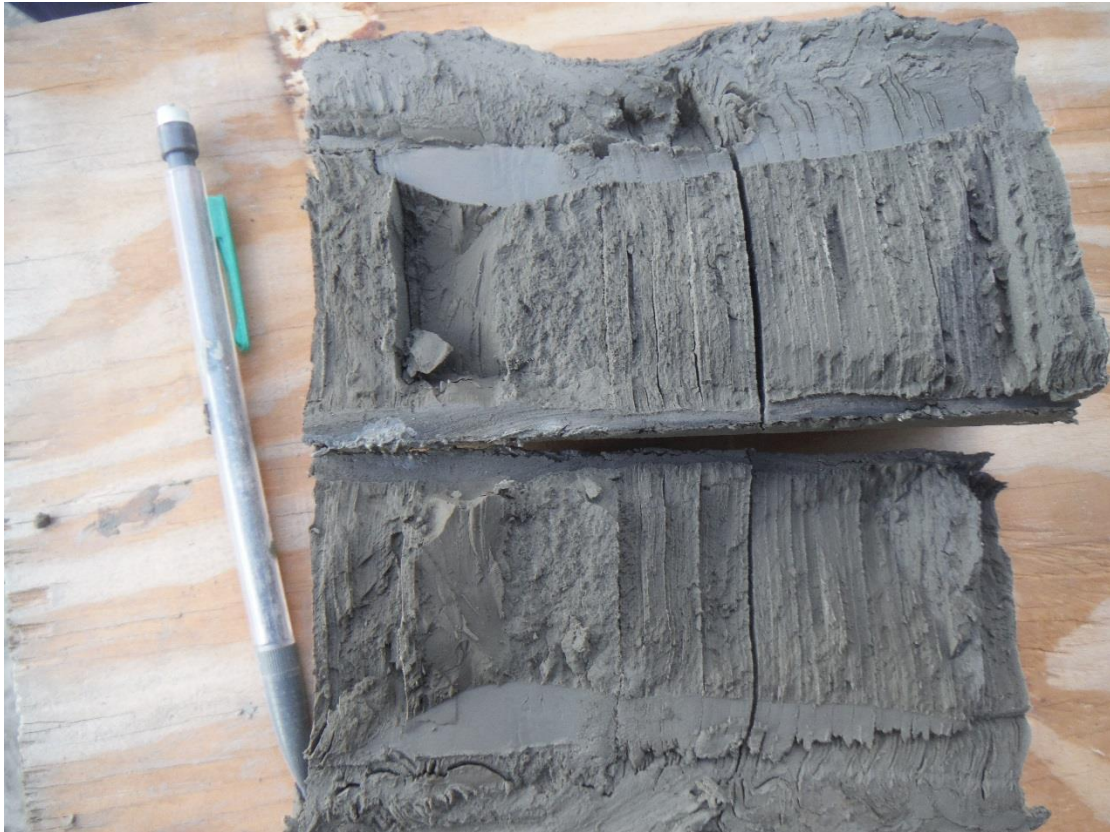
MR14-106 SAMPLE #6 – SAMPLE TUBE WAS SPLIT IN THE FIELD

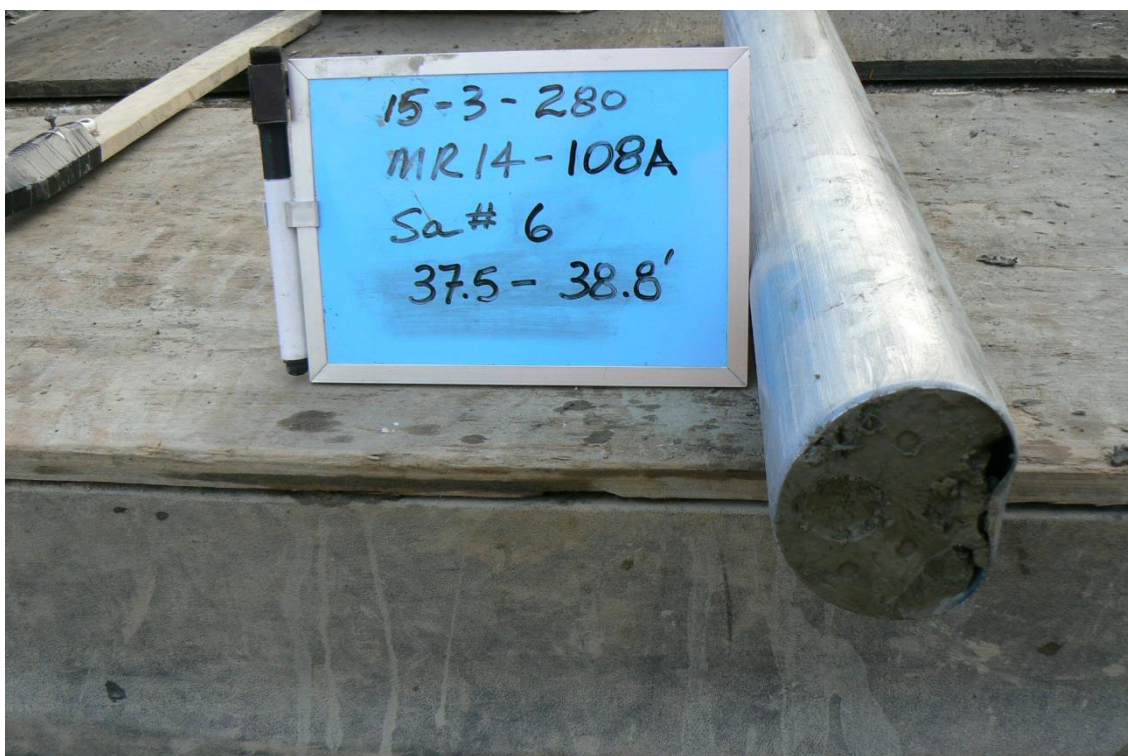
MR14-108A SAMPLE #5 – FIELD LABEL INCORRECT
