Independent Expert Engineering Investigation and Review Panel

**Report on Mount Polley
Tailings Storage Facility Breach**

Appendix D: Subsurface Investigation

January 30, 2015

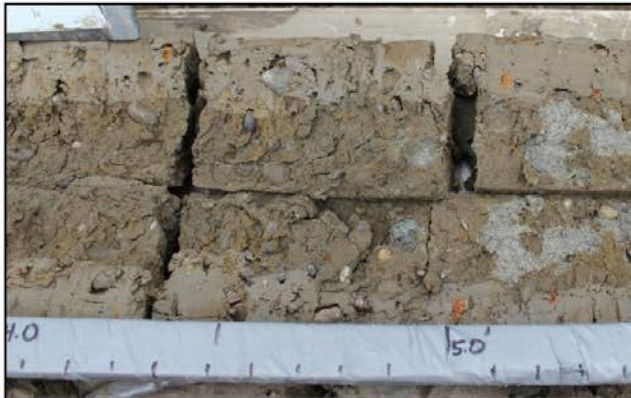
FIGURE D6.4.2A: UPPER TILL DESICCATED CRUST

CPT tip resistances (q_t) ranged as high as 120 bar in the desiccated crust and as low as 10 bar below the crust. SPT N values ranged as high as 20 in the desiccated crust and as low as 5 below the crust. Peak values for the CPT and SPT are likely influenced by the presence of gravel.

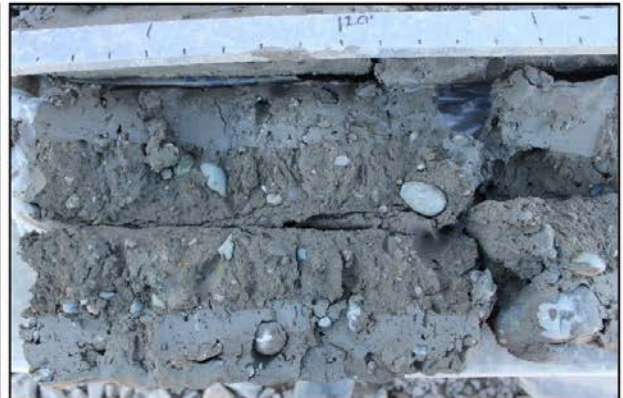
FIGURE D6.4.2B: UPPER TILL

The Upper Till is highly variable in composition, ranging from sandy clay to sand and silt, with gravel content ranging from trace to gravelly including cobbles up to 150 mm and trace to some organics near surface. Soil structure is typically massive within the Upper Till. Index testing on the relevant fractions suggest moisture content varies from approximately 5% to 30% and the plasticity index varies from approximately 5 to 20.

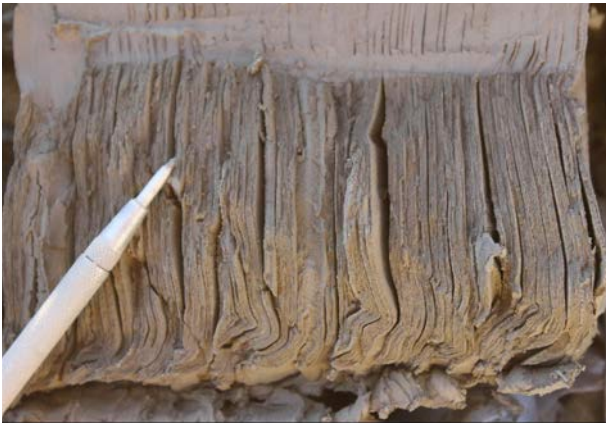
FIGURE D6.4.3A: UPPER GLU OUTSIDE BREACH AREA

The soil structure is strongly bedded, typically thinly laminated but with high variability, including zones with no apparent bedding. Often where thinly laminated, the clay is interbedded with fine sand in partings and occasional laminations (note that laminated fine grained soils are sometimes referred to as varved, which is customarily used to refer to laminations as a result of seasonal deposition). The bedding as observed in the sonic core was apparently deformed in several locations. Deformation was typically observed to be more common and severe within the breach area. Distal to the dam footprint, the soil structure was generally horizontal and deformations were generally not visible or were minor (refer to **Figures D6.4.3A** and **D6.4.3B**).

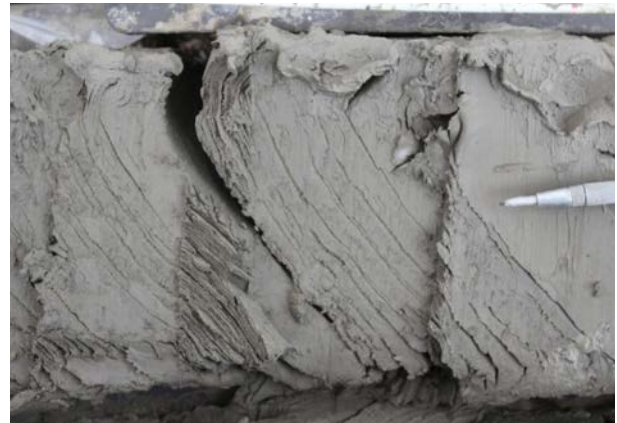
FIGURE D6.4.3B: UPPER GLU WITHIN BREACH AREA

At SH14-03 the bedding near the top of the Upper GLU unit was inclined (see **Figure D6.4.3B**), which is consistent with the observations reported by KCB at TP14-01. At SH14-06 the bedding within part of the Upper GLU unit was observed to be severely deformed with overturned folds and chaotic bedding orientations that may be indicative of the zone of shear that was involved in the failure (see **Figure D6.4.3C**). See section 6 of the main report for further discussion related to the failure mechanism.

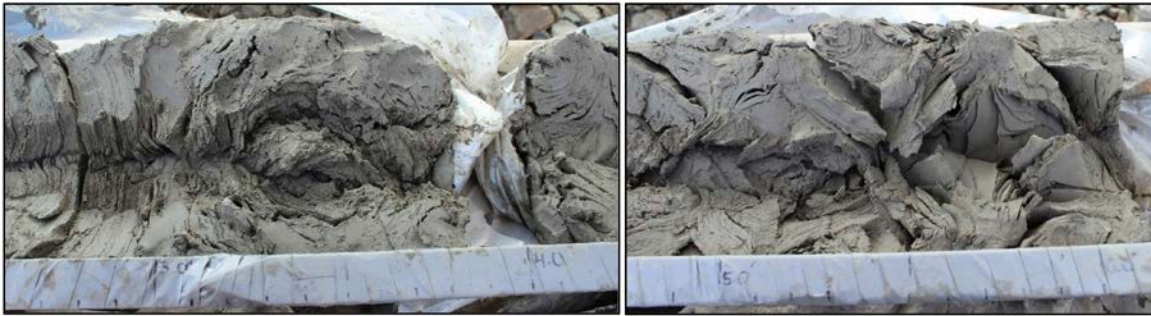
FIGURE D6.4.3C: POSSIBLE SHEAR ZONE IN UPPER GLU

Some of the observed deformations may be a result of, or modified by, the sonic drilling and sample extrusion methods. However, due to the inconsistent and non-systematic nature of the observed deformations, and based on previous experience with the sonic drilling method, it is unlikely that all of the observed features are drill induced.

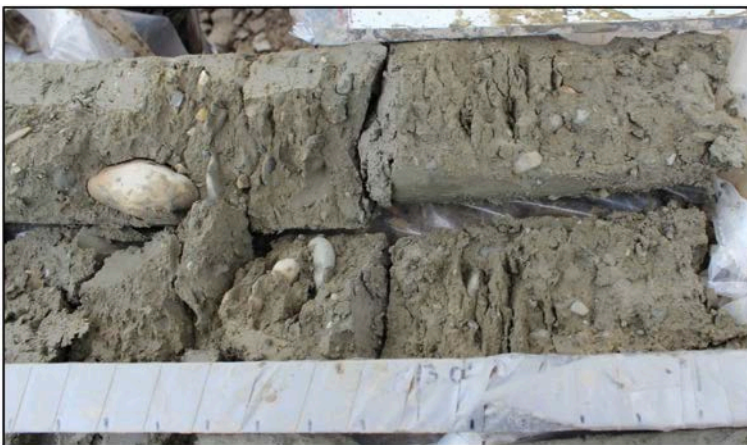
Similar to the Upper Till, the grey basal till is highly variable ranging from very stiff to hard sandy clay to very dense sand and silt, with gravel content ranging from trace to gravelly, including cobbles up to 150 mm. Soil structure is typically massive within the grey basal till as shown in **Figure D6.4.4**. Index testing on the relevant fractions suggest moisture content varies from approximately 5% to 20% and the plasticity index varies from approximately 5 to 20.

CPT tip resistances (q_t) ranged from as low as 20 bar to over 200 bar. Peak values for the CPT are likely influenced by the presence of gravel.

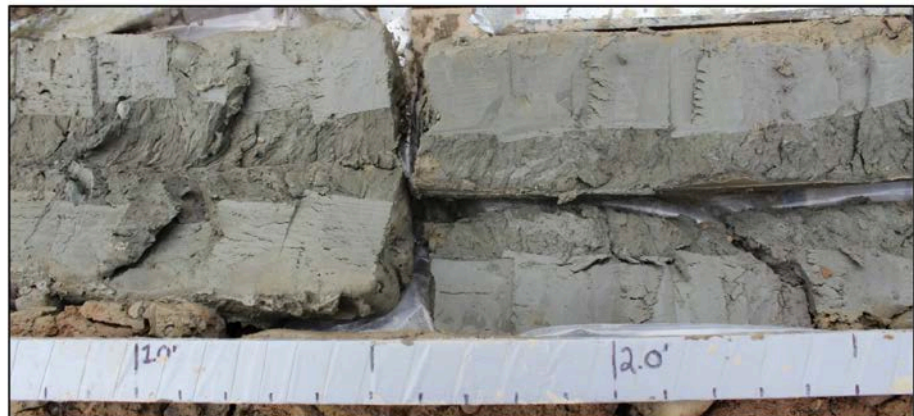
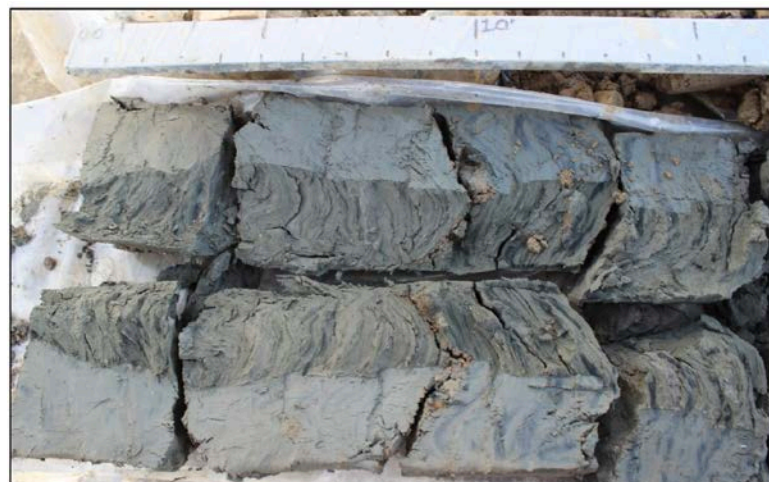
Soil structure in the recovered soil core was typically bedding that was highly variable and deformed in all locations where it was encountered (see **Figure D6.4.5A** and **D6.4.5B**). This contrasts with the Upper GLU that typically did not exhibit deformation distal to the breach. Occasional slickensides in random orientations are typical of this deposit. After careful review of the logs and sections, it was concluded that the slickensides are not continuous.

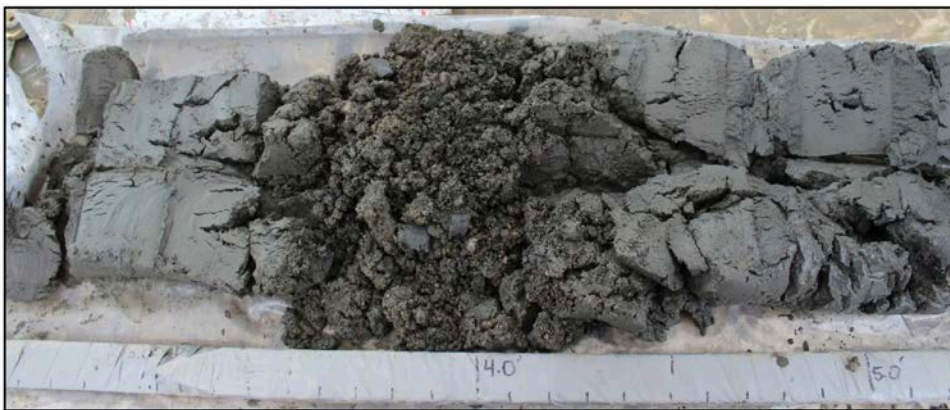
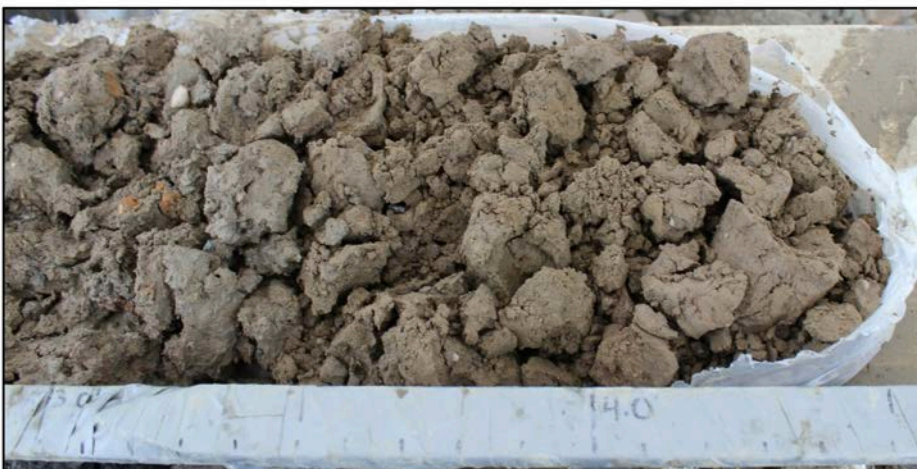
Compositionally, the glaciofluvial unit ranged from relatively clean sand and gravel mixtures, to fine sand and silt with fine organics. Typical particle size and grading varied significantly between and within beds (see **Figures D6.4.6A** and **D6.6.6B**). Colour ranged from dark grey (especially where organics present) to brown. Index testing on the relevant fractions suggest moisture content varies from approximately 10% to 25%, and the plasticity index (where measured) was 4 or less, indicating the behavior is generally non-plastic. CPT tip resistances (q_t) ranged from 80 bar to more than 200 bar, indicating this unit is compact to very dense. In several locations within the breach area this unit exhibited minor artesian pore water pressures especially at SH14-18.

Glaciofluvial deposits typically consisted of beds of highly variable thickness with some thick laminations in silty zones where depositional energy was apparently reduced especially approaching the lower surface of the overlying Lower GLU unit.

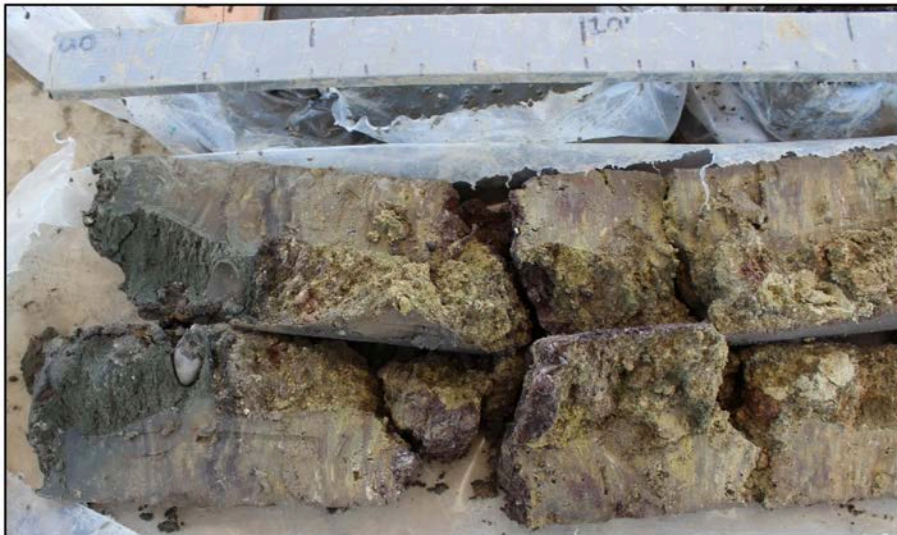
FIGURE D6.4.7: LOWER TILLS – MAROON BASAL TILL

The basal till was very stiff to hard in consistency within the sonic core sample with CPT tip resistances ranging from 100 to 300 bars in the few locations where it was measured. Index testing within this unit was less frequent, but where available the moisture content varies from about 5% to 30%.

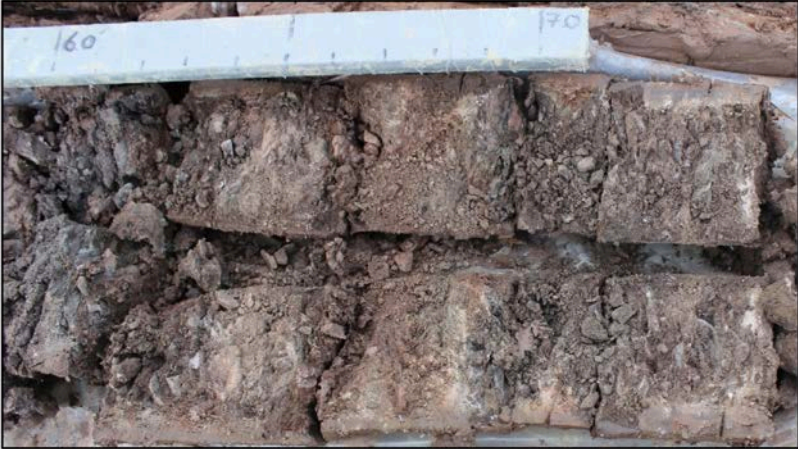
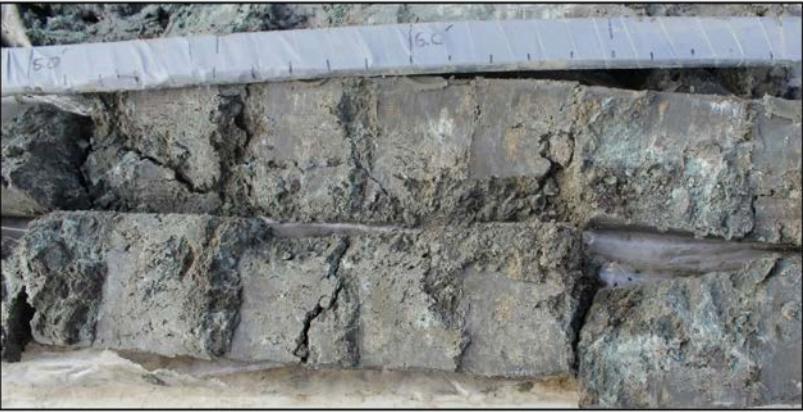
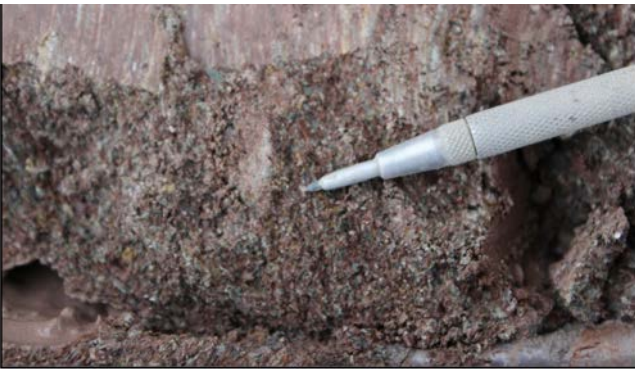
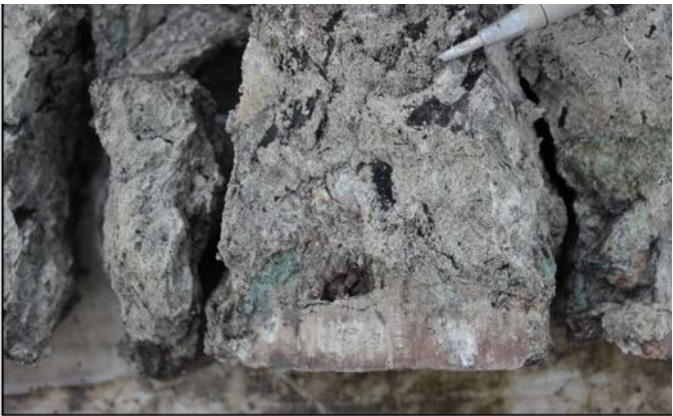
The bedrock within the investigation area varies significantly and rapidly between and within test holes. Intact competent bedrock was not encountered during the current investigation. The interpreted bedrock was identified by a transition to angular particles though the composition and consistency was often similar to the overlying till. Bedrock in the area has apparently been heavily modified and disturbed by tectonic deformation, hydrothermal alteration, intrusion and multiple glaciations. As a result the bedrock was observed to be substantially brecciated, altered, sheared, veined, and deformed.
