Independent Expert Engineering Investigation and Review Panel

Report on Mount Polley

Tailings Storage Facility Breach

Appendix F: Instrumentation and Monitoring

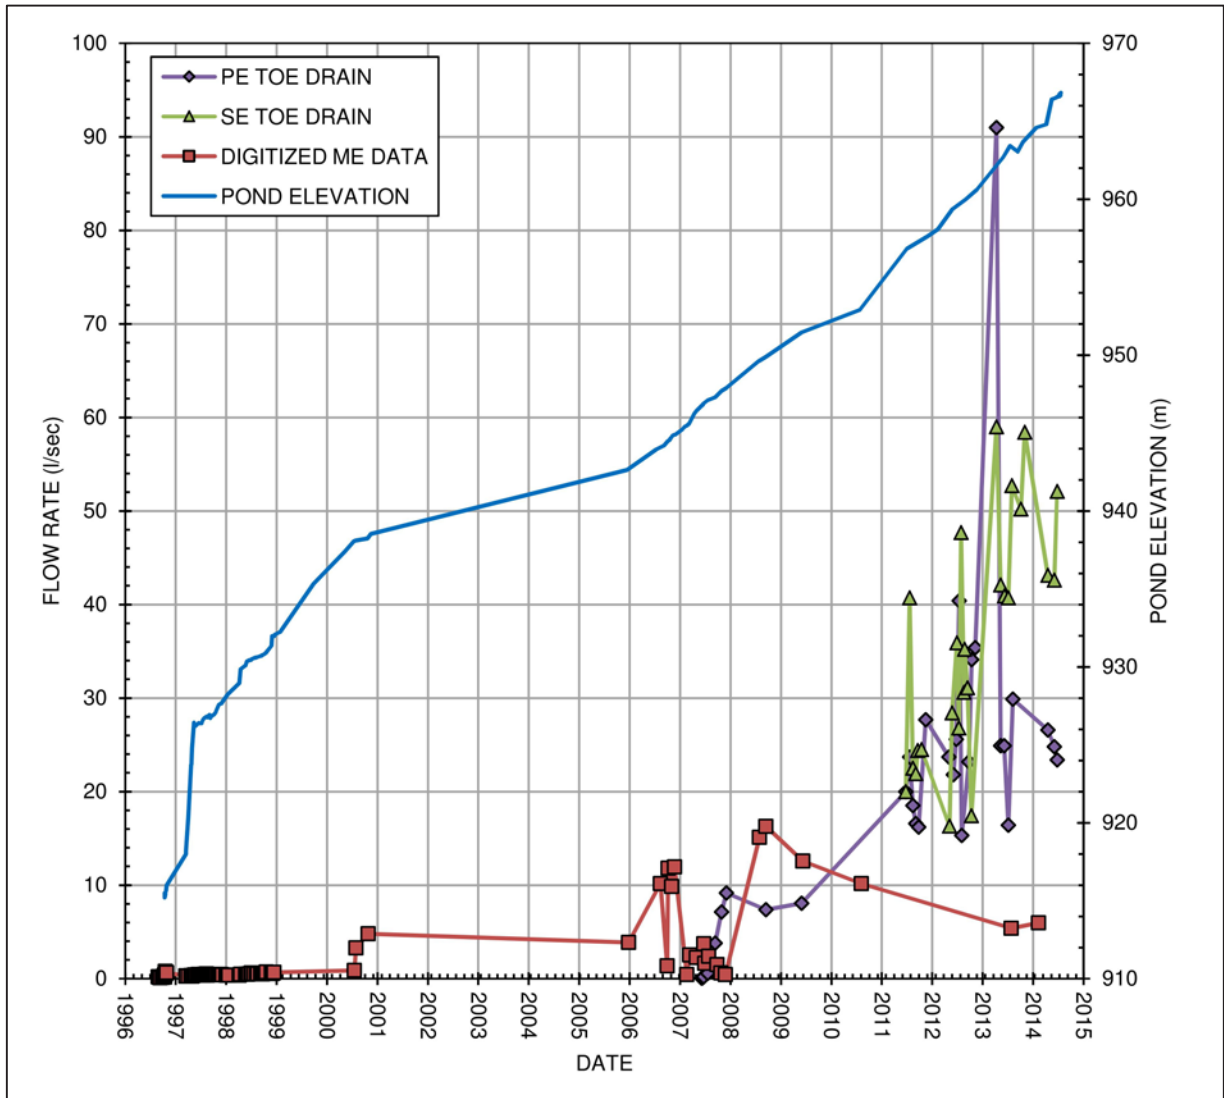
FIGURE F.1.2: MAIN EMBANKMENT, PERIMETER EMBANKMENT AND SOUTH EMBANKMENT DRAIN FLOW READINGS (FIGURE 2.2 MP00044)

Drain flow measurements from the foundation drains and chimney drain were initiated for the Main Embankment during the first phase of construction. Flow measurements were also initiated when similar drains were installed in the Perimeter and South Embankments. Upstream drains were installed in the tailings (also referred to as “upstream toe drains”⁴) at all the dams as they progressed in height, and these flows were also measured starting in 1996. Flows from these drains report to the respective seepage collection ponds constructed downstream of each of the dams. These flows were measured on a monthly basis (weather permitting) in a manifold for the Main Embankment and across the ditch profiles close to the ends of the outlet pipe for the Perimeter and South Embankments.⁵ Drain flow readings are shown in **Figure F.1.2**.⁶

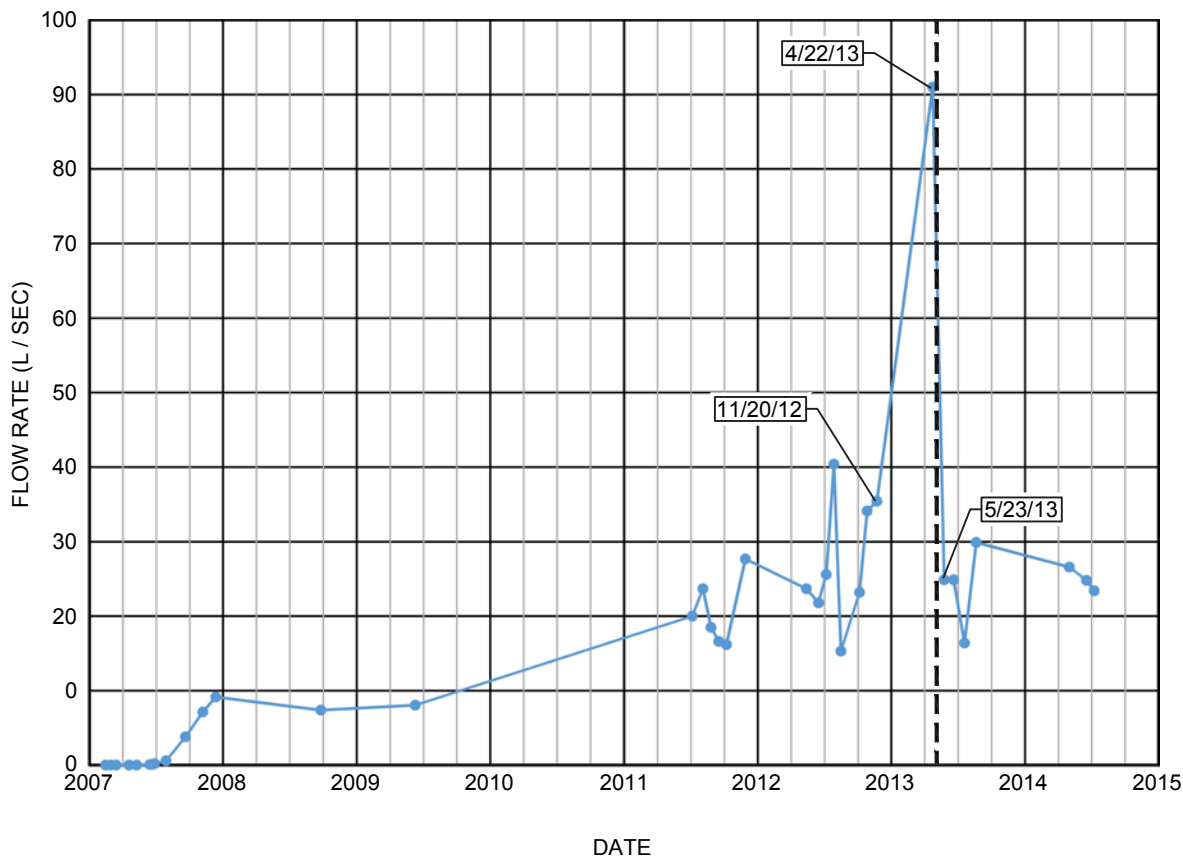
FIGURE F4.1: PERIMETER EMBANKMENT INTERPRETED UPSTREAM TOE DRAIN FLOWS

Prominent in the figure is an anomalously high flow rate of 90 litres/sec on April 22, 2013, the sole reading during the winter of 2012-2013, bracketed by readings on November 20, 2012 and May 23, 2013. Toe drain flows also varied erratically before and after, although to a lesser extent. The true extent of variability in seepage flows is masked by linear interpolation between the infrequent readings plotted in the figure, for example the extended period between mid-2009 and mid-2011 where readings are absent altogether.

Nevertheless, qualitatively similar patterns of transient and frequent seepage spikes have been associated with internal erosion in till-core dams elsewhere.¹⁰ Accordingly, this hypothesis was considered in relation to the Mount Polley Perimeter Embankment.

For reference, the toe drain is located 9.6 m above the cavity discovered in the core at the breach section, as documented in Appendix C. Also for reference, on April 22, 2013 tailings discharge into the Zone U cells was occurring between Stations 4+500 and 4+600 on the Perimeter Embankment.¹¹ A concrete-encased pipe conveying toe drain seepage passes through the dam at this location.¹²

Concurrent piezometric response around the date of the seepage excursion was examined at Instrumentation Section D. As shown in Drawing F3, piezometer D2 (formerly D1-PE1-02) is located in a transverse offtake to what was once planned to be a longitudinal drain on the downstream slope of Raise 1. This drain was subsequently covered by cycloned sand deposited during the downstream trial conducted in this area. Piezometers D6 and D7 are located in glaciolacustrine and glaciofluvial units, respectively, beyond the toe of the dam at the same section. On, or about April 22, 2013, muted responses were detected in all three piezometers, with drain piezometer D2 responding somewhat before, and foundation piezometers D6 and D7 slightly after.

Together with the toe drain seepage spike, these piezometric responses could be interpreted as indicative of a hydraulic connection through the dam core produced by internal erosion.

- It is difficult to reliably establish a characteristic pattern from the infrequent toe drain readings taken at irregular intervals.
- The toe drain discharge reports to an open-flow ditch upstream from the measuring point,¹³ potentially allowing surface runoff contributions or other inputs from site activities.
- Re-routing of toe drain conveyances and other construction activities during 2012 and 2013 may have affected flow measurements and/or measured flows.
- It is not immediately clear how internal erosion of the core could increase seepage flows into the toe drain located upstream from it.
- It is not possible to establish the location of seepage entry into the toe drain.

For these reasons, on balance, the toe drain seepage flows are judged to be inconclusive with regard to internal erosion.
