Independent Expert Engineering Investigation and Review Panel

Report on Mount Polley Tailings Storage Facility Breach Media Presentation

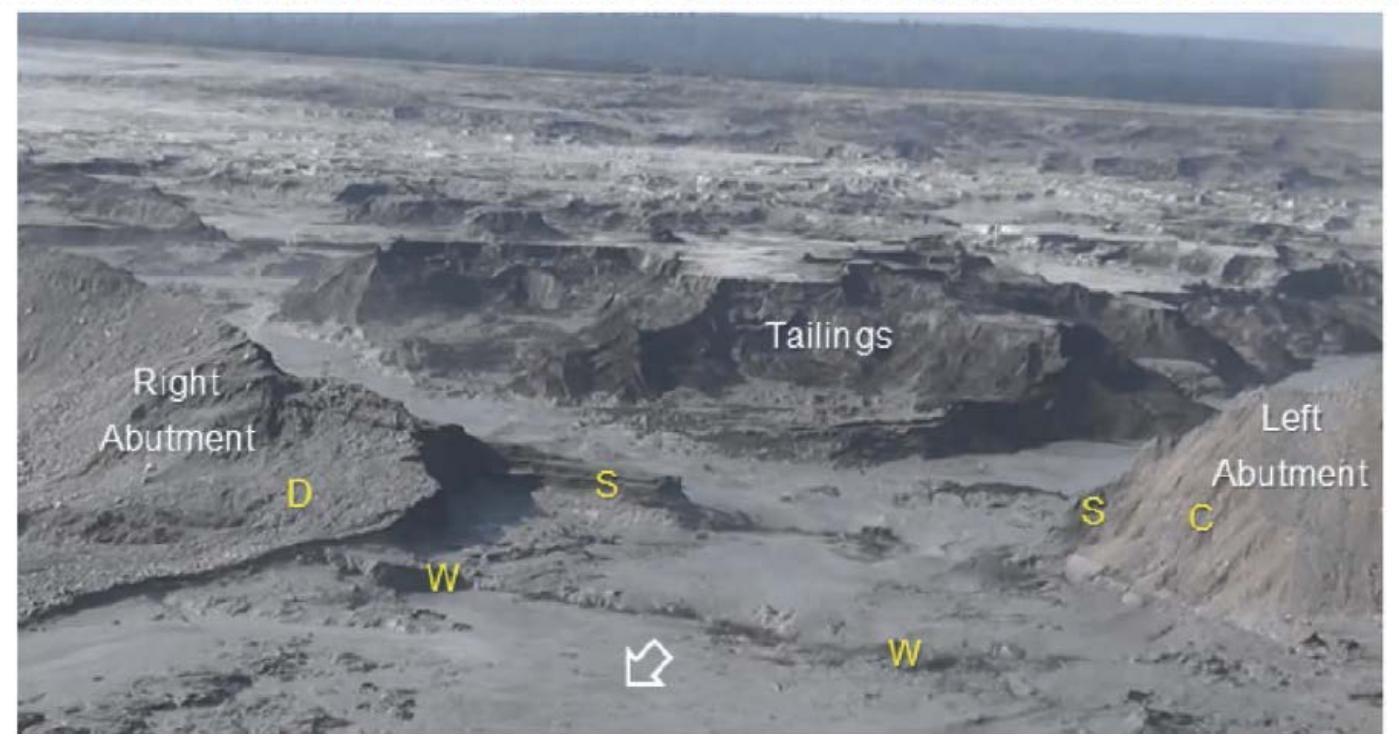
FIGURE 5.1.1: VIEW LOOKING UPSTREAM THROUGH THE BREACH (ARROW SHOWS DIRECTION OF OUTFLOW)

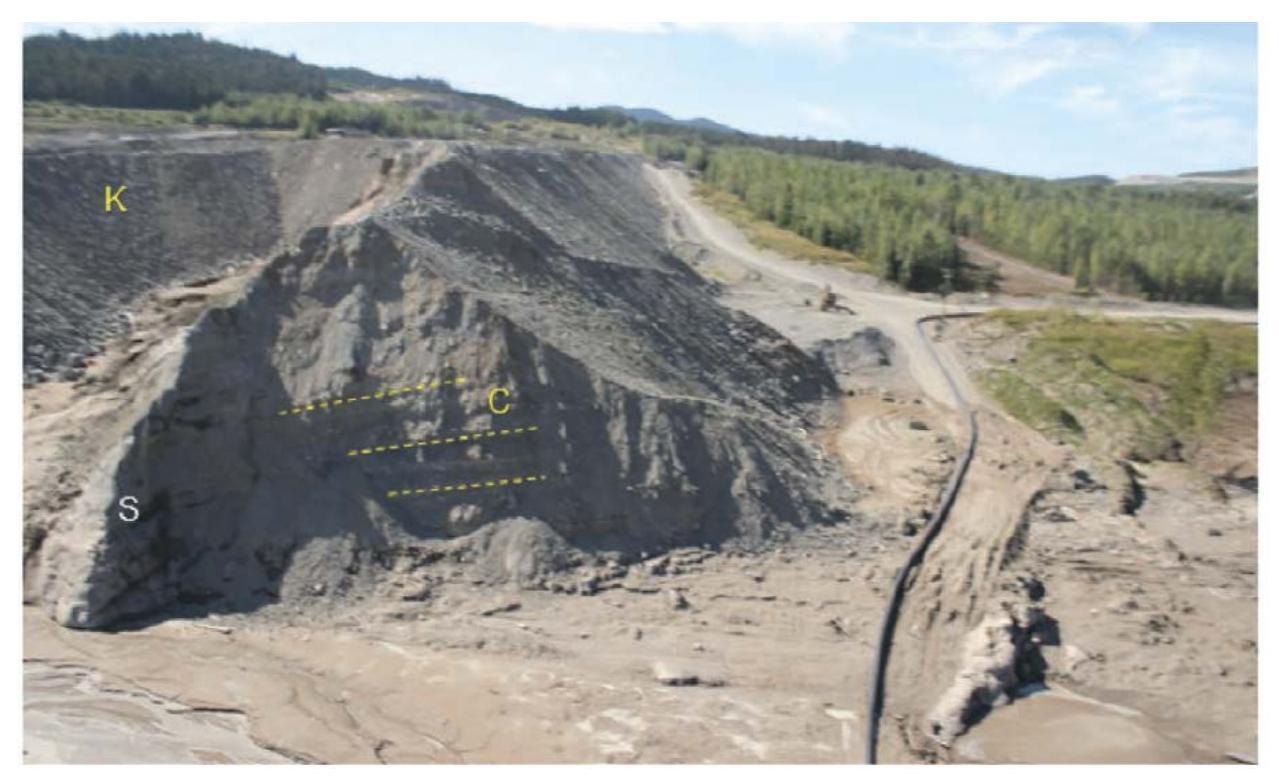
FIGURE 5.1.5: APPARENT BEDDING ROTATION ON LEFT ABUTMENT OF BREACH (SEPT. 4, 2014 PHOTO)

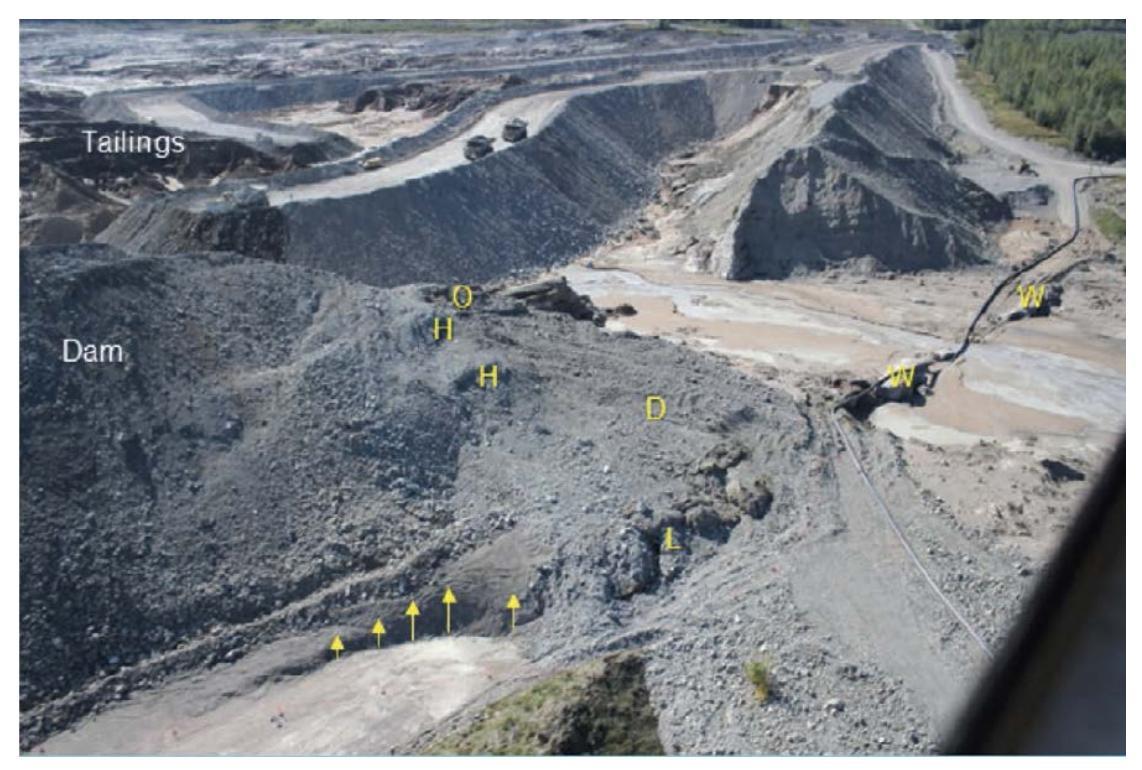
FIGURE 5.1.6: SLIDING-RELATED FEATURES AT RIGHT ABUTMENT (SEPT. 4, 2014 PHOTO)

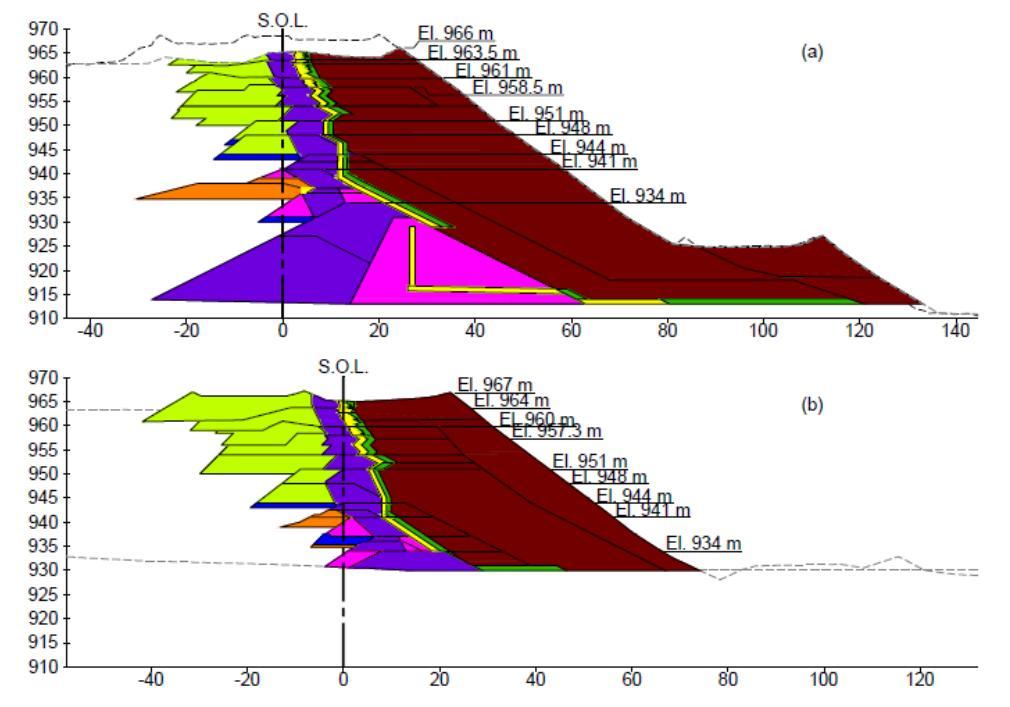
FIGURE 5.4.10: DAM CONFIGURATION ON AUGUST 3, 2014. (a) MAIN EMBANKMENT (b) PERIMETER

EMBANKMENT AT BREACH SECTION

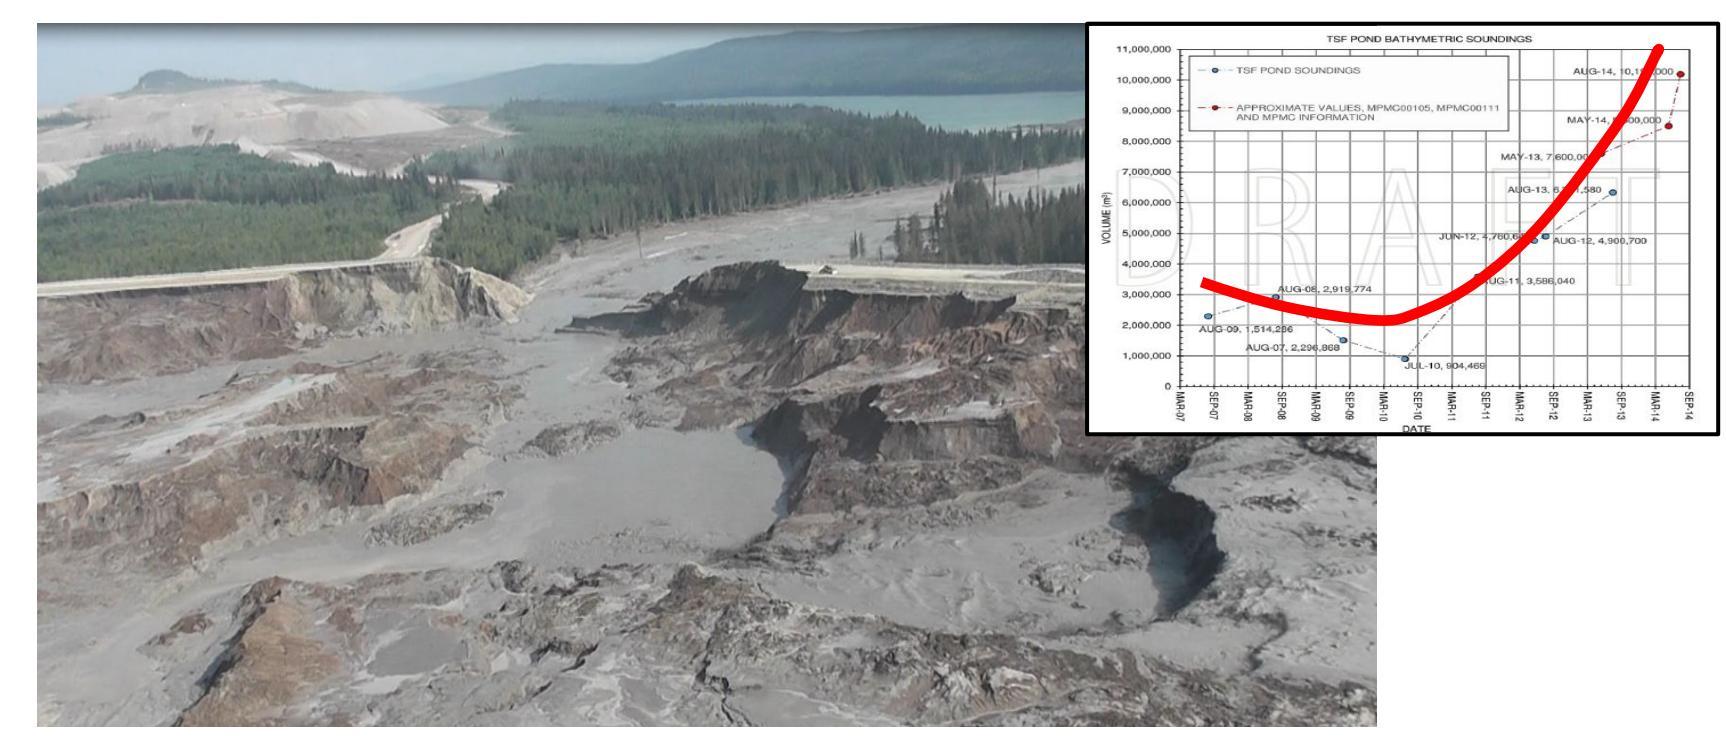
• Most of the tailings were released by erosion from the large volume of water available

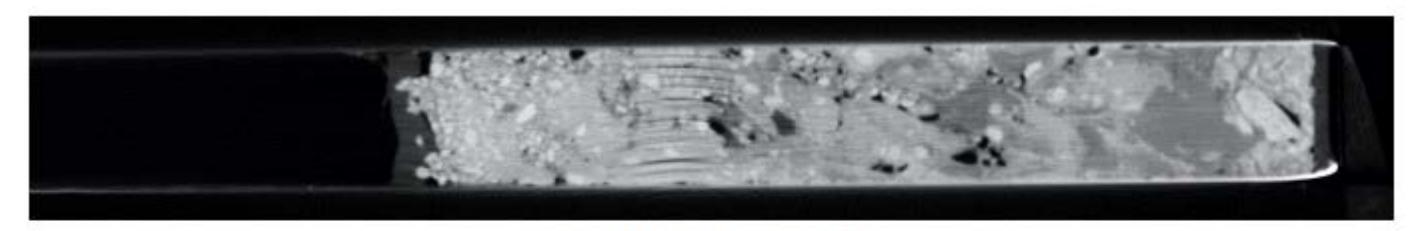
TILL SAMPLE (MR14-104-SA8)

DEPTH: 11.4 TO 12.0 M / EL. 920.3 TO 919.7 M

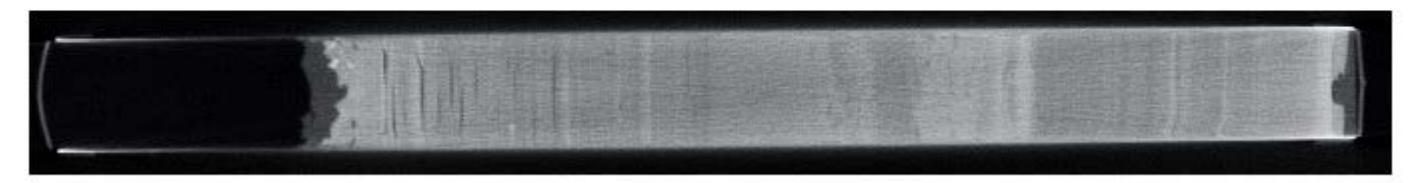
UPPER GLU SAMPLE (MR14-106E-SA3)

DEPTH: 8.2 TO 8.8 M / EL. 920.5 TO 919.9 M

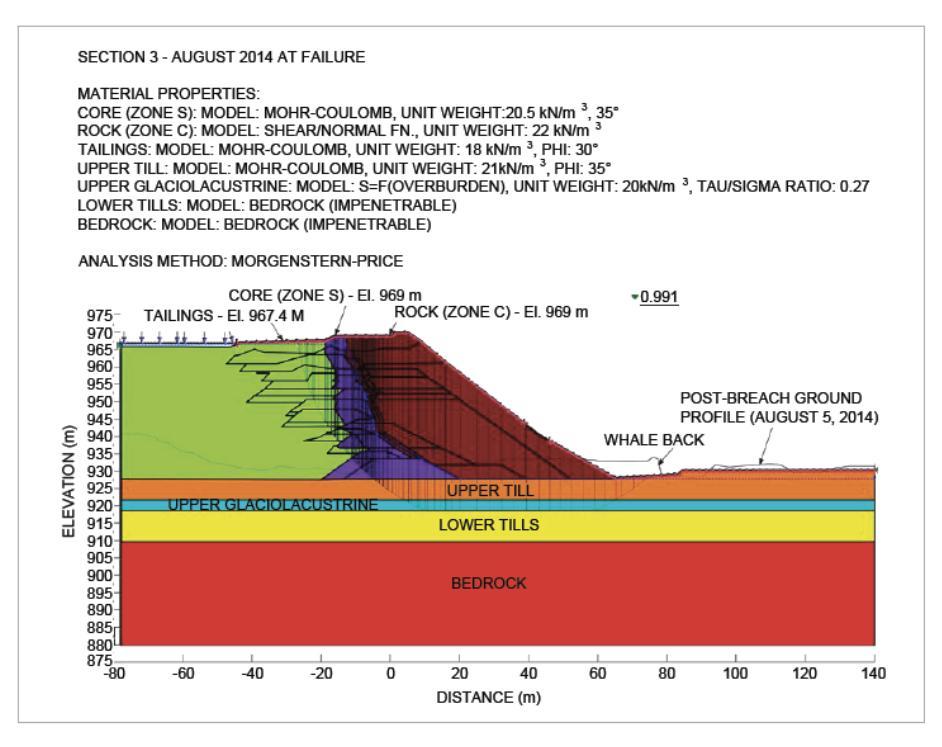
FIGURE 6.2.1: DETAILED SECTION USED FOR LIMIT EQUILIBRIUM ANALYSIS (HIGH WATER TABLE, UNDRAINED STRENGTH RATIO 0.27)
