TAILINGS STORAGE FACILITY REPORT ON 2009 ANNUAL INSPECTION

Mount Polley Mining Corporation P.O. Box 12 Likely, BC V0L 1N0

Knight Piésold Ltd. Suite 1400 – 750 West Pender Street Vancouver, BC V6C 2T8

VA101-1/27-1 Rev 0 December 18, 2009

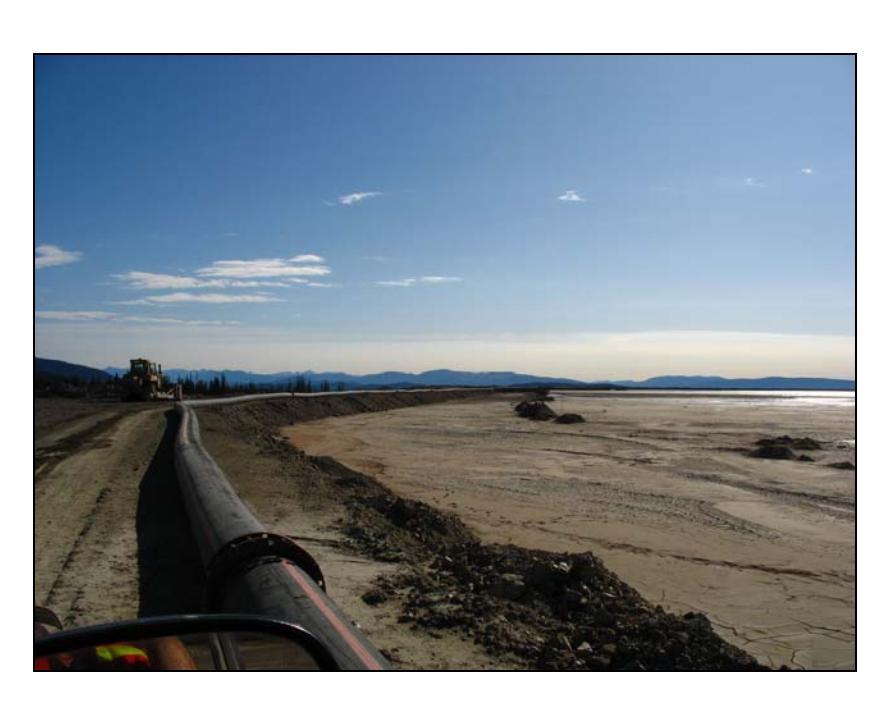
PHOTO 1 – Tailings beach development on the Perimeter Embankment

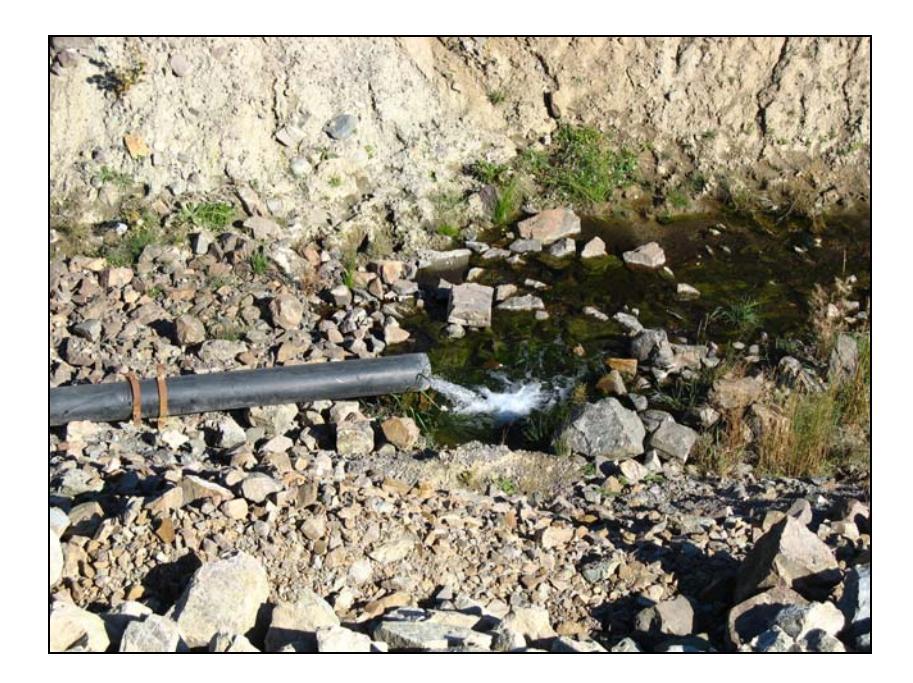
PHOTO 2 – Perimeter Embankment Toe Drain flow.

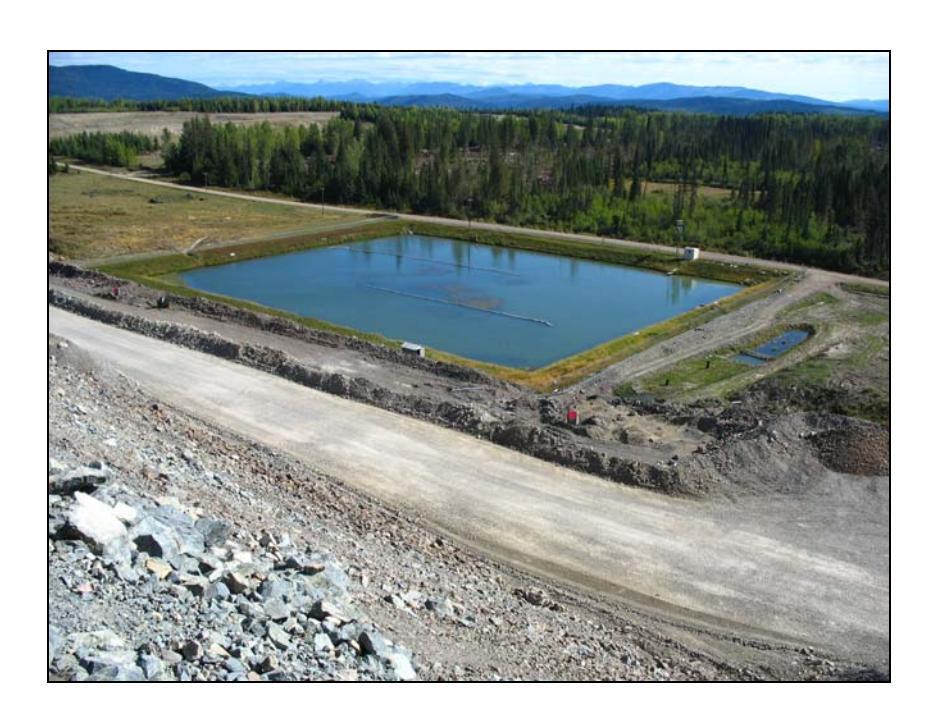
runoff. The seepage collection ponds were observed to be in good condition with no observed erosion activity.

PHOTO 3 – Main Embankment Seepage Collection Pond

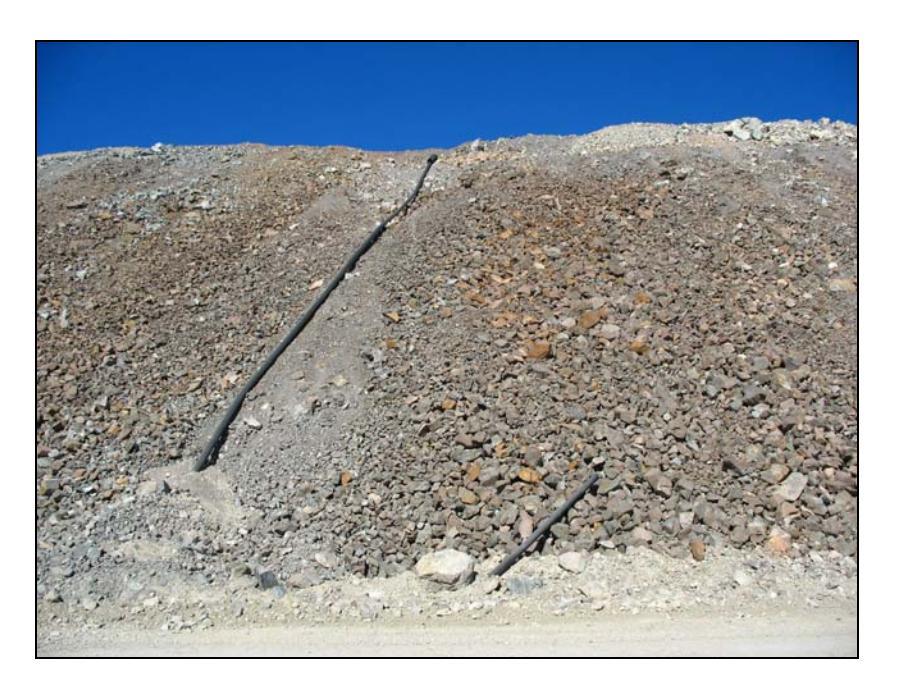
PHOTO 4 – Main Embankment Seepage Collection Pond Return Pipe

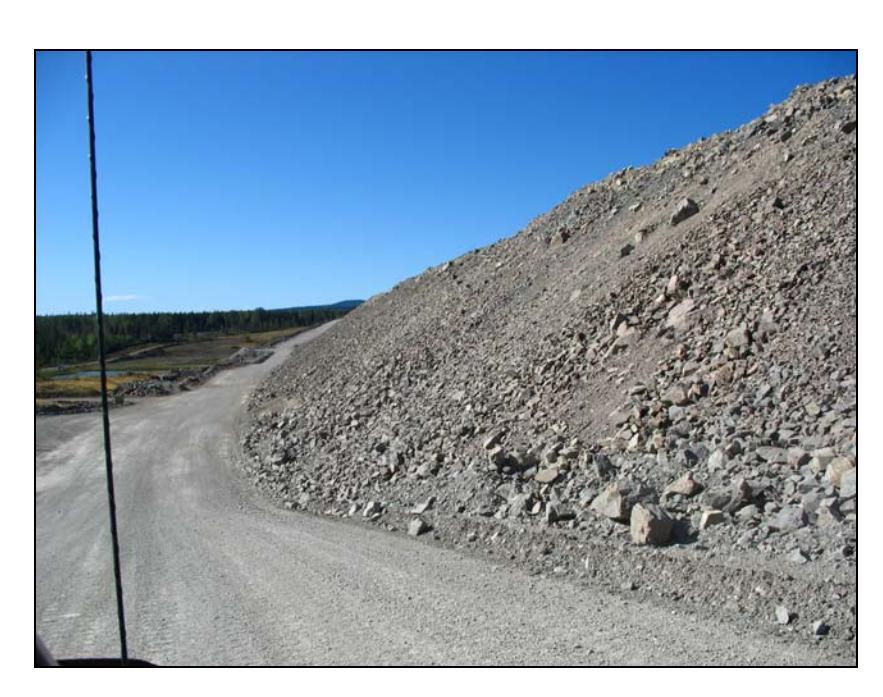
- No signs of distress were identified on the tailings embankments. The embankment slopes were approximately planar and there was no evidence of cracking, bulging or slumping in the embankment fill. The embankment crest appeared to be relatively level with no signs of differential settlement or distress. There was no evidence of animal burrowing.

PHOTO 5 - Main Embankment looking west

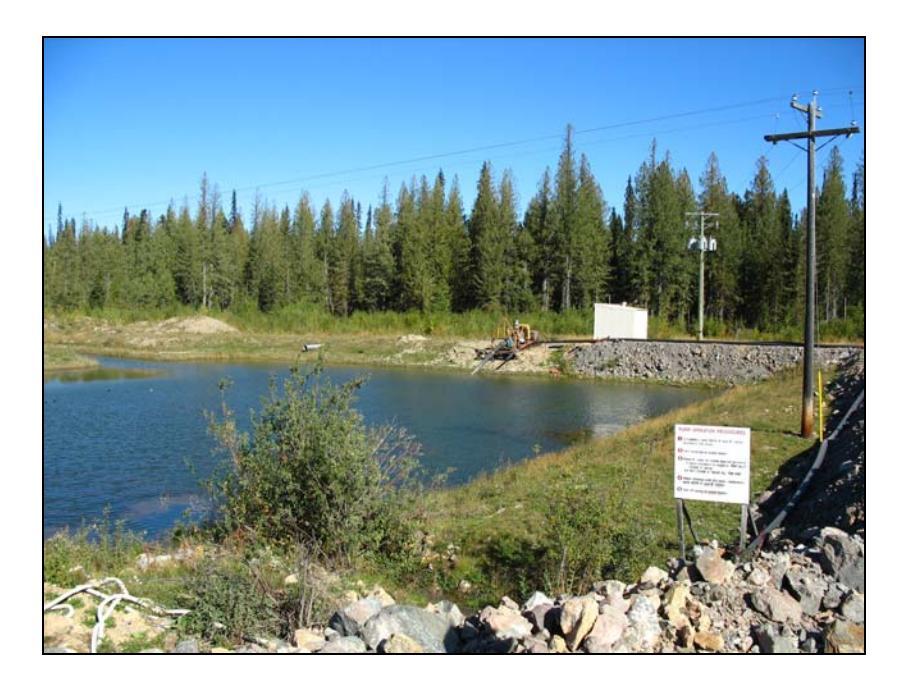
PHOTO 6 - Perimeter Embankment Seepage Collection Pond

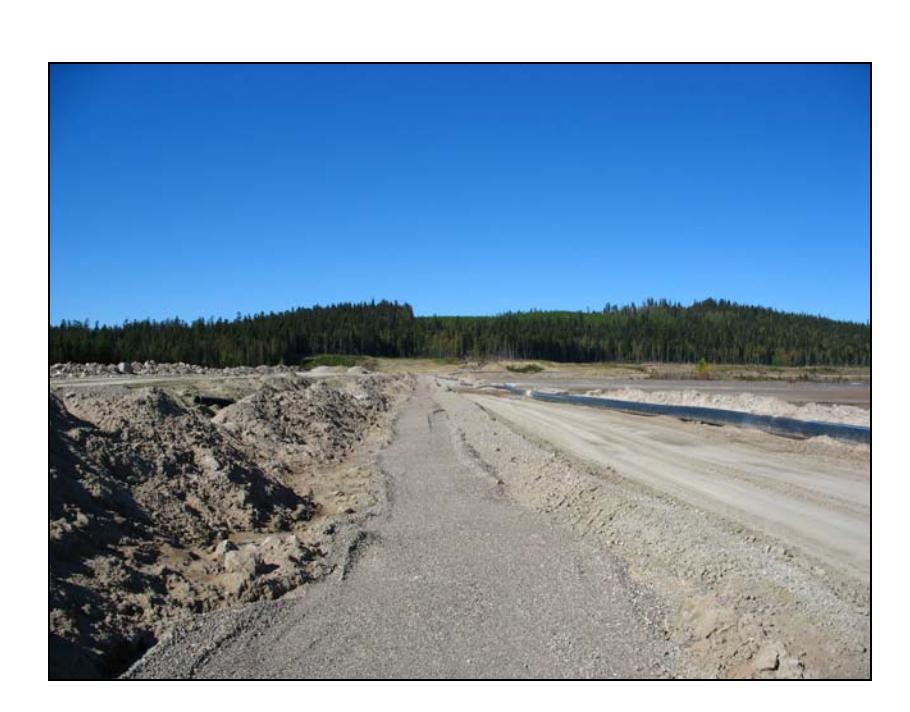
PHOTO 7 – South Embankment upstream toe drain.

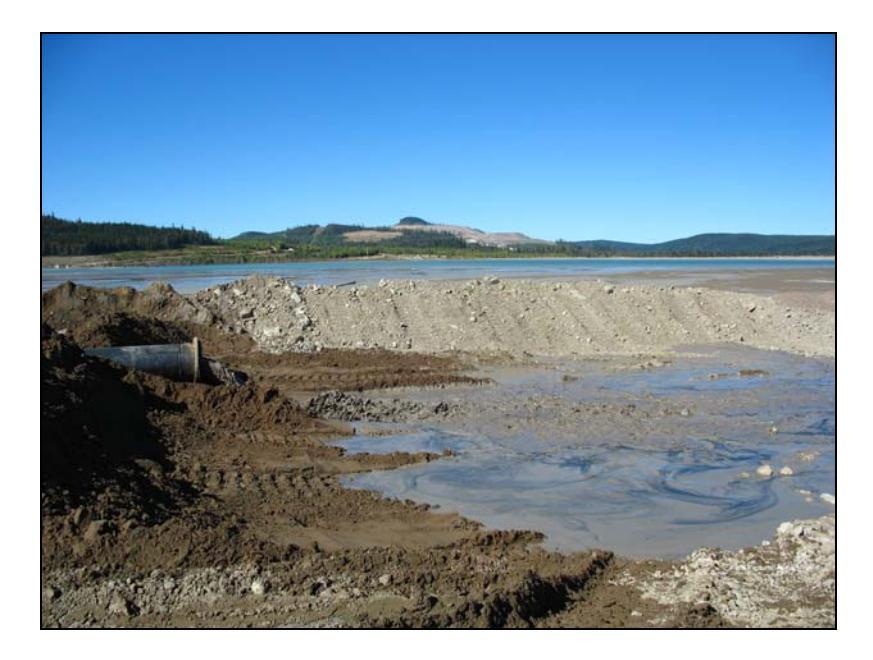
PHOTO 8 – Sand cell construction on Main Embankment.

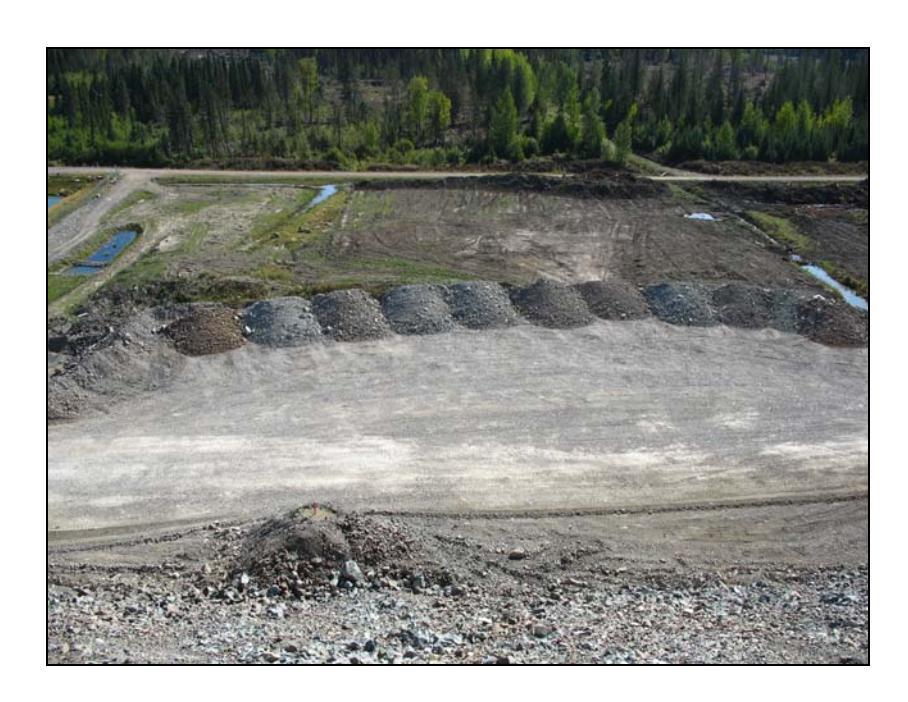
PHOTO 9 – Buttress construction at the Main Embankment.

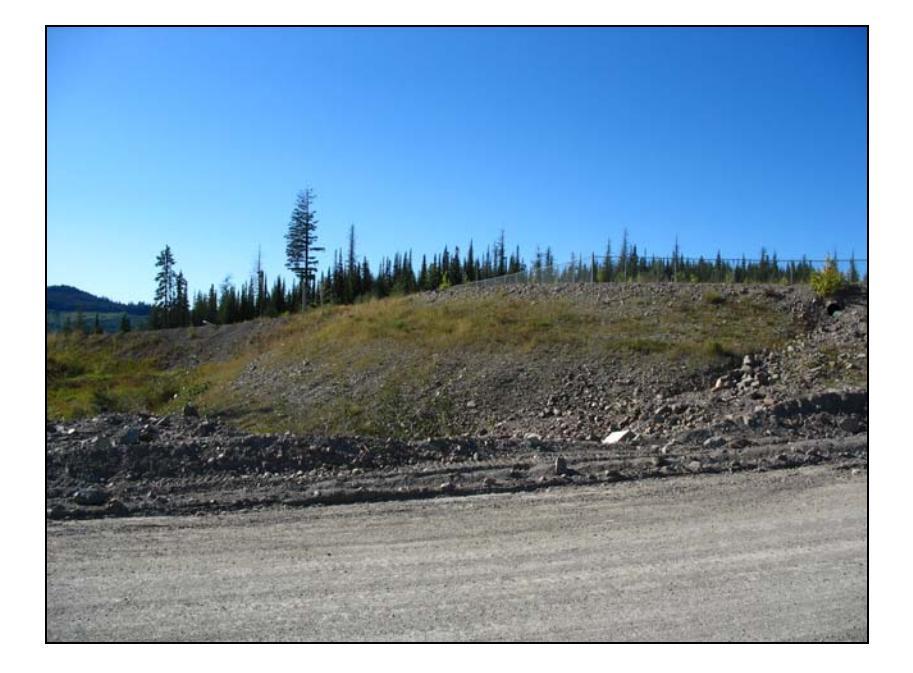
Surface water from the Mill Site Area is routed into the Mill Site Sump where it is transferred to the TSF via the tailings pipeline. The embankments at the Mill Site Sump were observed to be in good condition, and no cracks, seepage or slumping was noted. The emergency overflow culvert was clear of obstructions.

PHOTO 10 - Mill Site Sump Embankment

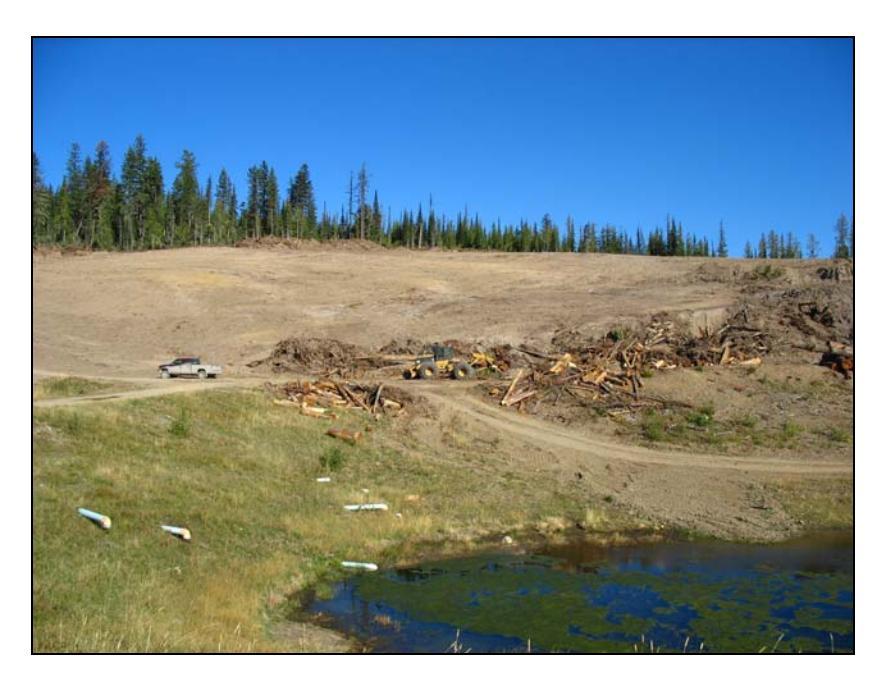
The Southeast Sediment Pond is no longer in service and runoff that previously reported to the Southeast Sediment Pond is now being routed to the Perimeter Embankment Seepage Collection Pond. The embankment at the Southeast Sediment Pond was observed to be in good condition.

PHOTO 11 - Southeast Sediment Pond, west end showing outlet pipes

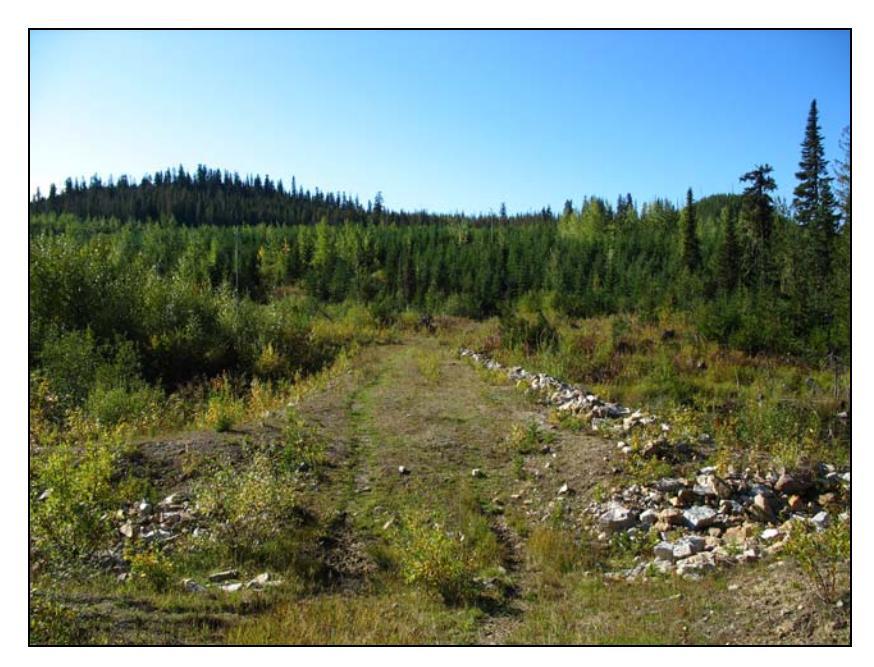
The South Bootjack Dam was observed to be in good condition at the time of the inspection. Observations include the following:

- The water level was low
- Both upstream and downstream fill slopes were in good condition, with no evidence of seepage or slumping
- No cracks were observed on the dam crest, and
- The spillway contained some minor vegetation, but was generally unobstructed.

PHOTO 12 - South Bootjack Dam
