## Electronic Field Vane Shear Test Plots

Job Number: 14-02091  
Client: Mount Polley  
Project: Mount Polley Mine, Likely, BC  
Sounding: VST14-03  
Sounding Date: 09-Oct-2014 14:38

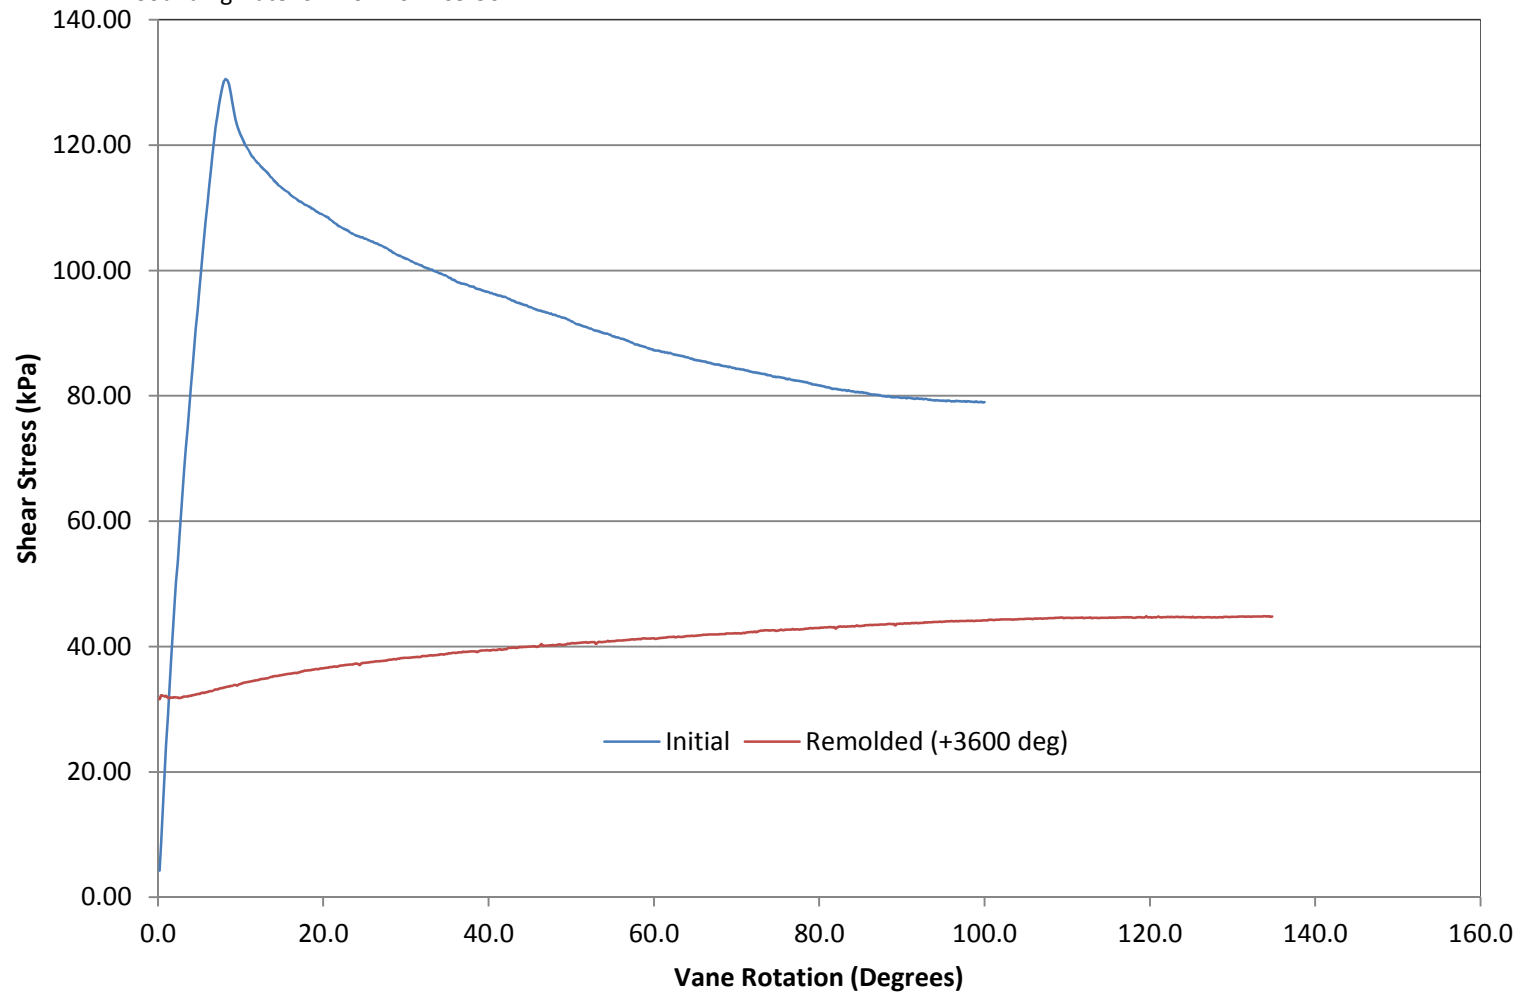
### Vane Shear Test

Job Number: 14-02091  
Client: Mount Polley  
Project: Mount Polley Mine, Likely, BC  
Sounding: VST14-22  
Sounding Date: 04-Nov-2014 09:56

Test Depth (m): 9.70  
Test Elevation (m): 920.1  
Vane Type: Tapered one end 50 x 110 mm
