Job Number: 14-02091  
Client: Mount Polley  
Project: Mount Polley Mine, Likely, BC  
Sounding: VST14-03  
Sounding Date: 09-Oct-2014 14:38

### Vane Shear Test

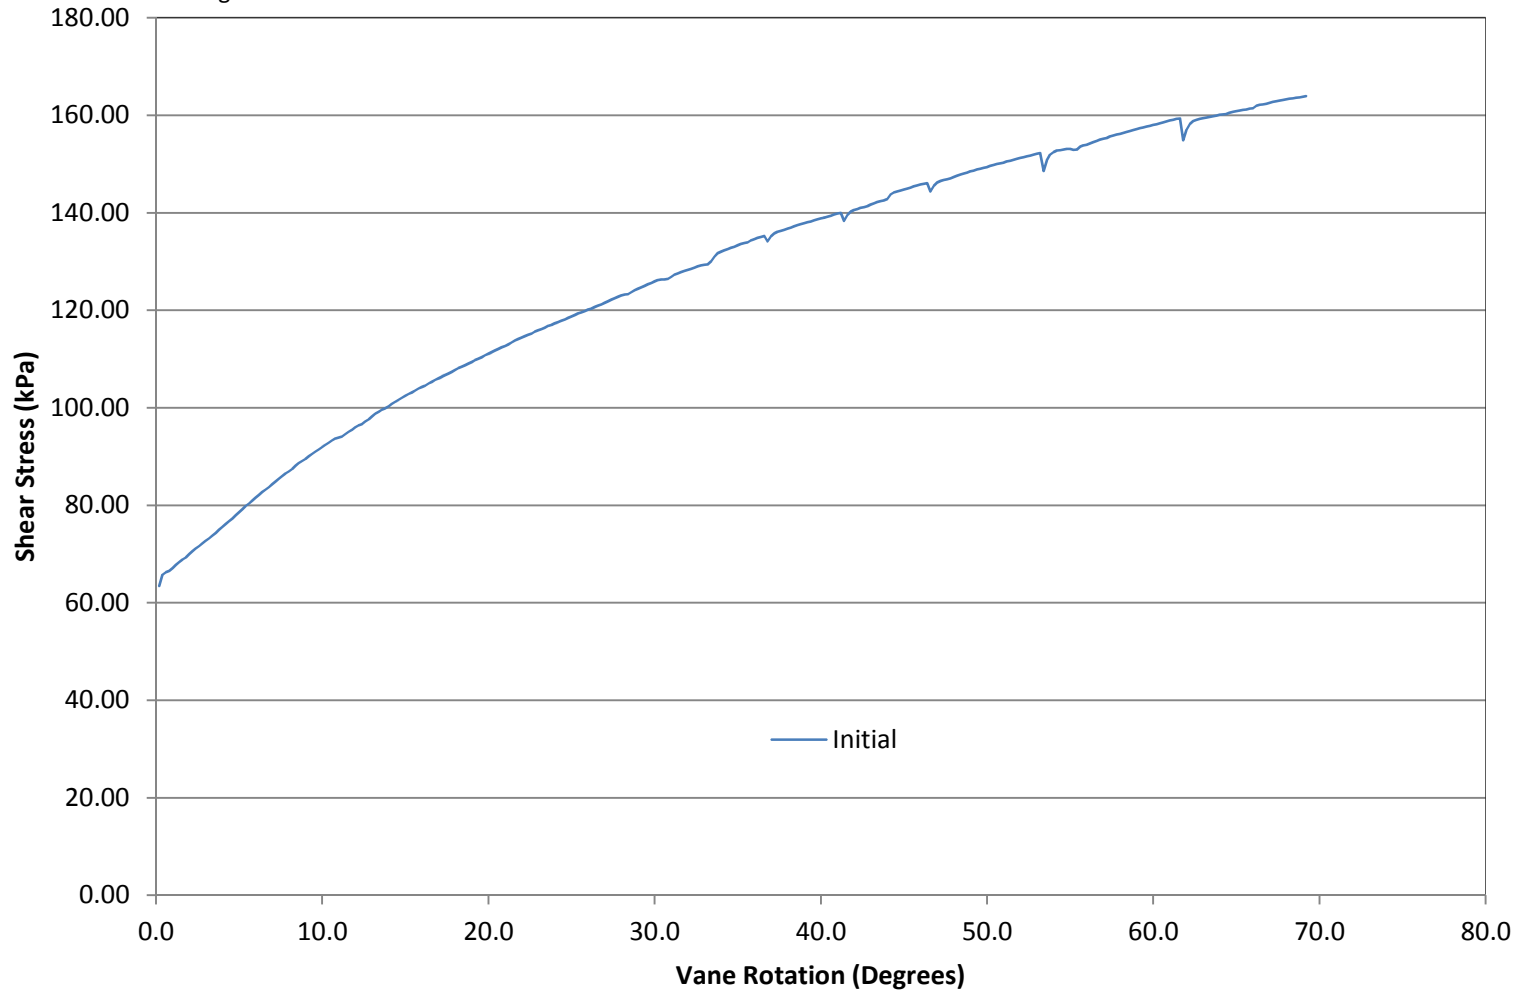
Test Depth (m): 6.93  
Test Elevation (m): 925.84  
Vane Type: Rectangular 55 x 110 mm

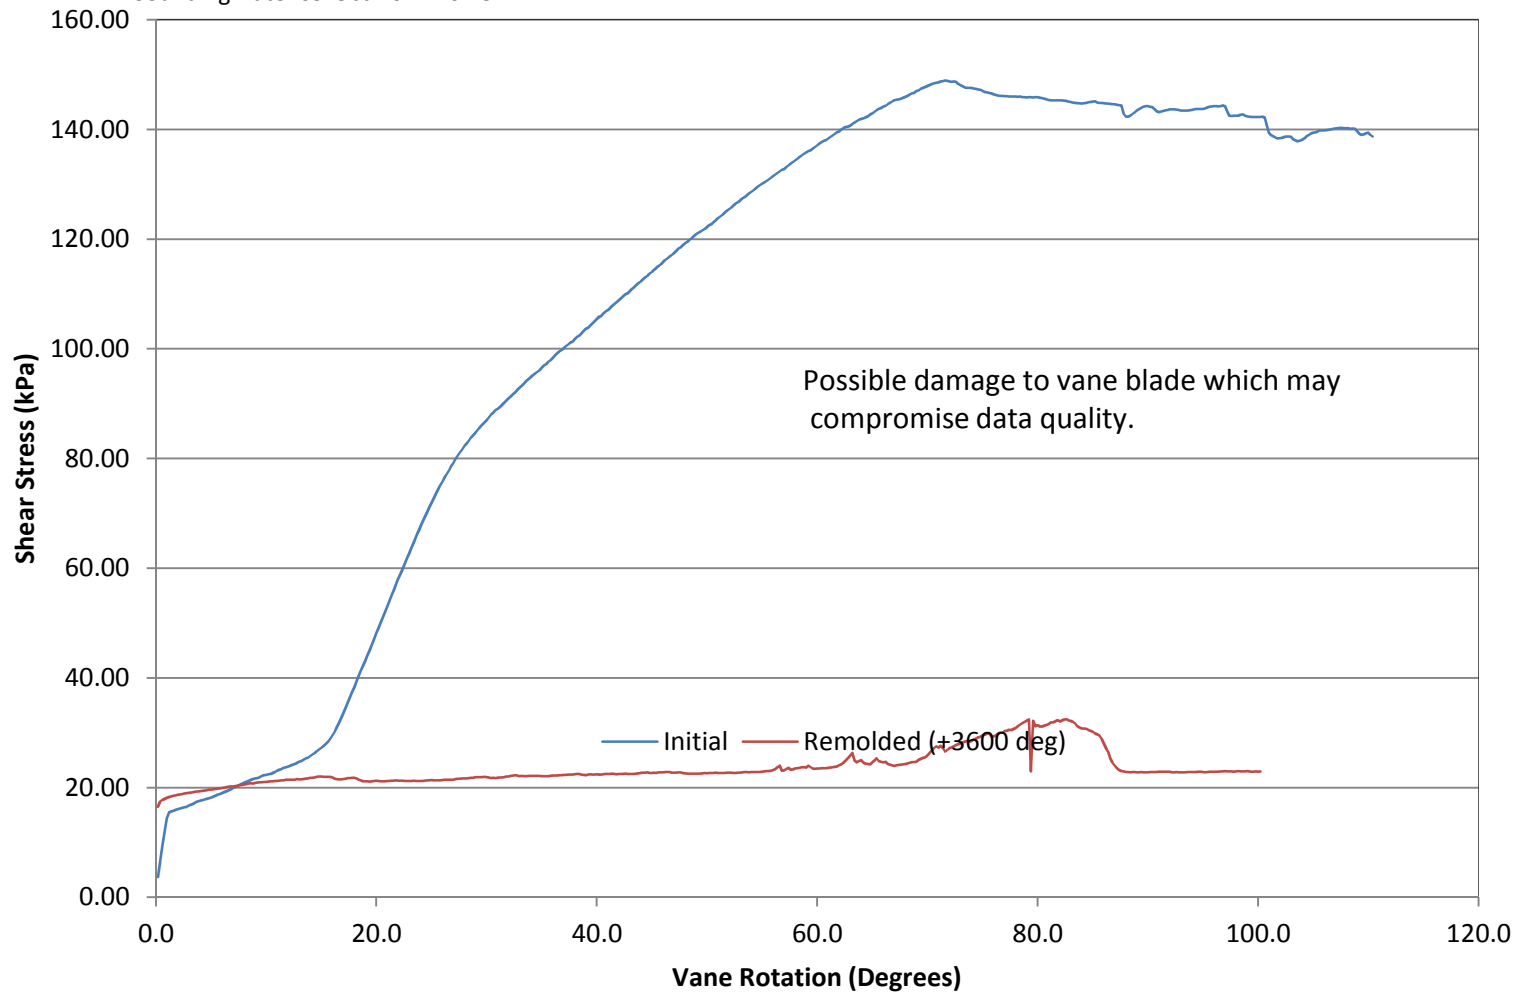
### Vane Shear Test

Test Depth (m): 12.20  
Test Elevation (m): 920.57  
Vane Type: Rectangular 55 x 110 mm

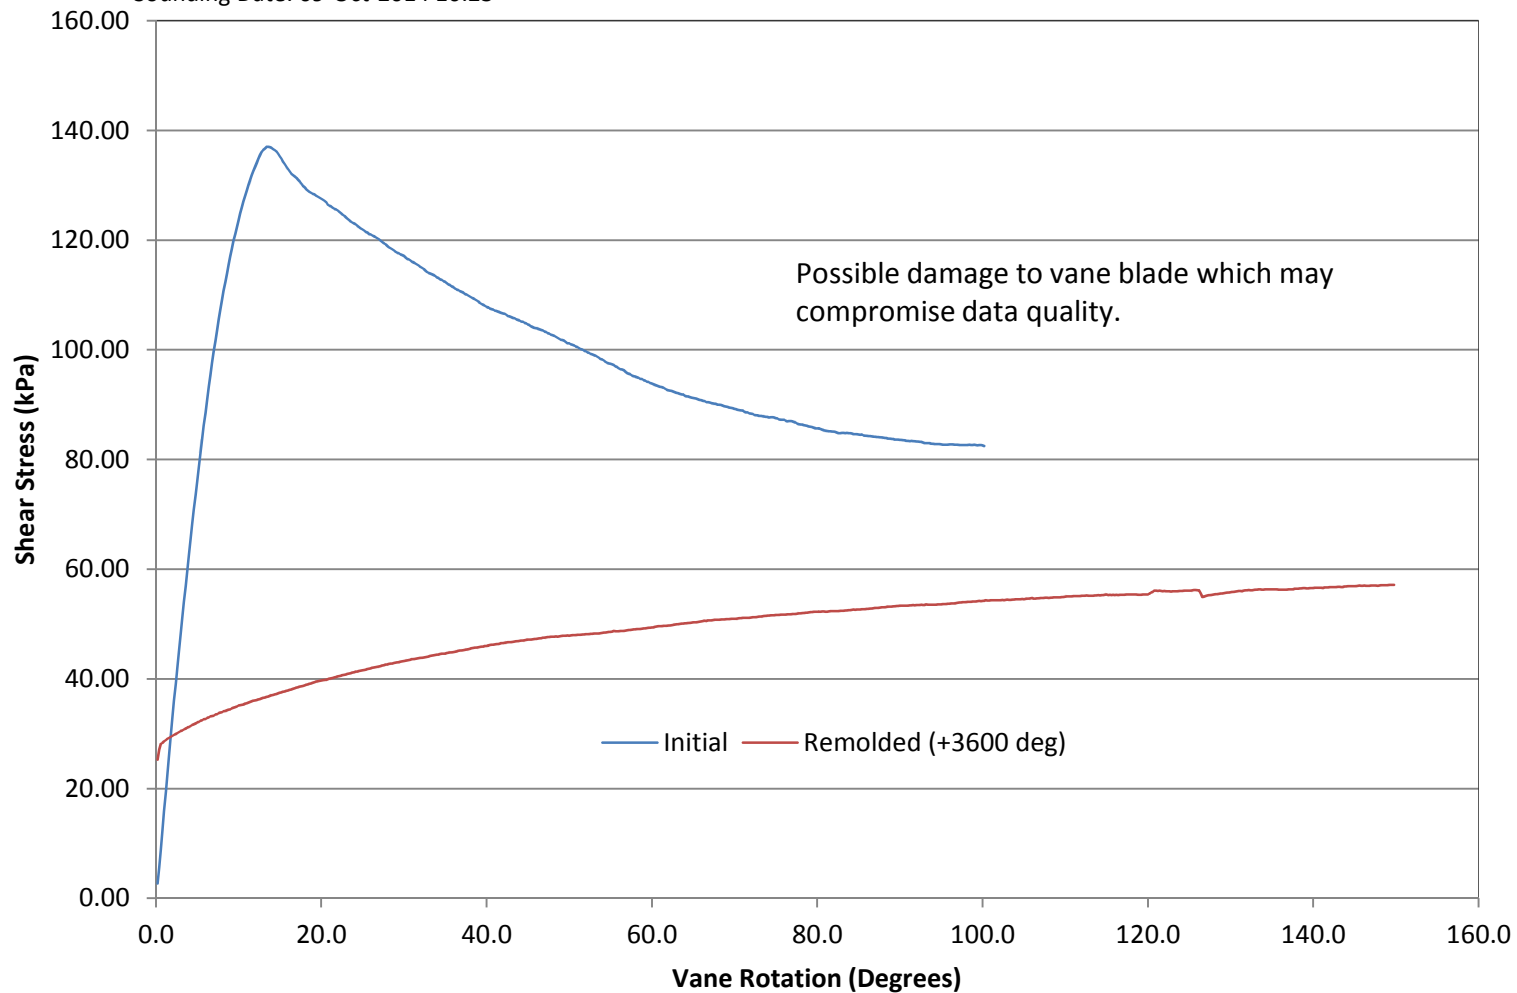
### Vane Shear Test

Test Depth (m): 12.50  
Test Elevation (m): 920.27  
Vane Type: Rectangular 55 x 110 mm
