Update on Mt Polley Failure

Dirk van Zyl

Mount Polley TMF Failed on August 4, 2014

Released: 10 million
cubic metres of water
and 4.5 million cubic
metres of tailings

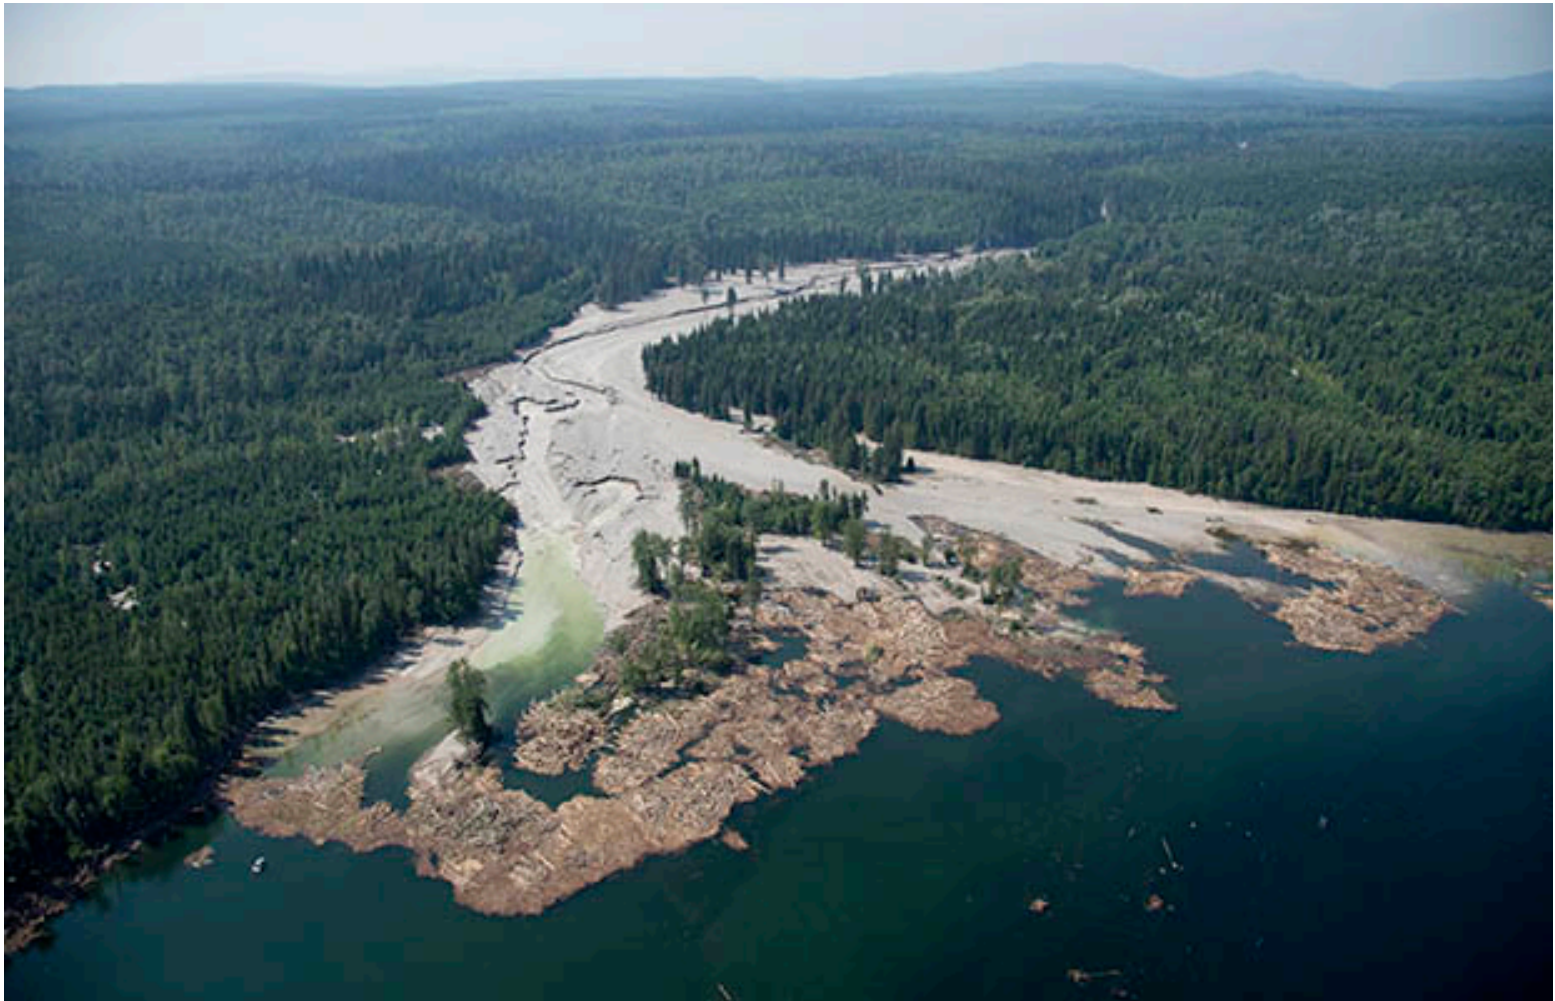
**Tailings near the Likely, BC August 5, 2014.
Hazeltine Creek in background (Vancouver Sun)**

- Time of failure: early morning of August 4, 2014 (BC Day)
- Flowed down Hazeltine Creek devastating the Creek Bed
 - Creek bed was 1 to 2m wide, now 50 plus meters, trees removed and tailings deposited

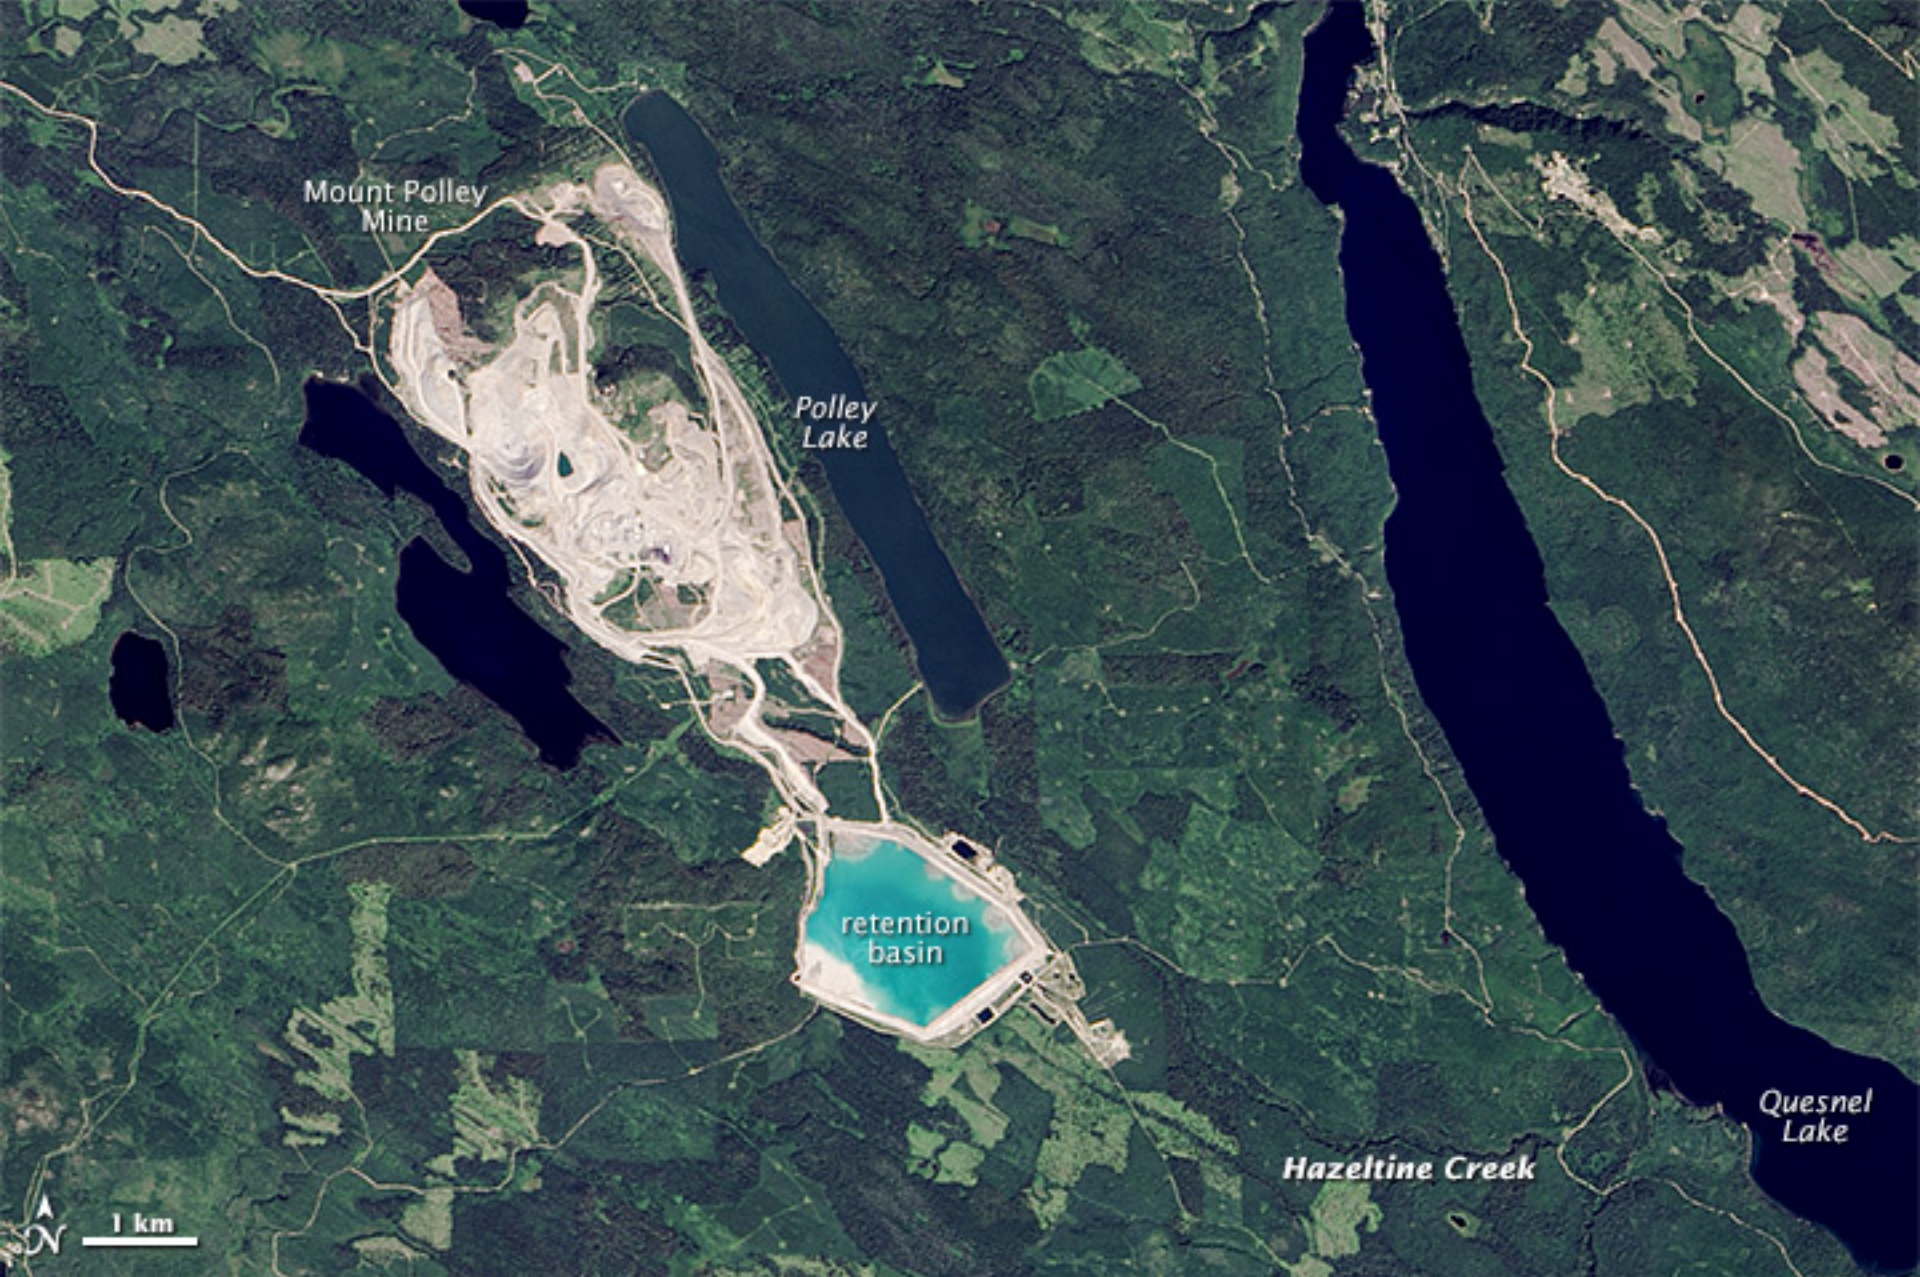
Satelite Images

Mount Polley
Mine

Polley
Lake

retention
basin

Hazeltine Creek

Quesnel
Lake

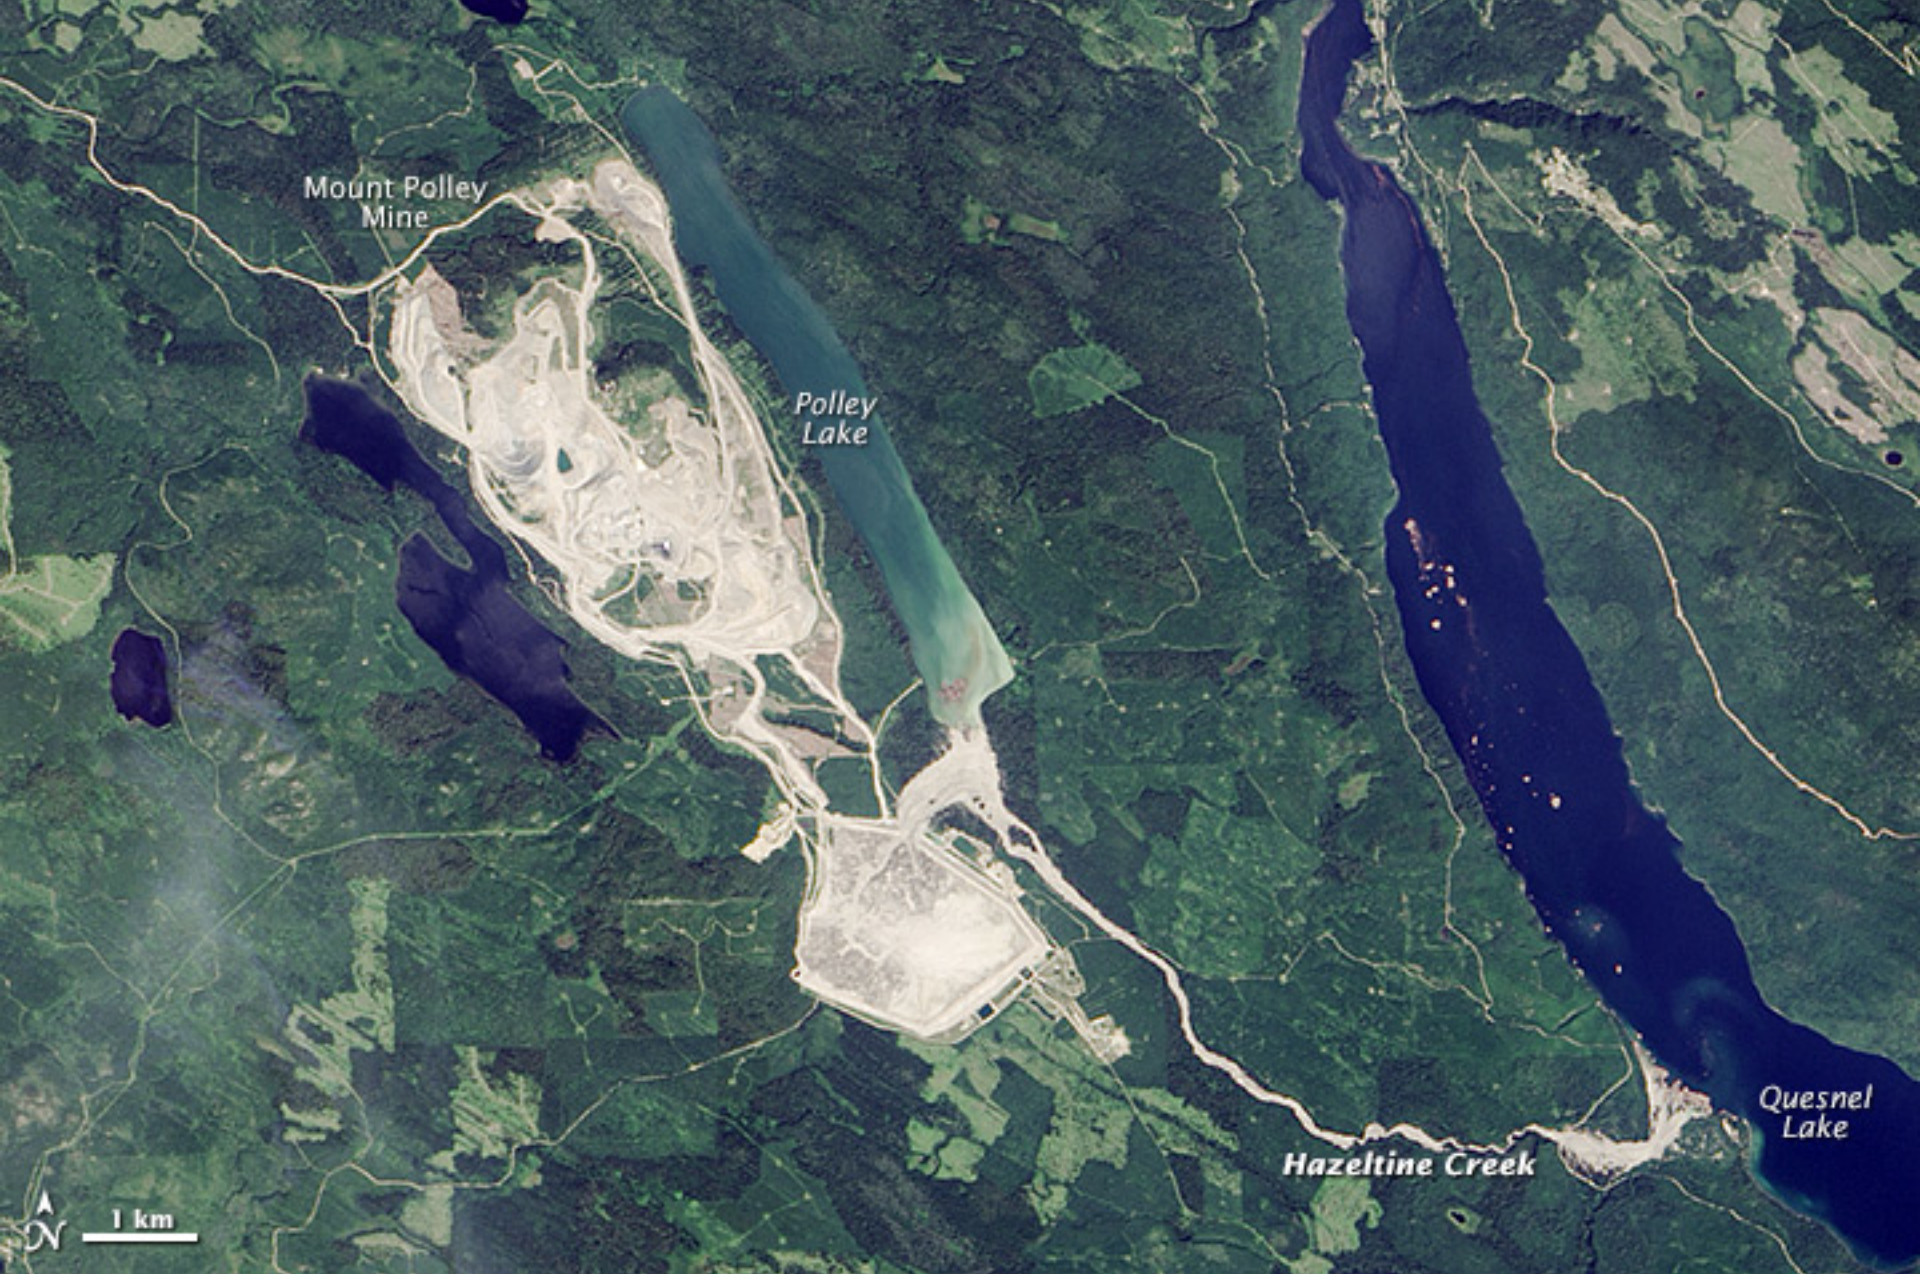
Mount Polley
Mine

Polley
Lake

Hazeltine Creek

Quesnel
Lake

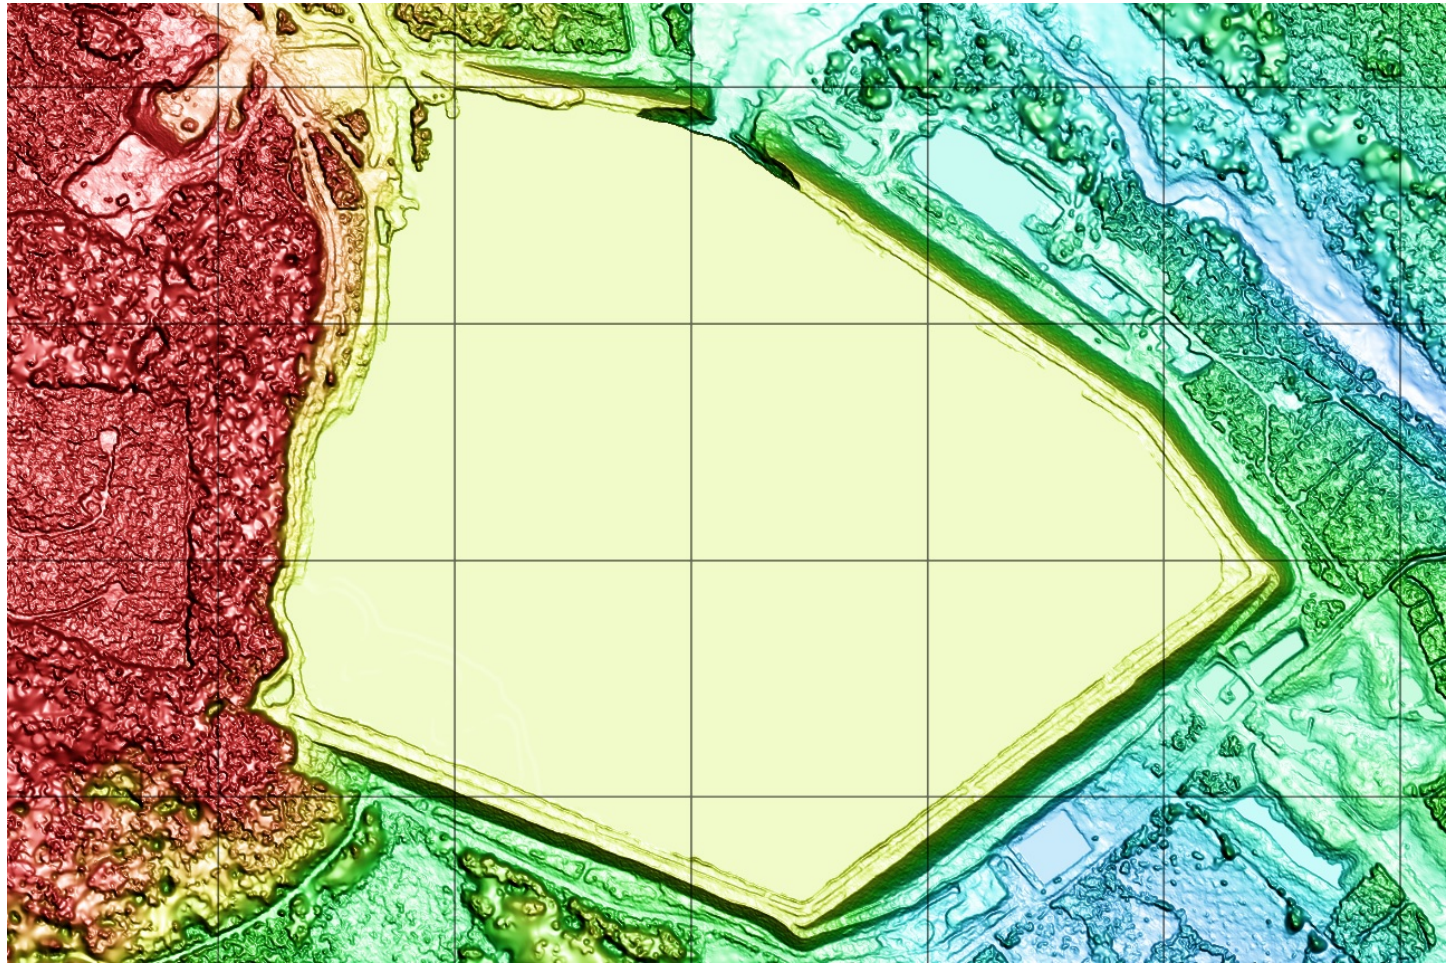
**Mount Polley Tailings
top surface a few days before the breach
overlaid on the breached structure**

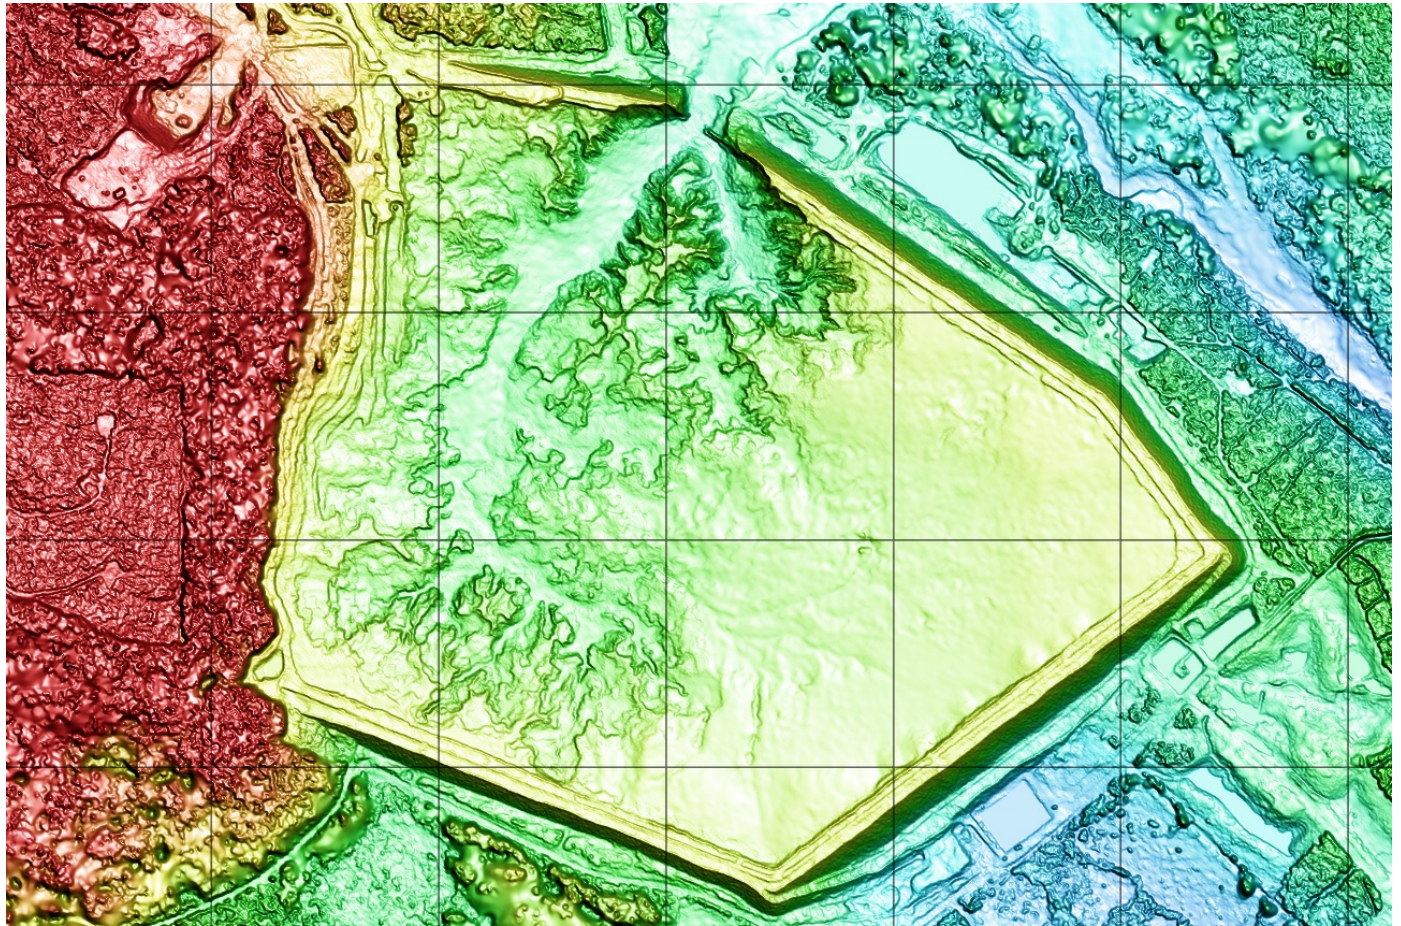
**Mount Polley tailings dam topography
after the breach**

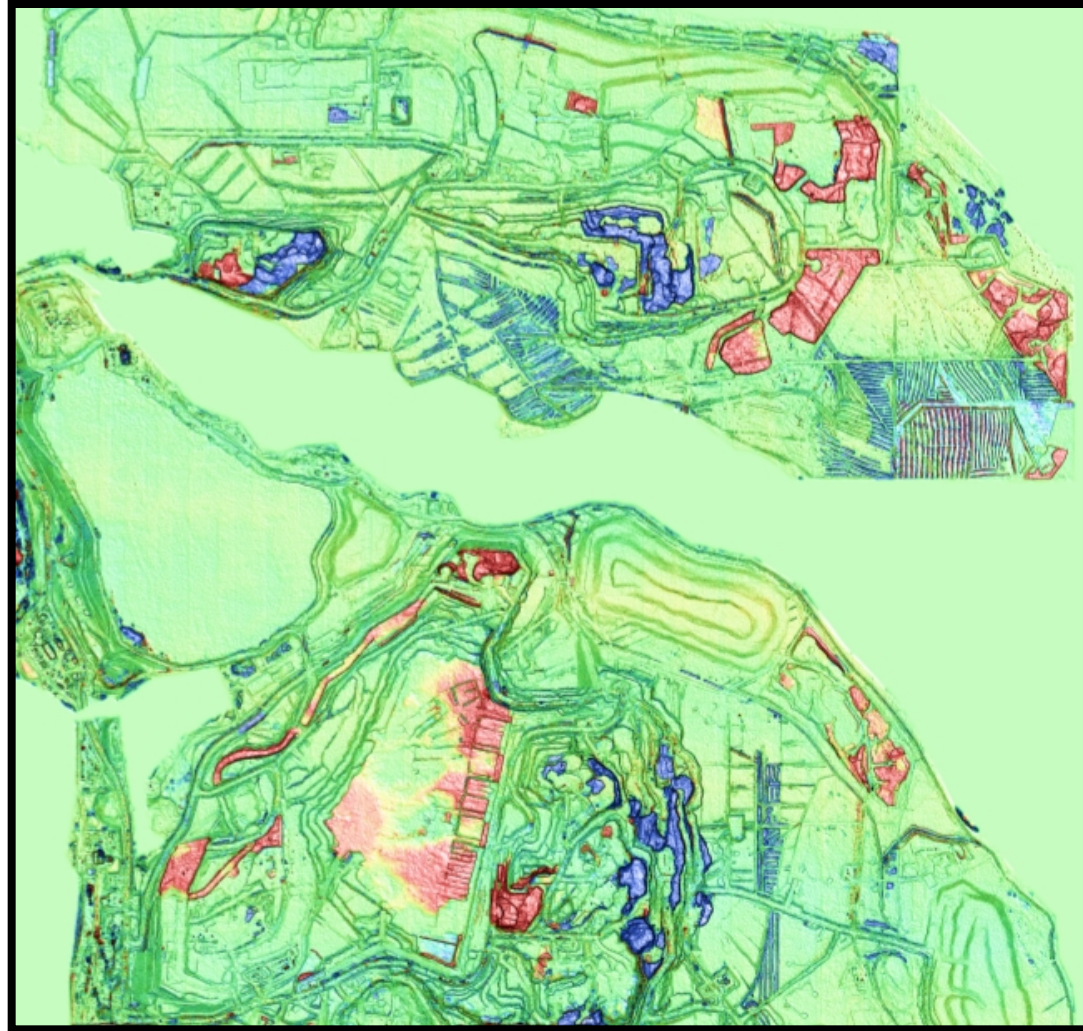
Monthly elevation differences. Blue areas are cuts. Yellow and red areas are fills and tailings disposal. Accuracy better than 15cm

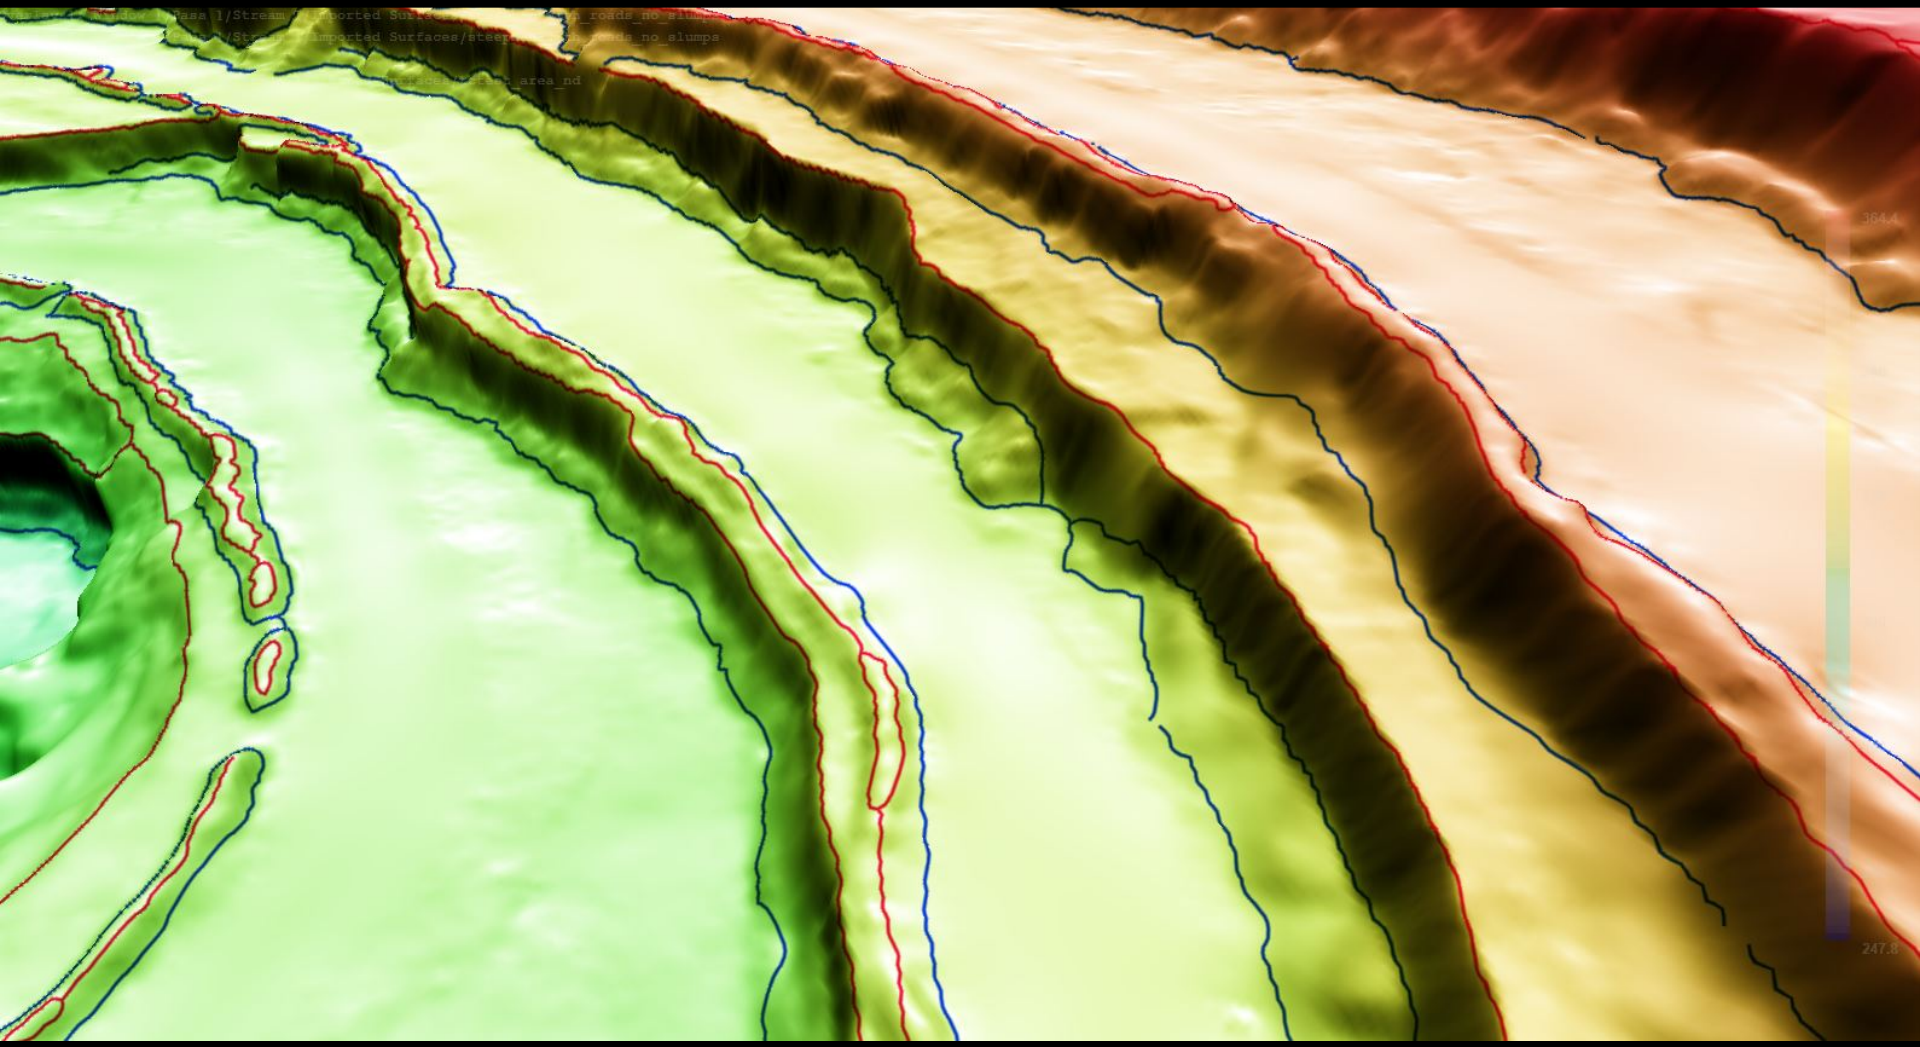
Automated Mapping of Toes and Crests

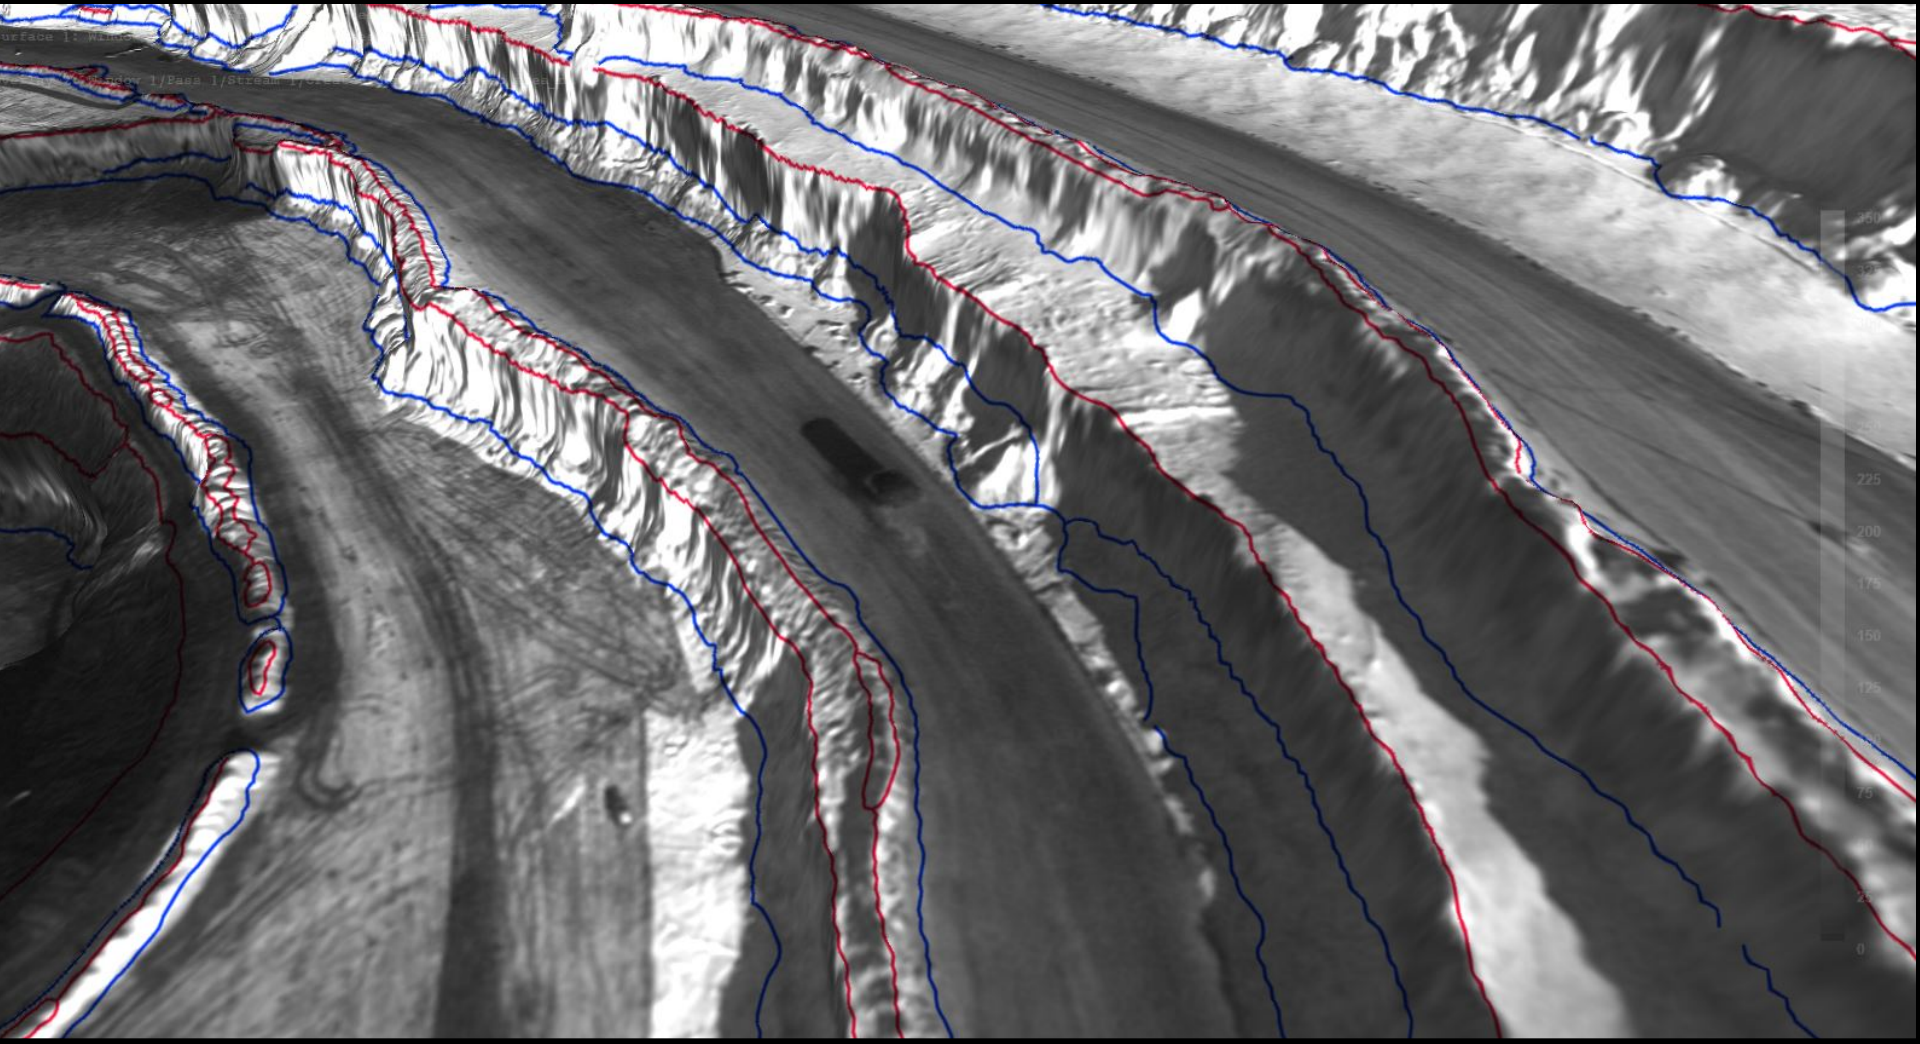
Mapping Toes and Crests
