Memorandum

Date:	June 14, 2005	Our Ref:	
To:	Ken Brouwer	Cont.#:	
From:	Mark Burke		
Re:	Mount Polley South Embankment Sand Trial, June 2005

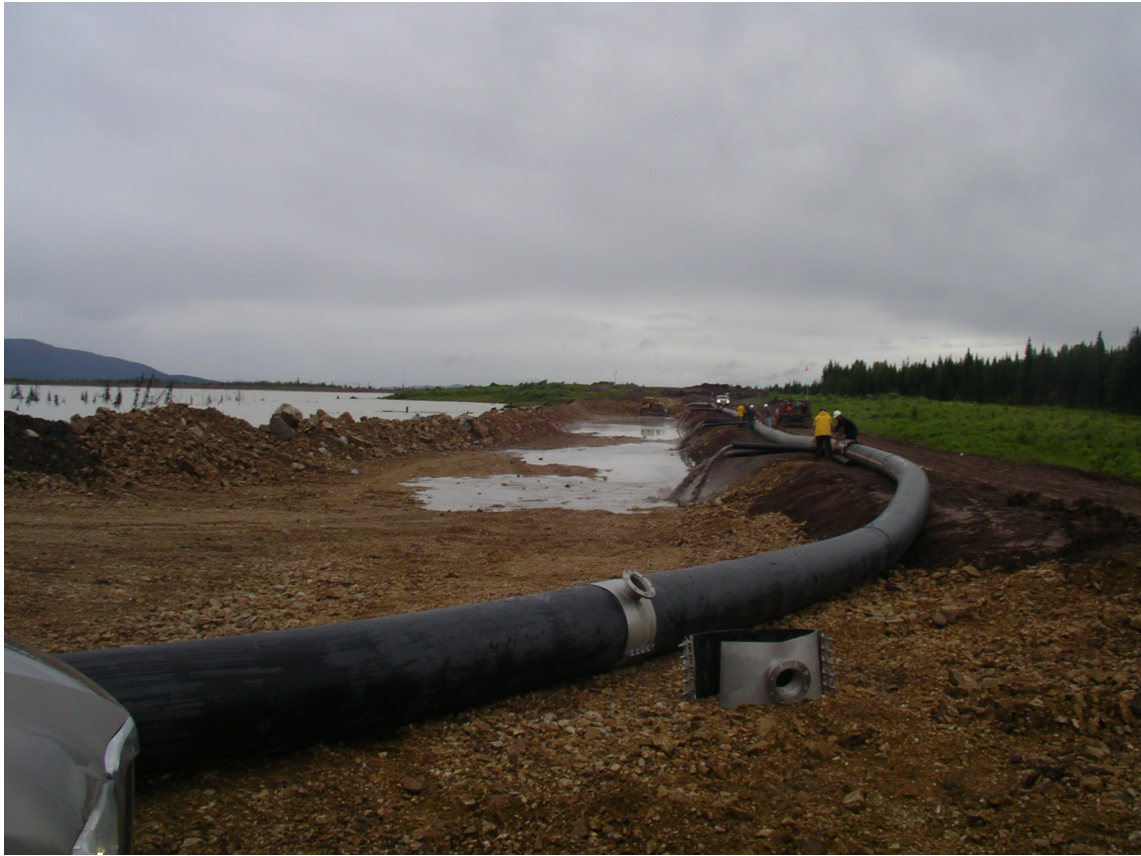
Figure 1: South embankment June 21, 2005

A sand trial was completed at Mount Polley on the tailings storage facility. The trial was located on the south embankment (stage 4 construction) between chainages 6+75 to 8+50. The sand trial used of 3 sets of 3 spigots to discharge tailings in to a panel 175m long by 18m wide (Figure 1). The panel was built using 2 coarse rock. A D7 cat was used in the slurry in order to create the proper gradient so that the fines would separate from the coarse sand in the tailings. One end of the panel a drain was made with 2 24 inch culverts. As the sand accumulated the drains were raised. It took 7.5 hours to get the first foot of sand to settle (Figure 3). The rate of deposition increased after the CBL was covered.
