**MOUNT POLLEY MINE
Tailings Storage Facility
2011 Construction**

As-Built Report and Annual Review

30 March 2012

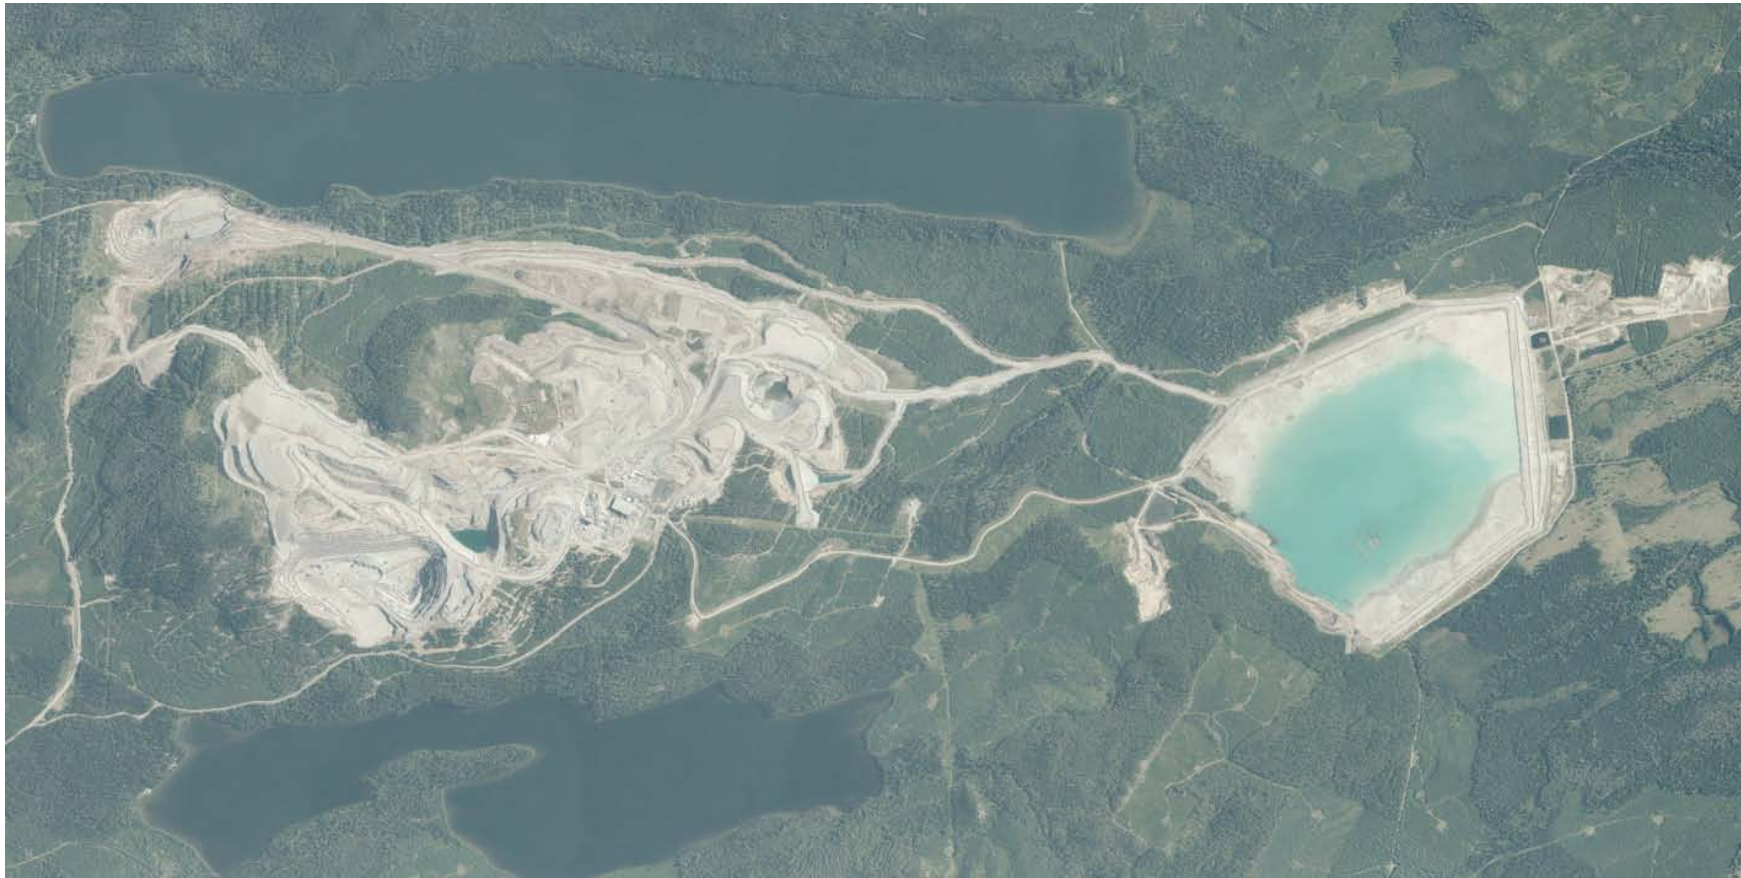
Figure 1.1: Aerial View of Mine Site: 2011

Drawing 2011AB.01 presents a plan of the as-built condition of the Mount Polley Mine site. Figure 1.1 shows an aerial view of the site from 2011.

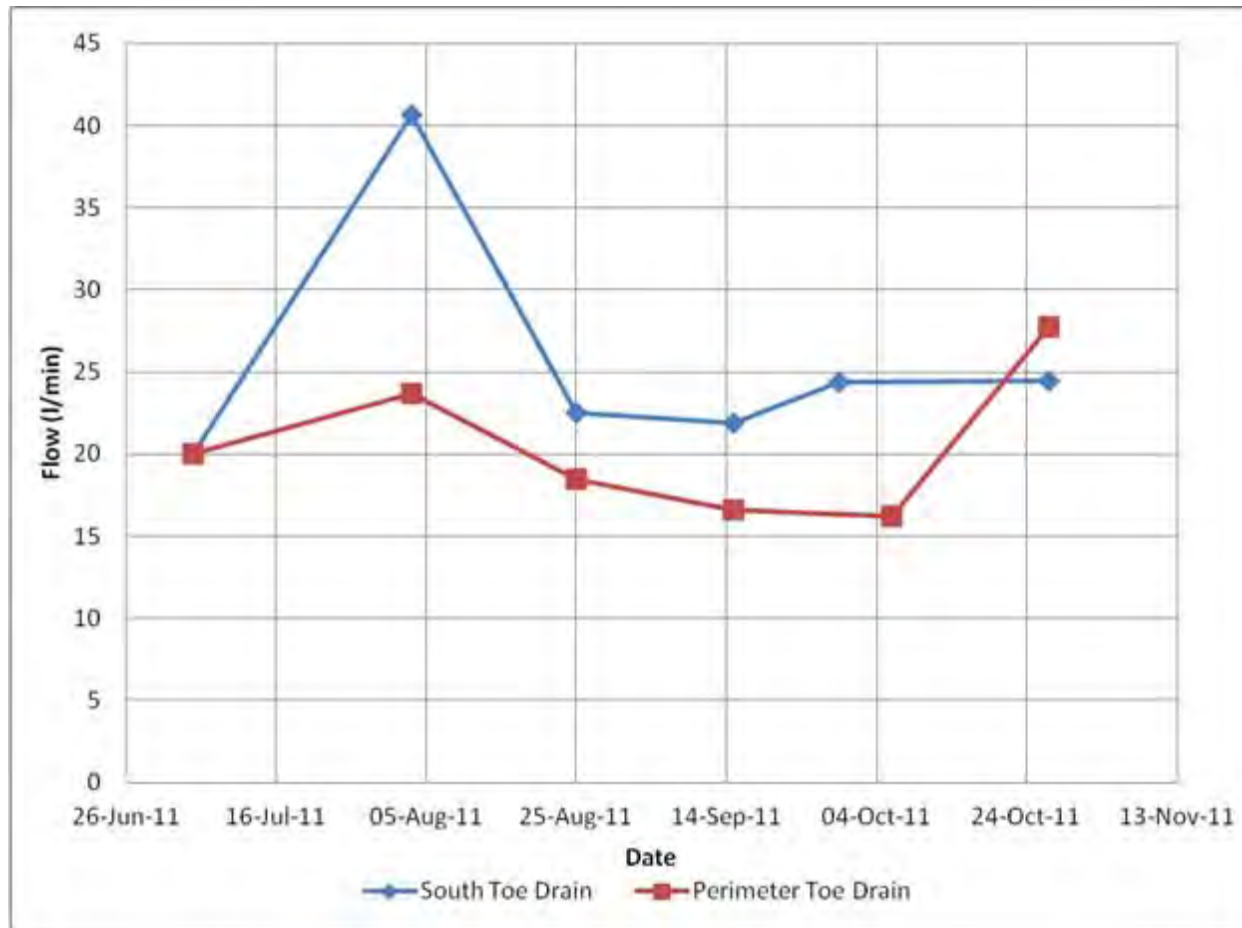
Figure 2.2: South and Perimeter Toe Drain Flow Readings – 2011

Flows from the upstream toe drain and foundation drains of the Main Embankment are measured at the sump located at the Main Embankment seepage collection pond. Upstream toe drains from the Perimeter and South Embankments discharge into ditches which carry the flow to their respective seepage collection ponds where it is measured at the end of pipe. Water from the upstream toe and foundation drains is recycled to the TSF.

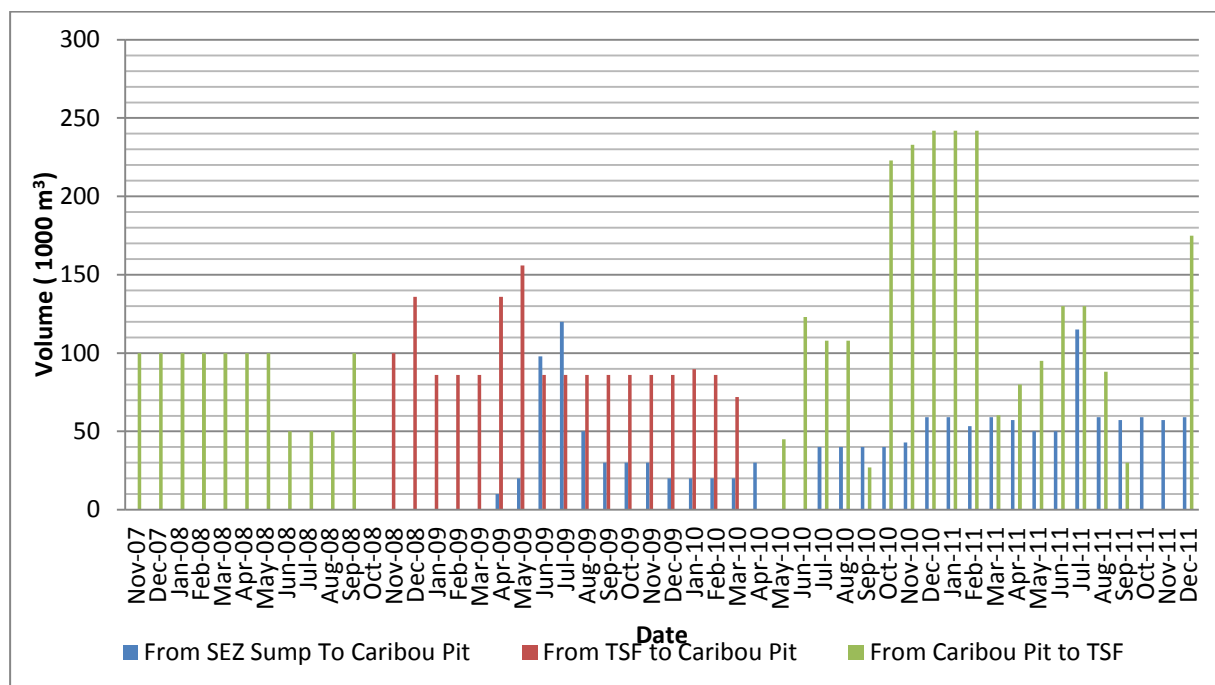
Figure 7.1: Water Transfer

It is AMEC's understanding that currently the total inflow from precipitation and surface runoff exceeds losses from evaporation and storage of water within the voids of deposited tailings. Thus, MPMC mine site is operating under a net annual water surplus condition, with the accumulating surplus being stored in the TSF and the Caribou Pit. MPMC transfers water as needed between the TSF and the Caribou Pit, with the volumes transferred, as provided by MPMC, shown in Figure 7.1.

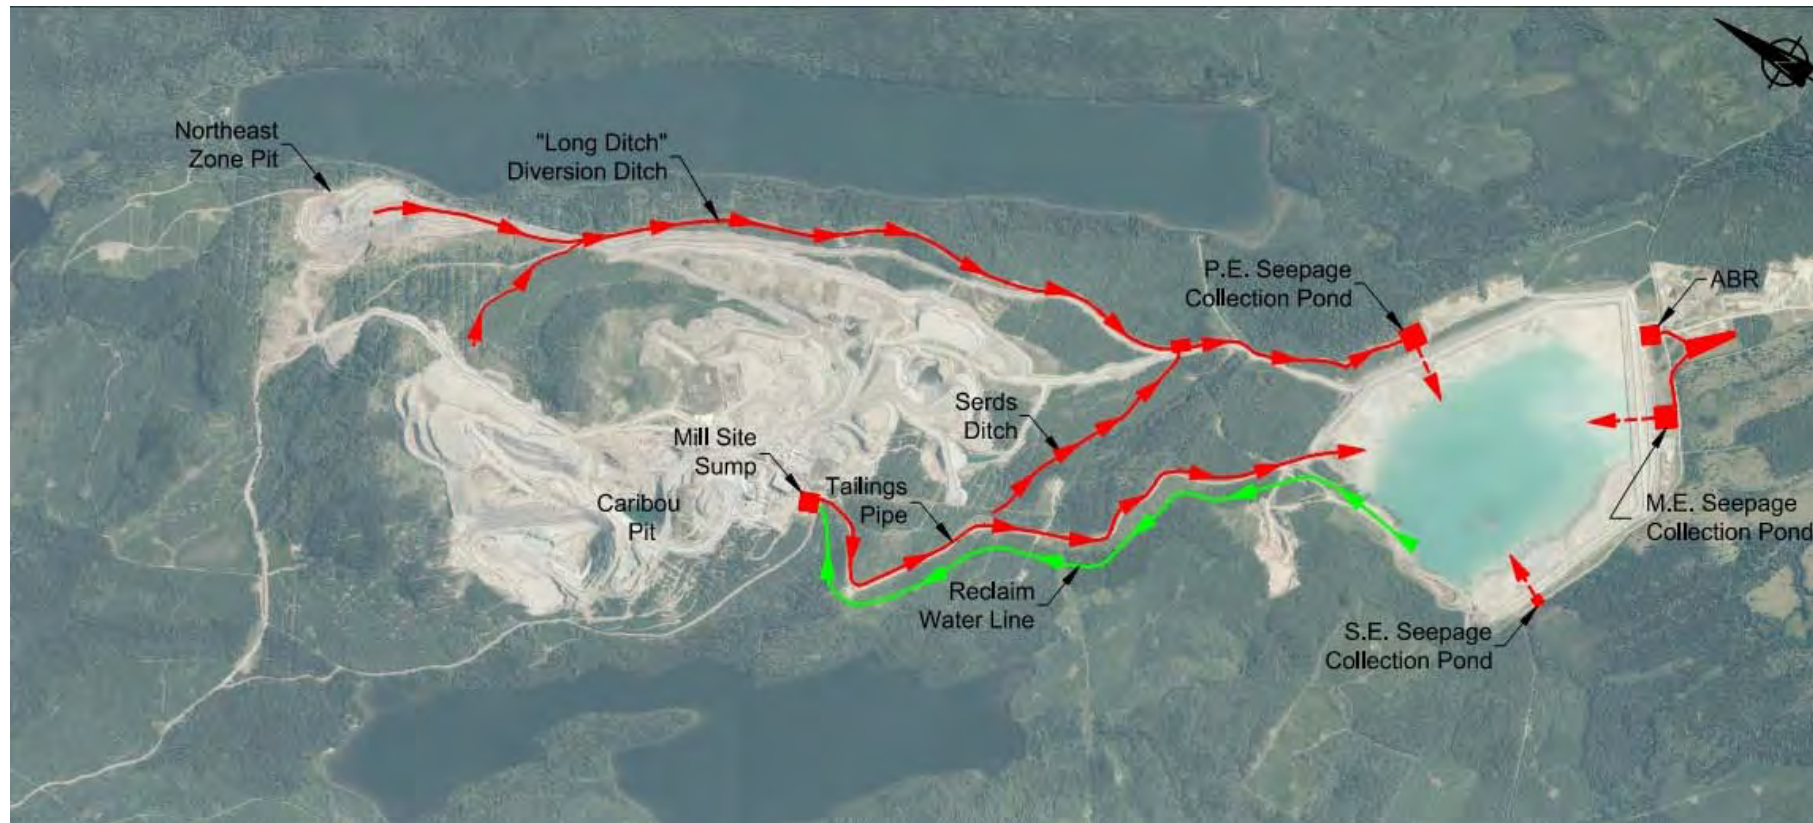
Figure 7.2: Site Water Management Schematic

Site water management is illustrated on Figure 7.2 and is described below:

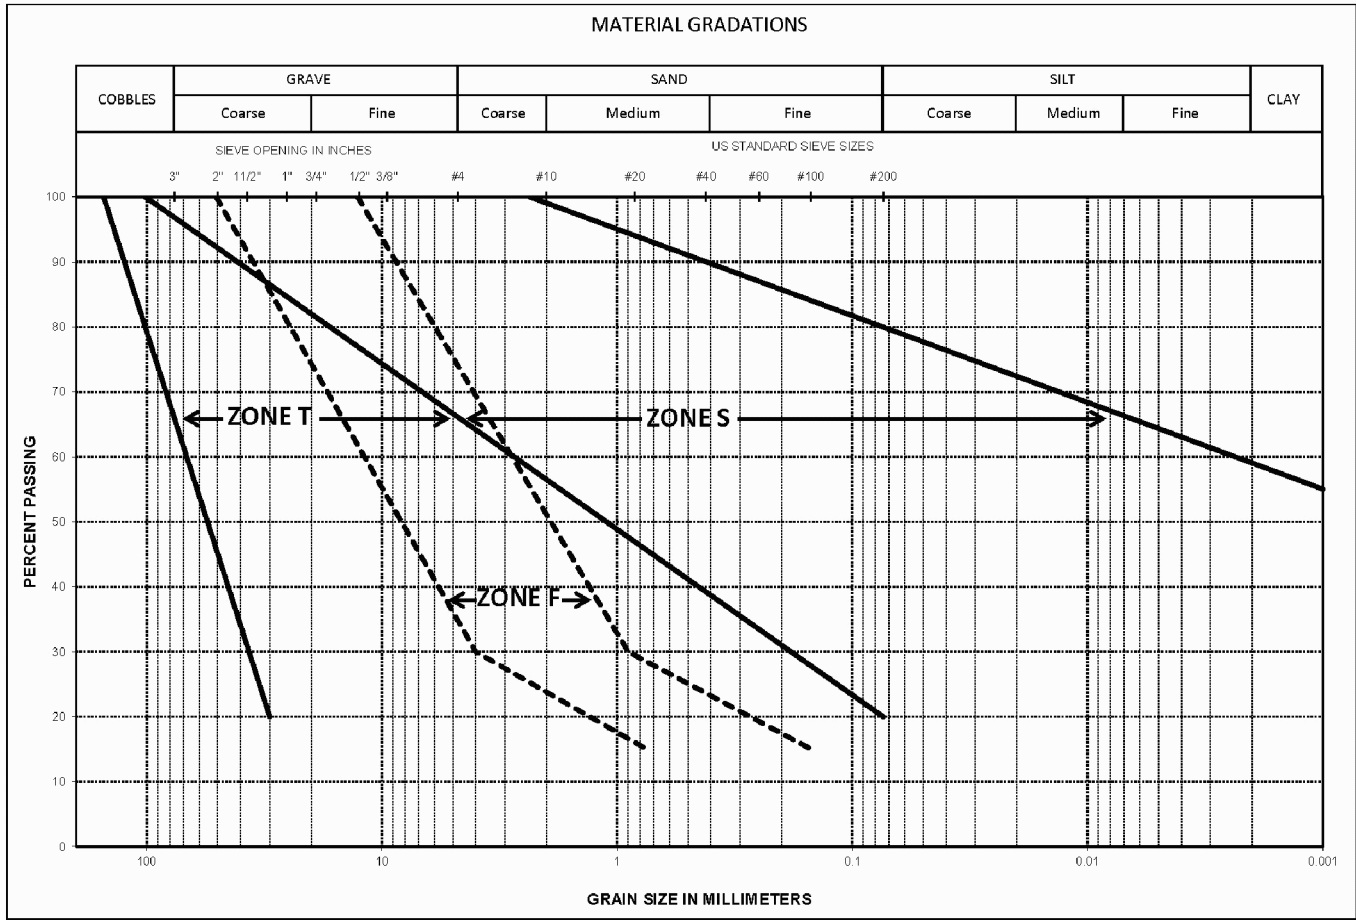
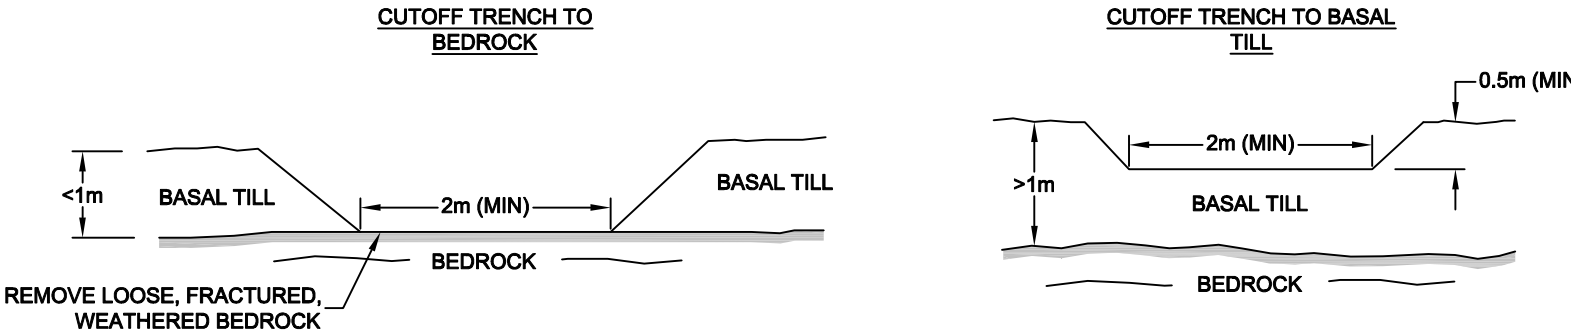
DETAIL 1 - CUTOFF TRENCH

- To accommodate a drainage trench detail implemented in past raises, aligned along the toe of the dam, a ditch approximately 1.0 m in depth and 2.0 m in width was excavated along the Perimeter and on the South Embankments downstream of the abutment core extensions. On the South Embankment it was noted that a corrugated drainage pipe was present. The pipe was extended and placed at the base of the trench. No drainage pipe was noted on the perimeter embankment. The trench was then backfilled with filter material (Zone F).

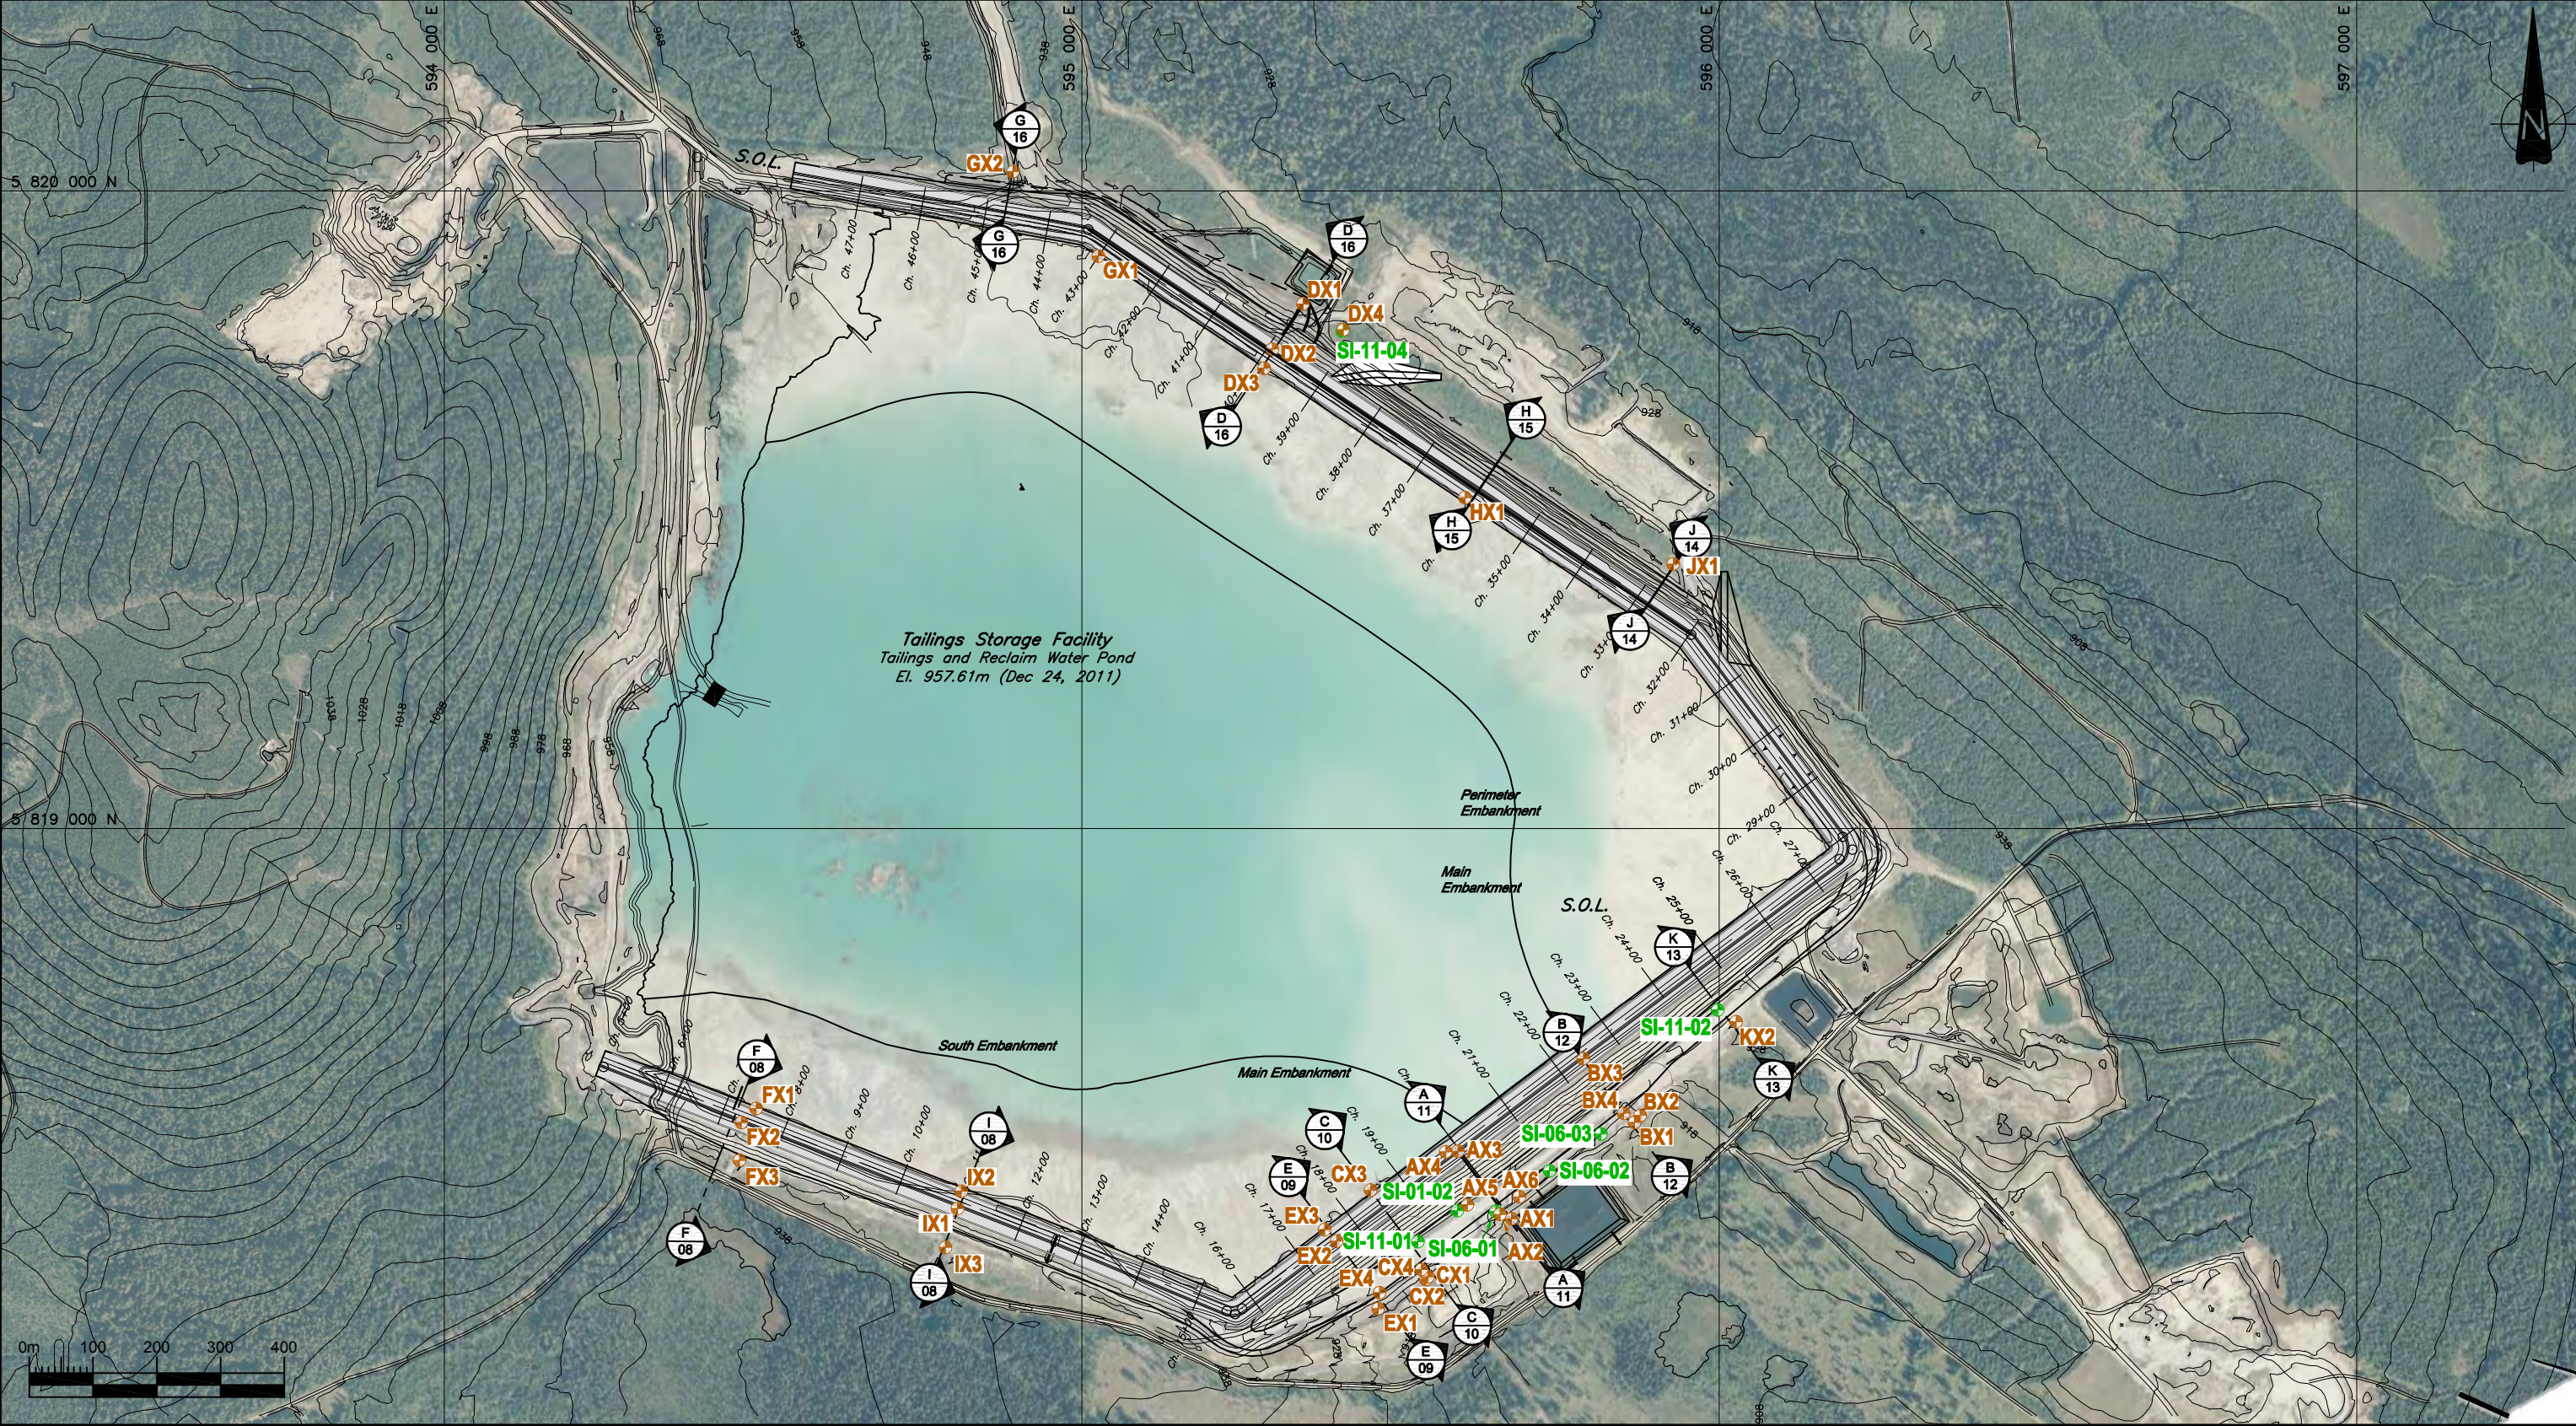
The drawings appended to this report include design and as-built sections of the TSF embankment current as of the end of 2011. The drawings, in plan view, show the locations of the readout stations for the instrumentation (piezometers, inclinometers), and in section view show the relative placement of the instruments within the embankment and its foundation.

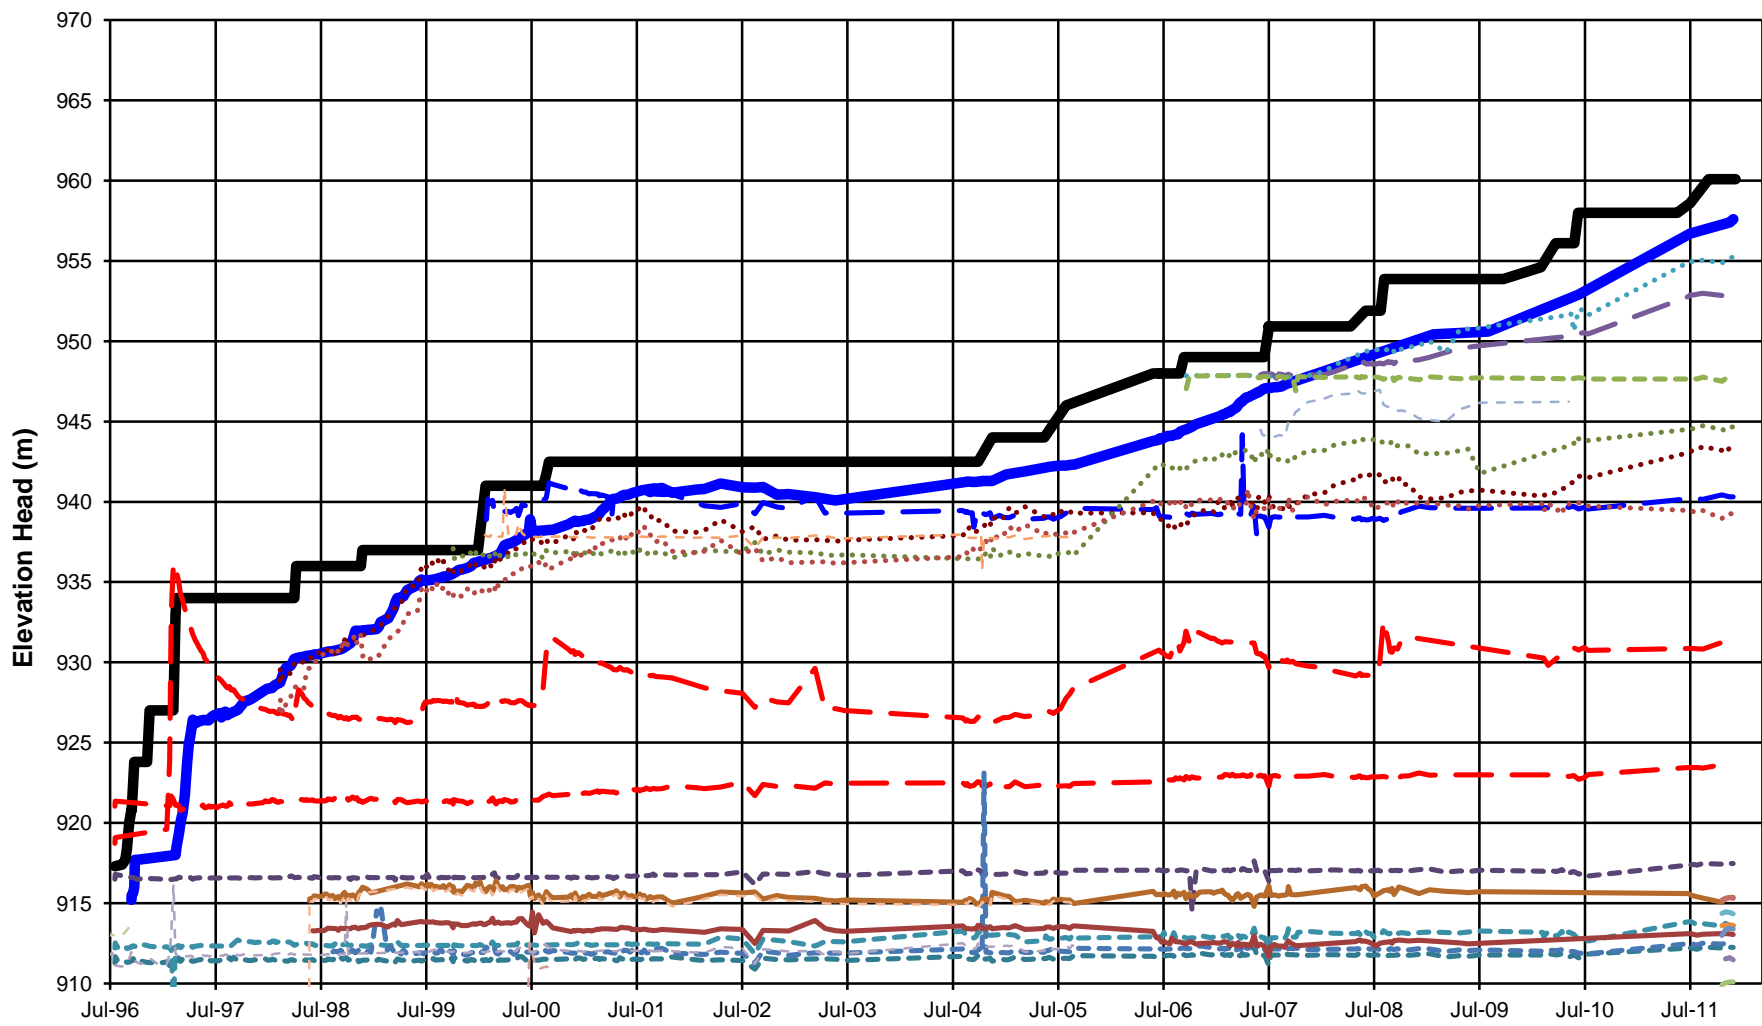
PROJECT NO. VM00560	Date. 12/24/11
	REV. A	FIGURE A

— Pond Level	— Fill Elevation	— A01 Till Core
--- A02 Till Core	--- A04 Till Core	--- A14 Till Core
... A03 Tailings	... A05 Upstream Fill	... A12 Tailings
... A15 Upstream Fill	--- A06 Chimney Drain	--- A07 Foundation Drain
--- A10 Foundation Drain	--- A11 Drain	--- A13 Filter
— A08 Foundation	— A09 Foundation	— A16 Foundation
— A17 Foundation	— A18 Foundation	— A19 Foundation
— A20 Foundation	— A21 Foundation	--- DEAD (A0-PE1-01)
--- DEAD (A0-PE2-03)	--- DEAD (A2-PE1-03)	--- DEAD (A2-PE2-01)
--- DEAD (A2-PE2-02)	--- DEAD (A2-PE2-04)	--- DEAD (A2-PE2-06)

- Pore pressures in foundation soils in and around the TSF embankment were noted as stable with minor fluctuations, except for D1 where an upward trend is noted. Newly installed piezometers appear to have stabilized but insufficient data has been collected to show any trends at this point.
- Pore pressures in the till core are found to be stable, with a slightly increasing trend in response to the rising pond level.
- Pore pressures in filter and drains remained unchanged throughout the year.
- Pore pressures in the tailings and upstream fill experienced an upwards trend in response to the rising pond level. Piezometers installed at a lower elevation within the upstream tailings experienced lower response relative to the piezometers near the pond elevation, likely the result of proximity to the upstream under-drainage system.

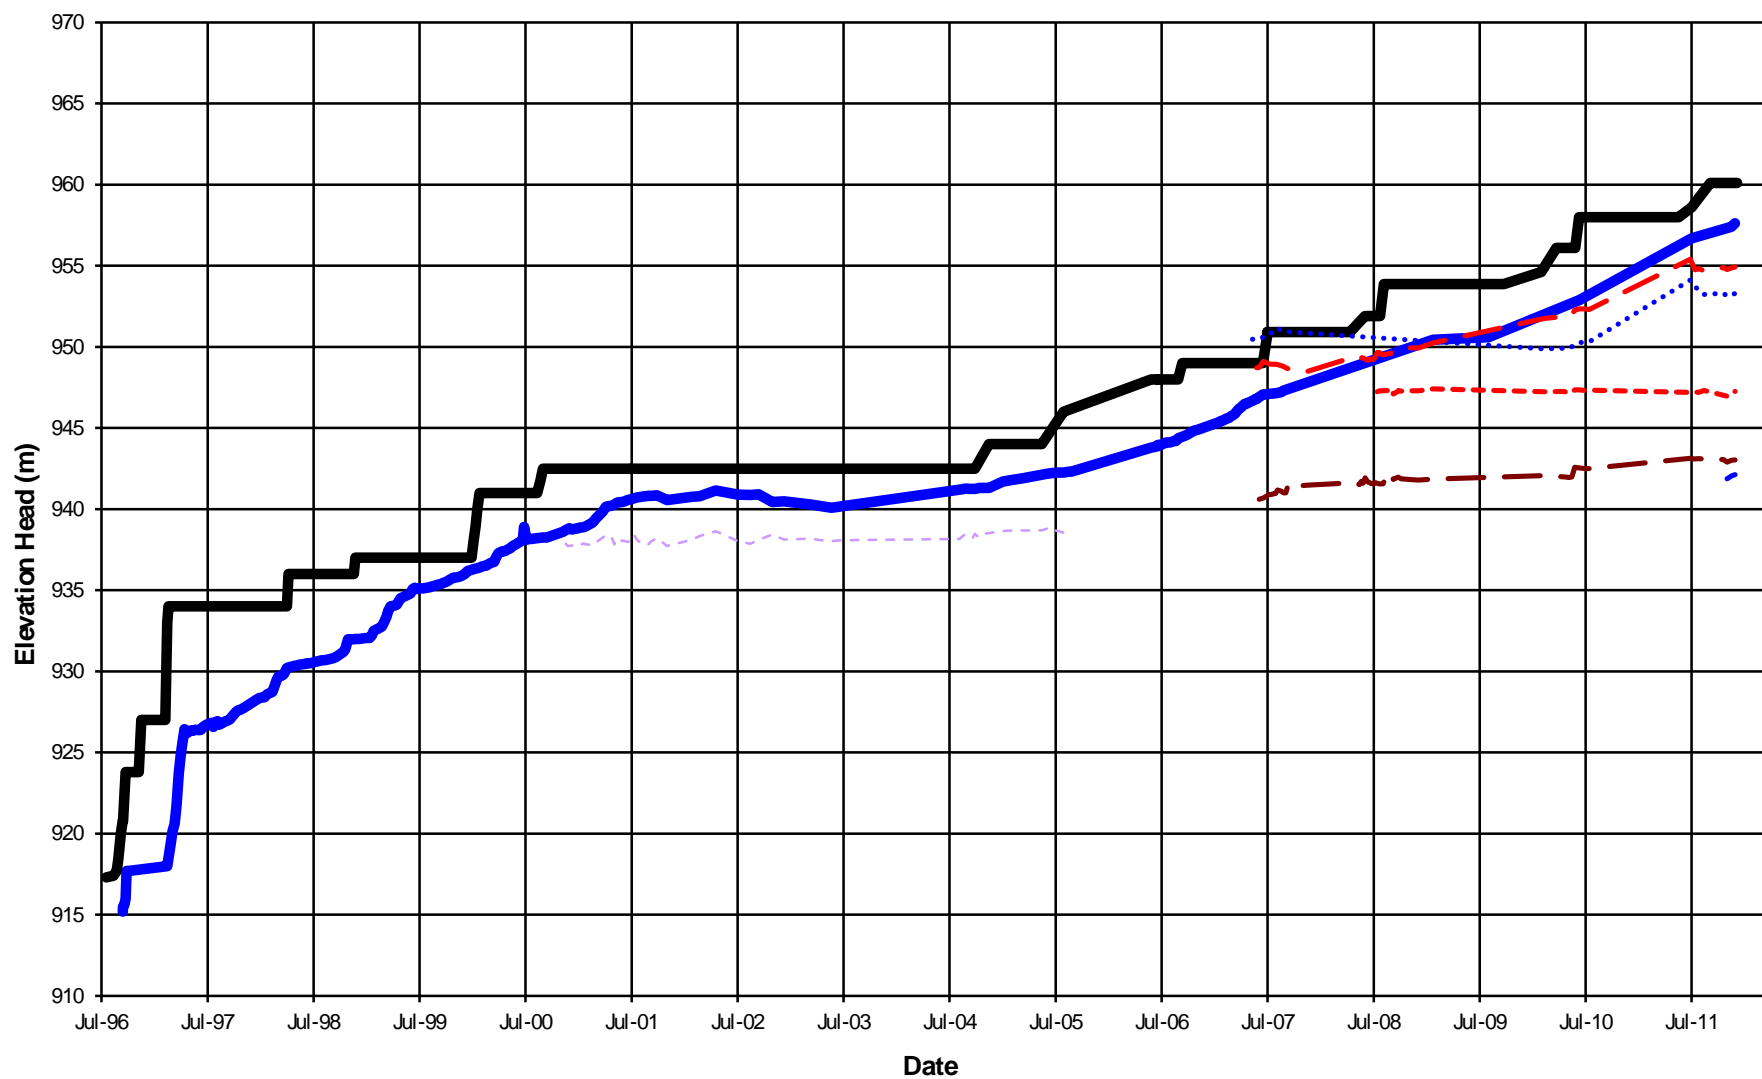
FIGURE F

— Pond Level — Fill Elevation ····· F1 Tailings
- - - F2 Till Core - - - F3 Till Core - . - . F4 Filter
— F5 Foundation - - - DEAD (F2-PE2-01)

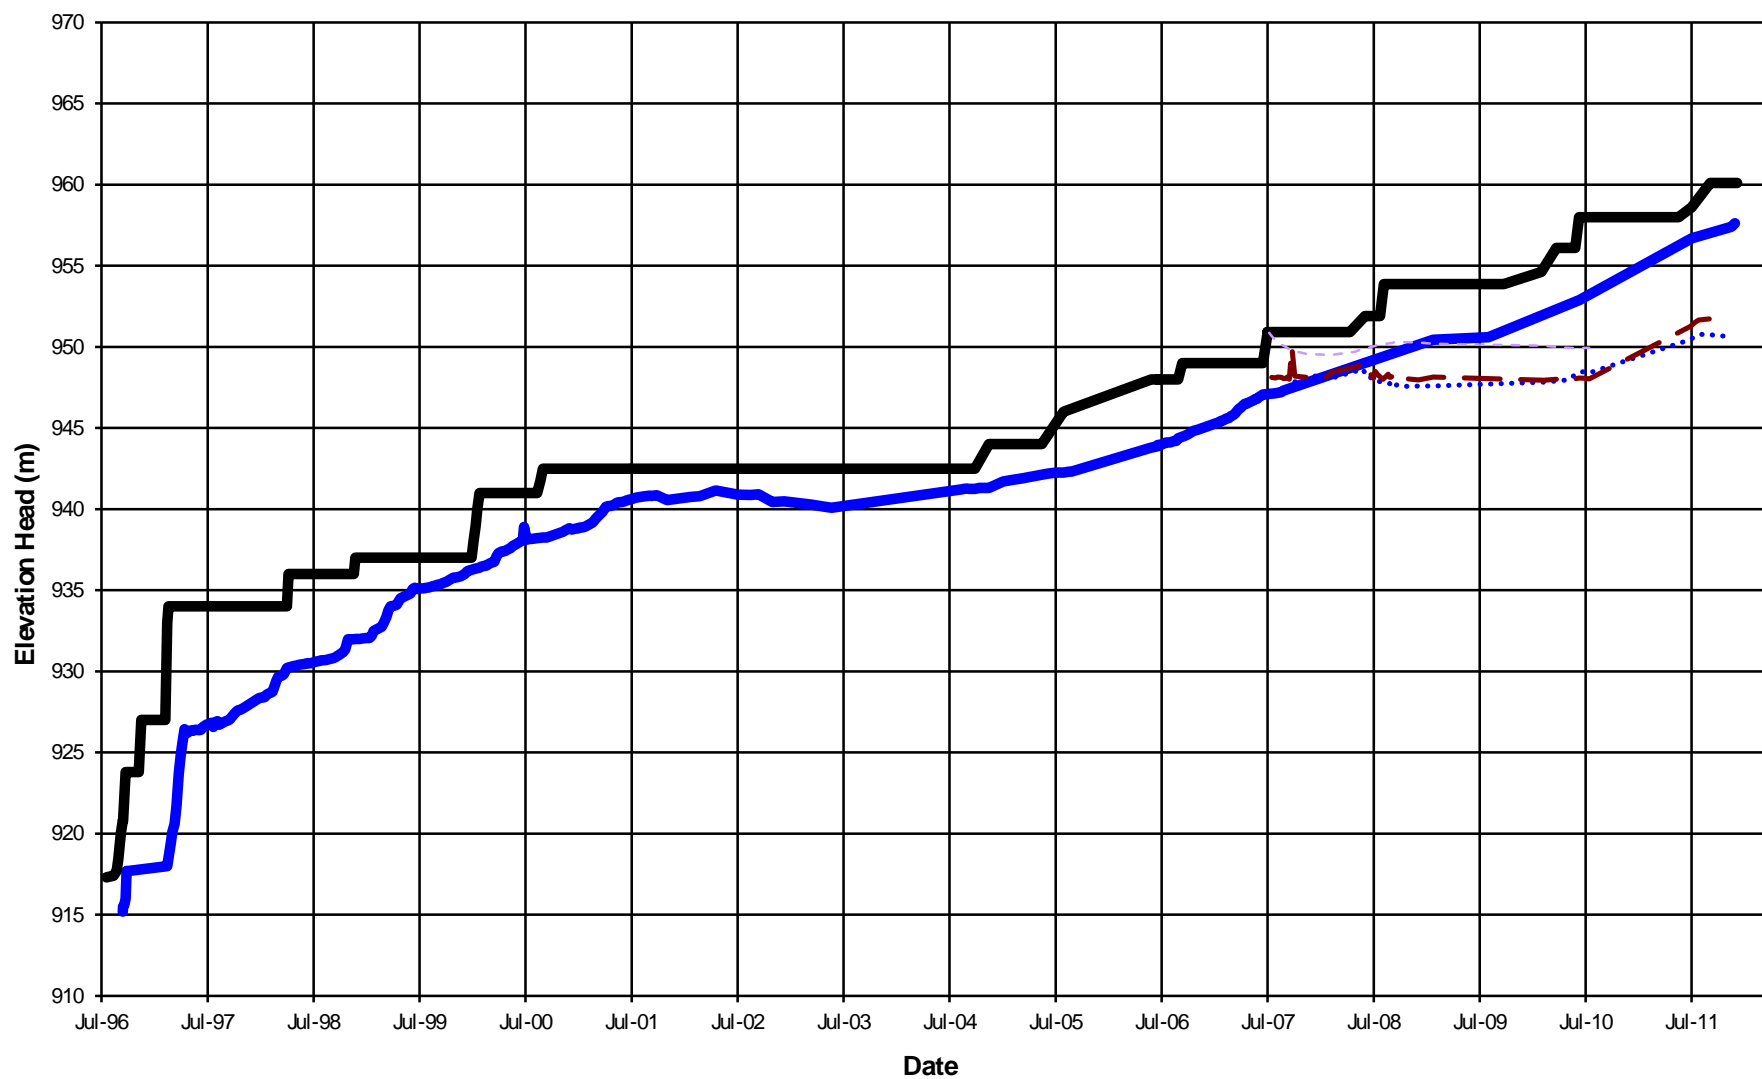
FIGURE H

— Pond Level
 — Fill Elevation
 H1 Tailings
 - - - H2 Till Core
 - - - DEAD (H2-PE2-02)
