**MOUNT POLLEY MINE  
Tailings Storage Facility Stage 8/8A  
2012 As-Built Report**

**Mount Polley Mining Corporation,**  
Likely, BC

**15 March 2013**

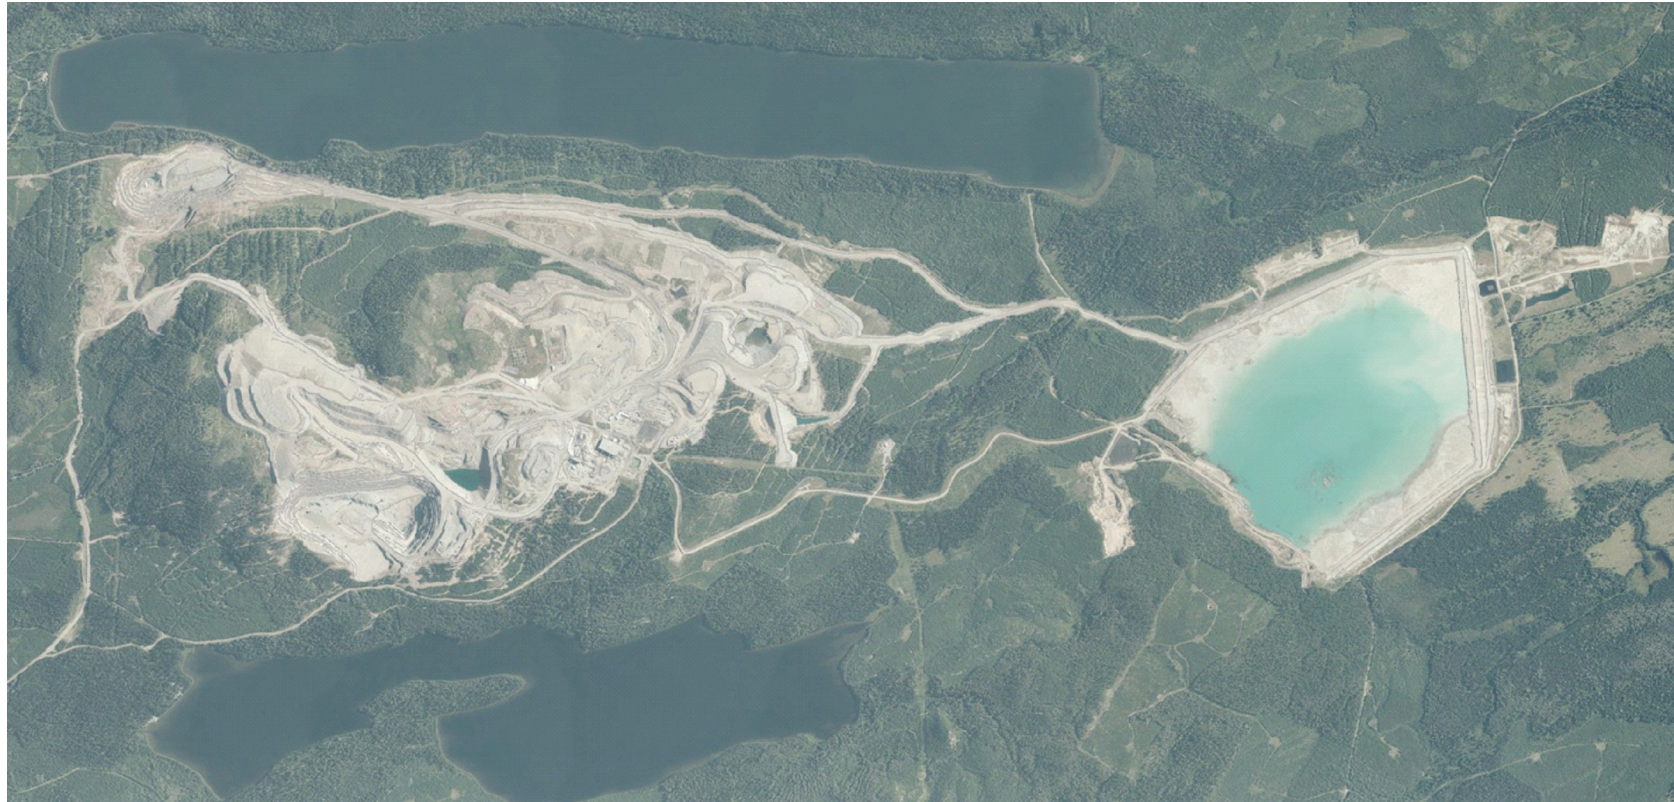
**Figure 1.1: Aerial View of Mount Polley Mine Site: 2012**

The Mount Polley Mine is located in central British Columbia, approximately 60 km northeast of Williams Lake. The Mount Polley copper and gold mine commenced production in 1997 and operated until October 2001 when operations were suspended for economic reasons. In March 2005 the mine restarted production and has been in continuous operation since. The mill throughput rate is approximately 20,000 tonnes per day (approx. 7.3 million tonnes per year). Mill tailings are discharged as slurry into the Tailings Storage Facility (TSF) located on the south area of the mine property. **Error! Reference source not found.** shows an aerial view of the site from 2012.
