**MOUNT POLLEY MINE  
Tailings Storage Facility Stage 8/8A  
2012 As-Built Report**

**Mount Polley Mining Corporation,**  
Likely, BC

30 March 2013

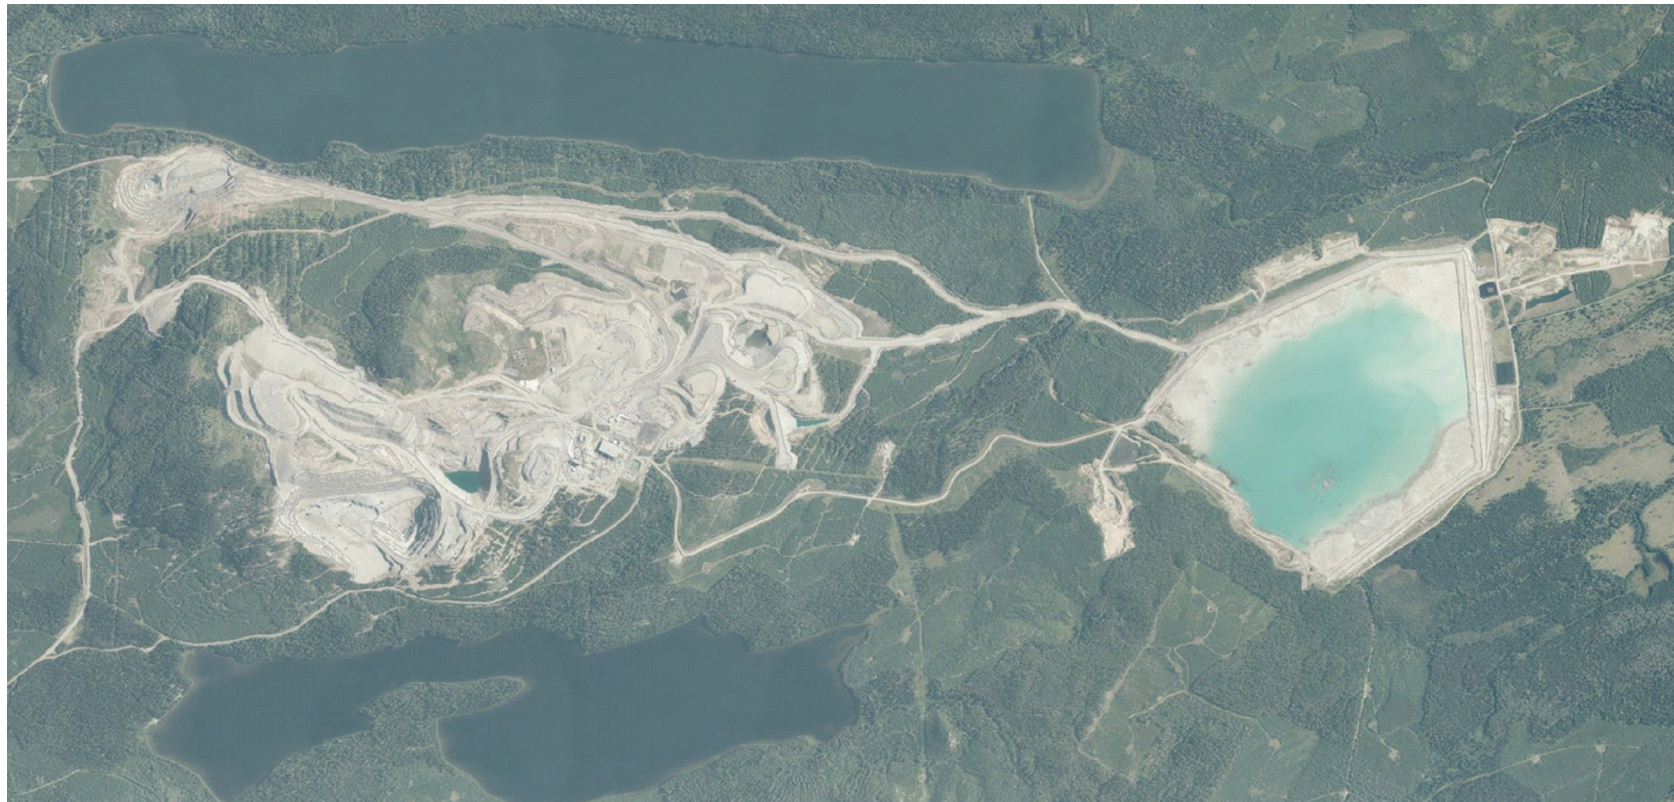
**Figure 1.1: Aerial View of Mount Polley Mine Site: 2012**

The Mount Polley Mine is located in central British Columbia, approximately 60 km northeast of Williams Lake. The Mount Polley copper and gold mine commenced production in 1997 and operated until October 2001 when operations were suspended for economic reasons. In March 2005, the mine restarted production and has been in continuous operation since. The mill throughput rate is approximately 20,000 tonnes per day (7.3 million tonnes per year). Mill tailings are discharged as slurry into the Tailings Storage Facility (TSF) located on the south area of the mine property. **Error! Reference source not found.** shows an aerial view of the site from 2012.
