**MOUNT POLLEY MINE  
Tailings Storage Facility Stage 8/8A  
2012 As-Built Report**

**Mount Polley Mining Corporation,**  
Likely, BC

**AMEC Environment & Infrastructure,**  
**a division of AMEC Americas Limited**  
Burnaby, BC

27 March 2013

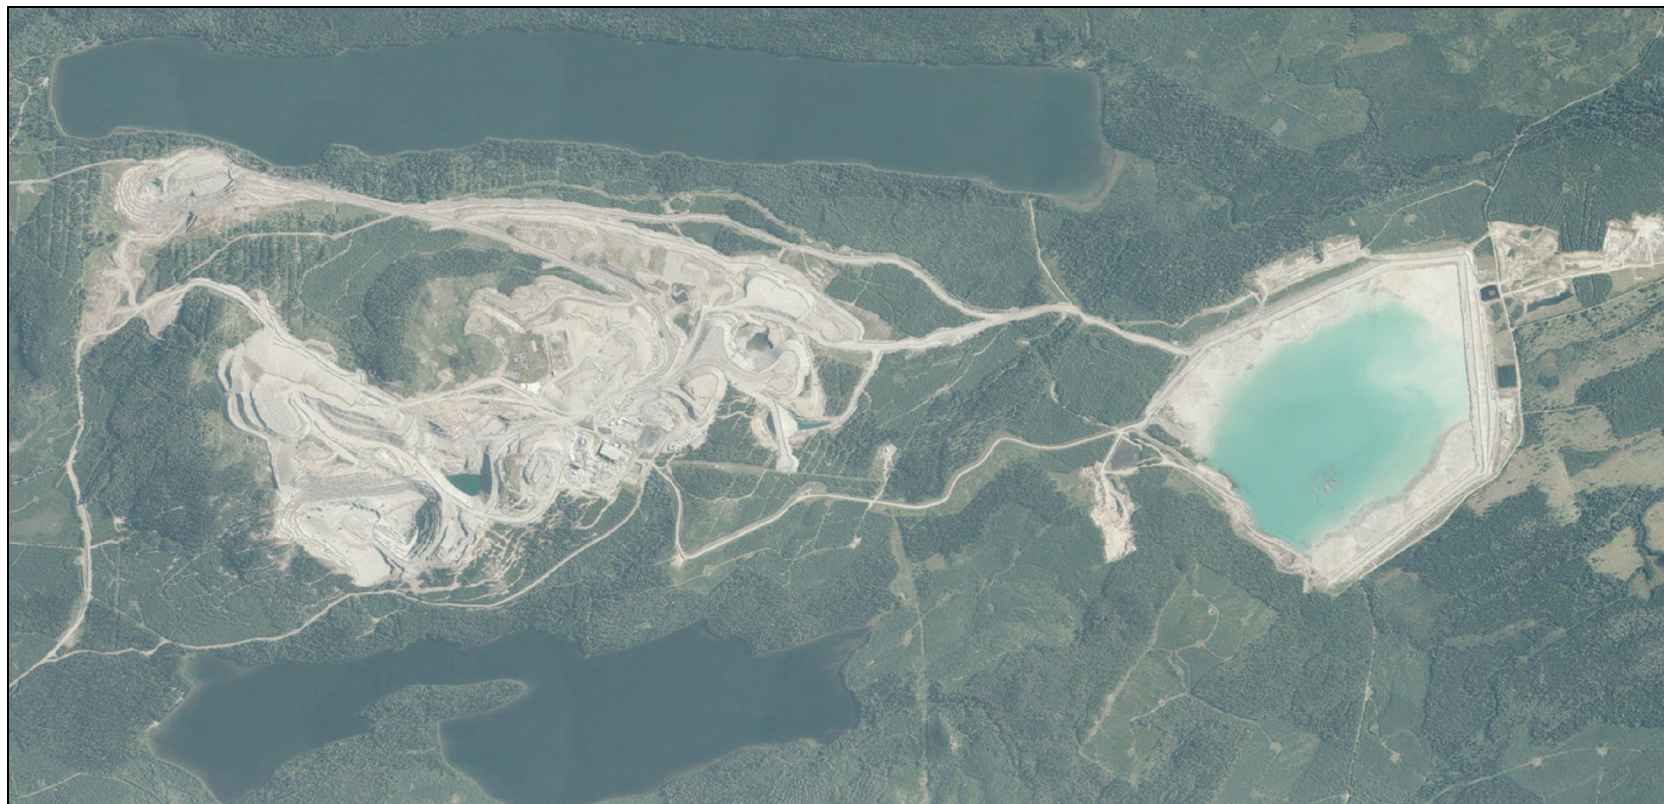
**Figure 1.1: Aerial View of Mount Polley Mine Site: 2012**

The Mount Polley Mine is located in central British Columbia, approximately 60 km northeast of Williams Lake. The Mount Polley copper and gold mine commenced production in 1997 and operated until October 2001 when operations were suspended for economic reasons. In March 2005 the mine restarted production and has been in continuous operation since. The mill throughput rate is approximately 20,000 tonnes per day (7.3 million tonnes per year). Mill tailings are discharged as slurry into the Tailings Storage Facility (TSF) located on the south area of the mine property. Figure 1.1 **Error! Reference source not found.** shows an aerial view of the site from 2012.
