**MOUNT POLLEY MINE
Tailings Storage Facility
2011 Construction**

As-Built Report and Annual Review

VM00560A.A.1

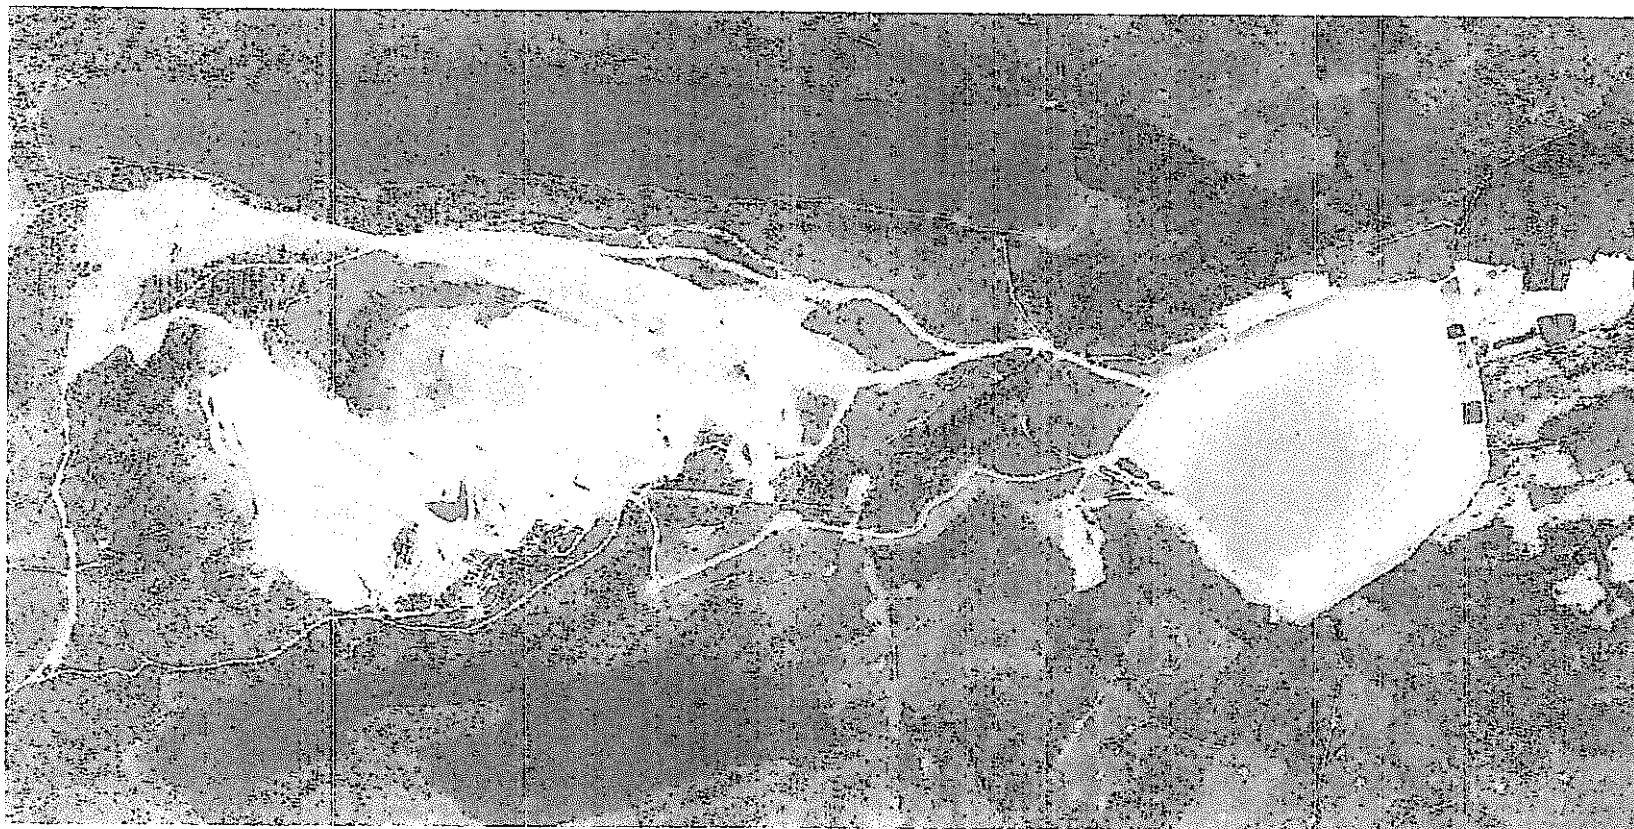
Figure 1.1: Aerial View of Mine Site: 2011

Drawing 2011AB.01 presents a plan of the as-built condition of the Mount Polley Mine site. Figure 1.1 shows an aerial view of the site from 2011.

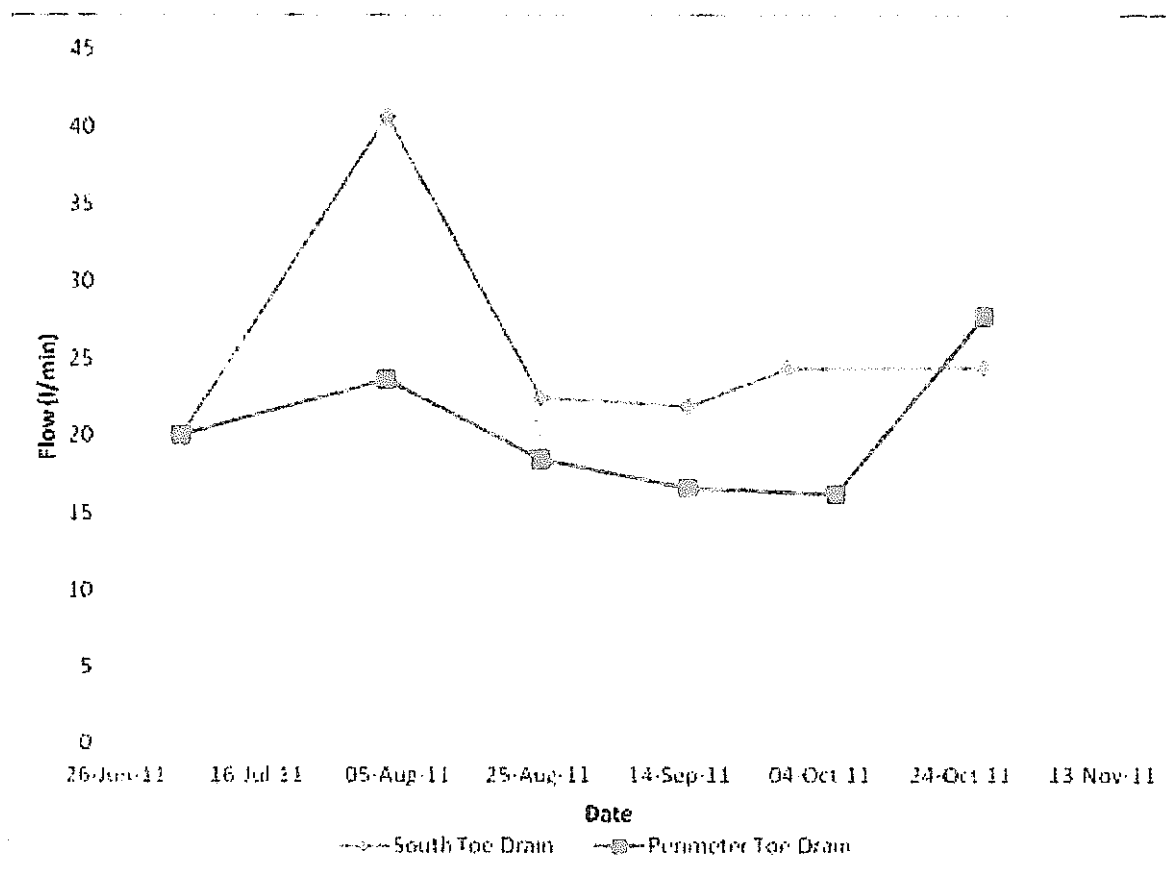
Figure 2.2: South and Perimeter Toe Drain Flow Readings – 2011

Flows from the upstream toe drain and foundation drains of the Main Embankment are measured at the sump located at the Main Embankment seepage collection pond. Upstream toe drains from the Perimeter and South Embankments discharge into ditches which carry the flow to their respective seepage collection ponds where it is measured at the end of pipe. Water from the upstream toe and foundation drains is recycled to the TSF.

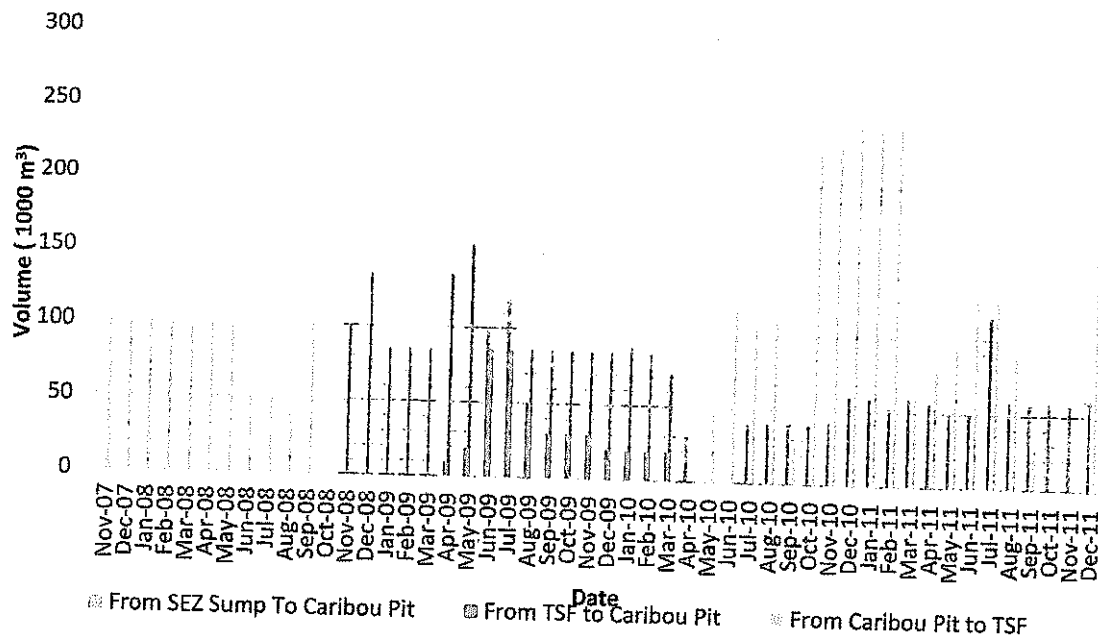
Figure 7.1: Water Transfer

It is AMEC's understanding that currently the total inflow from precipitation and surface runoff exceeds losses from evaporation and storage of water within the voids of deposited tailings. Thus, MPMC mine site is operating under a net annual water surplus condition, with the accumulating surplus being stored in the TSF and the Caribou Pit. MPMC transfers water as needed between the TSF and the Caribou Pit, with the volumes transferred, as provided by MPMC, shown in Figure 7.1.

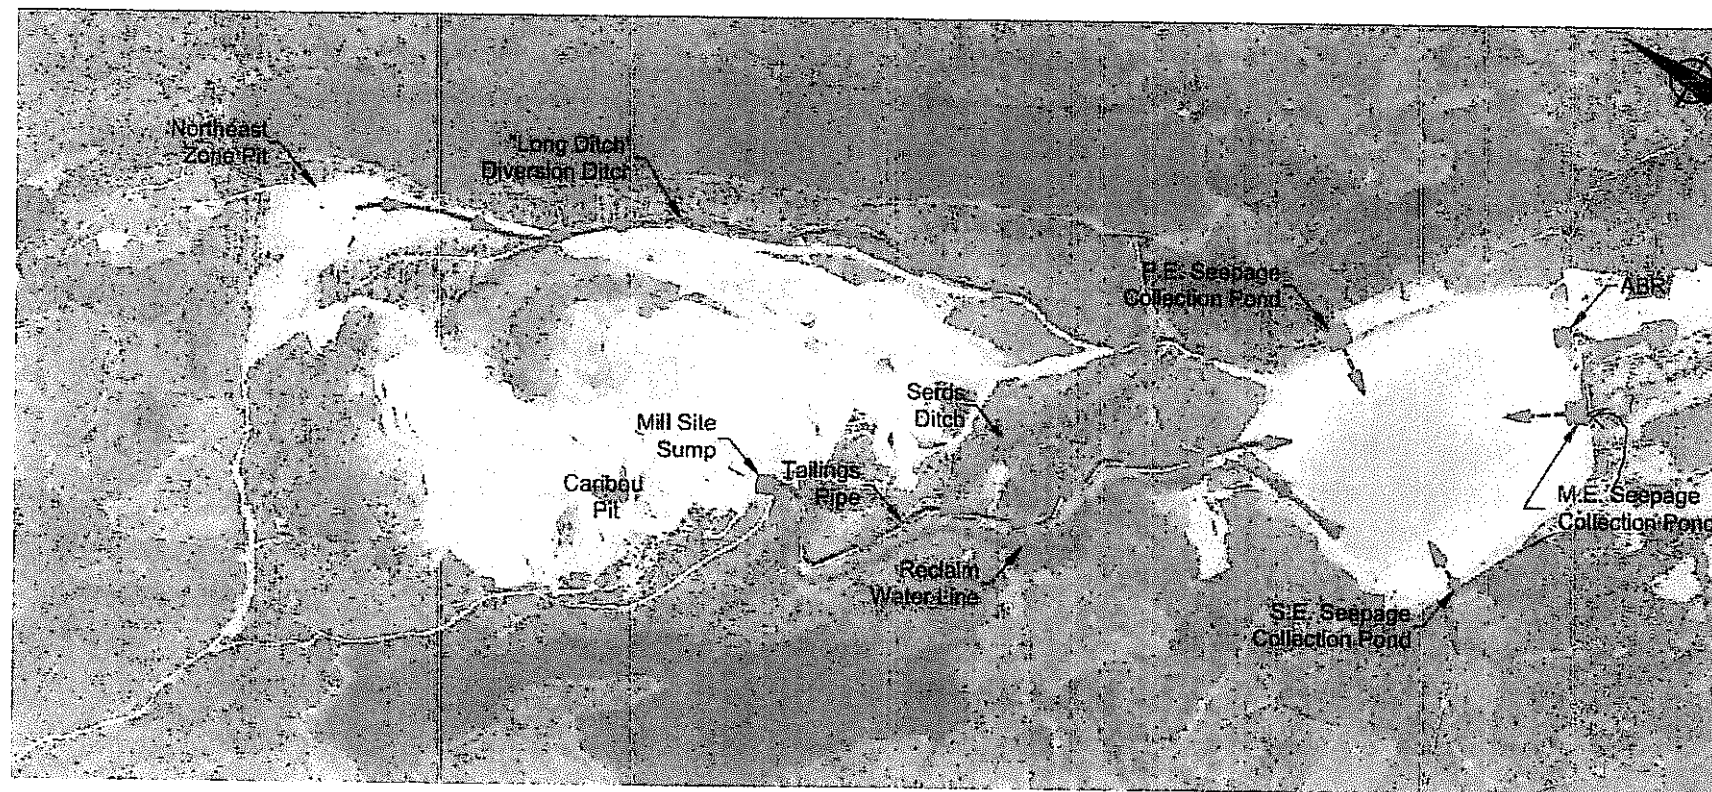
Figure 7.2: Site Water Management Schematic

Site water management is illustrated on Figure 7.2 and is described below:

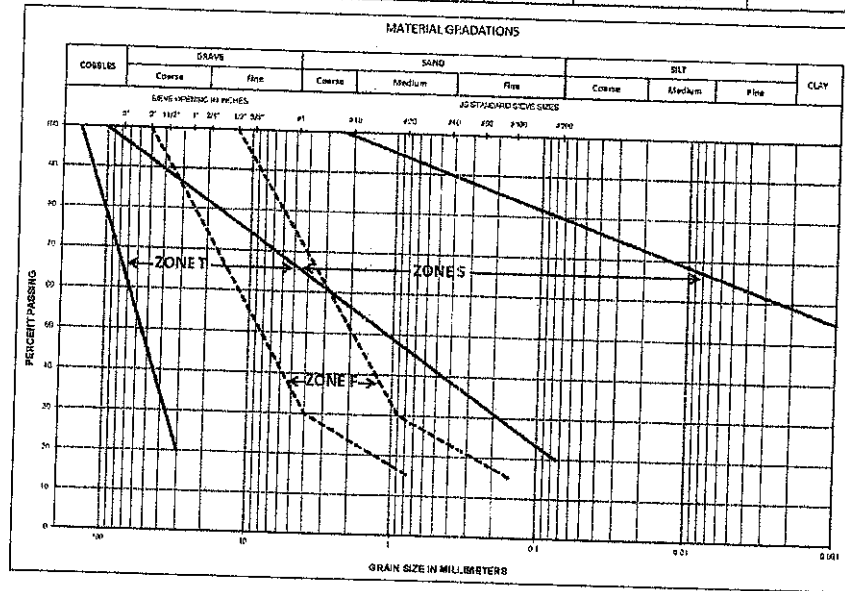
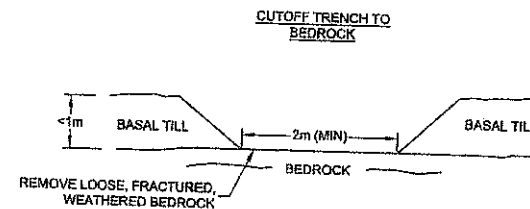
DETAIL 1 - CUTOFF TRENCH

- To accommodate a drainage trench detail implemented in past raises, aligned along the toe of the dam, a ditch approximately 1.0 m in depth and 2.0 m in width was excavated along the Perimeter and on the South Embankments downstream of the abutment core extensions. On the South Embankment it was noted that a corrugated drainage pipe was present. The pipe was extended and placed at the base of the trench. No drainage pipe was noted on the perimeter embankment. The trench was then backfilled with filter material (Zone F).

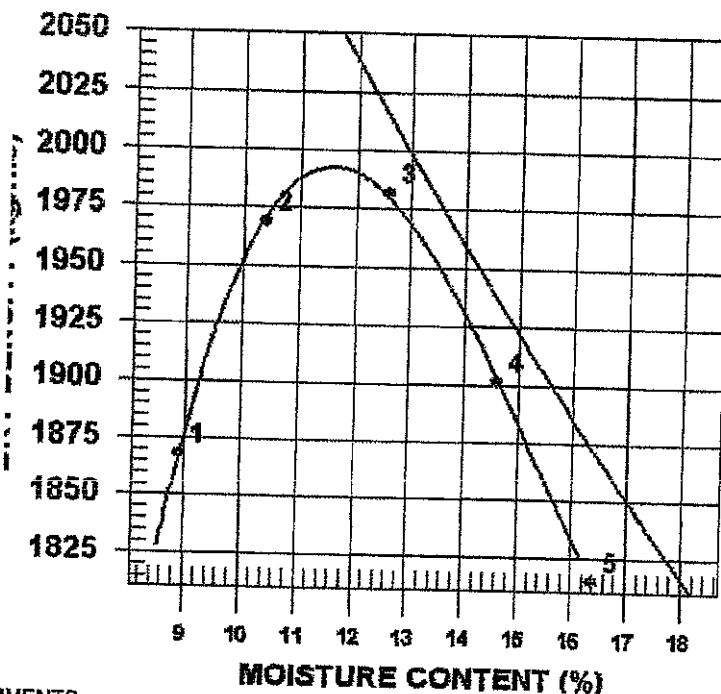
TRIAL NUMBER	WET DENSITY (kg/m3)	DRY DENSITY (kg/m3)	MOISTURE CONTENT (%)
1	2034	1868	8.9
2	2174	1969	10.4
3	2232	1982	12.6
4	2179	1901	14.6
5	2113	1815	16.4

ZERO AIR VOIDS CURVE FOR ESTIMATED SPECIFIC GRAVITY OF 2.70	MAXIMUM DRY DENSITY (kg/m3)	OPTIMUM MOISTURE CONTENT (%)
CALCULATED	1992	11.5
OVERSIZE CORRECTED	2029	11.0

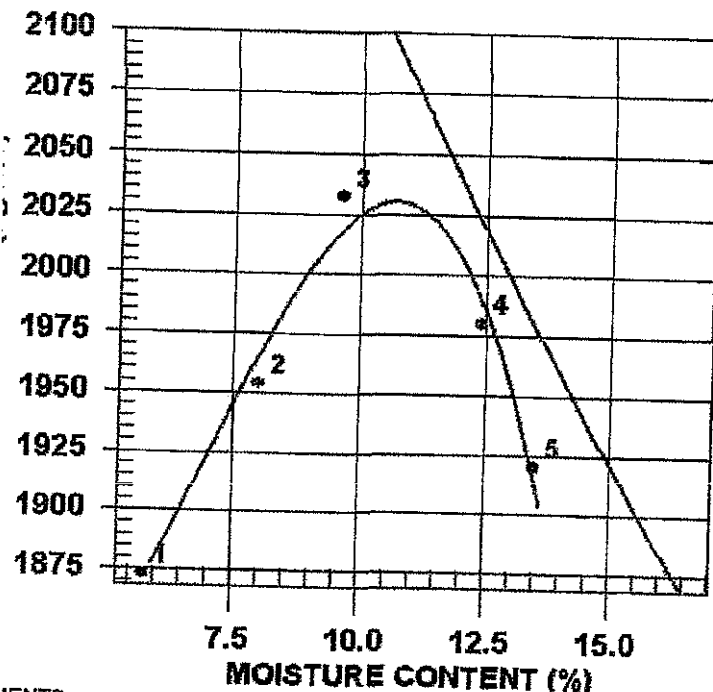
TRIAL NUMBER	WET DENSITY (kg/m3)	DRY DENSITY (kg/m3)	MOISTURE CONTENT (%)
1	1982	1873	5.8
2	2110	1954	8.0
3	2227	2032	9.6
4	2225	1980	12.4
5	2179	1920	13.5

ZERO AIR VOIDS CURVE FOR ESTIMATED SPECIFIC GRAVITY OF 2.70	MAXIMUM DRY DENSITY (kg/m3)	OPTIMUM MOISTURE CONTENT (%)
CALCULATED	2030	10.5
OVERSIZE CORRECTED	2056	10.0

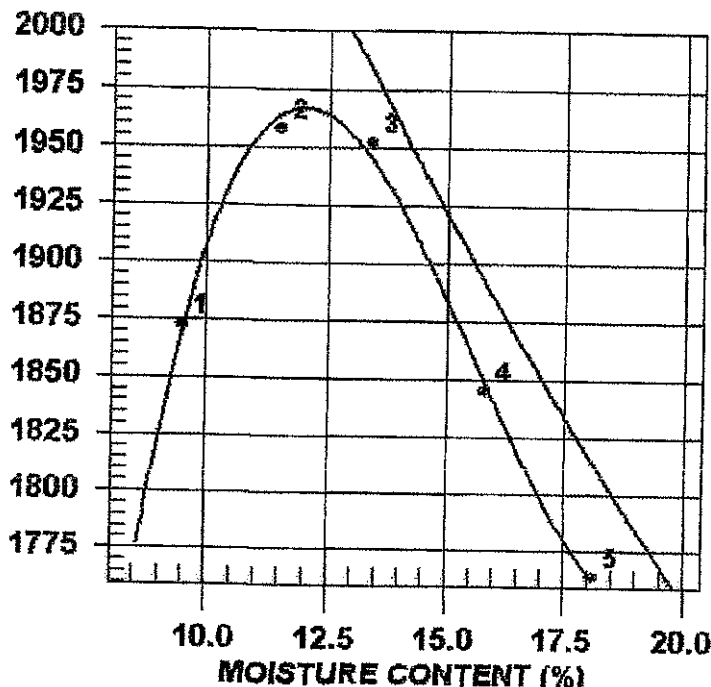
TRIAL NUMBER	WET DENSITY (kg/m³)	DRY DENSITY (kg/m³)	MOISTURE CONTENT (%)
1	2051	1873	9.5
2	2183	1958	11.5
3	2214	1952	13.4
4	2137	1845	15.8
5	2083	1764	18.1

ZERO AIR VOIDS CURVE FOR ESTIMATED SPECIFIC GRAVITY OF 2.70	MAXIMUM DRY DENSITY (kg/m³)	OPTIMUM MOISTURE CONTENT (%)
CALCULATED OVERSIZE CORRECTED	1967	12.0

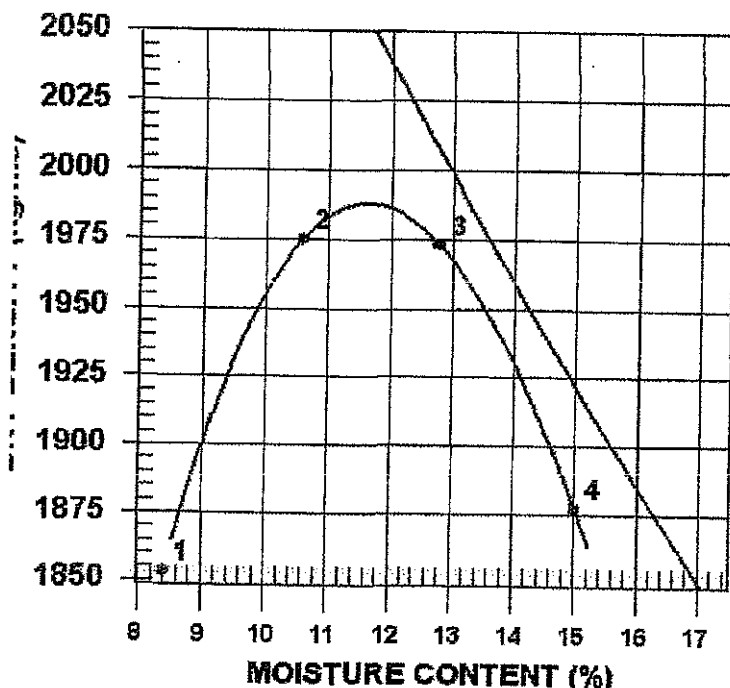
TRIAL NUMBER	WET DENSITY (kg/m ³)	DRY DENSITY (kg/m ³)	MOISTURE CONTENT (%)
1	2009	1853	8.4
2	2184	1975	10.6
3	2226	1973	12.8
4	2158	1877	15.0

ZERO AIR VOIDS CURVE FOR ESTIMATED SPECIFIC GRAVITY OF 2.70	MAXIMUM DRY DENSITY (kg/m ³)	OPTIMUM MOISTURE CONTENT (%)
CALCULATED	1988	11.5
OVERSIZE CORRECTED	2070	10.0

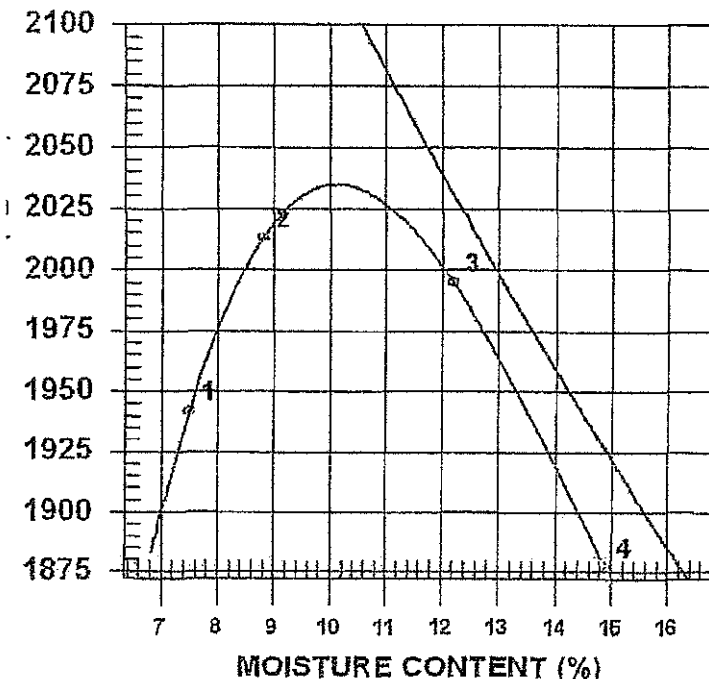
TRIAL NUMBER	WET DENSITY (kg/m3)	DRY DENSITY (kg/m3)	MOISTURE CONTENT (%)
1	2088	1942	7.5
2	2190	2013	8.8
3	2238	1995	12.2
4	2157	1877	14.9

ZERO AIR VOIDS CURVE FOR ESTIMATED SPECIFIC GRAVITY OF 2.70	MAXIMUM DRY DENSITY (kg/m3)	OPTIMUM MOISTURE CONTENT (%)
CALCULATED	2035	10.0
OVERSIZE CORRECTED	2066	9.5

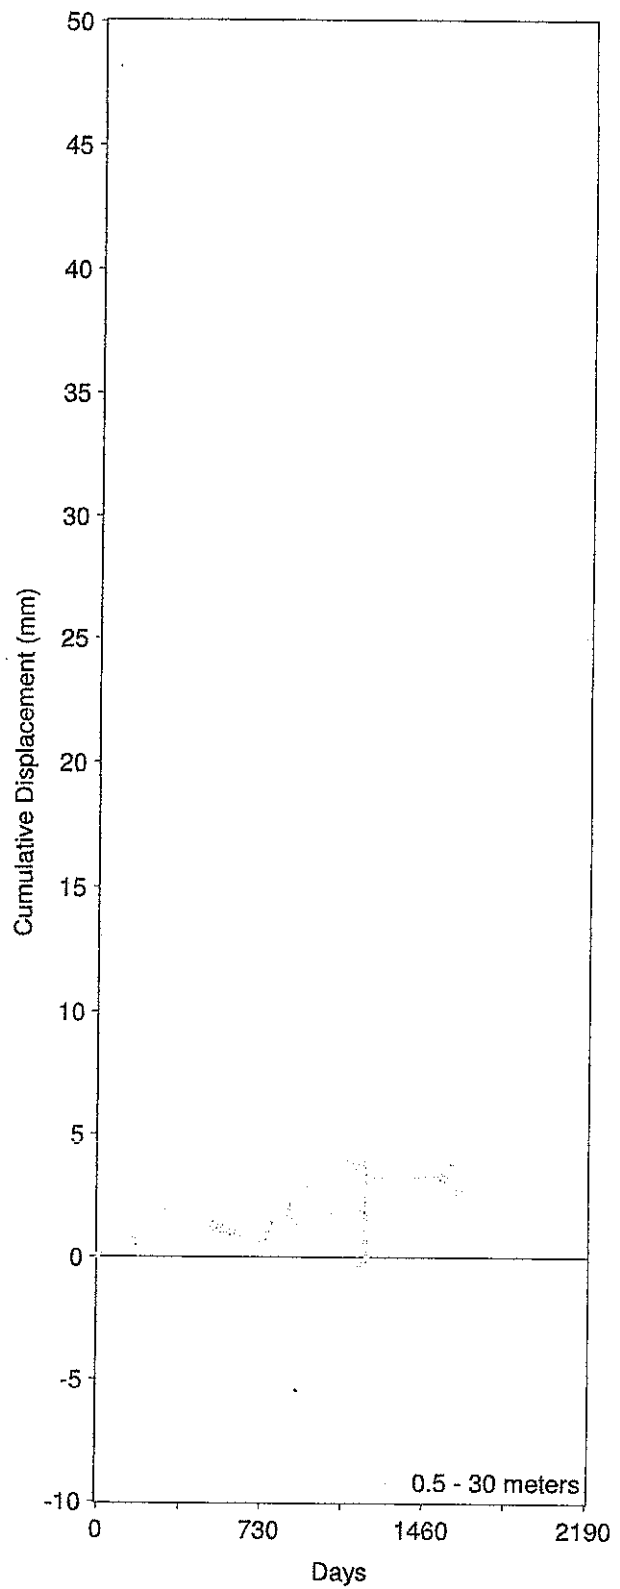
SI06-02 AB-Axis

- SI06-02 and SI06-03 also displayed slight displacements. Since initialization of these slope inclinometers (in 2006), cumulative lateral displacement of roughly 5 mm has been observed, with no well-defined discrete movement zone. These movements are well within tolerable limits.

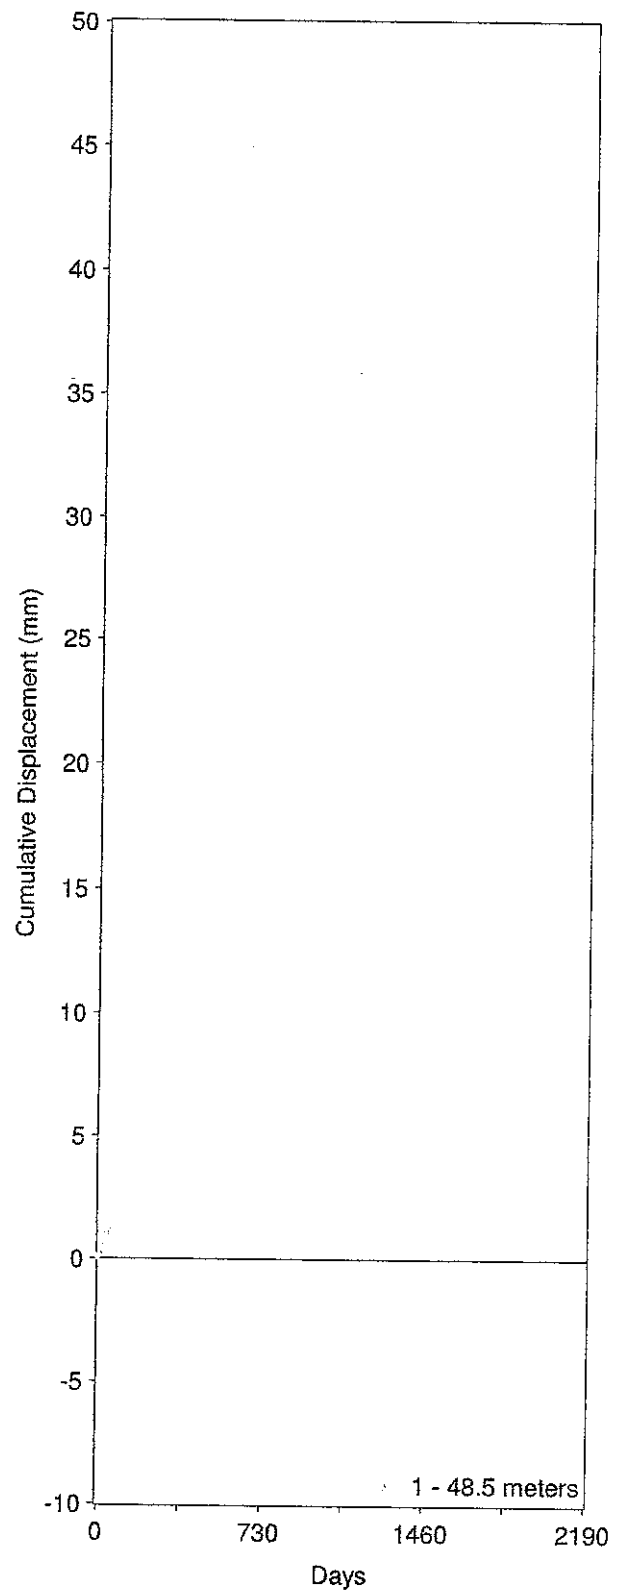
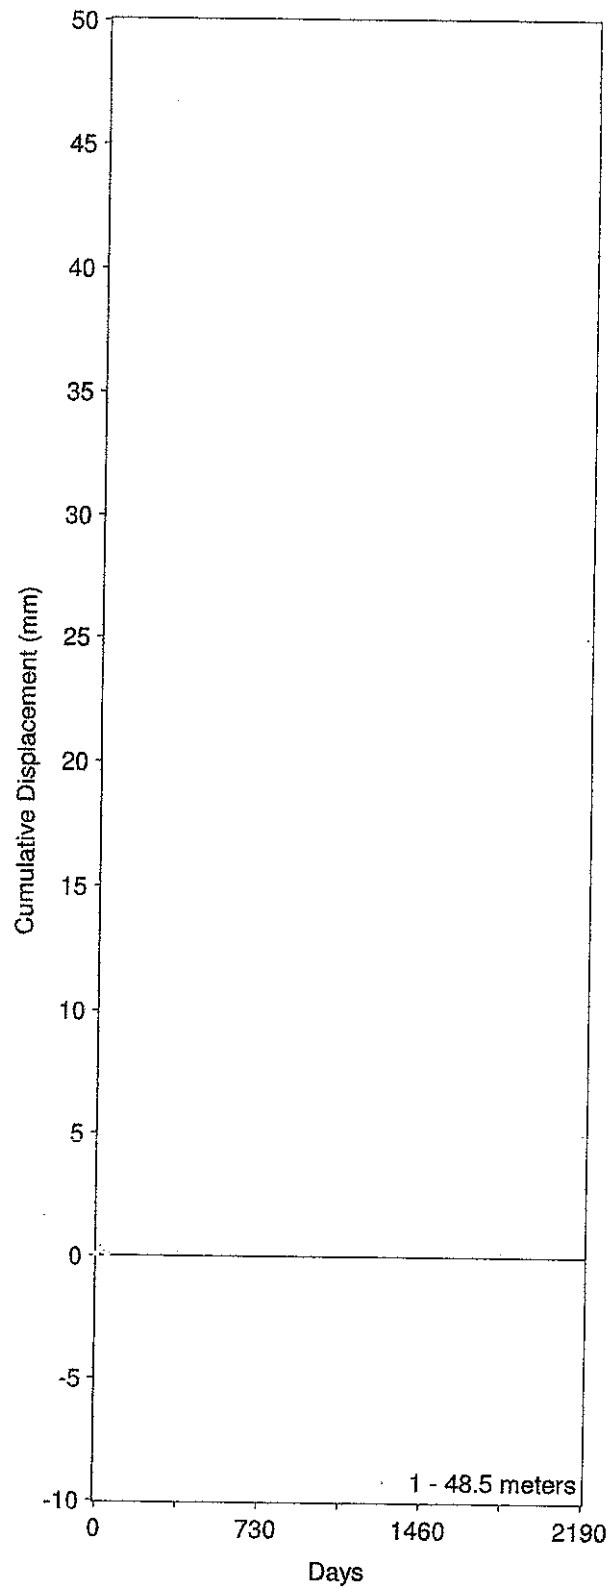
SI11-02 A-Axis

- SI11-02 showed an approximately 5 mm displacement over the course of the entire year. About half of that movement was observed sometime after or near completion of construction. Regular readings were not conducted during construction. The observed displacement is well within tolerable limits.

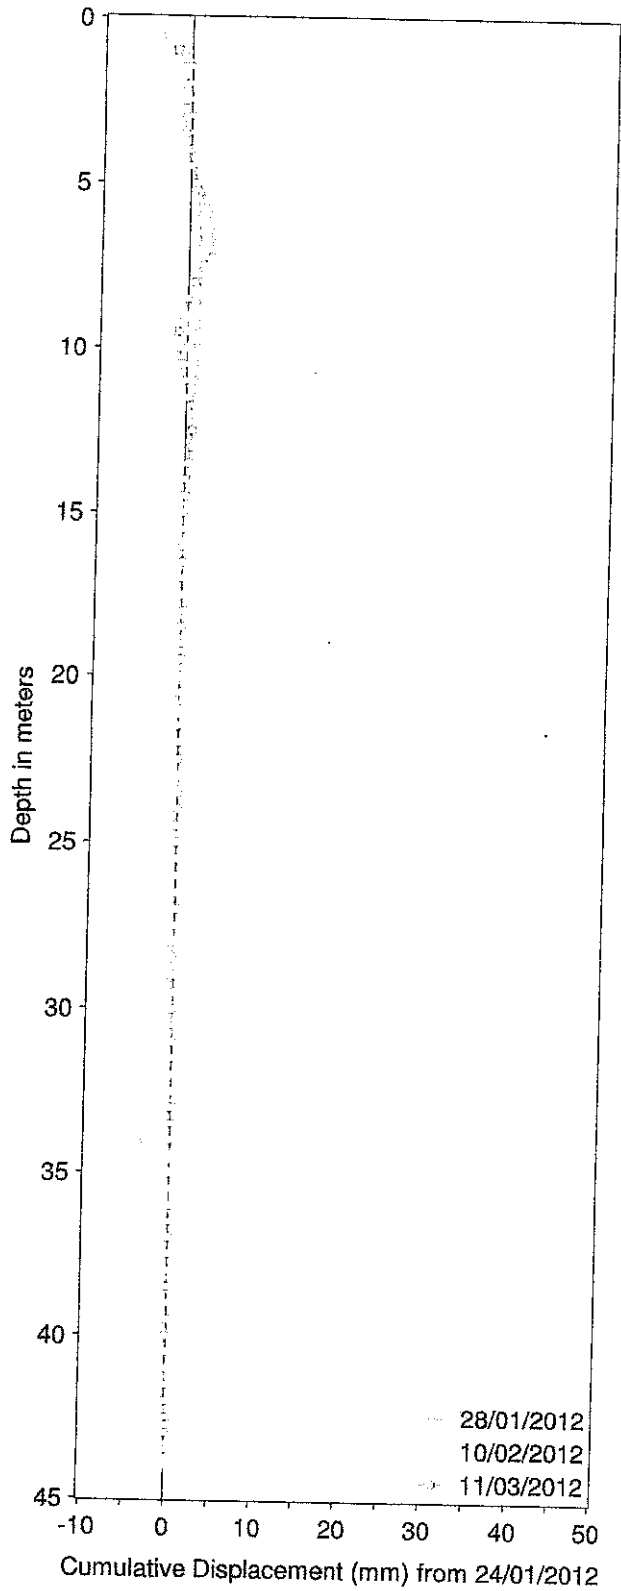
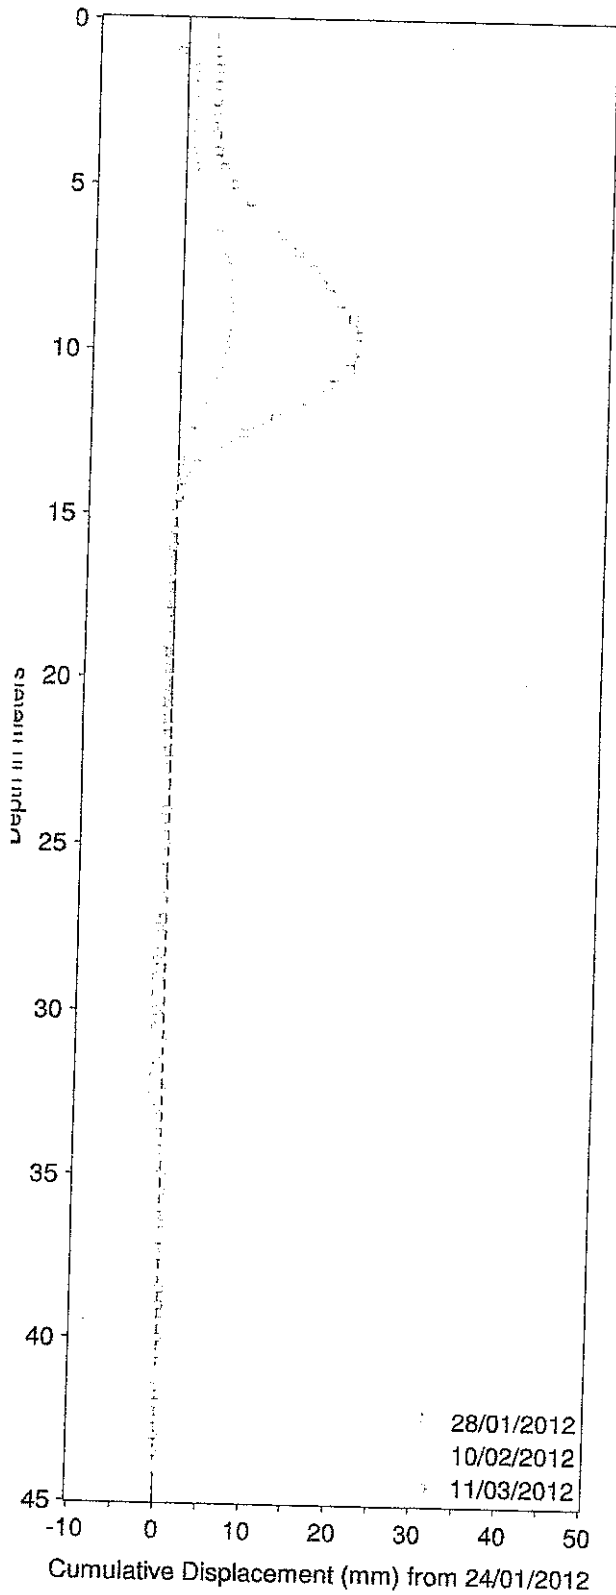
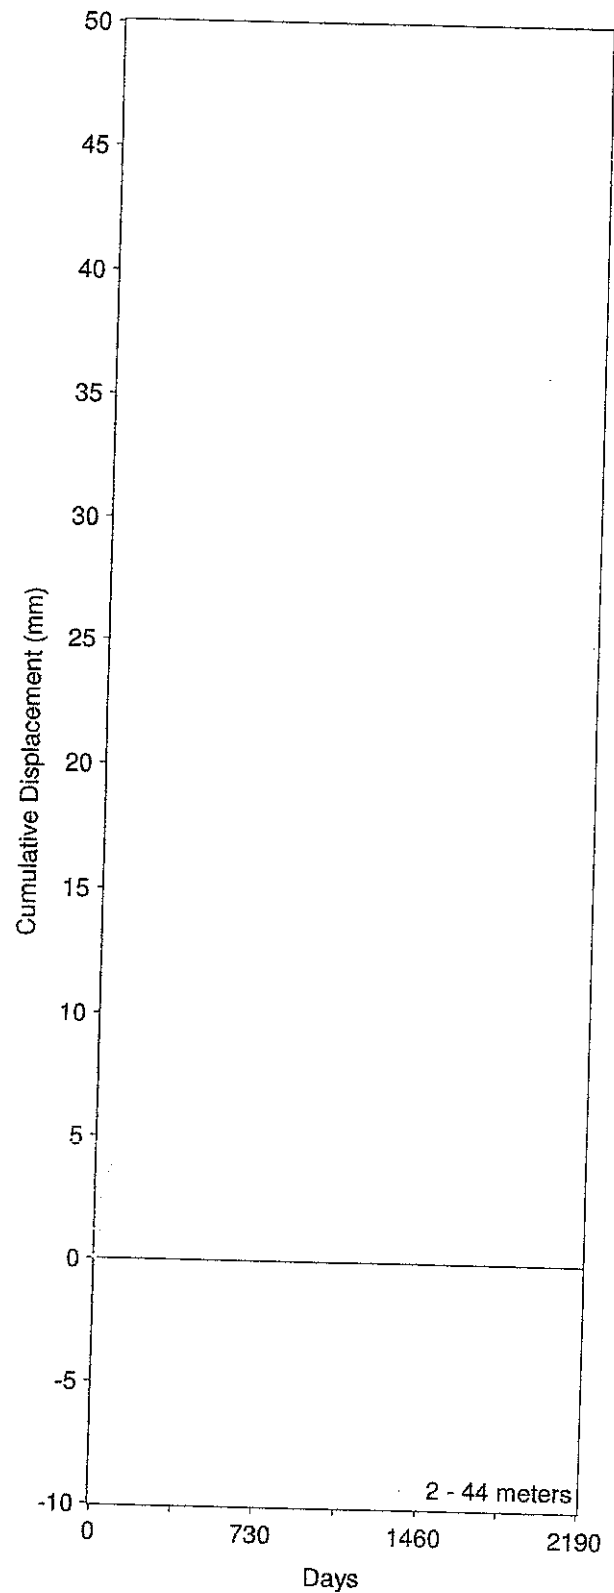
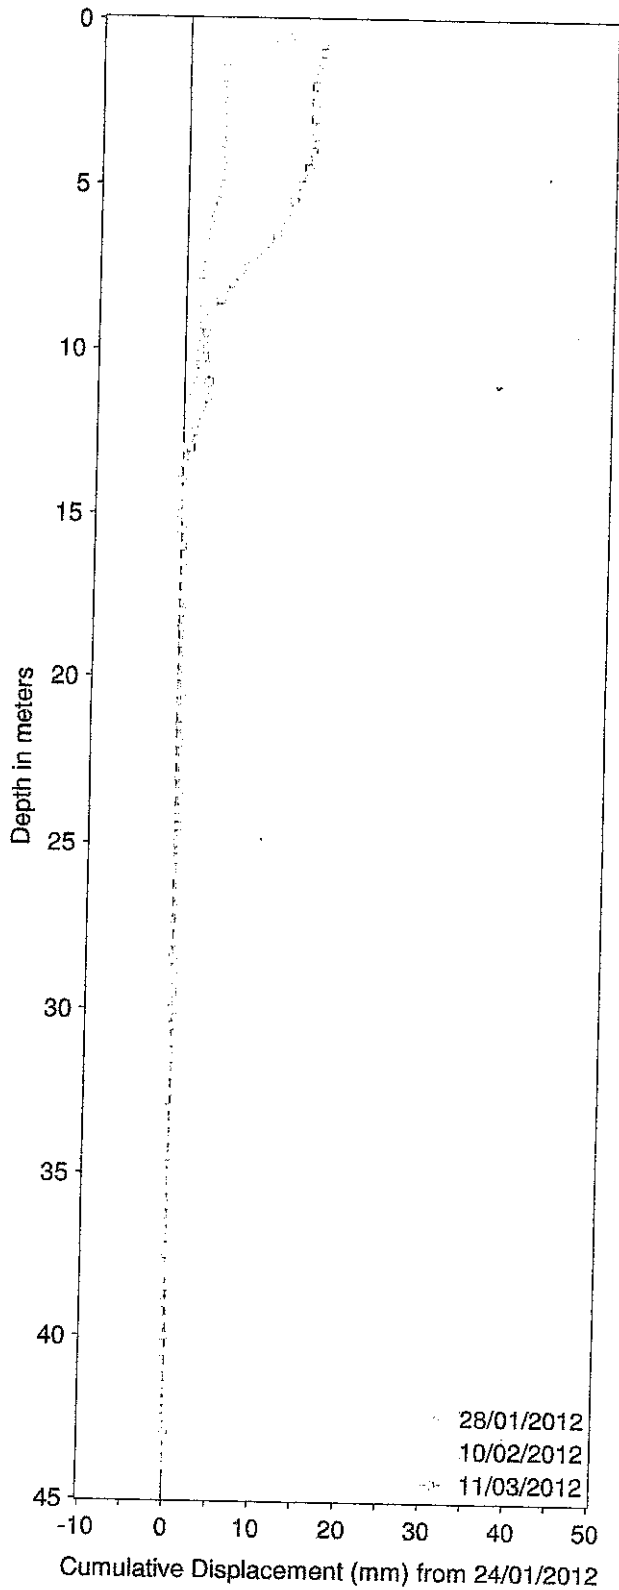
SI11-04 A-Axis

- No notable displacement has been noted on SI06-01, SI11-01, and SI11-02.
- SI11-04 has to date indicated displacement suggestive of compression rather than lateral displacement. Such a pattern of displacement sometimes occurs as a result of the installation process. This slope inclinometer should be reinitialized when the compression displacement stabilizes.

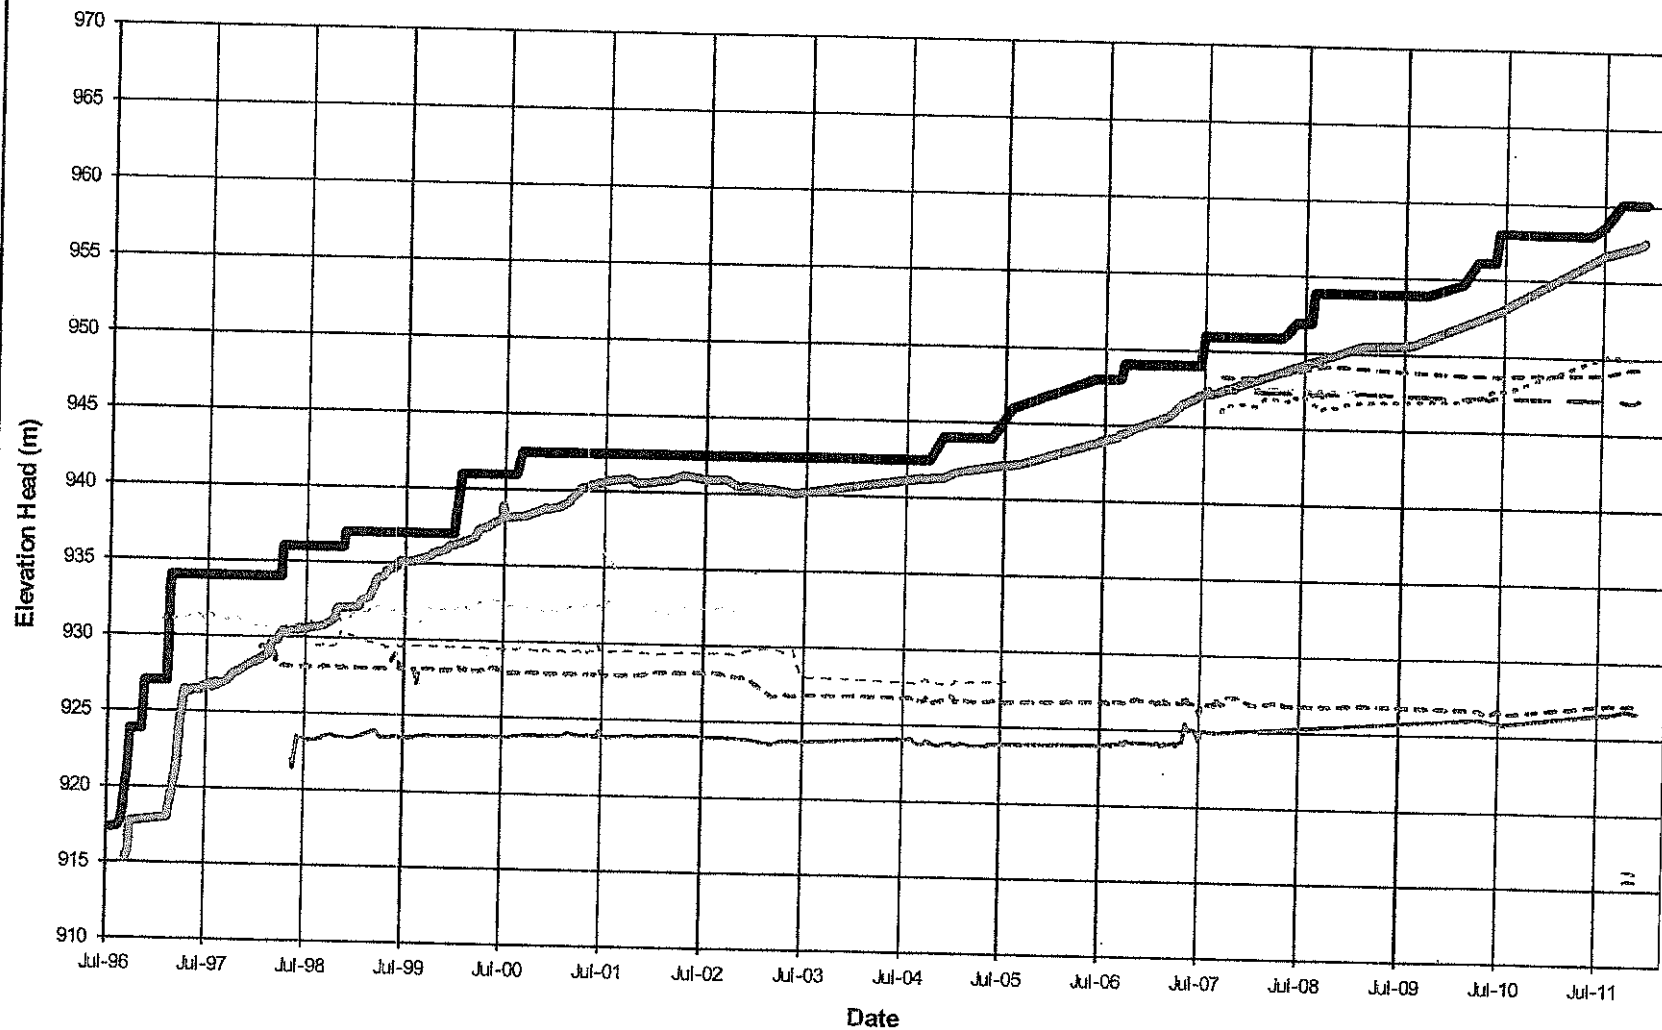
FIGURE D

- Pore pressures in foundation soils in and around the TSF embankment were noted as stable with minor fluctuations, except for D1 where an upward trend is noted. Newly installed piezometers appear to have stabilized but insufficient data has been collected to show any trends at this point.
- Pore pressures in the till core are found to be stable, with a slightly increasing trend in response to the rising pond level.
- Pore pressures in filter and drains remained unchanged throughout the year.
- Pore pressures in the tailings and upstream fill experienced an upwards trend in response to the rising pond level. Piezometers installed at a lower elevation within the upstream tailings experienced lower response relative to the piezometers near the pond elevation, likely the result of proximity to the upstream under-drainage system.

— Pond Level	— Fill Elevation	— D2 Drain
--- D3 Filter	— D4 Till Fill	--- D5 Tailings
--- D1 Foundation	— D6 Foundation	--- D7 Foundation
... DEAD (D1-PE1-03)	--- DEAD (D2-PE1-01)	... DEAD (D2-PE2-01)
... DEAD (D2-PE2-03)
