**MOUNT POLLEY MINING CORPORATION
MOUNT POLLEY MINE
TAILINGS STORAGE FACILITY**

**REPORT ON
1998 CONSTRUCTION AND ANNUAL INSPECTION
(REF. NO. 11162/10-1)**

Knight Piesold Ltd.
CONSULTING ENGINEERS

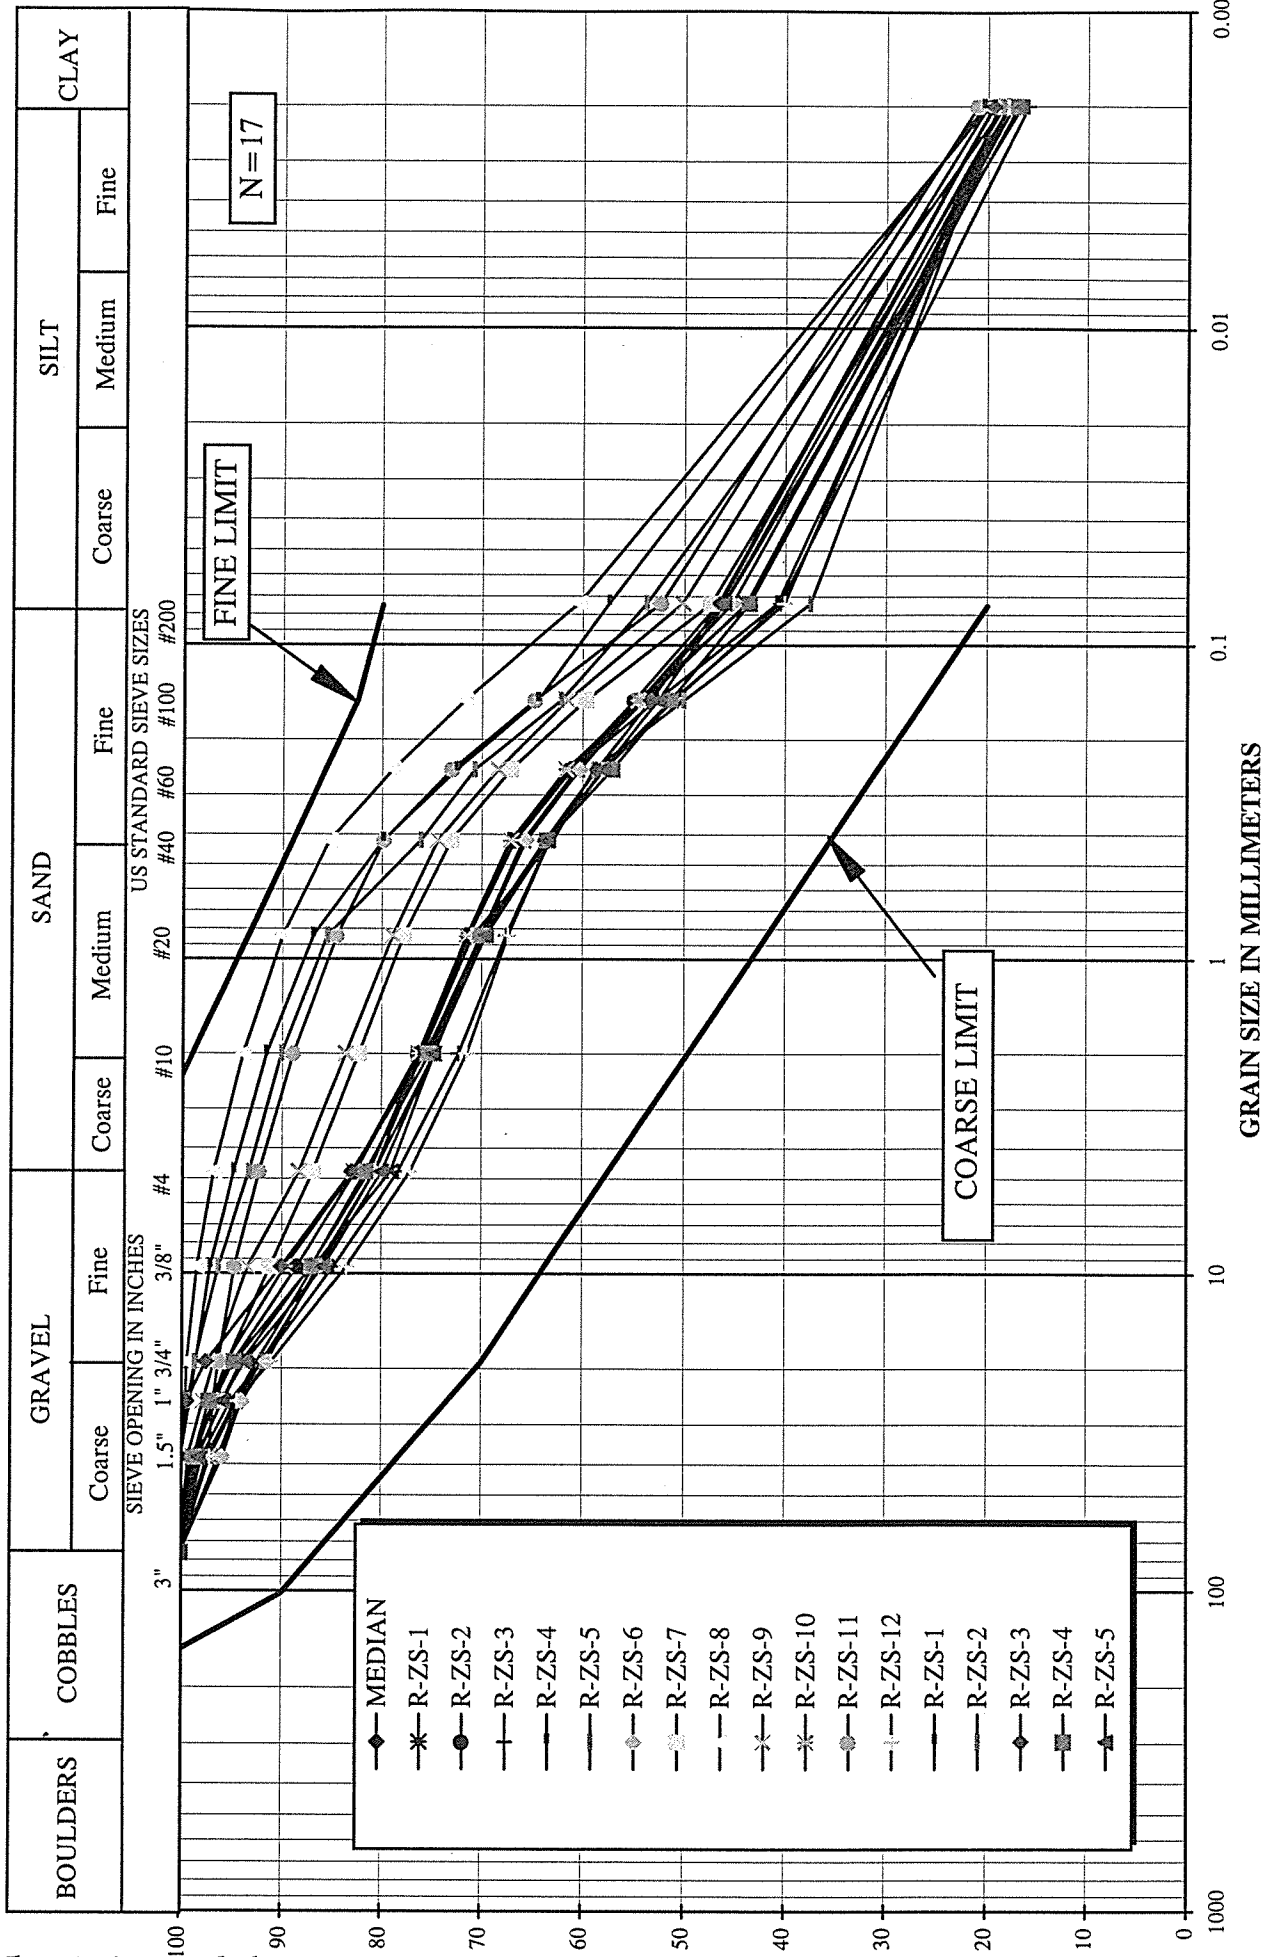
FIGURE 2.1

**MOUNT POLLEY MINING CORPORATION
MOUNT POLLEY MINE - TAILINGS STORAGE FACILITY
STAGE 2A/2B CONSTRUCTION - ZONE S RECORD SAMPLES - GRADATION CURVES**

A total of seventeen (17) samples were taken for record testing of Zone S material. Particle size analyses show that Zone S glacial till is a well-graded sandy silt with some clay and gravel. The gradation curves of the Zone S Record samples are shown on Figure 2.1.

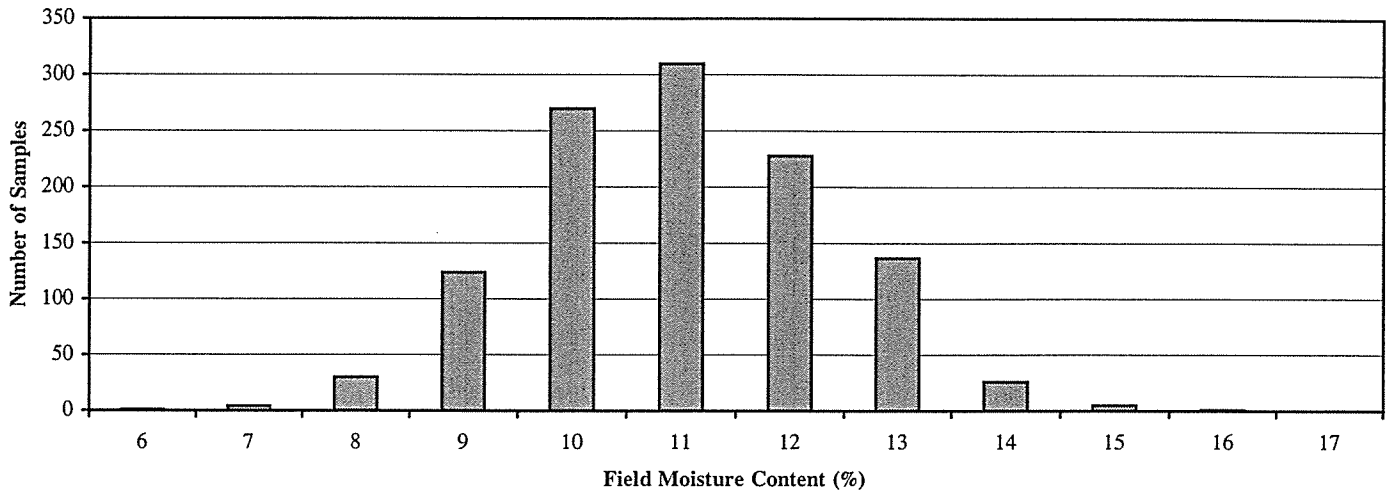
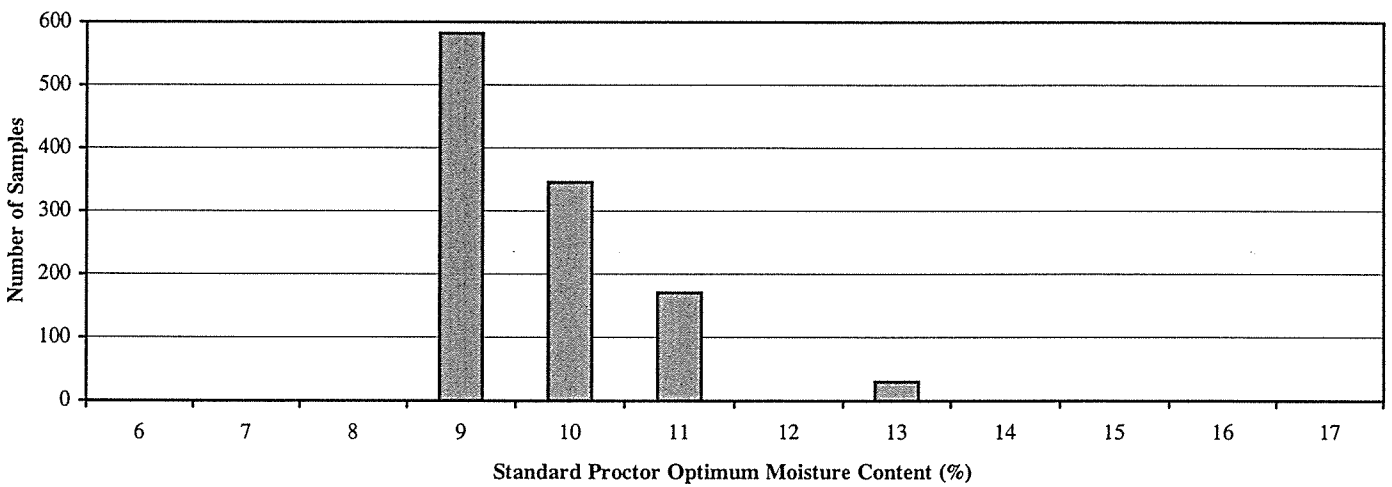
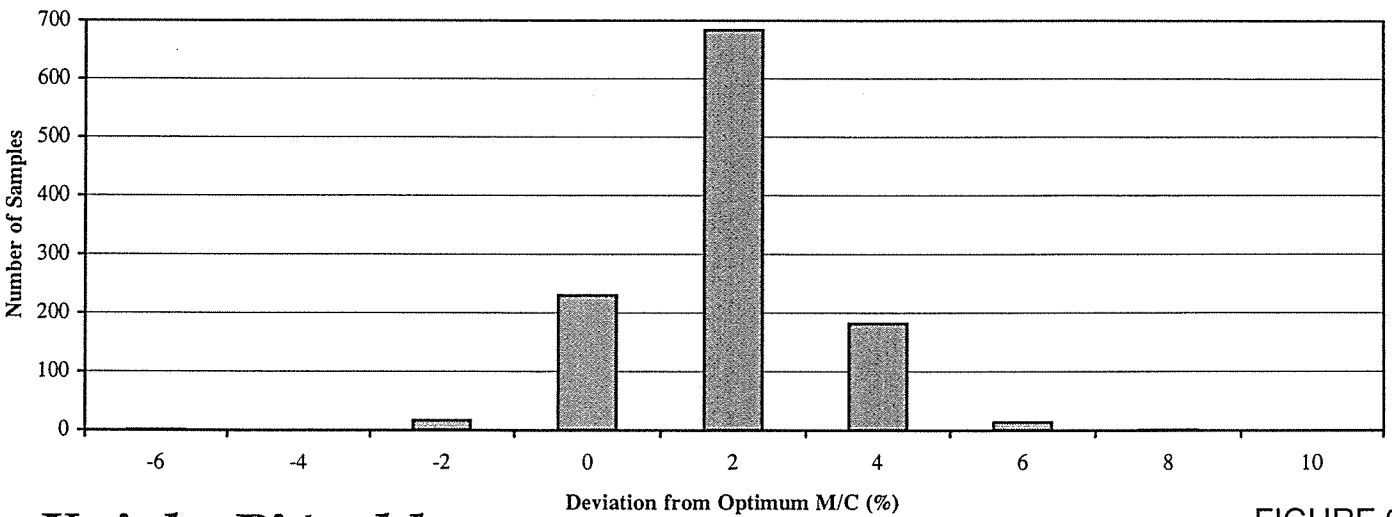
STAGE 2A/2B CONSTRUCTION - ZONE S RECORD SAMPLES -
MOISTURE CONTENT HISTOGRAMS

Histograms were generated to illustrate the results of the Field Density and Moisture Content testing. The field moisture content, Standard Proctor optimum moisture content and deviation from optimum for the Zone S Record samples are shown on Figure 2.2, while Figure 2.3 shows the measured field dry density, the Standard Proctor maximum dry density and the corresponding percent compaction. The compaction specification was revised from 98 to 95 percent of Standard Proctor maximum dry density during Stage 2A construction. Due to the small amount of tests that used the 98% compaction specification, these values are also included in Figure 2.3.

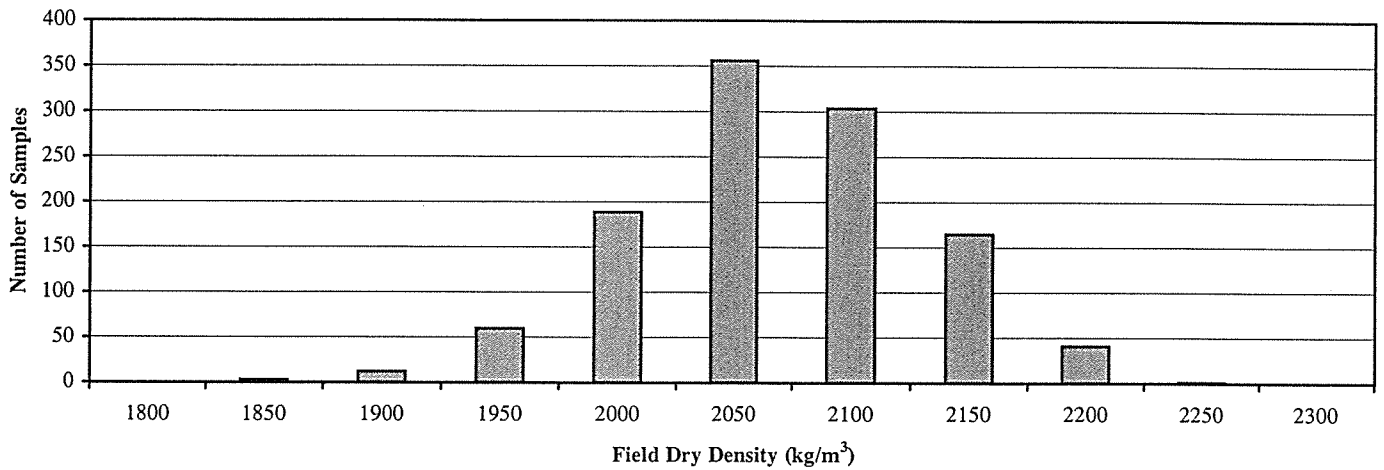
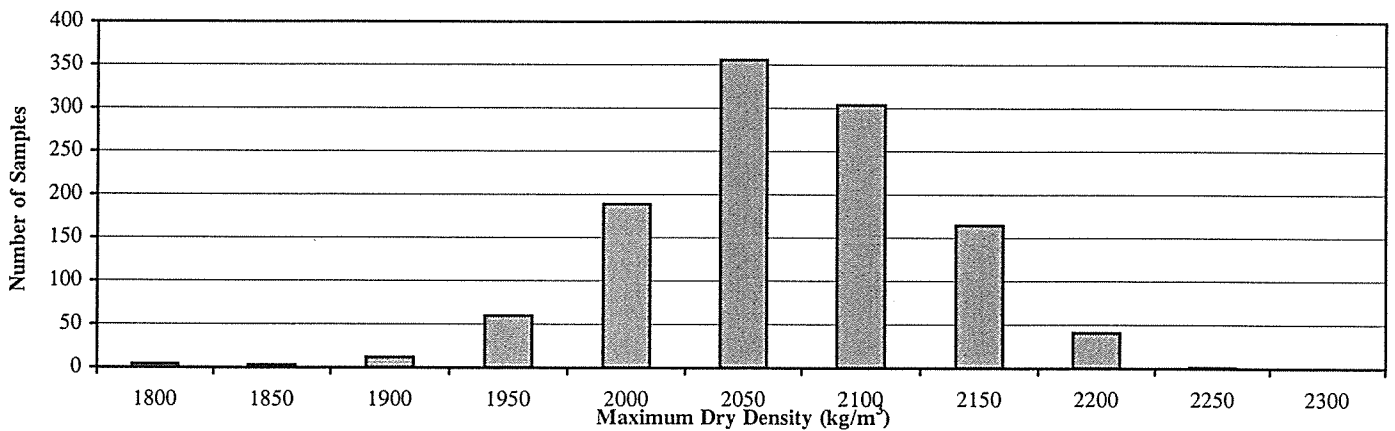
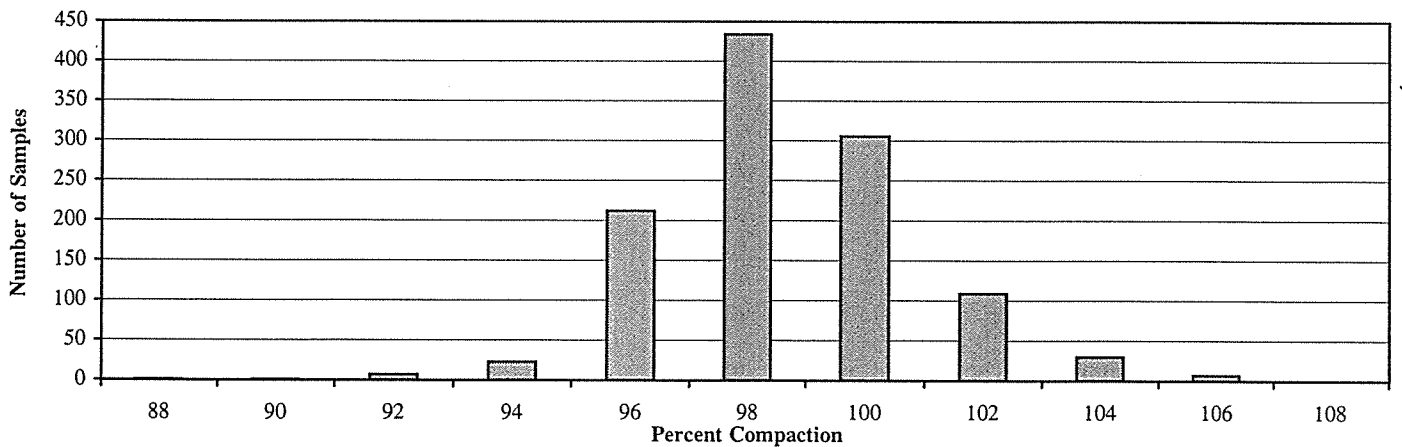
STAGE 2A/2B CONSTRUCTION - ZONE S RECORD SAMPLES -
DENSITY AND COMPACTION HISTOGRAMS

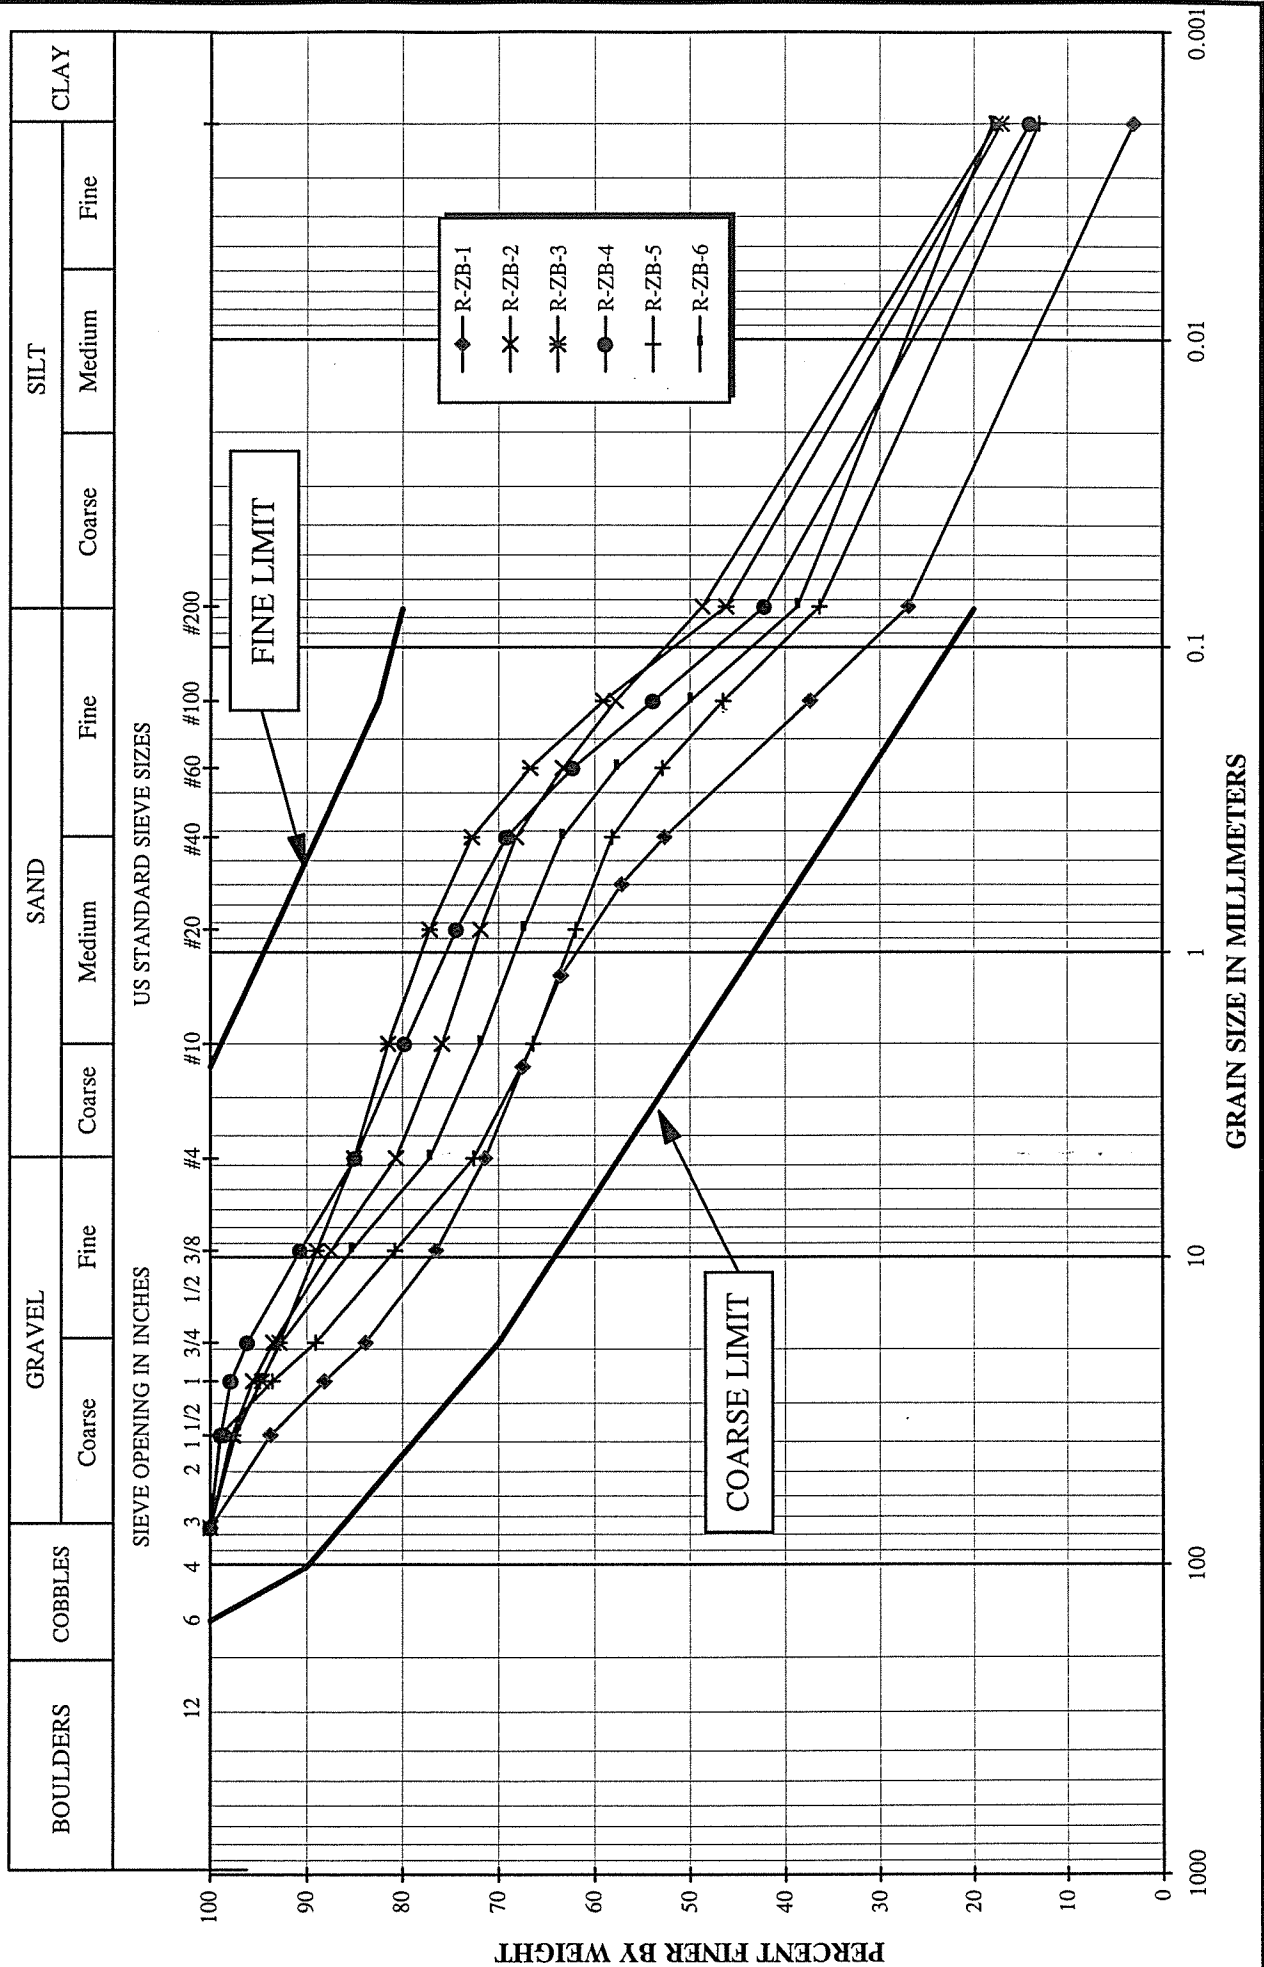
FIGURE 2.4

MOUNT POLLEY MINING CORPORATION
MOUNT POLLEY MINE - TAILINGS STORAGE FACILITY
STAGE 2A/2B CONSTRUCTION - ZONE B RECORD SAMPLES - GRADATION CURVES

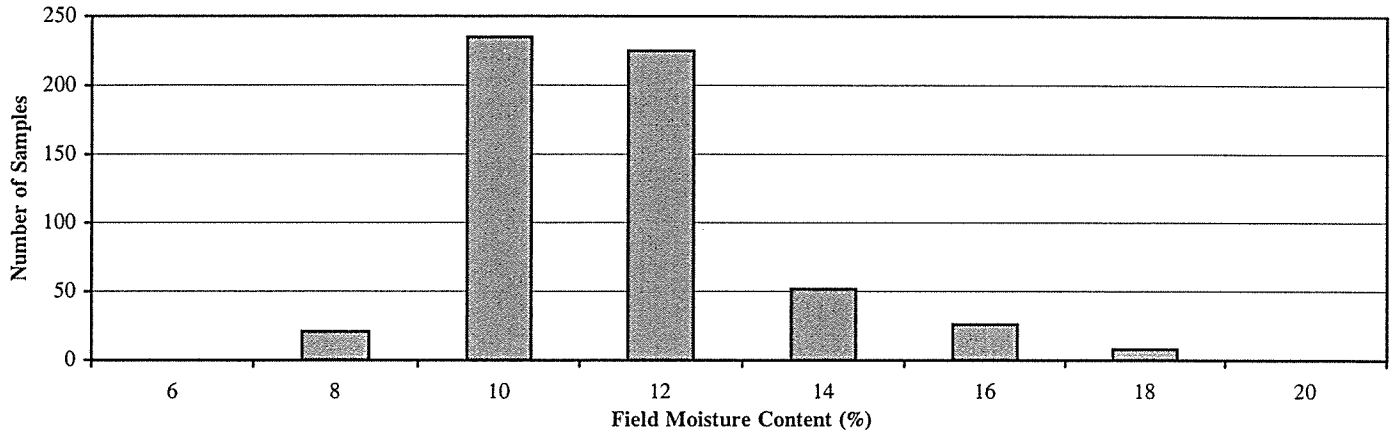
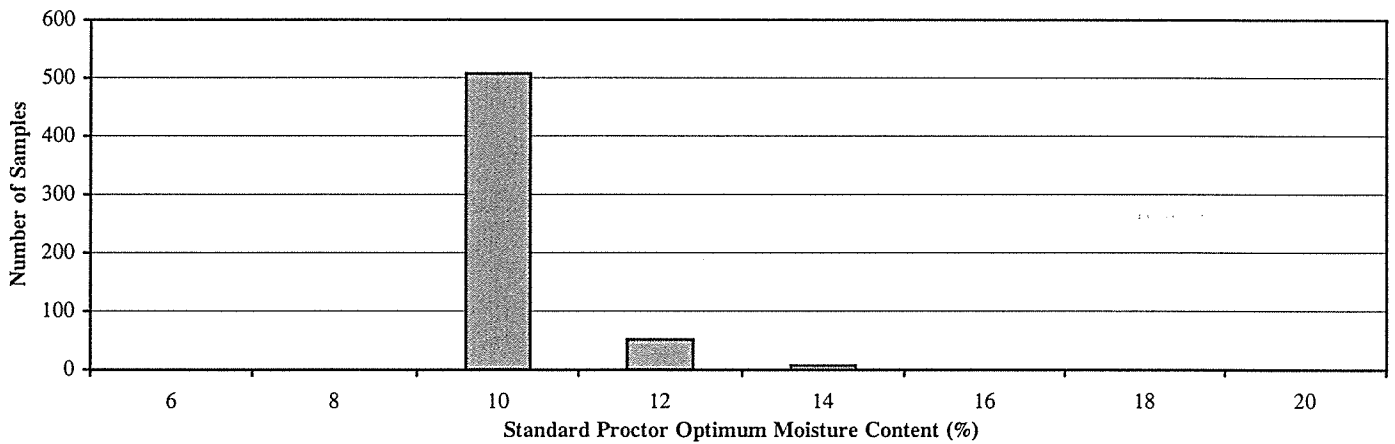
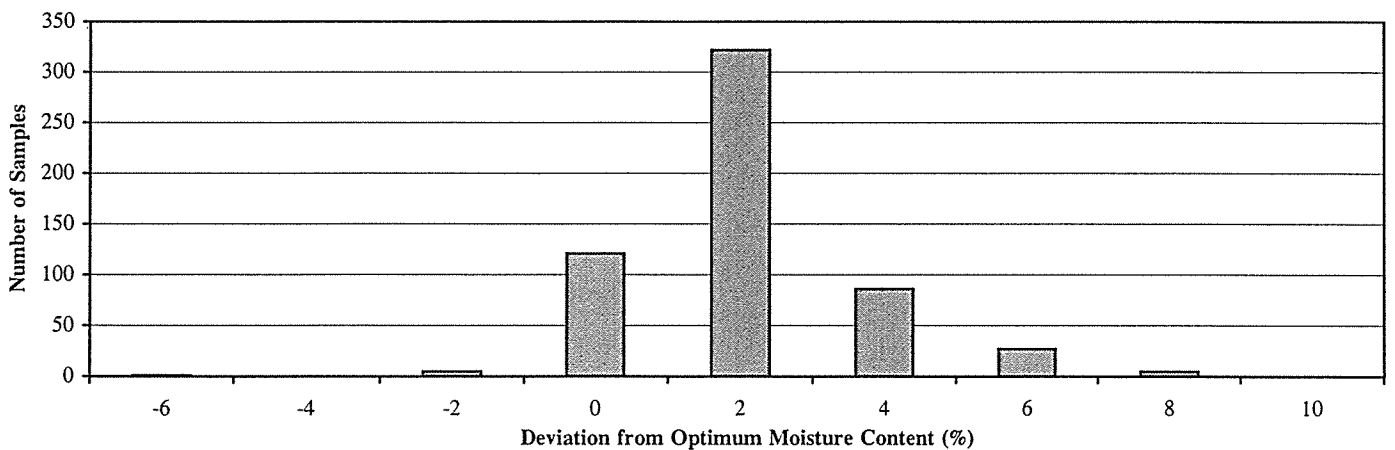
STAGE 2A/2B CONSTRUCTION - ZONE B RECORD SAMPLES -
MOISTURE CONTENT HISTOGRAMS

Histograms for moisture content and density from the Nuclear Densometer were generated. The measured field moisture content, the Standard Proctor optimum moisture content and deviation from optimum for the Zone B Record samples are shown on Figure 2.5, while Figure 2.6 shows the measured field dry density, the Standard Proctor maximum dry density and the corresponding percent compaction.

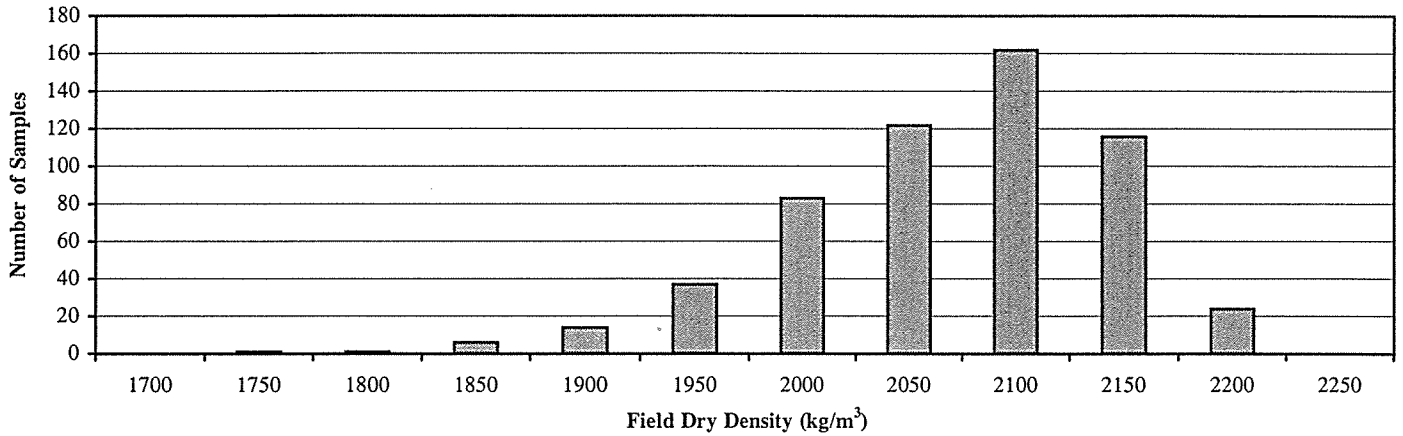
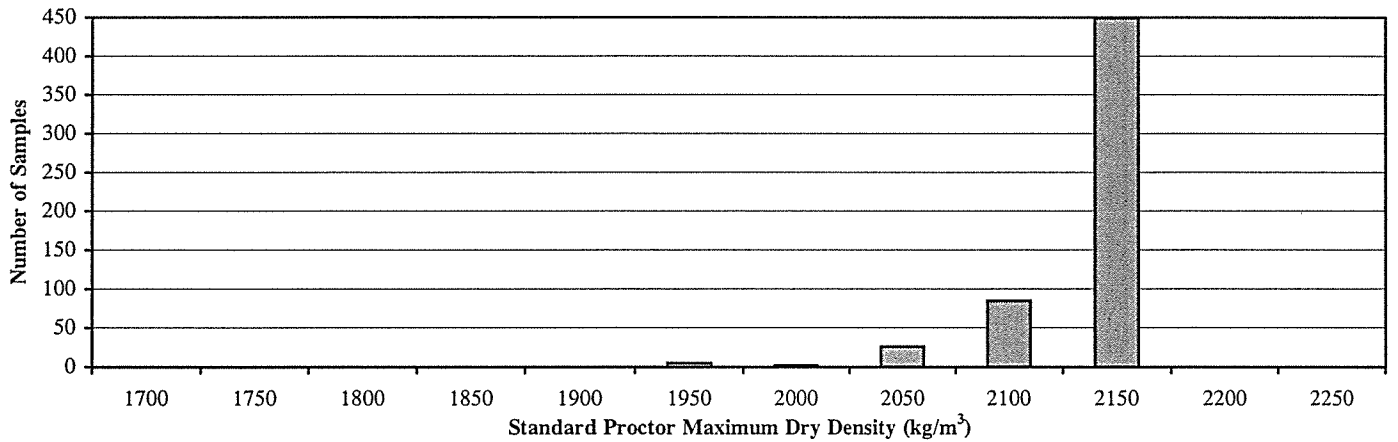
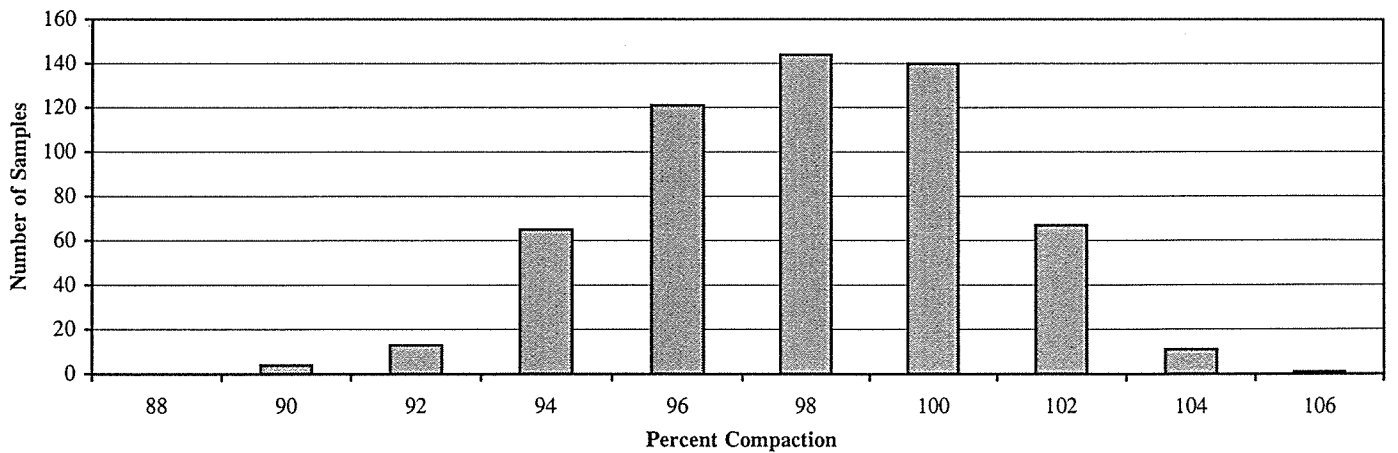
STAGE 2A/2B CONSTRUCTION - ZONE B RECORD SAMPLES -
DENSITY AND COMPACTION HISTOGRAMS

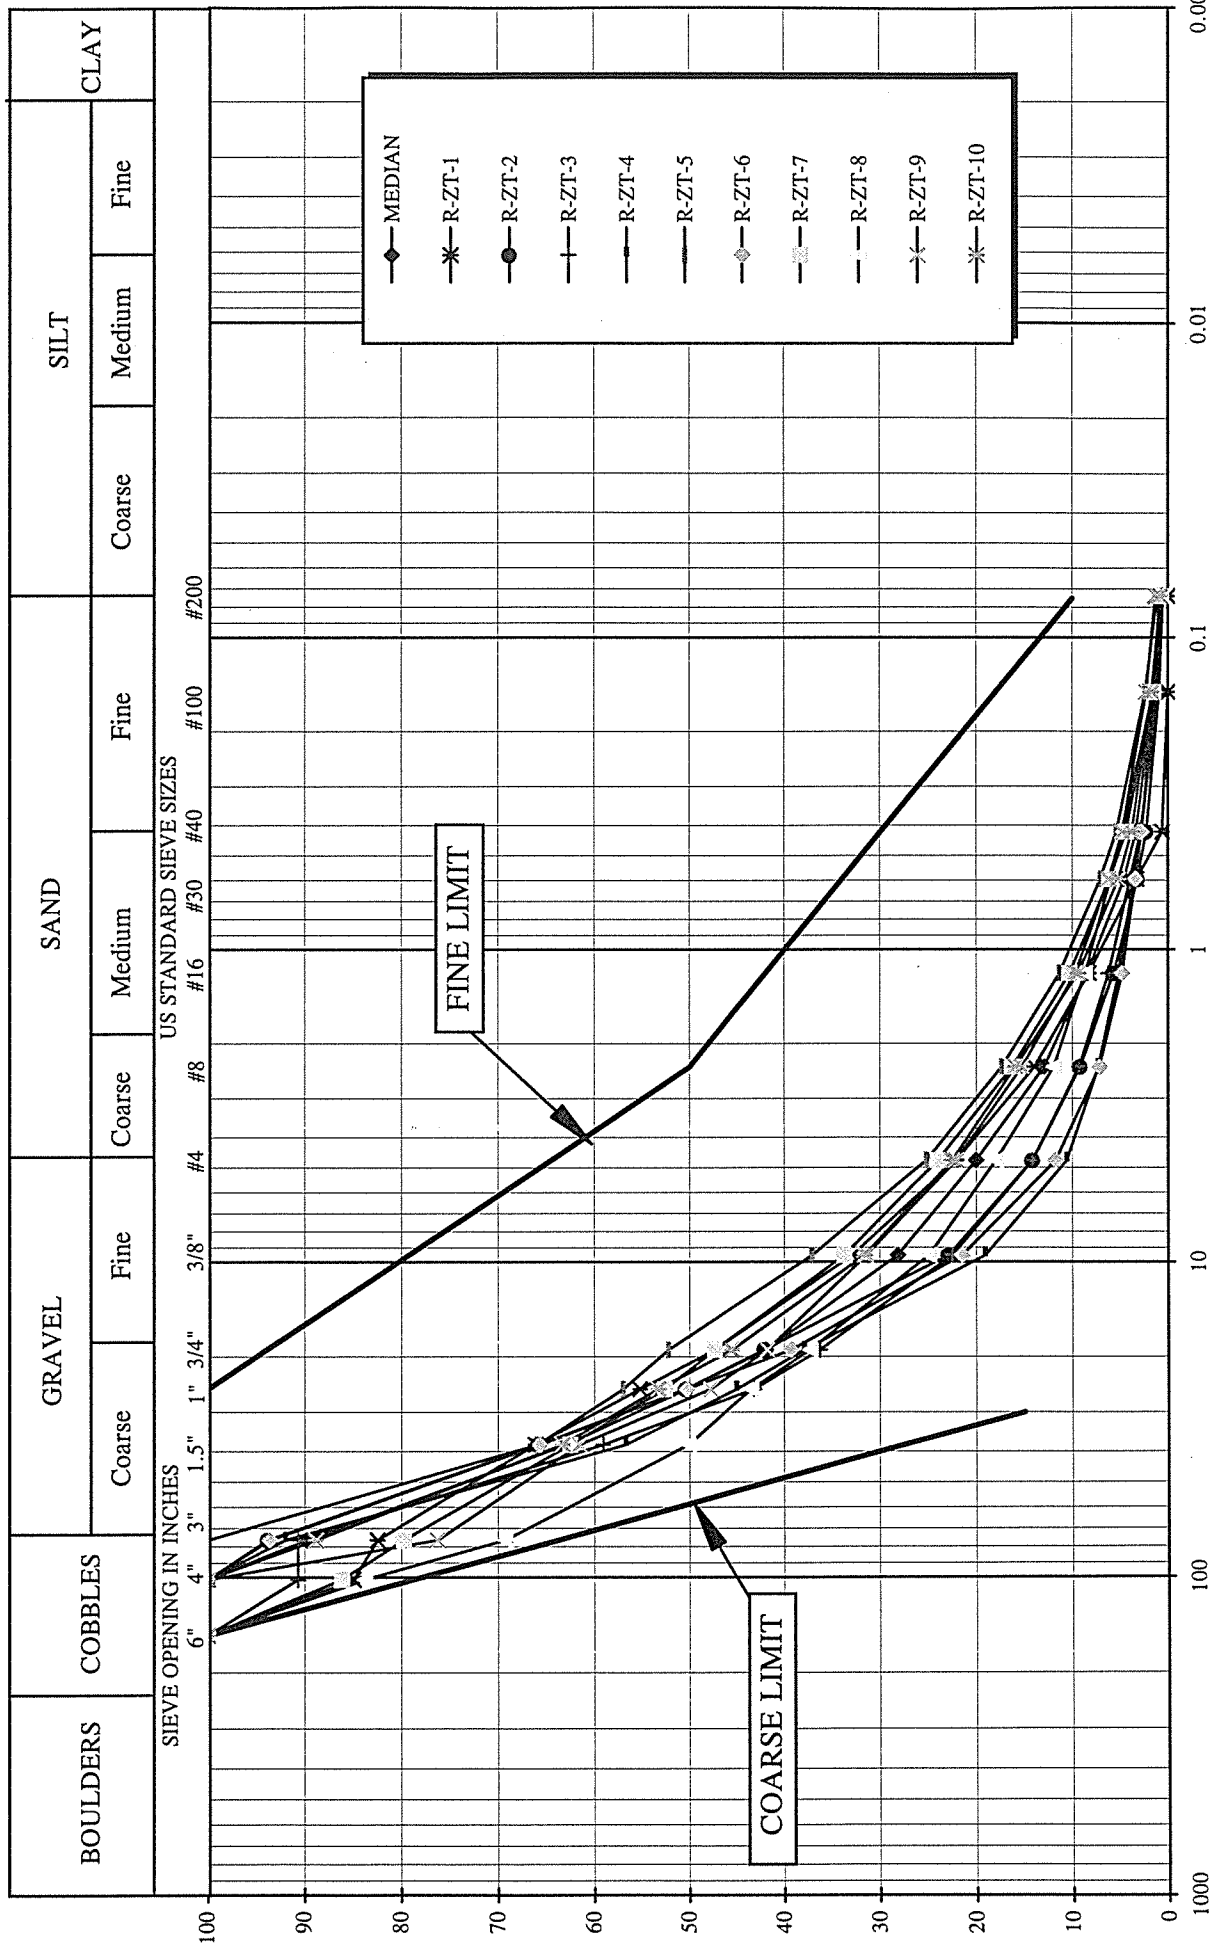
FIGURE 2.7

MOUNT POLLEY MINING CORPORATION
MOUNT POLLEY MINE - TAILINGS STORAGE FACILITY
STAGE 2A/2B CONSTRUCTION - ZONE T RECORD SAMPLES - GRADATION CURVES

A total of ten (10) samples were taken for record testing of Zone T material placed in the Zone T Haul Road. Particle size analyses show that Zone T rockfill is comprised of gravel with some sand and a trace of cobbles and silt. The Zone T material can be described as a poorly graded gravel and is classified as GP in the Unified Soil Classification System. The grain size curves for the Zone T Record samples are shown on Figure 2.7.

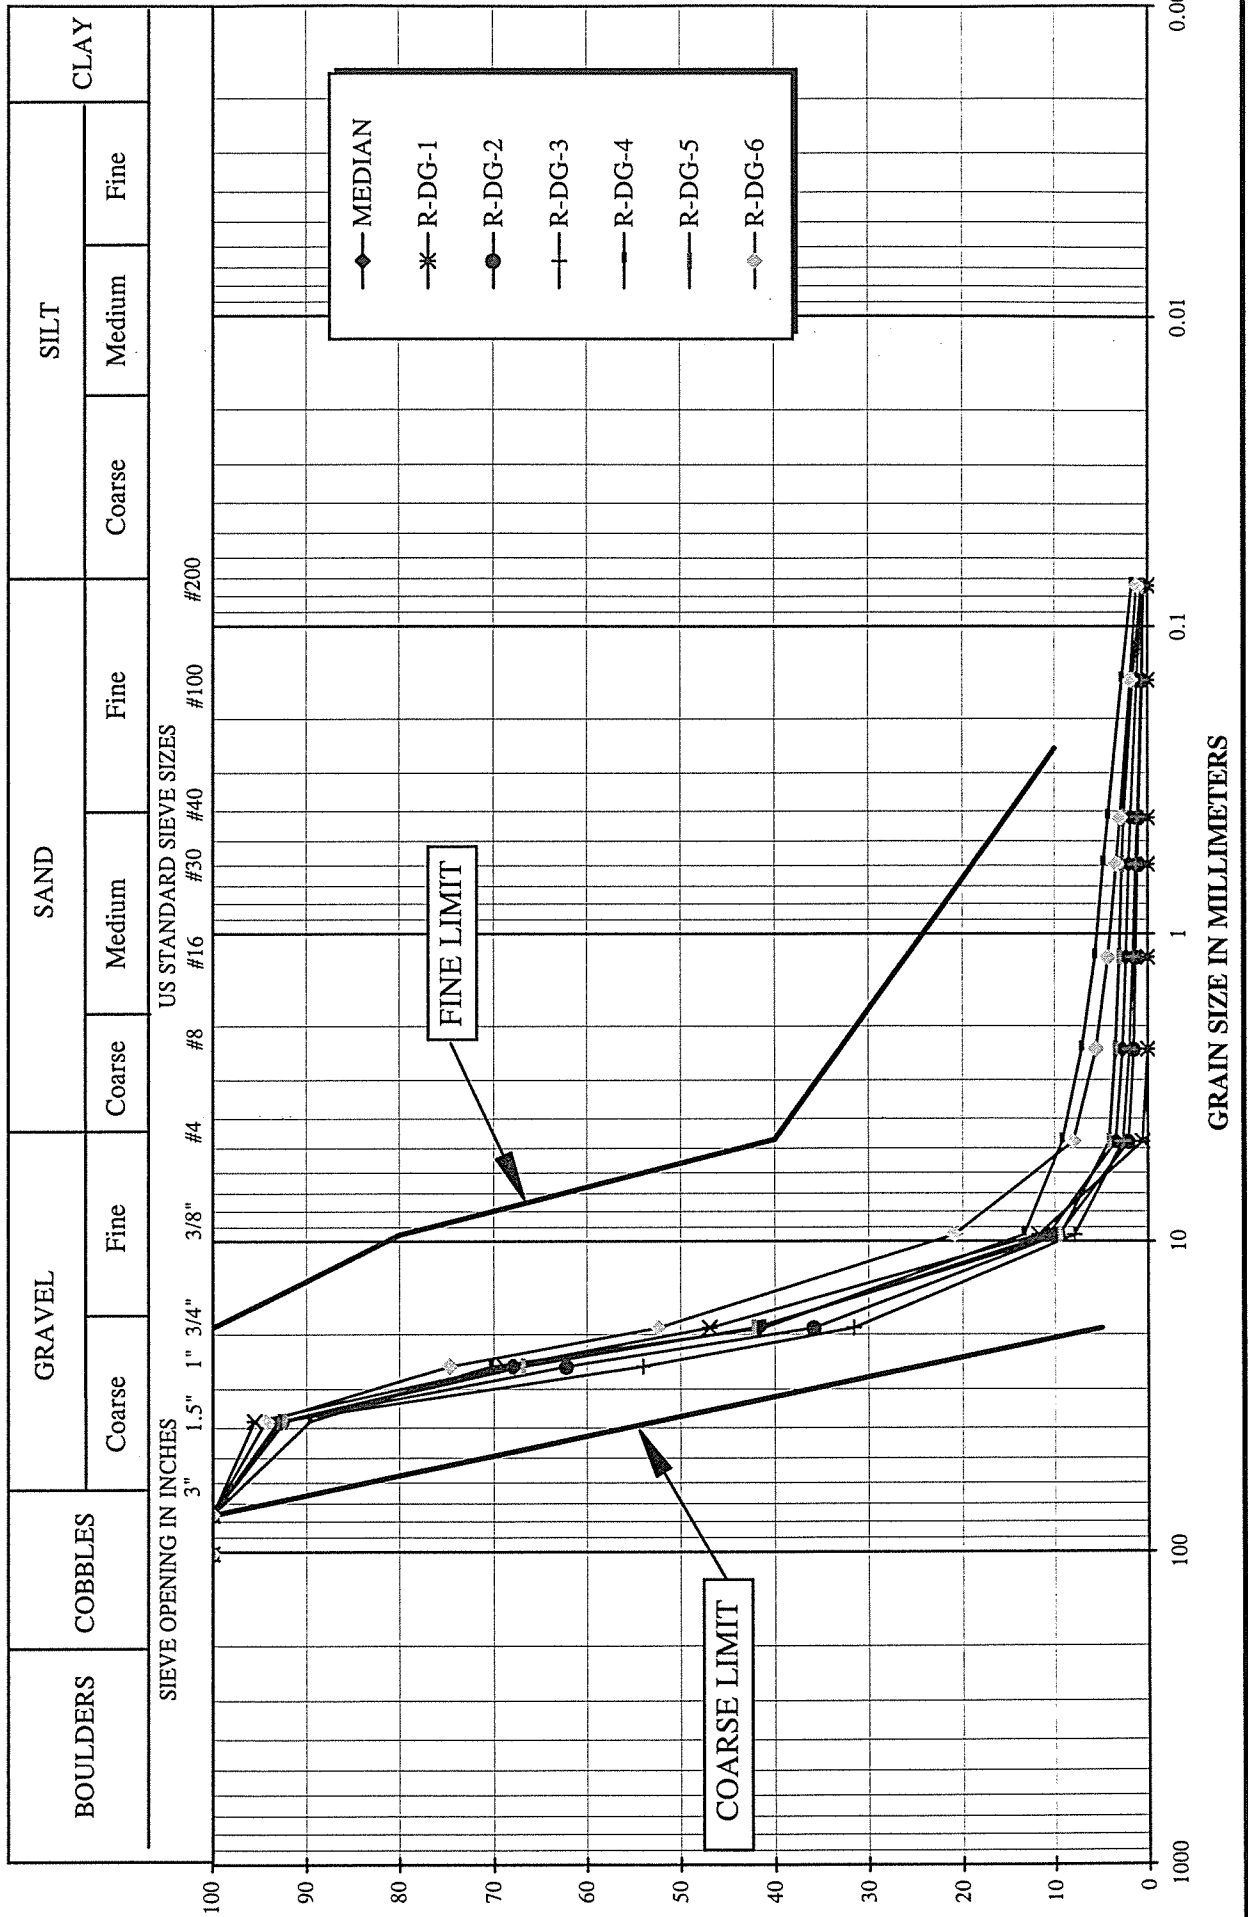
MOUNT POLLEY MINING CORPORATION
MOUNT POLLEY MINE - TAILINGS STORAGE FACILITY
STAGE 2A/2B CONSTRUCTION - ZONE G RECORD SAMPLES - GRADATION CURVES

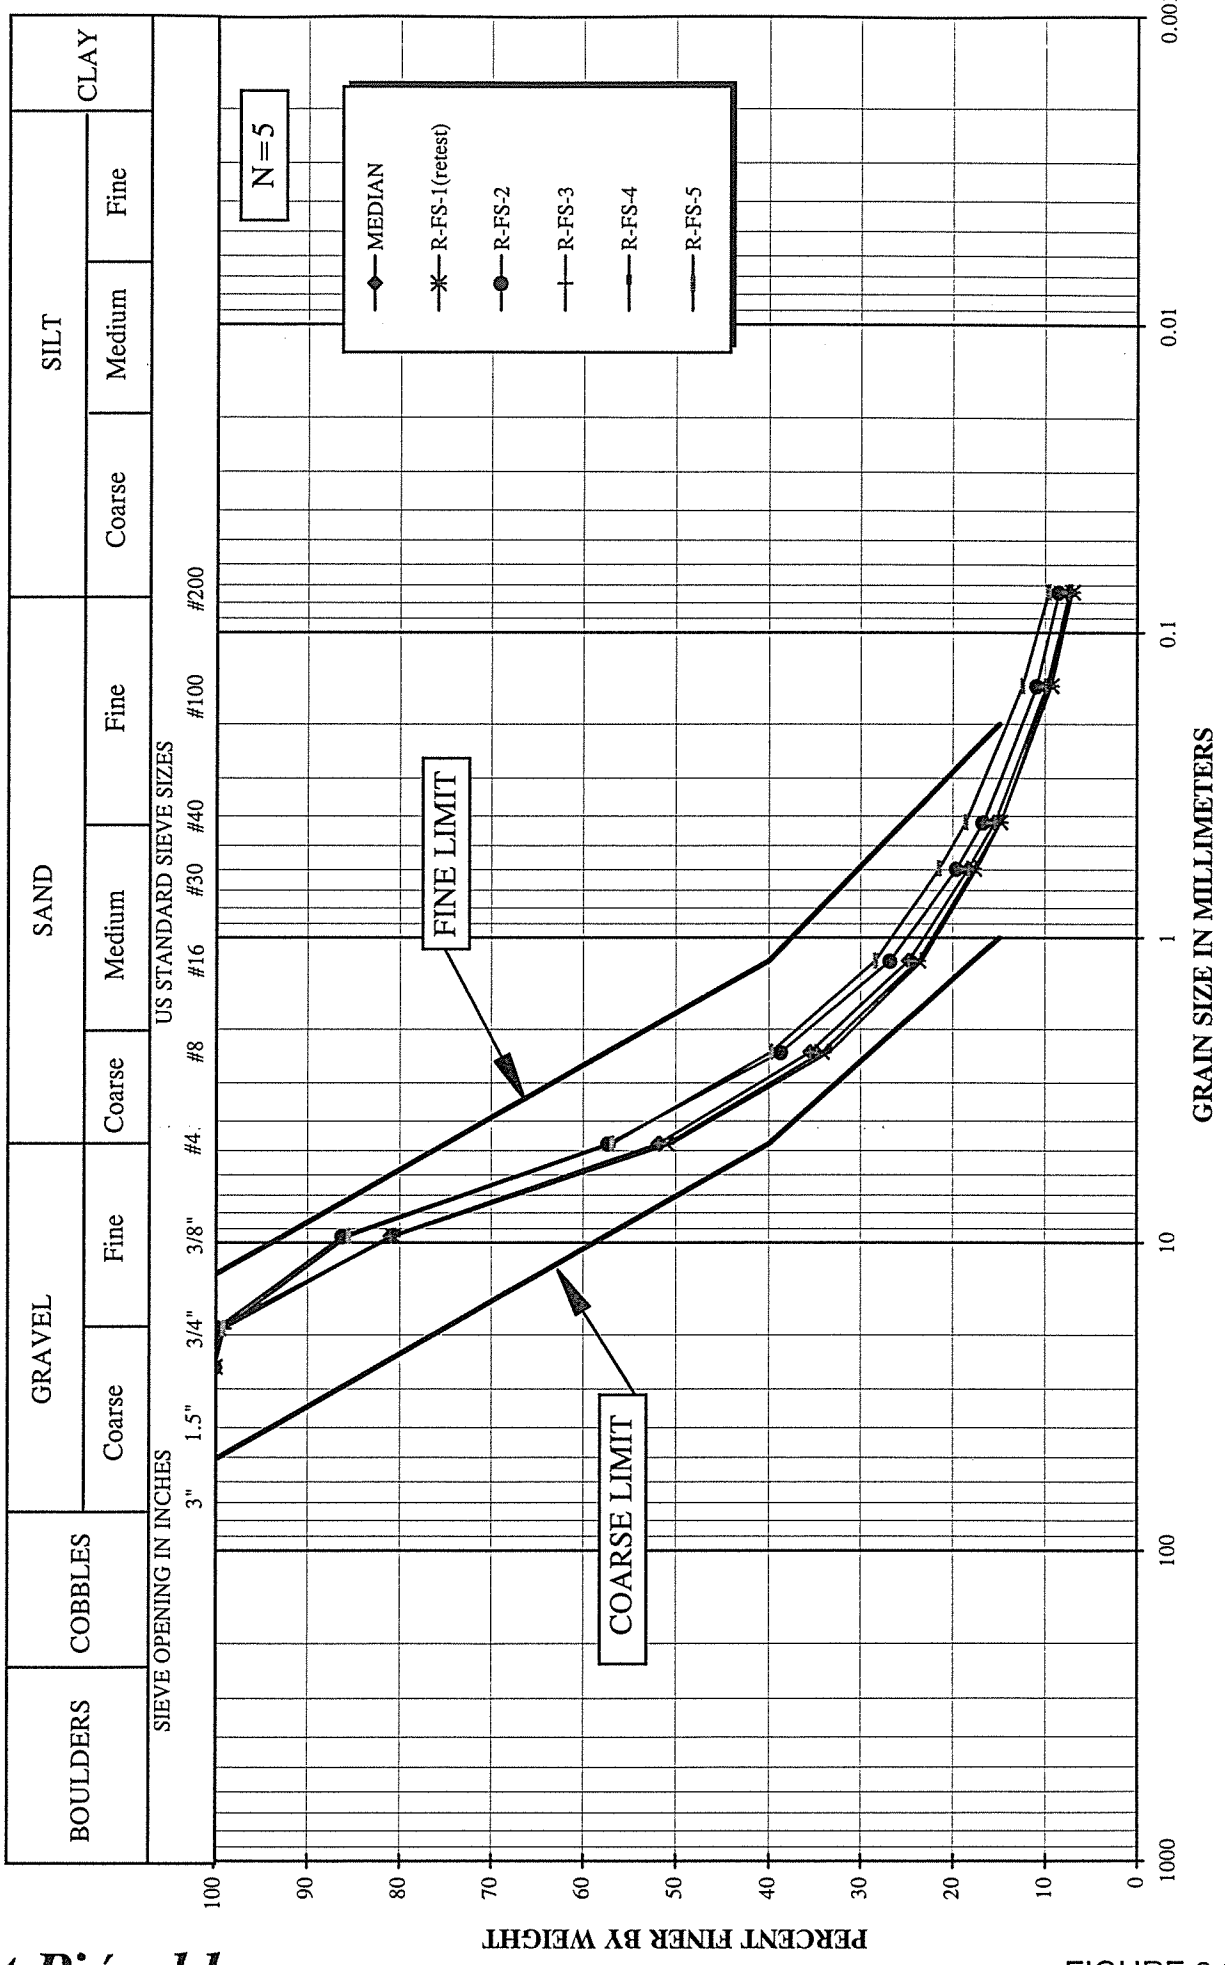
FIGURE 2.9

MOUNT POLLEY MINING CORPORATION
MOUNT POLLEY MINE - TAILINGS STORAGE FACILITY
STAGE 2A/2B CONSTRUCTION - ZONE F RECORD SAMPLES - GRADATION CURVES

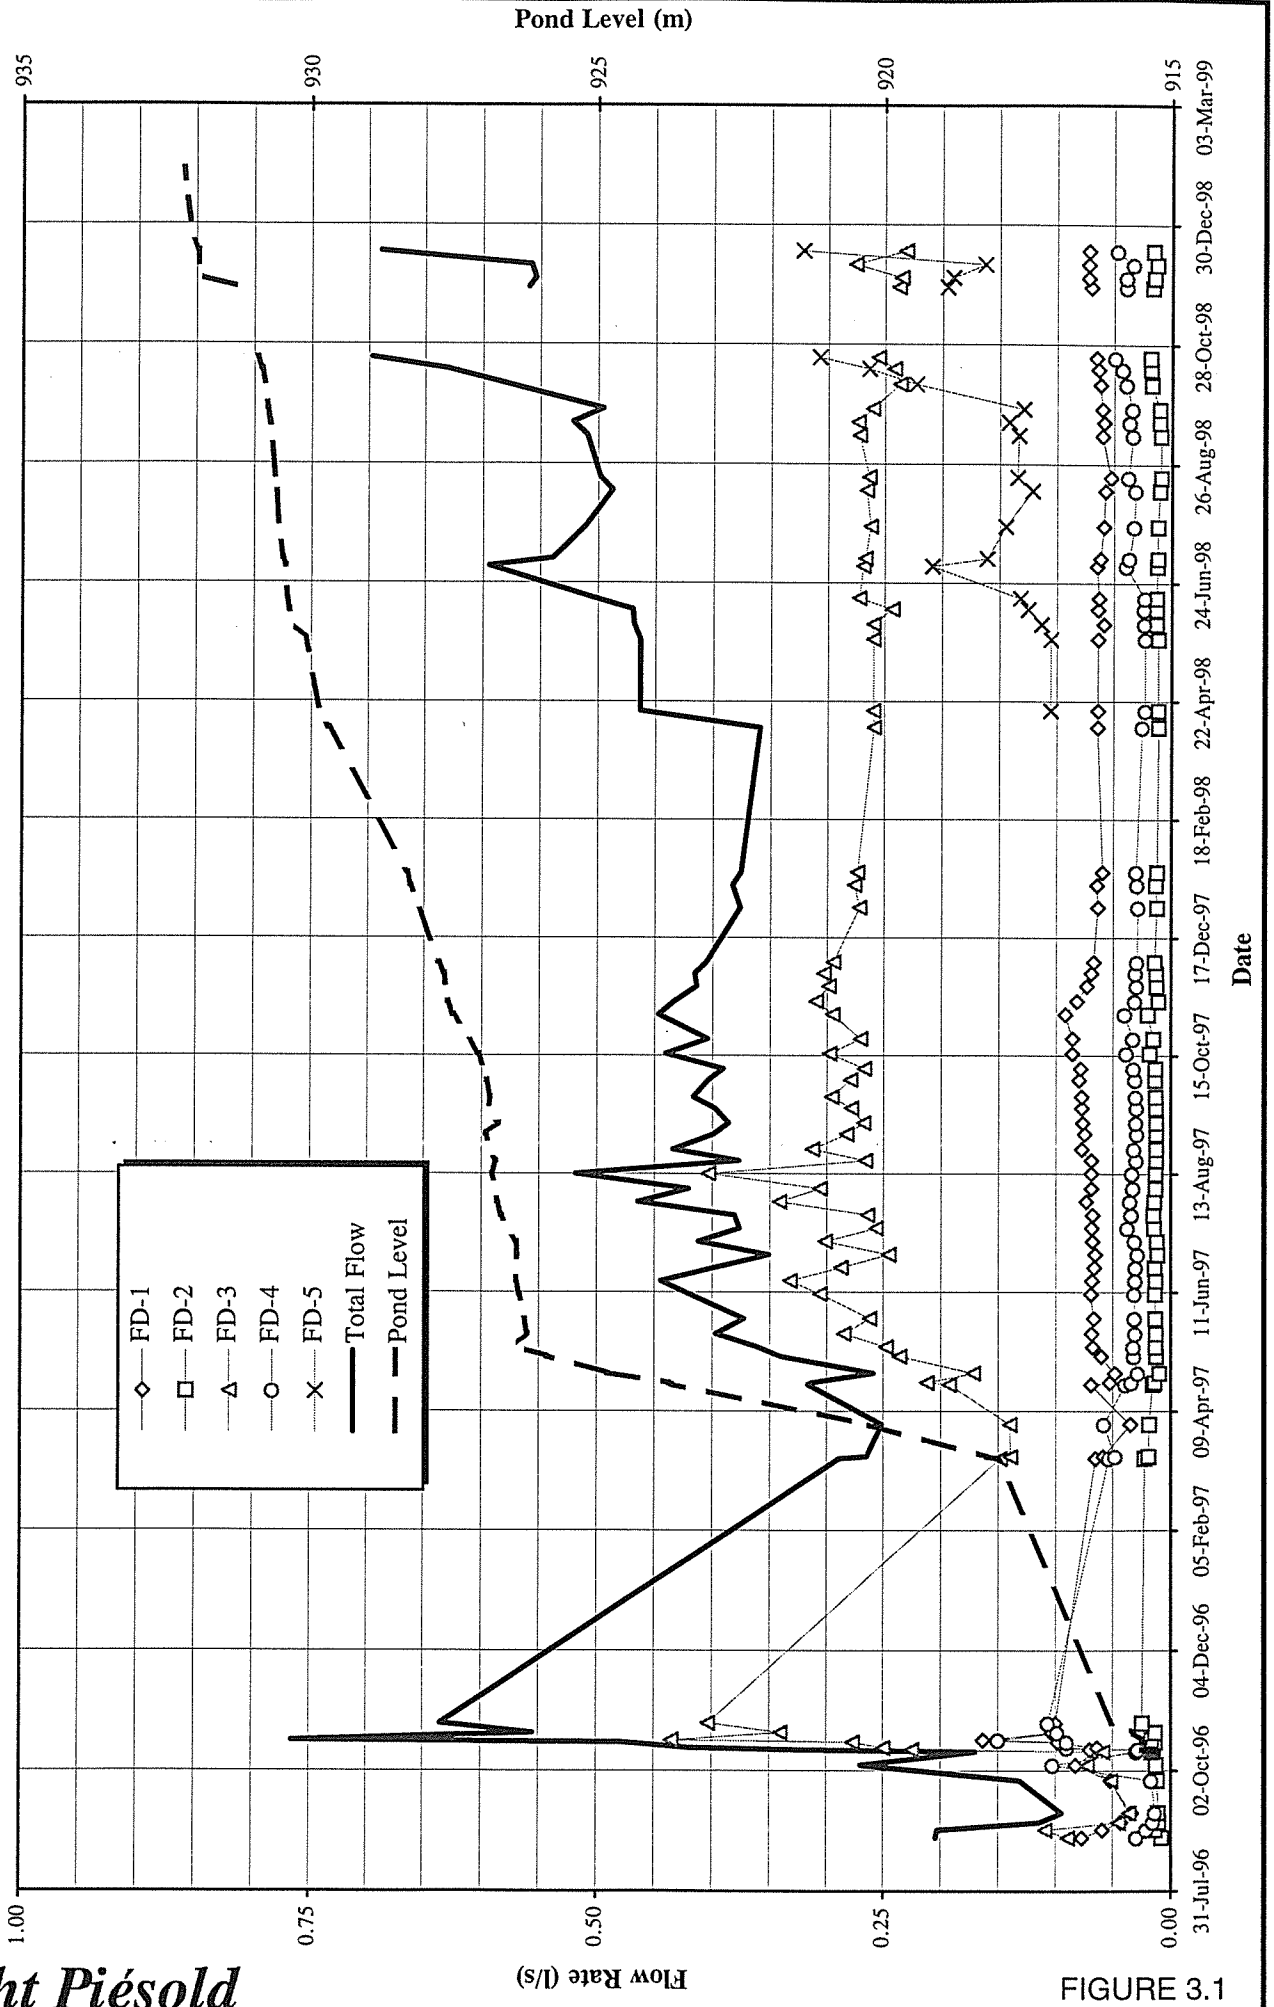
FIGURE 3.1

MOUNT POLLEY MINING CORPORATION
MOUNT POLLEY MINE
TAILINGS STORAGE FACILITY
MAIN EMBANKMENT FOUNDATION DRAIN FLOWS
