**MOUNT POLLEY MINING CORPORATION
MOUNT POLLEY MINE
TAILINGS STORAGE FACILITY**

**REPORT ON
1998 CONSTRUCTION AND ANNUAL INSPECTION
(REF. NO. 11162/10-1)**

Knight Piesold Ltd.
CONSULTING ENGINEERS

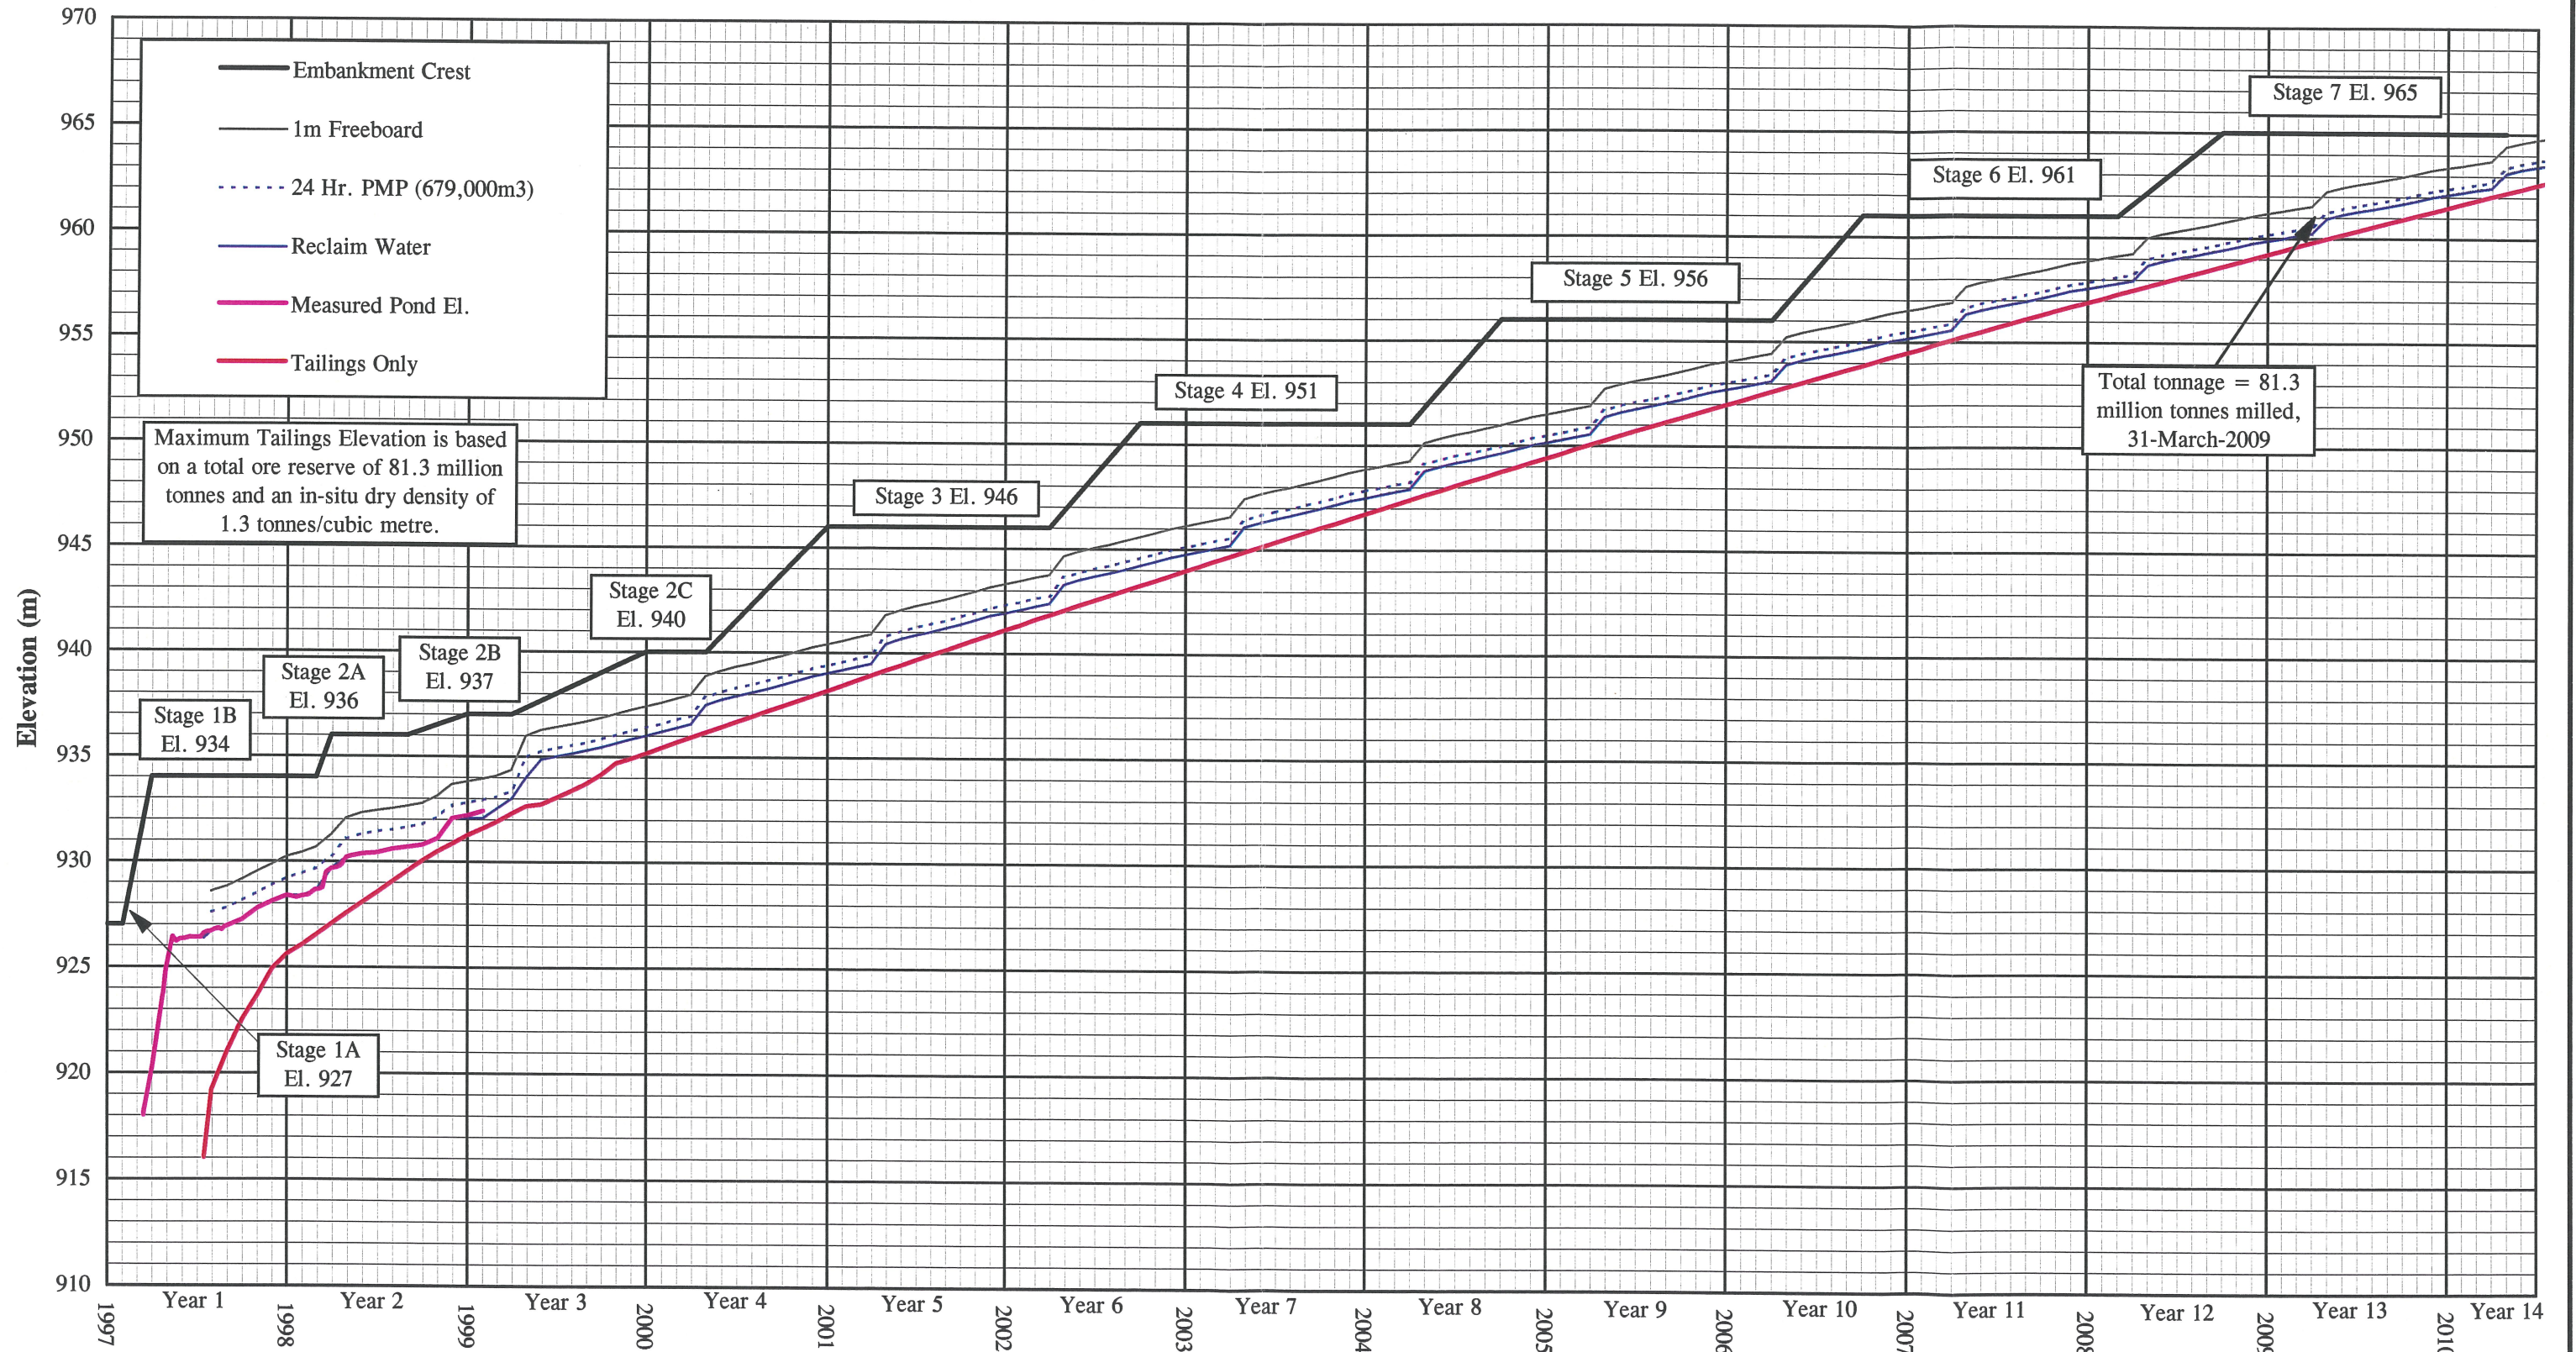
MOUNT POLLEY MINING CORPORATION
MOUNT POLLEY MINE
TAILINGS STORAGE FACILITY
FILLING SCHEDULE AND STAGED CONSTRUCTION FOR EARTH/ROCKFILL EMBANKMENT

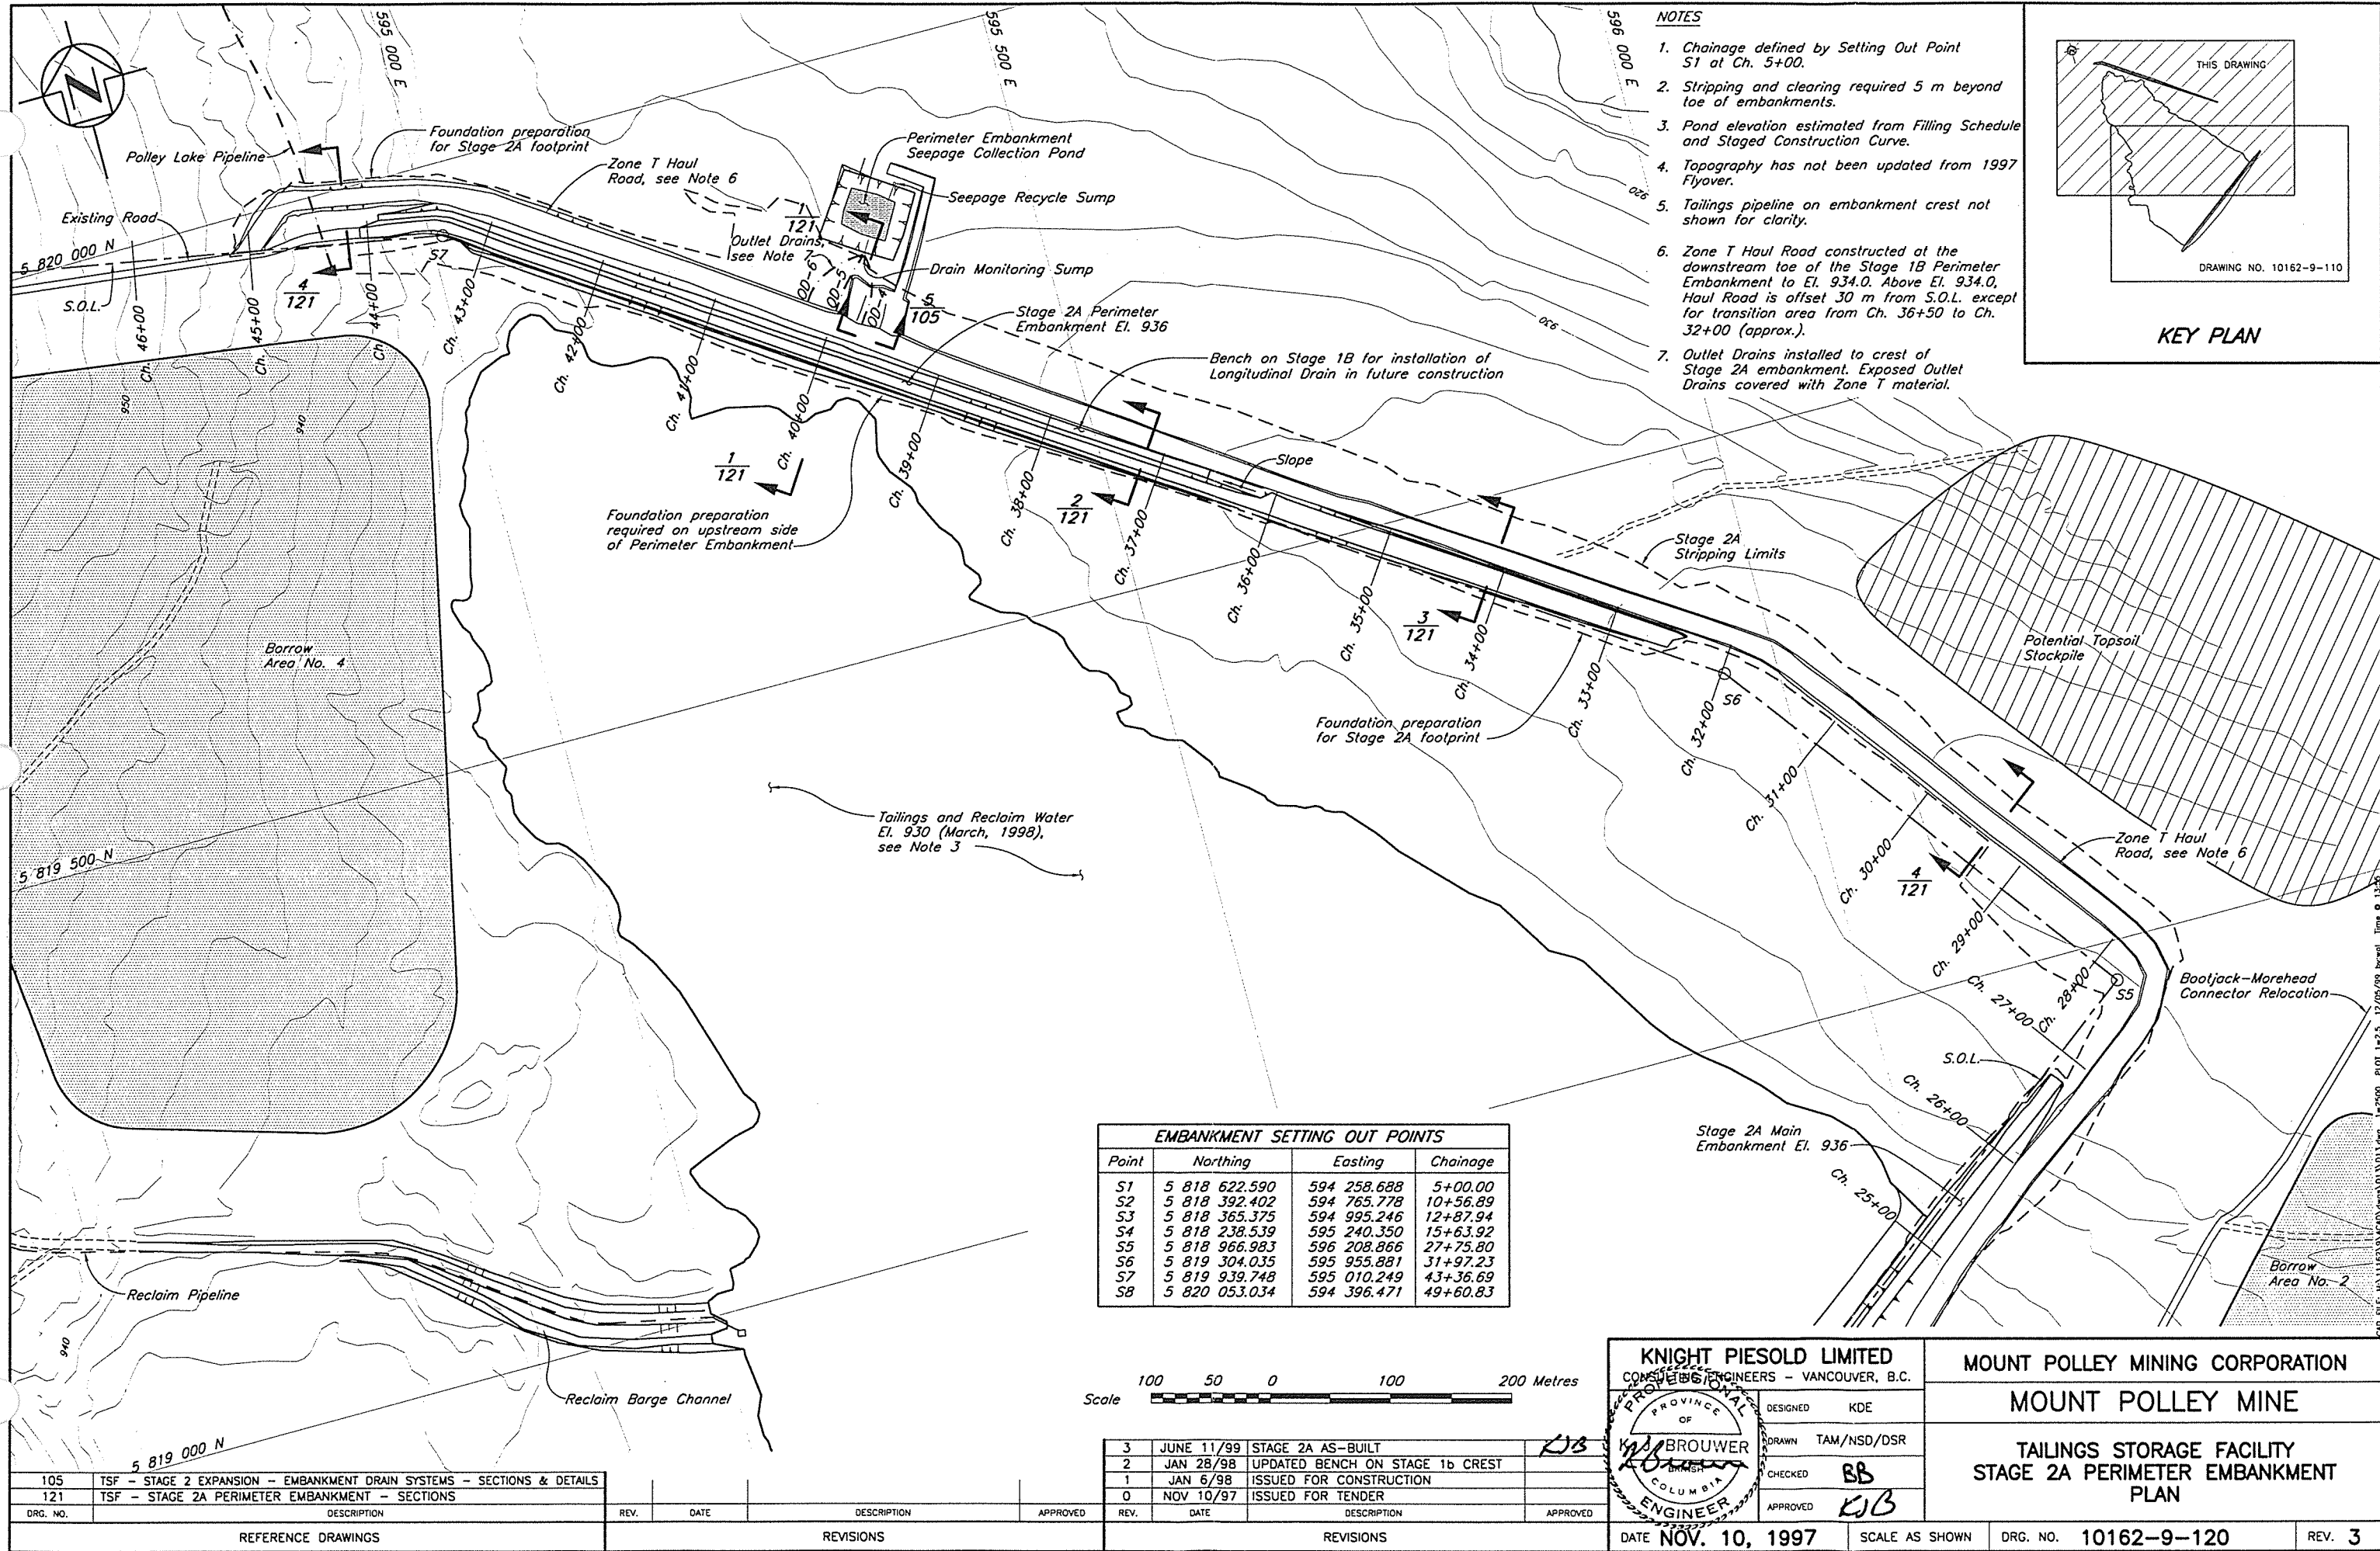
SCALE AS SHOWN
DRG. NO. 10162-9-120
REV. 3

TAILINGS STORAGE FACILITY
STAGE 2A PERIMETER EMBANKMENT
PLAN

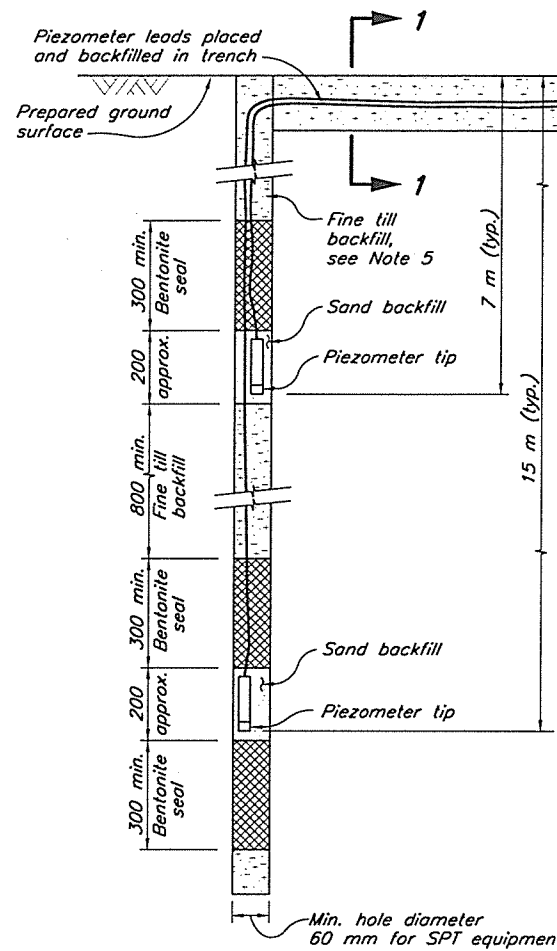
TYPICAL INSTALLATION OF PIEZOMETERS IN BOREHOLES
NTS

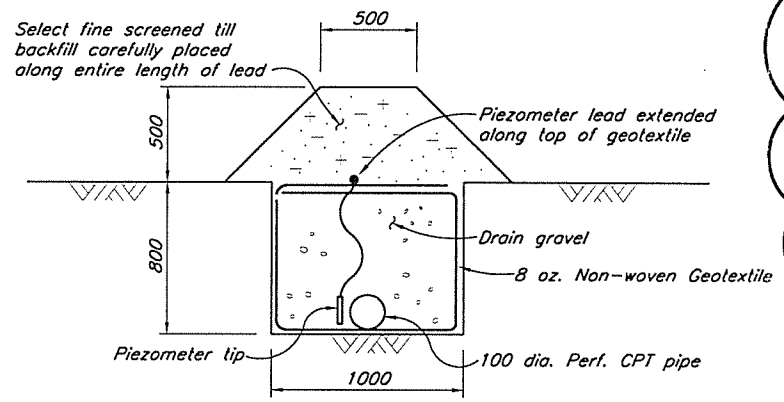
SECTION 1
TYPICAL SECTION THROUGH PIEZOMETER LEAD TRENCH IN PREPARED EMBANKMENT FOUNDATION OR FILL
Scale A

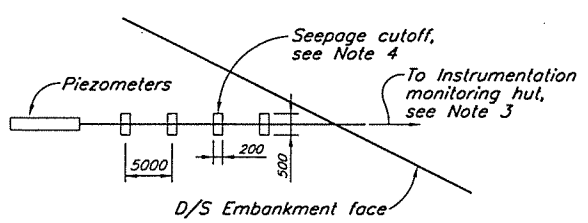
DETAIL A
TYPICAL DETAIL OF SEEPAGE CUTOFF FOR PIEZOMETER LEADS IN GLACIAL TILL
NTS

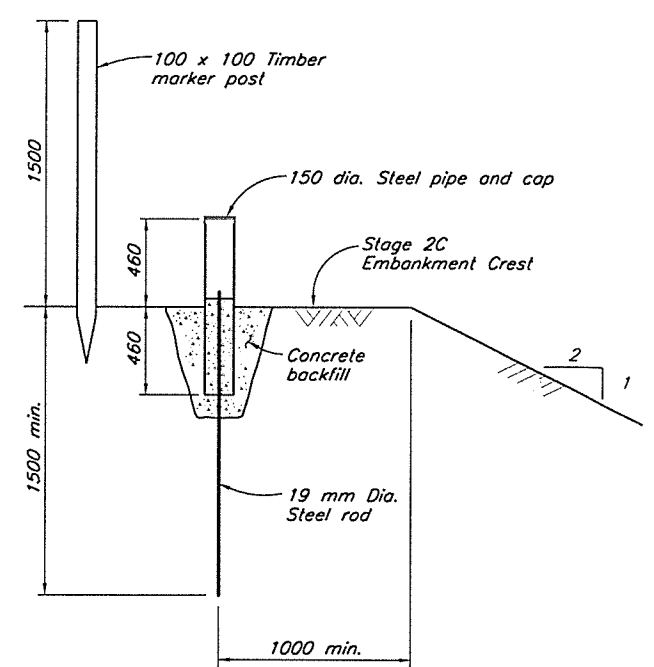
DETAIL OF SURFACE MOVEMENT MONUMENT
Scale A

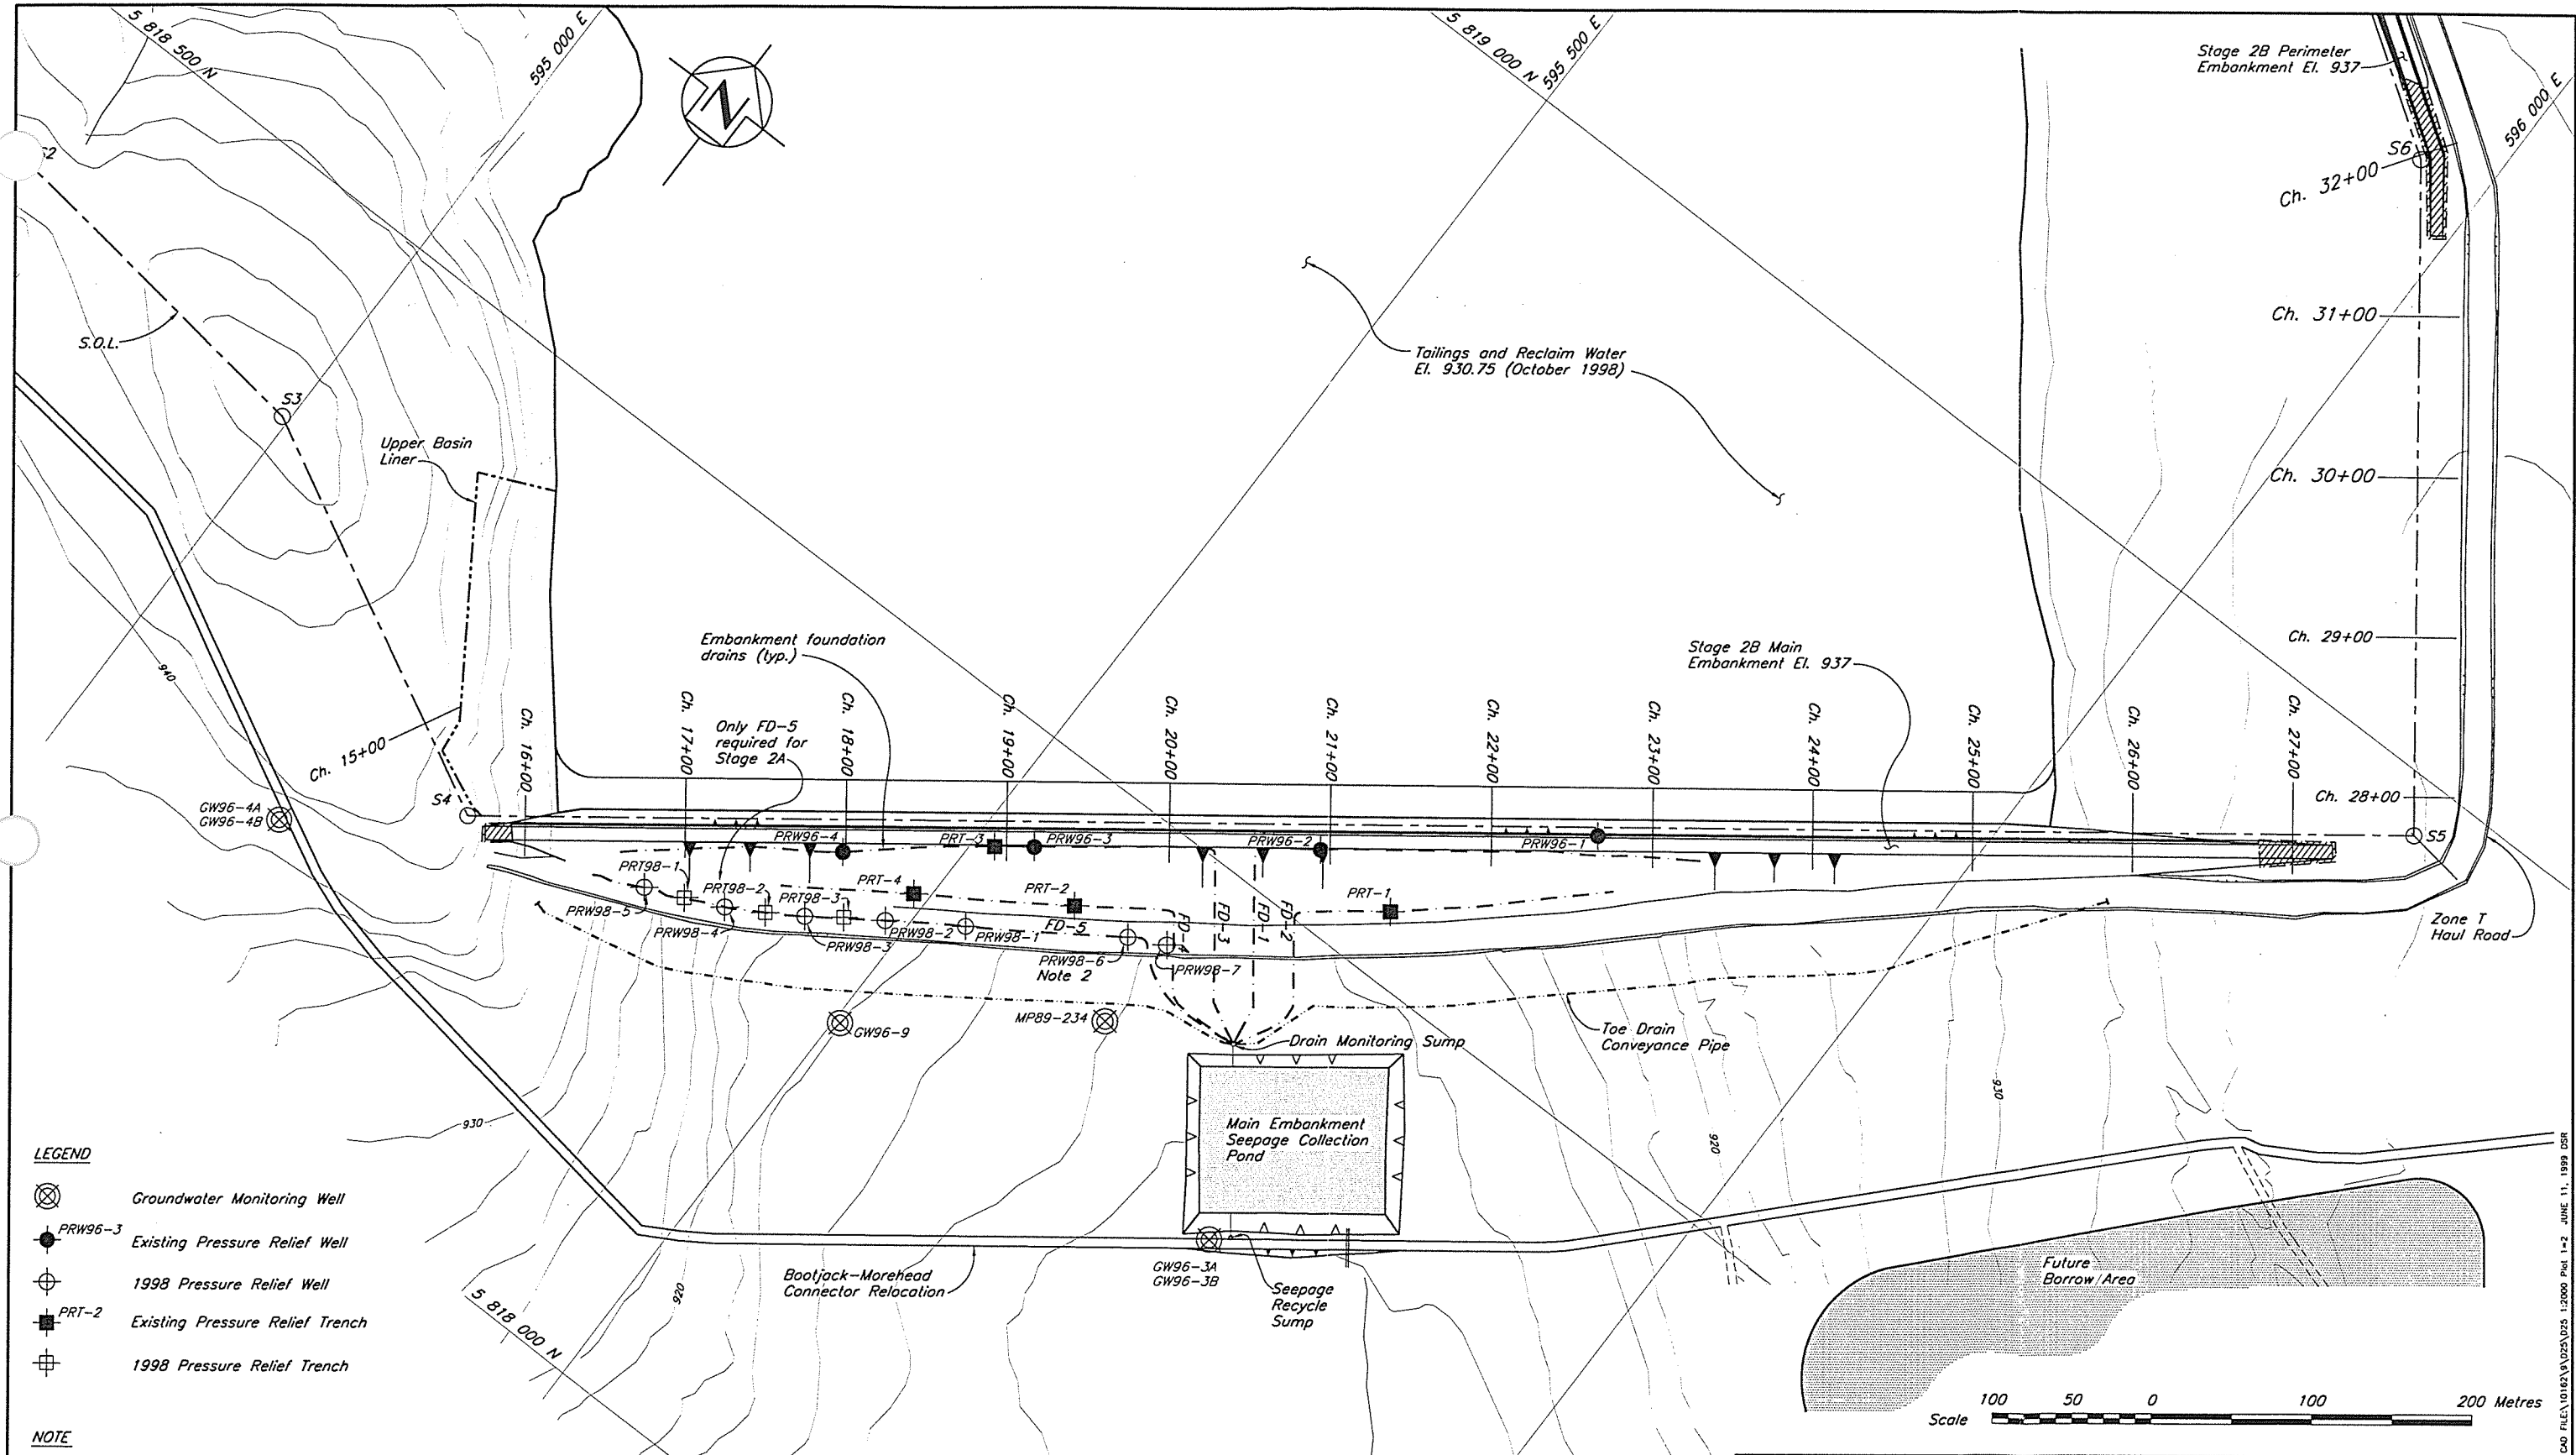
- LEGEND**
- Groundwater Monitoring Well
 - Existing Pressure Relief Well
 - 1998 Pressure Relief Well
 - Existing Pressure Relief Trench
 - 1998 Pressure Relief Trench

1. Pressure Relief Wells and Trenches tied into Foundation Drains.

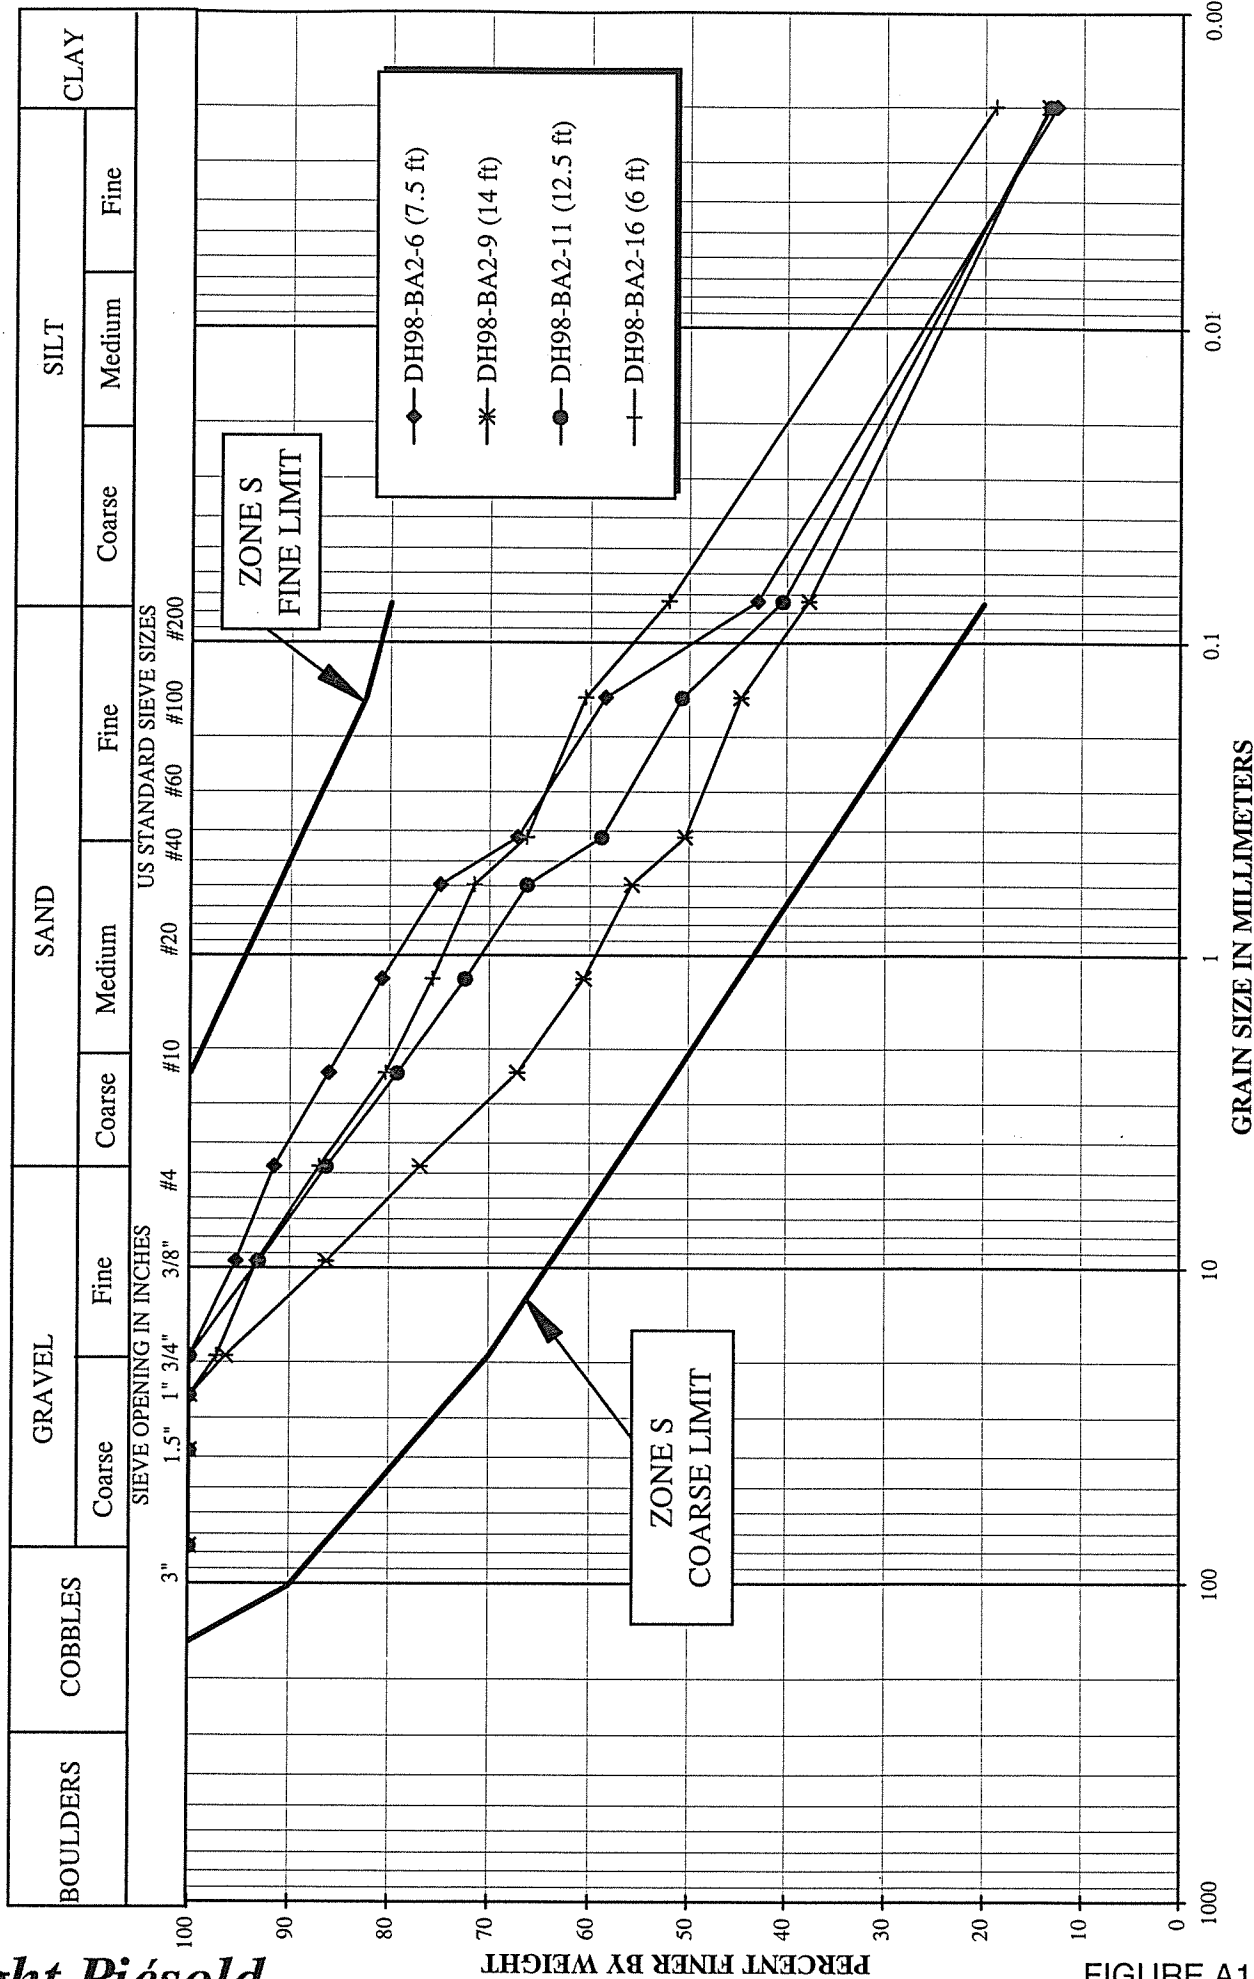
FIGURE A1

MOUNT POLLEY MINING CORPORATION
MOUNT POLLEY MINE - TAILINGS STORAGE FACILITY
BORROW AREA 2 INVESTIGATION - GLACIAL TILL SAMPLES - GRADATION CURVES

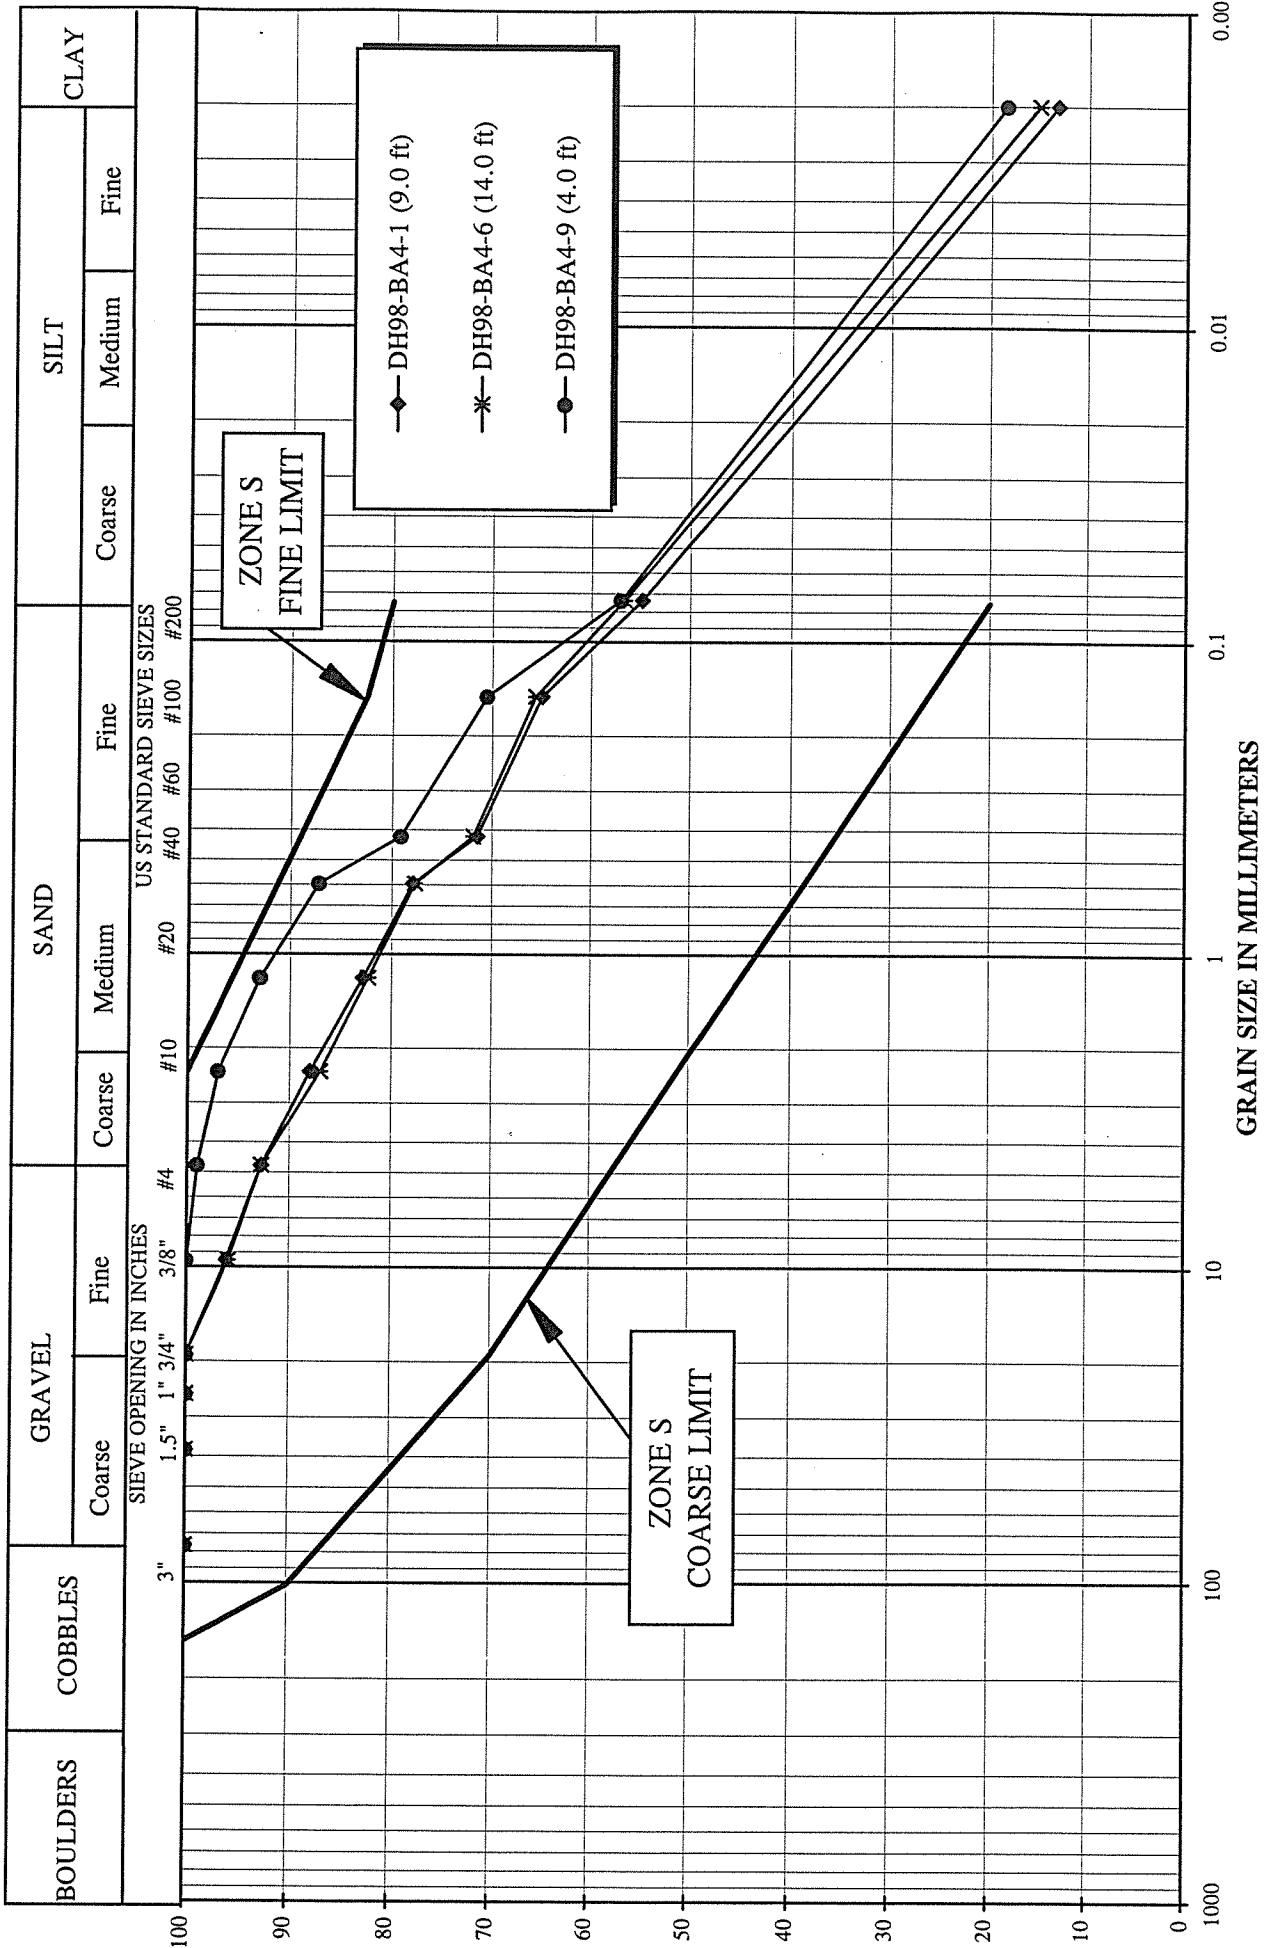
MOUNT POLLEY MINING CORPORATION
MOUNT POLLEY MINE - TAILINGS STORAGE FACILITY
BORROW AREA 4 INVESTIGATION - GLACIAL TILL SAMPLES - GRADATION CURVES

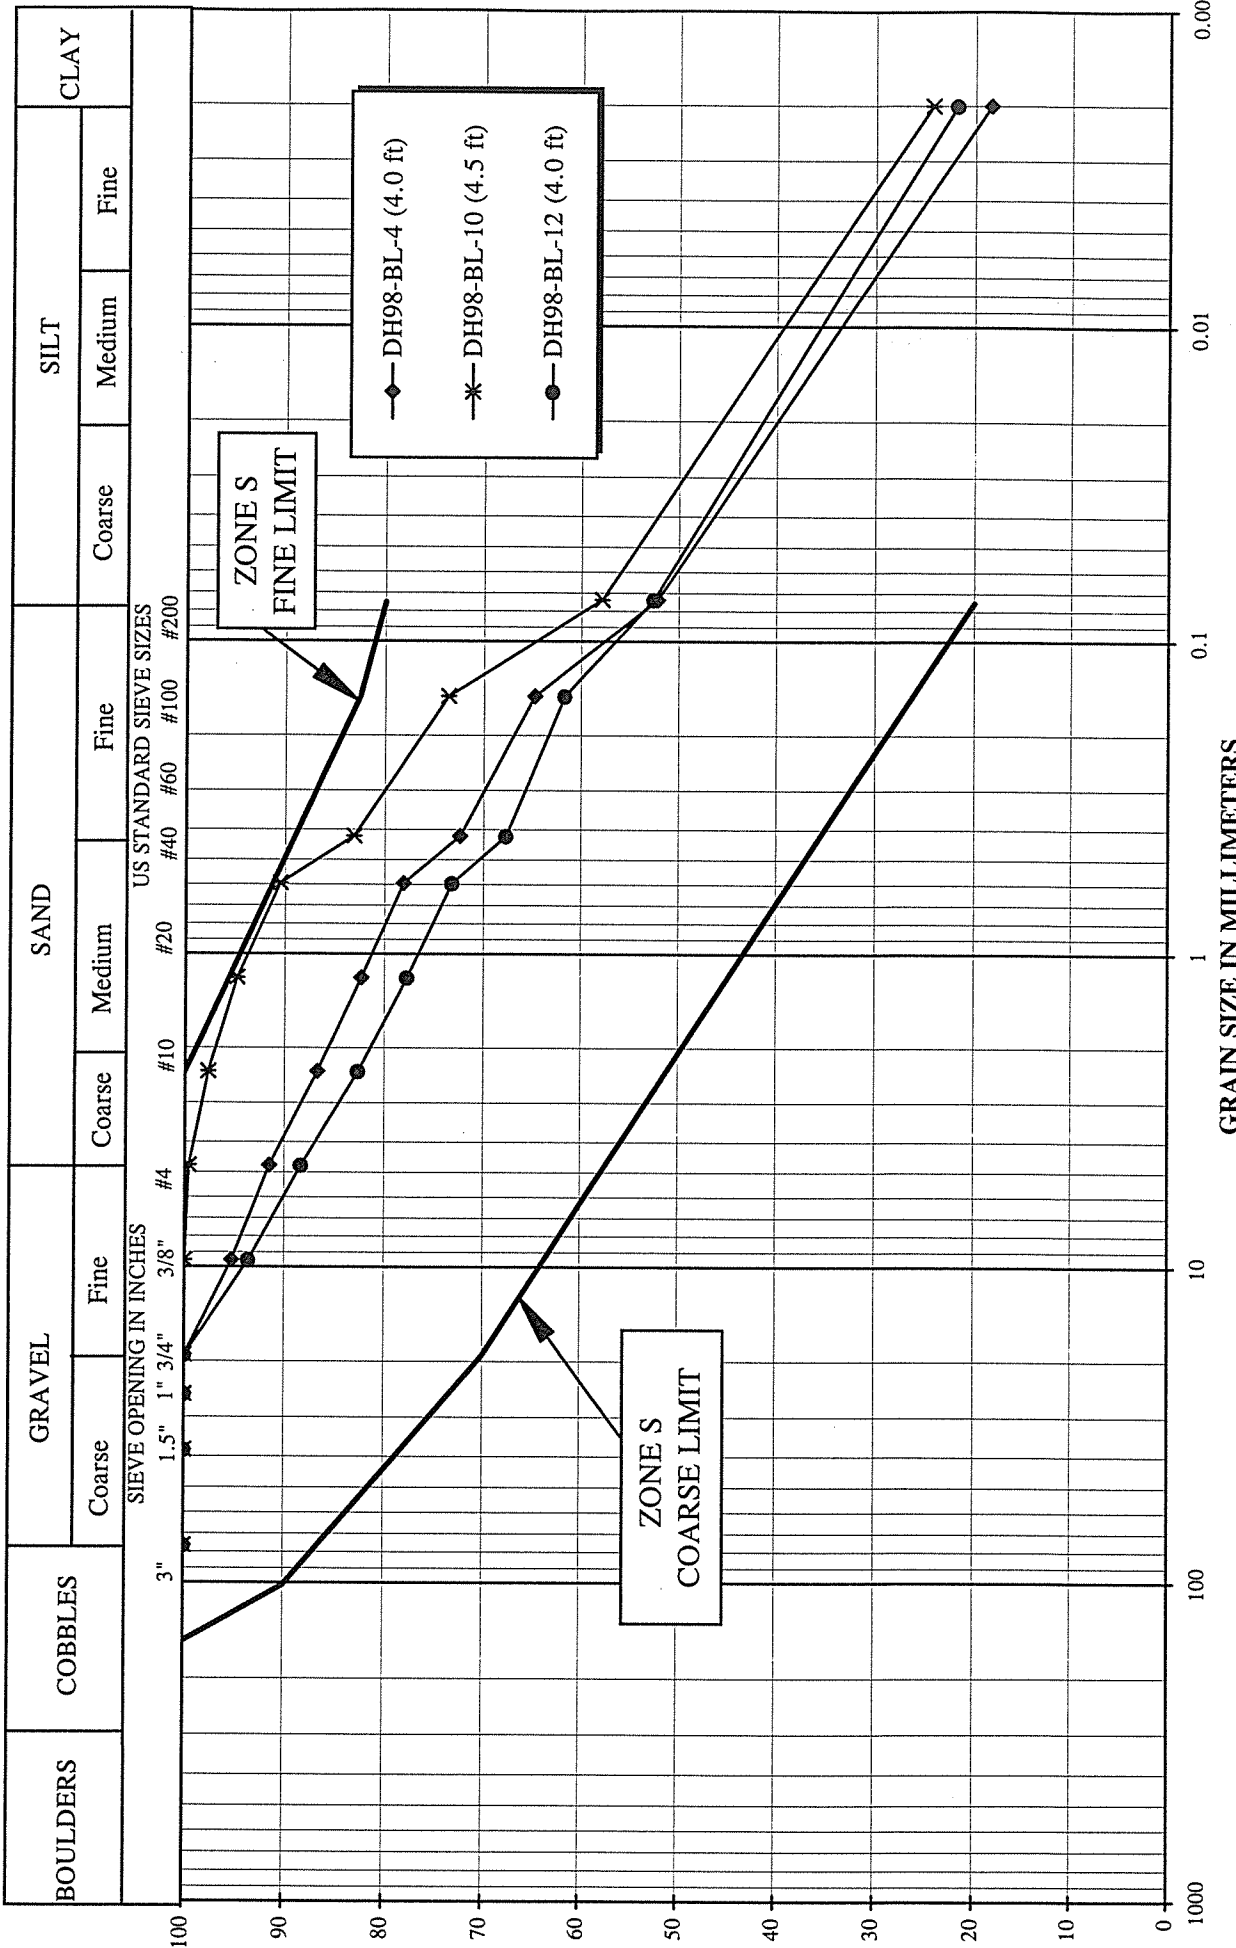
MOUNT POLLEY MINING CORPORATION
MOUNT POLLEY MINE - TAILINGS STORAGE FACILITY
1999 BASIN LINER INVESTIGATION - GLACIAL TILL SAMPLES - GRADATION CURVES

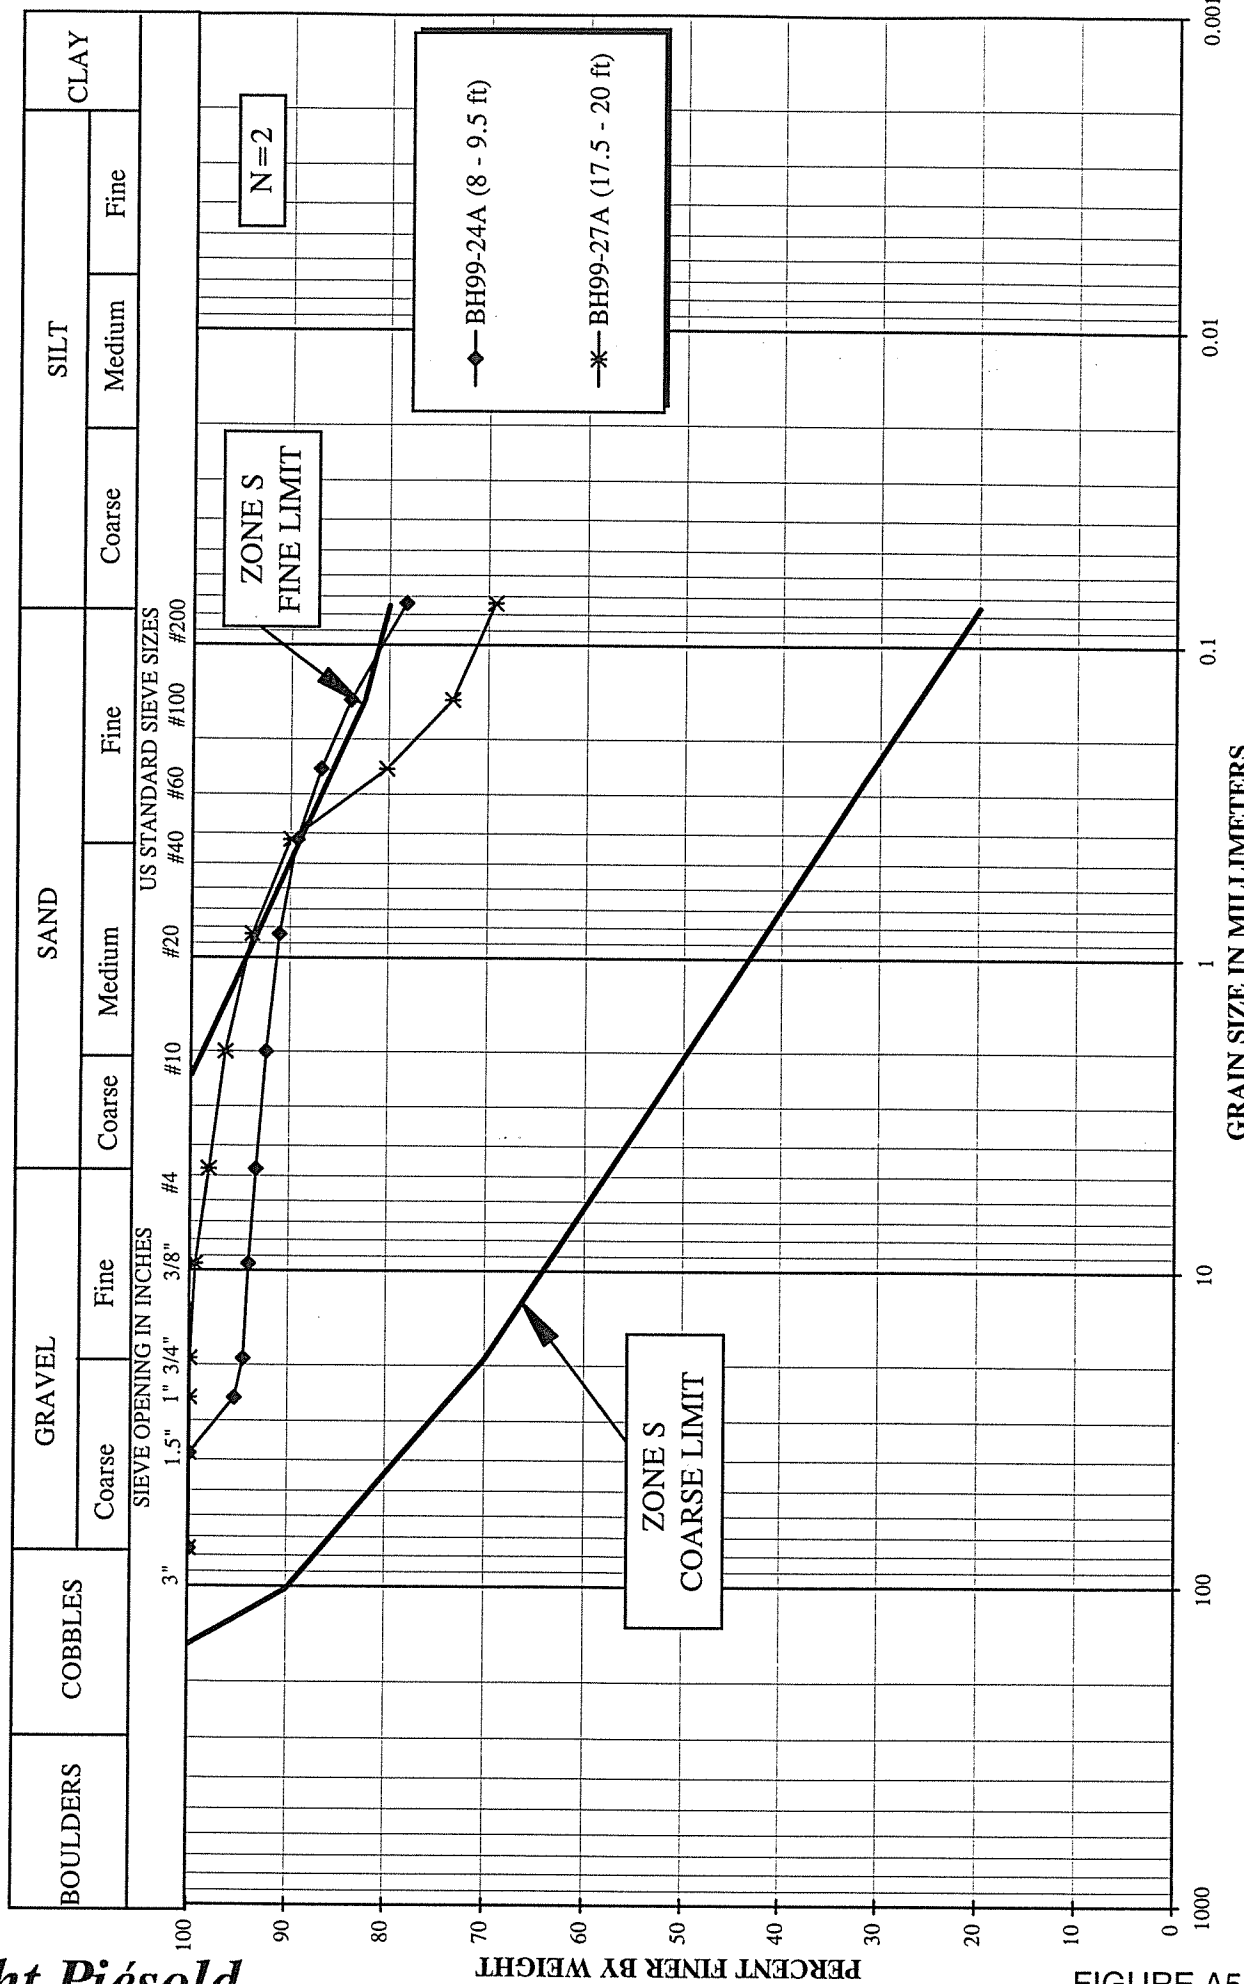
FIGURE A5

MOUNT POLLEY MINING CORPORATION
MOUNT POLLEY MINE - TAILINGS STORAGE FACILITY
1999 BASIN LINER INVESTIGATION - GLACIOLACUSTRINE SAMPLES - GRADATION CURVES
