**MOUNT POLLEY MINING CORPORATION
MOUNT POLLEY MINE
TAILINGS STORAGE FACILITY**

**REPORT ON
1998 CONSTRUCTION AND ANNUAL INSPECTION
(REF. NO. 11162/10-1)**

Knight Piesold Ltd.
CONSULTING ENGINEERS

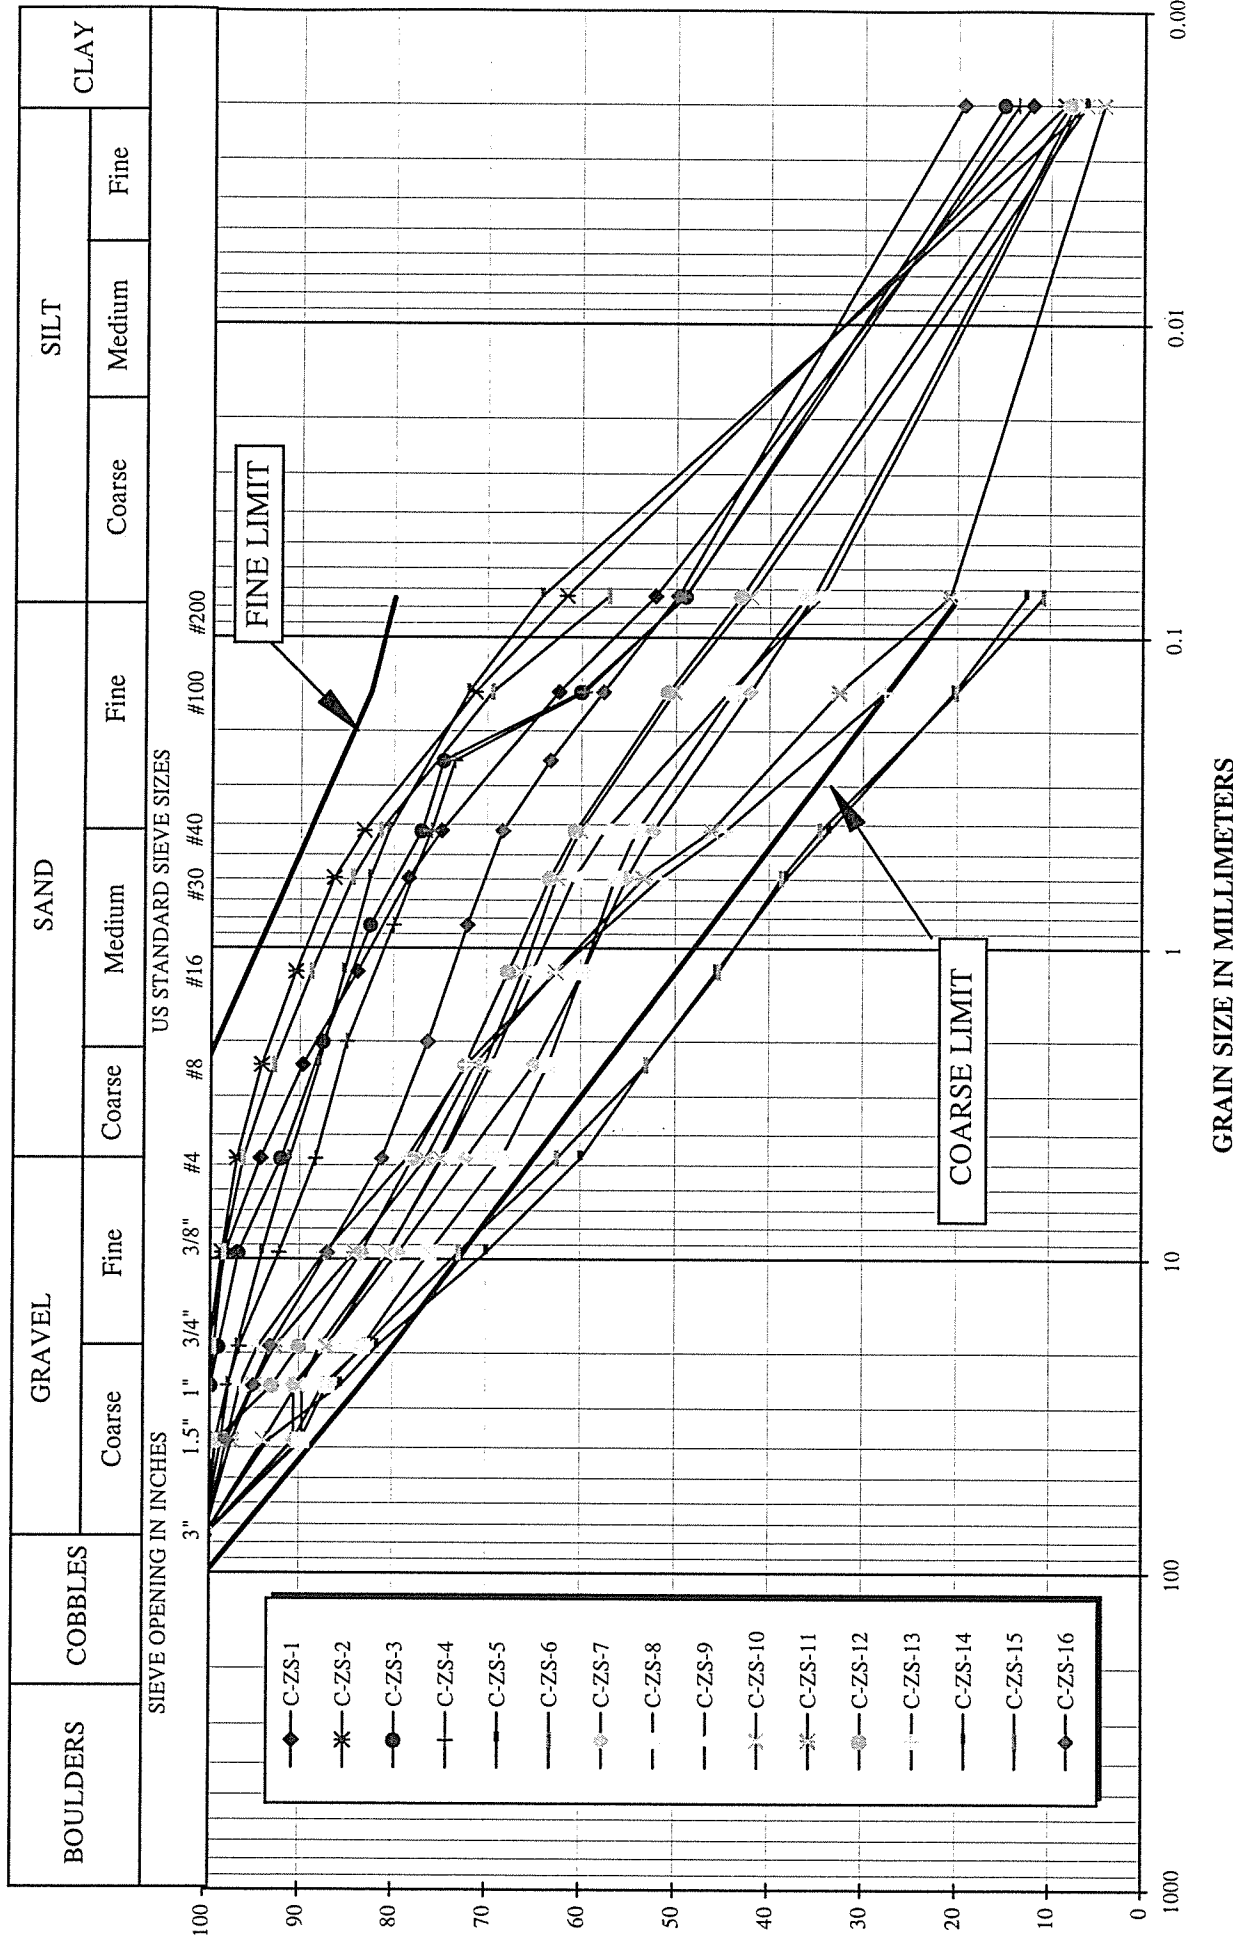
MOUNT POLLEY MINING CORPORATION
MOUNT POLLEY MINE - TAILINGS STORAGE FACILITY
STAGE 2A/2B CONSTRUCTION
ZONE S CONTROL TESTS - GRADATION PLOTS

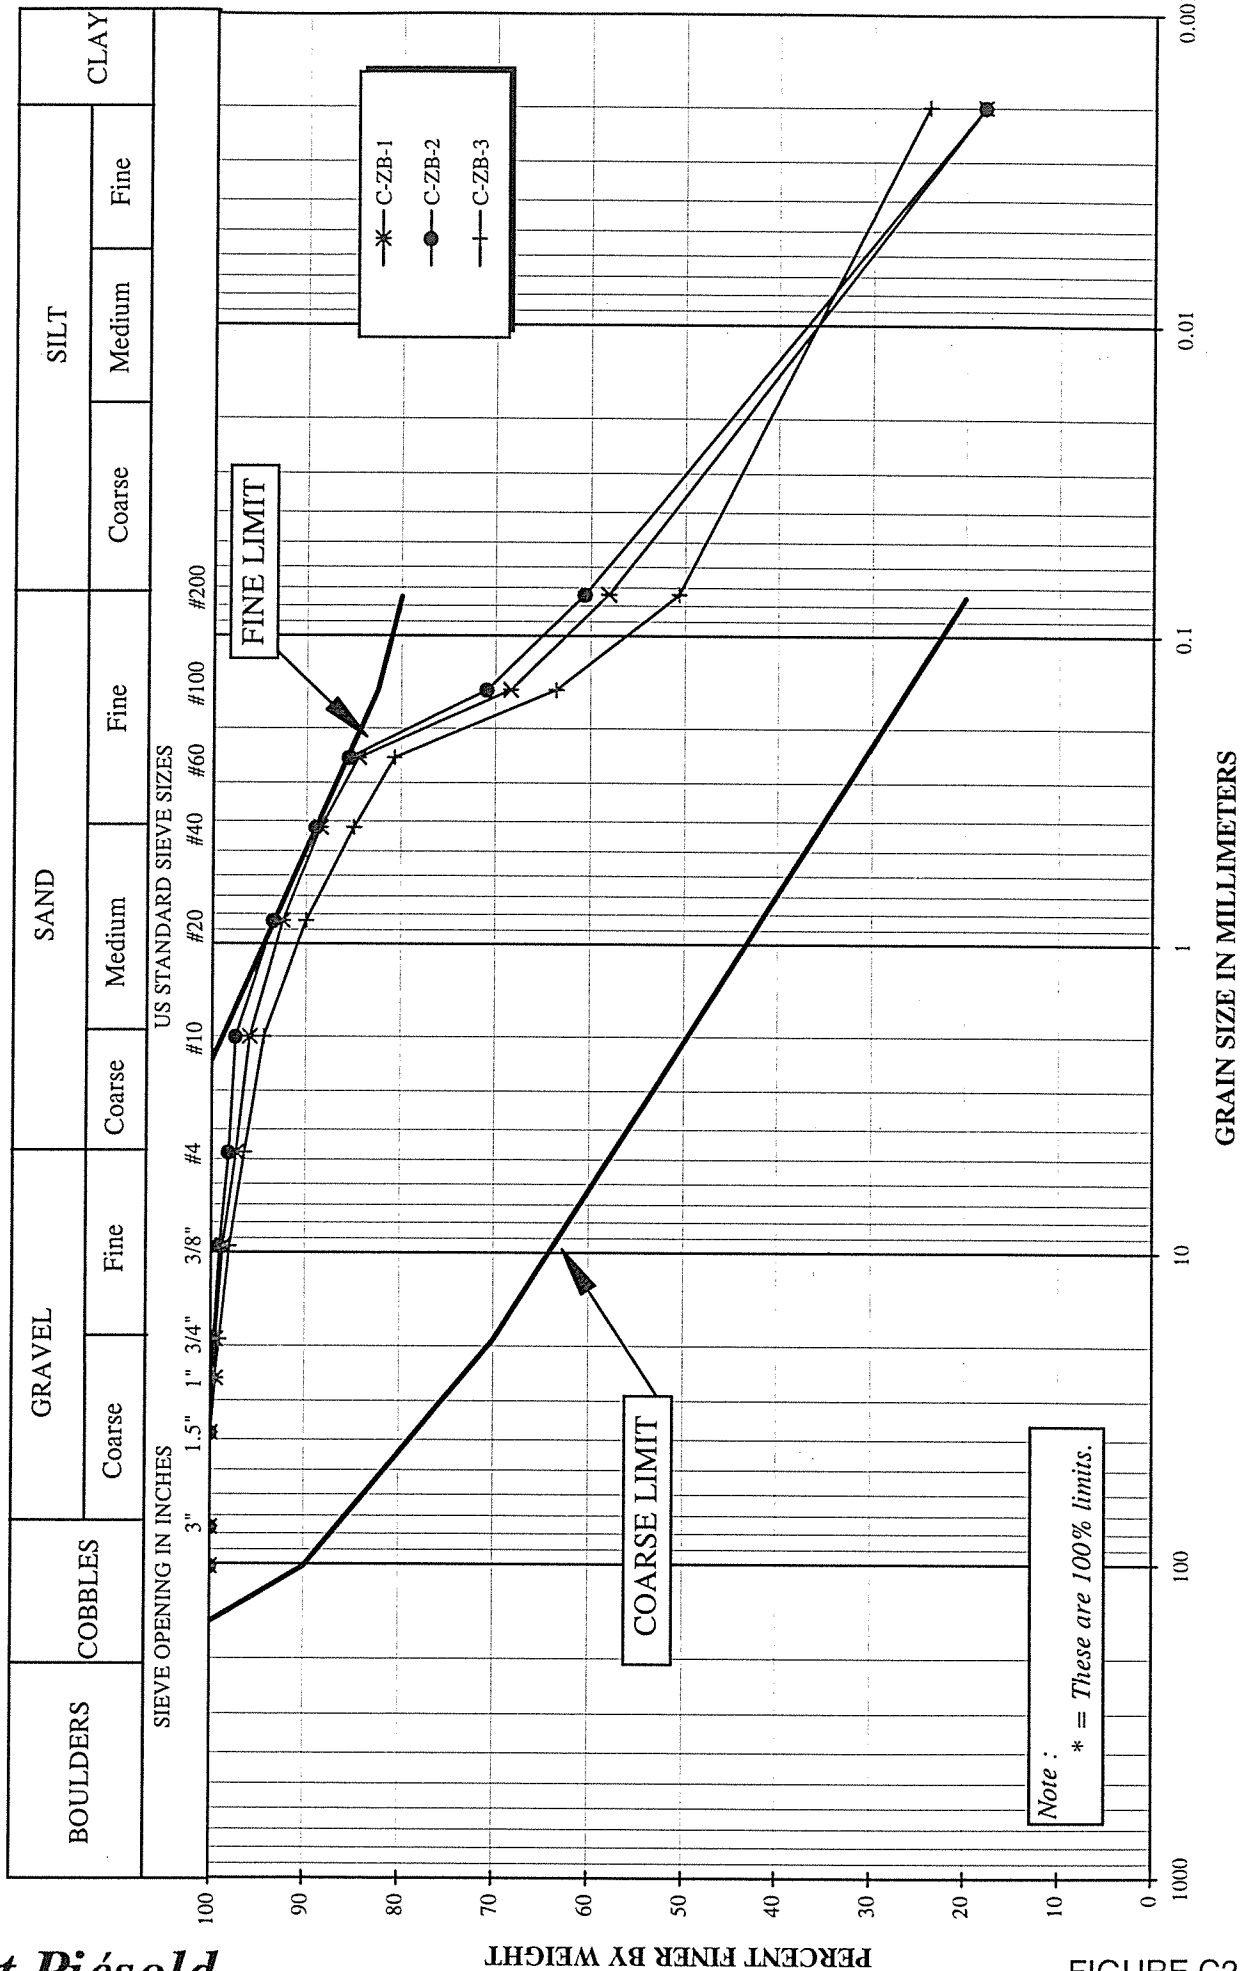
MOUNT POLLEY MINING CORPORATION
MOUNT POLLEY MINE - TAILINGS STORAGE FACILITY
STAGE 2A/2B CONSTRUCTION
ZONE B CONTROL TESTS - GRADATION PLOTS

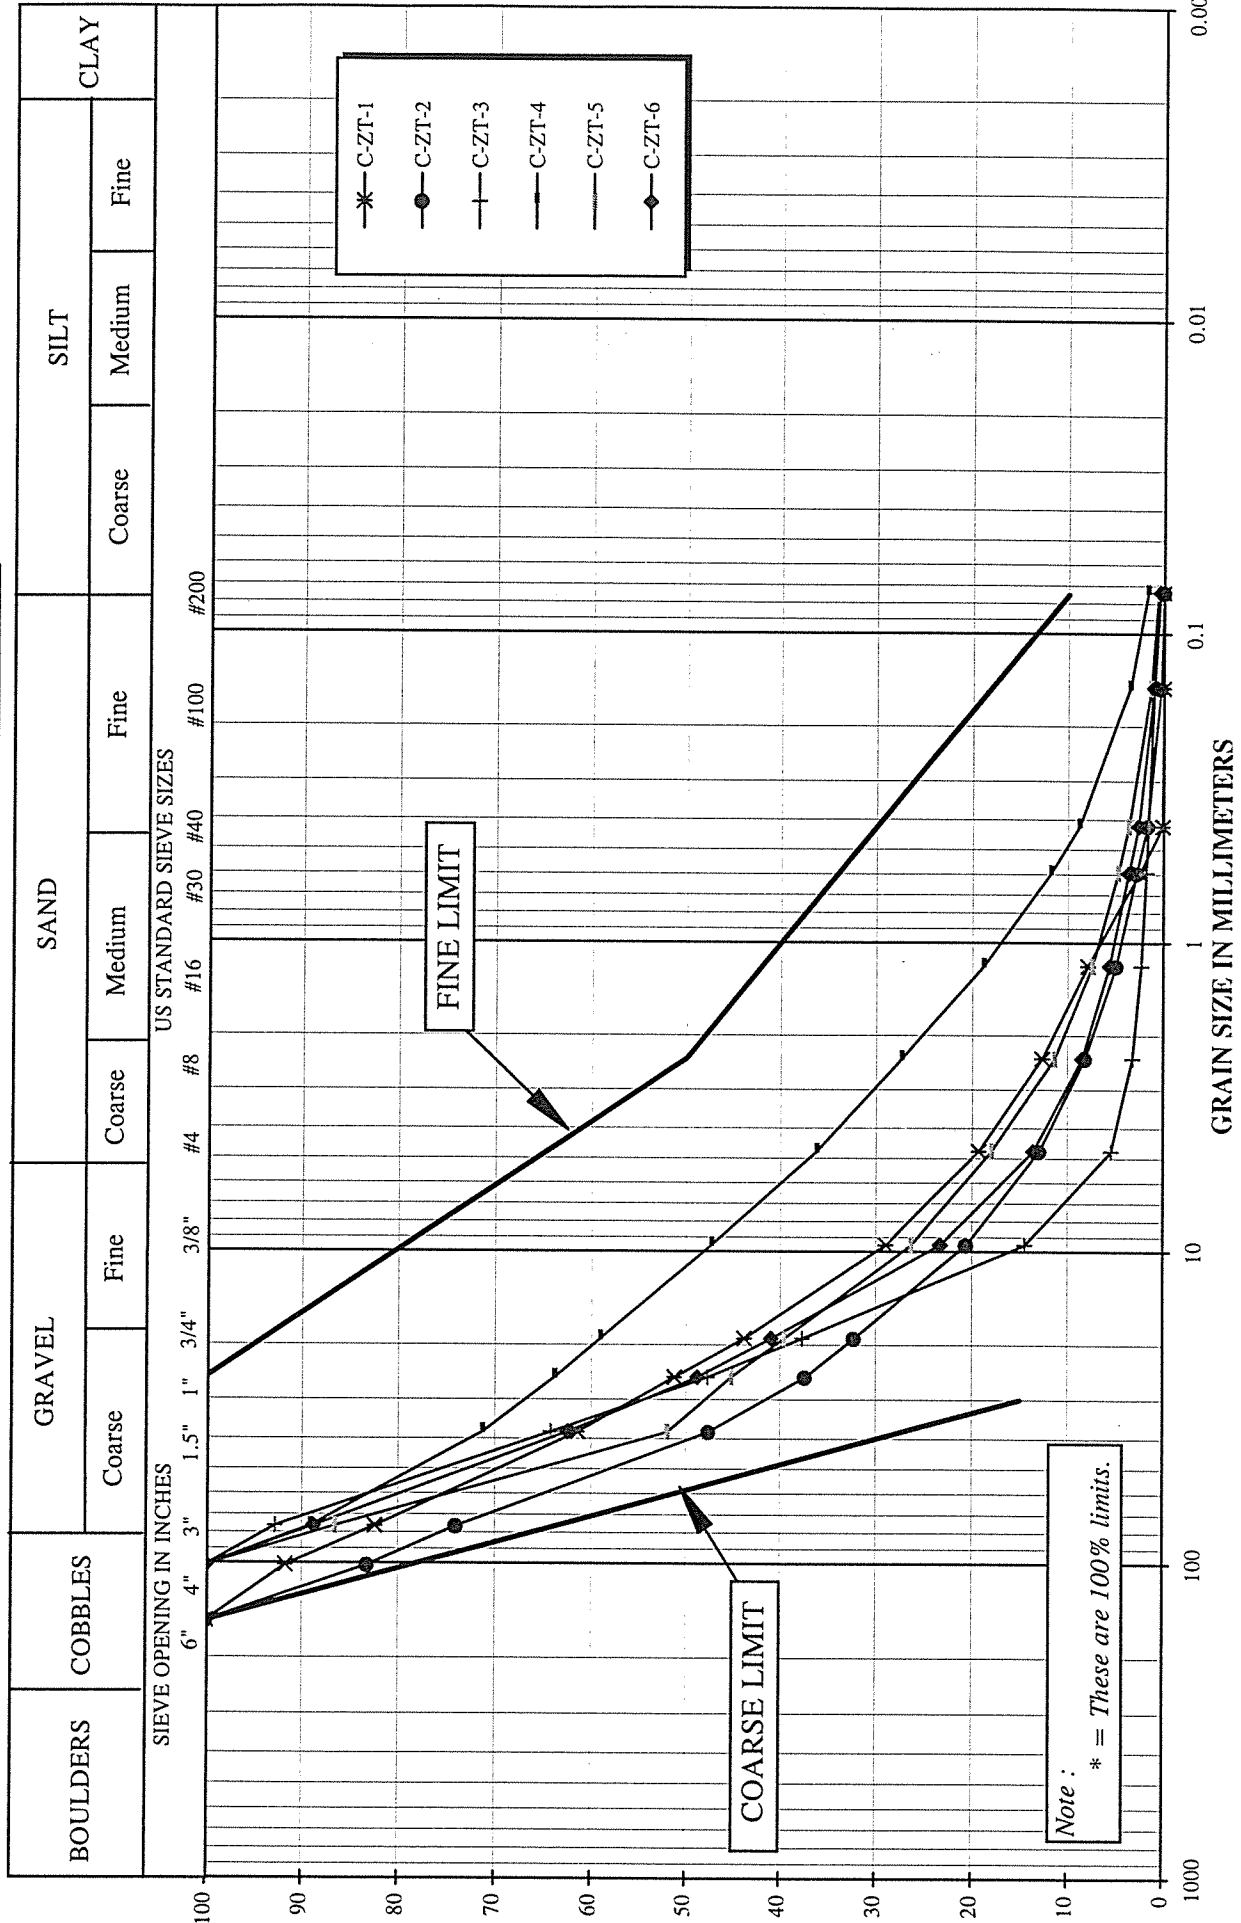
MOUNT POLLEY MINING CORPORATION
MOUNT POLLEY MINE - TAILINGS STORAGE FACILITY
STAGE 2A/2B CONSTRUCTION
ZONE T CONTROL TESTS - GRADATION PLOTS

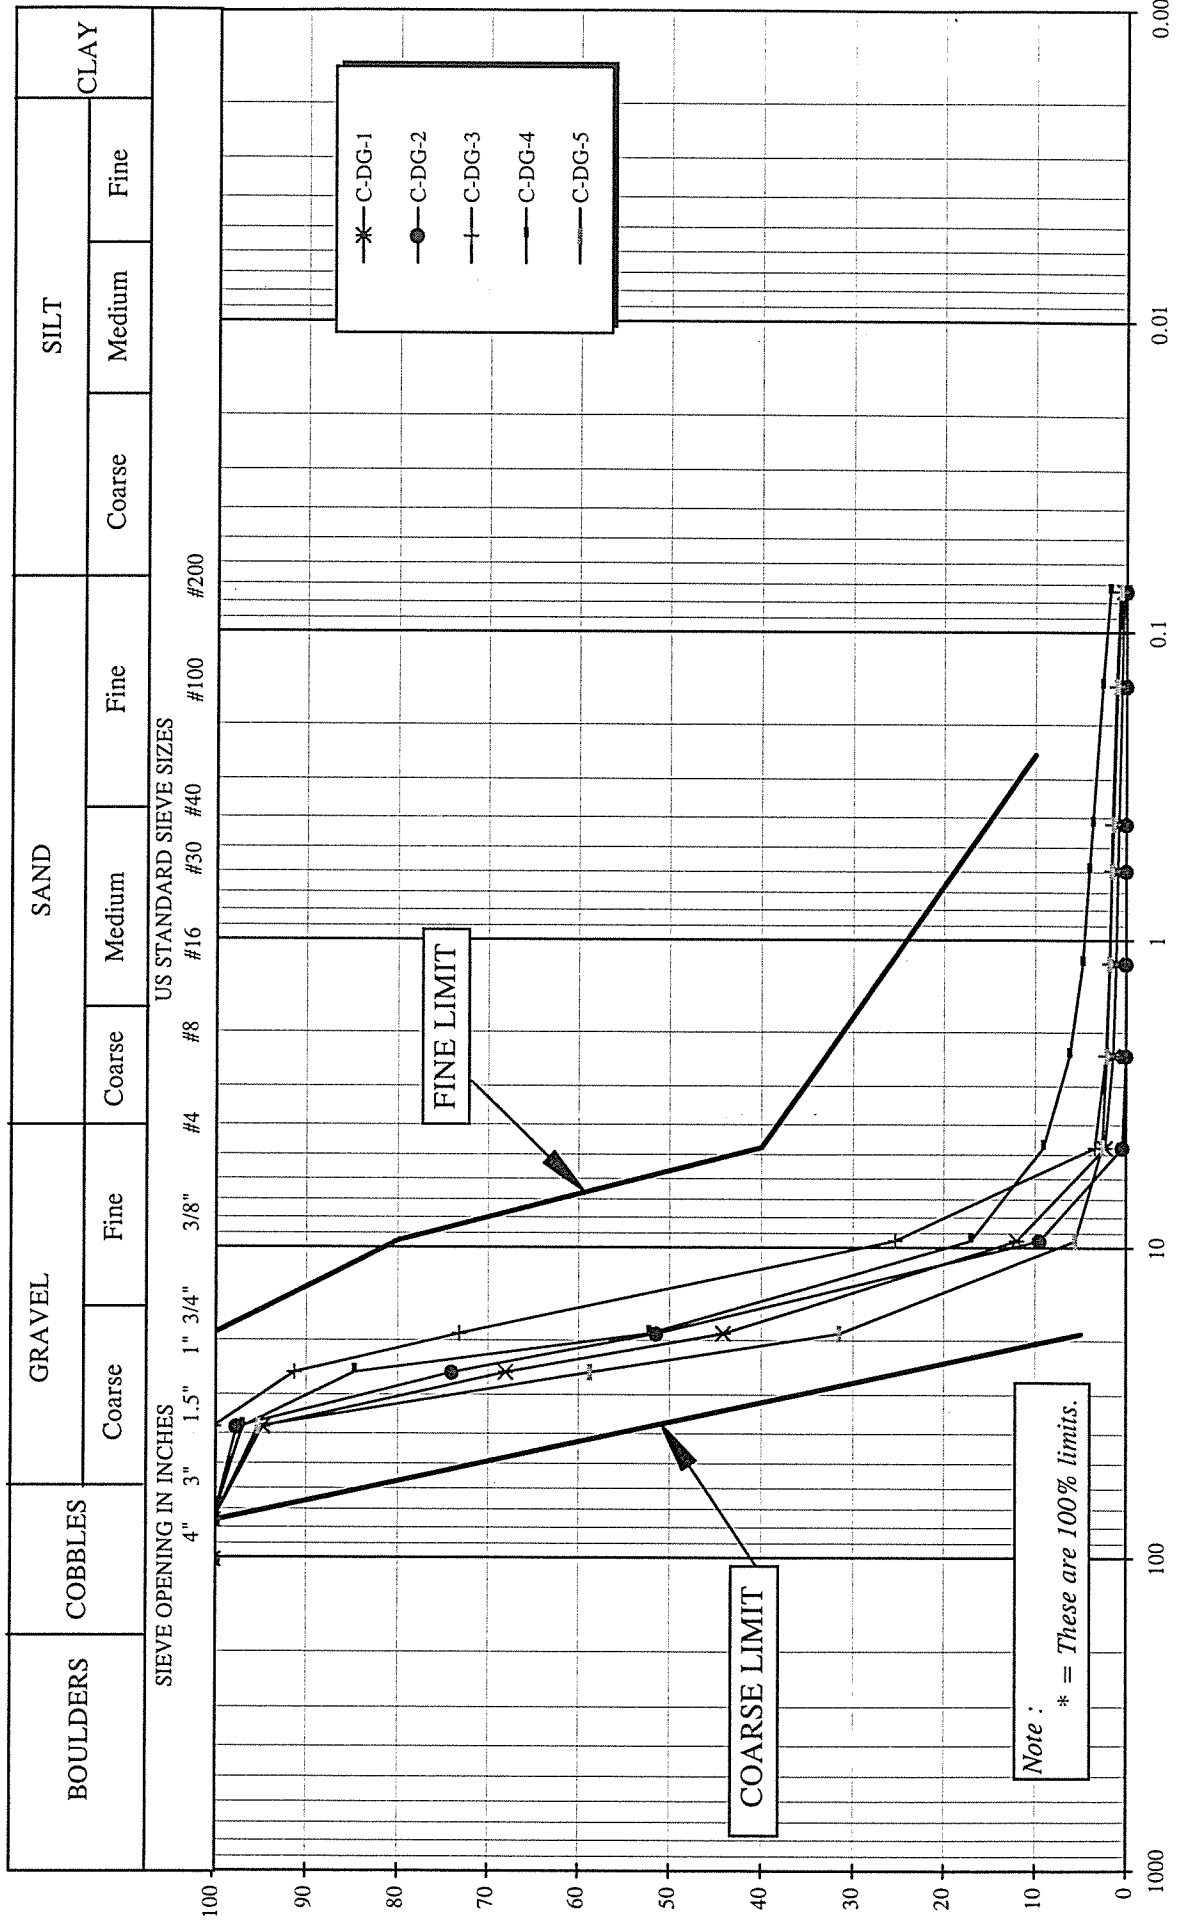
MOUNT POLLEY MINING CORPORATION
MOUNT POLLEY MINE - TAILINGS STORAGE FACILITY
STAGE 2A/2B CONSTRUCTION
ZONE G CONTROL TESTS - GRADATION PLOTS

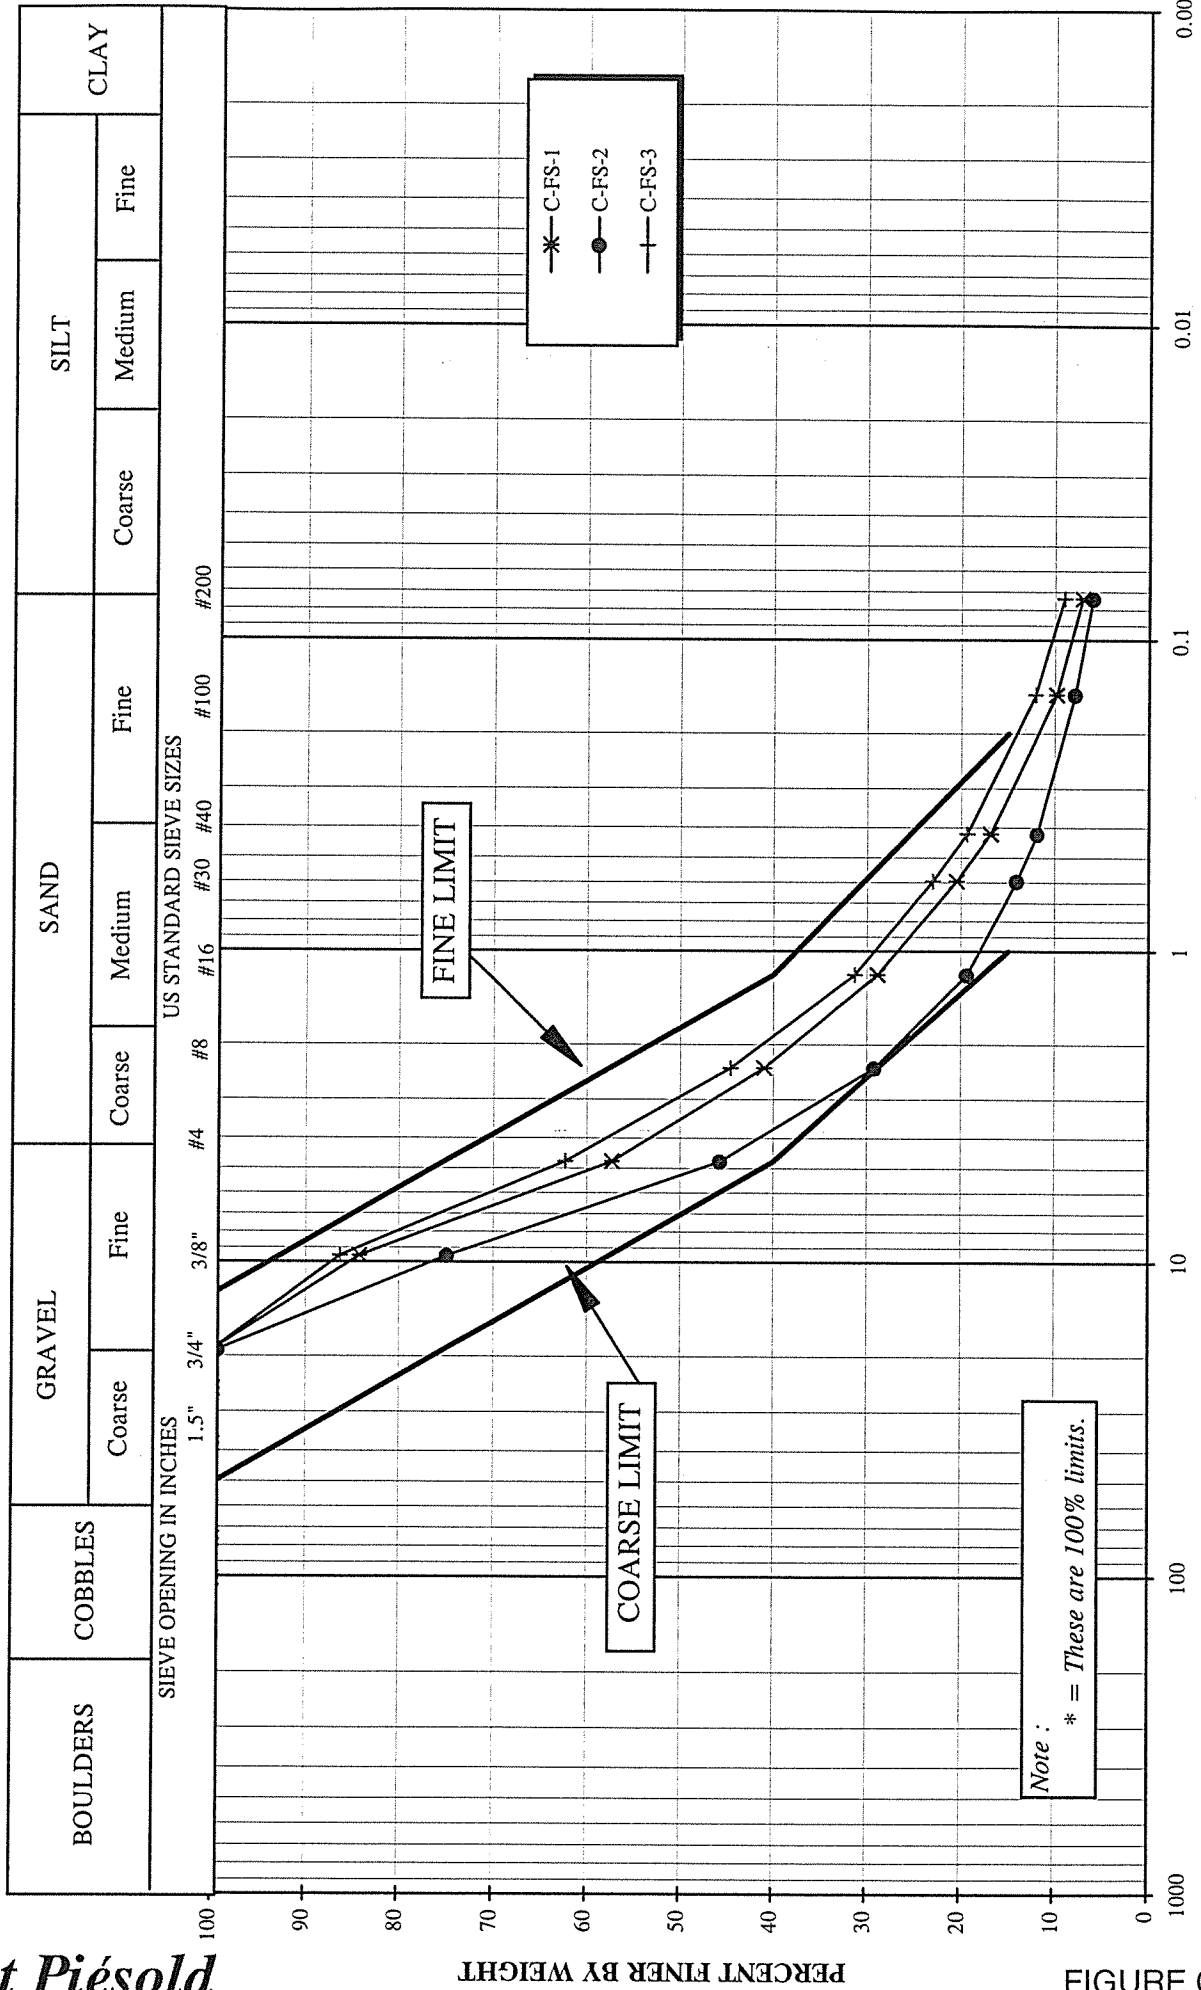
MOUNT POLLEY MINING CORPORATION
MOUNT POLLEY MINE - TAILINGS STORAGE FACILITY
STAGE 2A/2B CONSTRUCTION
ZONE F CONTROL TESTS - GRADATION PLOTS

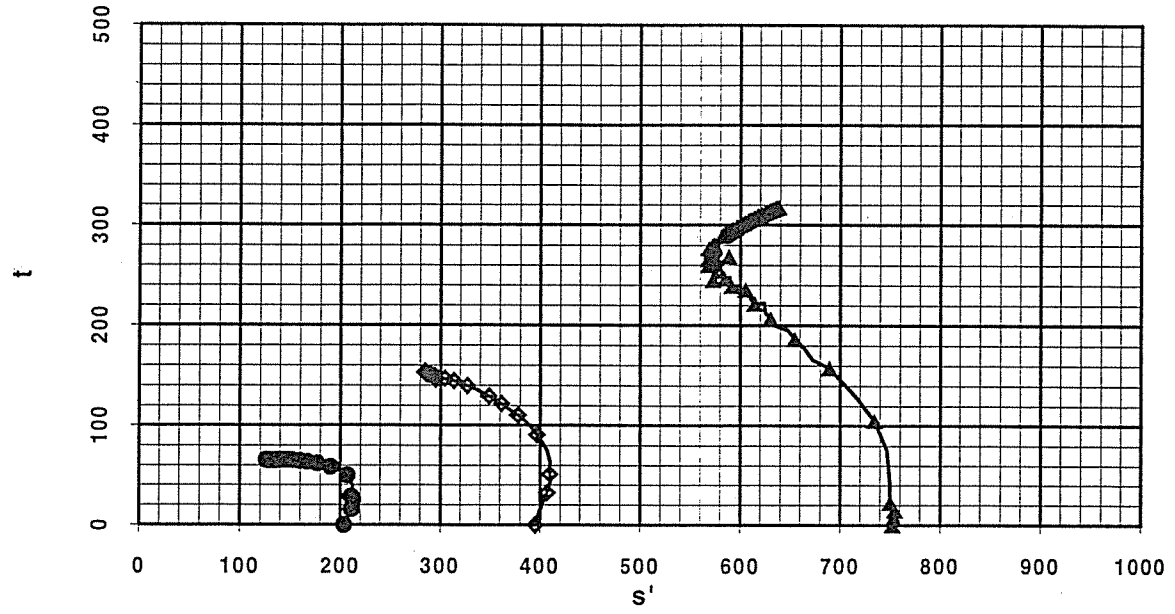
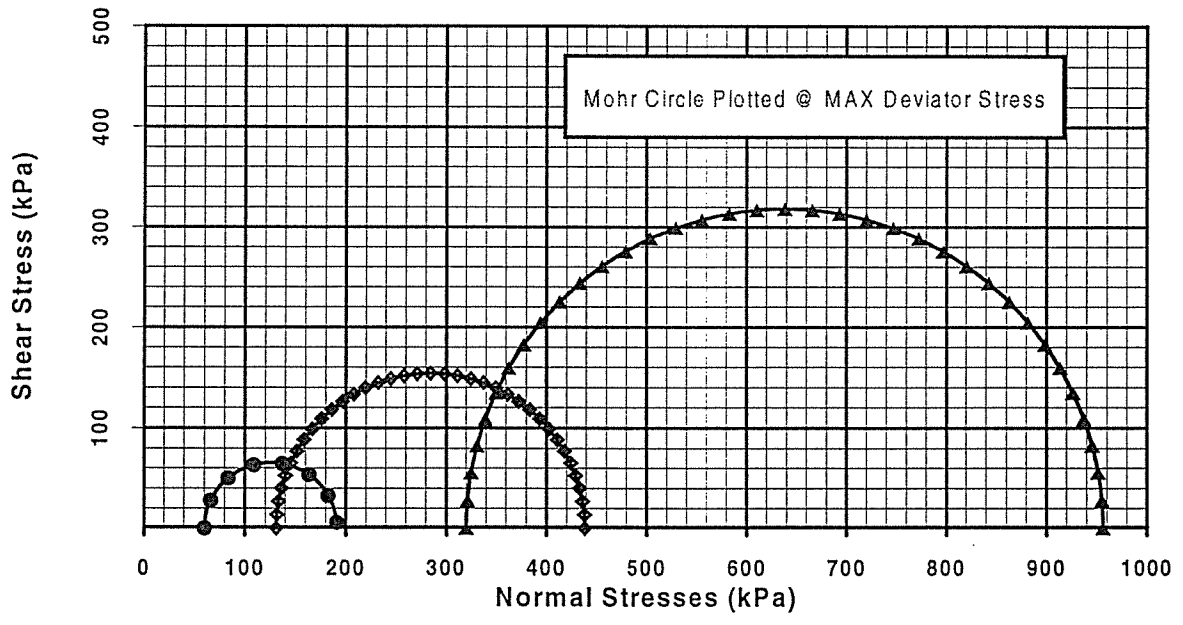
R-Z3-12 (Remoulded Sample)

Consolidated Undrained Triaxial Compression Test
 ASTM D 4767-88 (Multi-Stage Test)

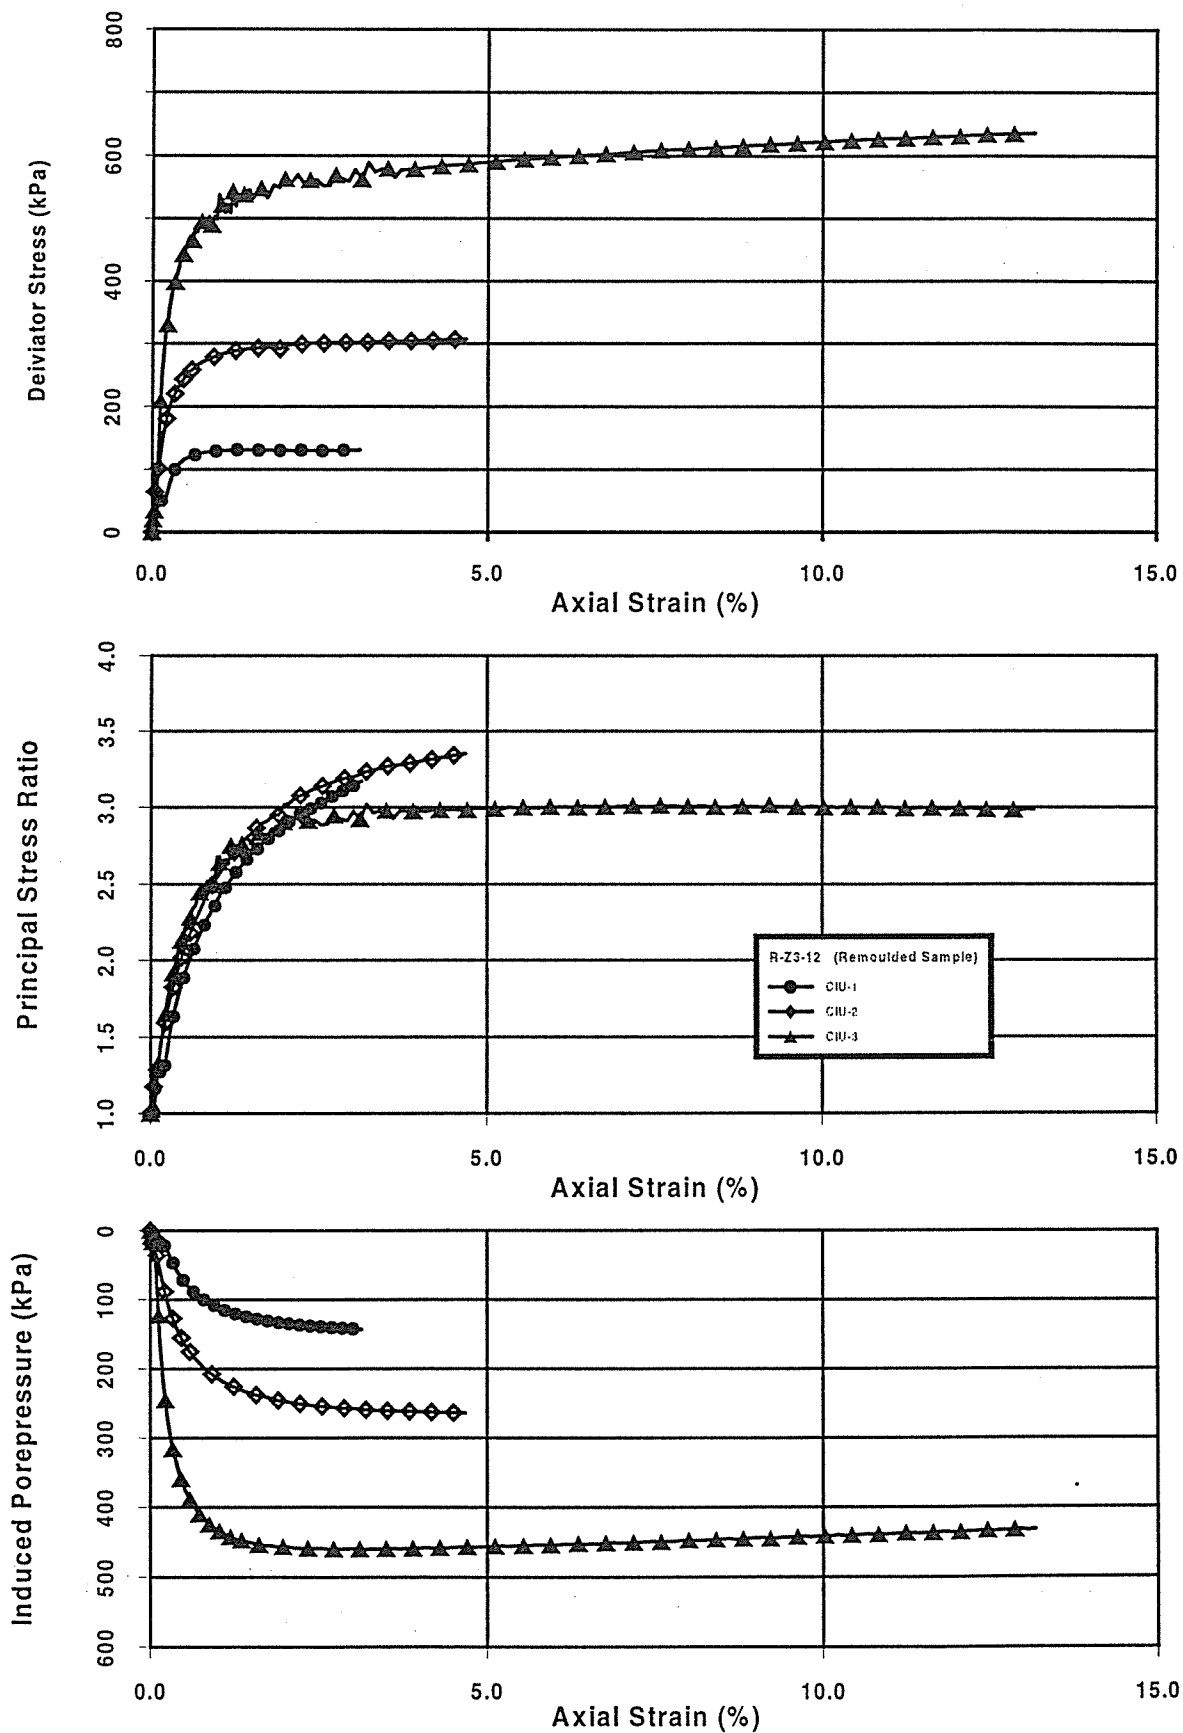
Consolidated Undrained Triaxial Compression Test
 ASTM D 4767-88 (Multi-Stage)

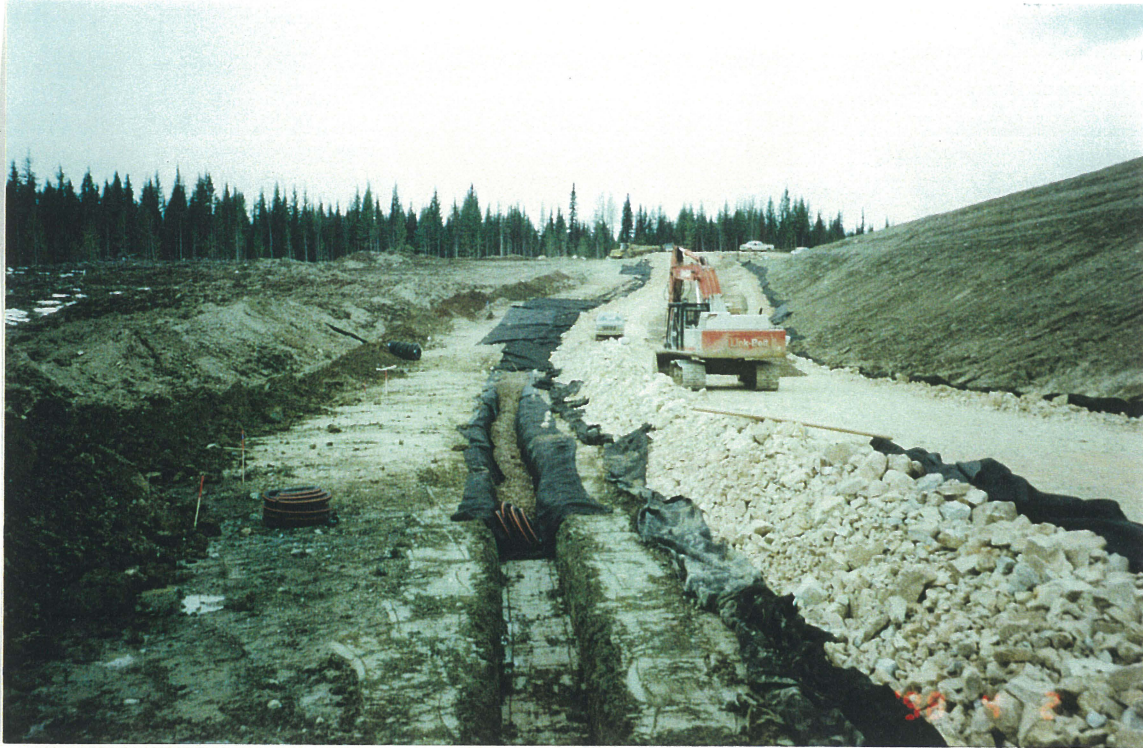
Photo No. 1: Installing Foundation Drain FD-5 at Main Embankment, April 2, 1998.

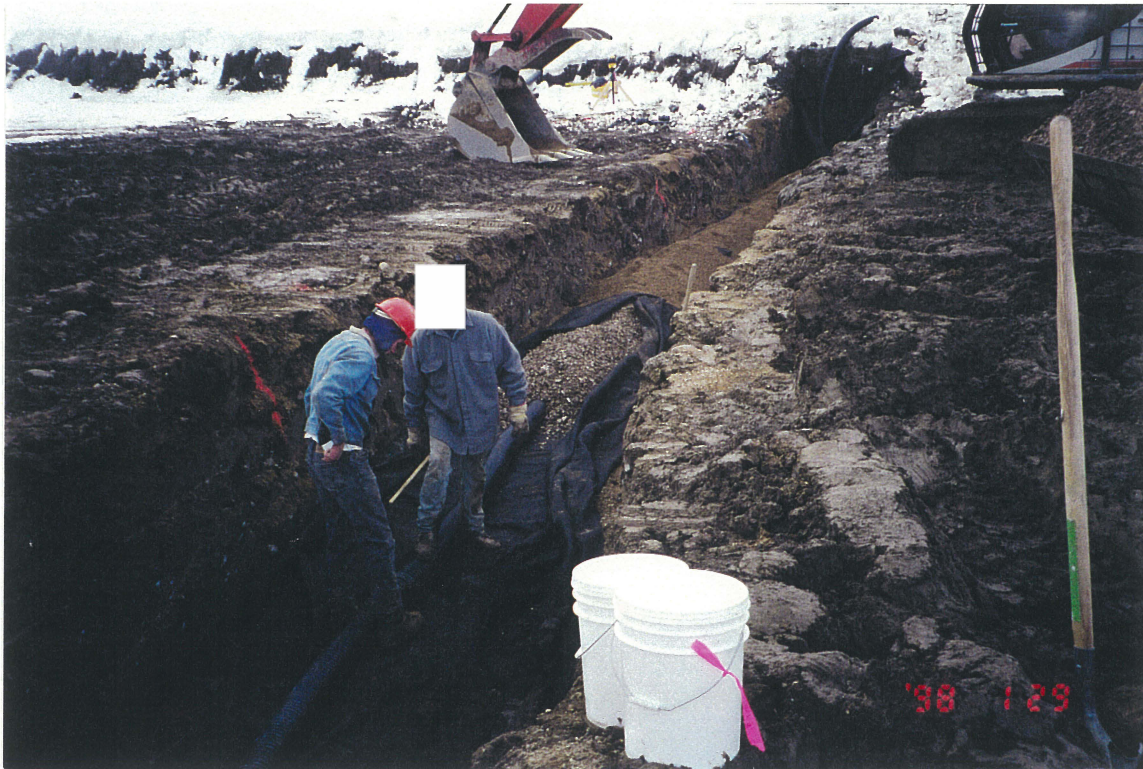
Photo No. 2: Installing Outlet Drain OD-5 at Perimeter Embankment, January 29, 1998.

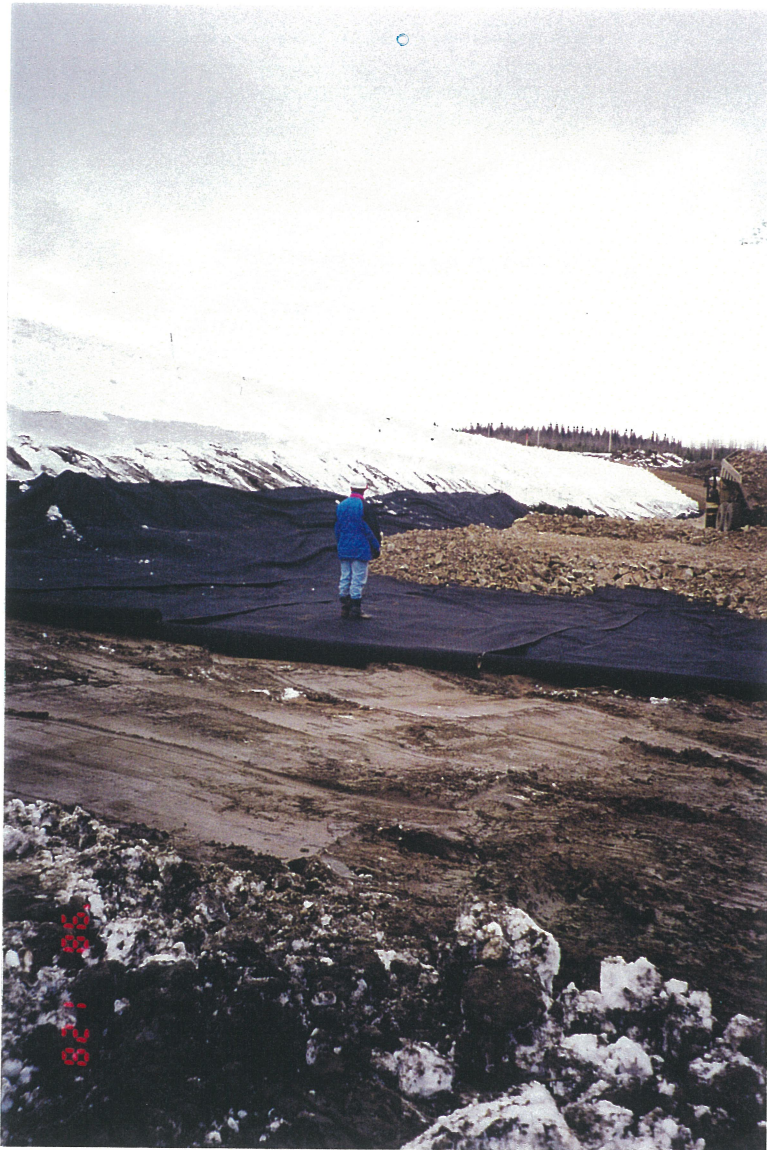
Photo No. 3: Prepared foundation at Perimeter Embankment with Type 2 Geotextile Filter Fabric layer between Transition Zone Material (Zone T) and Foundation Soil, January 28, 1998.

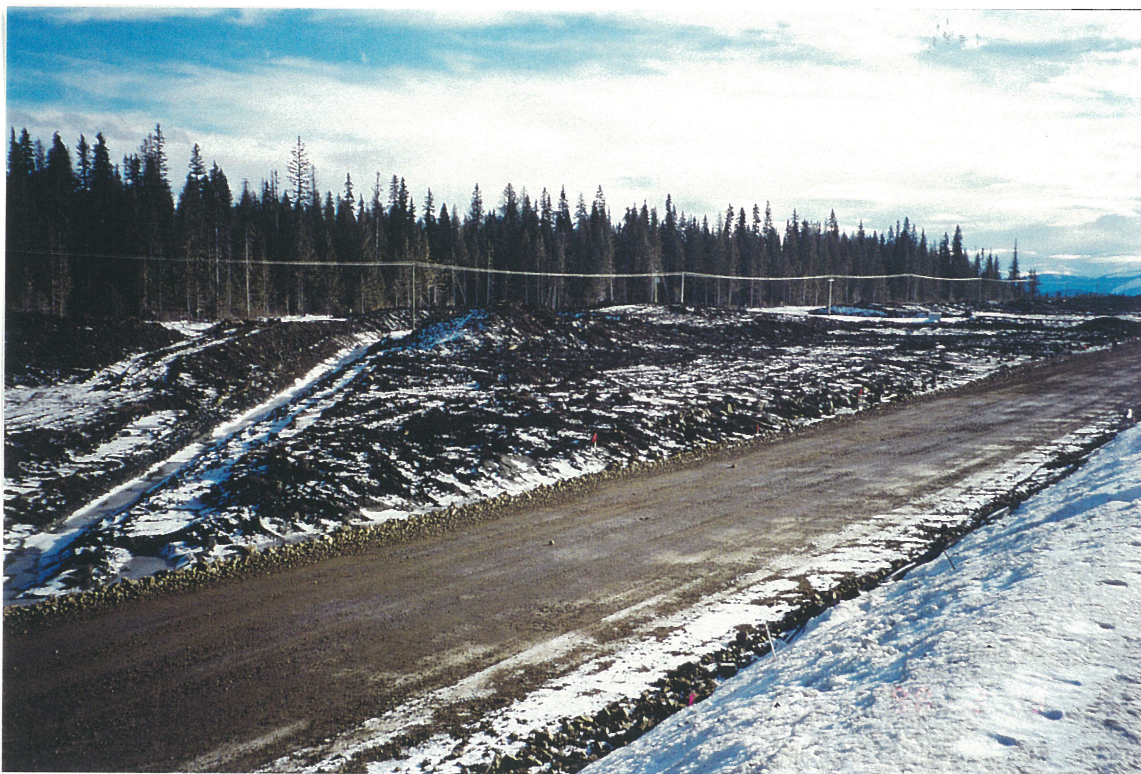
Photo No. 4: Completed Zone T Haul Road at Perimeter Embankment, February 13, 1998.

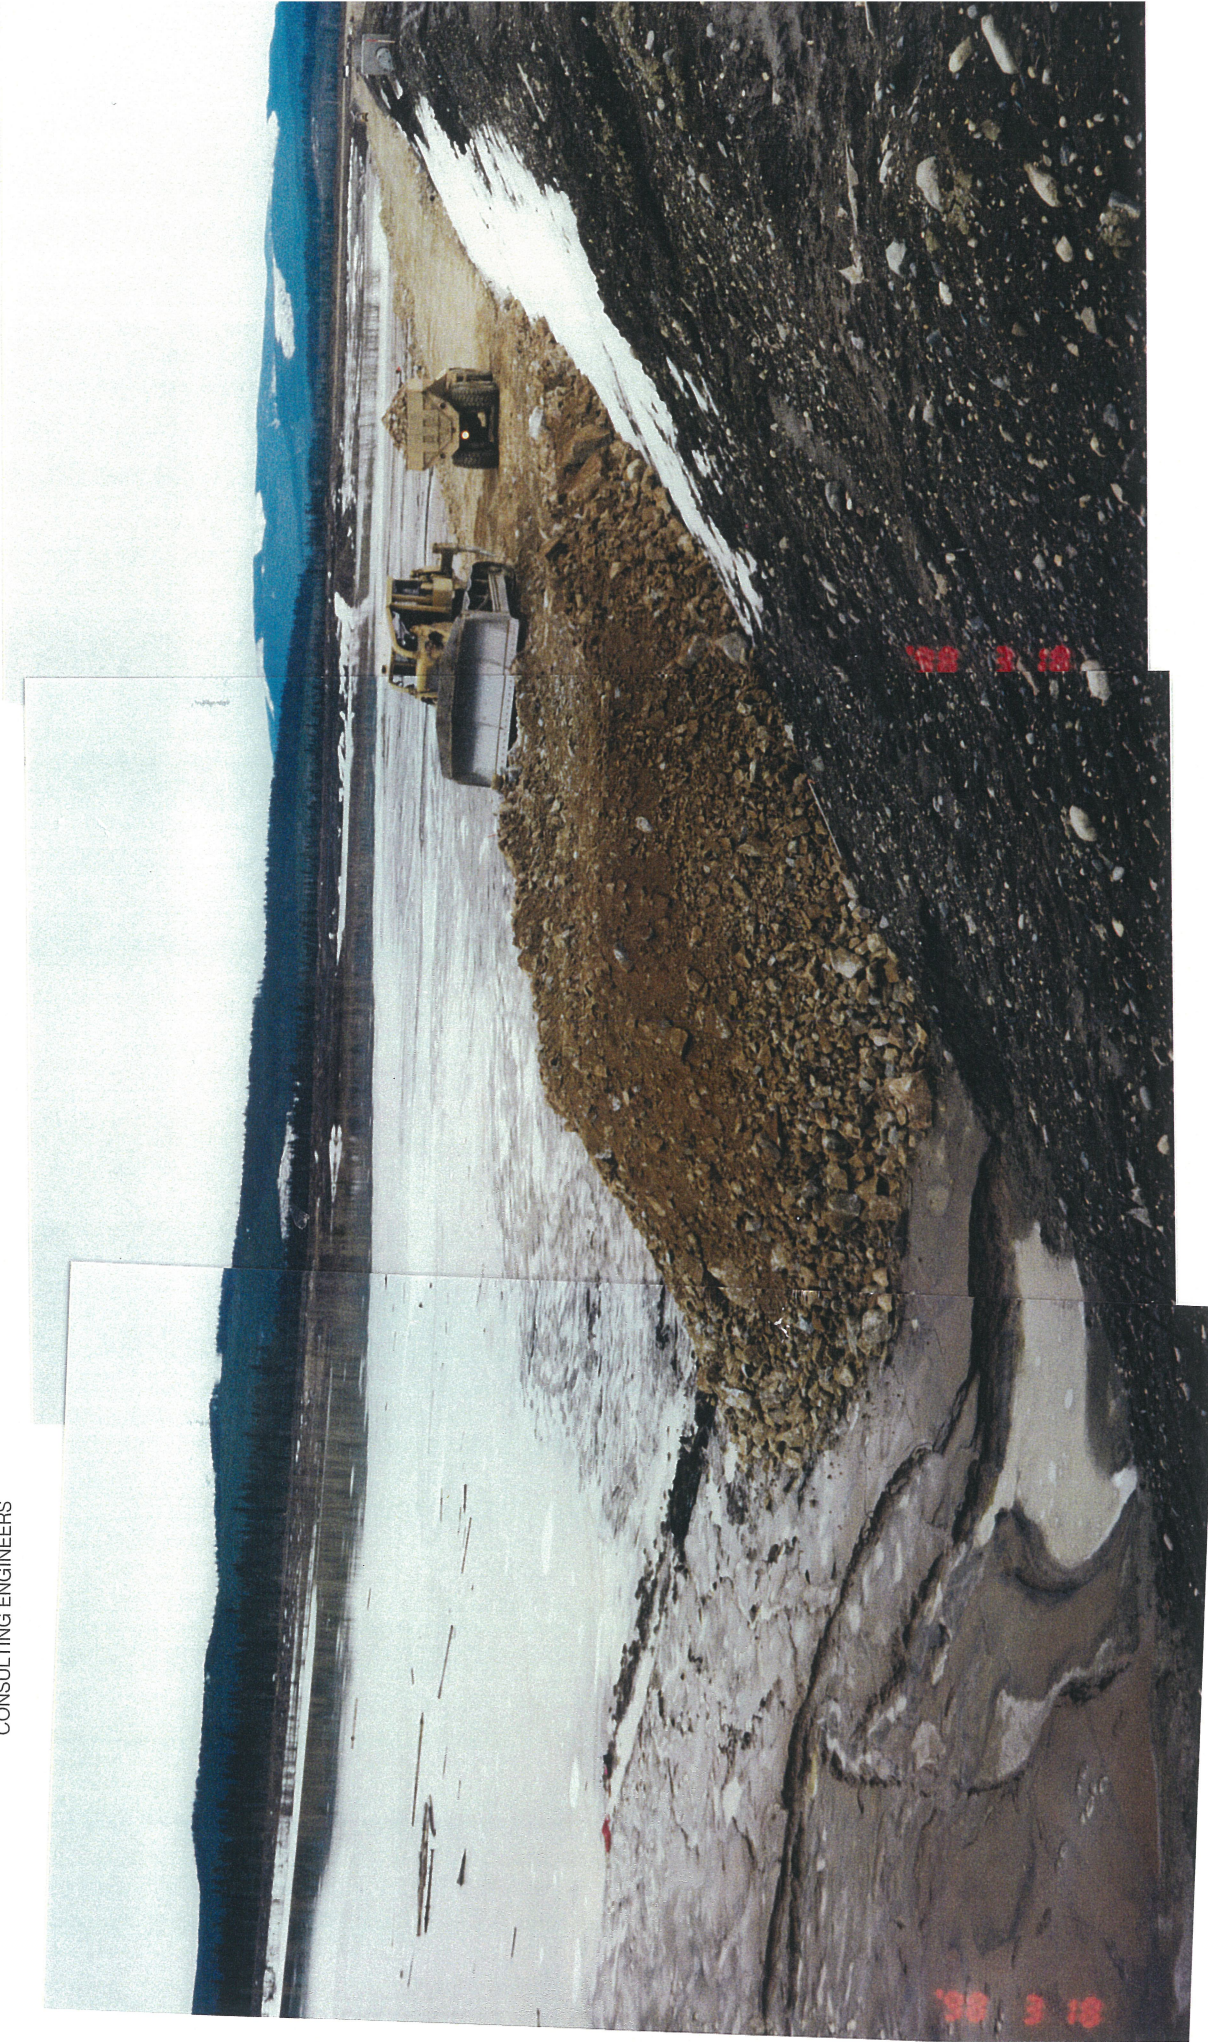
Photo No. 5: Placement of Coarse Bearing Layer (Zone CBL) on Tailings at Main Embankment,
March 18, 1998.

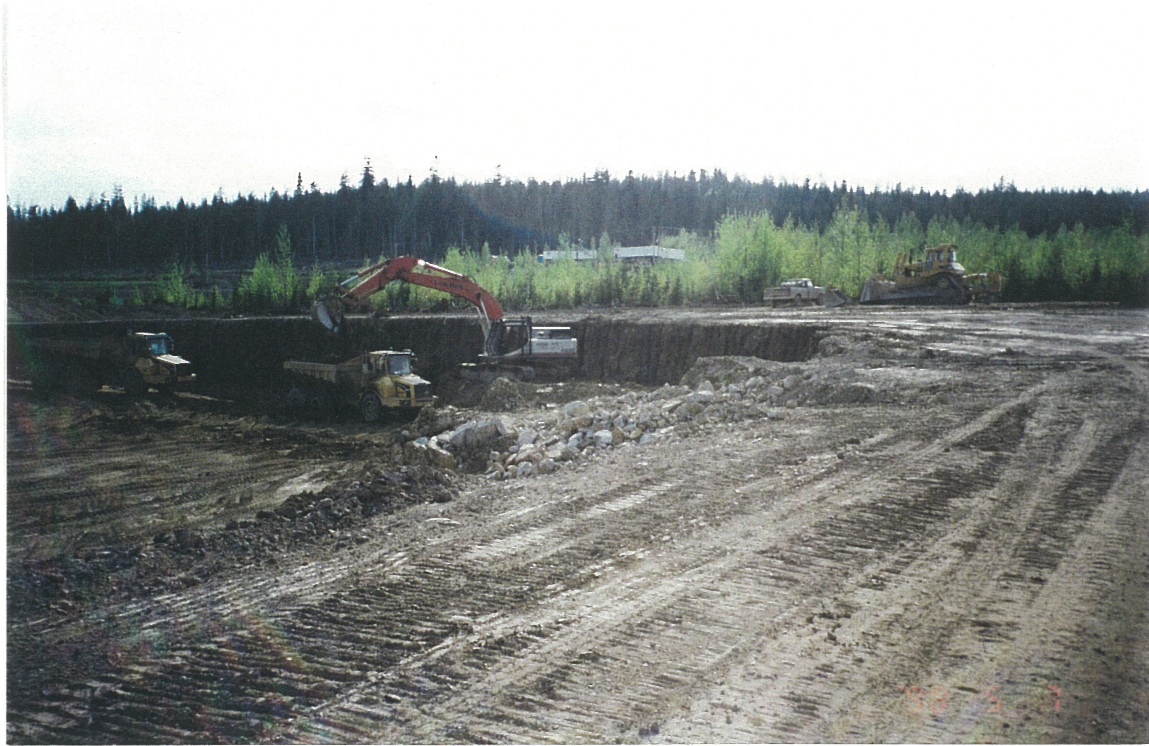
Photo No. 6: Glacial Till Borrow Area 4, near Perimeter Embankment, May 7, 1998.
