**MOUNT POLLEY MINING CORPORATION
MOUNT POLLEY MINE
TAILINGS STORAGE FACILITY**

**REPORT ON
1998 CONSTRUCTION AND ANNUAL INSPECTION
(REF. NO. 11162/10-1)**

Knight Piesold Ltd.
CONSULTING ENGINEERS

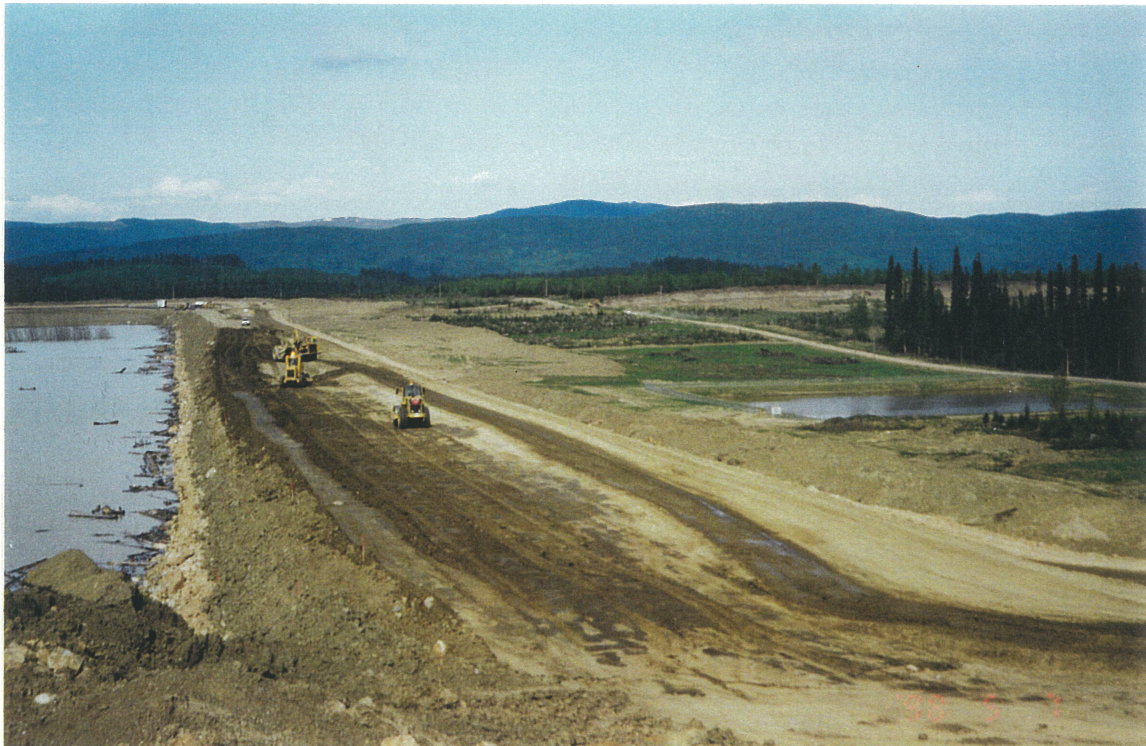
Photo No. 7: Placement of Zone S Glacial Till at Main Embankment, May 7, 1998.

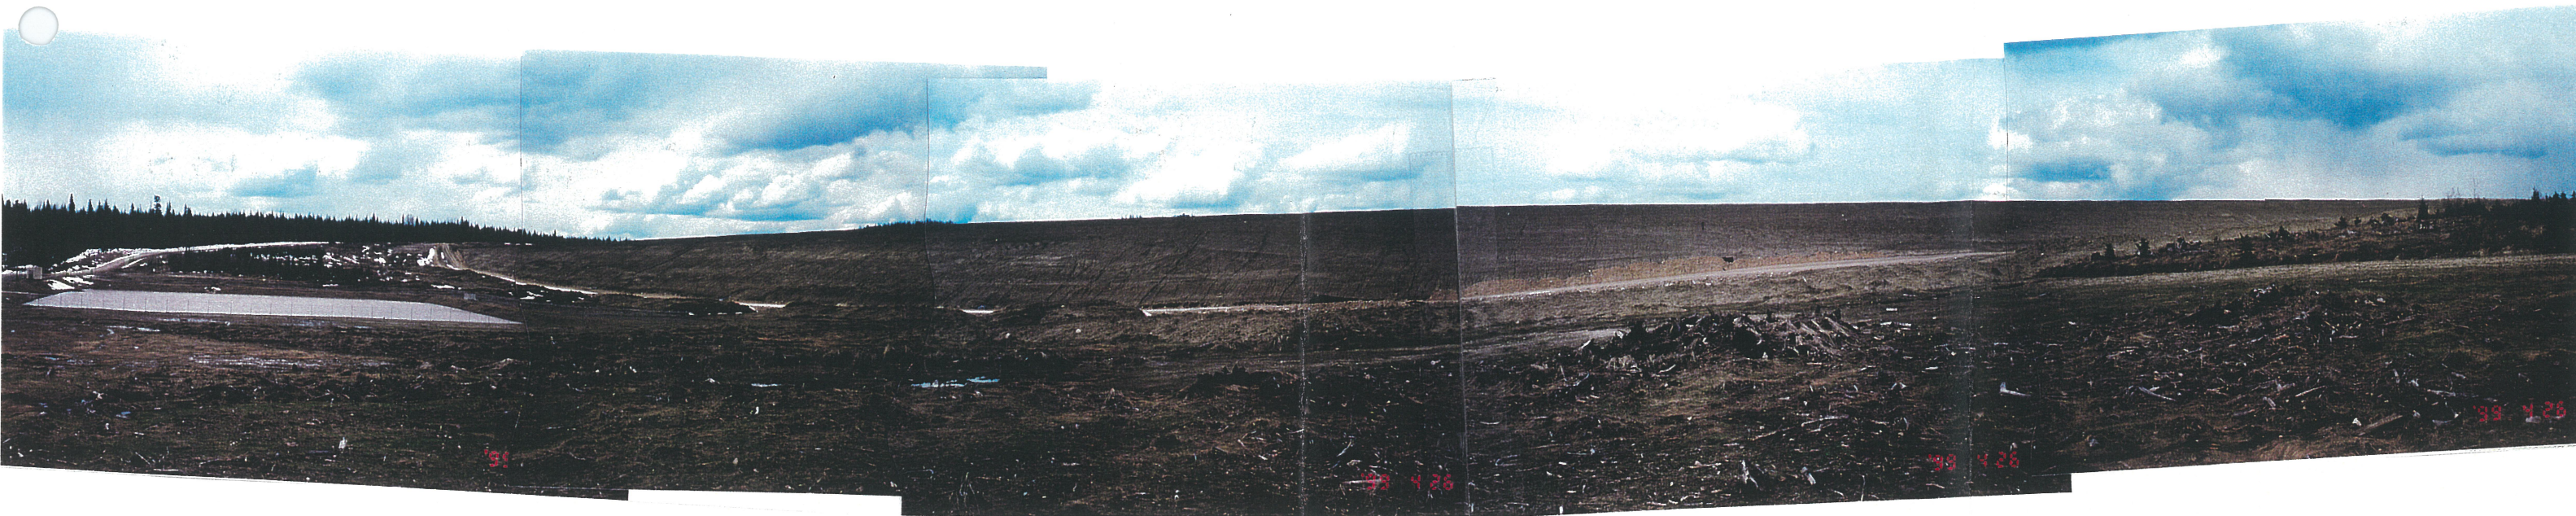
Photo No. 1: Main Embankment. View looking north, from Bootjack – Morehead Connector Road east of the Seepage Collection Pond. Note Seepage Collection Pond on left.

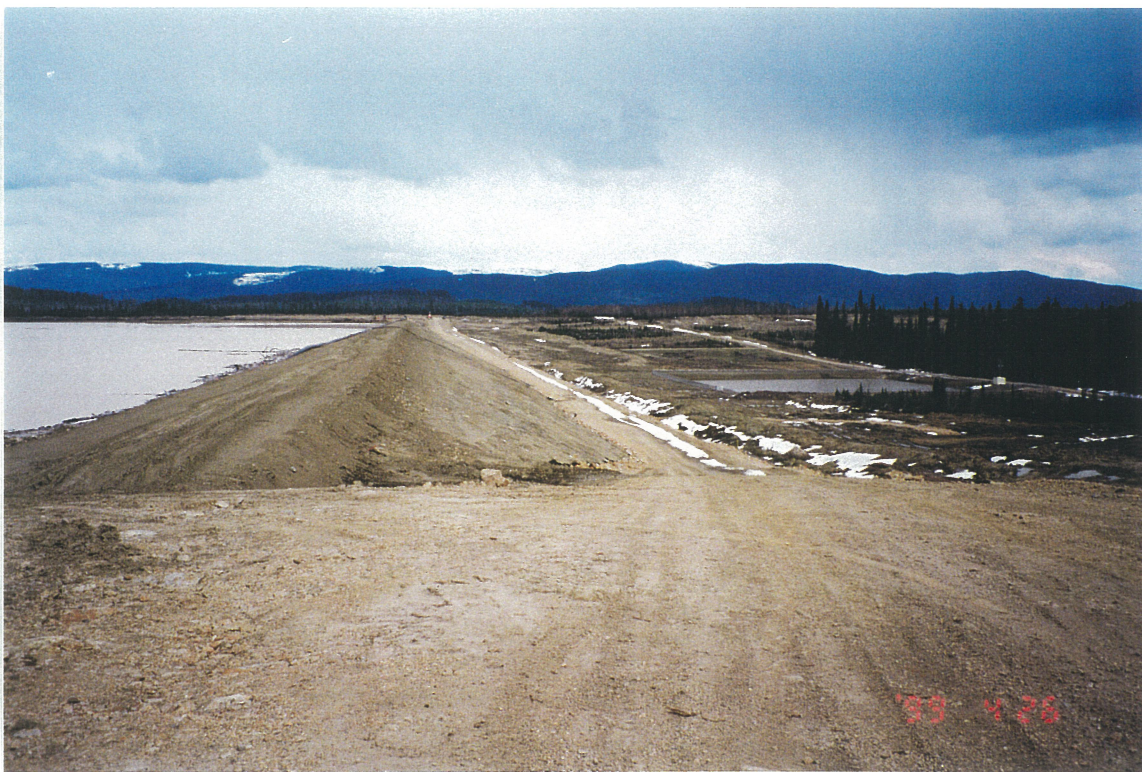
Photo No. 2: Main Embankment. View looking east, from right abutment.

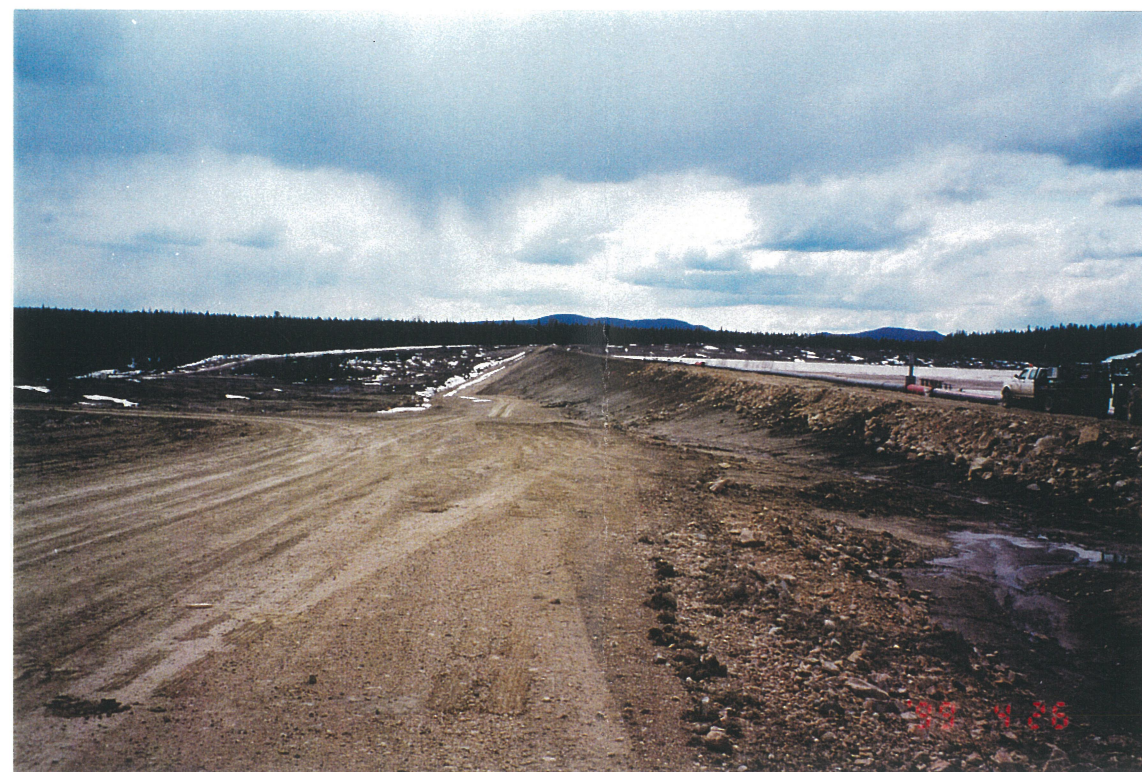
Photo No. 3: Main Embankment. View looking west, from left abutment.

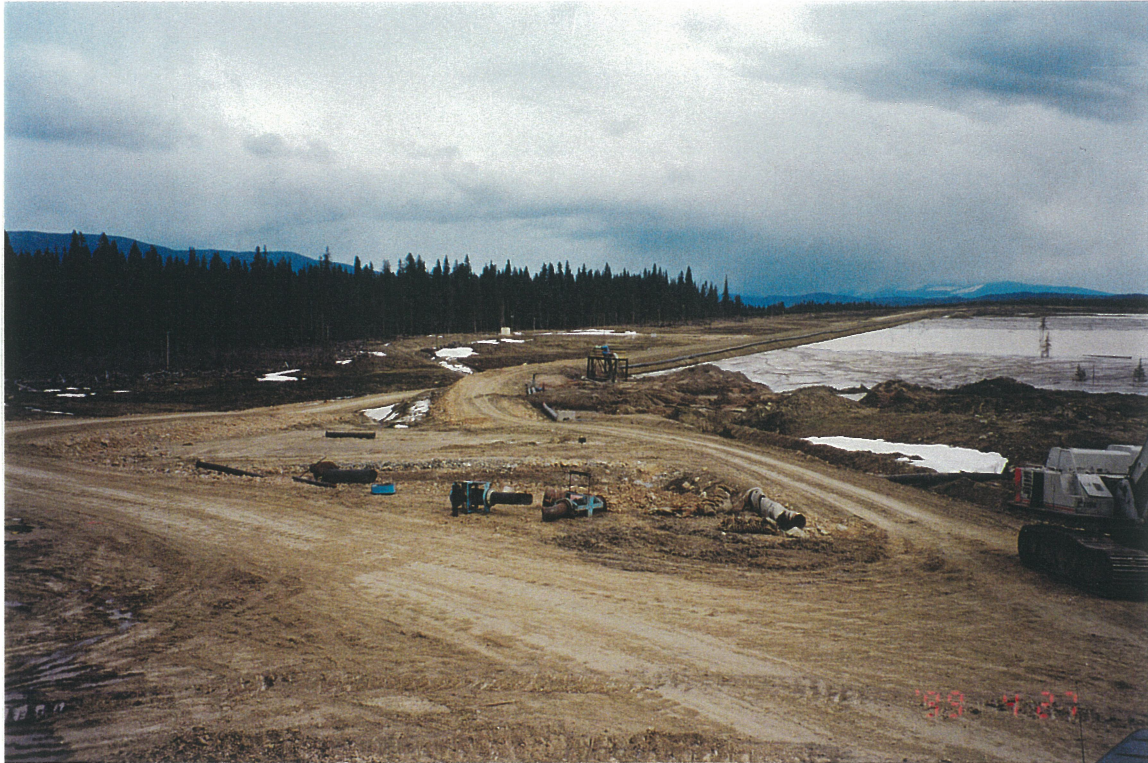
Photo No. 4: Perimeter Embankment from left abutment. Note tailings beach development and set-up of 60 inch cyclone.

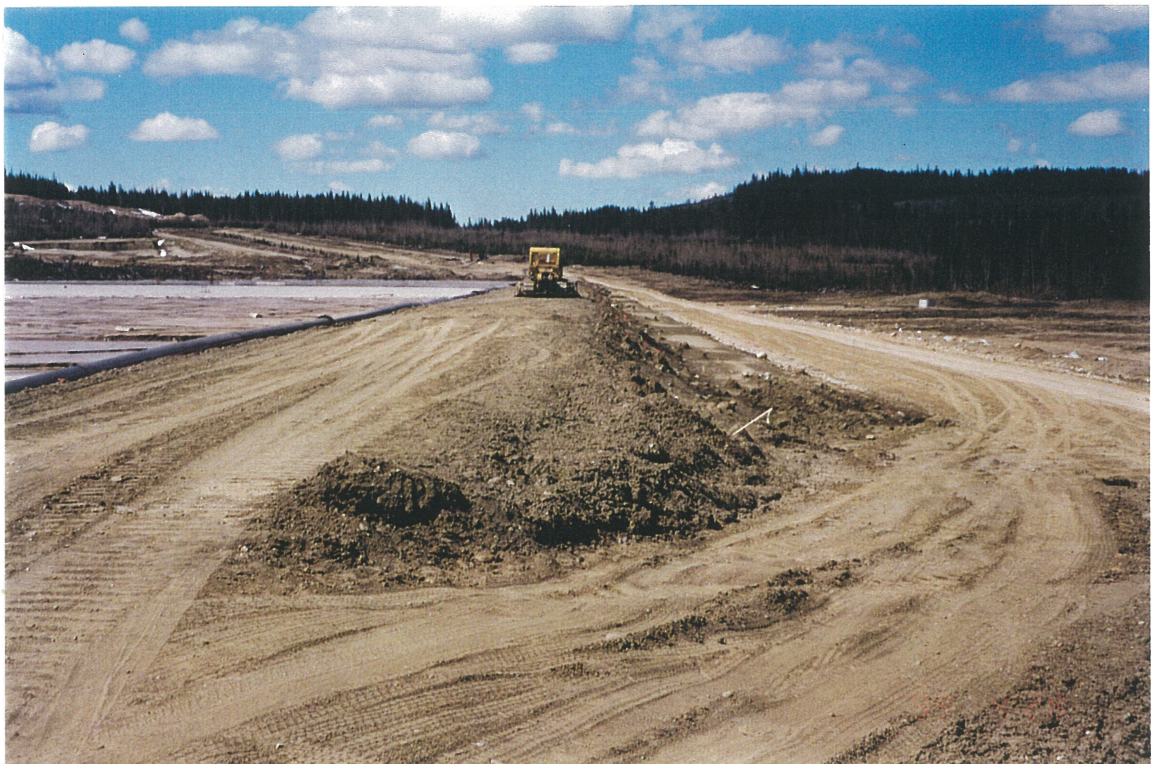
Photo No. 5: Perimeter Embankment from near right abutment.

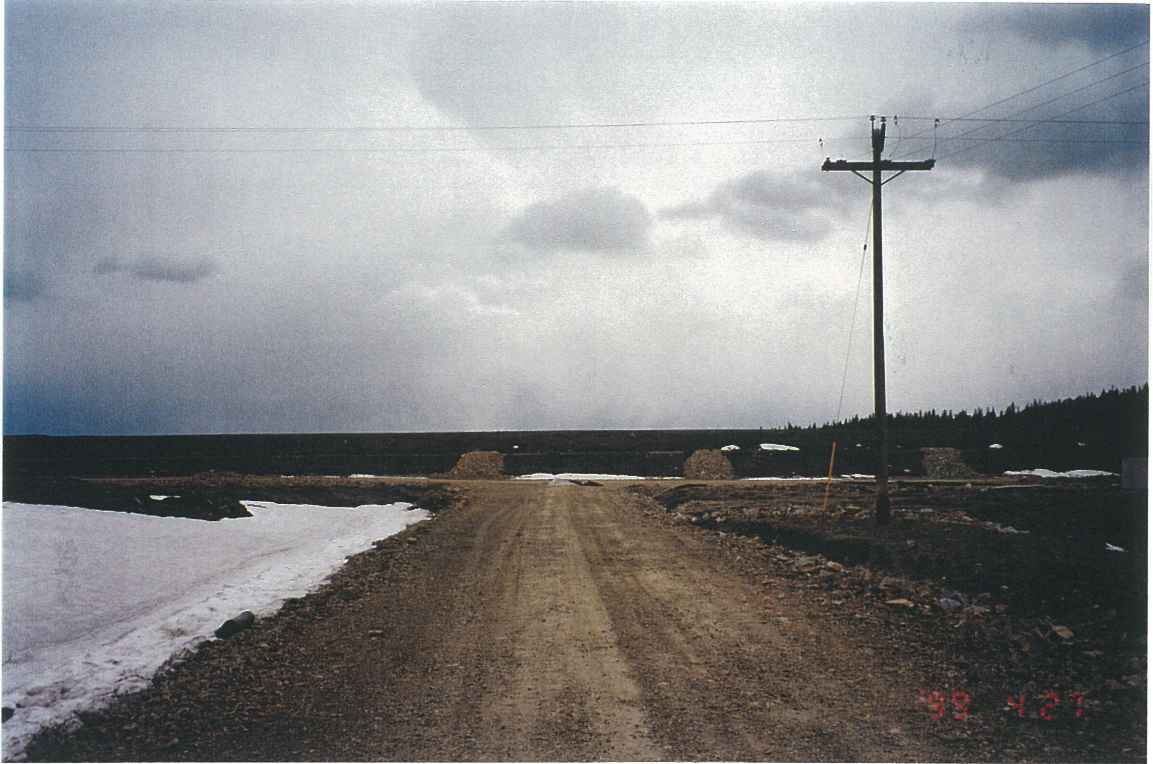
Photo No. 6: Perimeter Embankment. Looking upstream from access road on east side of Seepage Collection Pond. Note Outlet Drains going up face of embankment.

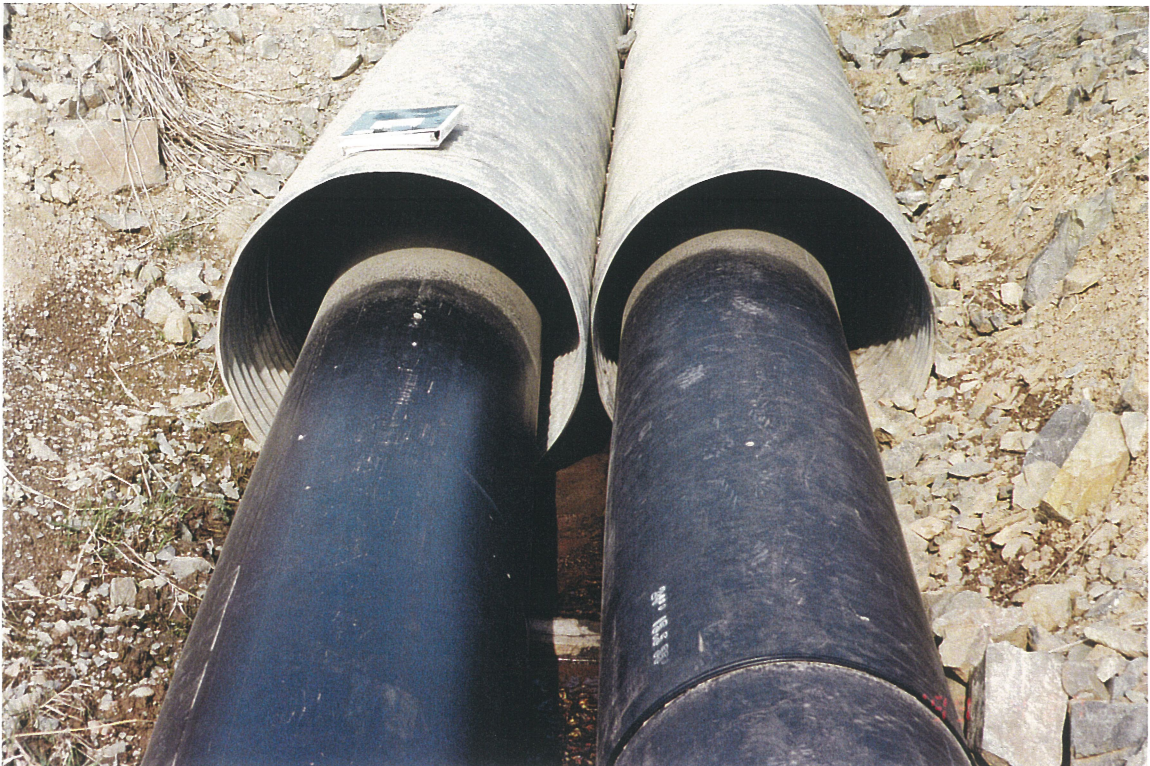
Photo No. 8: Pipeline Containment Channel. Upstream end of pipeline sleeves at Bootjack Creek Crossing. Minor amount of tailings at bottom of sleeves.

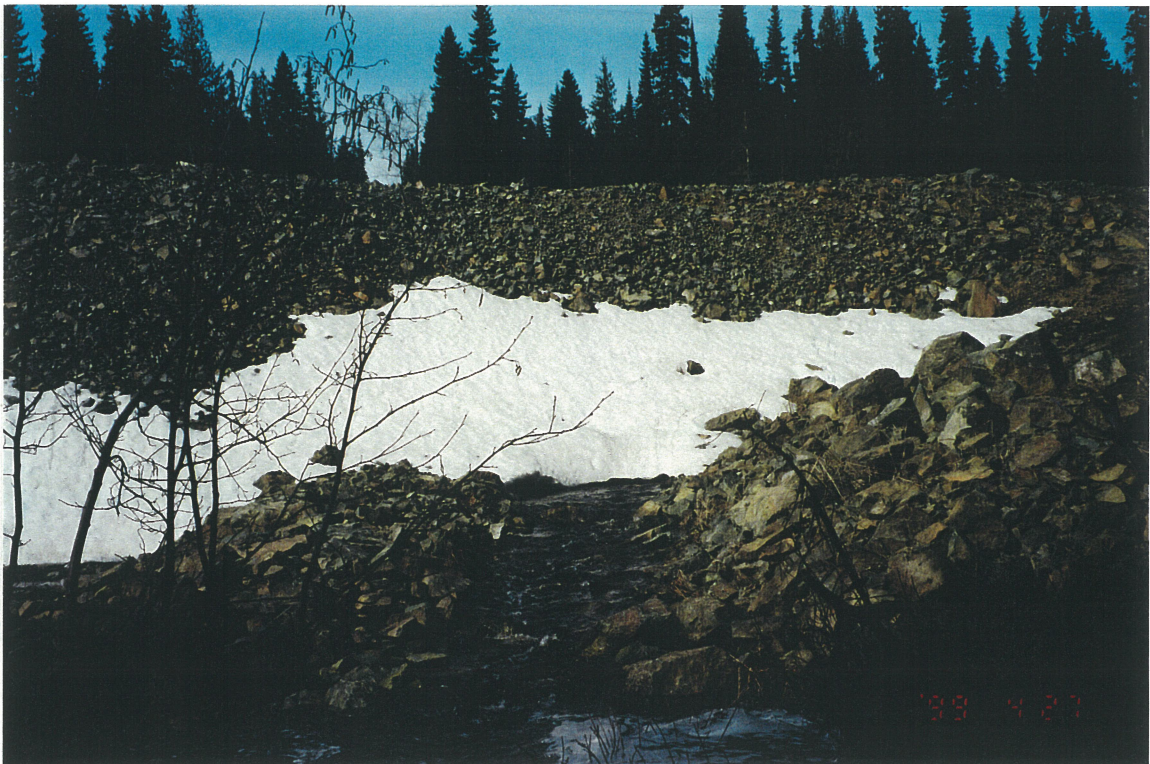
Photo No. 10: Bootjack Creek Culvert. Upstream side.

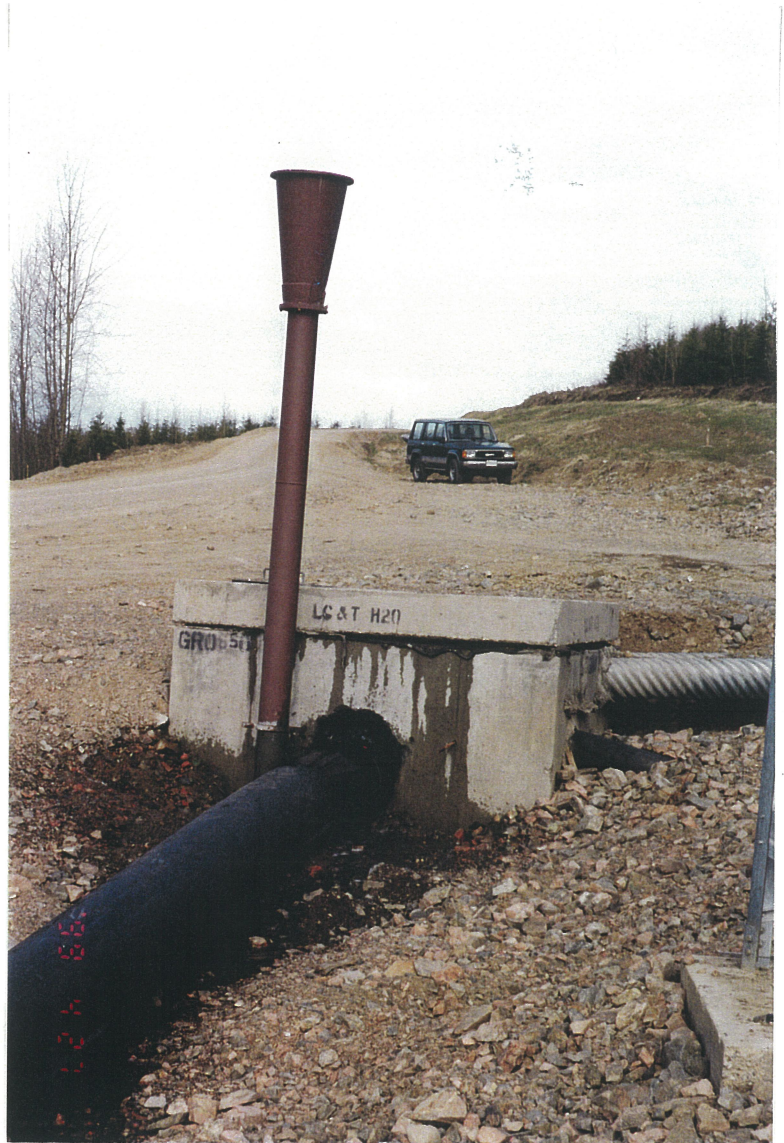
Photo No. 12: Tailings Pipeline System. Revised T2 Dropbox. Tailings Pipeline now extends all the way from the Mill to the Tailings Storage Facility. T2 Dropbox provides surge protection and is connected to the pipeline by a bifurcation.

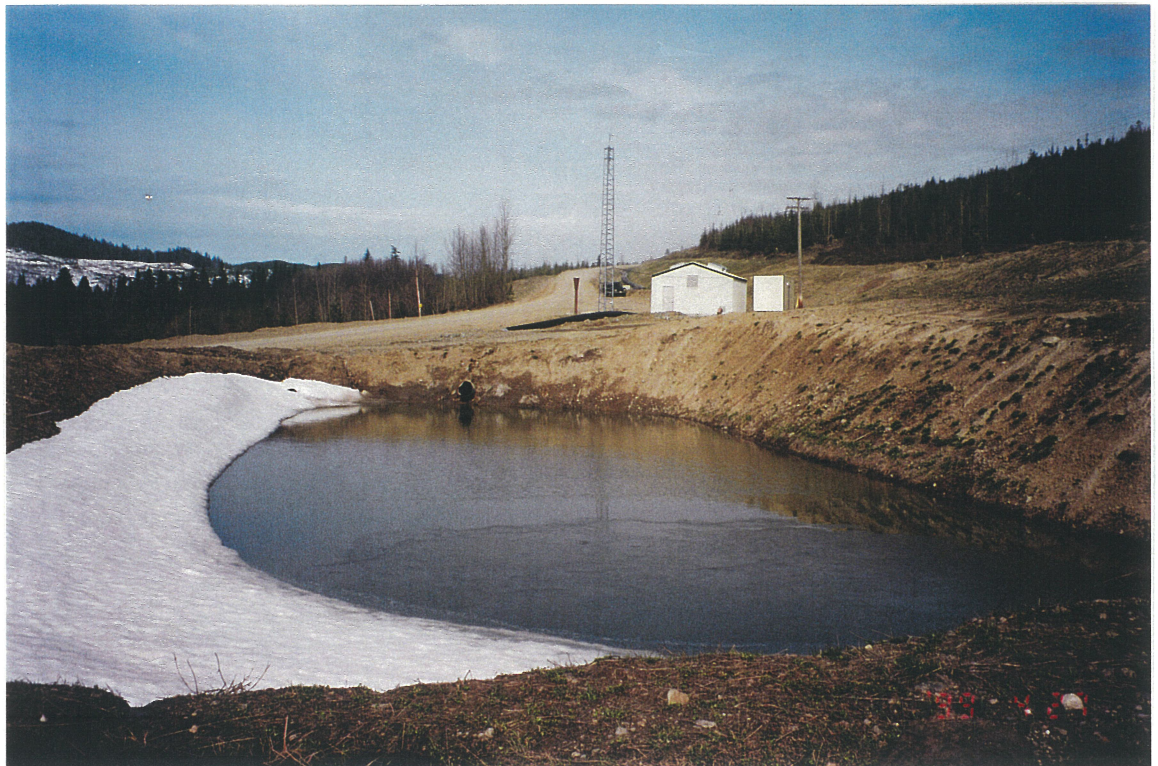
Photo No. 13: Tailings Pipeline System. Full T2 Overflow Pond (water).

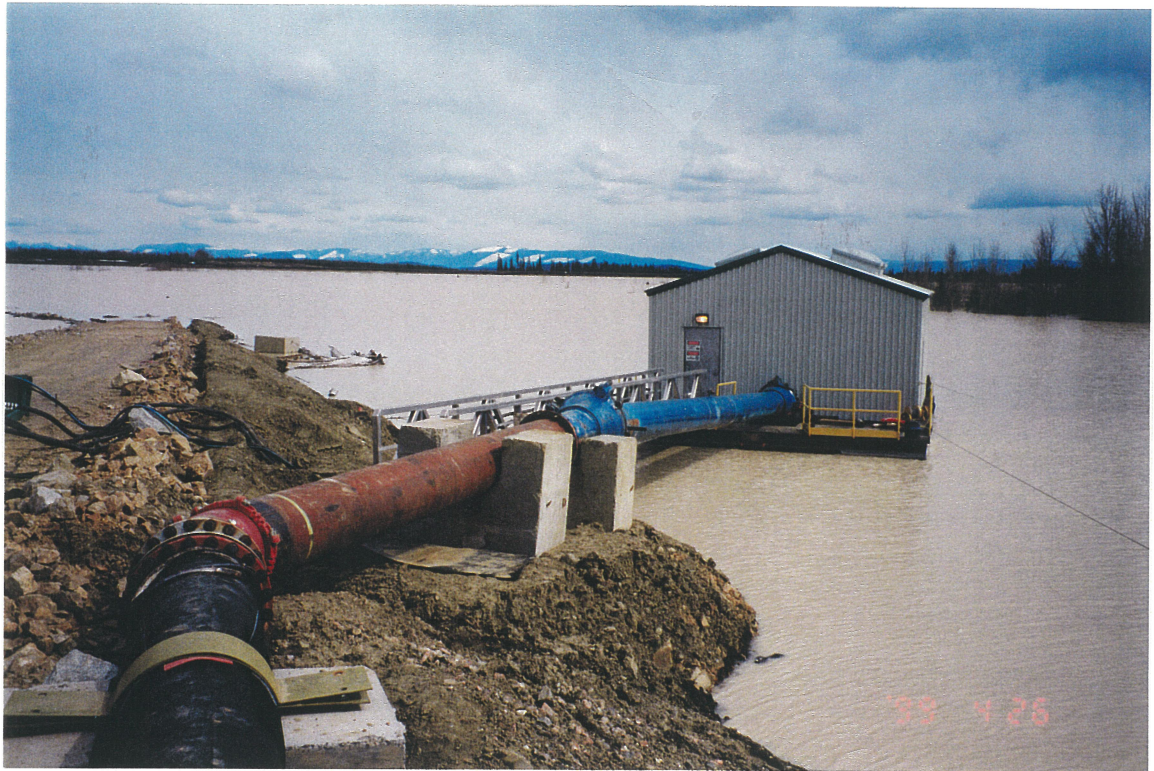
Photo No. 14: Reclaim Pipeline System. Reclaim Barge and Channel. Note 35 degree elbow added and barge alignment changed.

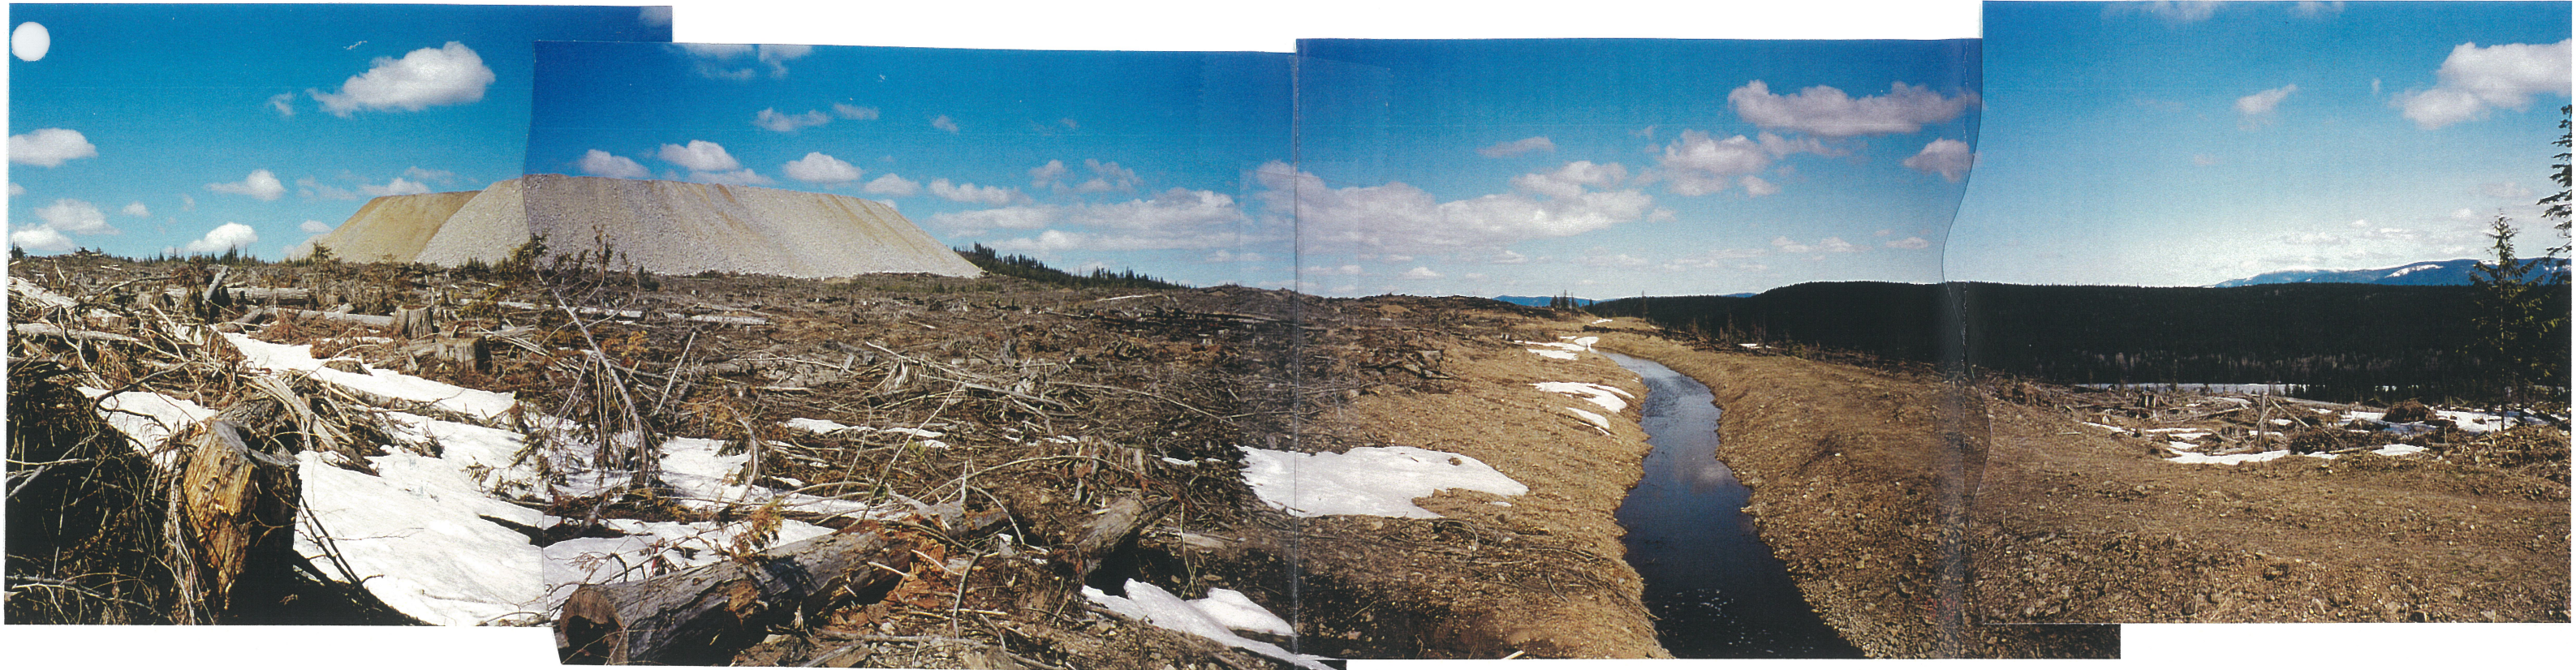
Photo No. 15: Southeast Sediment Pond – Runoff collection ditch, looking north. Note Mine waste dump to left and Polley Lake to right.

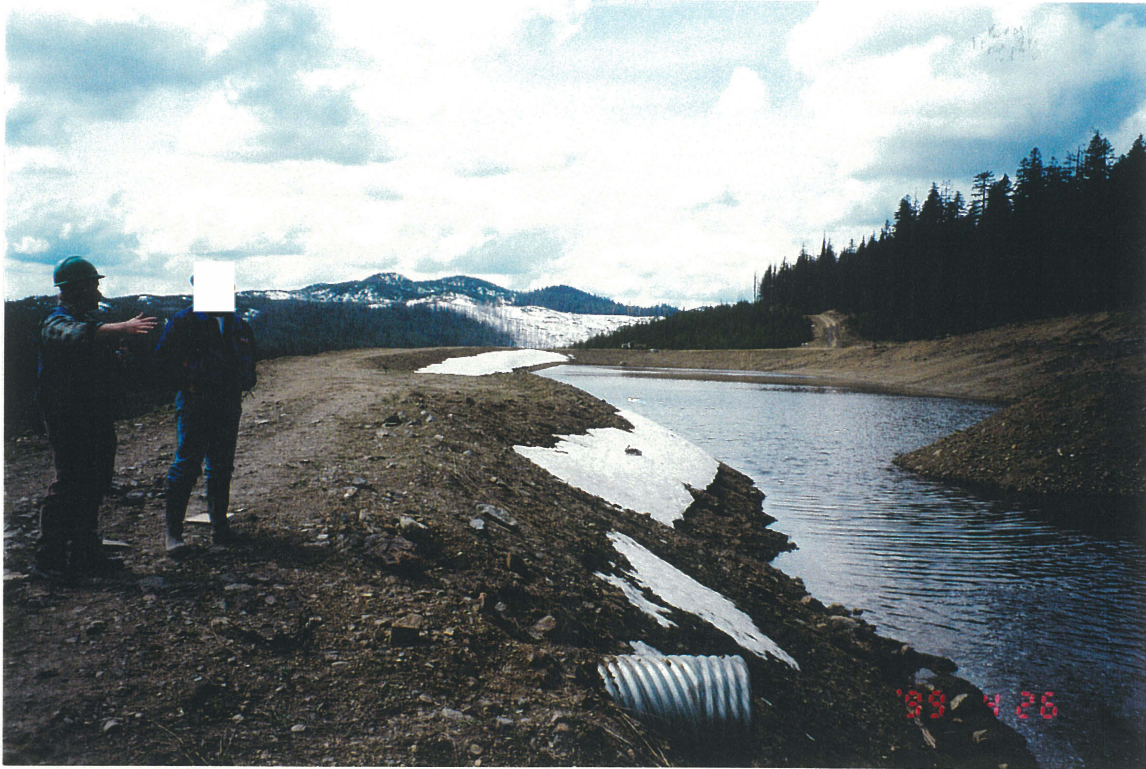
Photo No. 16: Southeast Sediment Pond – Runoff collection ditch, looking south.

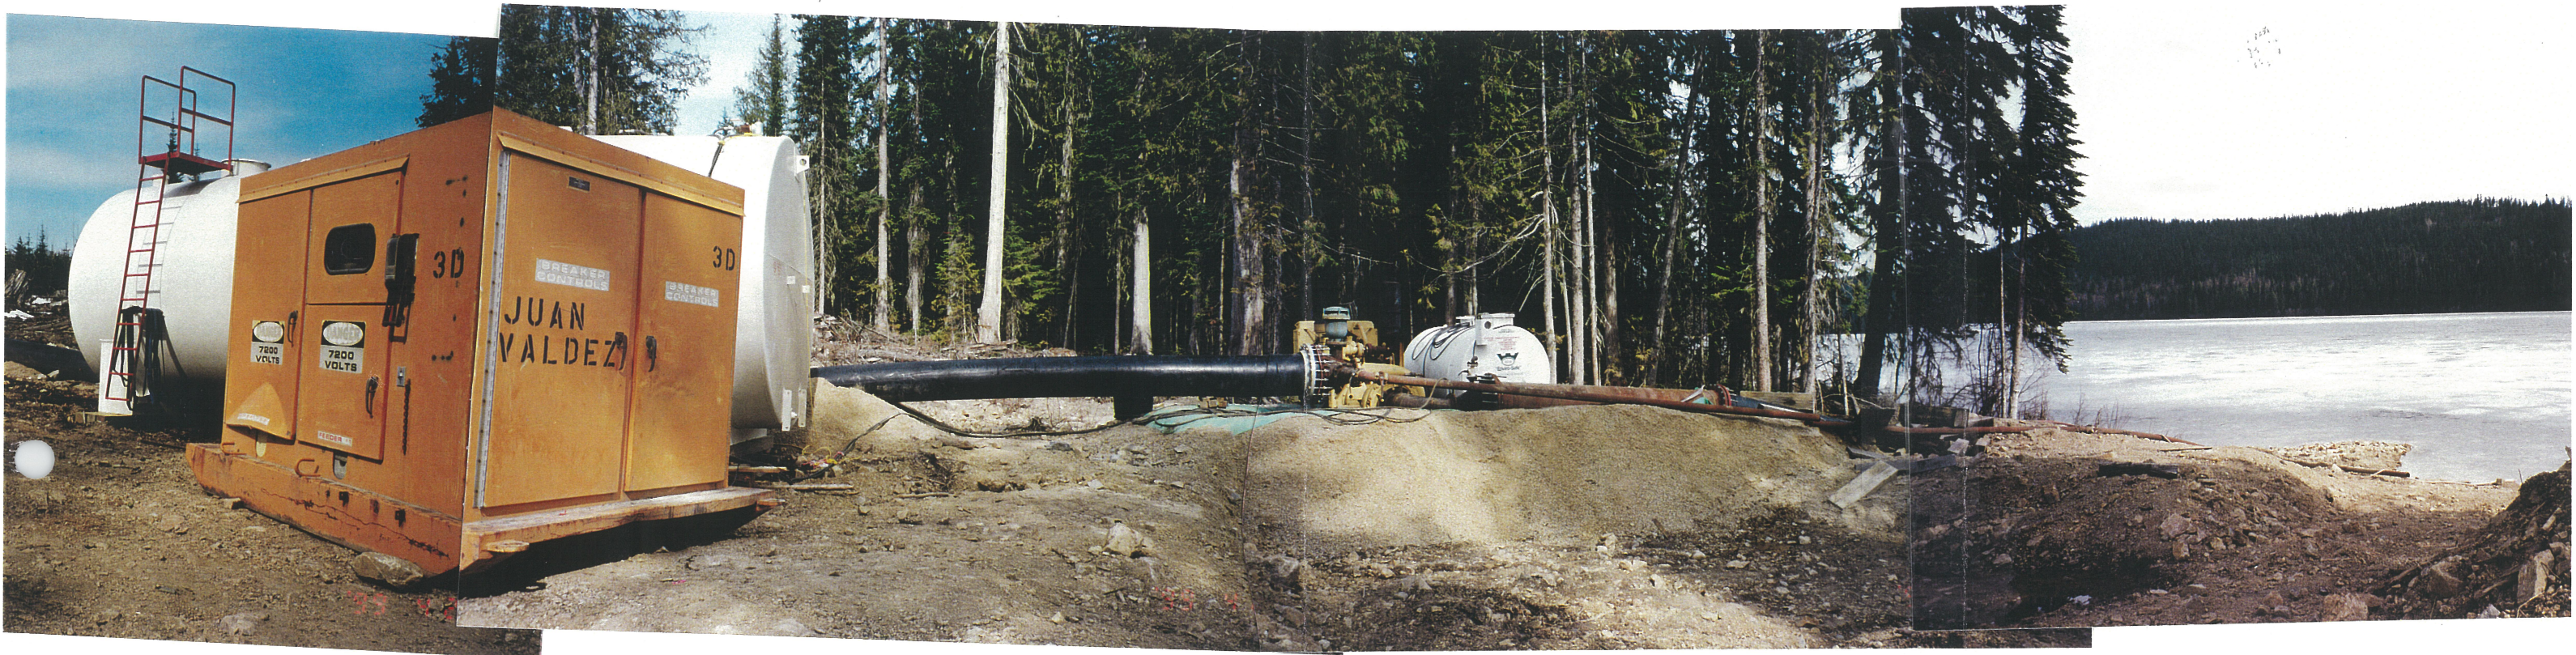
Photo No. 19: Polley Lake Pumping System. Intake Area. Note float on Polley Lake. Float is attached to the intake.

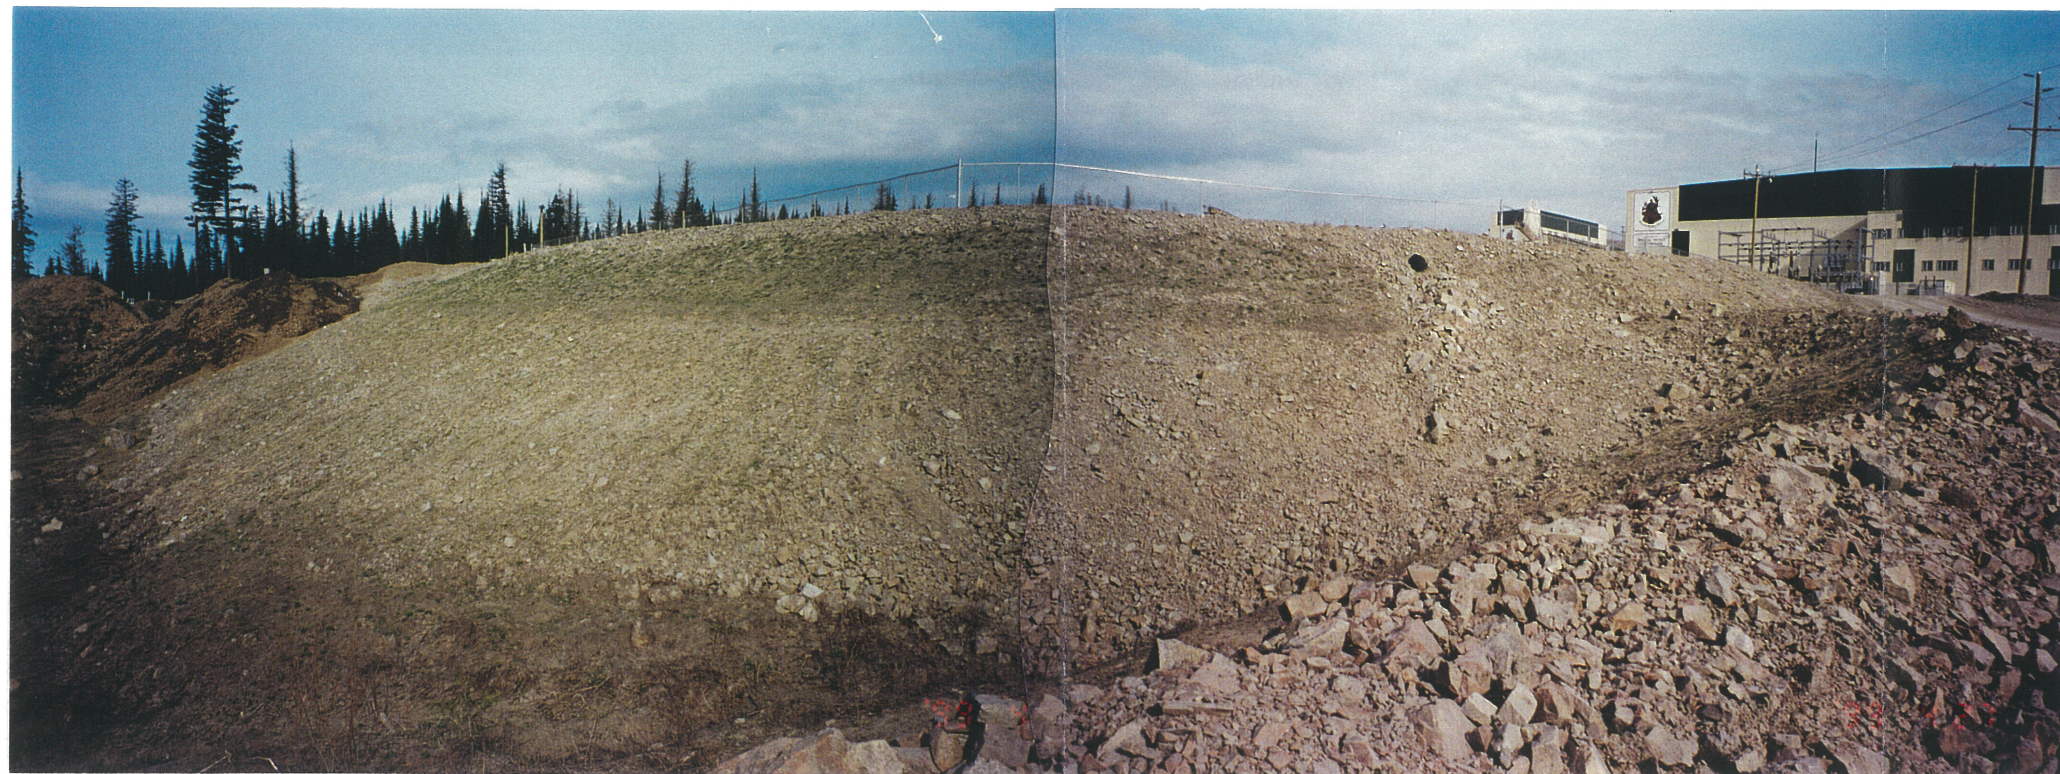
Photo No. 21: Millsite Sump. View of south slope, looking west. Slope is stable. No seepage observed.

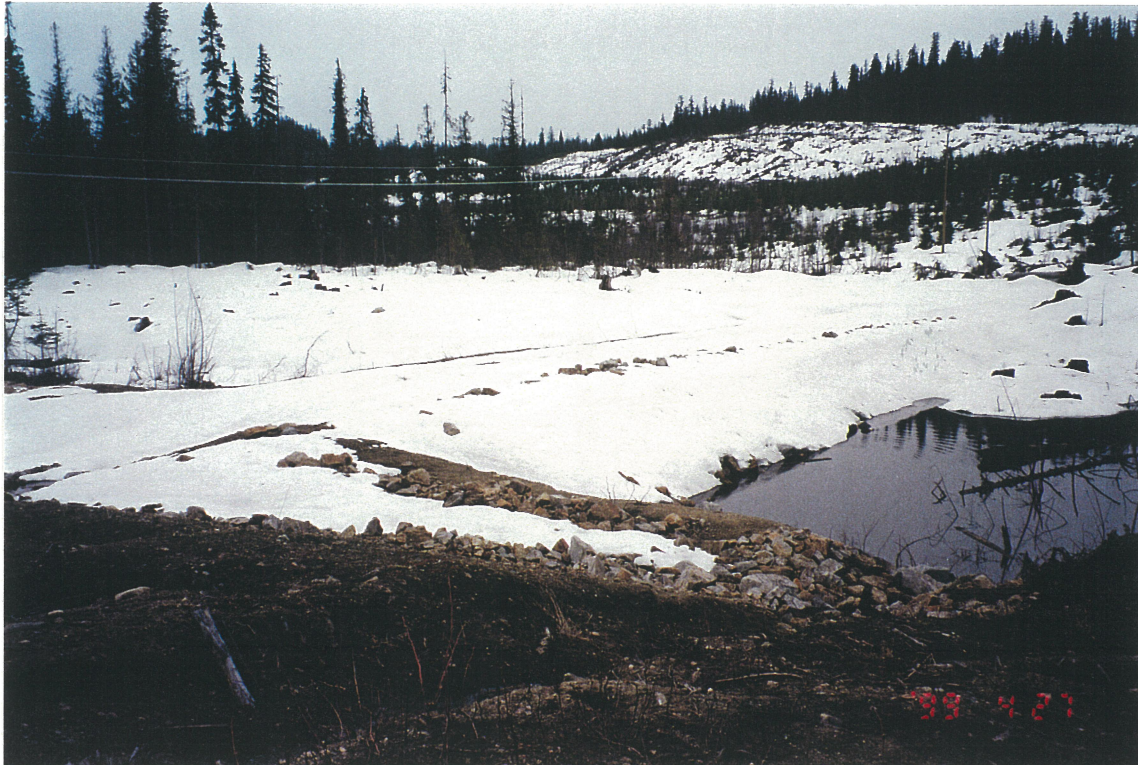
Photo No. 22: South Bootjack Dam. View of upstream face of embankment, looking northwest. Ponded water is now seeping through old dam back into Bootjack Lake.

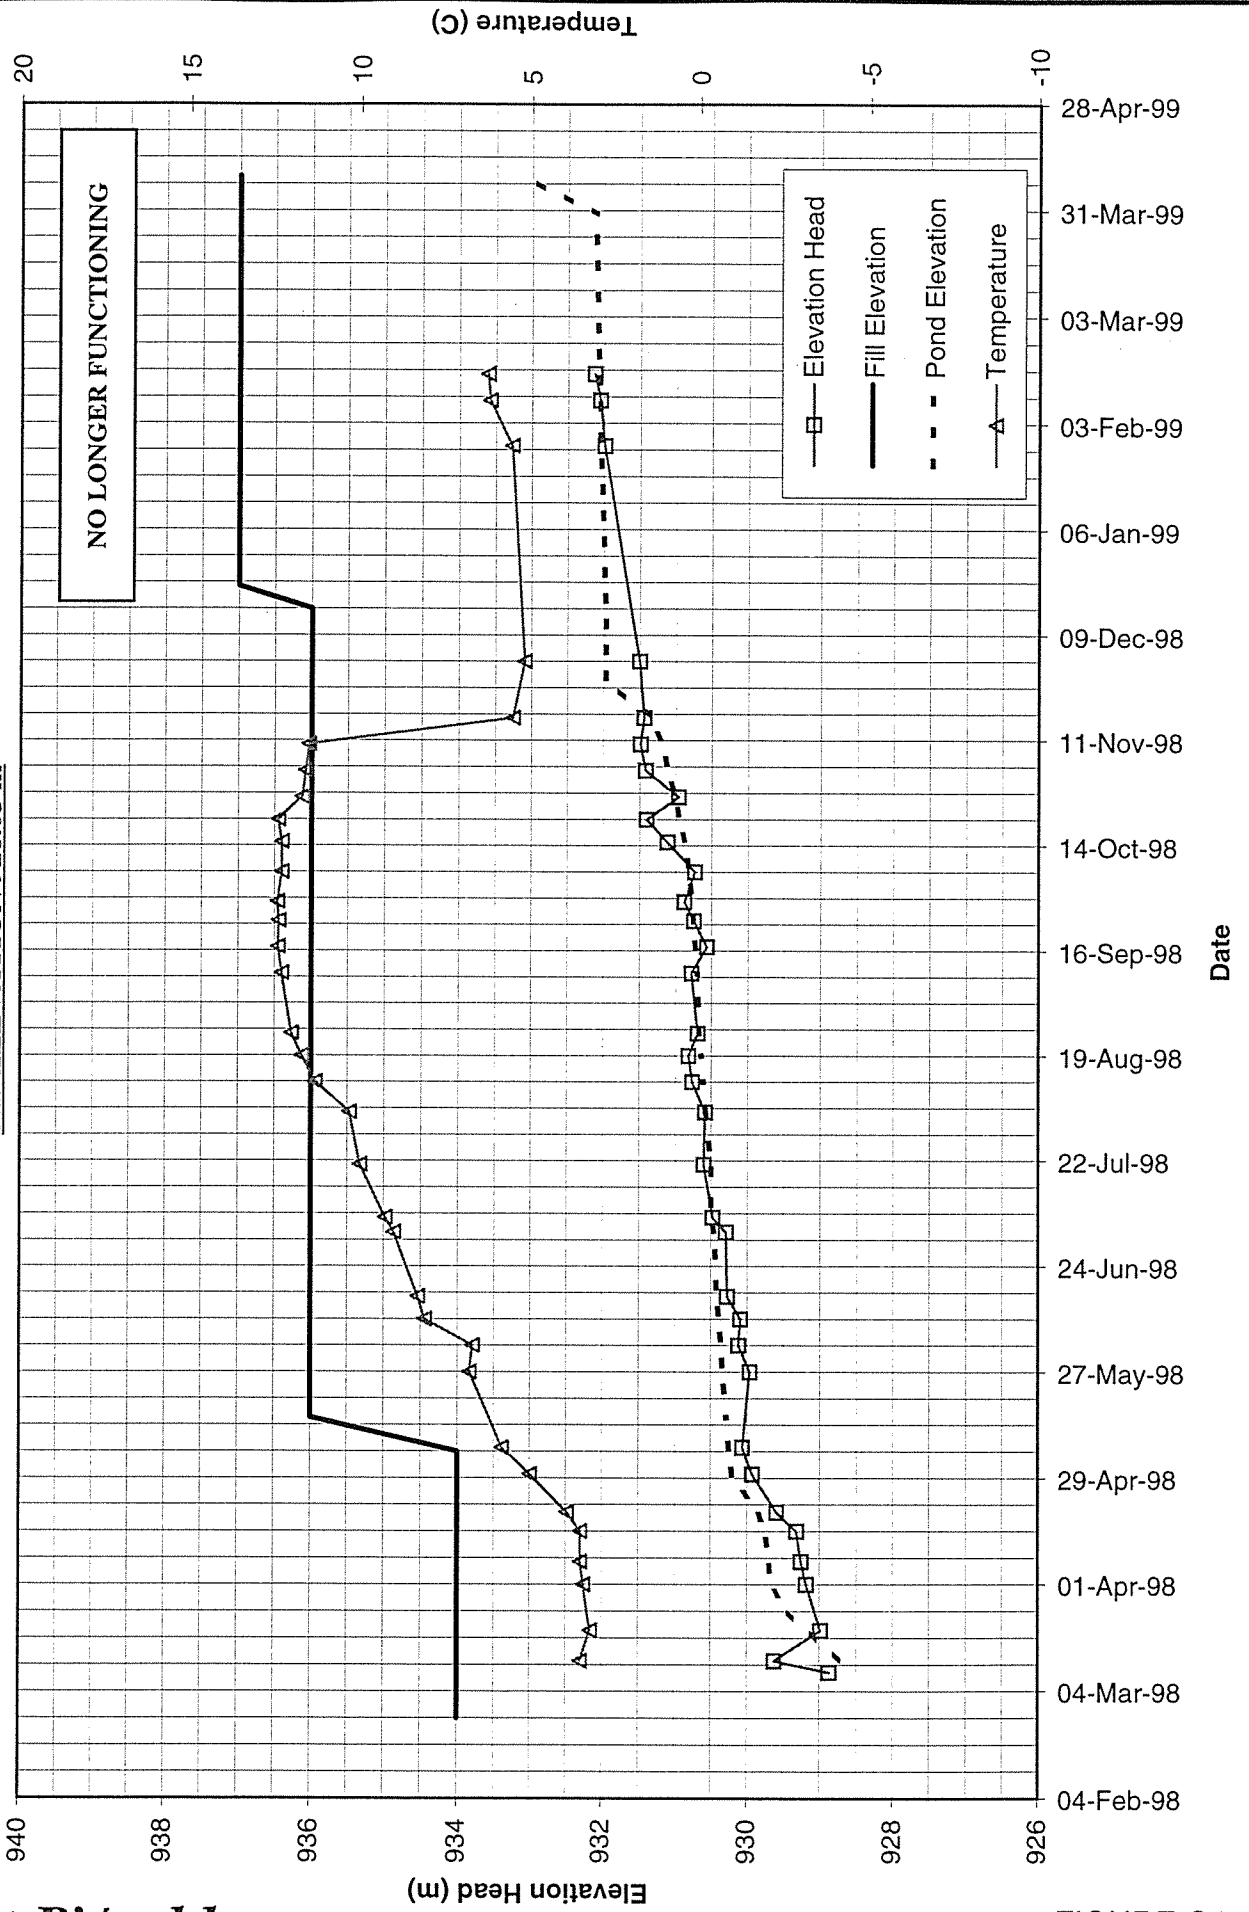
FIGURE G1-1

MOUNT POLLEY MINING CORPORATION
MOUNT POLLEY MINE
PIEZOMETER A0-PE2-01
TAILINGS PIEZOMETER
TIP ELEVATION 928.03 m

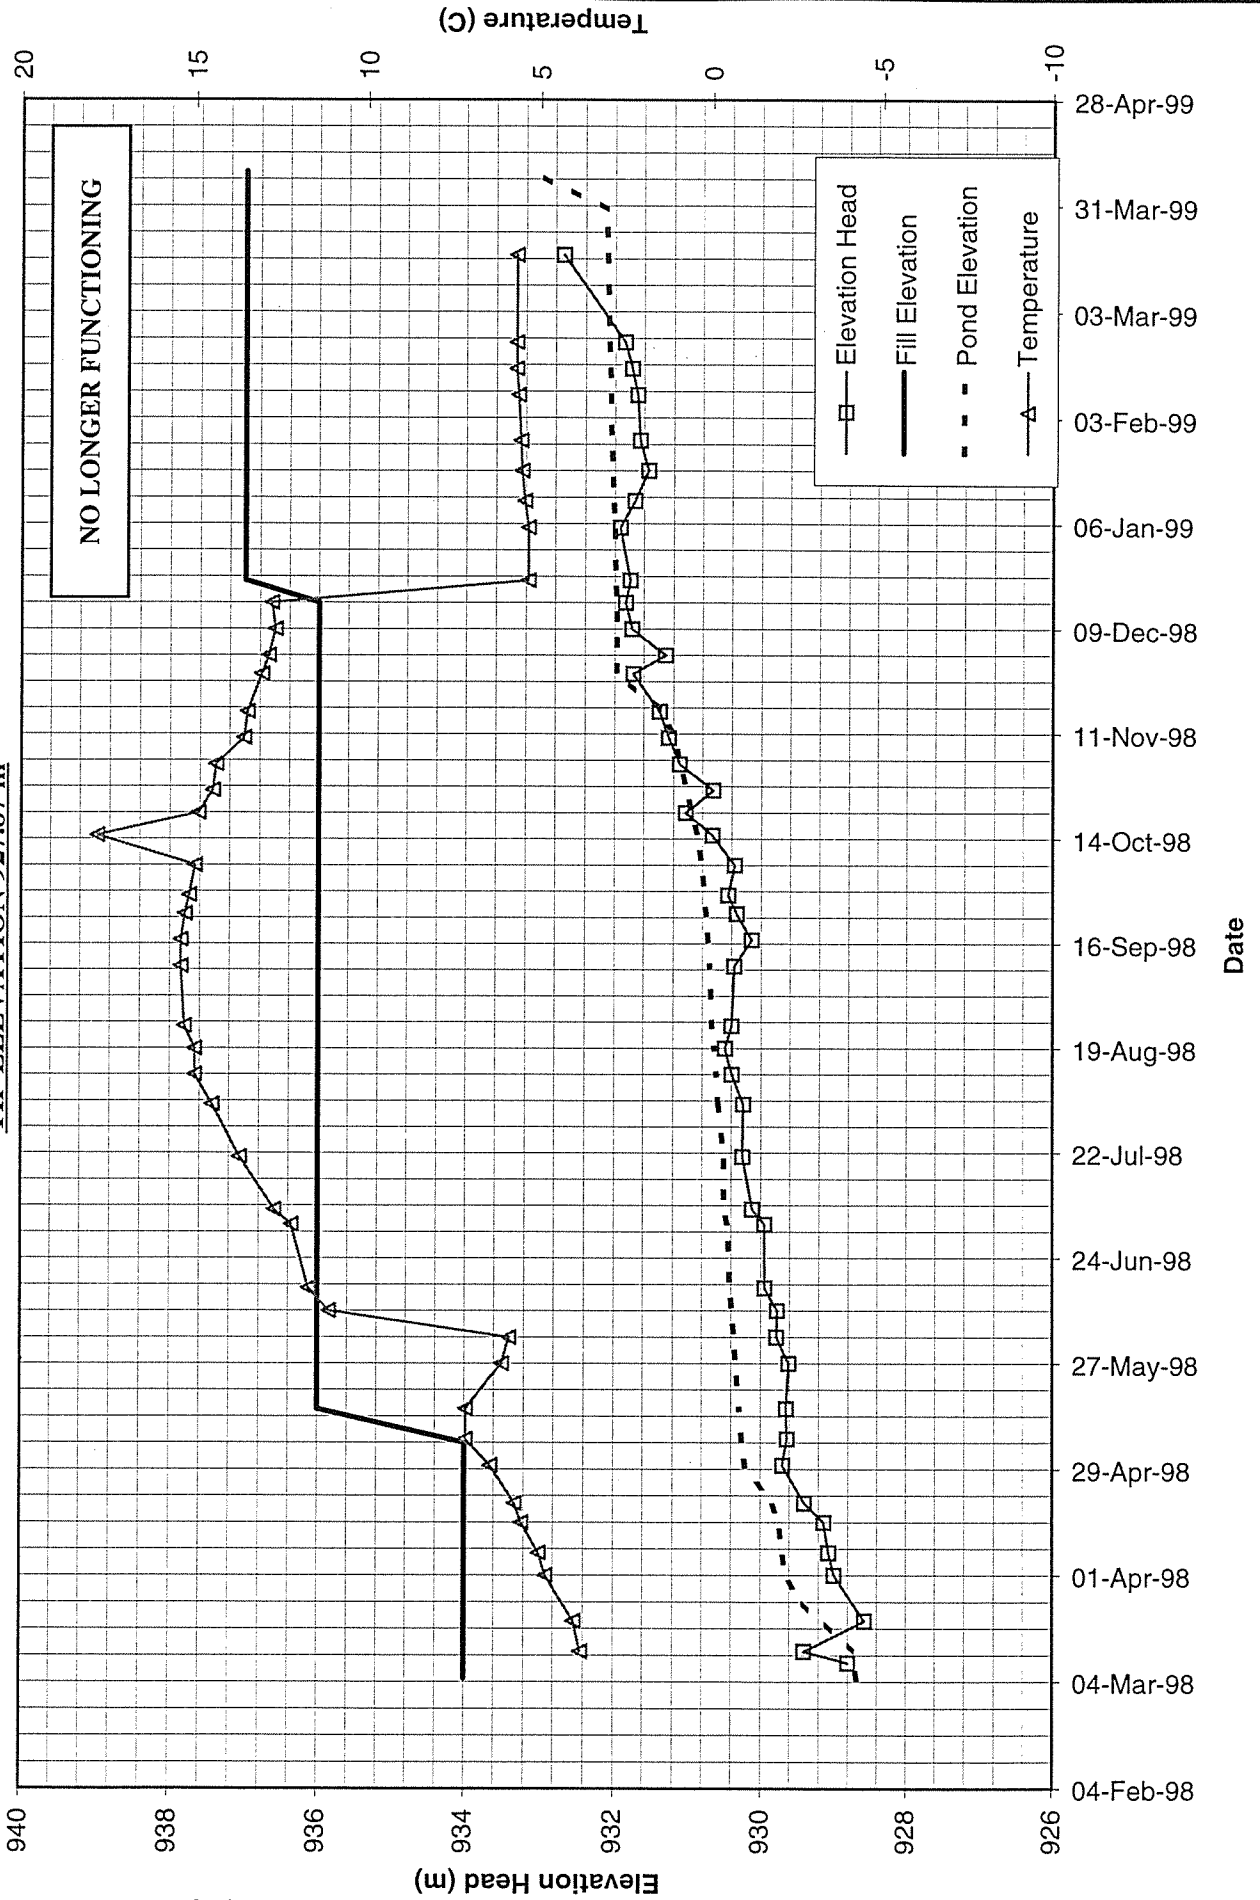
FIGURE G1-2

MOUNT POLLEY MINING CORPORATION
MOUNT POLLEY MINE
PIEZOMETER A0-PE2-02
TAILINGS PIEZOMETER
TIP ELEVATION 927.87 m
