**MOUNT POLLEY MINING CORPORATION
MOUNT POLLEY MINE
TAILINGS STORAGE FACILITY**

**REPORT ON
1998 CONSTRUCTION AND ANNUAL INSPECTION
(REF. NO. 11162/10-1)**

Knight Piesold Ltd.
CONSULTING ENGINEERS

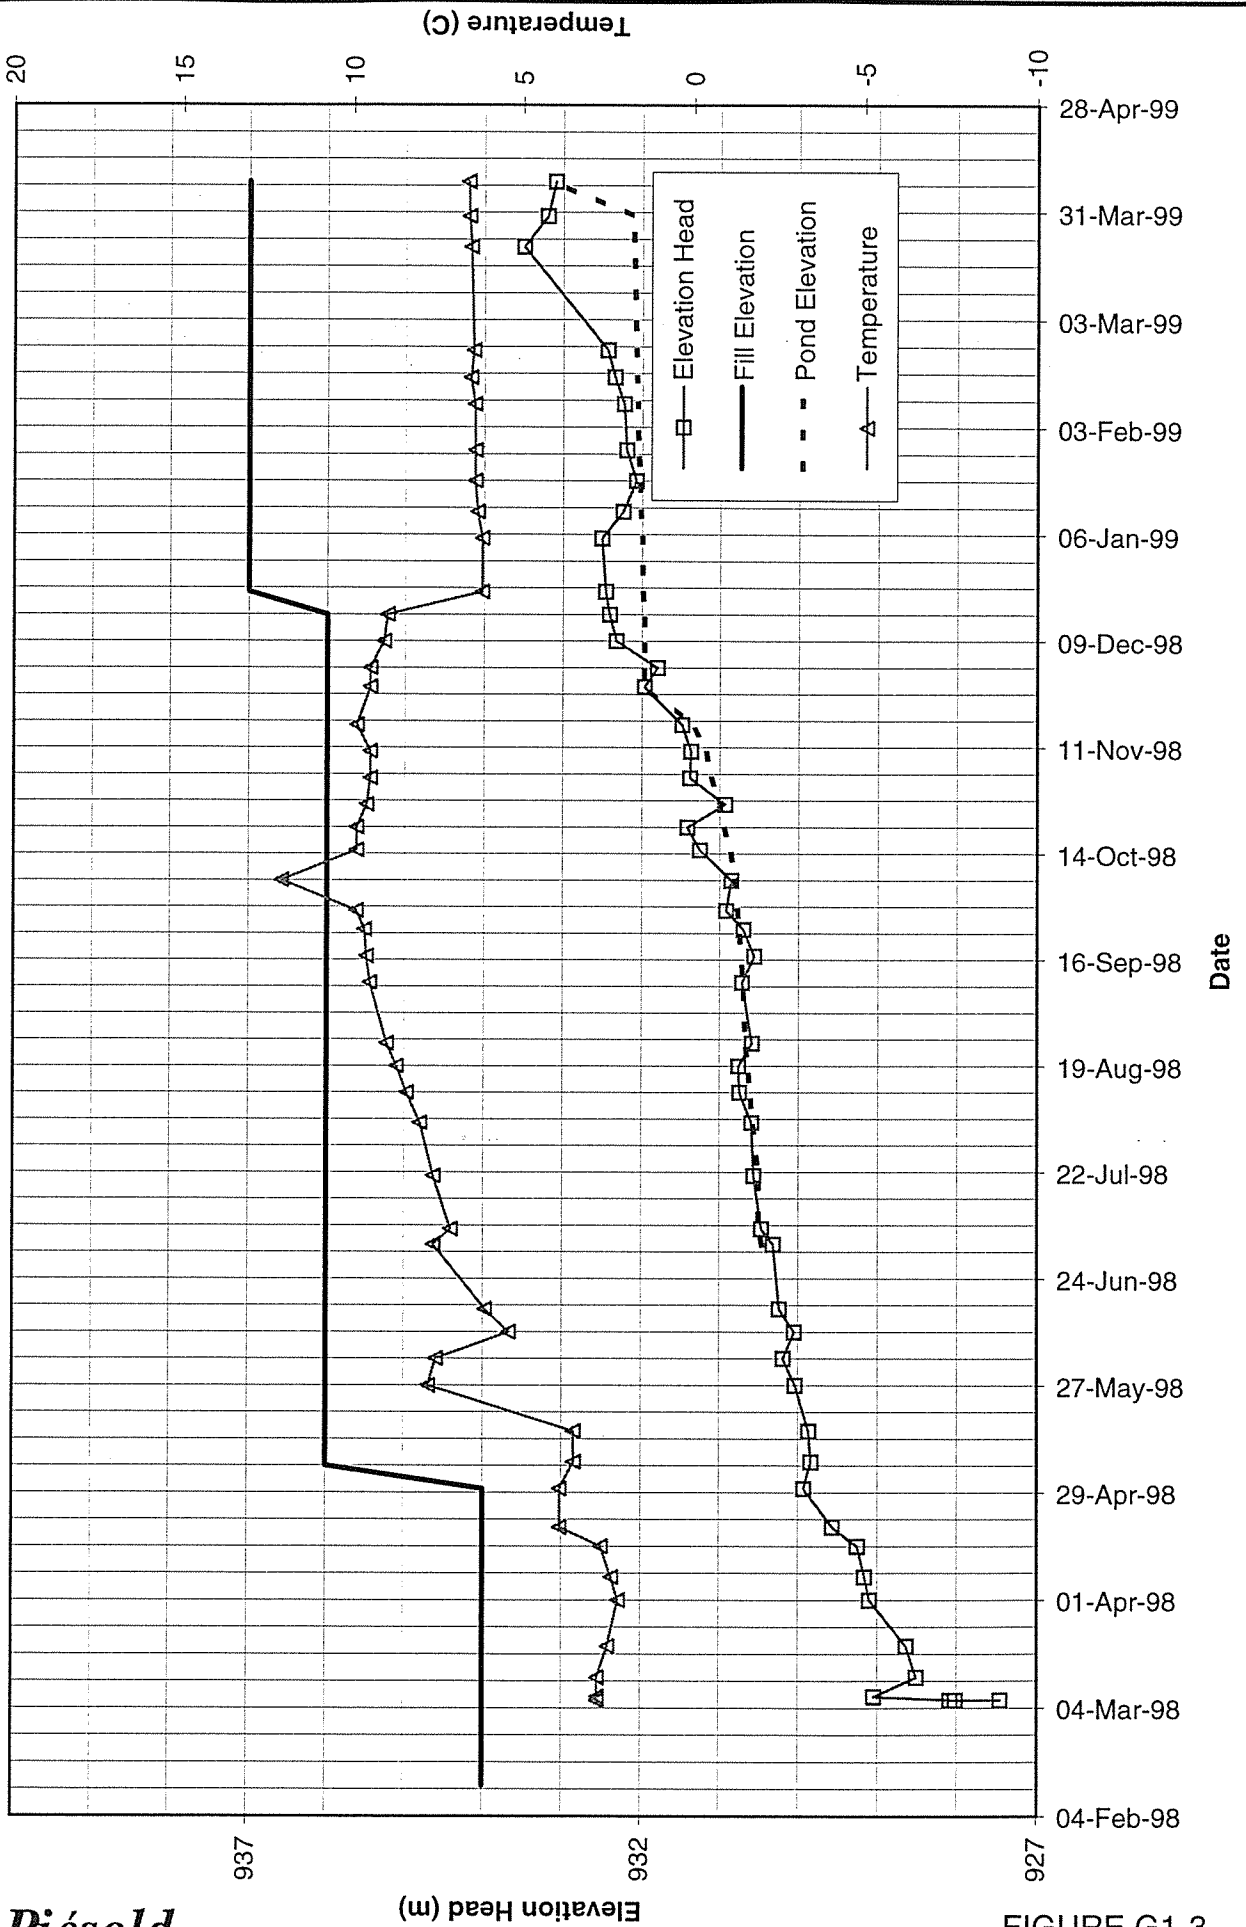
MOUNT POLLEY MINING CORPORATION
MOUNT POLLEY MINE
PIEZOMETER B0-PE2-01
TAILINGS PIEZOMETER
TIP ELEVATION 927.30 m

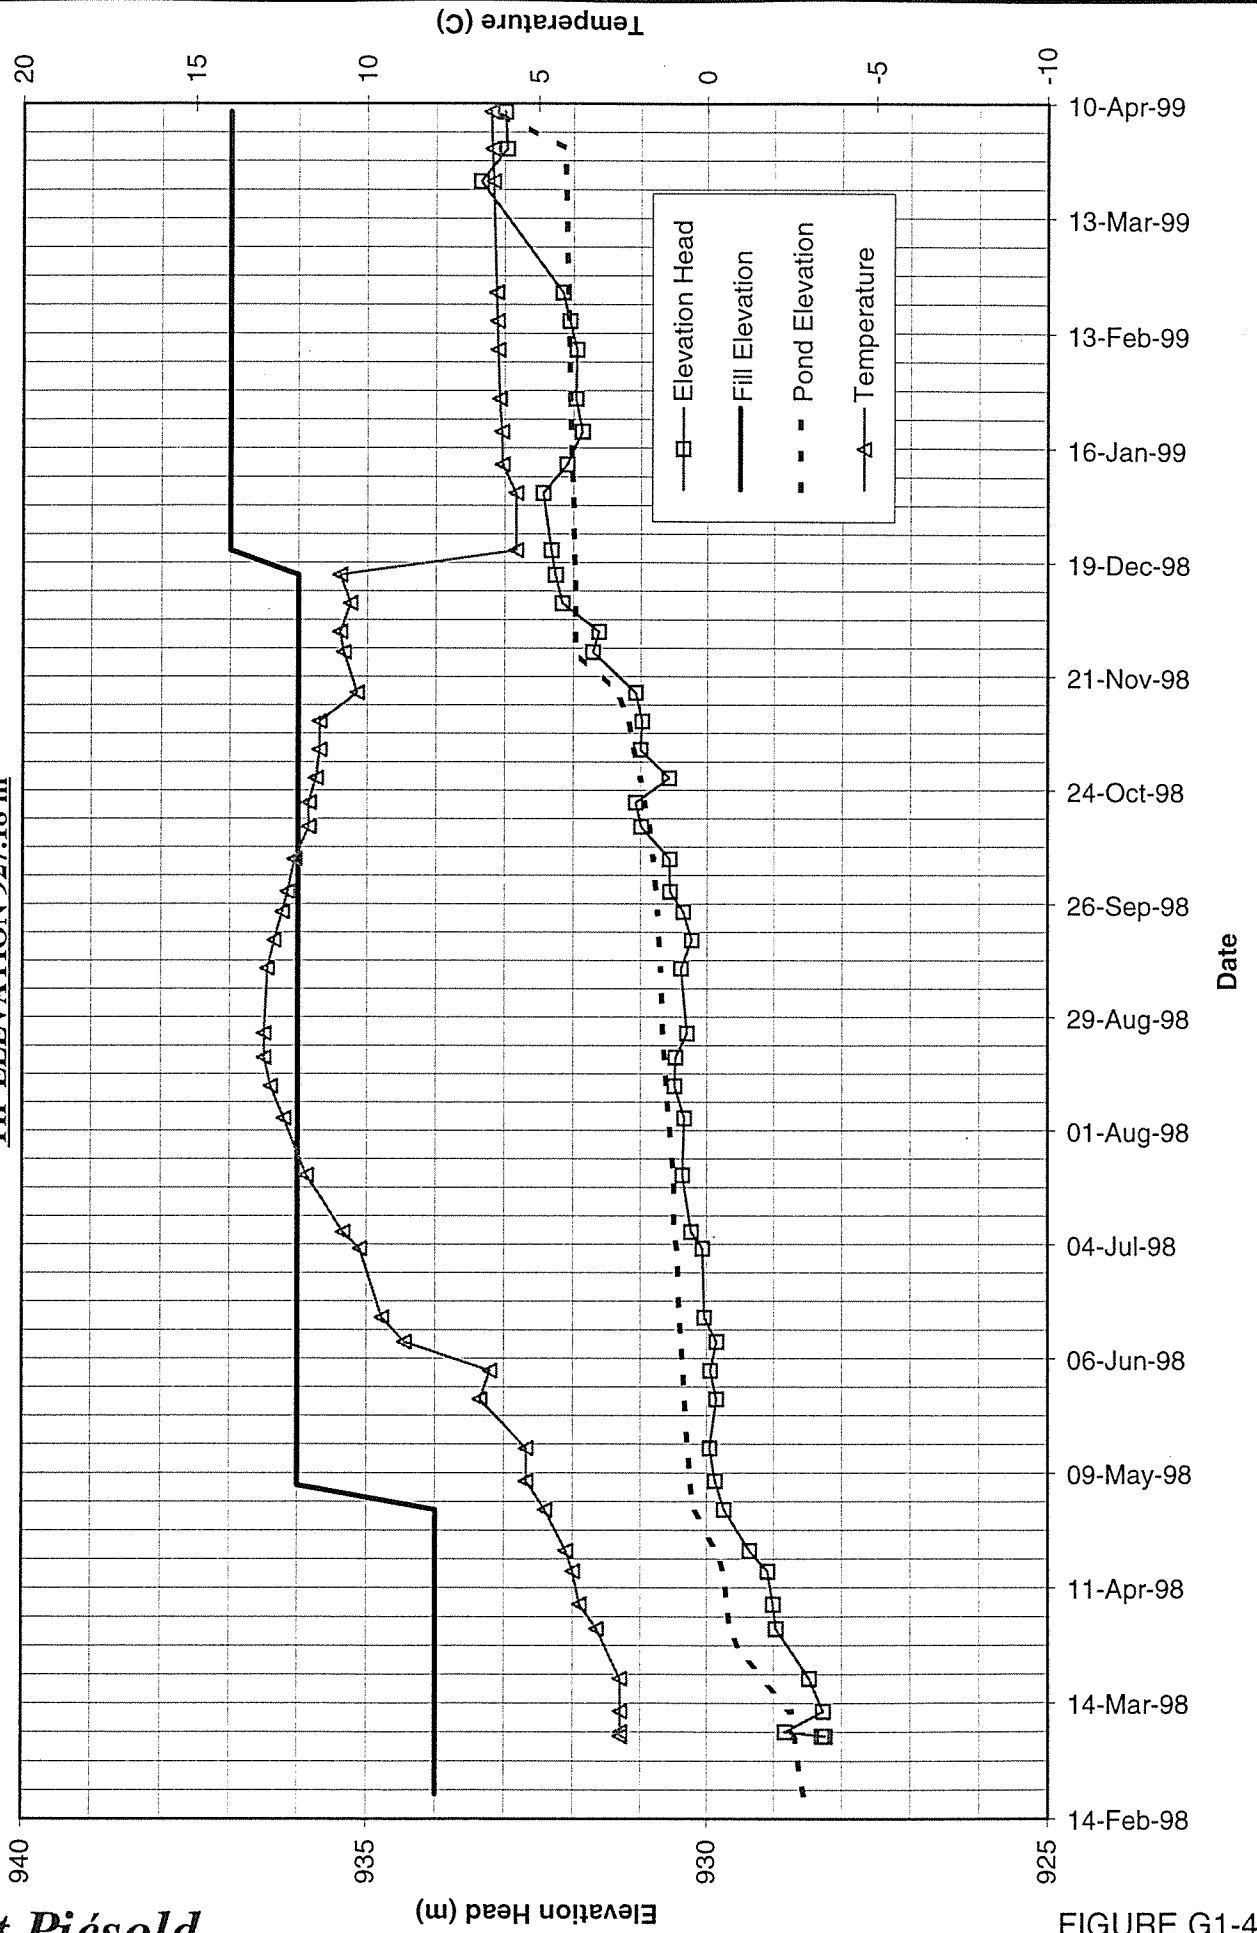
MOUNT POLLEY MINING CORPORATION
MOUNT POLLEY MINE
PIEZOMETER B0-PE2-02
TAILINGS PIEZOMETER
TIP ELEVATION 927.18 m

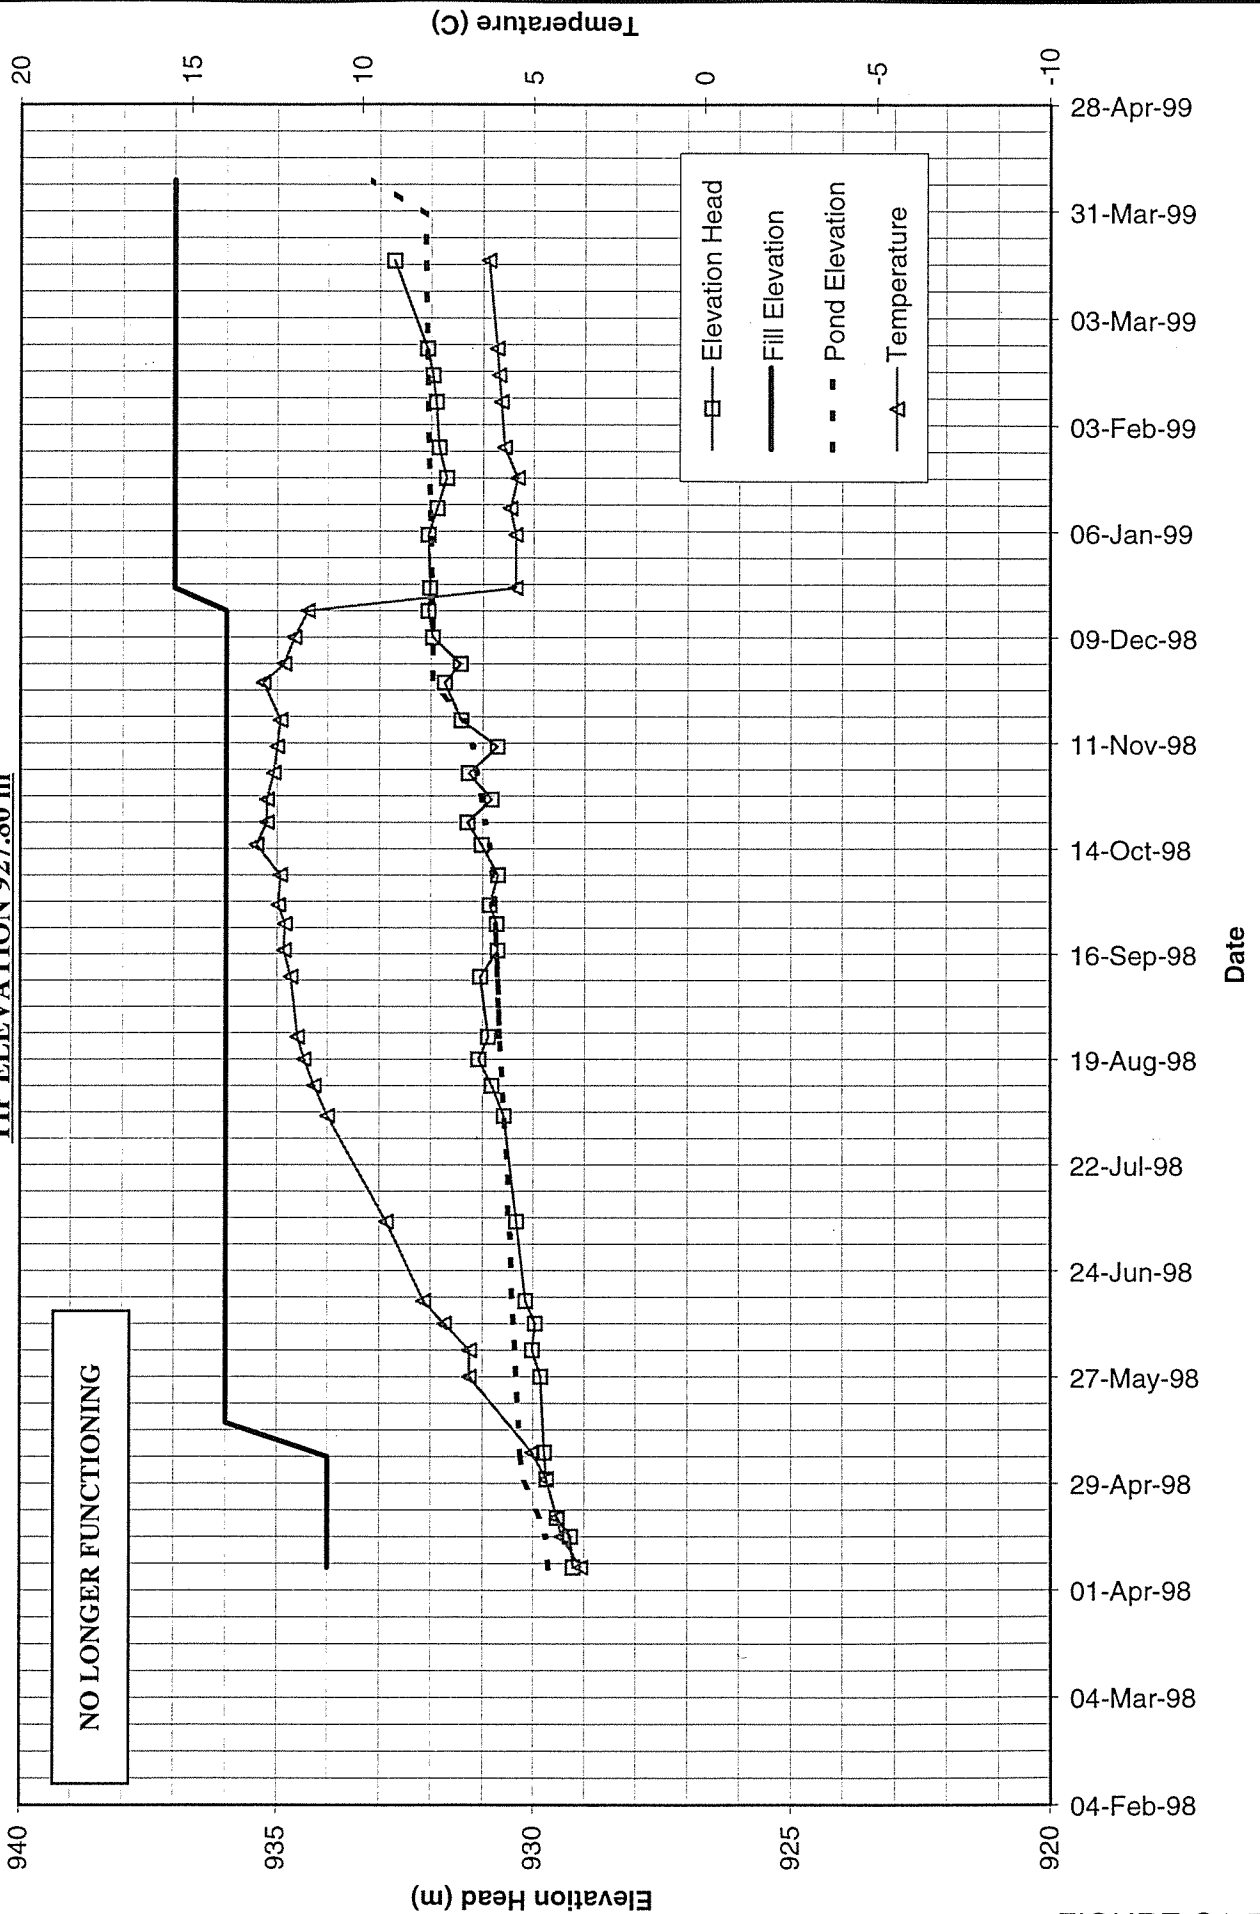
FIGURE G1-5

MOUNT POLLEY MINING CORPORATION
MOUNT POLLEY MINE
PIEZOMETER C0-PE2-01
TAILINGS PIEZOMETER
TIP ELEVATION 927.80 m

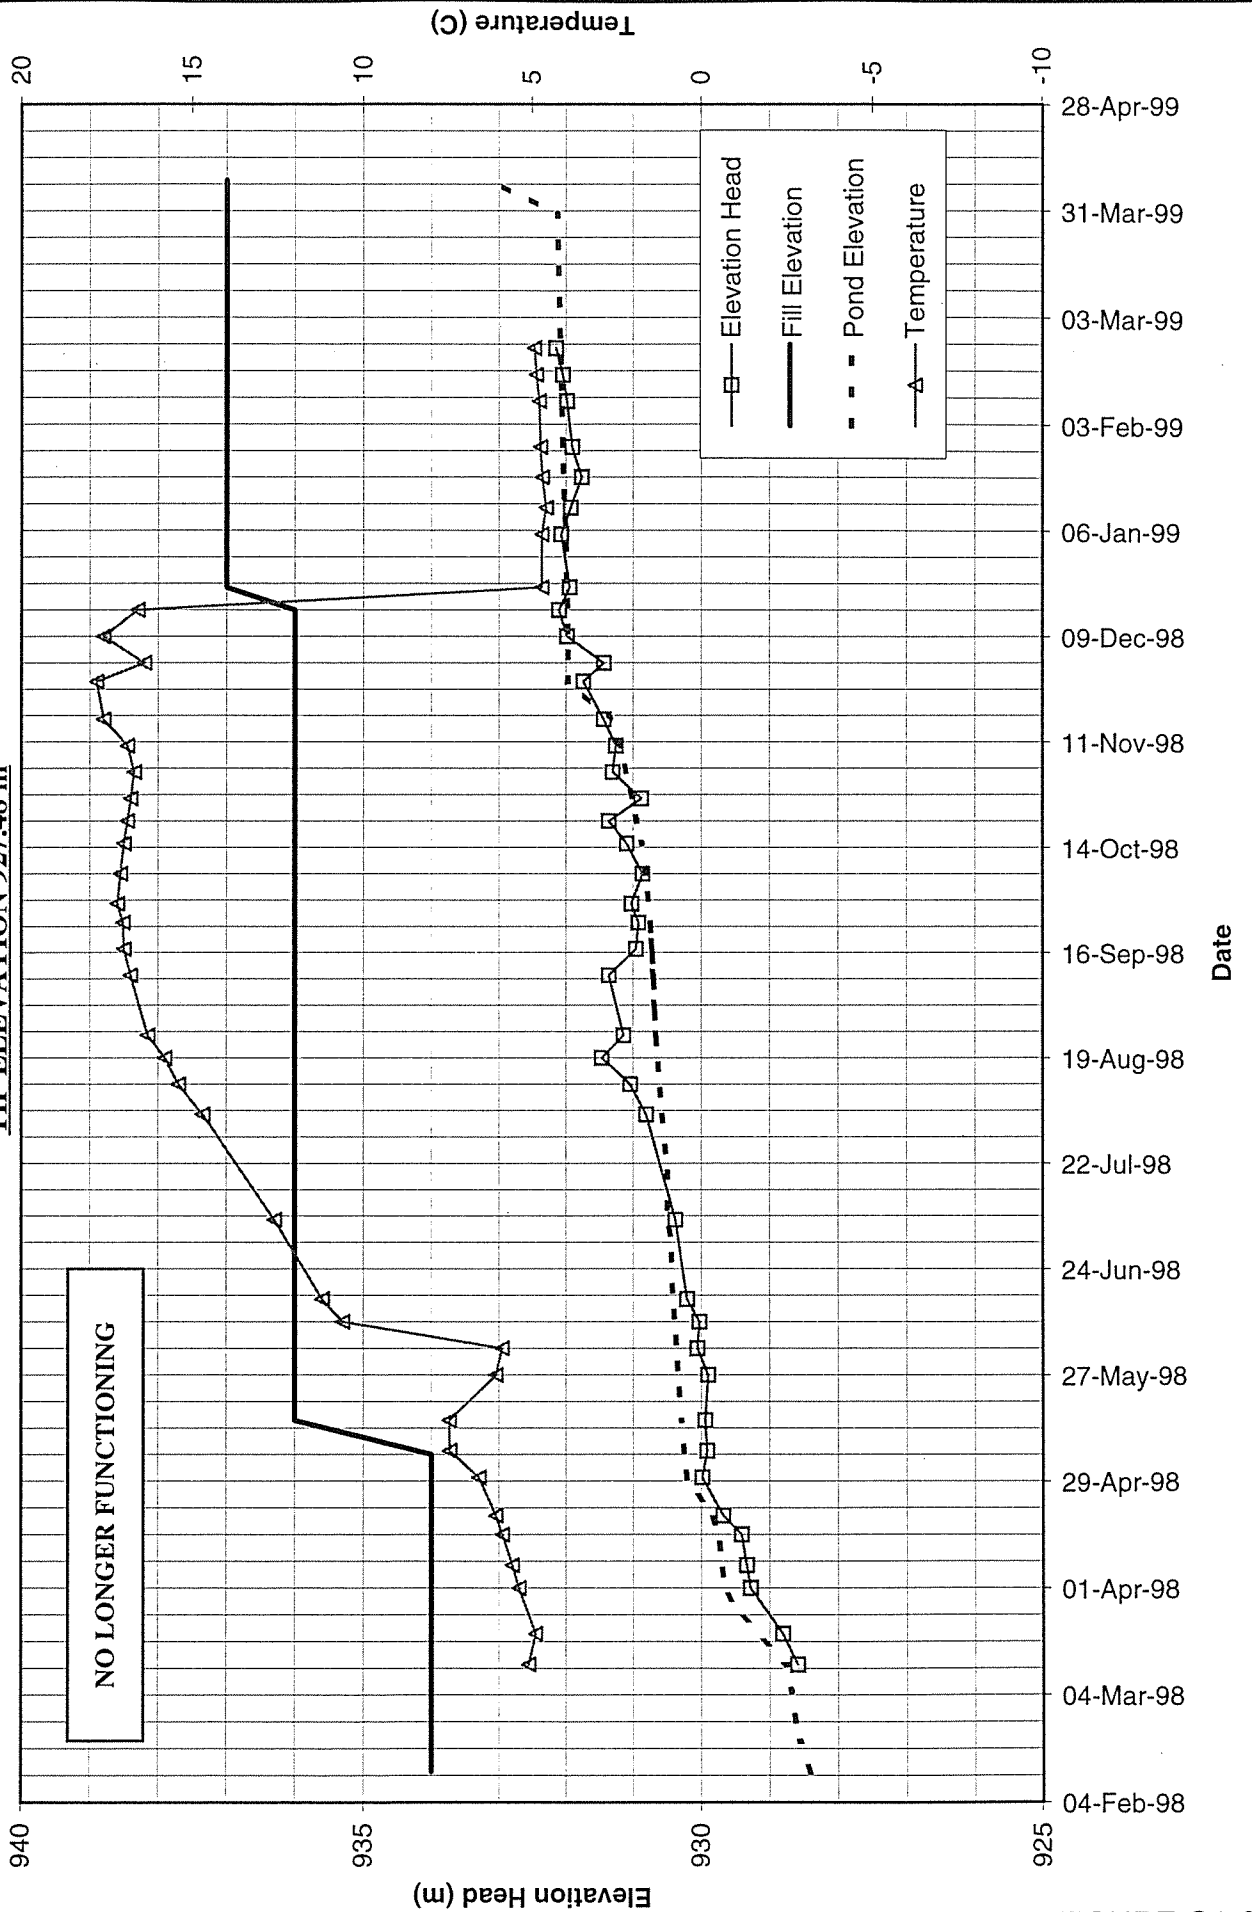
MOUNT POLLEY MINING CORPORATION
MOUNT POLLEY MINE
PIEZOMETER C0-PE2-02
TAILINGS PIEZOMETER
TIP ELEVATION 927.48 m

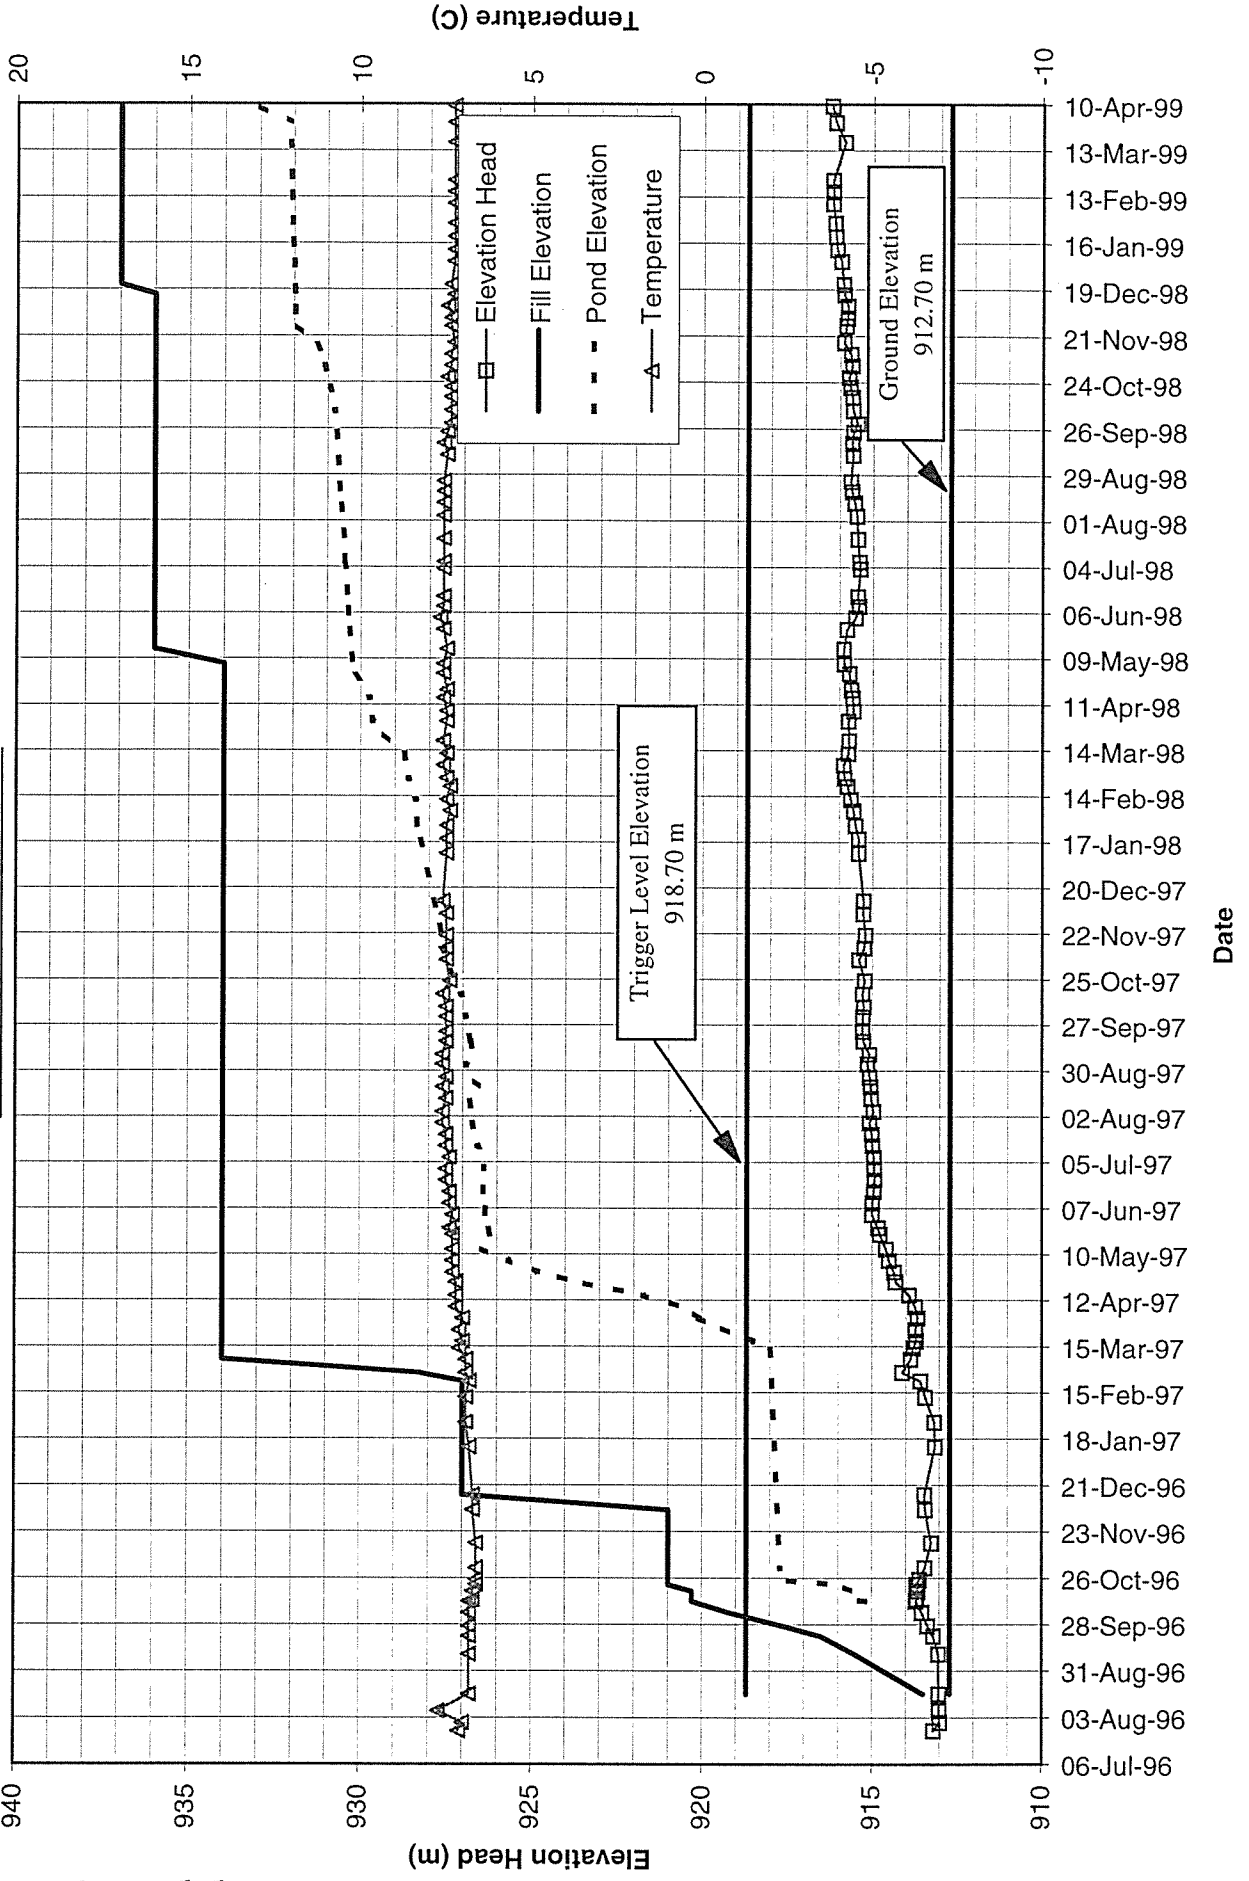
MOUNT POLLEY MINING CORPORATION
MOUNT POLLEY MINE
PIEZOMETER A2-PE2-01
EMBANKMENT FOUNDATION PIEZOMETER
TIP ELEVATION 903.68 m

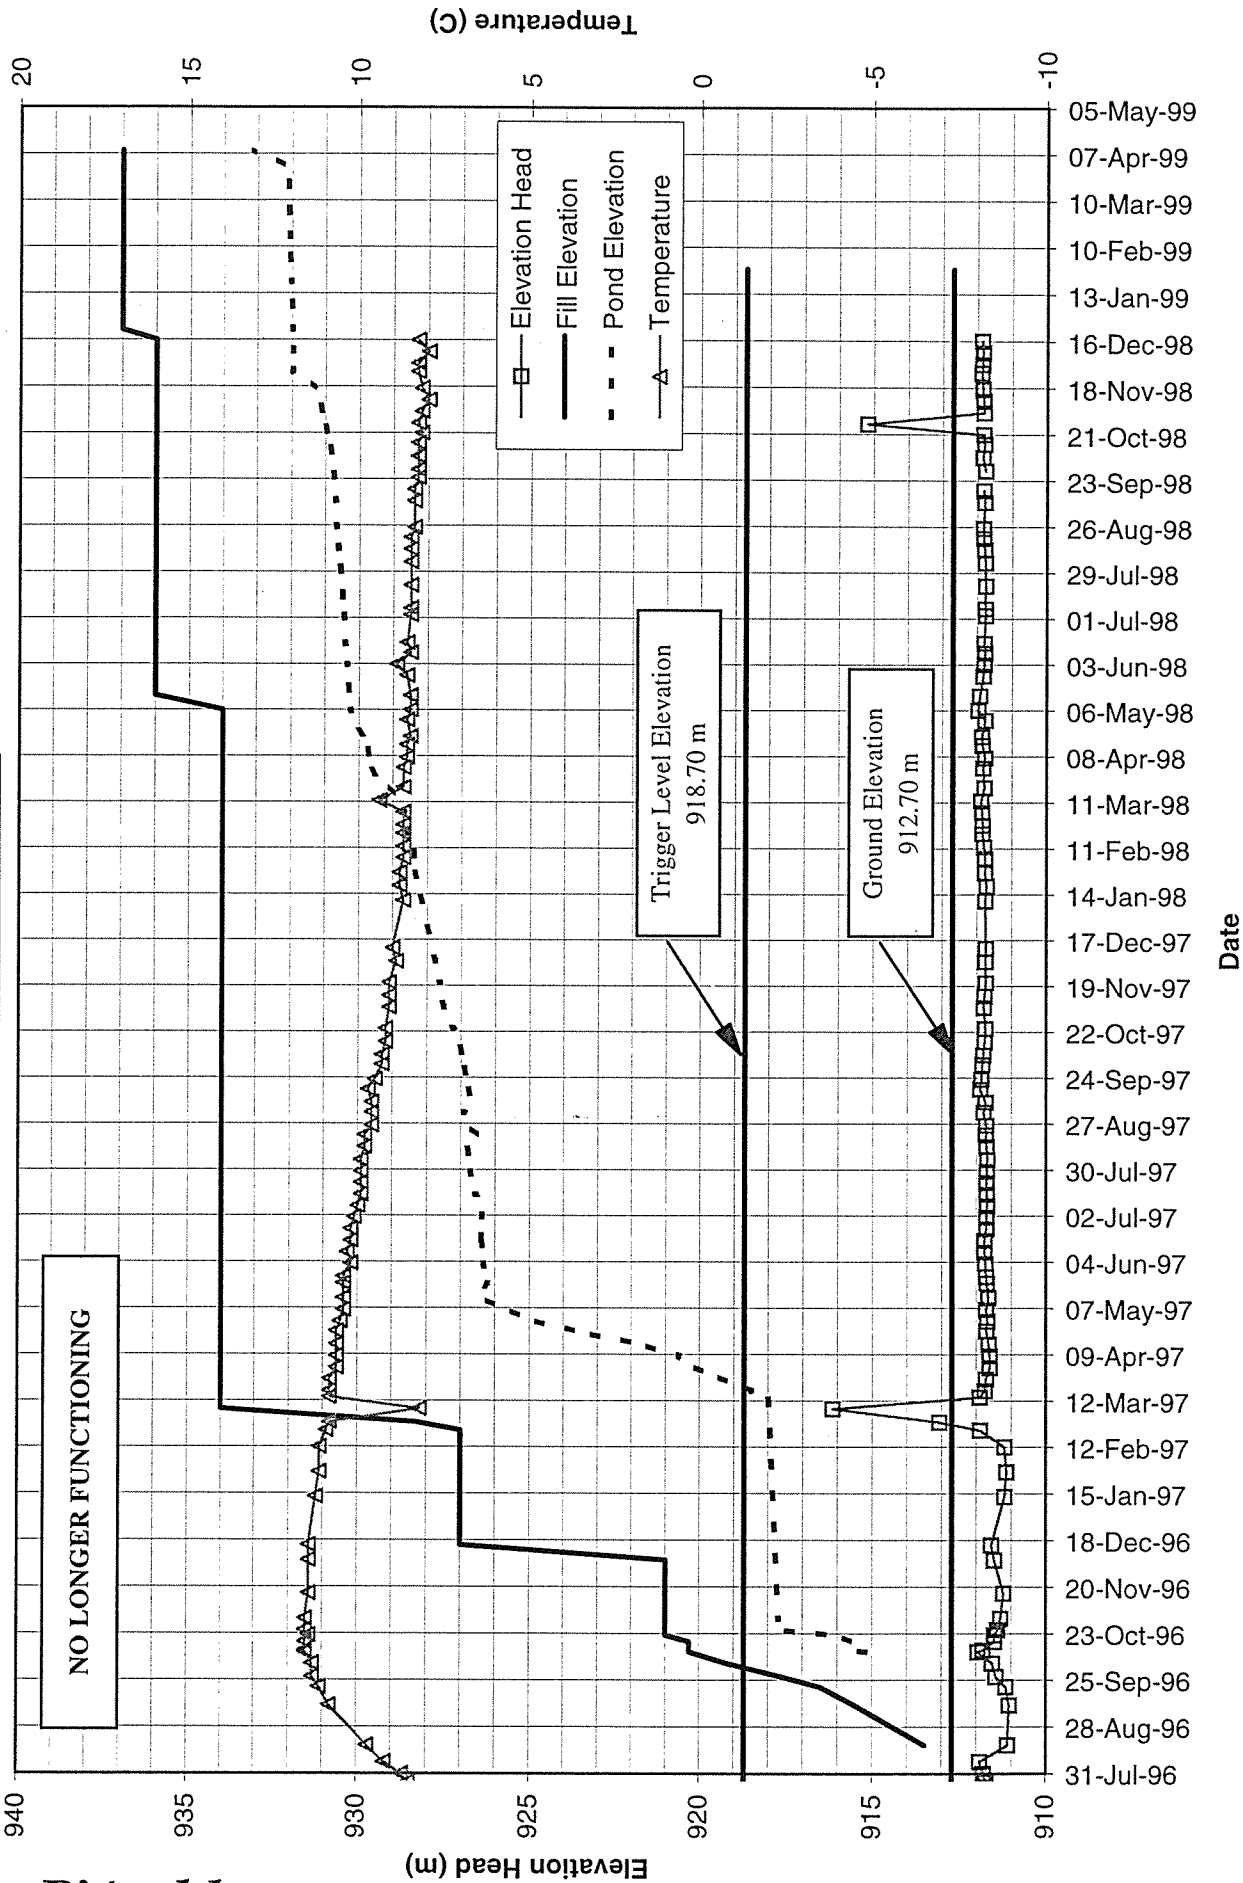
FIGURE G2-2

MOUNT POLLEY MINING CORPORATION
MOUNT POLLEY MINE
PIEZOMETER A2-PE2-02
EMBANKMENT FOUNDATION PIEZOMETER
TIP ELEVATION 909.77 m

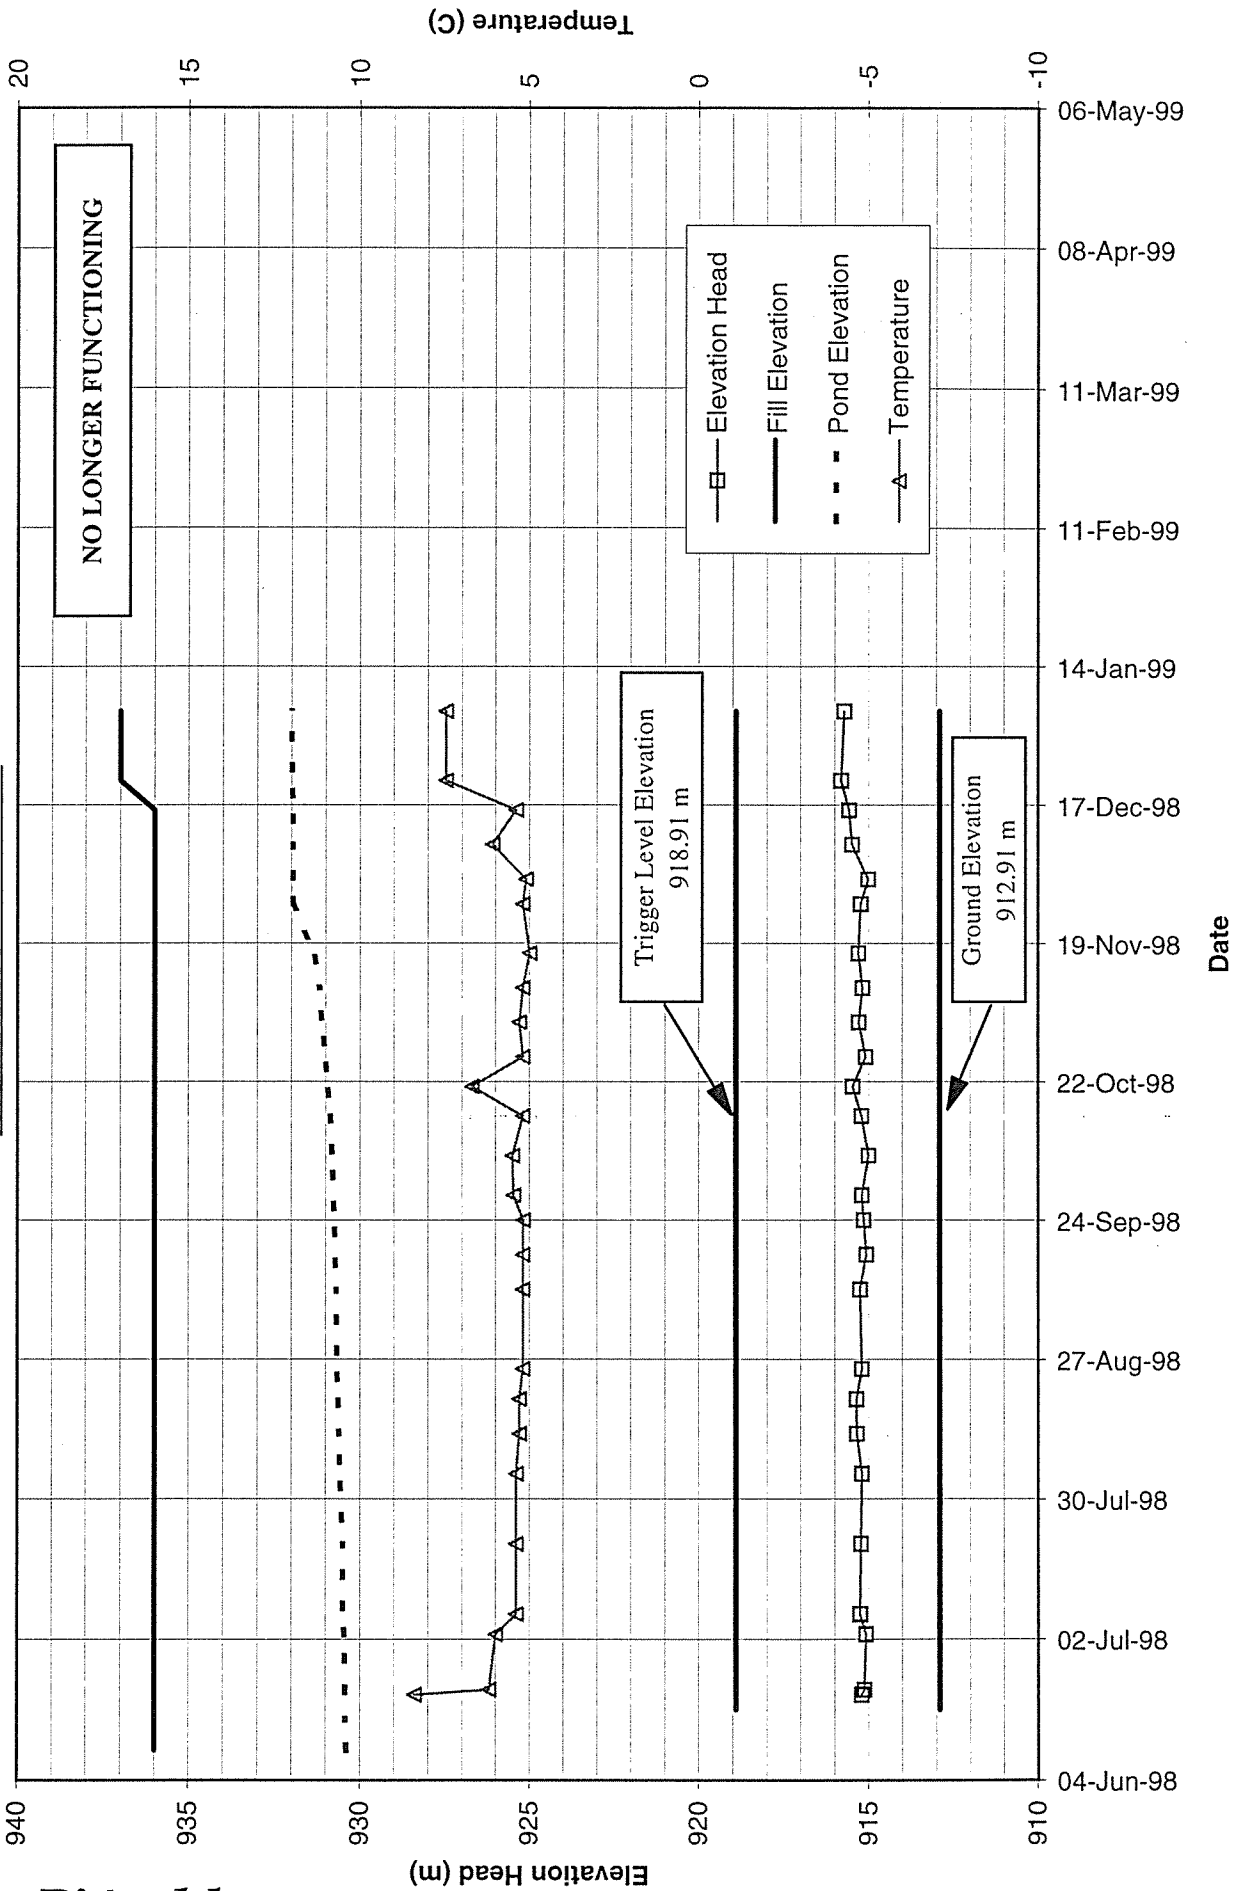
MOUNT POLLEY MINING CORPORATION
MOUNT POLLEY MINE
PIEZOMETER A2-PE2-06
EMBANKMENT FOUNDATION PIEZOMETER
TIP ELEVATION 898.01 m

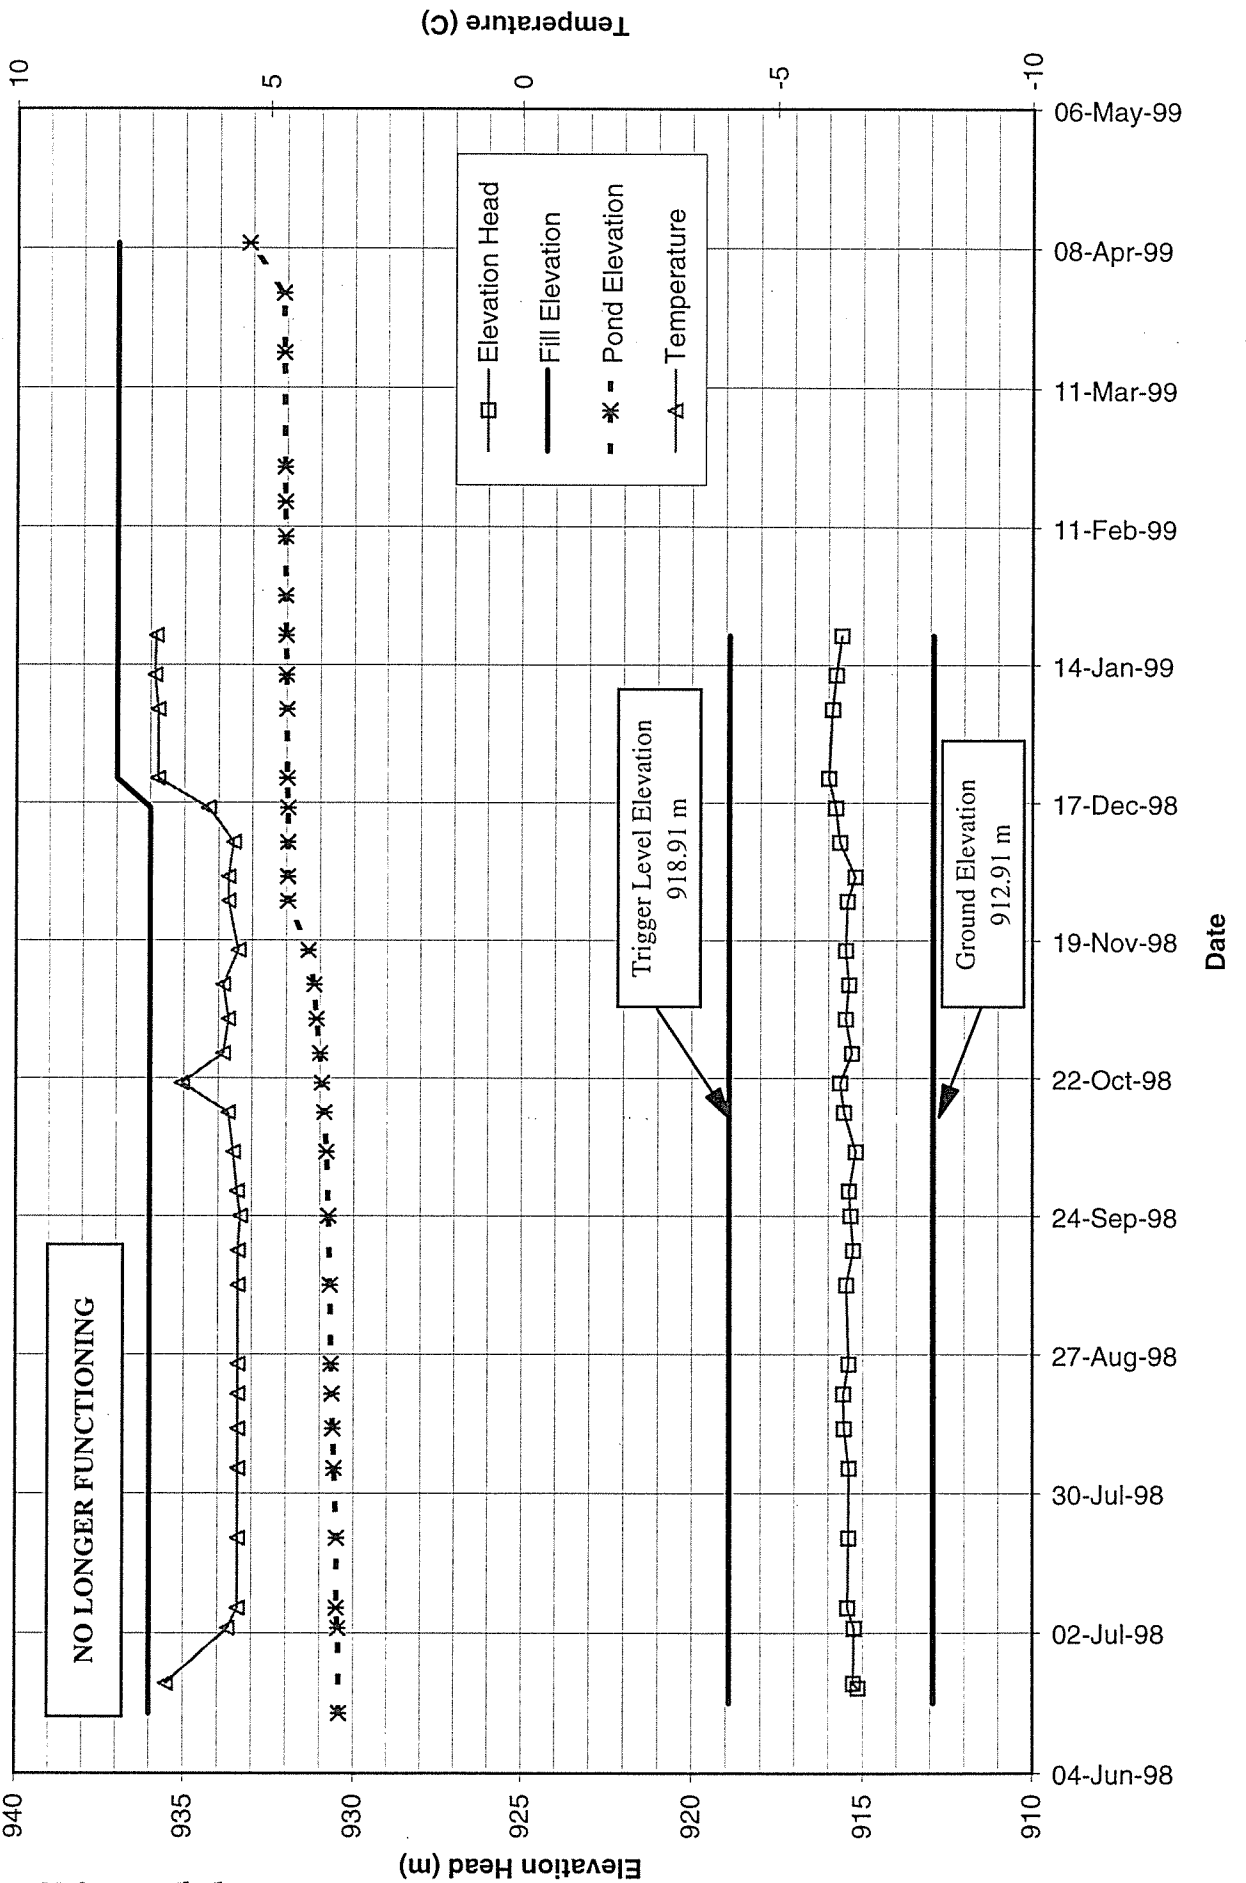
MOUNT POLLEY MINING CORPORATION
MOUNT POLLEY MINE
PIEZOMETER A2-PE2-07
EMBANKMENT FOUNDATION PIEZOMETER
TIP ELEVATION 902.81 m

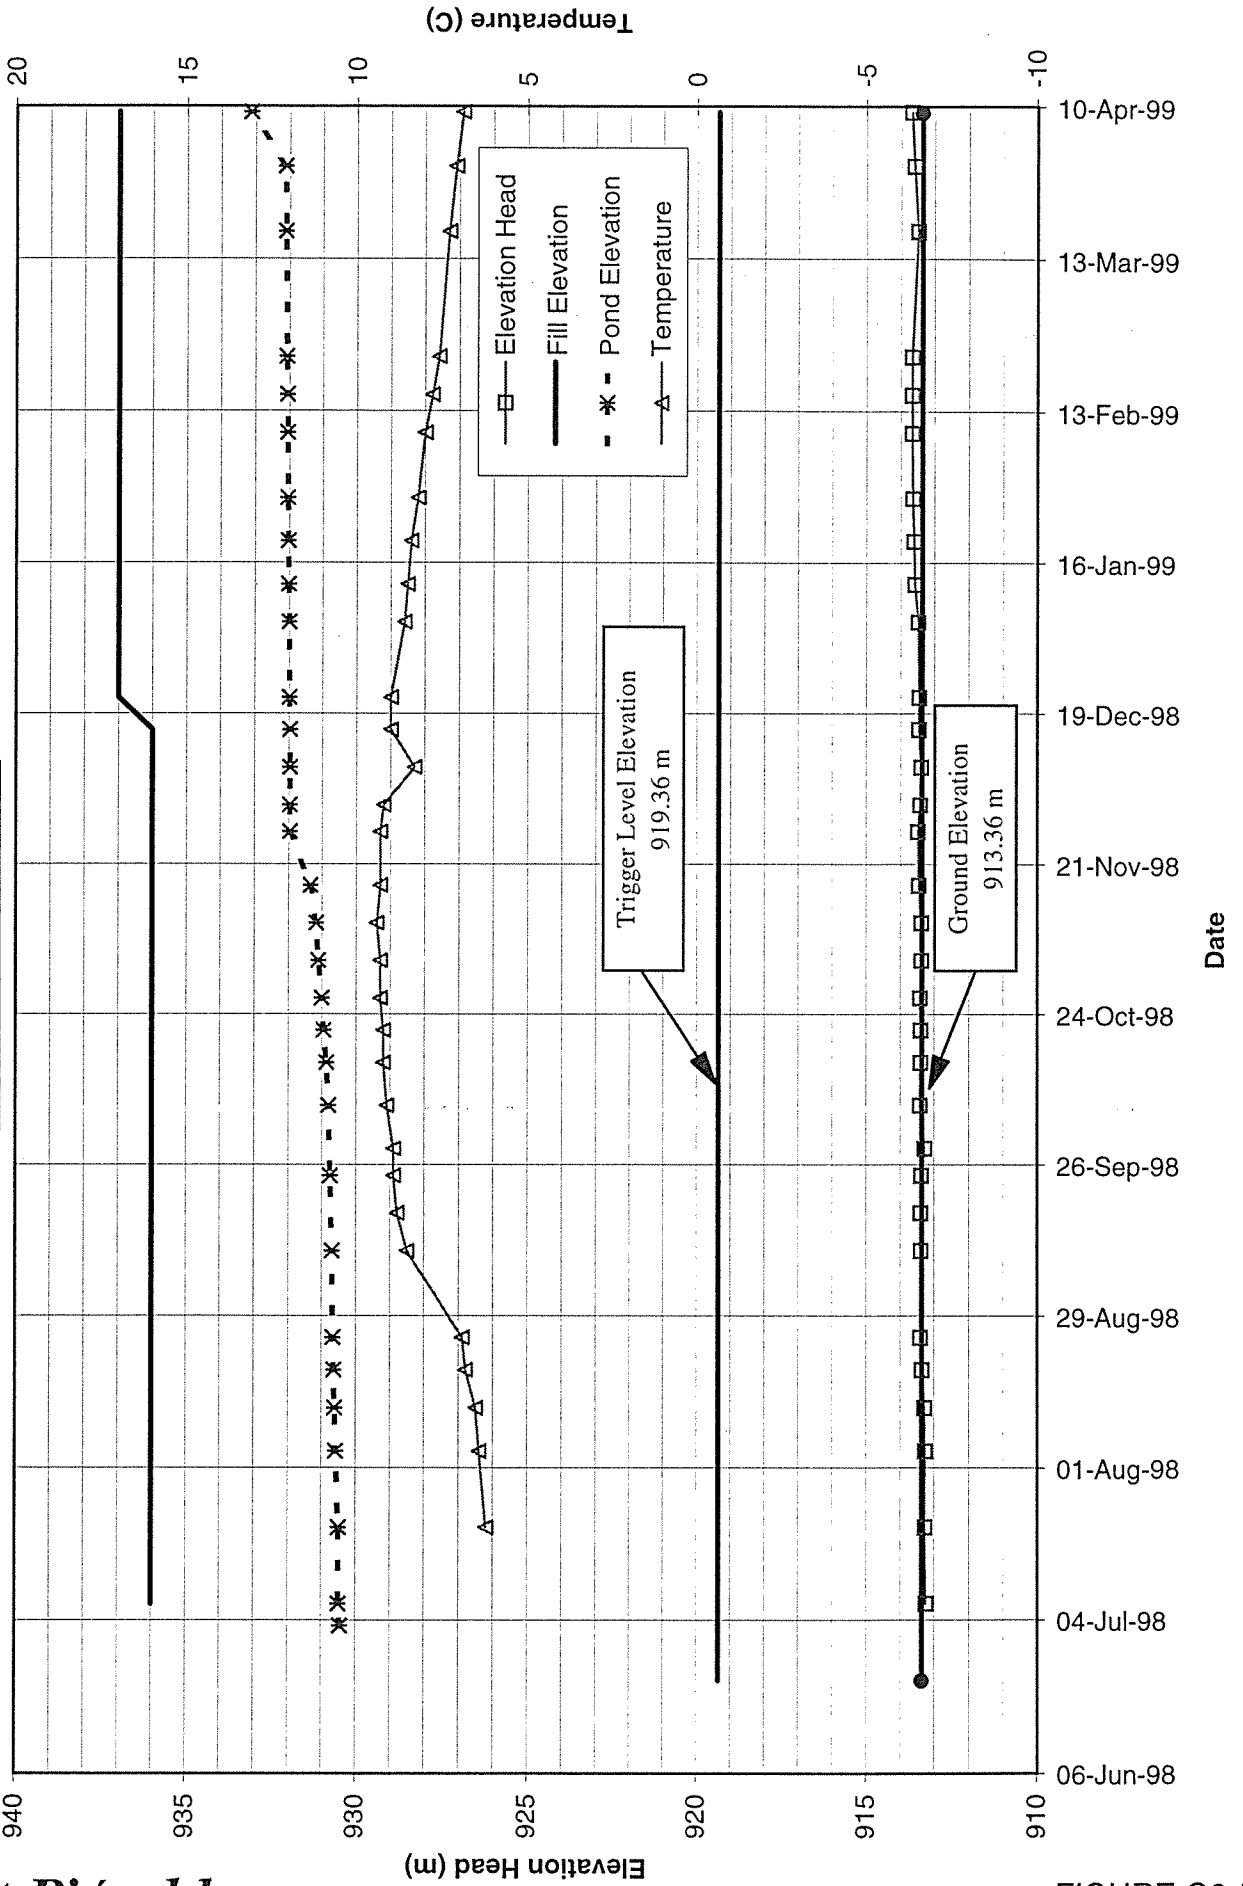
MOUNT POLLEY MINING CORPORATION
MOUNT POLLEY MINE
PIEZOMETER A2-PE2-08
EMBANKMENT FOUNDATION PIEZOMETER
TIP ELEVATION 907.56 m
