**MOUNT POLLEY MINING CORPORATION
MOUNT POLLEY MINE
TAILINGS STORAGE FACILITY**

**REPORT ON
1998 CONSTRUCTION AND ANNUAL INSPECTION
(REF. NO. 11162/10-1)**

Knight Piesold Ltd.
CONSULTING ENGINEERS

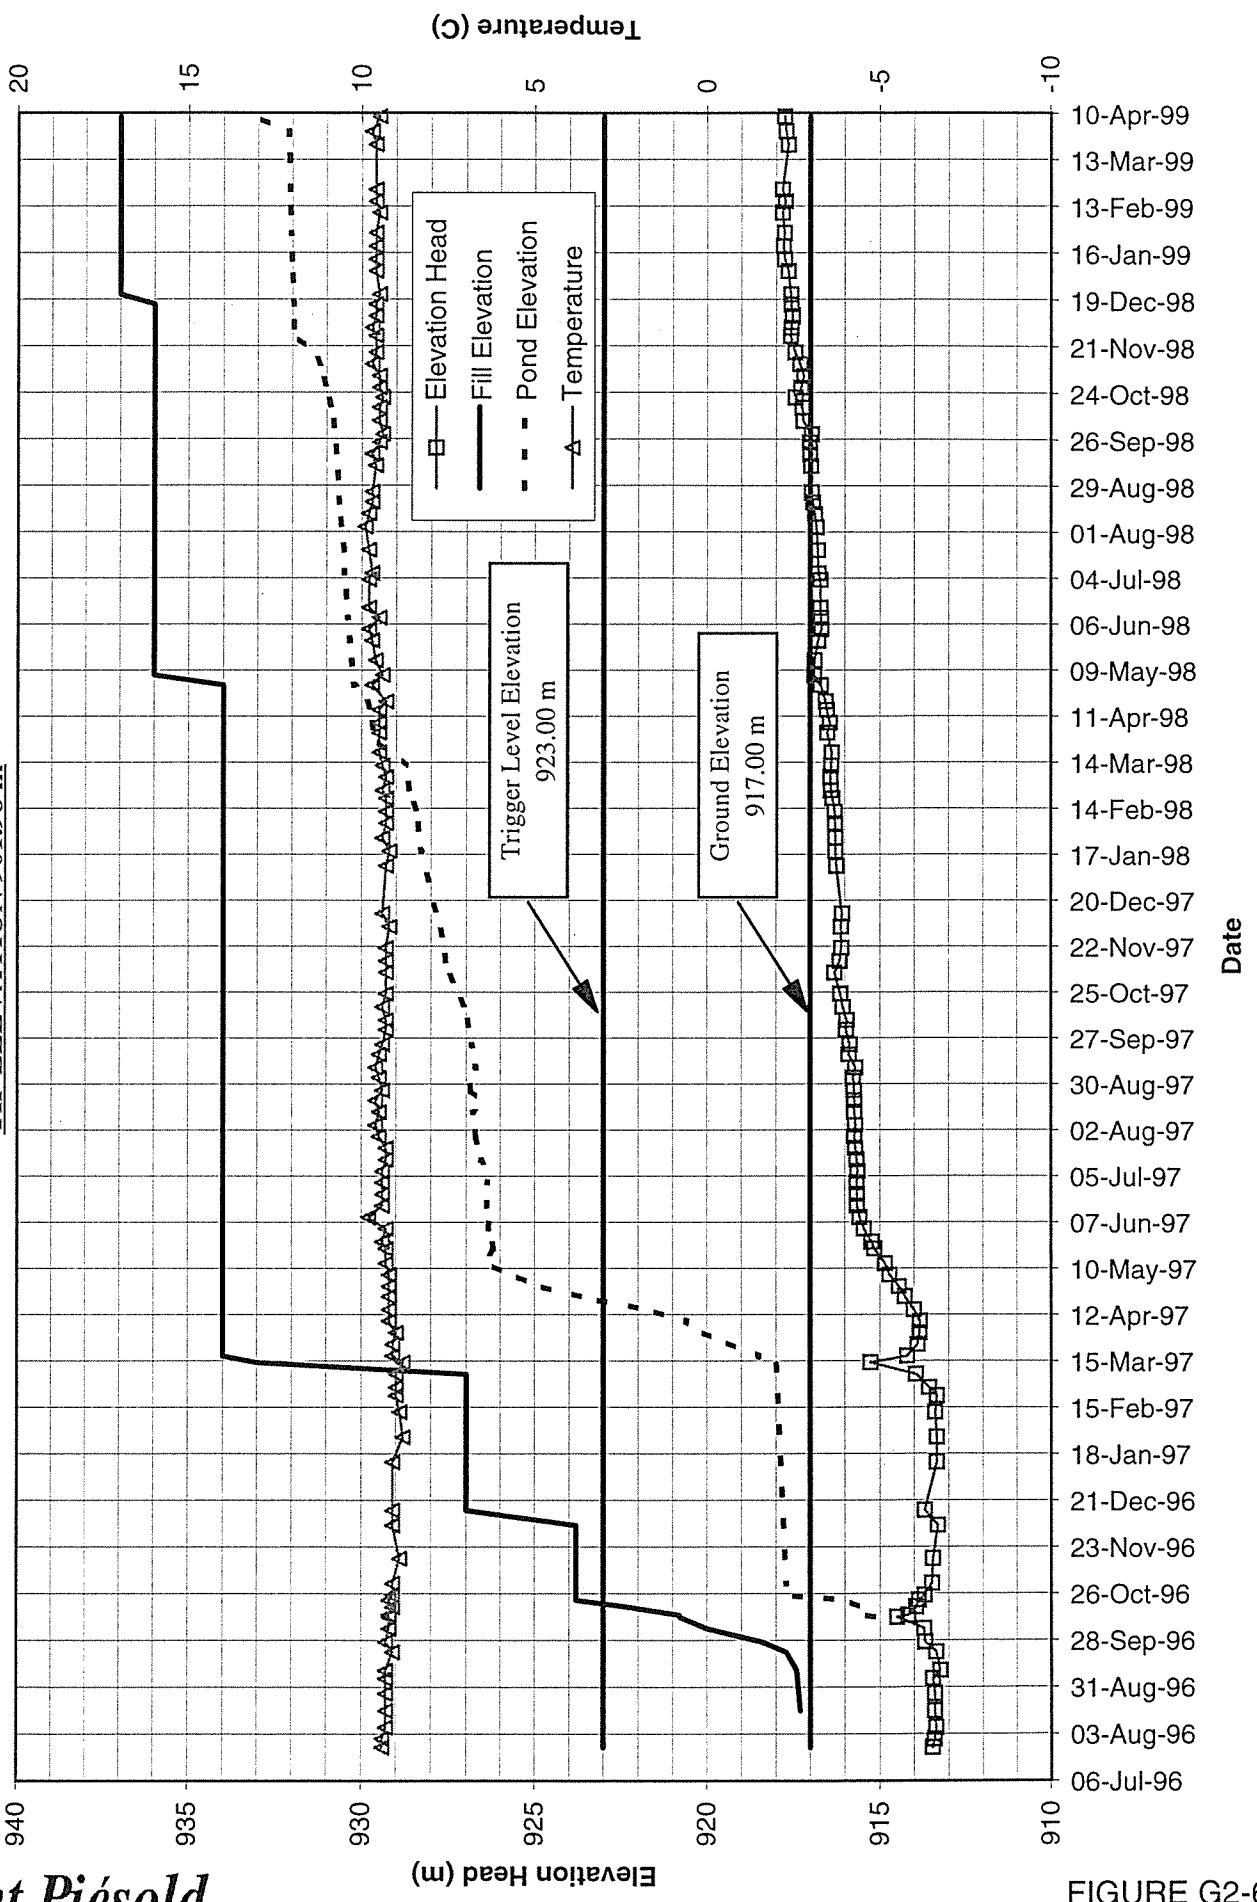
FIGURE G2-6

MOUNT POLLEY MINING CORPORATION
MOUNT POLLEY MINE
PIEZOMETER B2-PE2-01
EMBANKMENT FOUNDATION PIEZOMETER
TIP ELEVATION 901.98 m

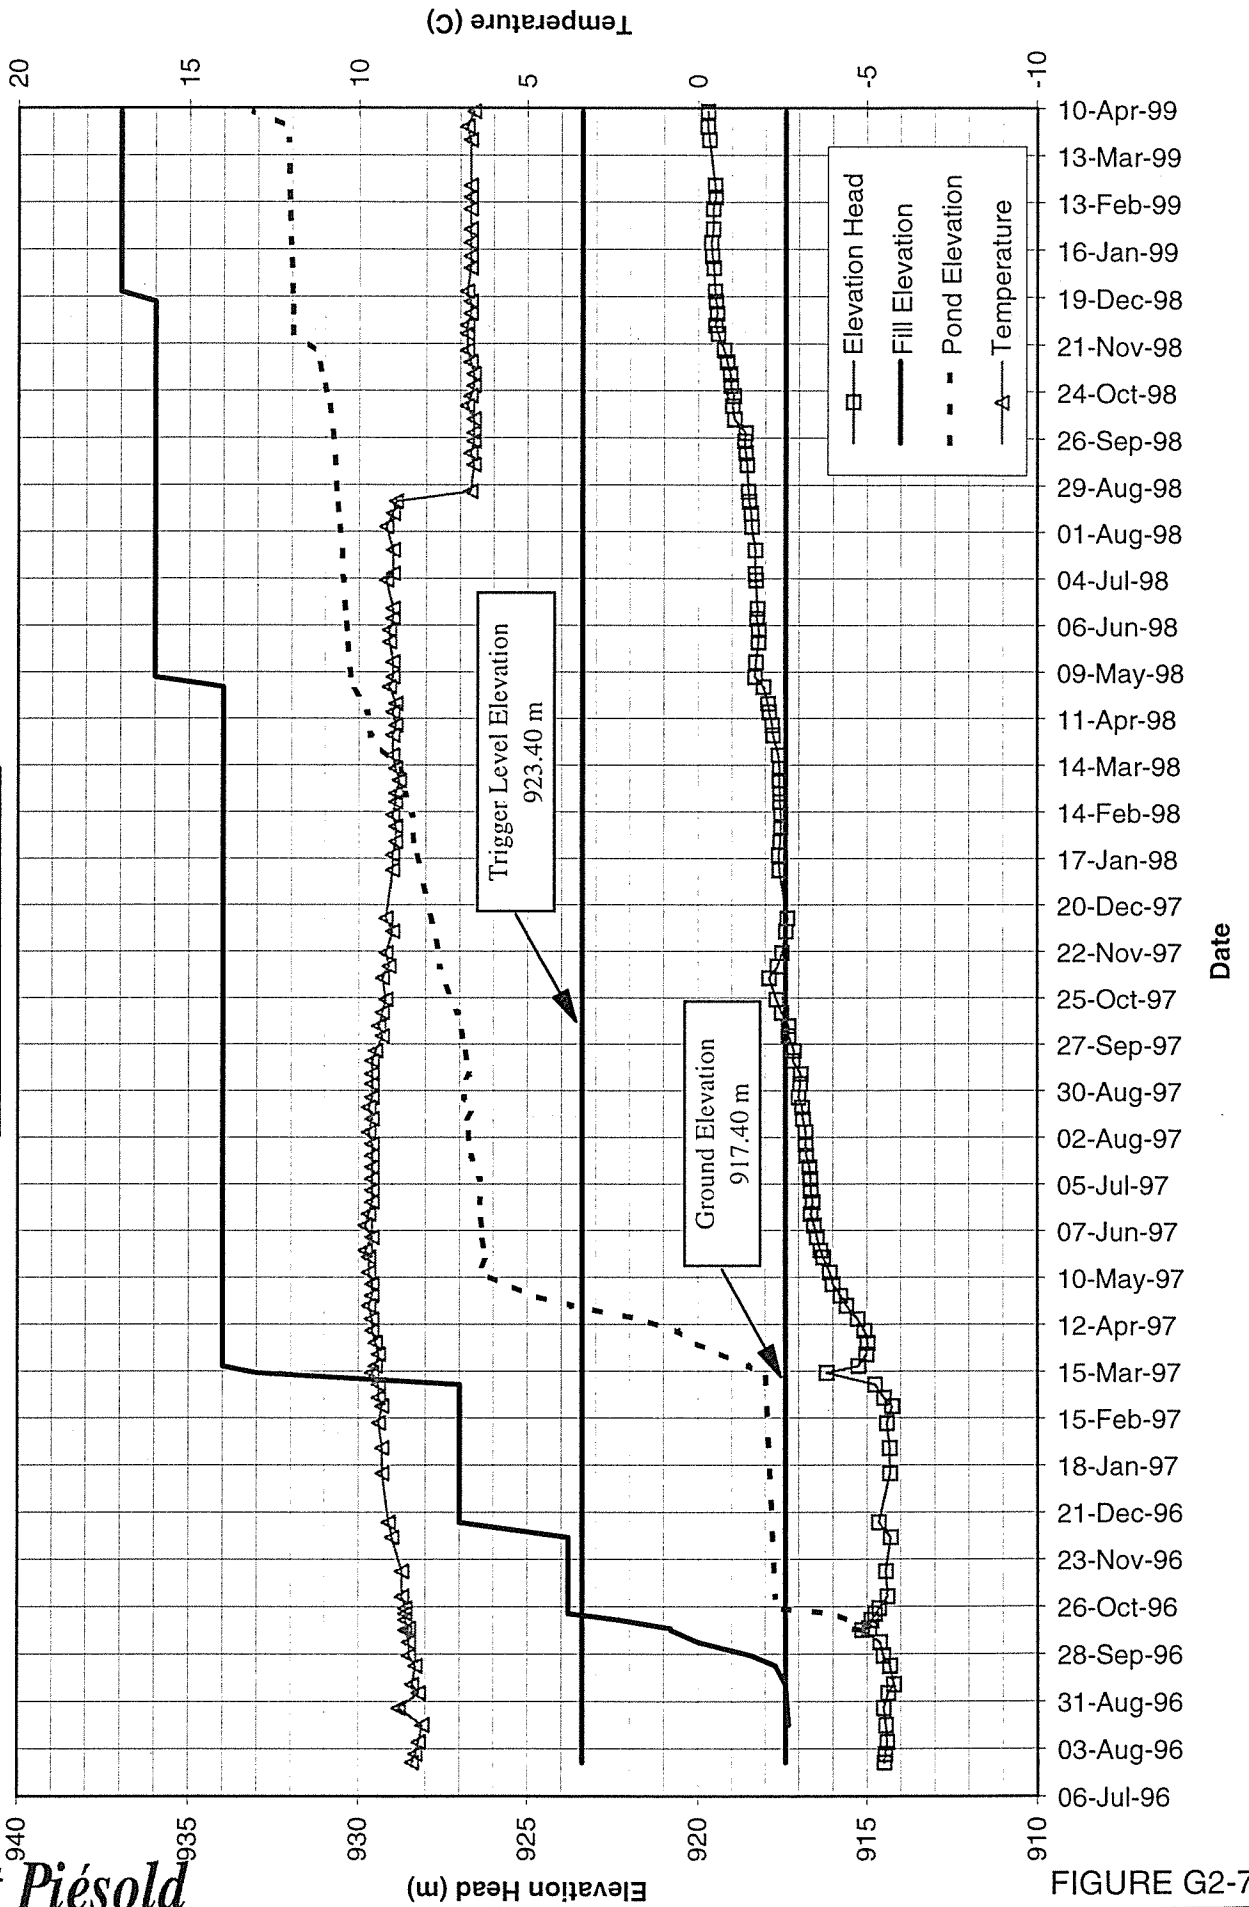
FIGURE G2-7

MOUNT POLLEY MINING CORPORATION
MOUNT POLLEY MINE
PIEZOMETER B2-PE2-02
EMBANKMENT FOUNDATION PIEZOMETER
TIP ELEVATION 909.51 m

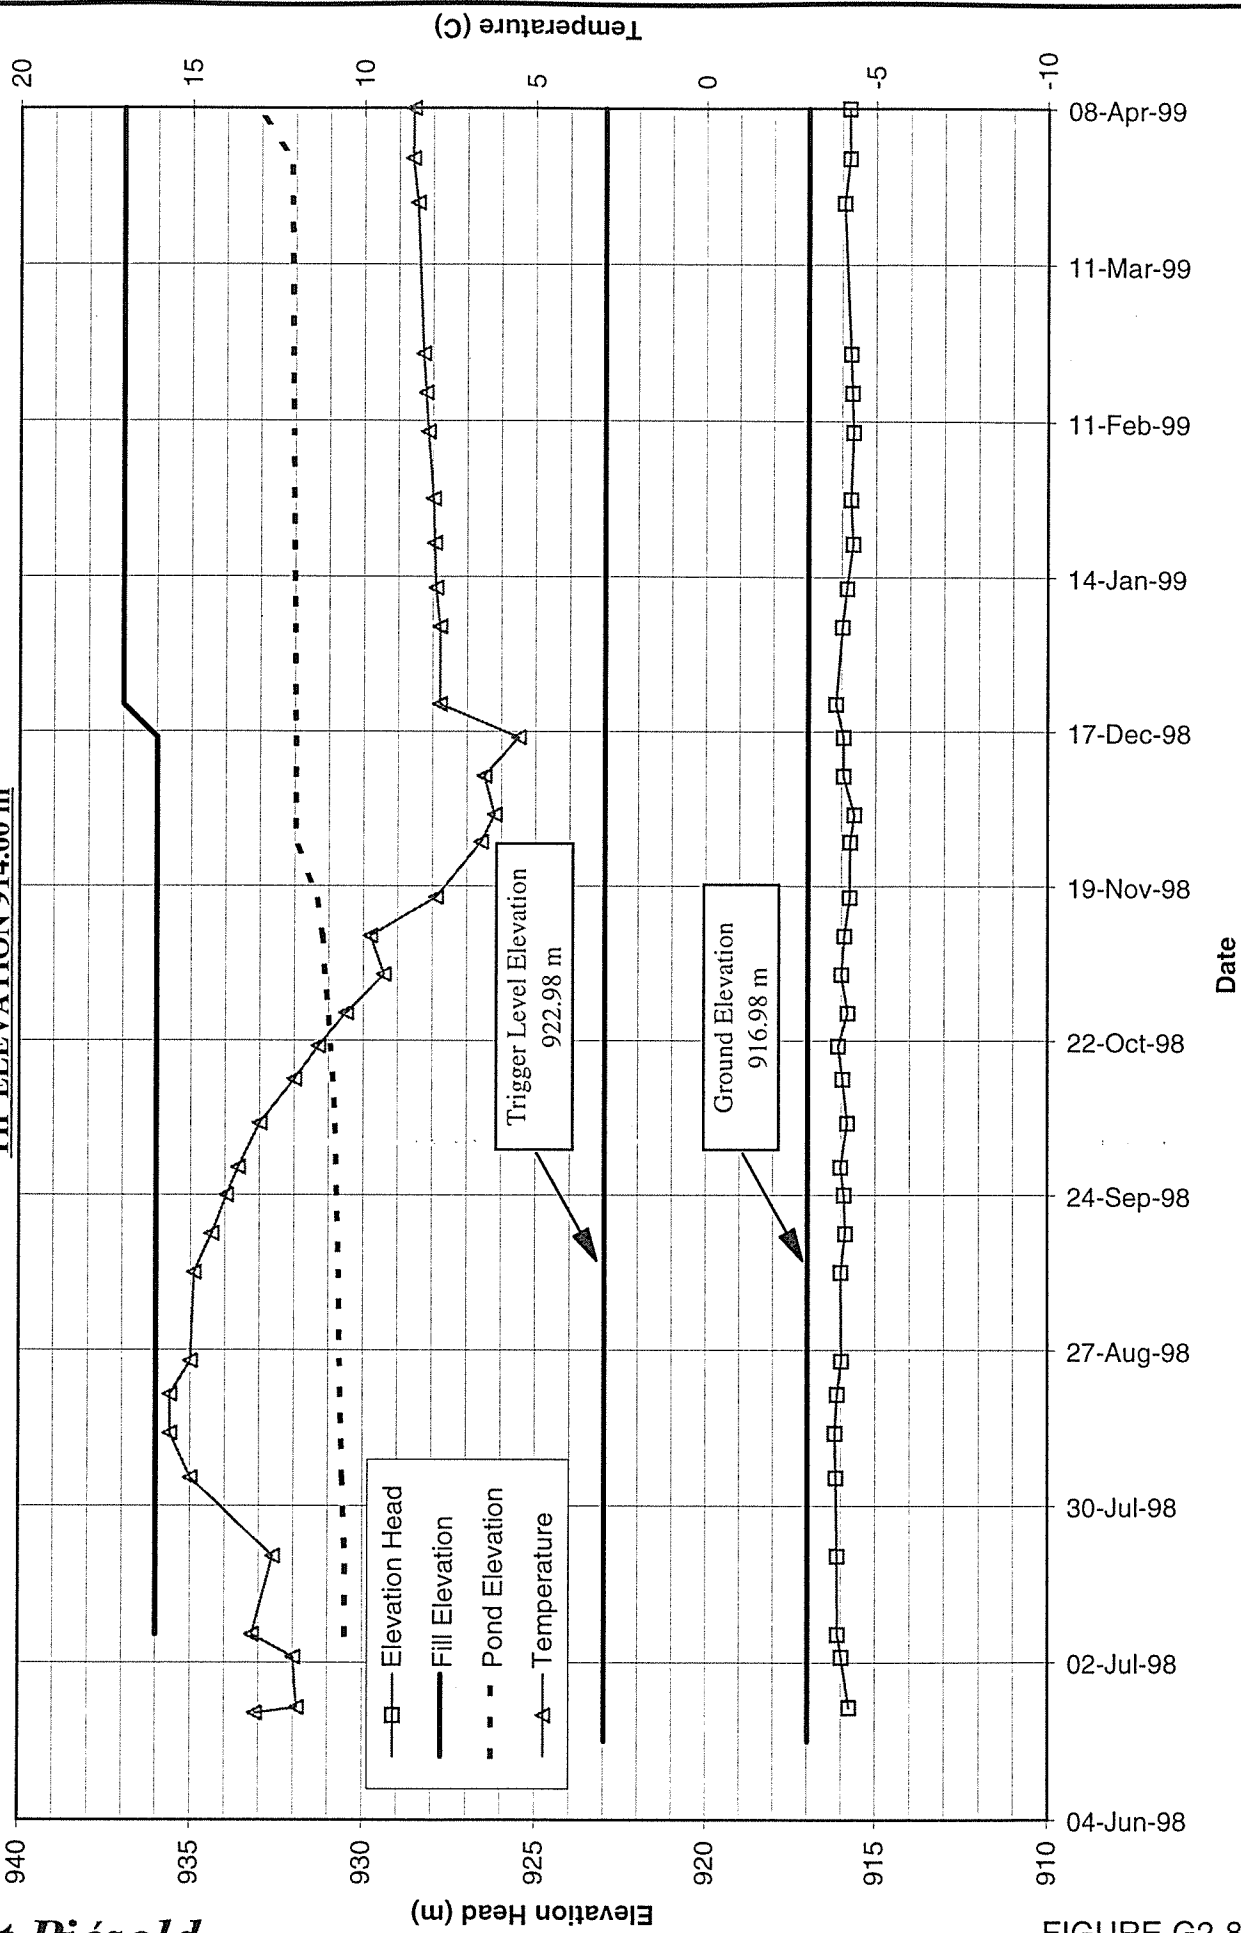
MOUNT POLLEY MINING CORPORATION
MOUNT POLLEY MINE
PIEZOMETER B2-PE2-06
EMBANKMENT FOUNDATION PIEZOMETER
TIP ELEVATION 914.60 m

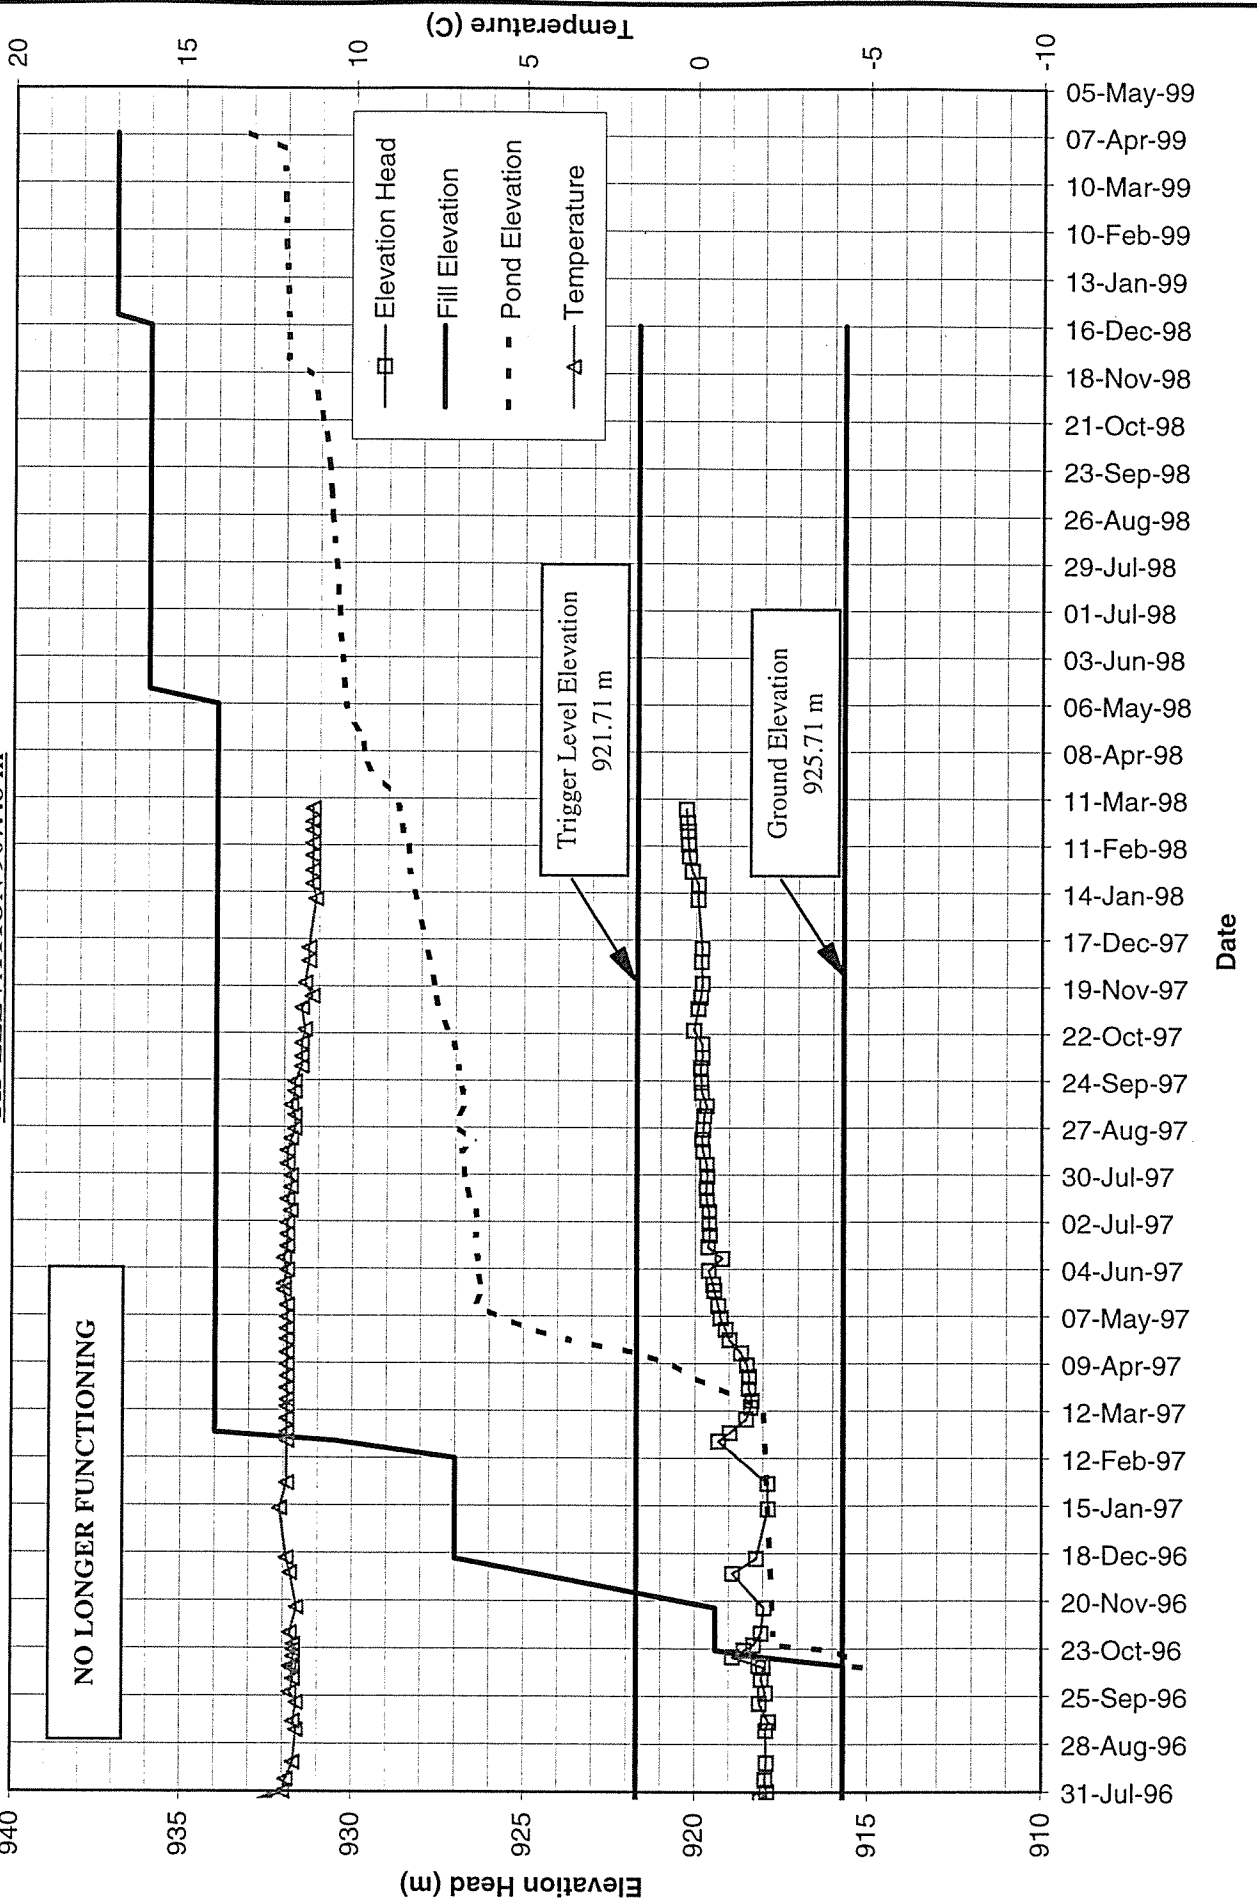
MOUNT POLLEY MINING CORPORATION
MOUNT POLLEY MINE
PIEZOMETER C2-PE2-01
EMBANKMENT FOUNDATION PIEZOMETER
TIP ELEVATION 907.48 m

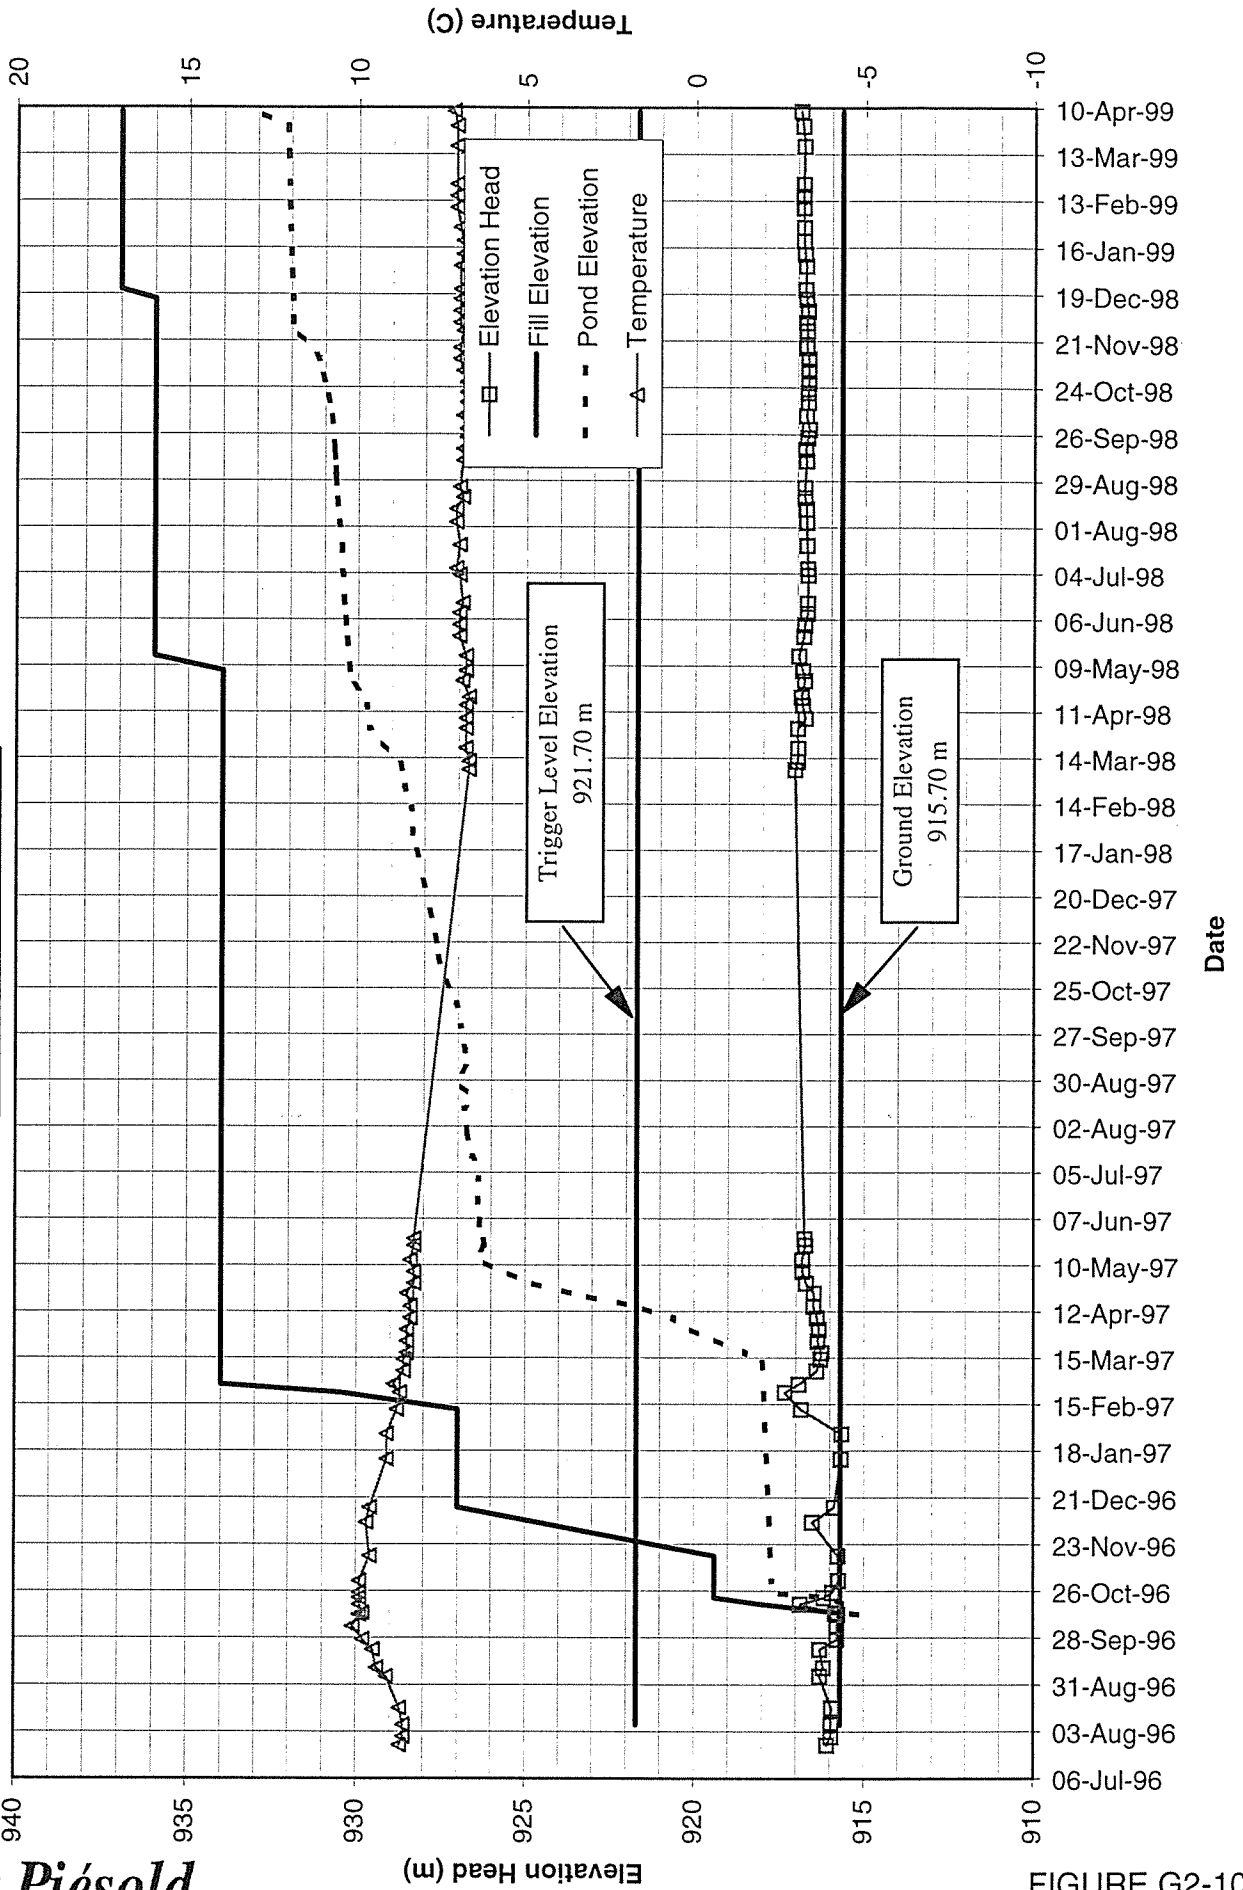
MOUNT POLLEY MINING CORPORATION
MOUNT POLLEY MINE
PIEZOMETER C2-PE2-02
EMBANKMENT FOUNDATION PIEZOMETER
TIP ELEVATION 910.53 m

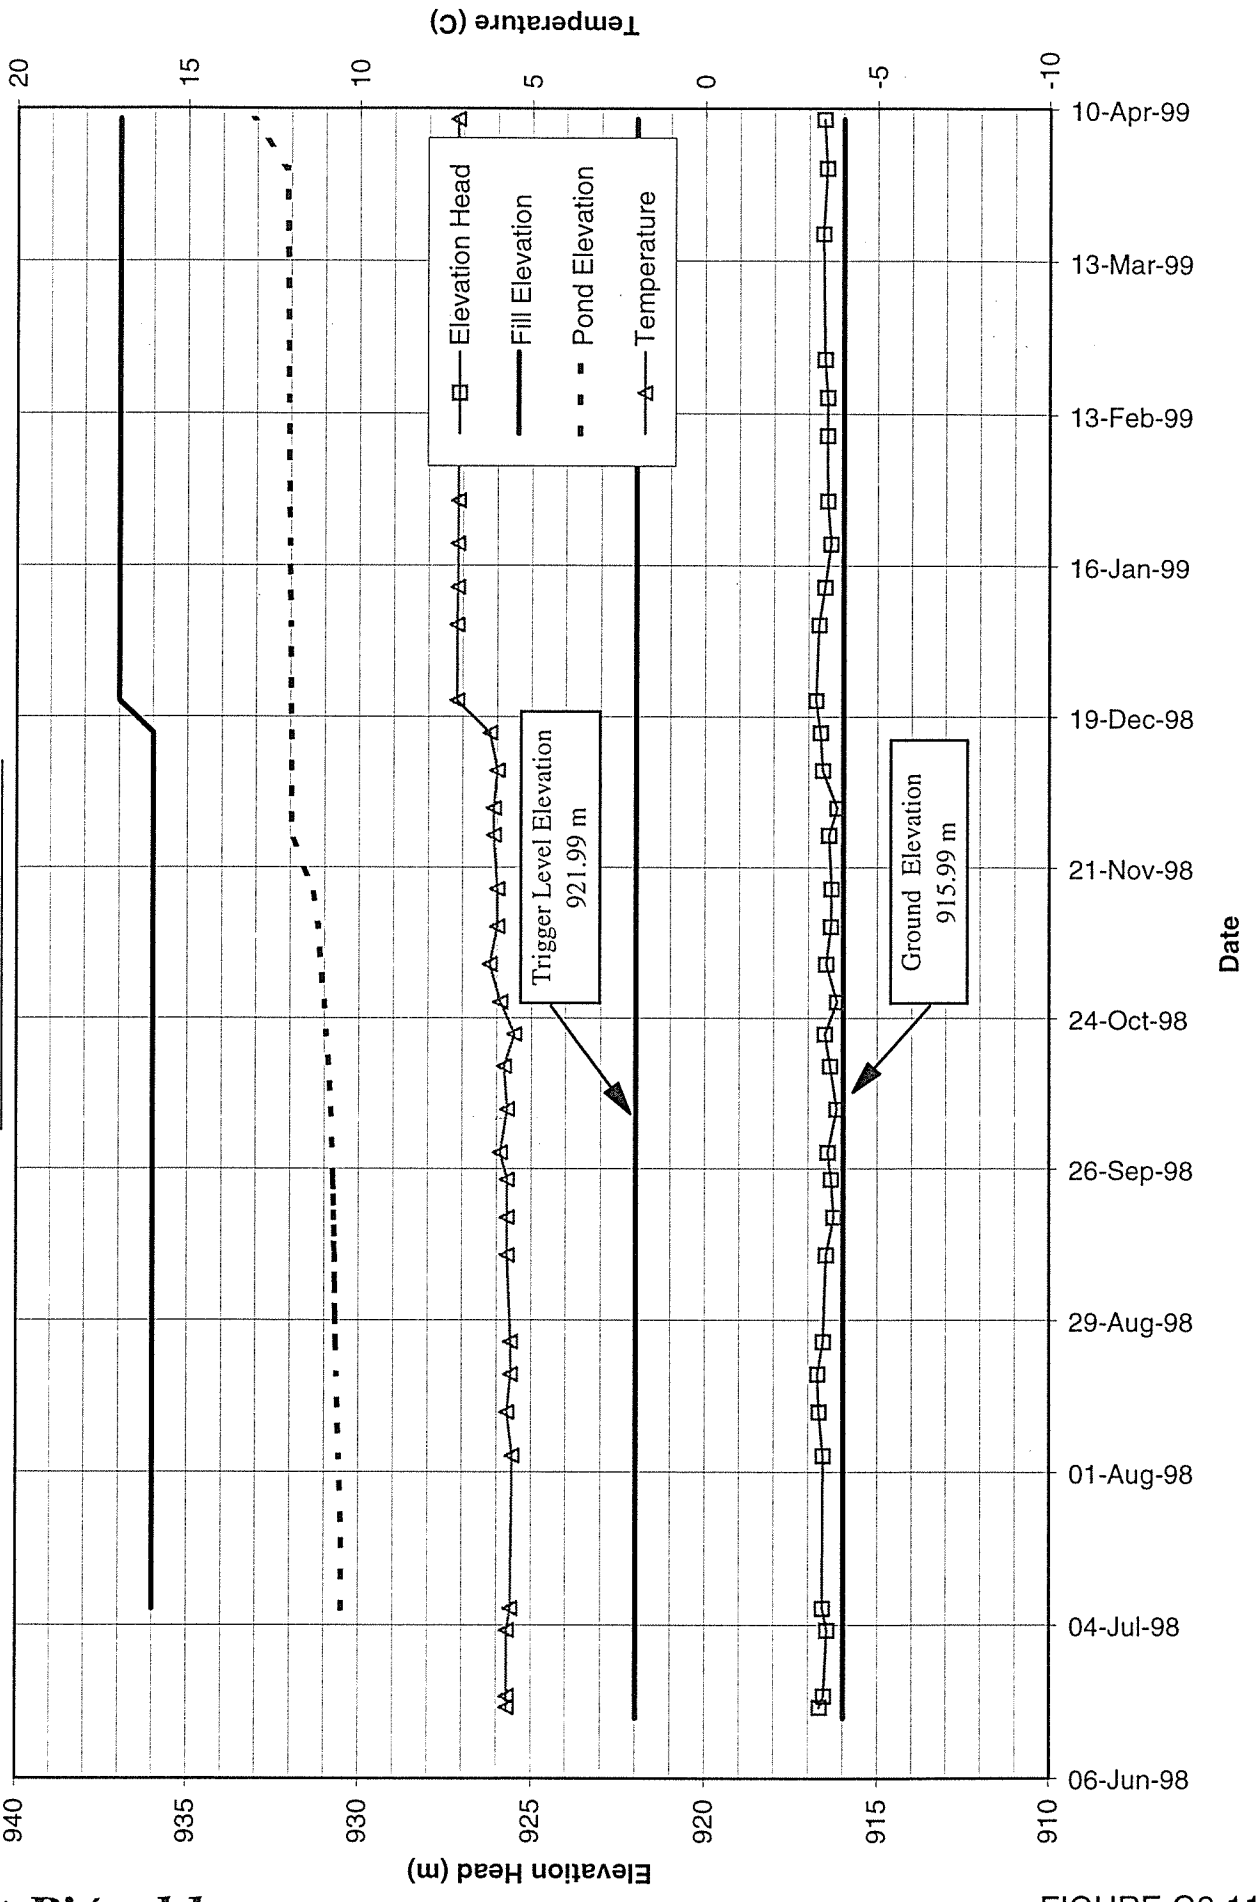
FIGURE G2-11

MOUNT POLLEY MINING CORPORATION
MOUNT POLLEY MINE
PIEZOMETER C2-PE2-06
EMBANKMENT FOUNDATION PIEZOMETER
TIP ELEVATION 906.84 m

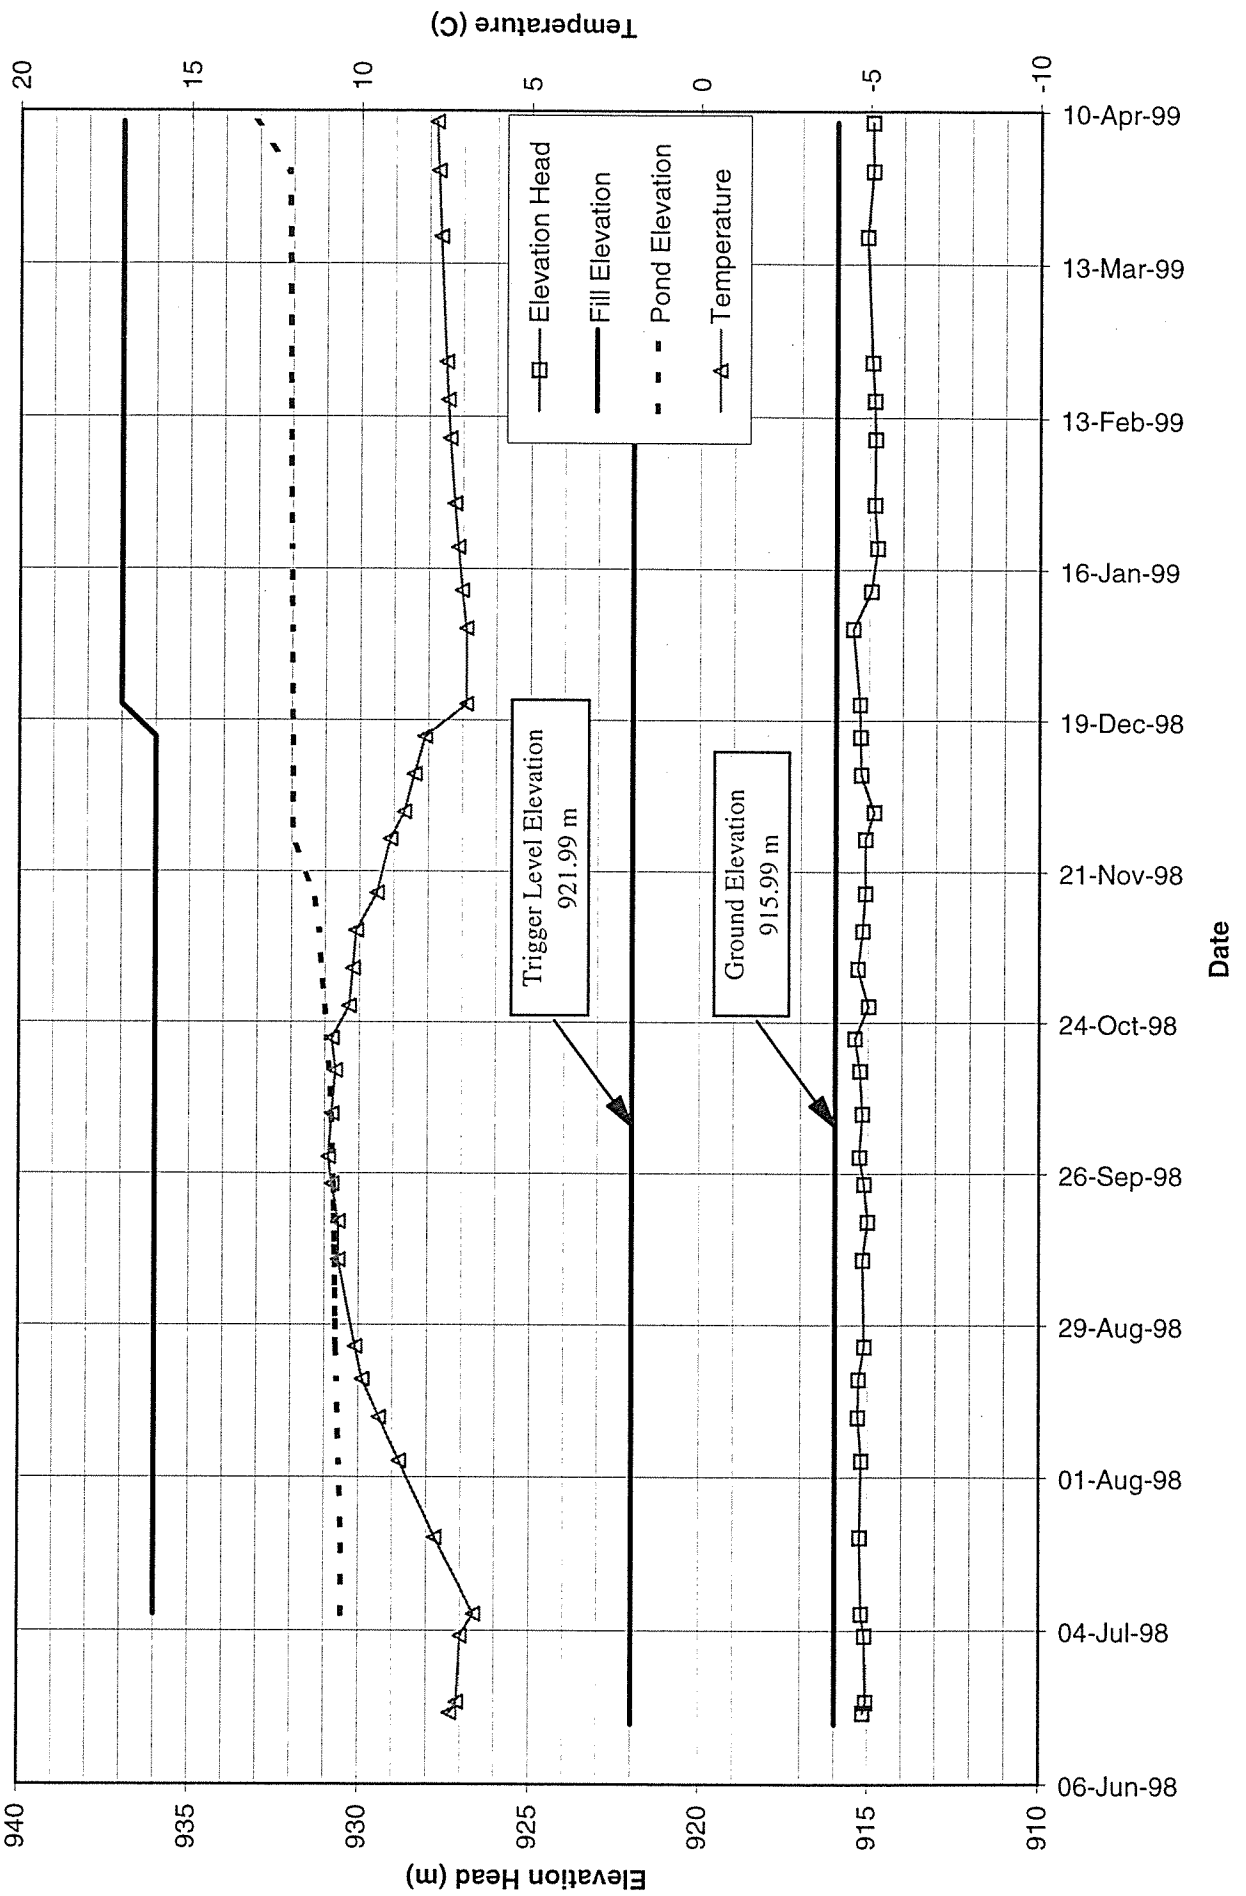
MOUNT POLLEY MINING CORPORATION
MOUNT POLLEY MINE
PIEZOMETER C2-PE2-07
EMBANKMENT FOUNDATION PIEZOMETER
TIP ELEVATION 912.29 m

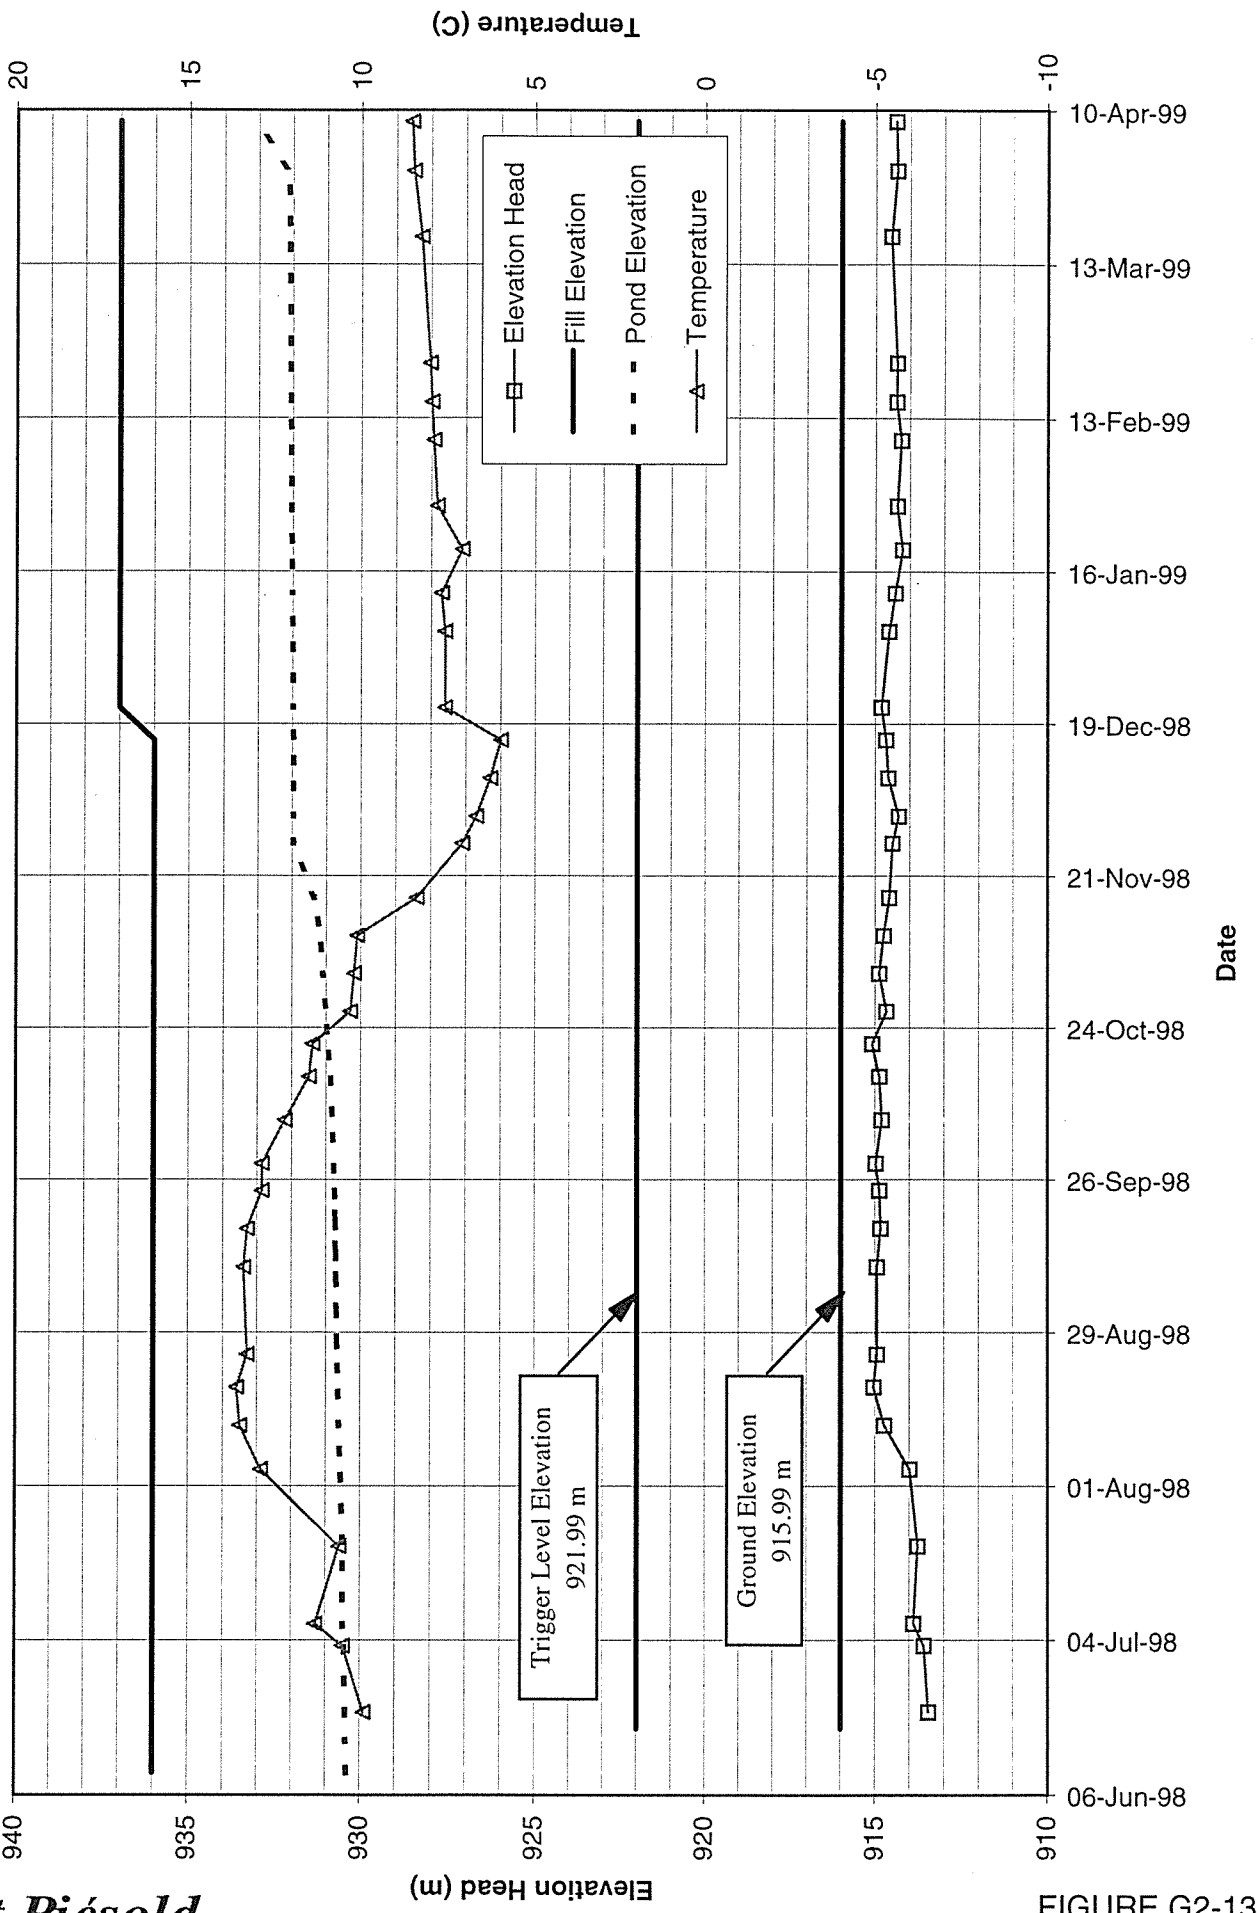
FIGURE G2-13

MOUNT POLLEY MINING CORPORATION
MOUNT POLLEY MINE
PIEZOMETER C2-PE2-08
EMBANKMENT FOUNDATION PIEZOMETER
TIP ELEVATION 914.03 m

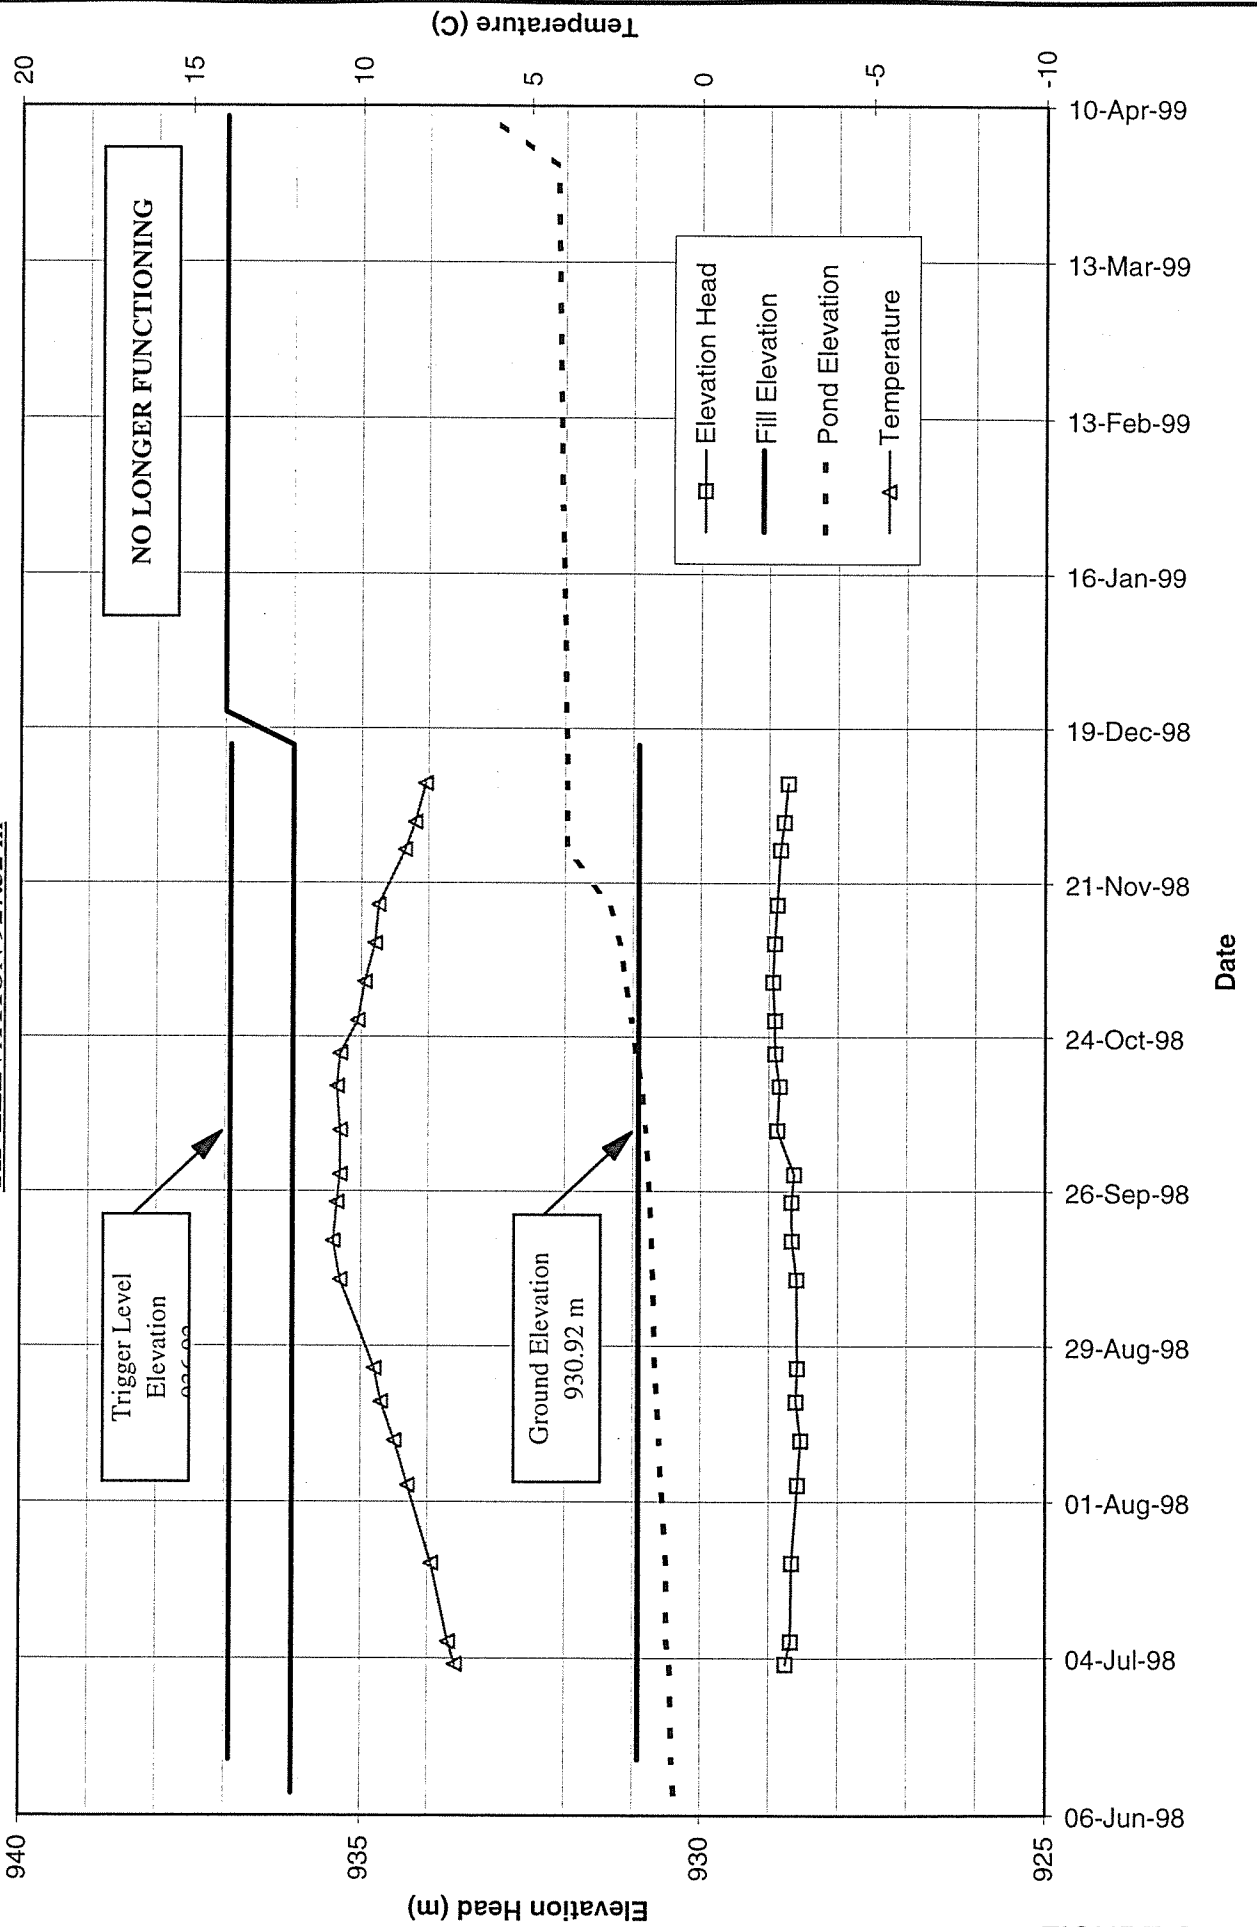
MOUNT POLLEY MINING CORPORATION
MOUNT POLLEY MINE
PIEZOMETER D2-PE2-02
EMBANKMENT FOUNDATION PIEZOMETER
TIP ELEVATION 927.32 m
