**MOUNT POLLEY MINING CORPORATION
MOUNT POLLEY MINE
TAILINGS STORAGE FACILITY**

**REPORT ON
1998 CONSTRUCTION AND ANNUAL INSPECTION
(REF. NO. 11162/10-1)**

Knight Piesold Ltd.
CONSULTING ENGINEERS

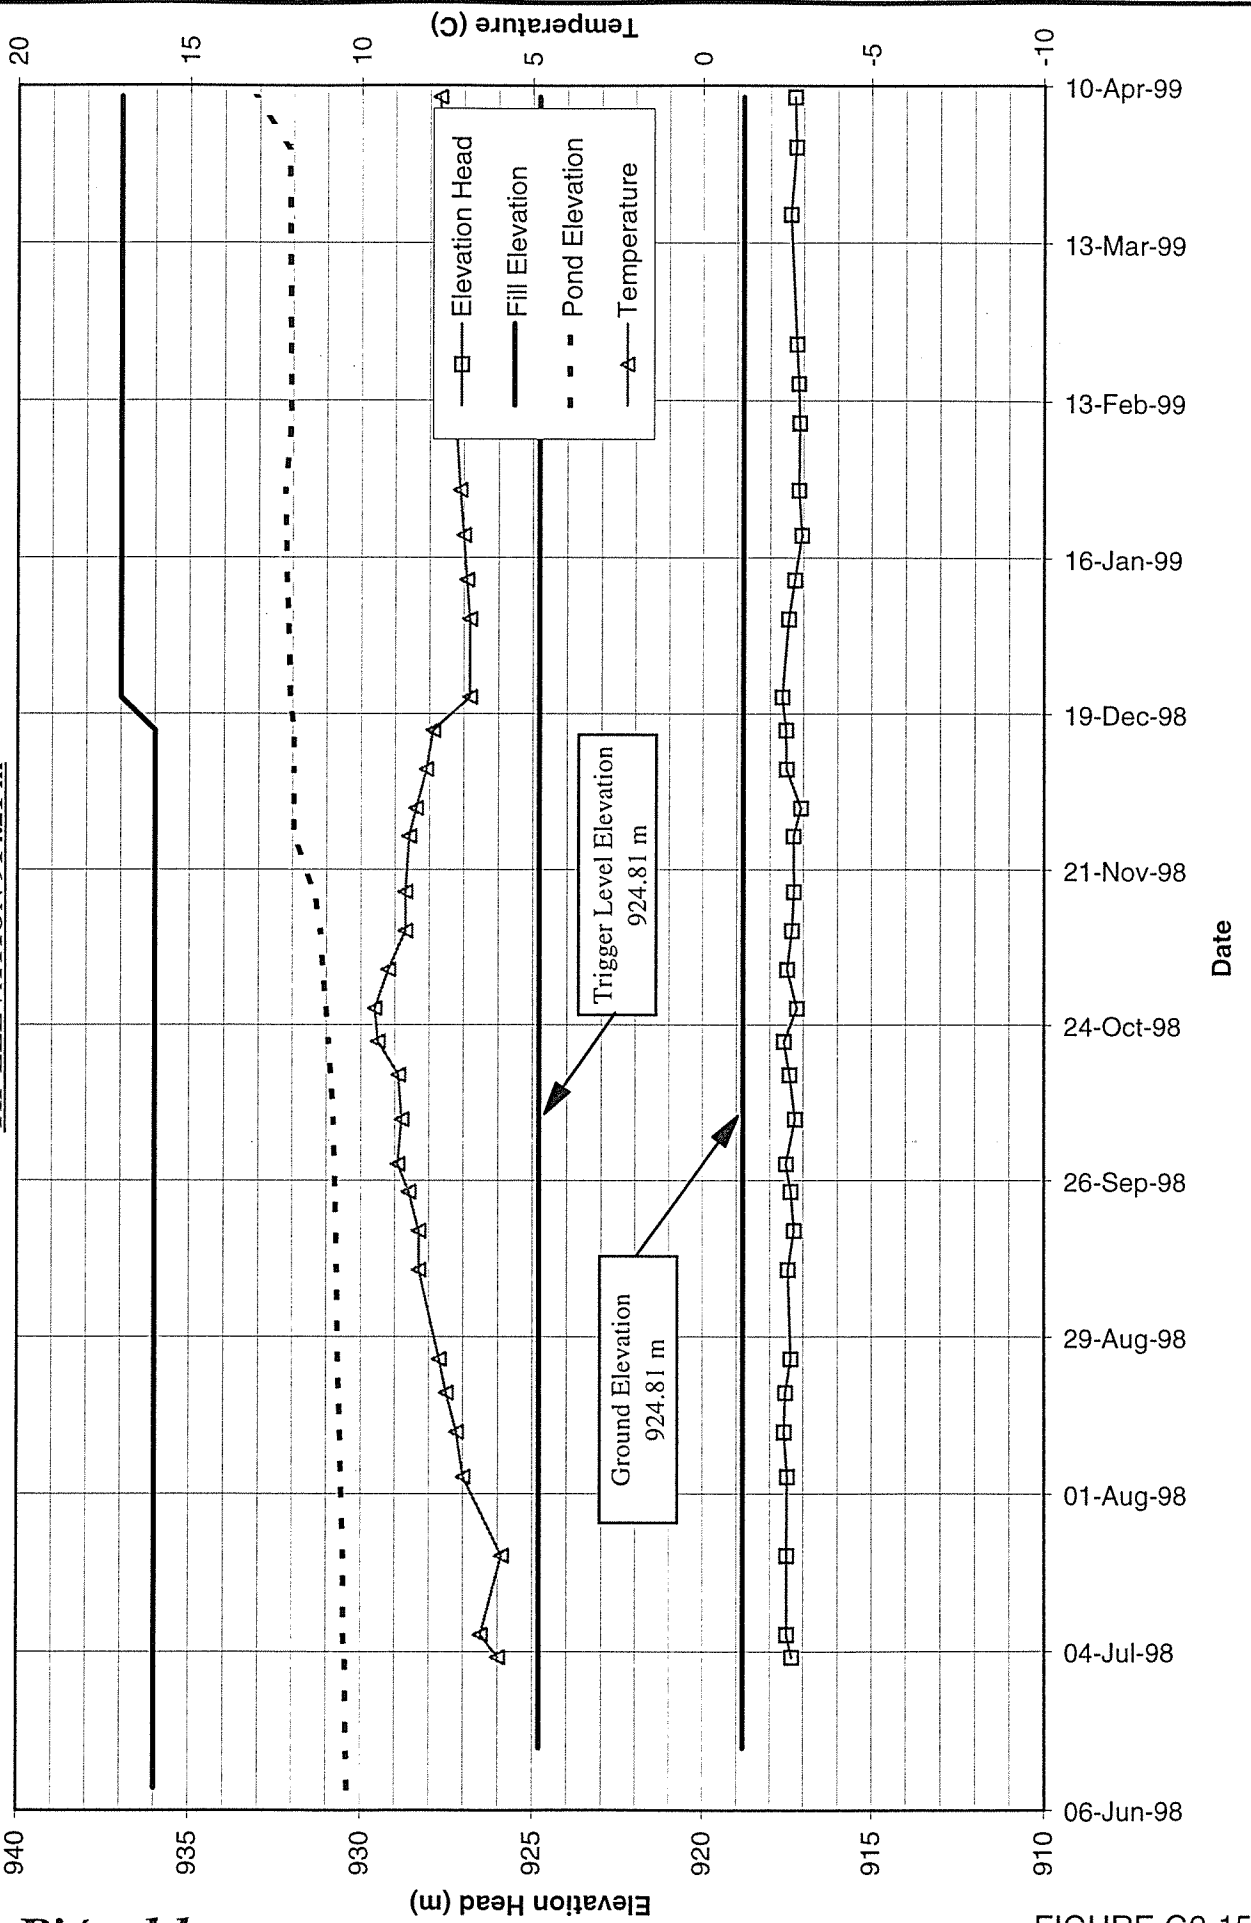
MOUNT POLLEY MINING CORPORATION
MOUNT POLLEY MINE
PIEZOMETER E2-PE2-01
EMBANKMENT FOUNDATION PIEZOMETER
TIP ELEVATION 914.21 m

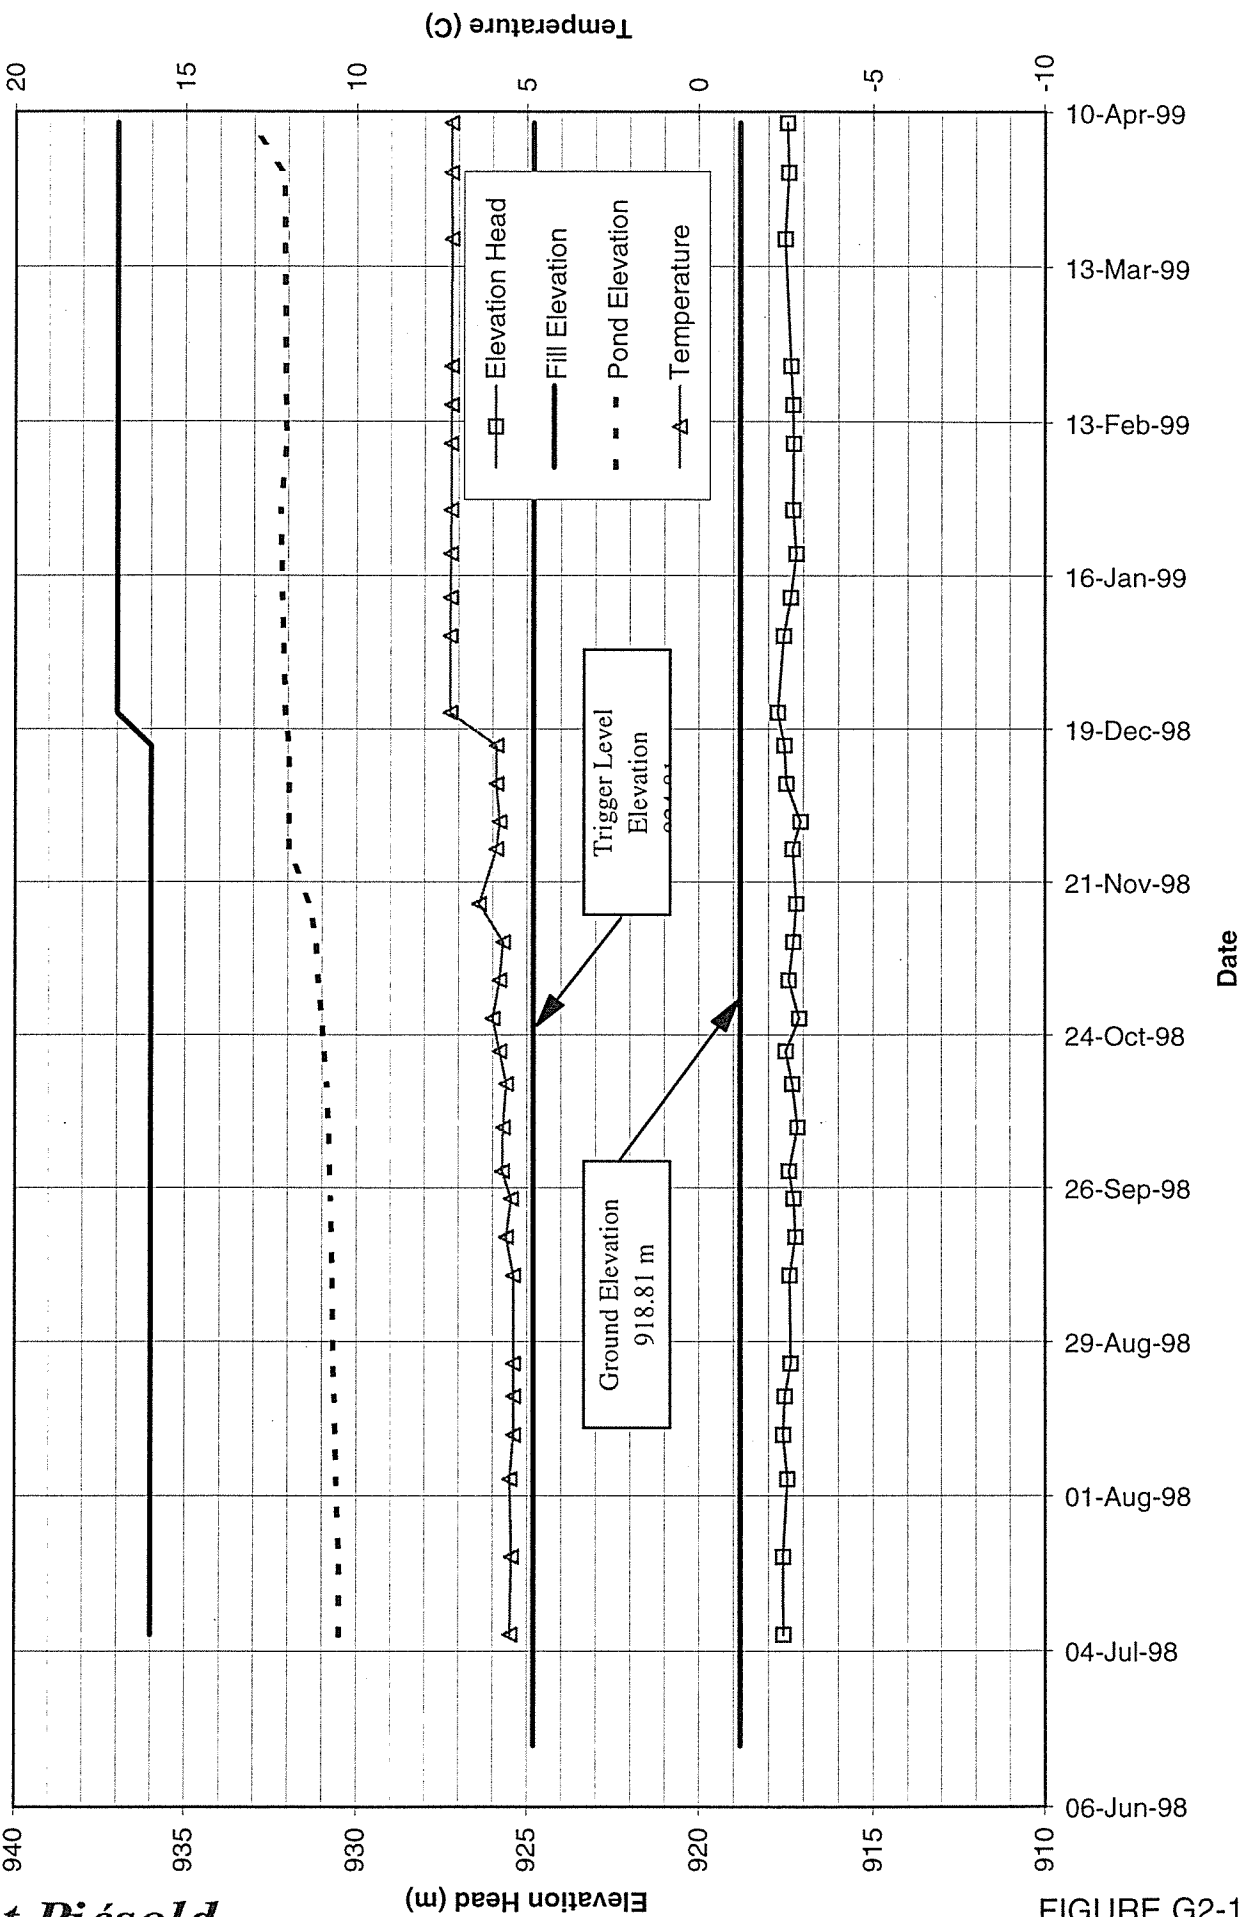
MOUNT POLLEY MINING CORPORATION
MOUNT POLLEY MINE
PIEZOMETER E2-PE2-02
EMBANKMENT FOUNDATION PIEZOMETER
TIP ELEVATION 909.66 m

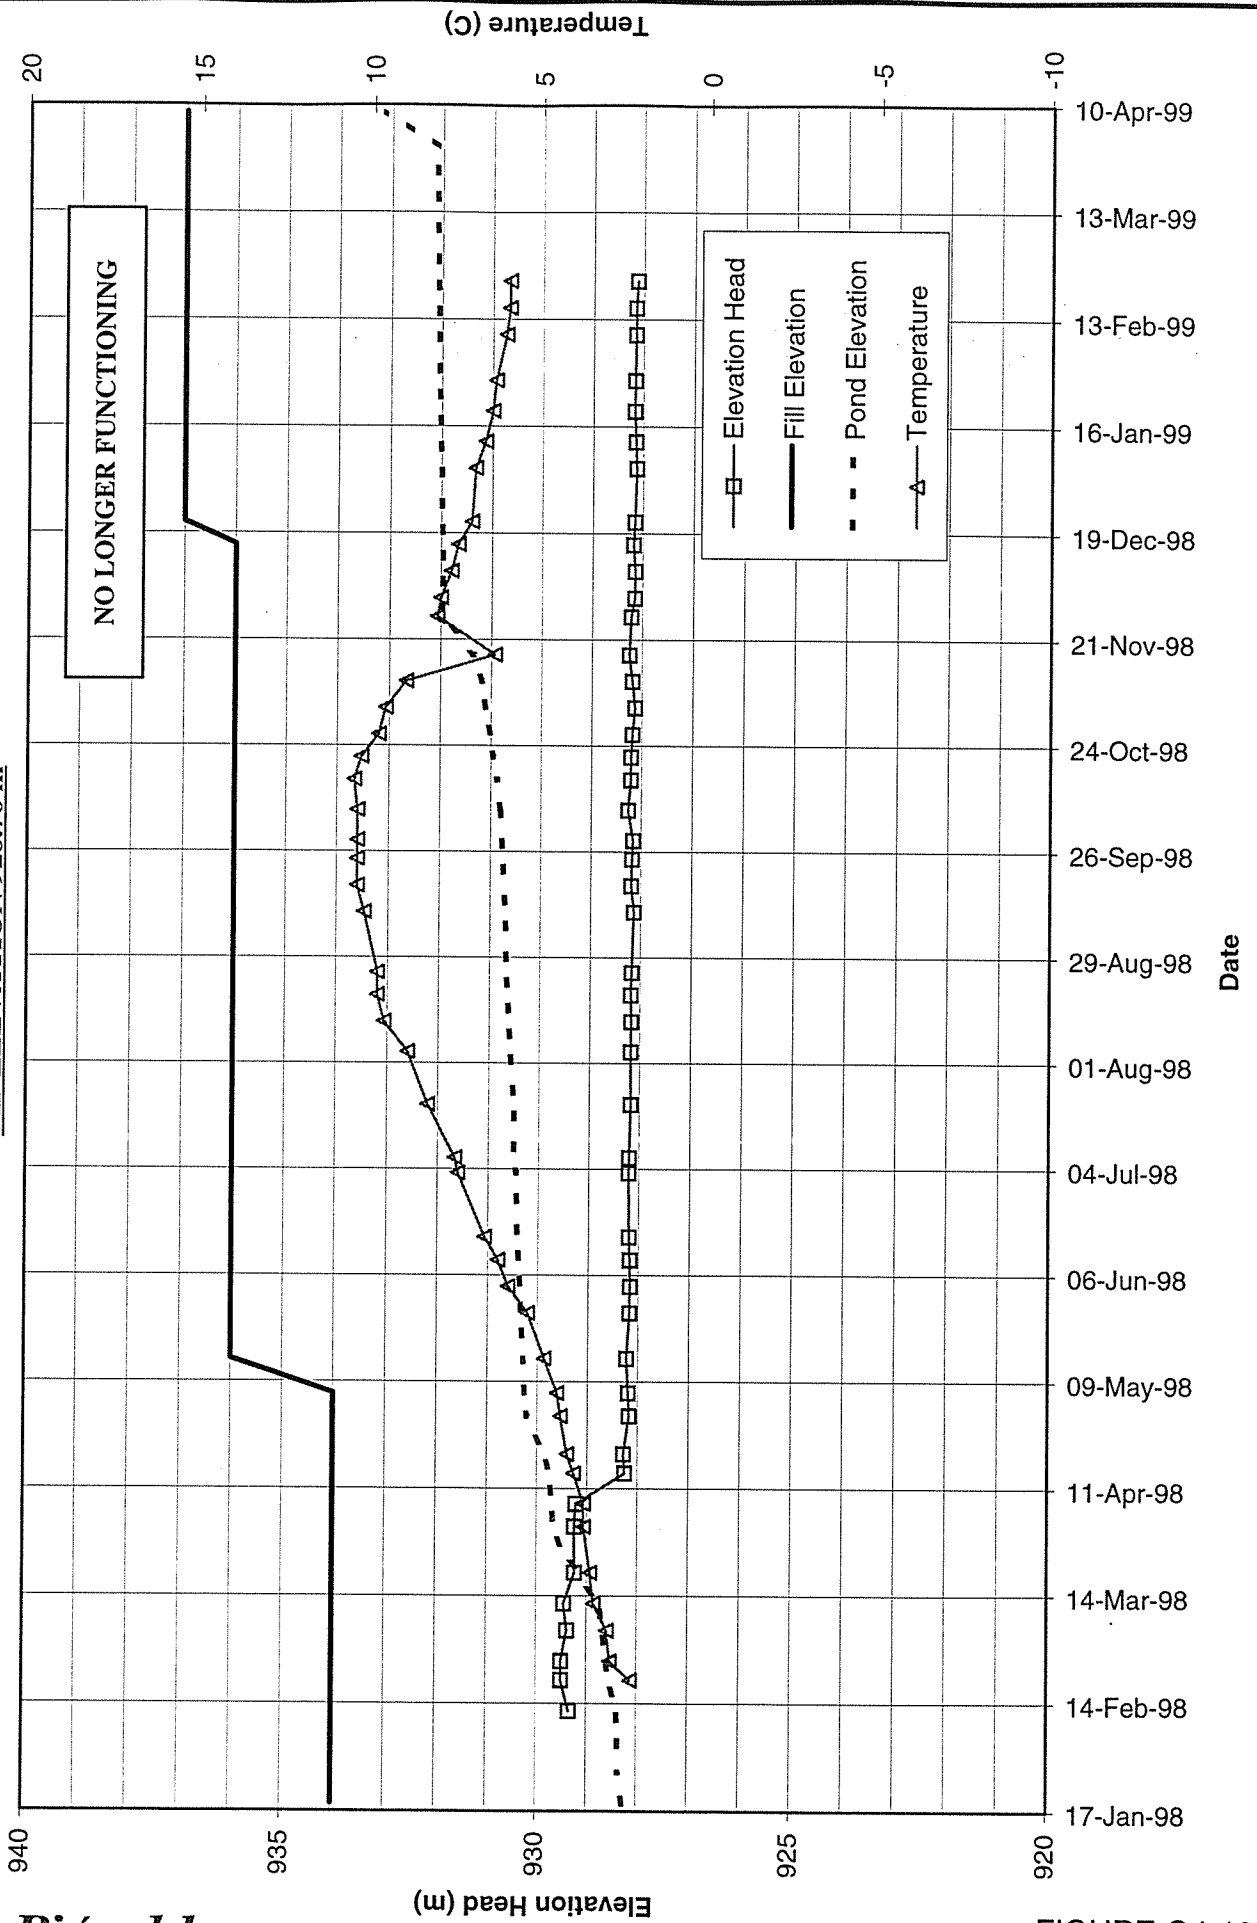
MOUNT POLLEY MINING CORPORATION
MOUNT POLLEY MINE
PIEZOMETER D1-PE1-02
DRAIN PIEZOMETER - OD-4
TIP ELEVATION 928.76 m
