Mount Polley Mining Corporation

NEZ Dump Seed Plot Success Analysis 2011

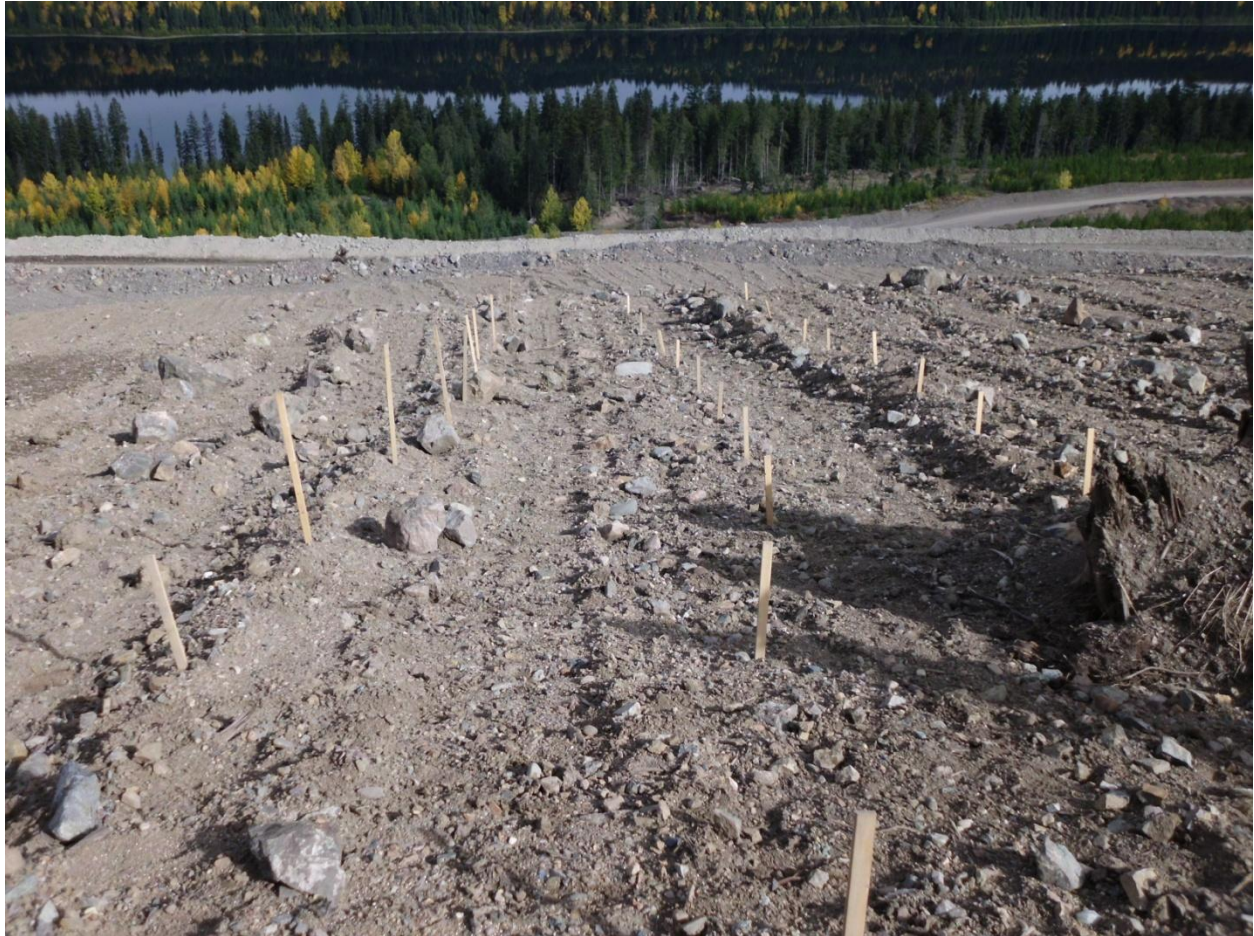
Figure 2. Newly planted NEZ dump re-vegetation test plots

treatment unit was seeded with a native seed mixture containing eight (8) grasses (Mountain Brome, Native Red Fescue, Rocky Mountain Fescue, Wheat Grass-Blue Bunch, Blue Wild Rye, June Grass, and Tickle Grass) and two (2) forbs (Fireweed, and Lupines). Individual hand-seed trial plots of each of the nine (9) native seed types were also established in September 2010 on each treatment unit to investigate the re-vegetative success of each species (Figure 2).

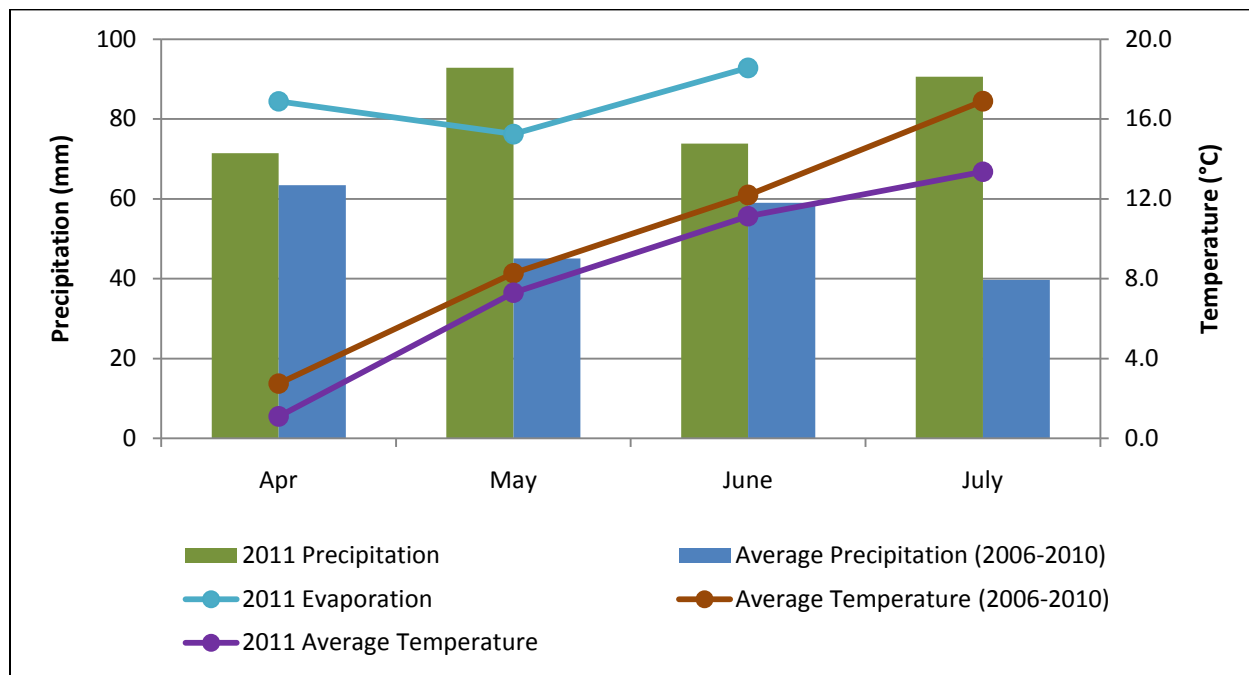
Figure 3. Mount Polley spring 2011 weather statistics

It is also important to note that in the spring and early summer of 2011 MPMC recorded above average precipitation and below average temperatures, which may have influenced plant growth on the sites. This is shown in Figure 3 (note that July 2011 values are based on data from July 1 to July 18). Similarly, a

period of unusually cold weather in November 2010 may have had an effect, as the area was seeded in the fall. The average temperature was -4.7, compared to an average of -2.07 between 2006 and 2009.

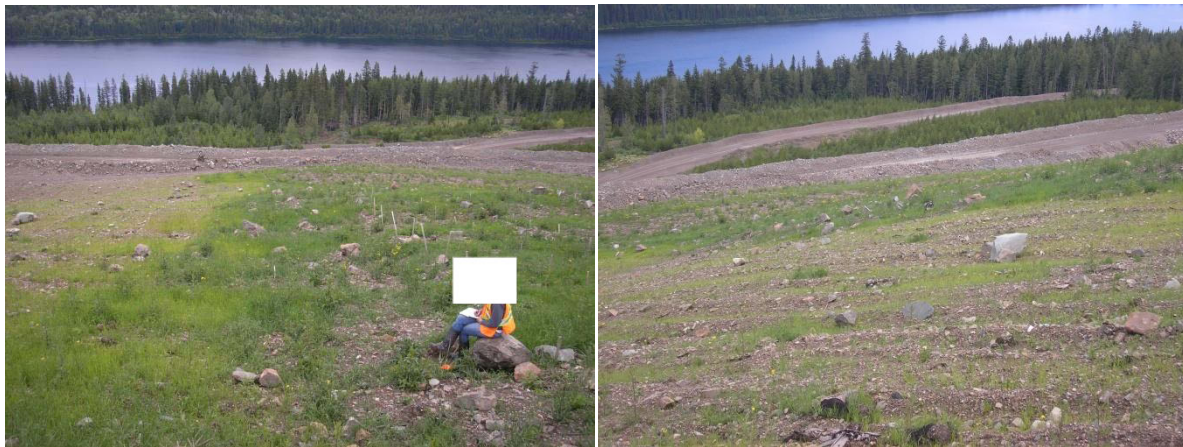
Figure 4. Transition between sites 2b¹ and 2b²

Much less growth was observed on this site, presumably because no fertilizer was applied, although slightly more growth was observed towards the bottom of the hill. The effects of fertilizer can be observed in the transition between sites 2b¹ and 2b², in Figure 4. Almost all of the plants growing are species from the native seed mixture. Mostly grasses were observed, although some small lupines were present.

Overall growth appeared to be the greatest on 2b² and the poorest on 2b¹. The fertilizer applied to 2b² appeared to have significantly improved growth compared to 2b¹. On site 2a, increased fertilizer application (283 kg/ha compared to 71 kg/ha at 2b²) did not appear to be advantageous. This may have been caused by the higher seeding rate (45 kg/ha at 2a compared to 34 kg/ha at 2b²), which can stifle seed growth. These results at site 2a may be a function of the observed differences in soil. It is also of note that no biosolids were incorporated into the soil at 2a, but the application of biosolids at 2b was likely too deep to have affected plant growth.

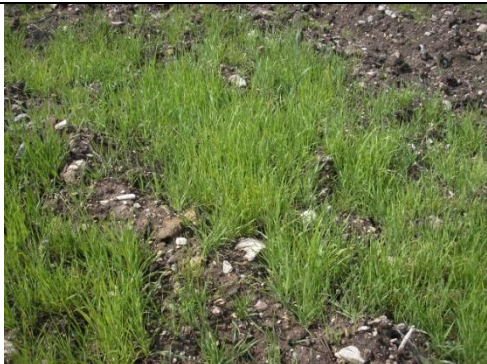
Plot	Species	% Cover	% Other Species	Vigor	Comments	Photo		
1	Mtn. Brome	70	5	4	v. few weeds, visible seeds

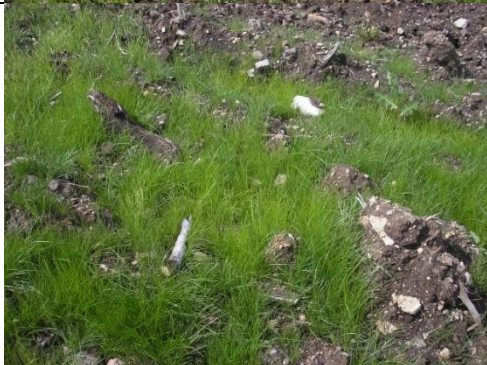
2	Native Red Fescue	80	5	4	No seeds visible on grasses

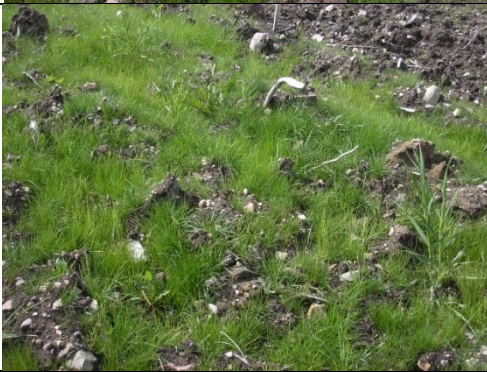
3	Rocky Mtn. Fescue	80	10	4	Very similar in appearance to the Native Red Fescue

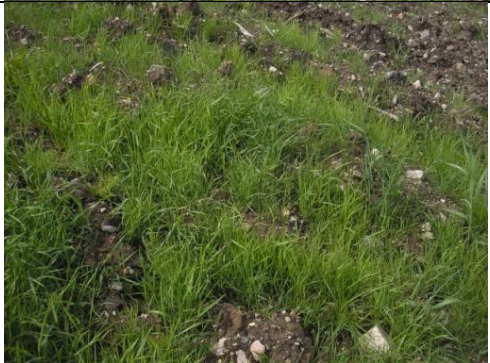
5	Blue Wild Rye	80	10	4	Black soil visible

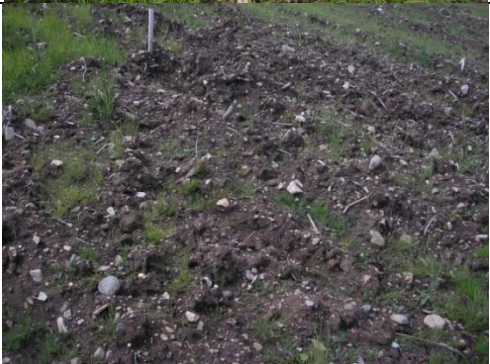
6	June Grass	10	30	1	Not very healthy

Based on these results the lower seeding rate of 34 kg/ha is recommended. 71 kg/ha of fertilizer appears to be sufficient for sites similar to the NEZ Dump. The native seed mix should be adjusted, and June Grass and Tickle Grass removed (so that it contains Mountain Brome, Native Red Fescue, Rocky Mountain Fescue, Wheat Grass-Blue Bunch, Blue Wild Rye, Fireweed, and Lupines). Reclamation areas with a rougher surface, contours and debris will exhibit more successful plant growth.

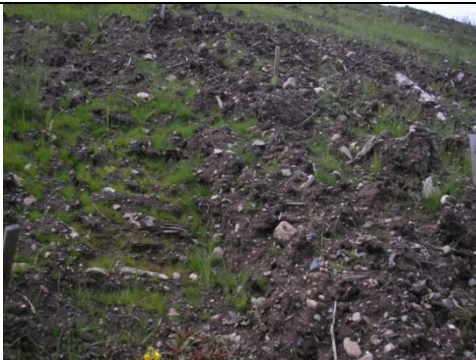
Plot	Species	% Cover	% Other Species	Vigor	Comments	Photo
7	Tickle Grass	30	10	3	Some plants more vigorous than others; appears not to like damp micro sites

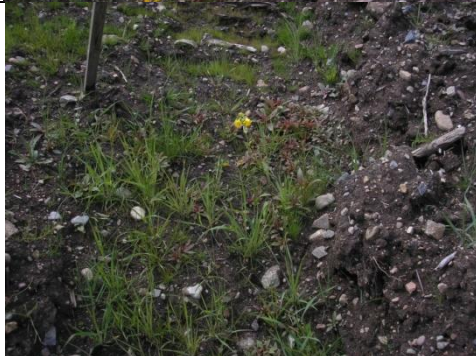
8	Fireweed	5	20	1	Could this be a function of the way the seed was applied? Fireweed seed is very fine

Using a hydroseeding method for seed application will be advantageous providing more even seed distribution, better erosion control, and protection against invasive species.

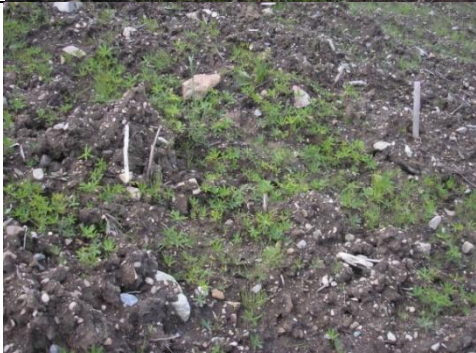
9	Lupine	40	10	3	No flowers

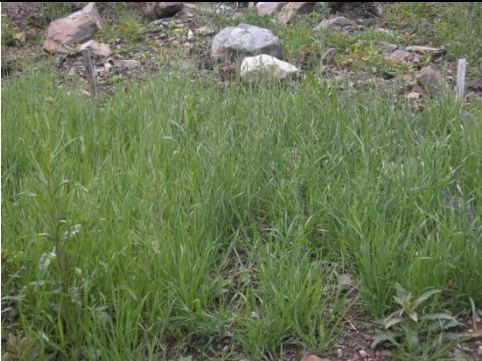
Plot	Species	% Cover	% Other Species	Vigor	Comments	Photo		
1	Mtn. Brome	80	10	4	Rocky, more compact, till-like soil

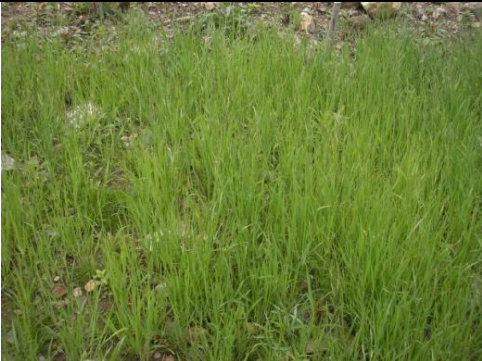
Plot	Species	% Cover	% Other Species	Vigor	Comments	Photo		
1	Mtn. Brome	70	5	4	Tallest and most dense of all 2b ² plots

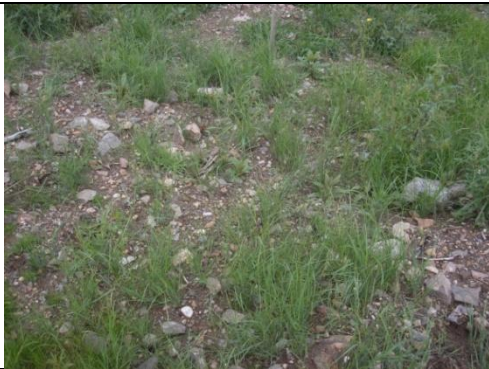
Plot	Species	% Cover	% Other Species	Vigor	Comments	Photo
4	Wheat Grass-Blue Bunch	30	10	4	Good vigor, but sparse and clumped (may be a function of hand seeding)

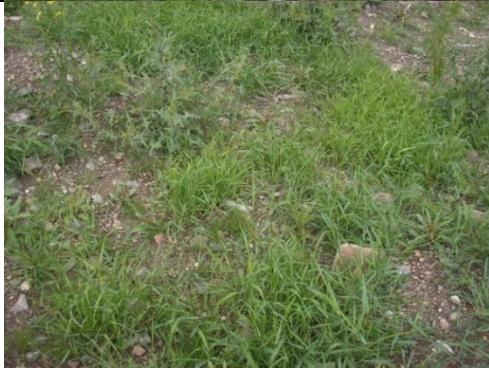
5	Blue Wild Rye	50	40	4	Starting to go to seed

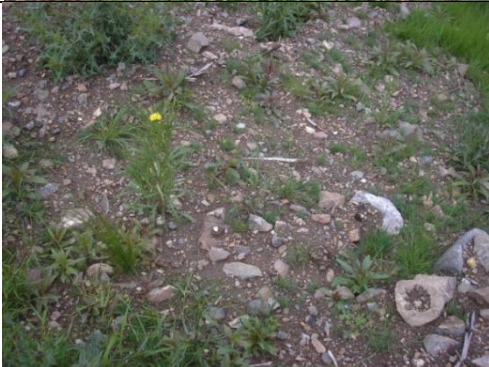
6	June Grass	15	40	2	v. sparse and low to the ground

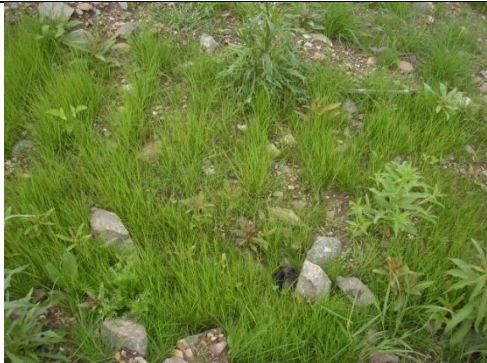
Plot	Species	% Cover	% Other Species	Vigor	Comments	Photo
7	Tickle Grass	80	20	4	Drastically more successful compared to the 2b plots

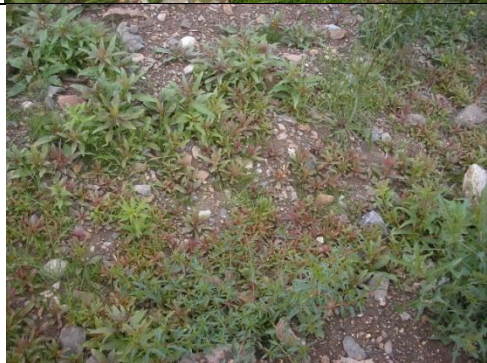
8	Fireweed	70	10	2	Small compared to non-seeded fireweed

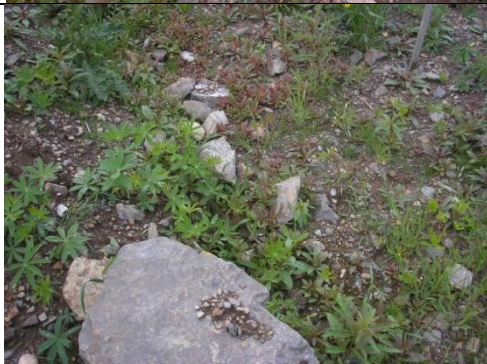
9	Lupine	30	50	3	Not flowering
