**Mount Polley Mining Corporation**  
**2012 North Bell Dump Reclamation Update**

**Reclamation Summary**

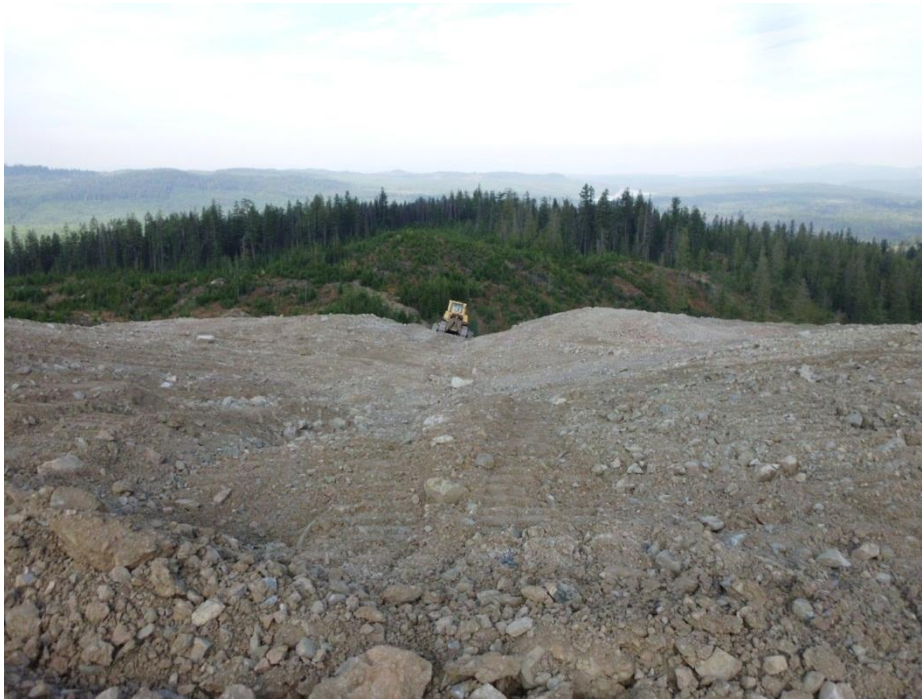
The hauling of waste rock to the top of the North Bell Dump ceased in July and sloping began shortly afterwards. 5 ha areas on both the north and south portions of the dump were re-sloped. Areas were designated for “features” to add terrain diversity to the slope (Figure 1). Shallow gullies and ridges were shaped.

**Figure 1.** Creation of a swale on the NBD

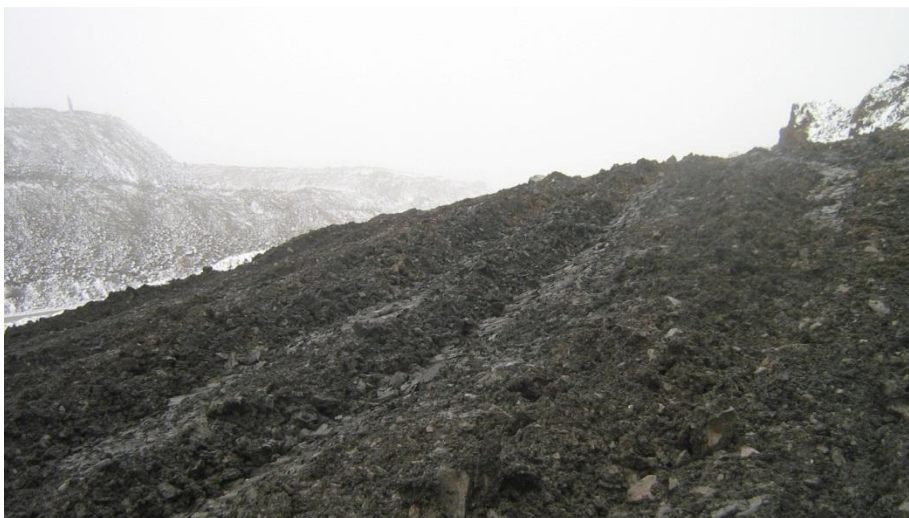
end of the dump) at a uniform depth of 20 cm, with a final application rate of 138 /ha. Mixed biosolids were also applied to a 3.1 ha area entitled Phase 2 (on the South portion of the dump). The soil was applied using a horizontal windrow method to increase micro-topography (Figure 2), with an average depth of 20 cm. The final application rate was 135 dt/ha. These two parcels were hand-seeded between October 17 and 22 at a rate of 35 kg/ha. The seed mix for Parcel 1 is presented in Table 2, while the seed mix for Parcel 2 is the same as Table 1, except lupin seed was planted as well.

**Figure 2.** Horizontal windrows on Phase 2 of the NBD

- Further research should be done to confirm the necessity of using soil amendments such as biosolids, char, or fly ash.
- Reclamation sites with a rougher surface, contours and debris will exhibit more successful plant growth. Efforts should be made to create natural landforms or features when re-contouring, and to use the horizontal windrow approach when applying soil.

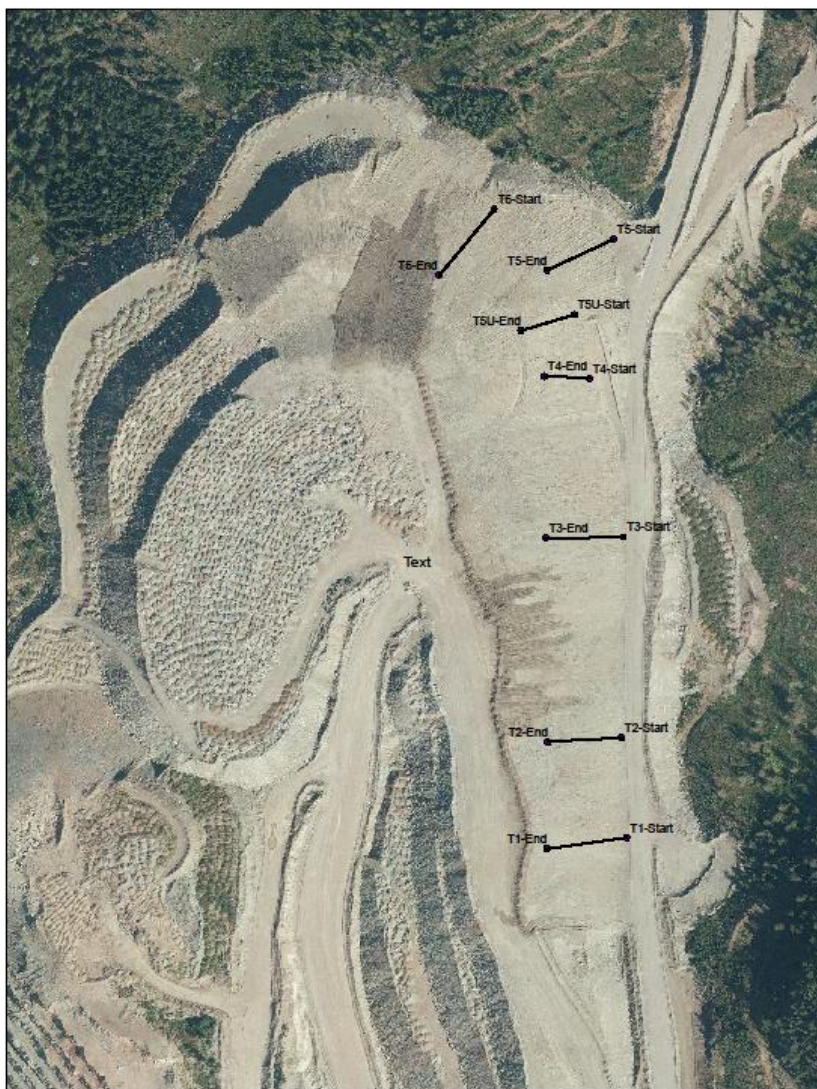
To assess re-vegetative success on the NBD in the first growing season, percent ground cover, percent planted species present, and vigor (on a scale of 0 to 5, where 0=very poor, 5 = very good) were recorded for 10 metre sections along 7 transects (T1, T2, T3, T4, T5, T5-Upper, and T6) , as shown in Figure 4. The assessment extended 1 metre on either side of each transect. These transects were selected prior to the field assessment to avoid bias.

**Figure 4.** NBD assessment transects

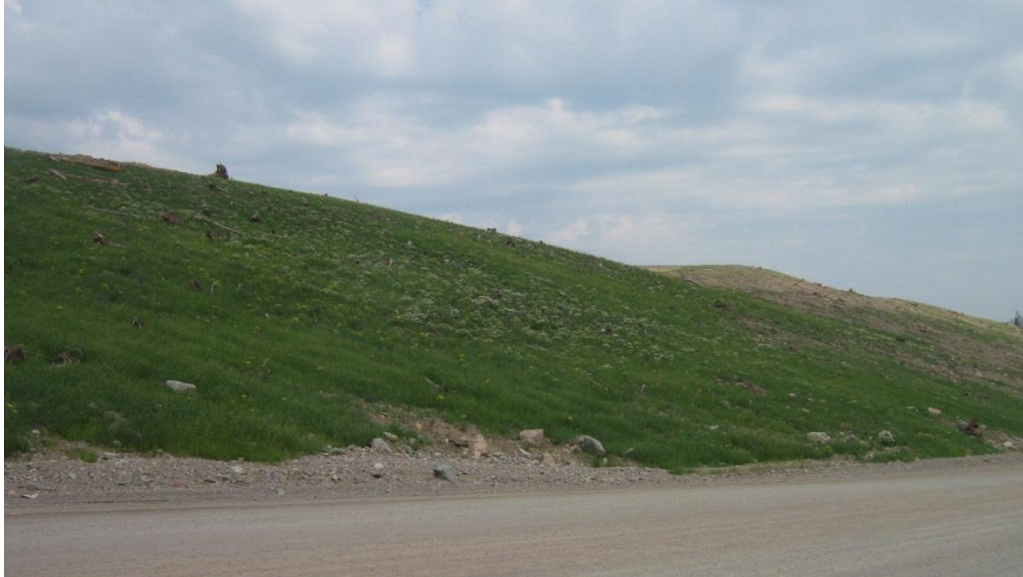
The differences in re-vegetation across the slope (between transects) after one year can likely be largely attributed to soil quality variability. For example, growth was more uniform in Transect 2, while in Transects 5 and 6, it was more irregular. In addition, areas with little to no growth had much rockier soil, with virtually no topsoil (A horizon) and very little subsoil (B Horizon). These areas were generally at the lower portion of the slope, and likely did not receive the prescribed soil application, as it was a long “push” for equipment. Soil variability could also be responsible for the differences in invasive and non-planted species, as species and abundance of viable seed in the soil units applied can vary (Figure 5).

**Figure 5.** Variation in species and abundance of non-planted species across the reclaimed slope

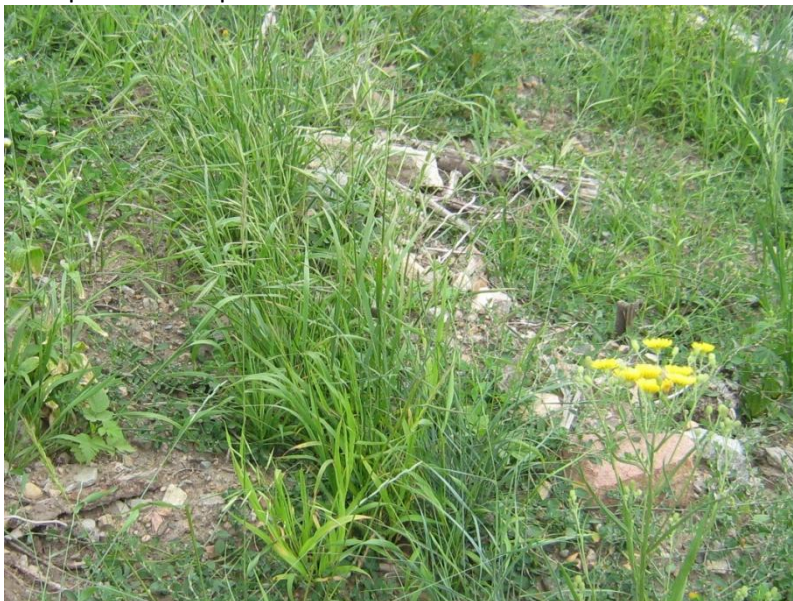
The application of woody debris to the reclaimed surface proved successful and creating improved microsites for plants, as did any berms or areas surface roughness (Figure 6).

**Figure 6.** Improved growth in microsites created by surface roughness
