**Independent Expert Engineering Investigation and Review Panel**

**Report on Mount Polley  
Tailings Storage Facility Breach**

**Appendix C: ATTACHMENTS**

## ATTACHMENT C1: LABORATORY TEST RESULTS

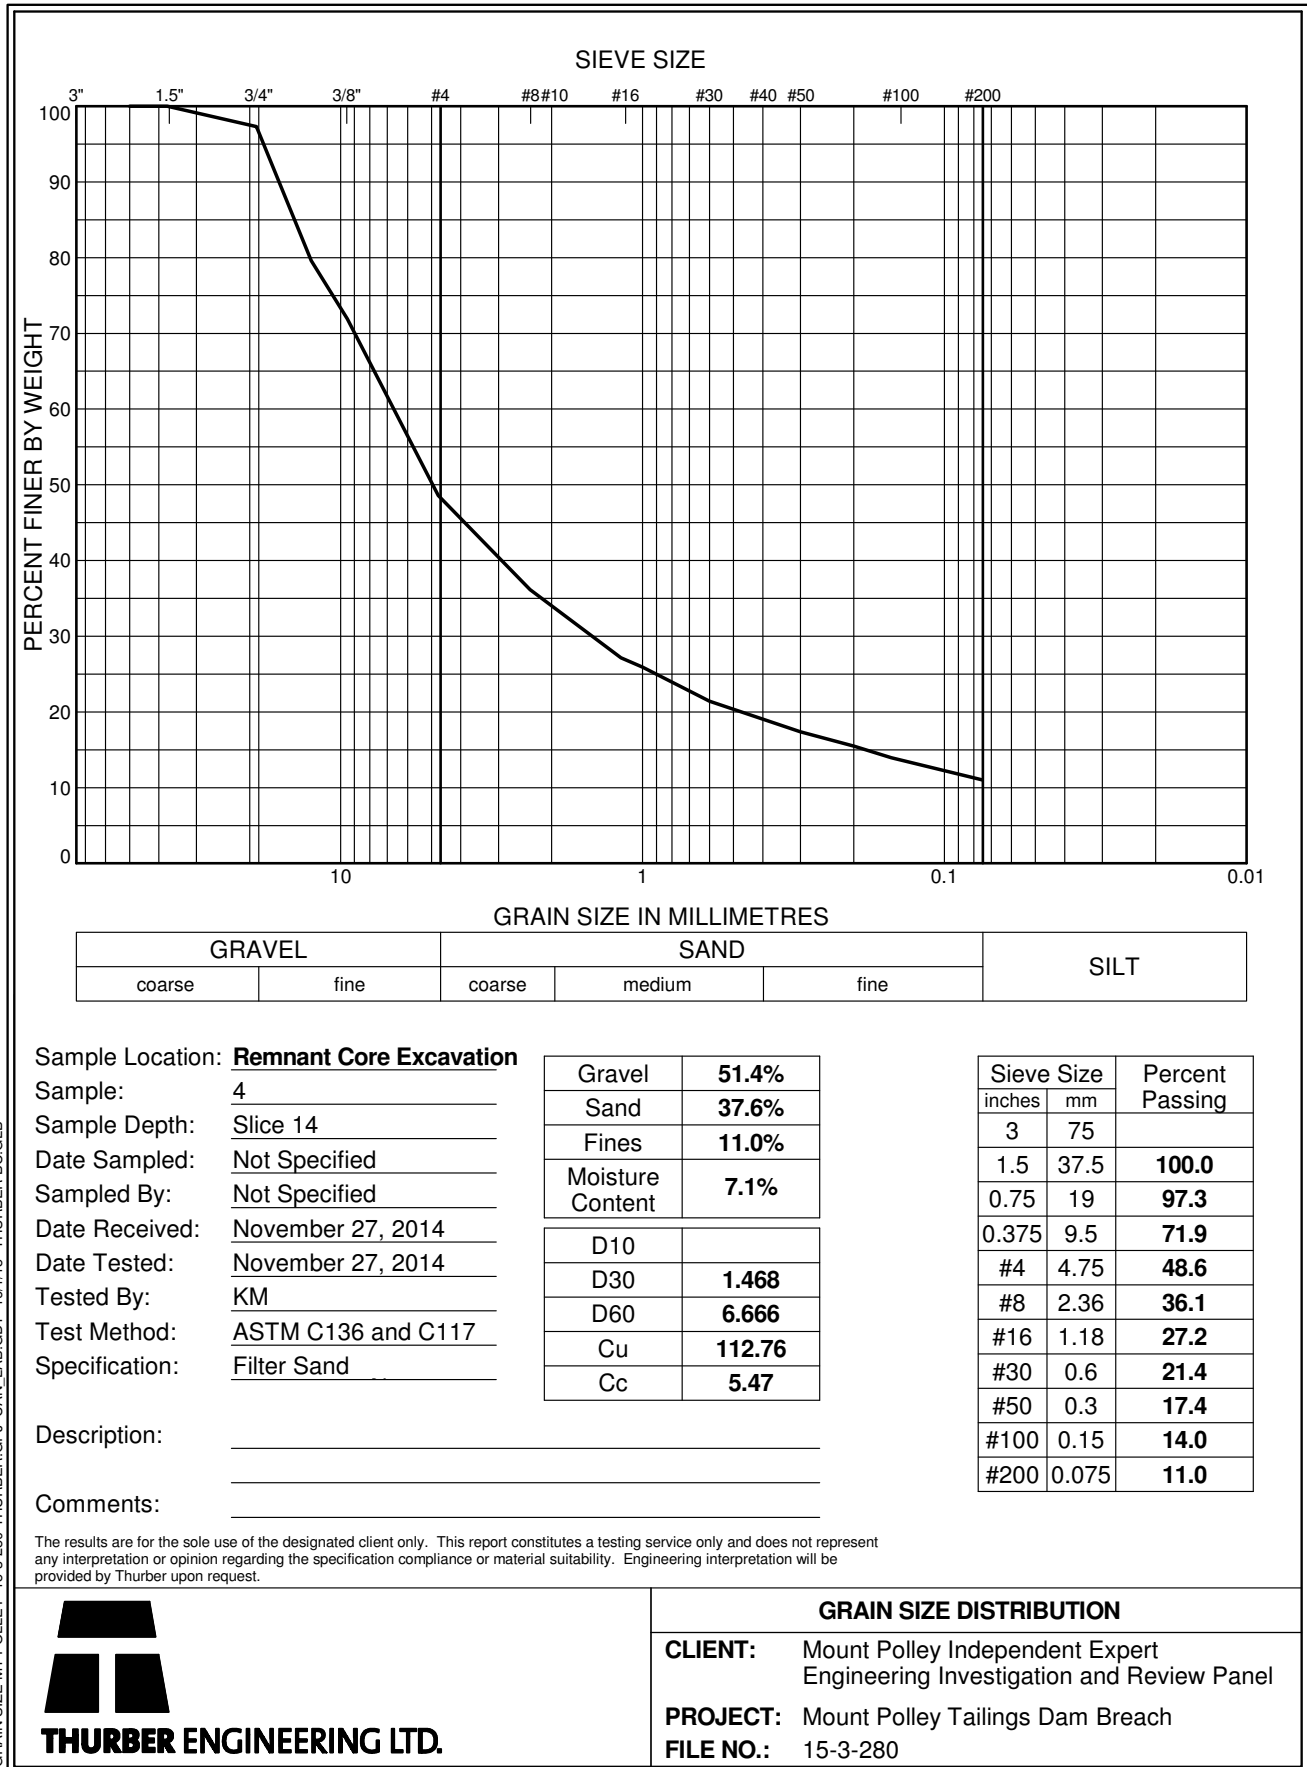
Gradation curves are shown on the following grain size plots.<sup>1</sup>

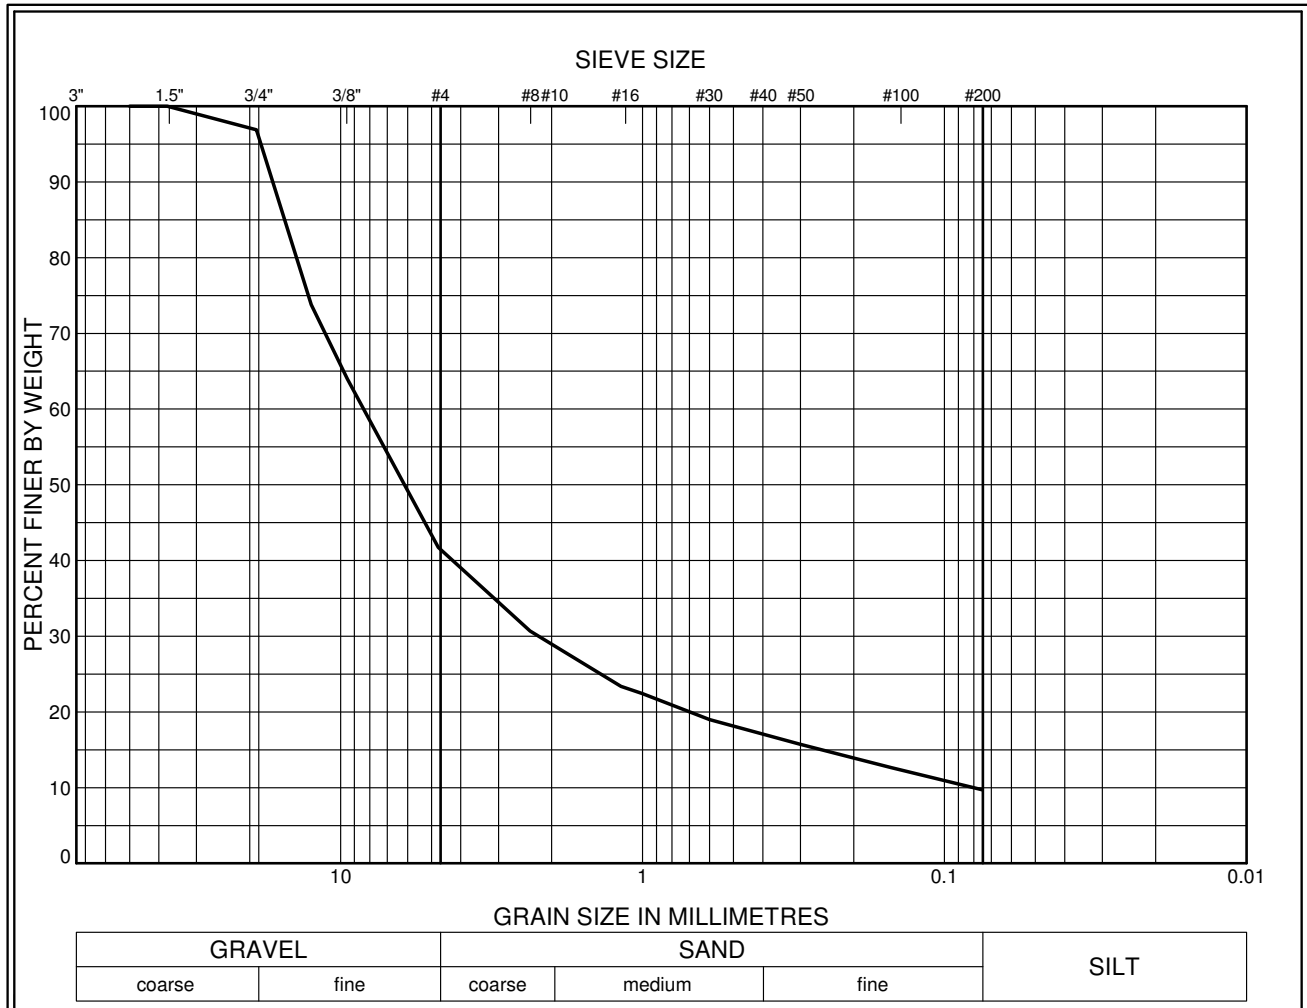
Sample Location: **Remnant Core Excavation**

Sample: 7  
 Sample Depth: Slice 18  
 Date Sampled: Not Specified  
 Sampled By: Not Specified  
 Date Received: November 27, 2014  
 Date Tested: November 27, 2014  
 Tested By: KM  
 Test Method: ASTM C136 and C117  
 Specification: Filter Sand

Gravel	<b>58.3%</b>
Sand	<b>32.0%</b>
Fines	<b>9.7%</b>
Moisture Content	<b>6.8%</b>

D10	<b>0.08</b>
D30	<b>2.208</b>
D60	<b>8.39</b>
Cu	<b>104.59</b>
Cc	<b>7.24</b>

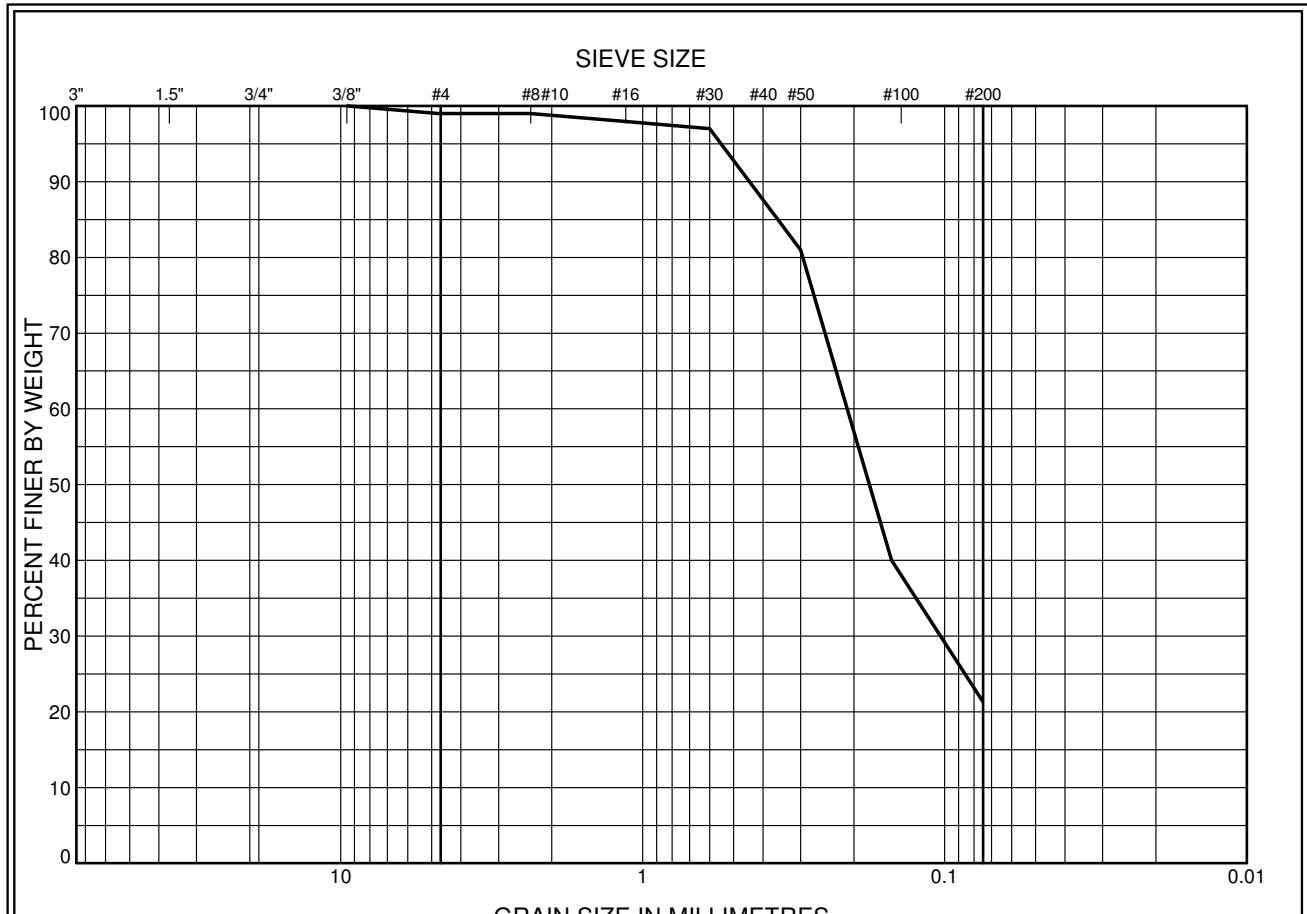
Sample Location: **Remnant Core Excavation**

Sample: 8

Sample Depth: Slice 18

Gravel	<b>1.0%</b>
Sand	<b>77.6%</b>
Fines	<b>21.4%</b>
Moisture Content	<b>15.7%</b>

D10	
D30	<b>0.103</b>
D60	<b>0.21</b>
Cu	
Cc

Sieve Size		Percent Passing
inches	mm	
3	75	
1.5	37.5	
0.75	19	
0.375	9.5	<b>100.0</b>
#4	4.75	<b>99.0</b>
#8	2.36	<b>99.0</b>
#16	1.18	<b>98.0</b>
#30	0.6	<b>97.0</b>
#50	0.3	<b>81.0</b>
#100	0.15	<b>40.0</b>
#200	0.075	<b>21.4</b>

The following describes an assessment of the origin of the reddish sand observed in the remnant core in cracks, pockets and the shear during the remnant till core excavation. Grain size analyses (GSA) were conducted on the Slice 18 sand sample, three of the till samples, and on the sand grab samples collected during the initial field mapping investigation for comparison.

The GSA of the Slice 18 sand sample was compared to the coarse and fine limits of cycloned sand underflow measured during construction in 1999.<sup>2</sup> The particle shape, colour and visual mineralogy of the sand-size particles from the Slice 18 sand were also compared to the till core samples. The Slice 18 sample has a similar distribution of particle sizes to the cycloned sand, but is at or beyond the coarse limit of the 1999 samples.

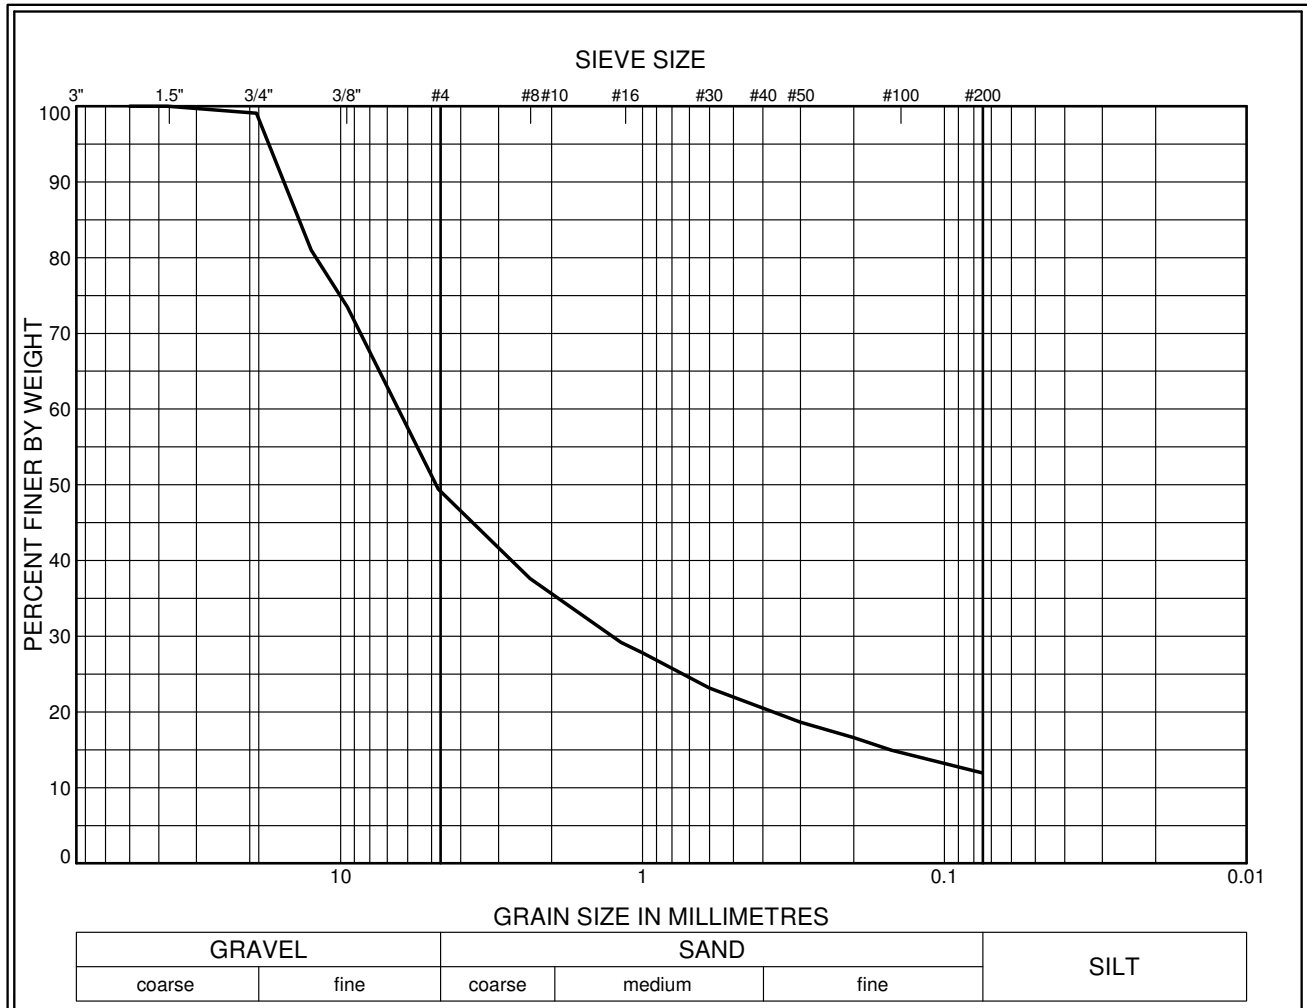
Sample Location: **Remnant Core Excavation**

Sample: 9  
 Sample Depth: Slice 20  
 Date Sampled: Not Specified  
 Sampled By: Not Specified  
 Date Received: November 27, 2014  
 Date Tested: November 27, 2014  
 Tested By: KM  
 Test Method: ASTM C136 and C117  
 Specification: Filter Sand

Gravel	<b>50.6%</b>
Sand	<b>37.5%</b>
Fines	<b>12.0%</b>
Moisture Content	<b>8.1%</b>

D10	
D30	<b>1.262</b>
D60	<b>6.439</b>
Cu	<b>134.50</b>
Cc	<b>5.17</b>

Sieve Size		Percent Passing
inches	mm	
3	75	
1.5	37.5	<b>100.0</b>
0.75	19	<b>99.1</b>
0.375	9.5	<b>73.5</b>
#4	4.75	<b>49.4</b>
#8	2.36	<b>37.6</b>
#16	1.18	<b>29.2</b>
#30	0.6	<b>23.1</b>
#50	0.3	<b>18.7</b>
#100	0.15	<b>15.0</b>
#200	0.075	<b>12.0</b>

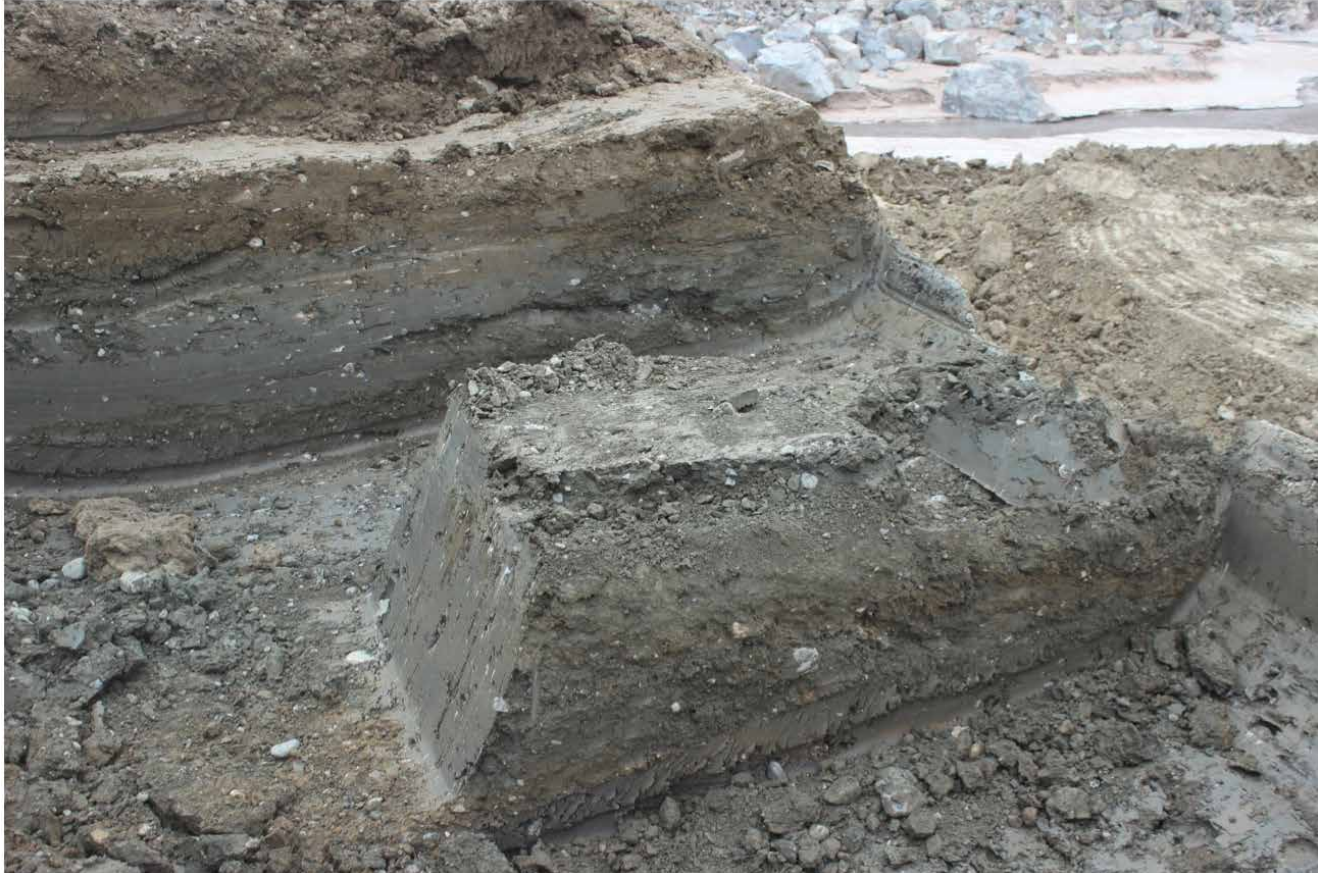
**FIGURE 1: EXCAVATED PEDESTAL FOR BLOCK SAMPLE 1**

**Figure 1** below shows the pedestal prepared for Block Sample 1.

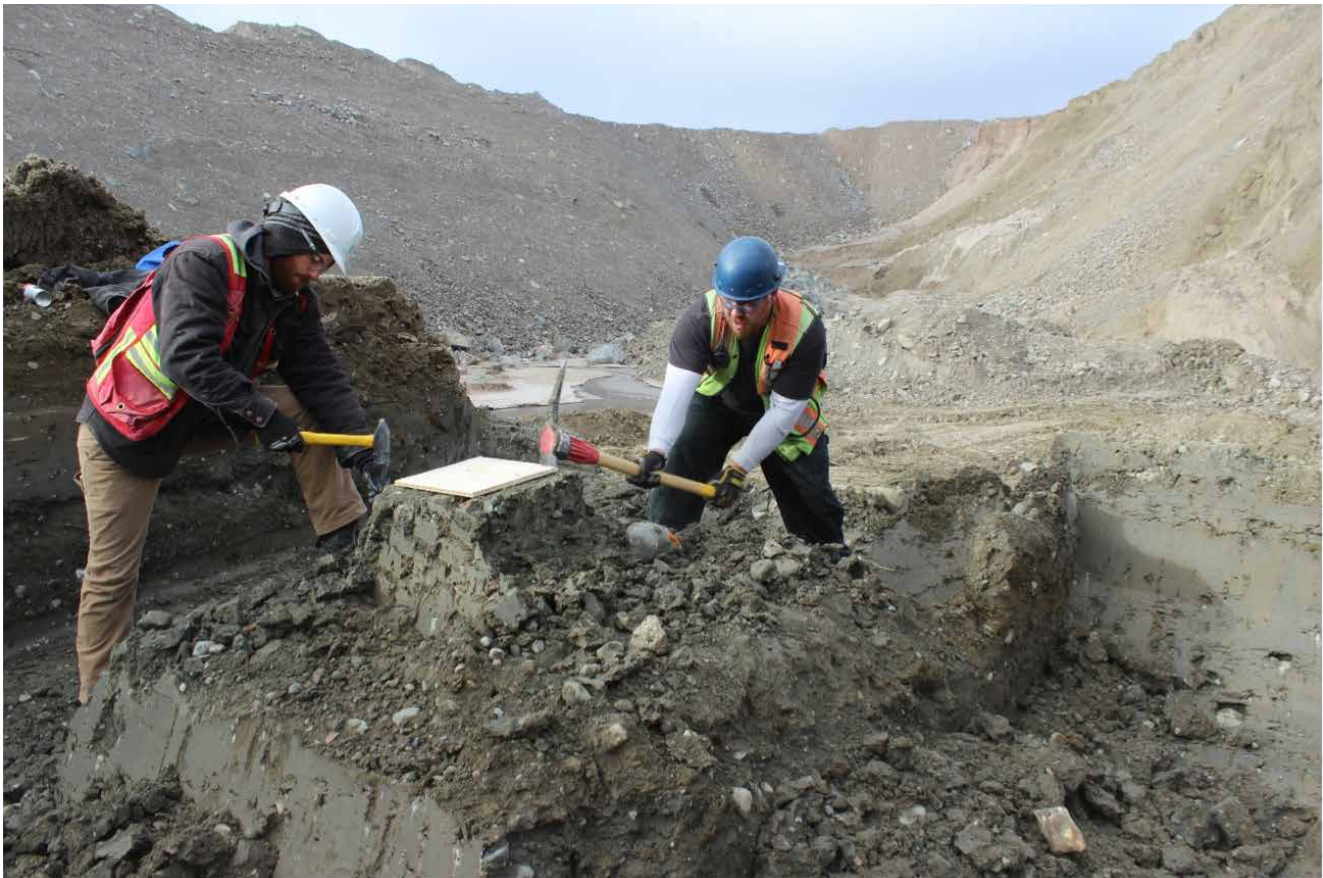
**FIGURE 2: TRIMMING BLOCK SAMPLE 1**

**Figure 2** below shows Block Sample 1 being trimmed to final size using a pick axe and a sledge hammer with a chisel. The material classified as very stiff till with trace to some gravel and cobbles, and the cobble content made trimming to the exact size difficult. Consequently, it was decided to use a large box (450 mm inside dimensions) to allow placement of packing materials around the oversize sample to avoid the precise trimming and the significant gravel and cobble removal this would entail.

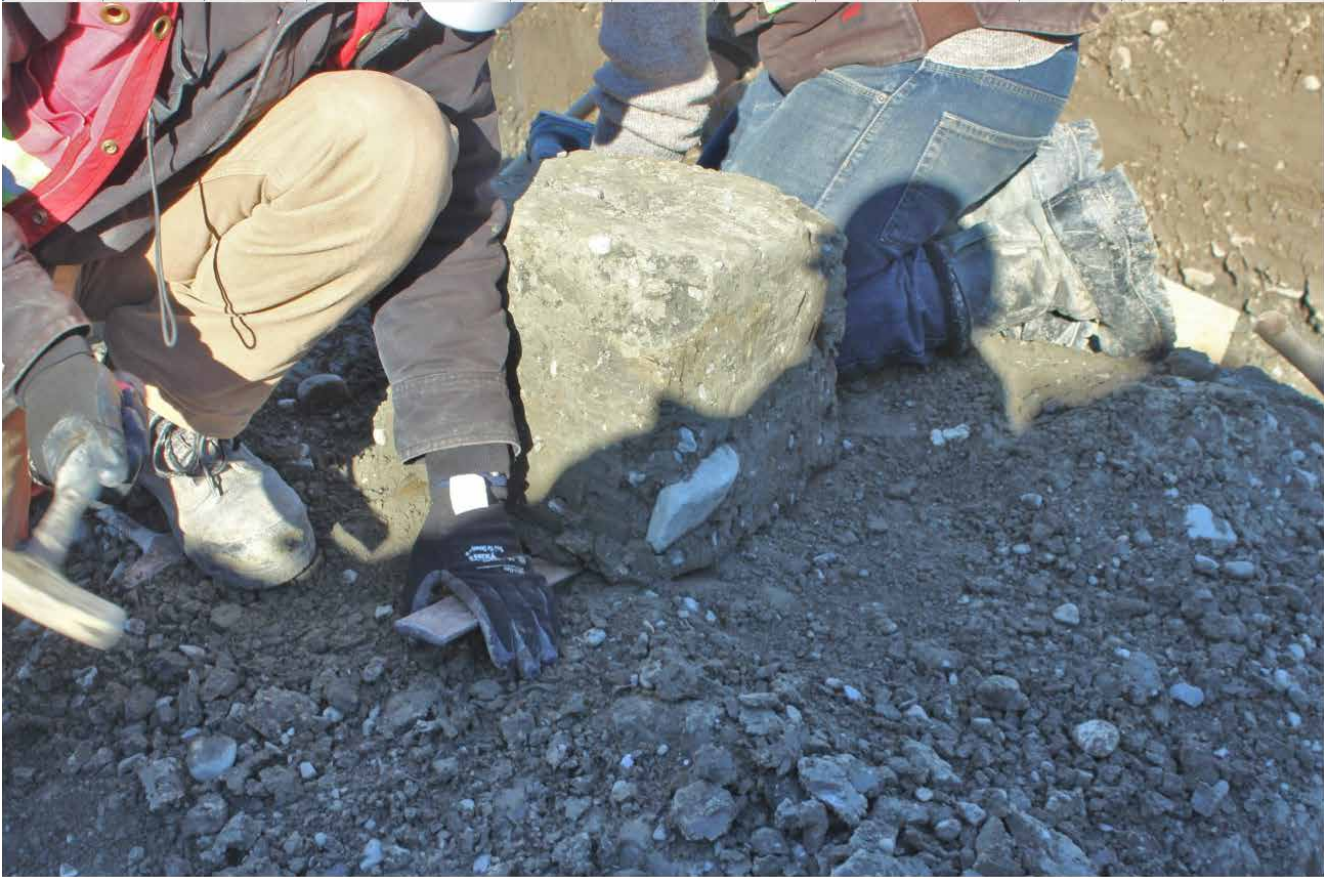
**FIGURE 3: CHISELING THE BASE OF BLOCK SAMPLE 1**

**Figure 3** below shows the final trimming step using 50 mm wide, 5 mm thick steel chisels with a single-beveled tip to cut the sample from the base of the pedestal. Once the chisels had been inserted from all sides, the sample was pried off the foundation using a flat shovel underneath the fully inserted chisels.

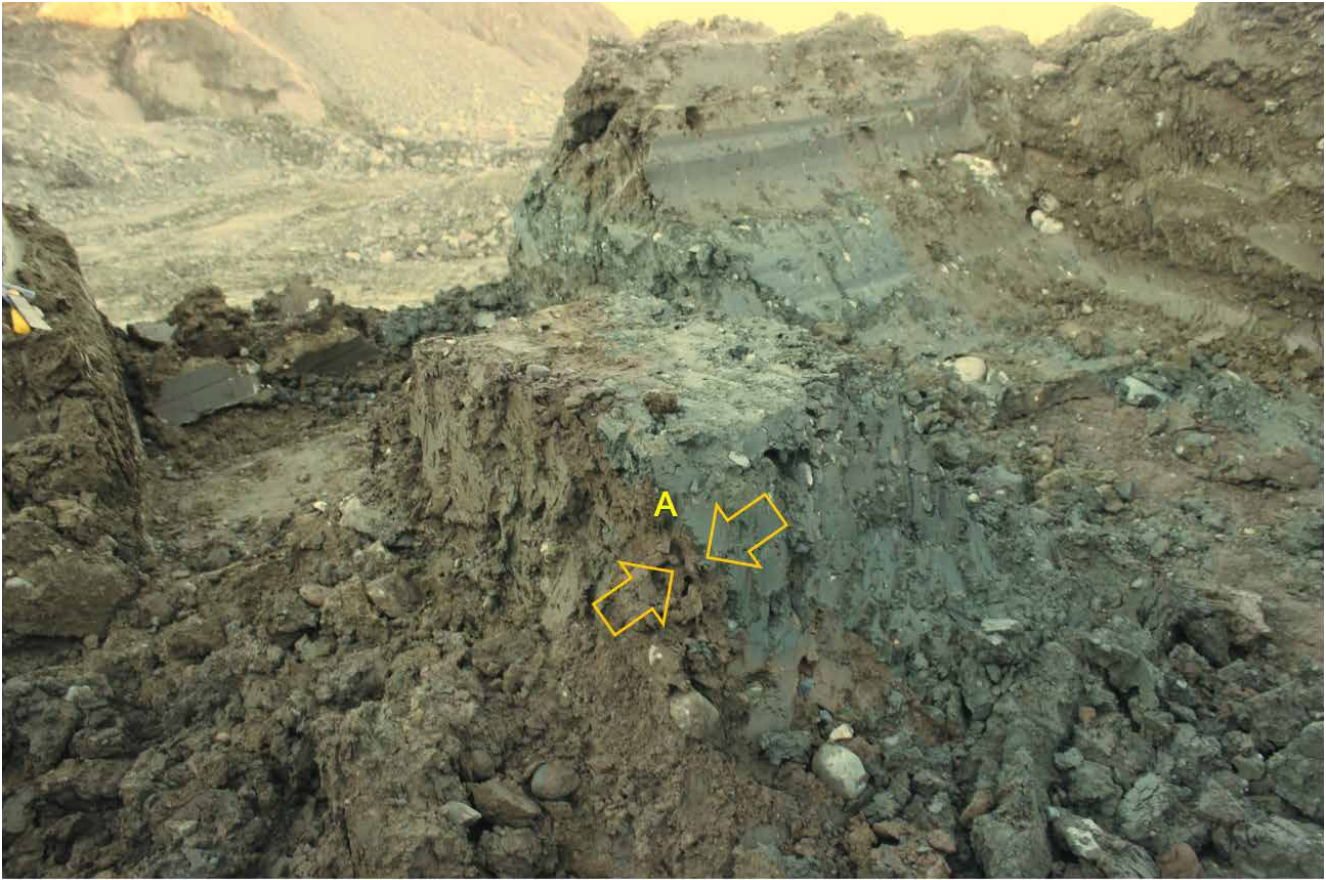
**FIGURE 4: PEDESTAL FOR BLOCK SAMPLE 2**

**Figure 4** below shows the pedestal prepared for Block Sample 2. The shear (A) passing through the pedestal is denoted by a distinct contact between brown till fill on the upstream side and grey on the downstream side. It is not known if the shear is also associated with a construction material interface.

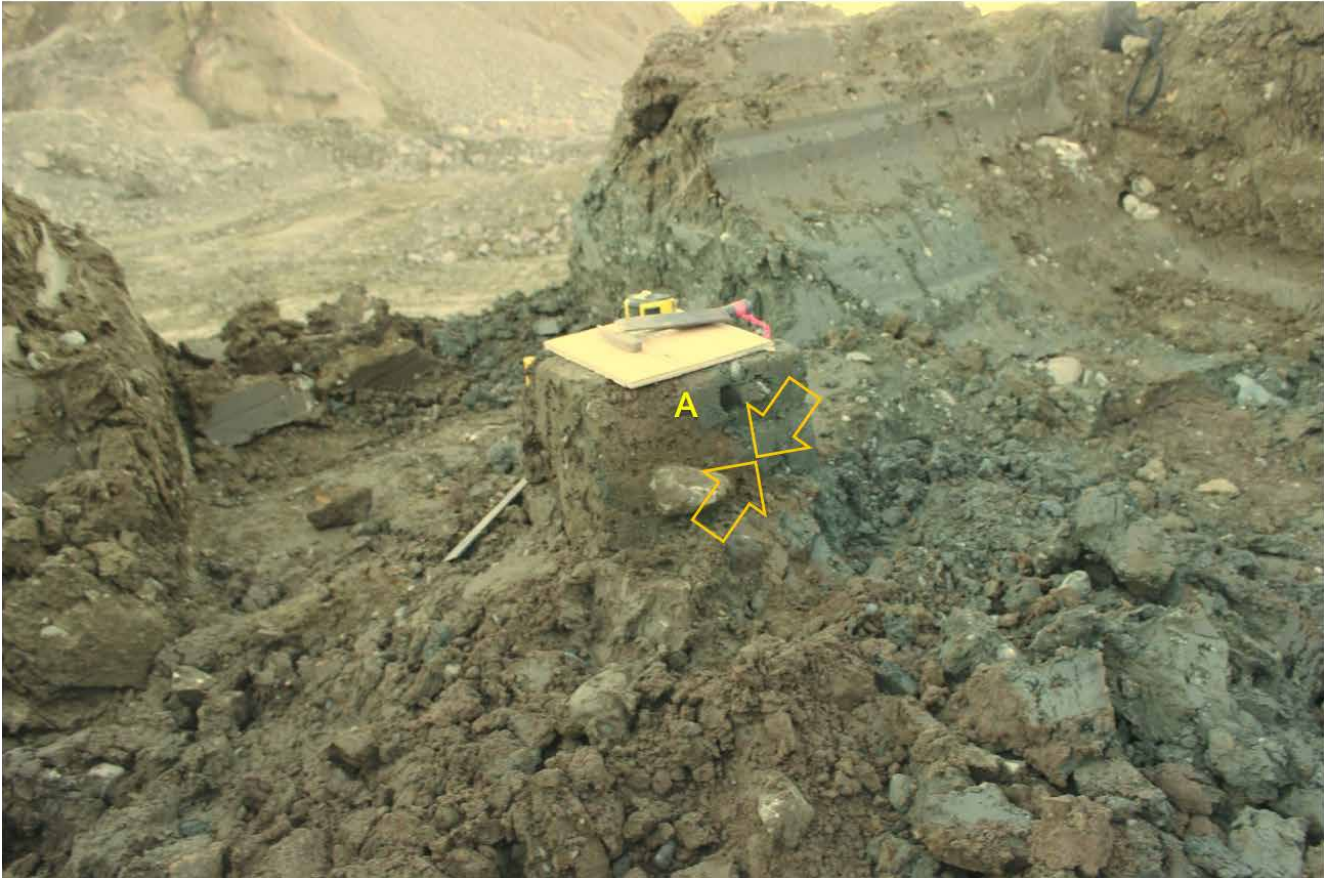
**FIGURE 5: PHOTO SHOWING THE PARTIALLY TRIMMED BLOCK SAMPLE 2**

**Figure 5** below shows the Block Sample 2 prior to final trimming. Several large cobbles near the shear plane make trimming difficult. Sand deposits are also present along the shear plane (A) and very little cohesion was observed in the plane during trimming. The sample is considered very fragile was allowed to freeze overnight to reduce the likelihood of breakage during removal.

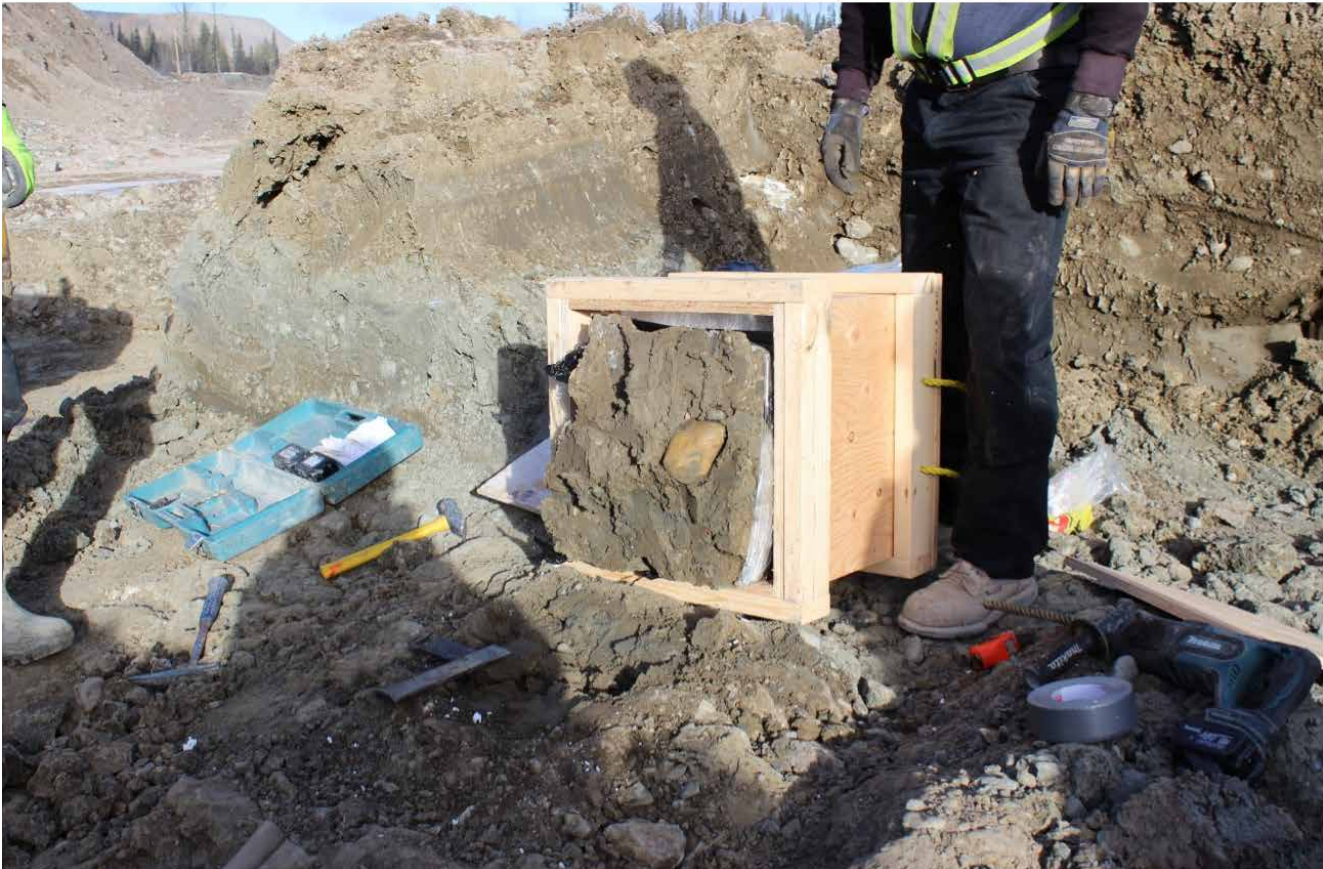
**FIGURE 6: BASE OF BLOCK SAMPLE 2 READY FOR FINAL TRIMMING**

**Figure 6** below shows Block Sample 2 being prepared for transport. The open plywood box was lowered over the sample and packed with polystyrene foam on the sides. The top was then packed with polystyrene foam and the lid screwed in place. The sample was tilted on its side for final trimming of the base and installation of the box bottom.

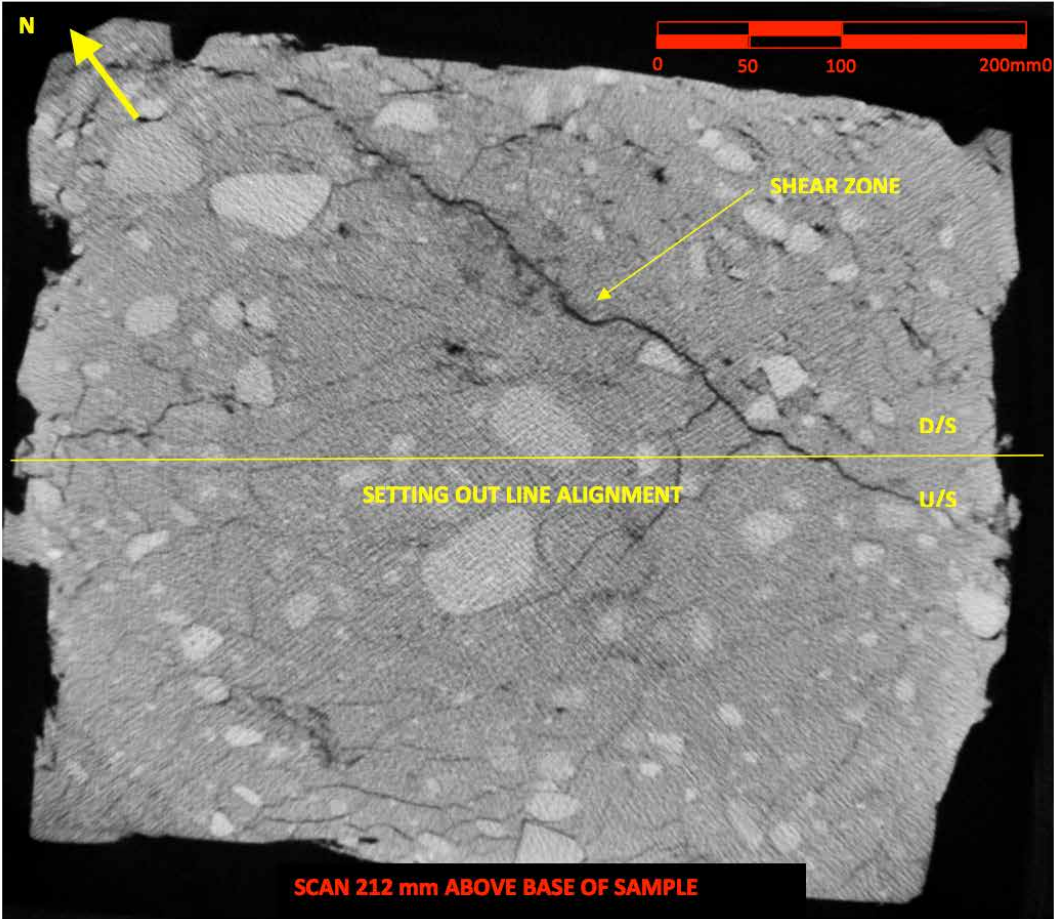
FIGURE 7: ORIENTATION AND CONFIGURATION OF SHEAR ZONE IN BLOCK SAMPLE SCAN

The block sample remained in the field packaging and was oriented vertically when placed on the scanning platform. CT scans were completed at horizontal slices at a 50 mm vertical spacing up the entire height of the sample. The CT scanning method utilized does produce some noise in the images due to wave interference, typically manifesting as small scale lineal features. A select CT scan is shown in **Figure 7** where the shear zone can be clearly identified.

Block sample 2 across the shear zone was subjected to scanning at FP Innovations at the University of British Columbia, a facility capable of completing X-rays and CT scanning on large items. CT scanning on the block samples was performed following several rounds of CT scans on thin-walled tube samples, which included a prototyping scanning exercise to determine the scanning technique and orientation providing the best information.
