Independent Expert Engineering Investigation and Review Panel

**Report on Mount Polley
Tailings Storage Facility Breach**

Appendix G: DRAWINGS

Drawing G1: TSF Crest and Pond Elevations

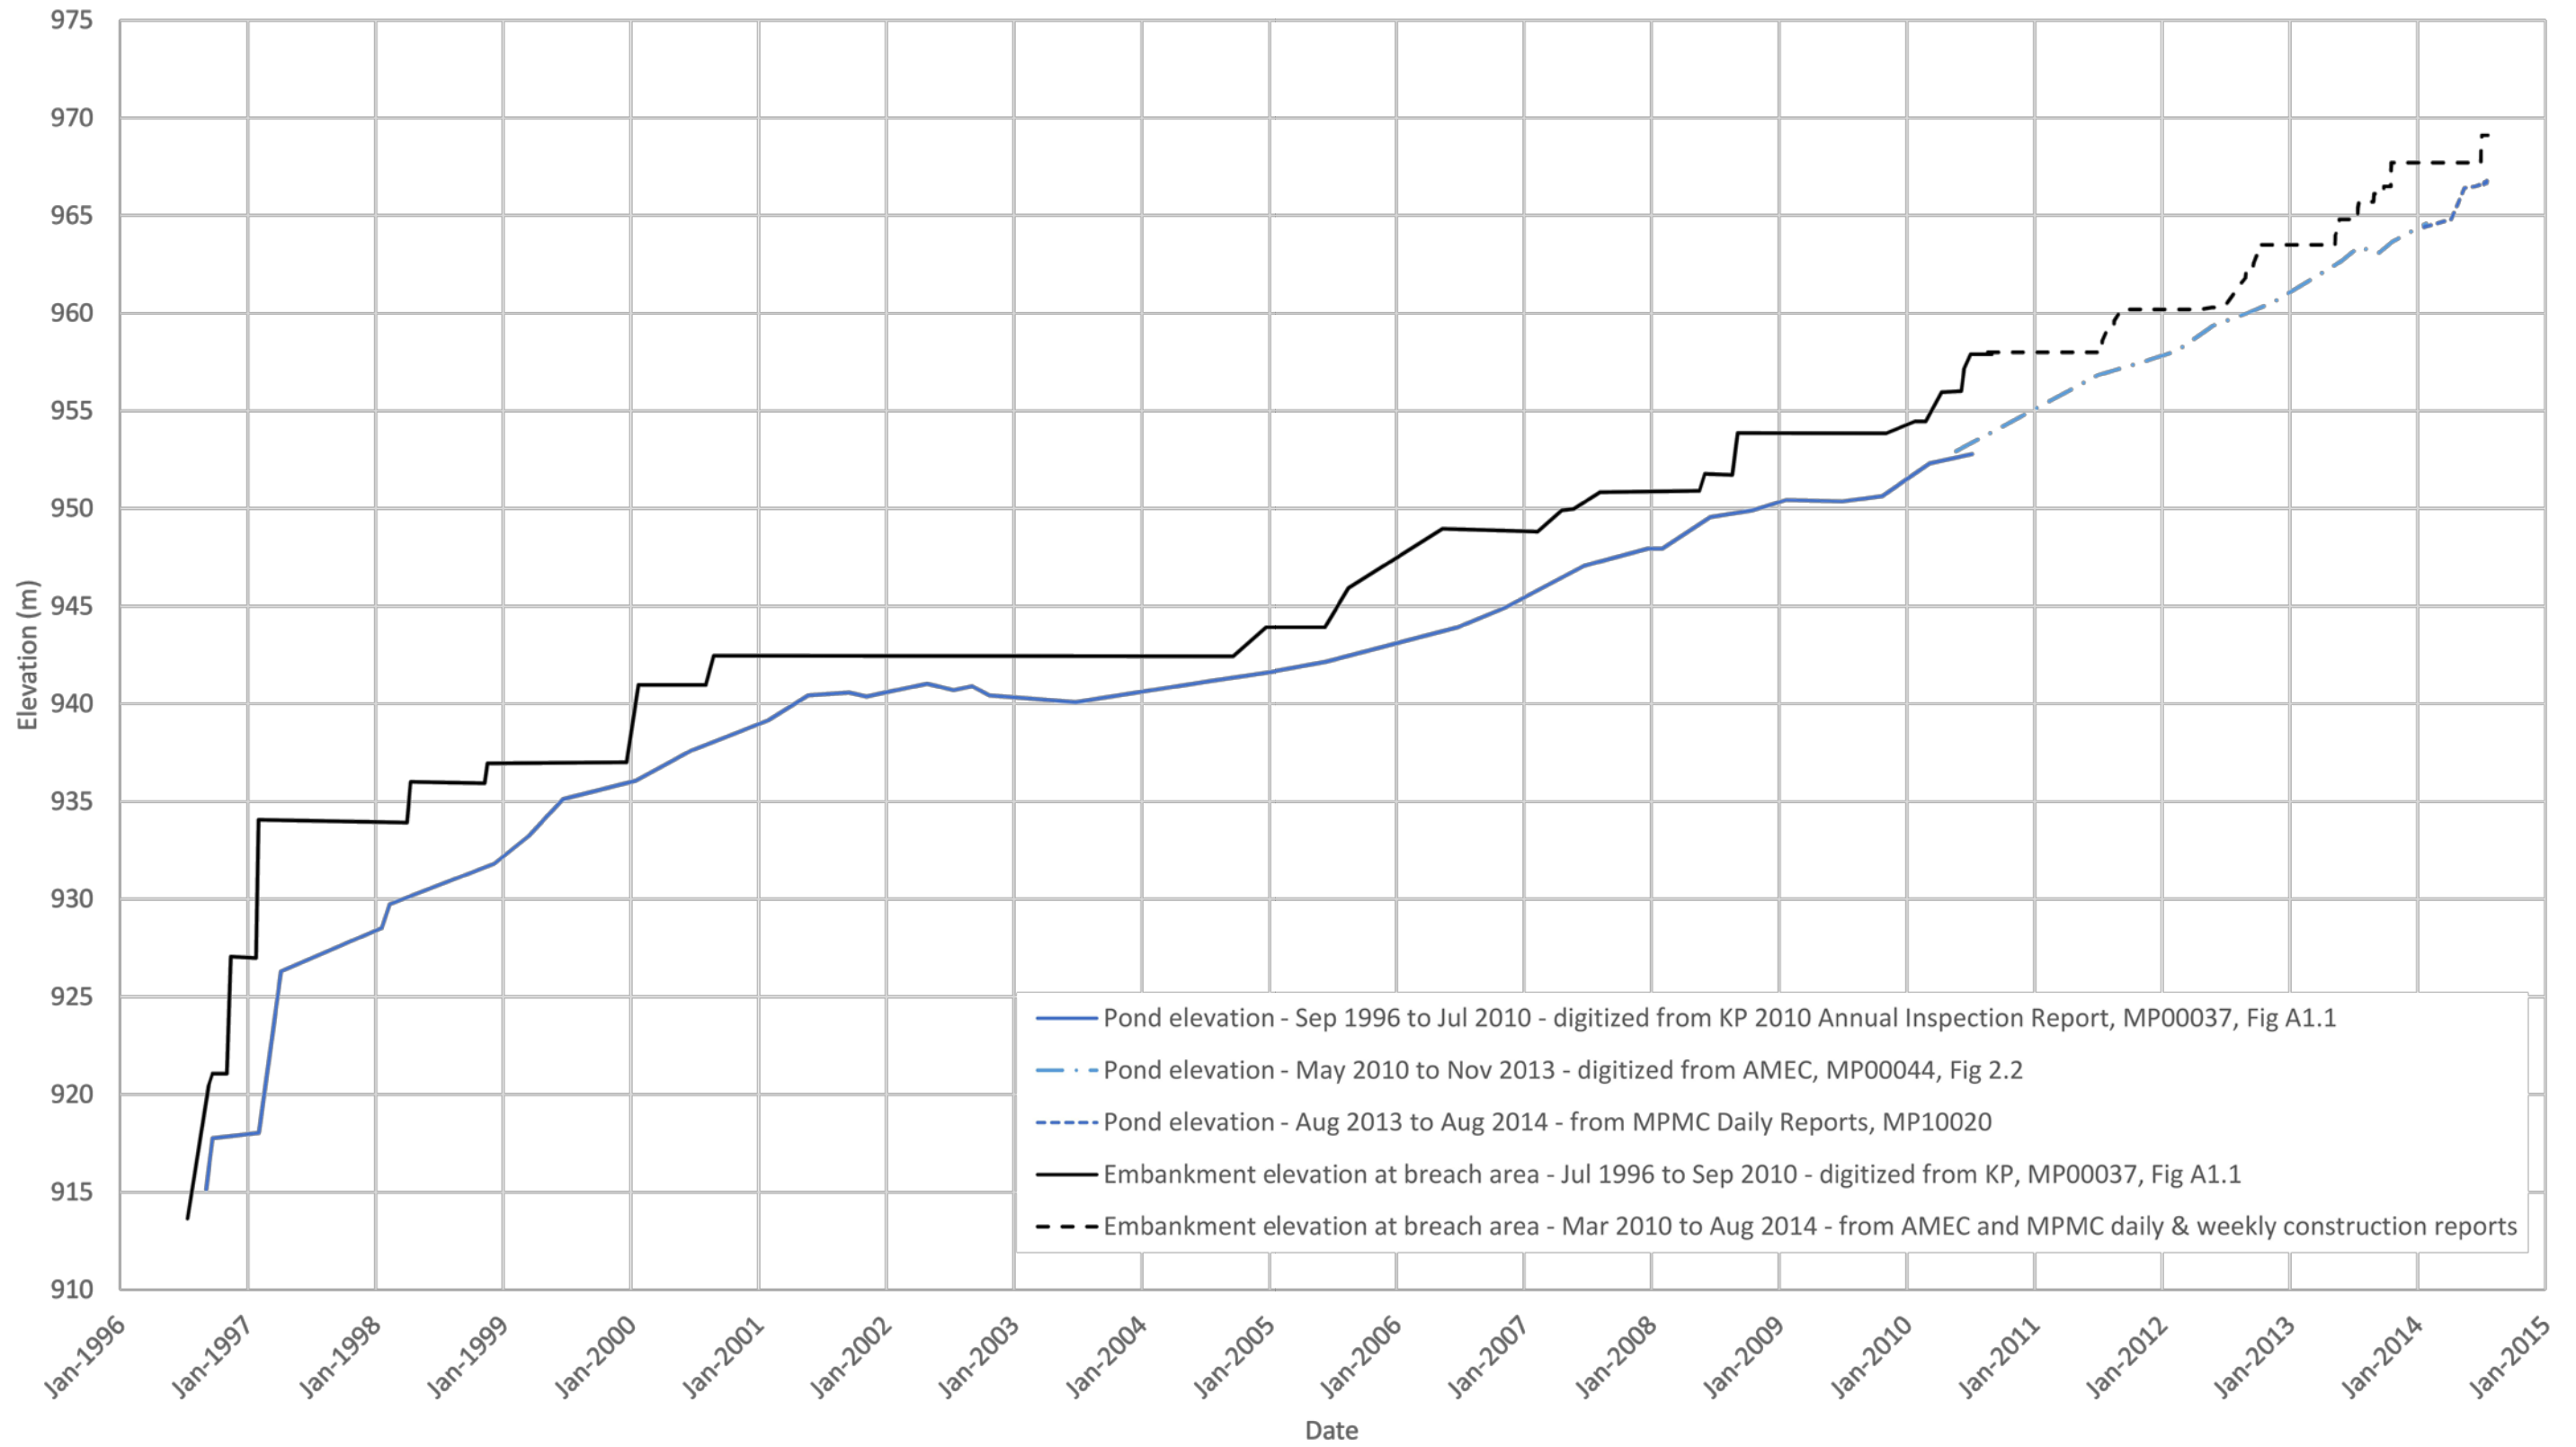
Mount Polley TSF Filling Curve

— Pond elevation - Sep 1996 to Jul 2010 - digitized from KP 2010 Annual Inspection Report, MP00037, Fig A1.1
 - · - Pond elevation - May 2010 to Nov 2013 - digitized from AMEC, MP00044, Fig 2.2
 - - - Pond elevation - Aug 2013 to Aug 2014 - from MPMC Daily Reports, MP10020
 — Embankment elevation at breach area - Jul 1996 to Sep 2010 - digitized from KP, MP00037, Fig A1.1
 - - - Embankment elevation at breach area - Mar 2010 to Aug 2014 - from AMEC and MPMC daily & weekly construction reports
