# MOUNT POLLEY MINE
# Tailings Storage Facility Stage 9
# 2013 As-Built Report and Annual Report

**Mount Polley Mining Corporation,**
Likely, BC

**AMEC Environment & Infrastructure,**
**a division of AMEC Americas Limited**
Burnaby, BC

February 2014
VM00560C

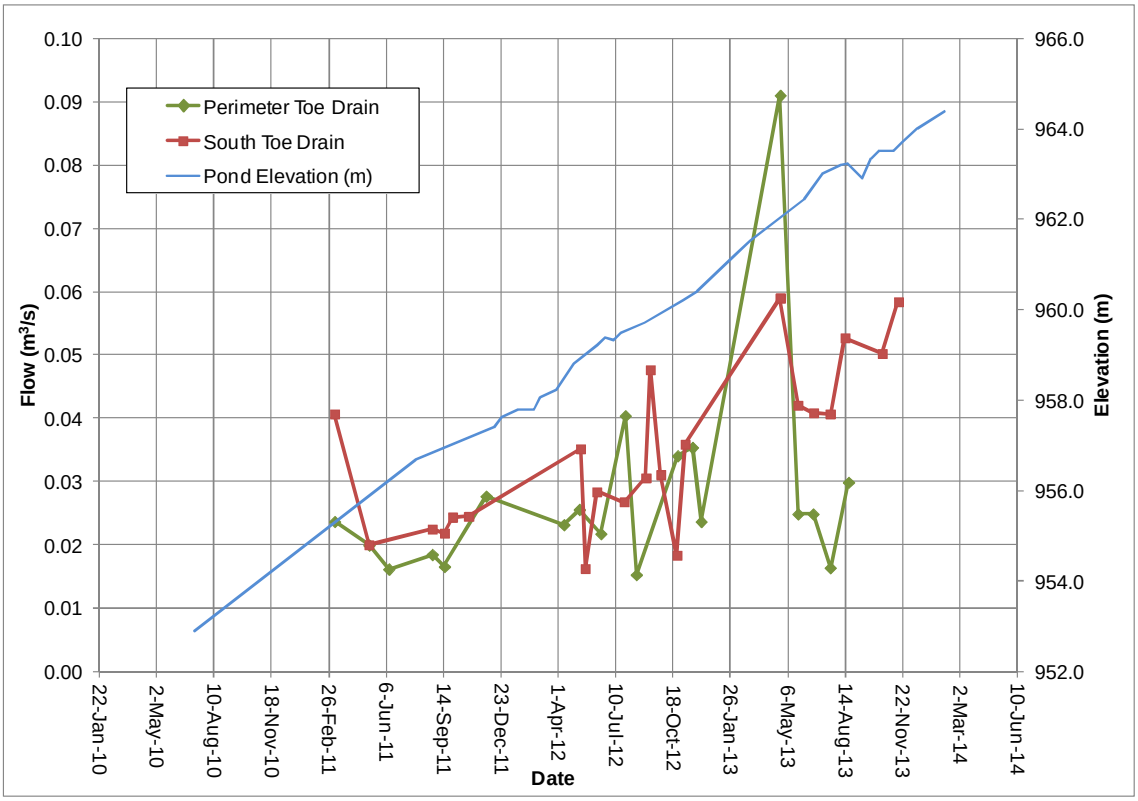
***Figure 2.1: Main Embankment, Perimeter Embankment and South Embankment Drain Flow Readings***

Flows from the upstream toe drain and foundation drains of the Main Embankment were historically measured at the sump located at the Main Embankment seepage collection pond, and are now measured at a manifold located at a water transfer station near the Main Embankment seepage collection pond (constructed as part of the discharge system installation completed in 2013). Upstream toe drains from the Perimeter Embankment and South Embankment discharge into ditches which carry the flow to their respective seepage collection ponds. Flow for the Perimeter Embankment and South Embankment are measured across the ditch profile as close to the end of the pipe as possible. Water from the upstream toe and foundation drains is recycled to the TSF, evaporated or discharged in accordance with permitted activities, the combination of which is dictated by the site water management strategy.
