Independent Expert Engineering Investigation and Review Panel

Report on Mount Polley Tailings Storage Facility Breach Media Presentation

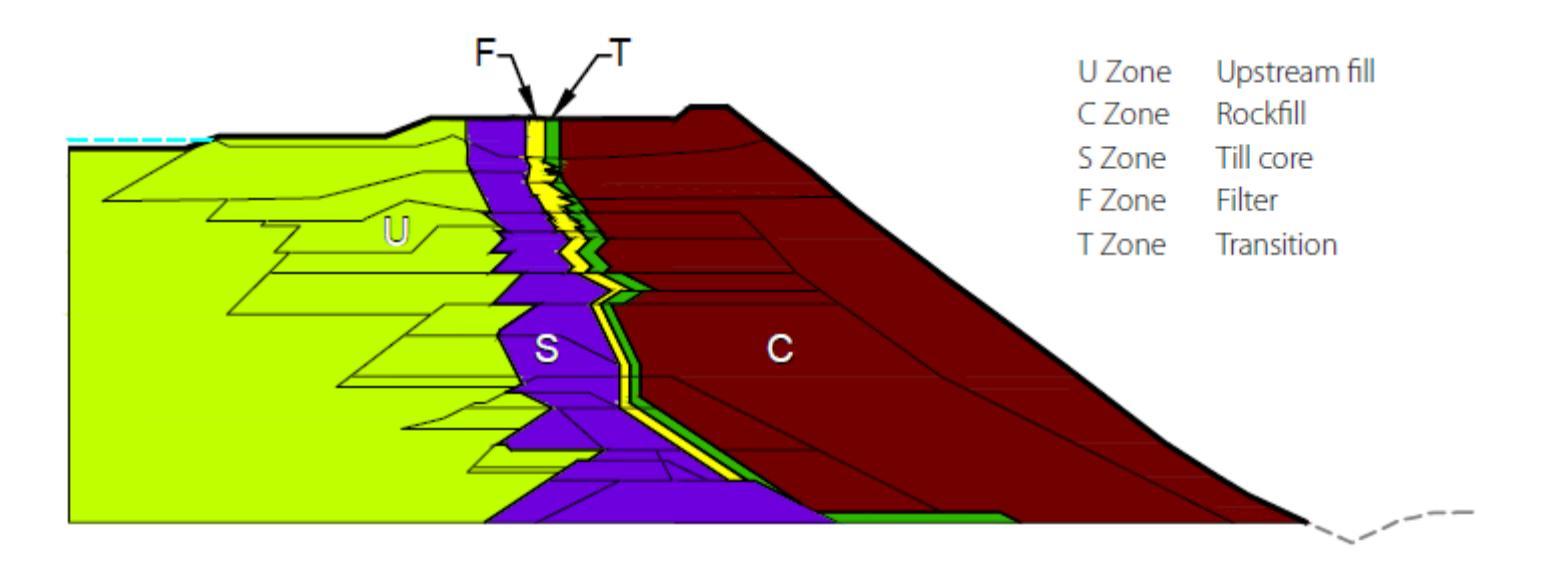
FIGURE 4.1.1: SIMPLIFIED CROSS-SECTION OF THE MOUNT POLLEY DAM

- The Panel concluded that evidence indicates the breach was the result of failure in the foundation of the embankment, a failure that occurred in a glaciolacustrine (GLU) layer of the embankment's foundation.
- According to the Panel's report: "The Panel concluded that the dominant contribution to the failure resides in the design. The design did not take into the account the complexity of the sub-glacial and pre-glacial geological environment associated with the perimeter embankment foundation. As a result, foundation investigations and associated site characterization failed to identify a continuous GLU layer in the vicinity of the breach and to recognize that it was susceptible to undrained failure when subject to the stresses associated with the embankment."
