**MOUNT POLLEY MINING CORPORATION  
MOUNT POLLEY MINE**

**TAILINGS STORAGE FACILITY  
REPORT ON 2009 ANNUAL INSPECTION**

VA101-1/27-1  
Rev 1  
January 5, 2010

**TAILINGS STORAGE FACILITY  
REPORT ON 2009 ANNUAL INSPECTION  
(REF. NO. VA101-1/27-1)**

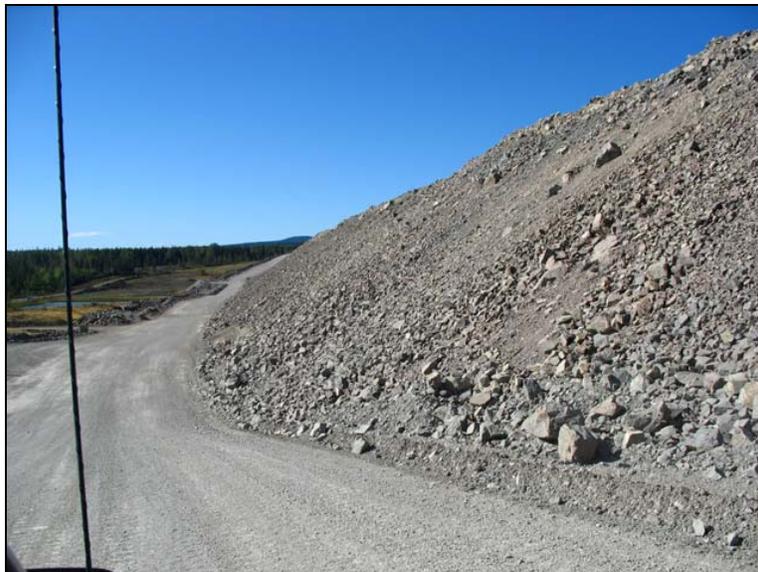
**PHOTO 5** – Main Embankment looking west

The TSF embankments were observed to be in good condition. No seepage or slumping was observed and no signs of instability were observed in the embankment fill slopes. No major unexpected or uncontrolled seepage was observed from the embankments.
