**MOUNT POLLEY MINING CORPORATION
MOUNT POLLEY MINE**

**TAILINGS STORAGE FACILITY
REPORT ON 2007 ANNUAL INSPECTION
(REF. NO. VA101-01/20-1)**

Knight Piésold Ltd.

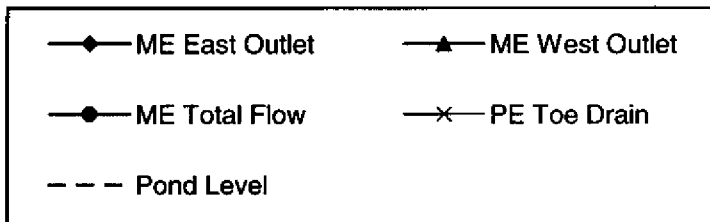
MOUNT POLLEY MINING CORPORATION	
MOUNT POLLEY MINE	
TAILINGS STORAGE FACILITY UPSTREAM TOE DRAIN FLOWS	
	PROJECT / ASSIGNMENT NO. VA 101-1/20
	REF NO. 1
FIGURE 3.1	
REV. 0

The recommended minimum tailings beach widths were generally being achieved by MPMC. However, the tailings pond was up against a section of the Main Embankment at the time of the inspection which has resulted in increased flows in the Main Embankment upstream toe drain. The first flows reporting to the Perimeter Embankment upstream toe drain that was installed in 2006 were observed in July 2007.

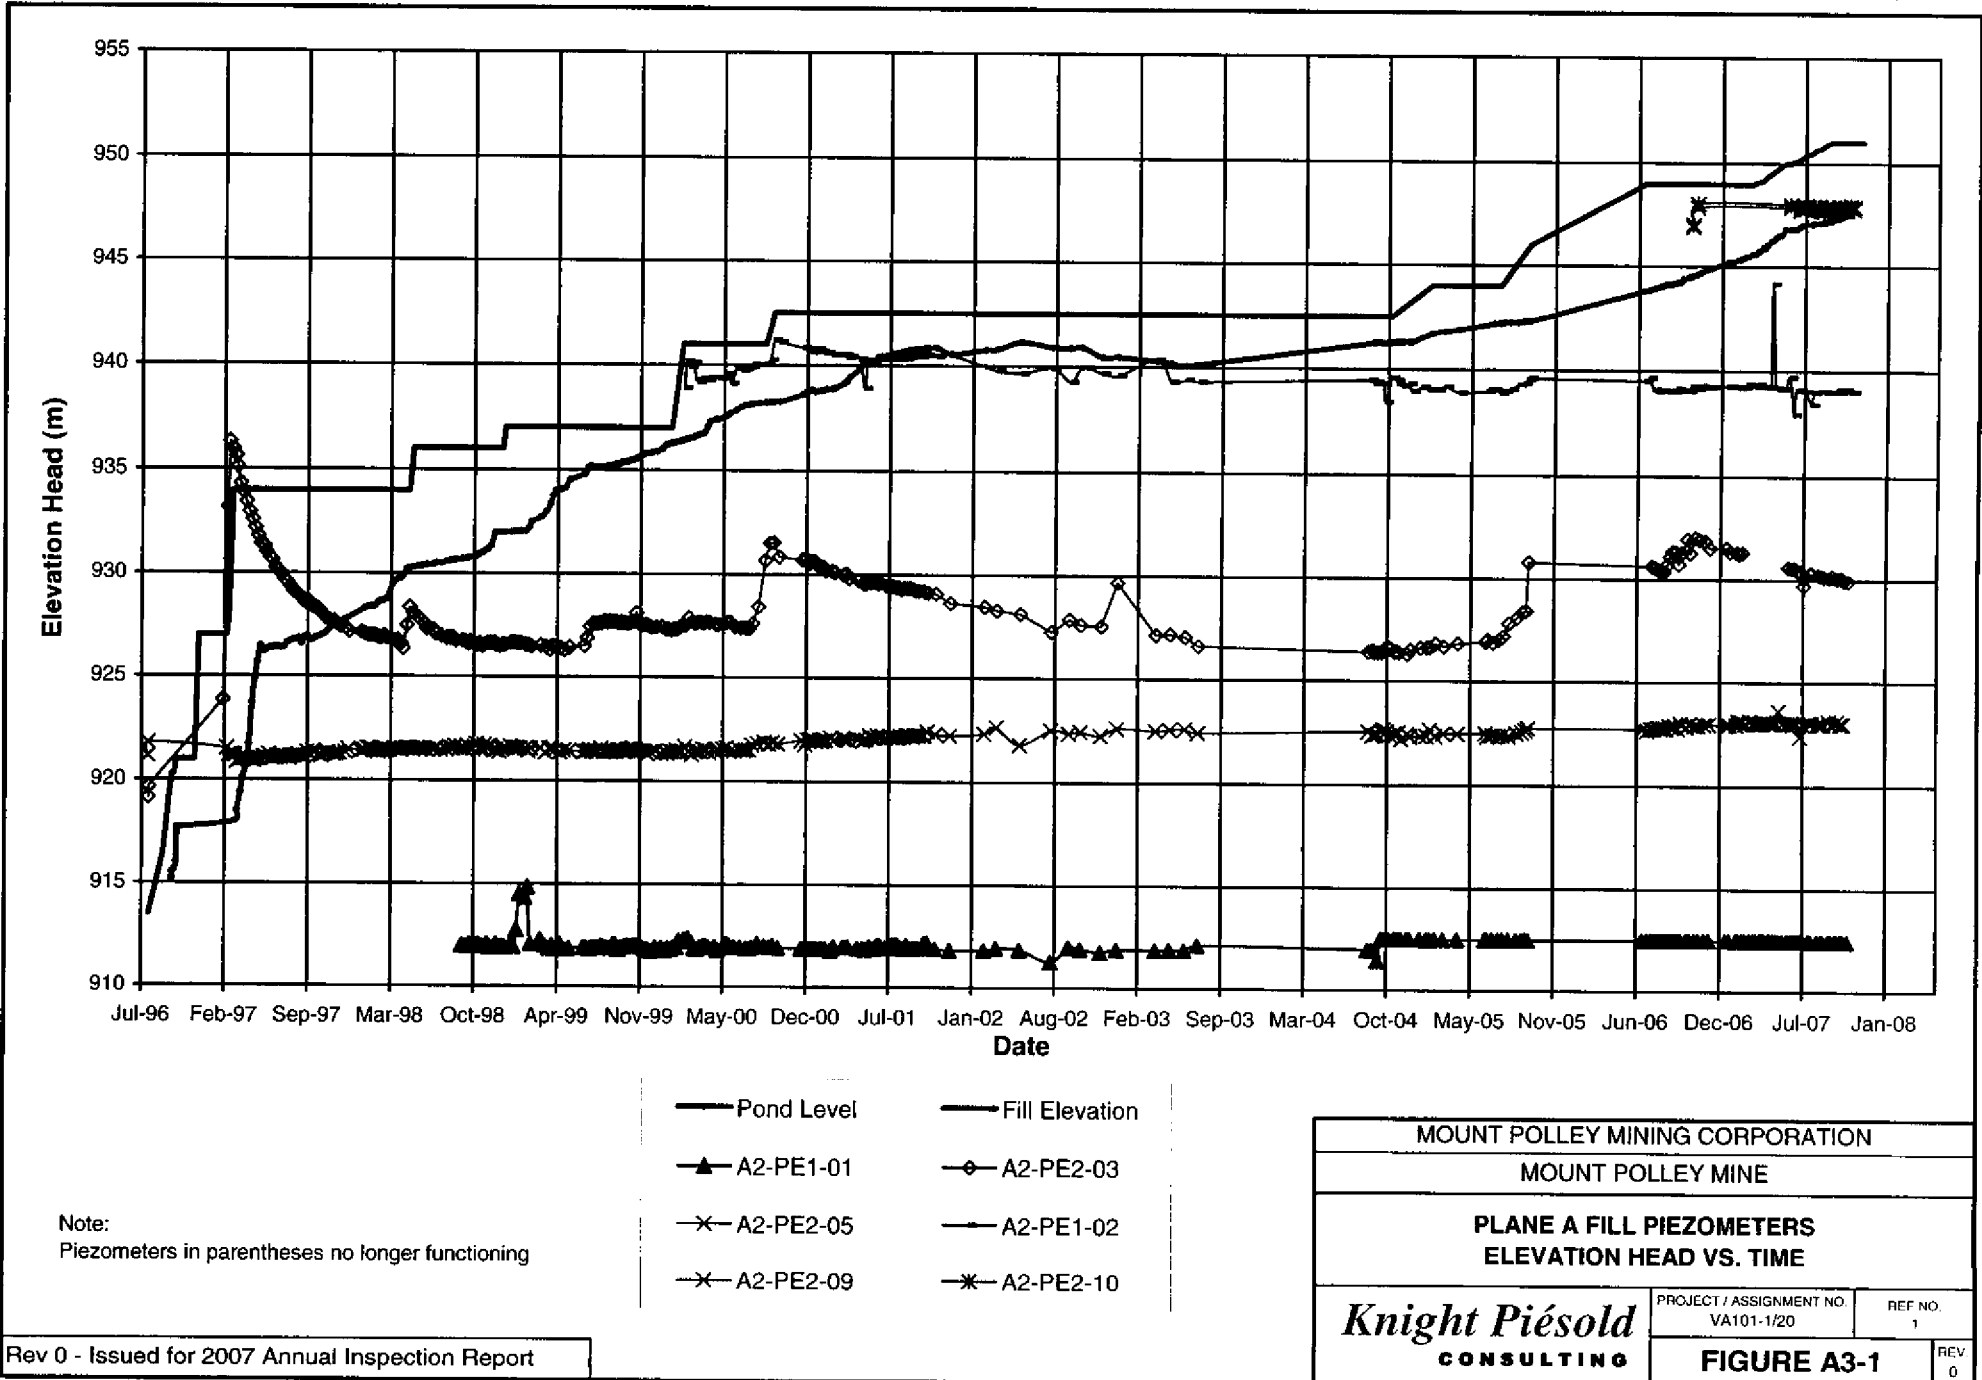
MOUNT POLLEY MINING CORPORATION		
MOUNT POLLEY MINE		
PLANE A FILL PIEZOMETERS ELEVATION HEAD VS. TIME		
<i>Knight Piésold</i> CONSULTING	PROJECT / ASSIGNMENT NO. VA101-1/20	REF NO. 1
	FIGURE A3-1	
		REV 0

There have been no significant changes in the trends for most of the embankment fill piezometers. Piezometer A2-PE2-O3, which is located at the Main Embankment, showed a slight increase in pore pressures corresponding to the placement of fill during the Stage 5 construction program. This trend has been observed in the past with this piezometer and it is anticipated that the slightly elevated pore pressures will dissipate following the construction programs as they have previously.

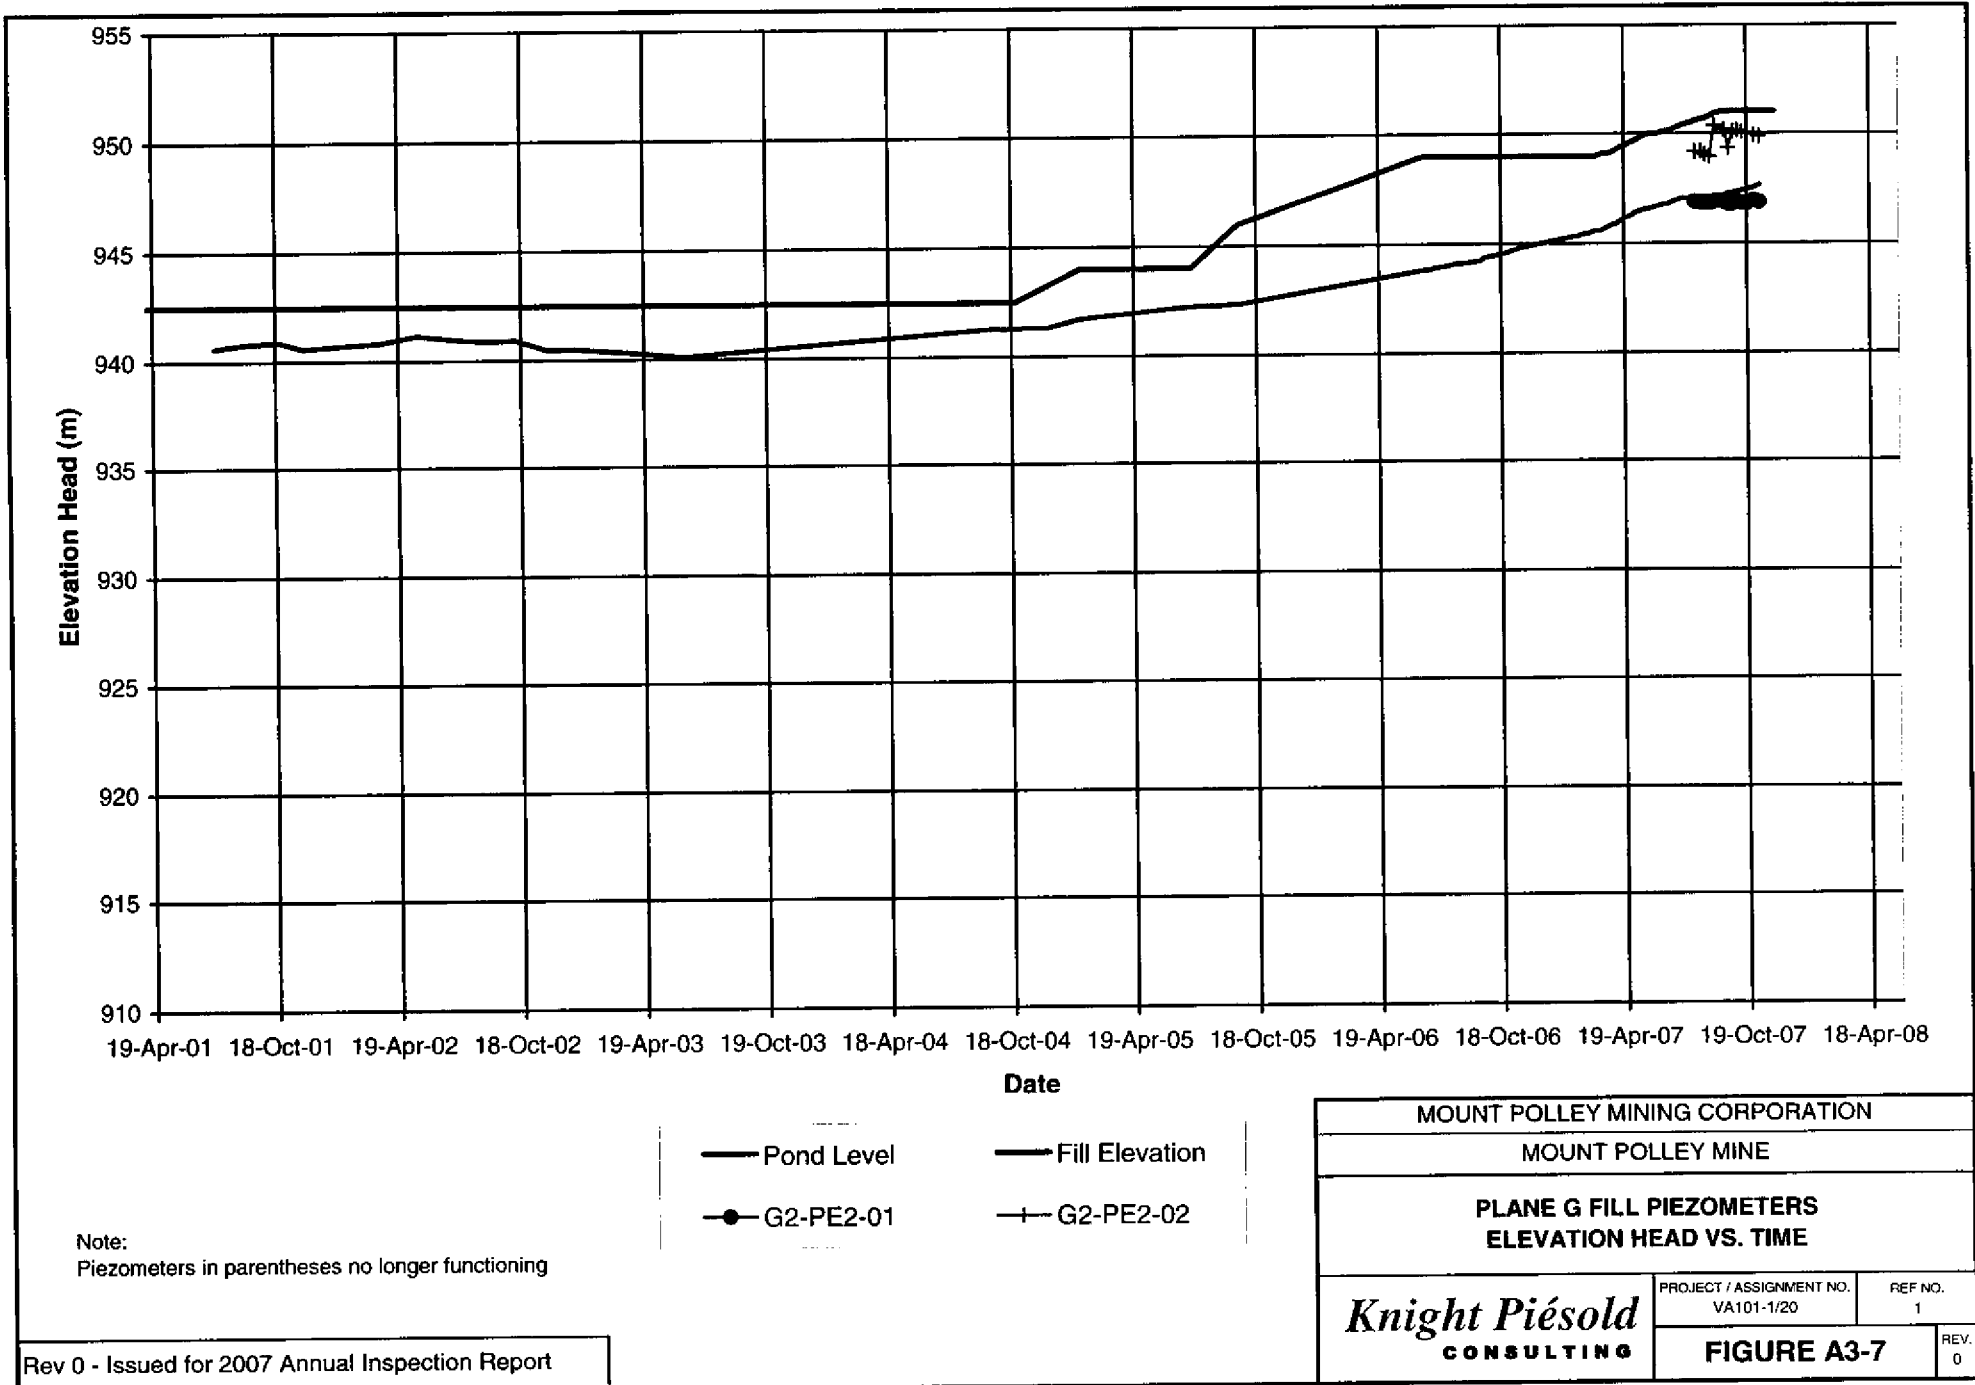
Note:
Piezometers in parentheses no longer functioning

MOUNT POLLEY MINING CORPORATION		
MOUNT POLLEY MINE		
PLANE G FILL PIEZOMETERS ELEVATION HEAD VS. TIME		
<i>Knight Piésold</i> CONSULTING	PROJECT / ASSIGNMENT NO. VA101-1/20	REF NO. 1
	FIGURE A3-7	
Rev 0 - Issued for 2007 Annual Inspection Report		REV. 0

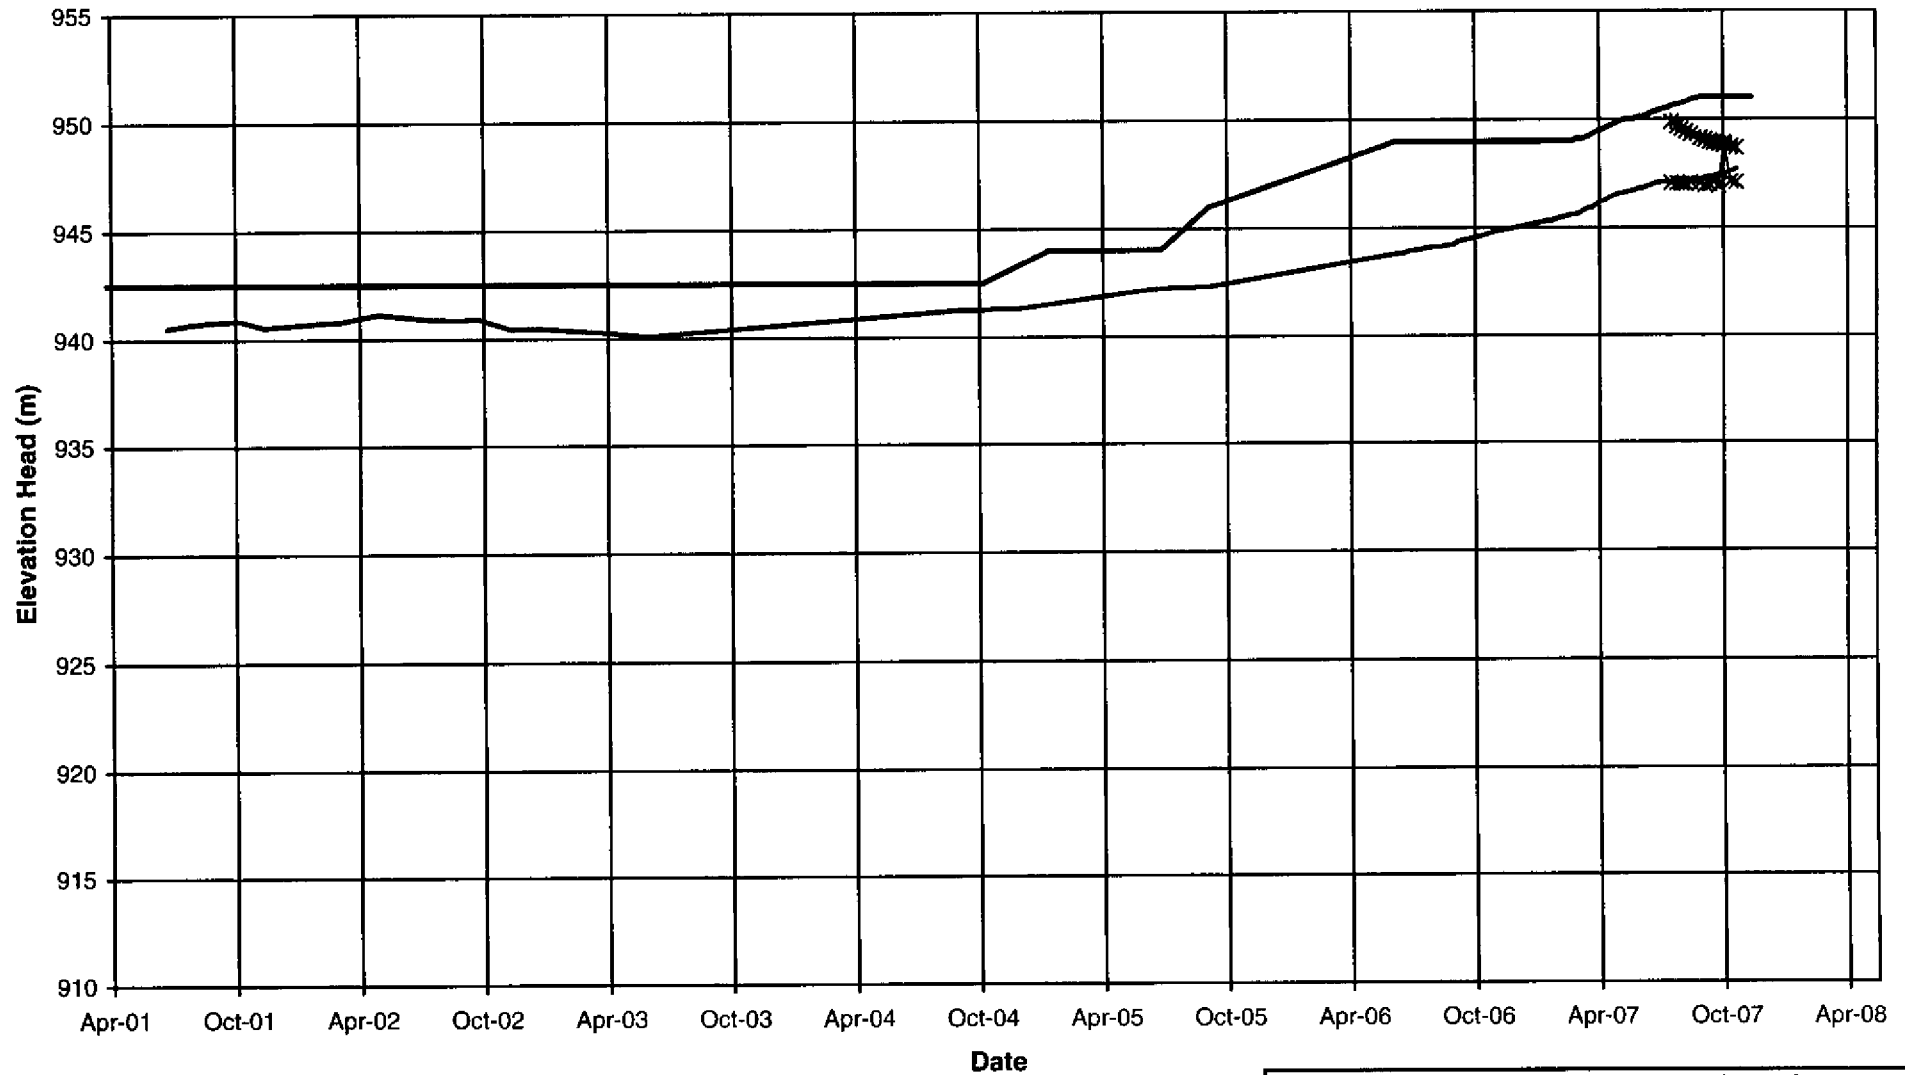
Note:
Piezometers in parentheses no longer functioning

MOUNT POLLEY MINING CORPORATION	
MOUNT POLLEY MINE	
PLANE H FILL PIEZOMETERS ELEVATION HEAD VS. TIME	
	PROJECT / ASSIGNMENT NO. VA101-1/20
	REF NO. 1
FIGURE A3-8	
REV. 0

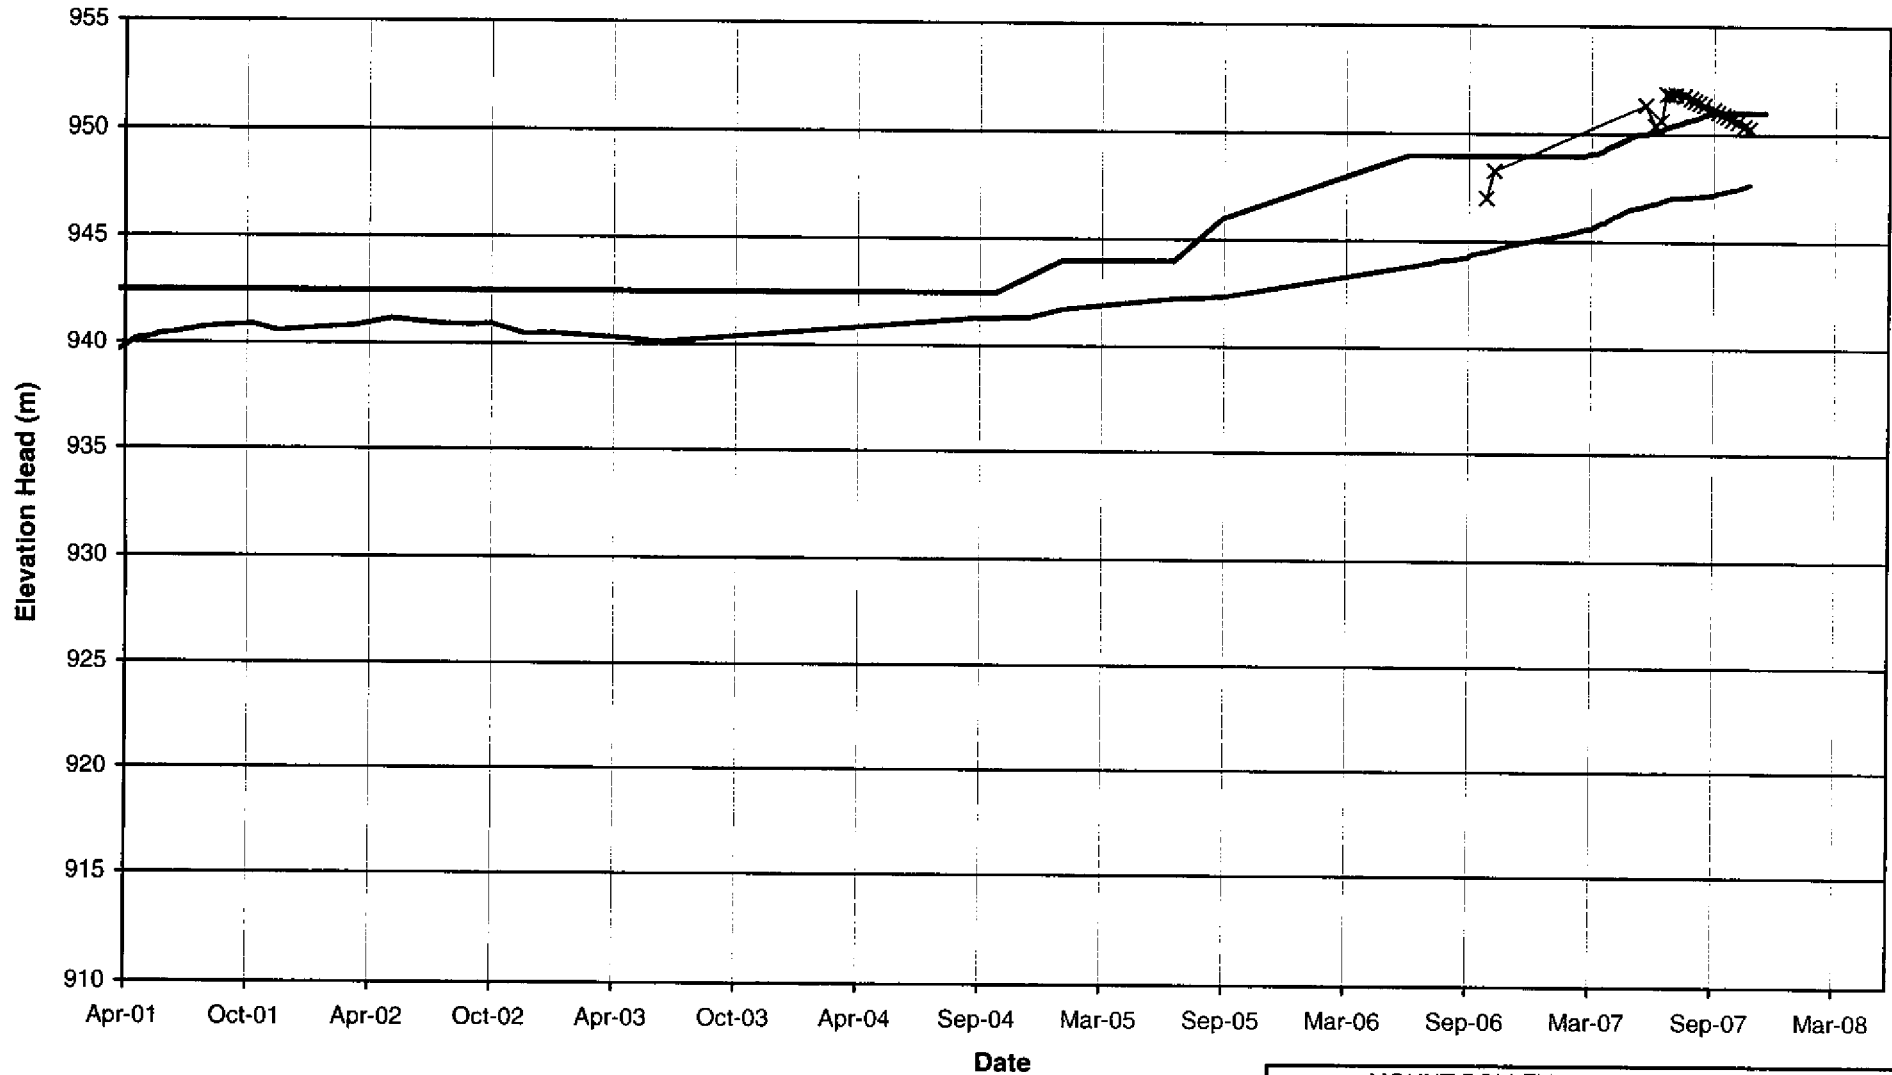
Note:
Piezometers in parentheses no longer functioning

MOUNT POLLEY MINING CORPORATION		
MOUNT POLLEY MINE		
PLANE I FILL PIEZOMETERS ELEVATION HEAD VS. TIME		
<i>Knight Piésold</i> CONSULTING	PROJECT / ASSIGNMENT NO. VA101-1/20	REF NO. 1
	FIGURE A3-9	
Rev 0 - Issued for 2007 Annual Inspection Report		REV 0

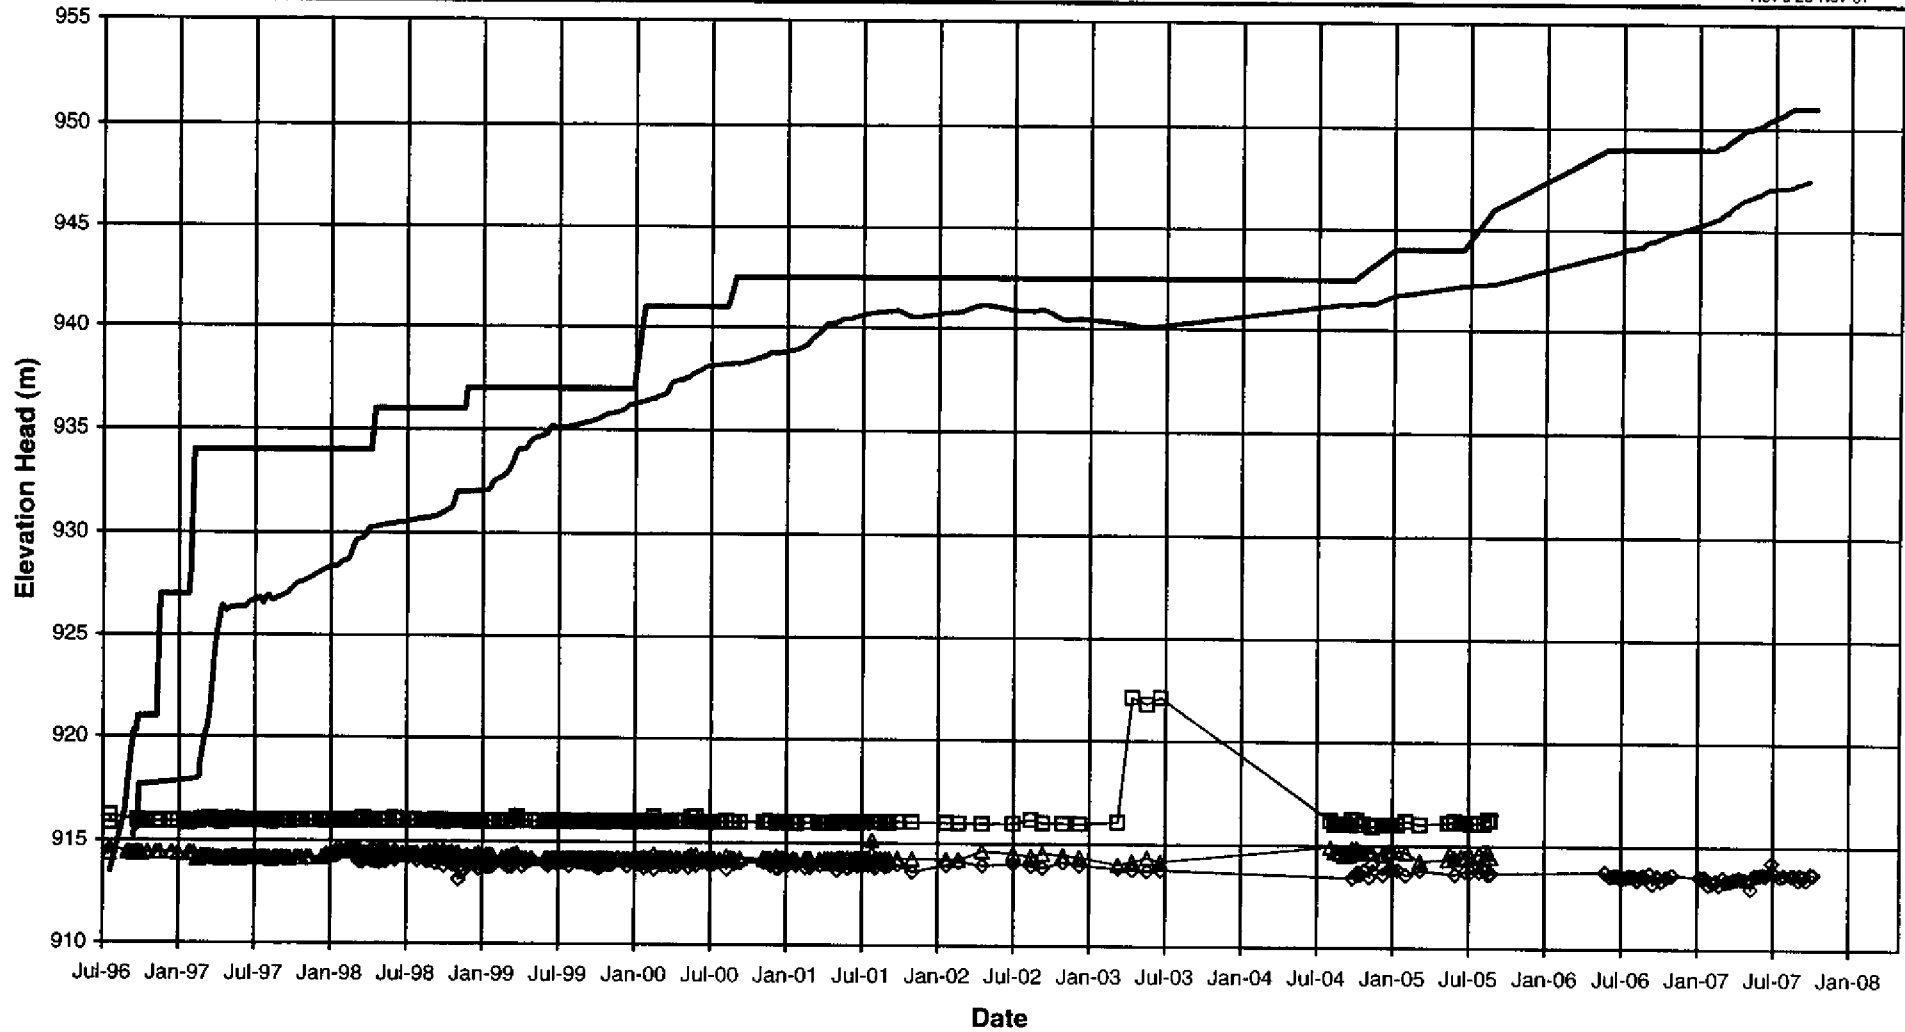
Note:
Piezometers in parentheses no longer functioning

MOUNT POLLEY MINING CORPORATION	
MOUNT POLLEY MINE	
PLANE C DRAIN PIEZOMETERS ELEVATION HEAD VS. TIME	
<i>Knight Piésold</i> CONSULTING	PROJECT / ASSIGNMENT NO. VA101-1/20
	REF NO. 1
FIGURE A4-3	
REV. 0

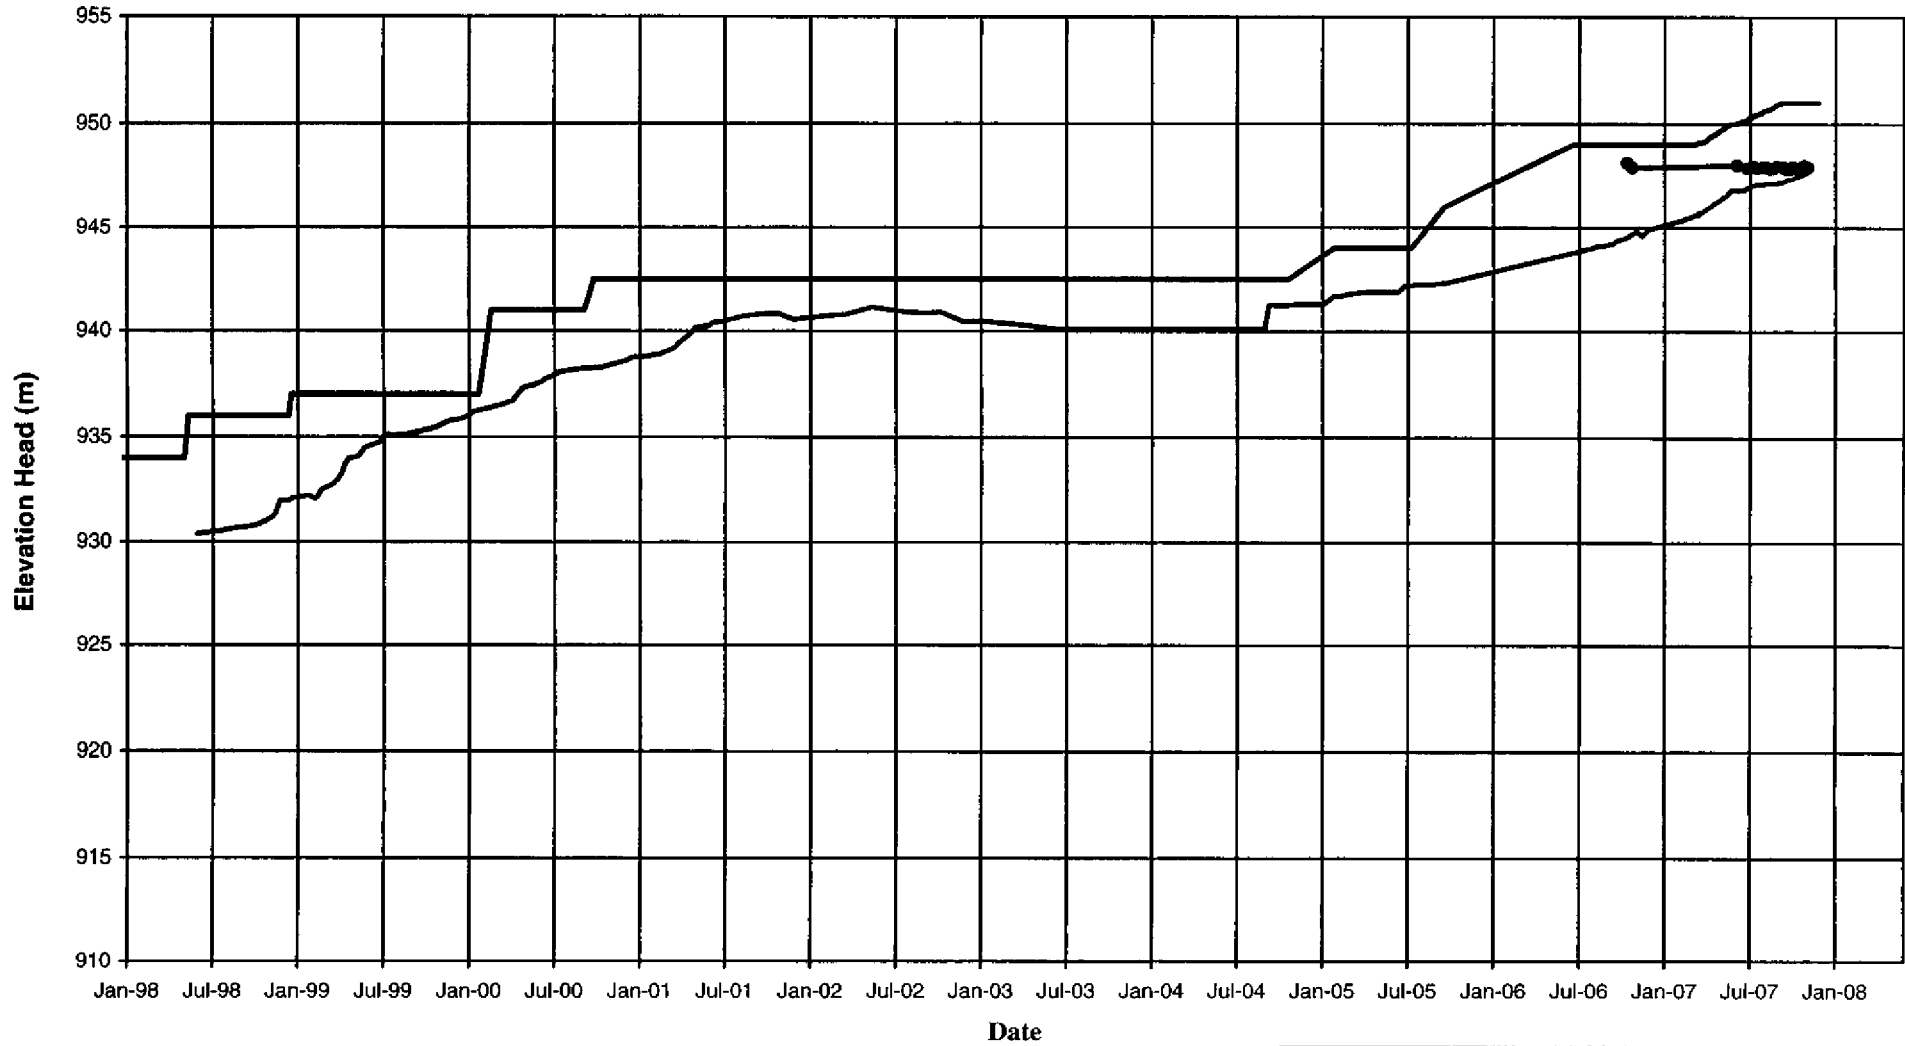
Note:
Piezometers in parentheses no longer functioning

MOUNT POLLEY MINING CORPORATION		
MOUNT POLLEY MINE		
PLANE E DRAIN PIEZOMETERS ELEVATION HEAD VS. TIME		
<i>Knight Piésold</i> CONSULTING	PROJECT / ASSIGNMENT NO. VA101-1/20	REF NO. 1
	FIGURE A4-5	
Rev 0 - Issued for 2007 Annual Inspection Report		REV. 0

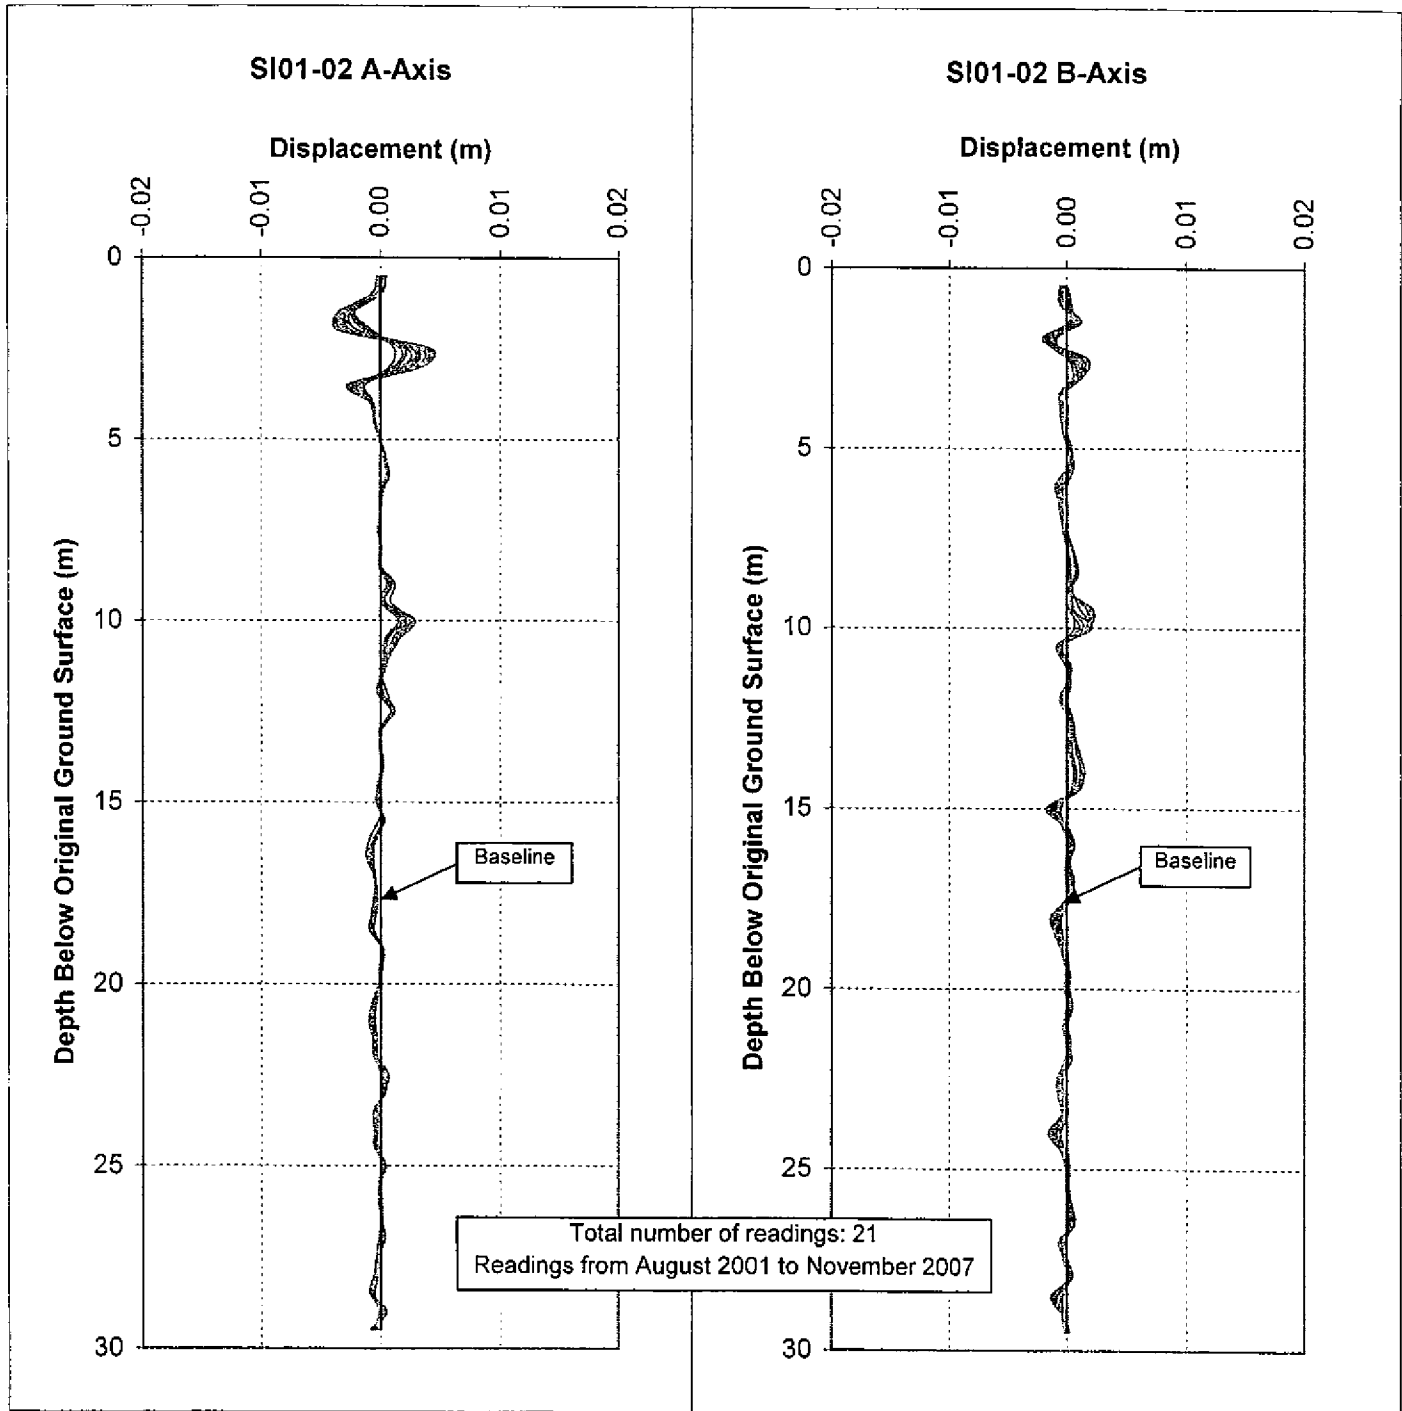
1) Displacement is calculated relative to the initial data set, recorded in August 2001.

MOUNT POLLEY MINING CORPORATION		
MOUNT POLLEY MINE		
TAILINGS STORAGE FACILITY INCLINOMETER SI01-02 DISPLACEMENT VS. DEPTH		
<i>Knight Piésold</i> CONSULTING	PROJECT / ASSIGNMENT NO. VA101-1/20	REF NO. 1
	FIGURE B-2	
		REV. 0

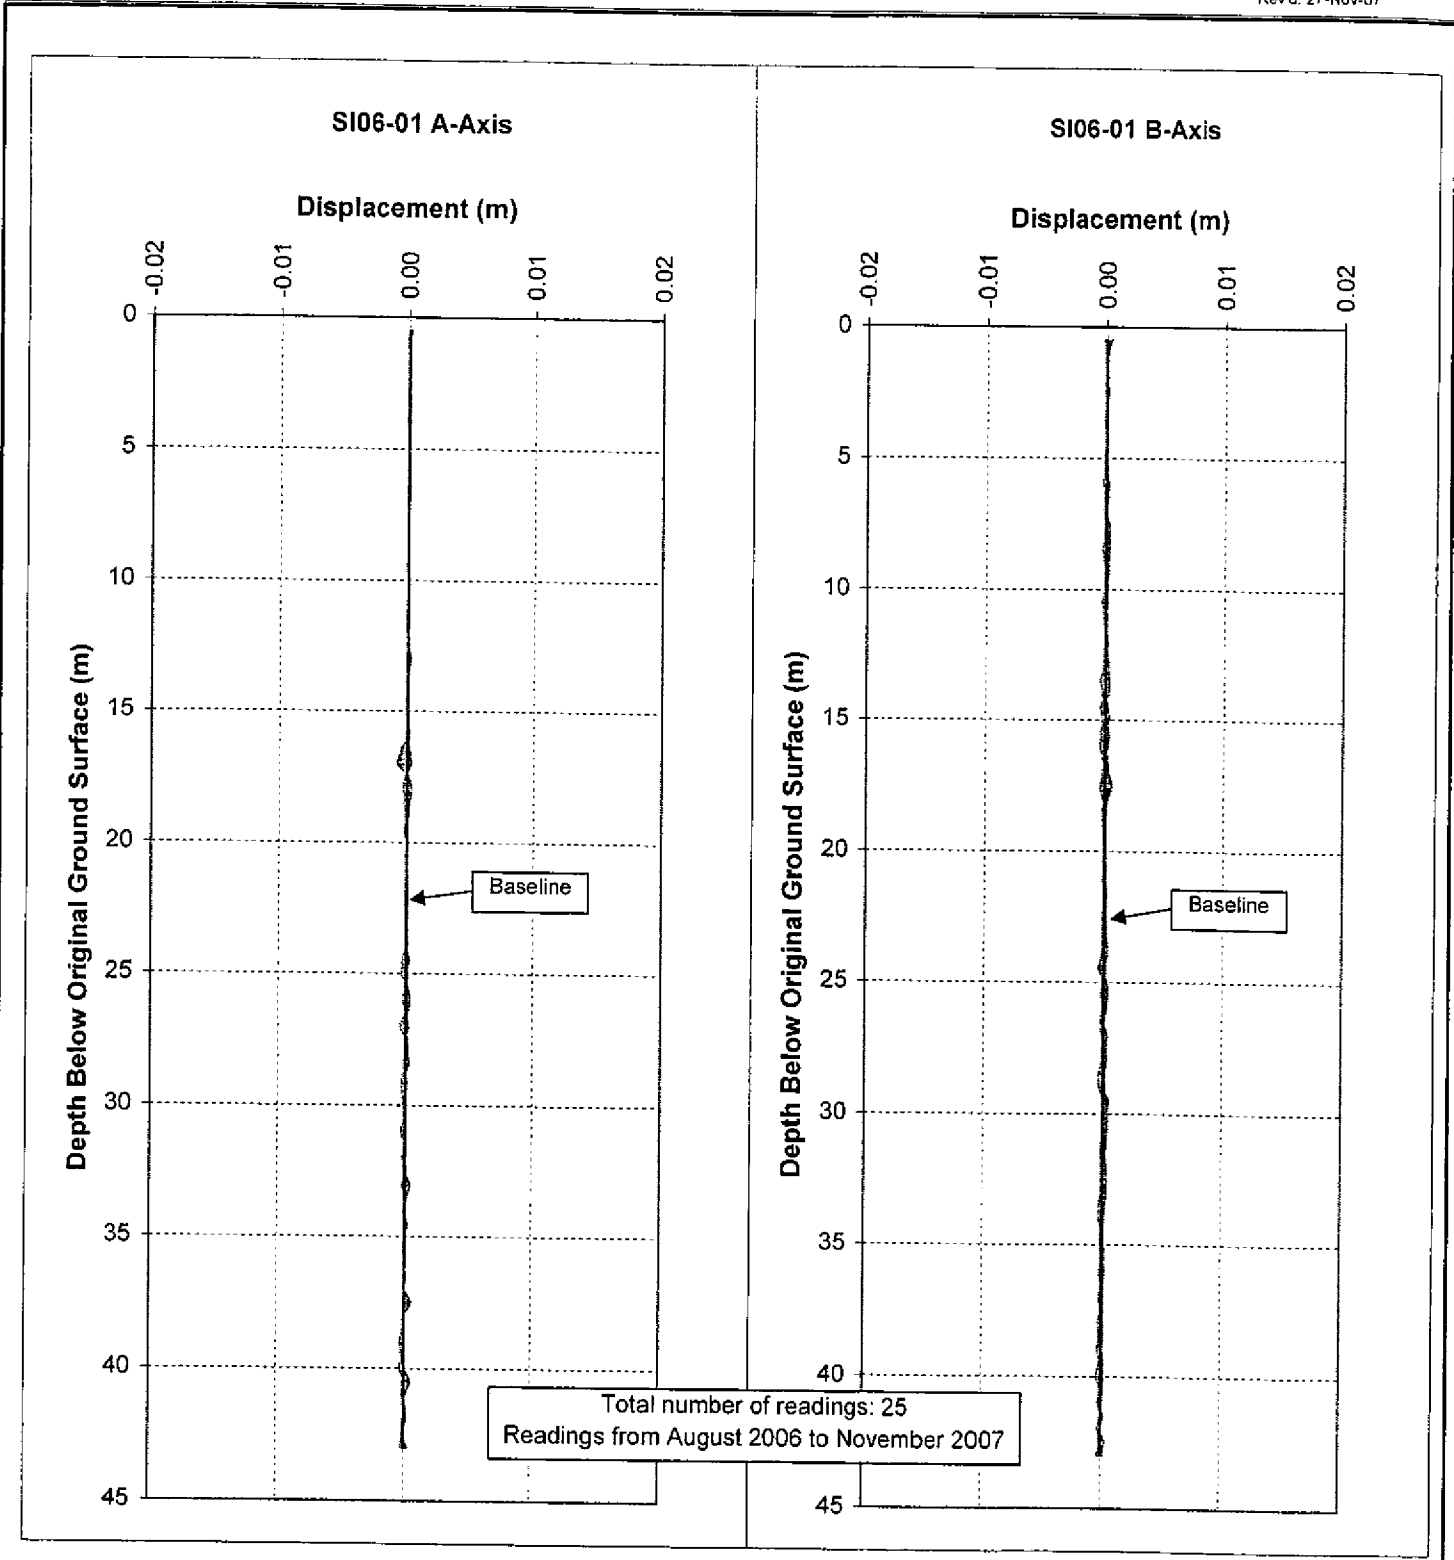
1) Displacement is calculated relative to the initial data set, recorded in August 2006.

MOUNT POLLEY MINING CORPORATION		
MOUNT POLLEY MINE		
TAILINGS STORAGE FACILITY INCLINOMETER SI06-01 DISPLACEMENT VS. DEPTH		
<i>Knight Piésold</i> CONSULTING	PROJECT / ASSIGNMENT NO. VA101-1/20	REF NO. 1
	FIGURE B-3	
		REV. 0

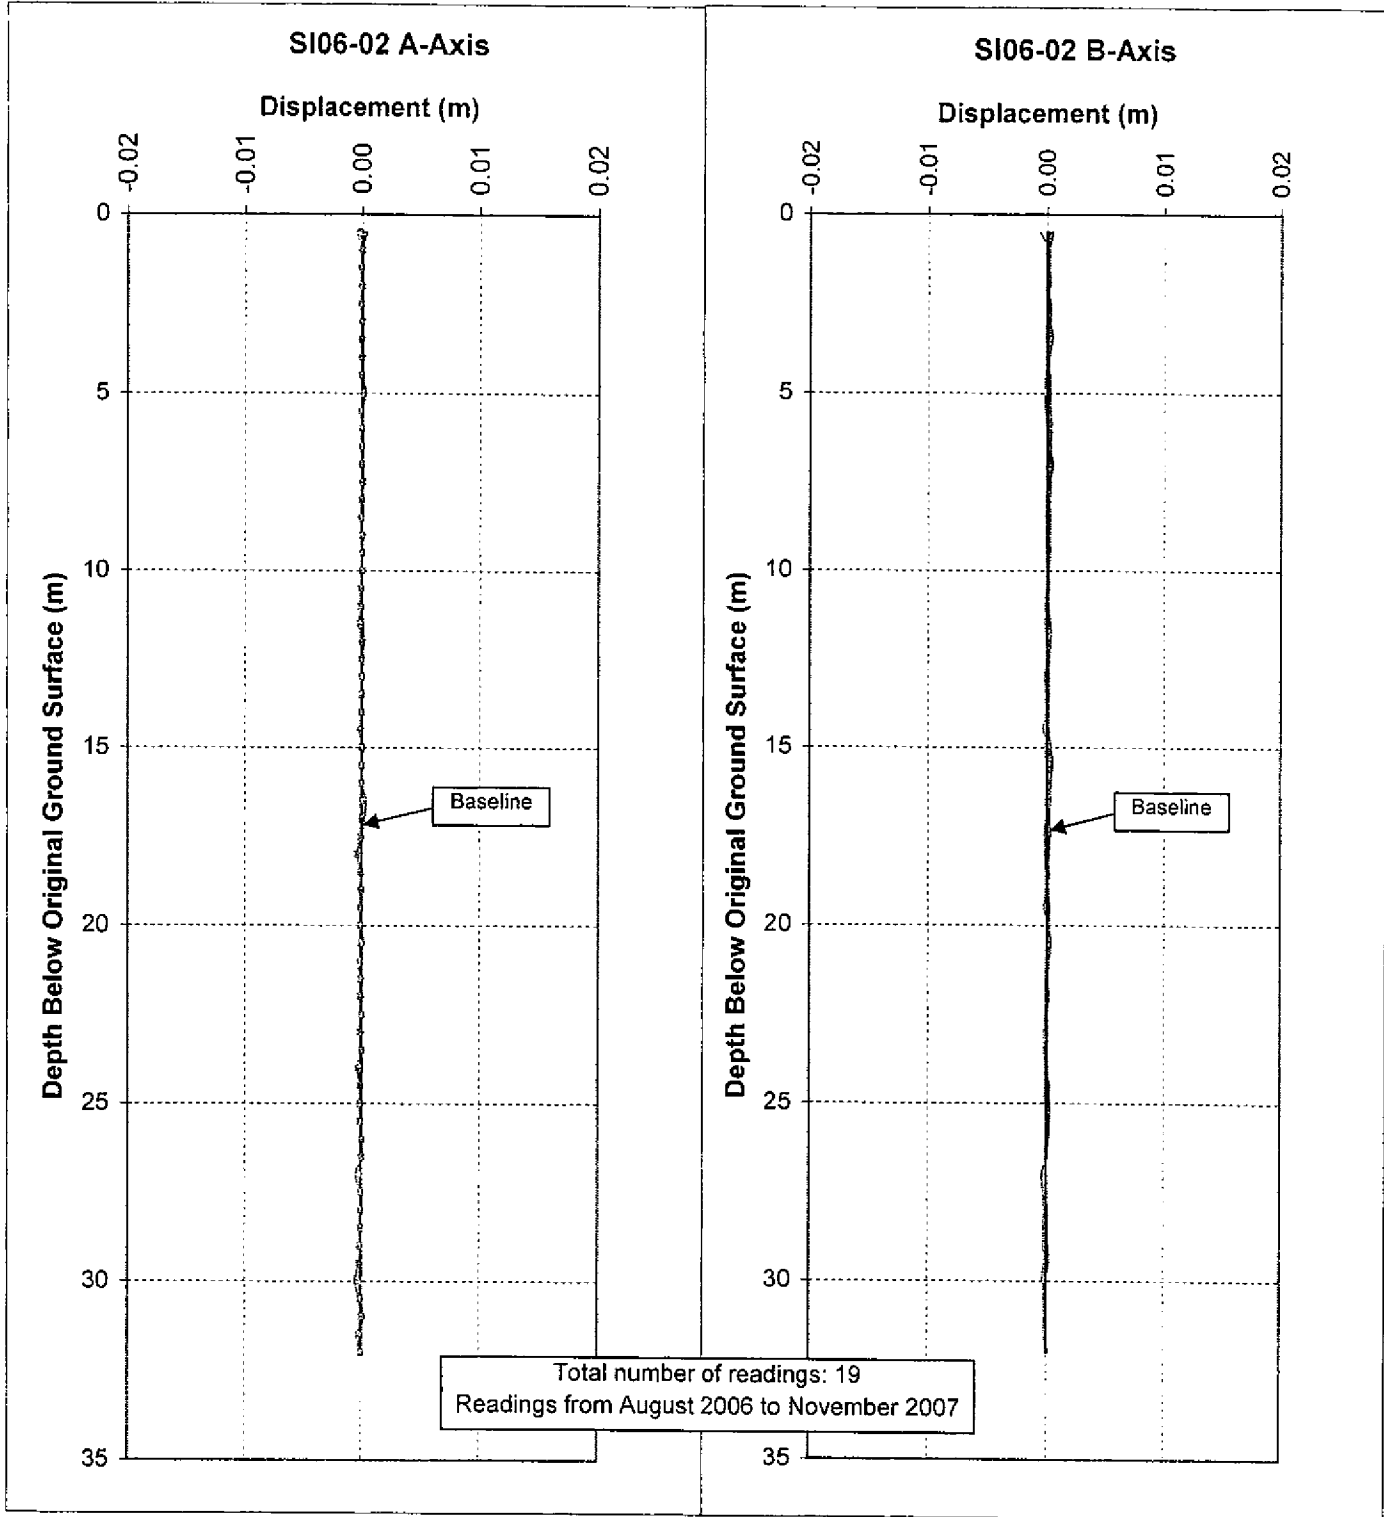
- 1) Displacement is calculated relative to the initial data set, recorded in August 2006.
- 2.) SI06-02 was blocked by ice burin the winter 06/06/07, therefore, no data was recorded.

MOUNT POLLEY MINING CORPORATION		
MOUNT POLLEY MINE		
TAILINGS STORAGE FACILITY INCLINOMETER SI06-02 DISPLACEMENT VS. DEPTH		
<i>Knight Piésold</i> CONSULTING	PROJECT / ASSIGNMENT NO. VA101-120	REF NO. 1
	FIGURE B-4	
		REV. 0

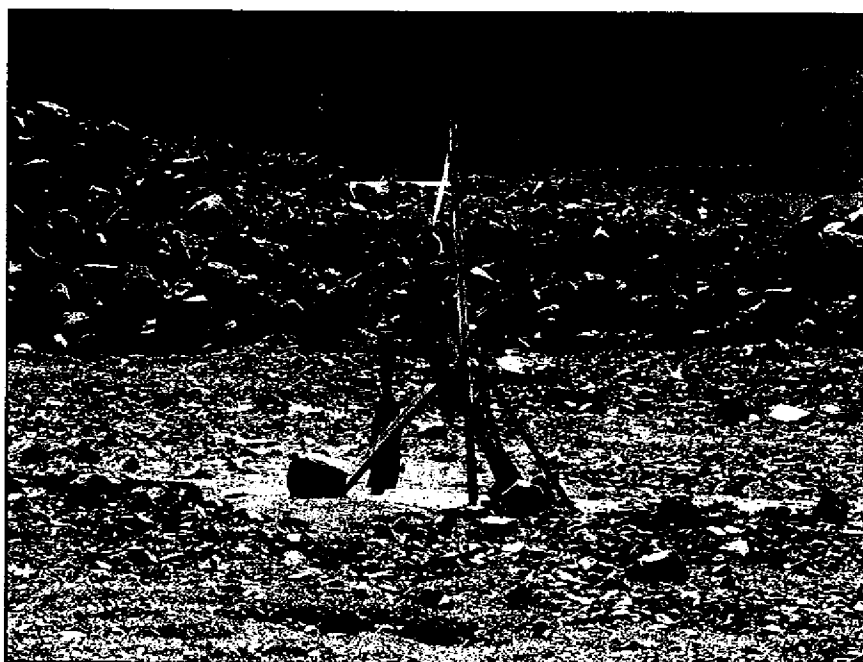
PHOTO 16 – Existing inclinometer at the Main Embankment.

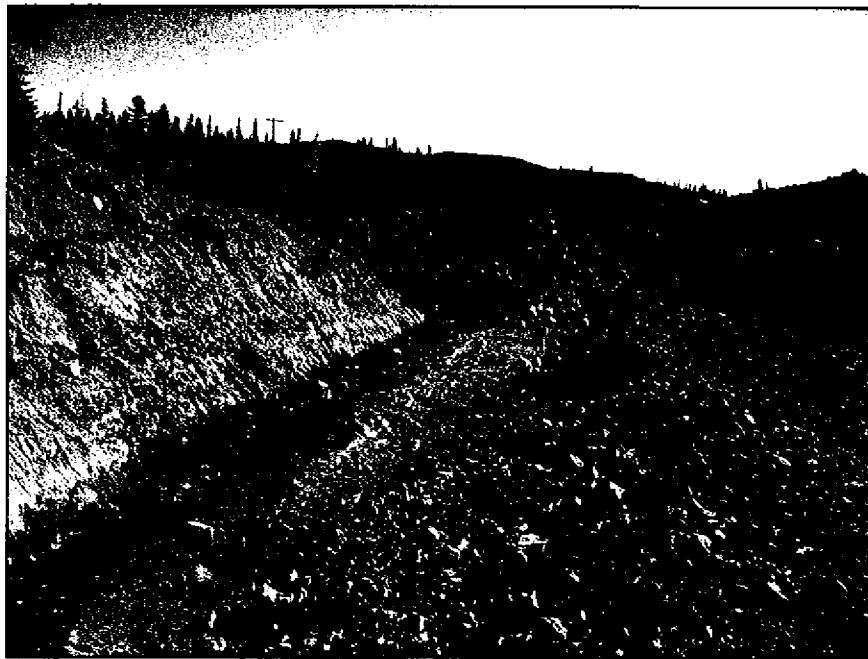
PHOTO 18 – Perimeter Embankment ditch routed to Perimeter Embankment Seepage Collection Pond for the upstream toe drain flow.

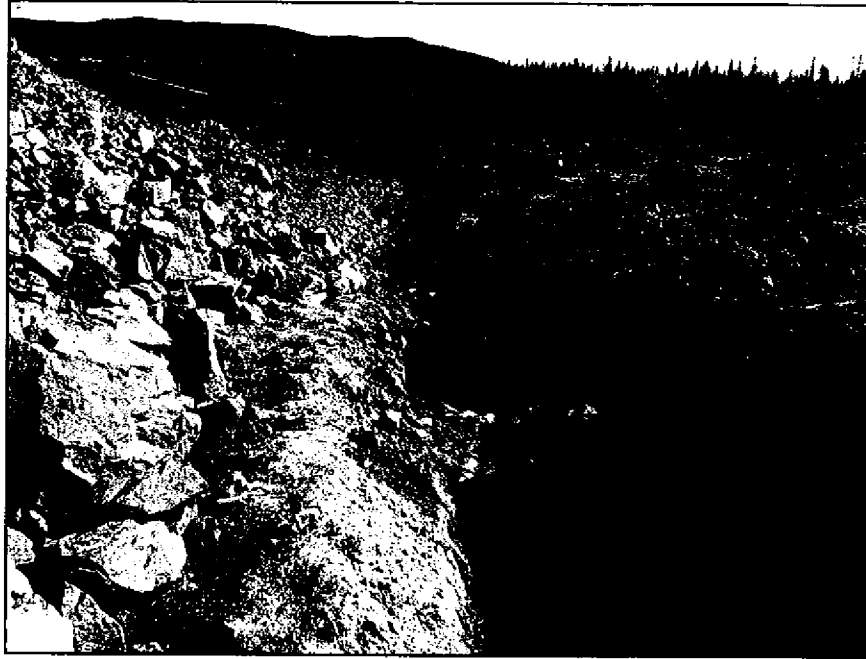
PHOTO 19 – Seepage from the Main/South Embankment corner routed to the Main Embankment Seepage Collection Pond.
