**MOUNT POLLEY MINE
Tailings Storage Facility Stage 9
2013 As-Built and Annual Review Report**

Mount Polley Mining Corporation,
Likely, BC

AMEC Environment & Infrastructure,
a division of AMEC Americas Limited
Burnaby, BC

February 2014
VM00560C

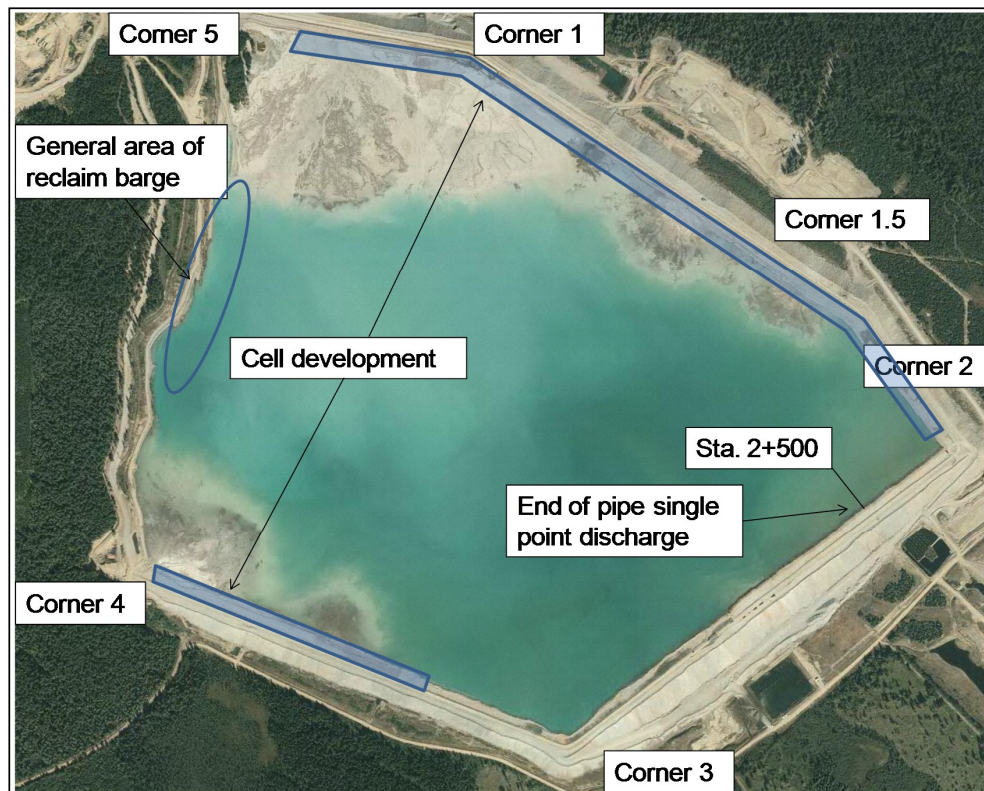
Figure 2.1: 2013 Cell Development

Cell construction was carried out from Corner 5 advancing along the Perimeter Embankment to the Main Embankment to about Station 2+500. Near the end of the 2013 construction season, the pipeline route was re-graded near Corner 5 to provide room for embankment expansion at the abutment. Insufficient tailings line pressure prevented cell construction along the central portion of the Main Embankment and single point discharge was employed (approximately Sta. 2+500) to facilitate the beach development in this area. Discharge from Station 2+500 was maintained for about two weeks, after which discharge was relocated to Corner 4. Cellular development began along the South Embankment towards the end of 2013. Figure 2.1 illustrates the cell development locations during 2013.
