**MOUNT POLLEY MINING CORPORATION
MOUNT POLLEY MINE
TAILINGS STORAGE FACILITY**

**1998 ANNUAL INSPECTION REPORT
(REF. NO. 10162/9-5)**

JUNE 26, 1998

Knight Piésold
CONSULTING ENGINEERS

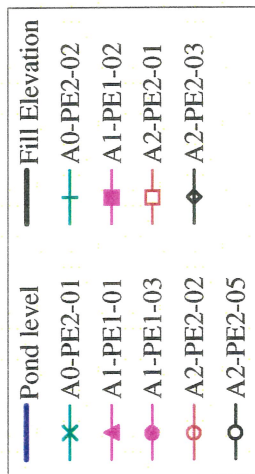
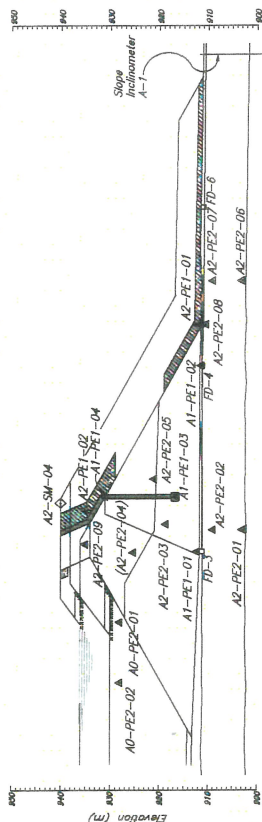
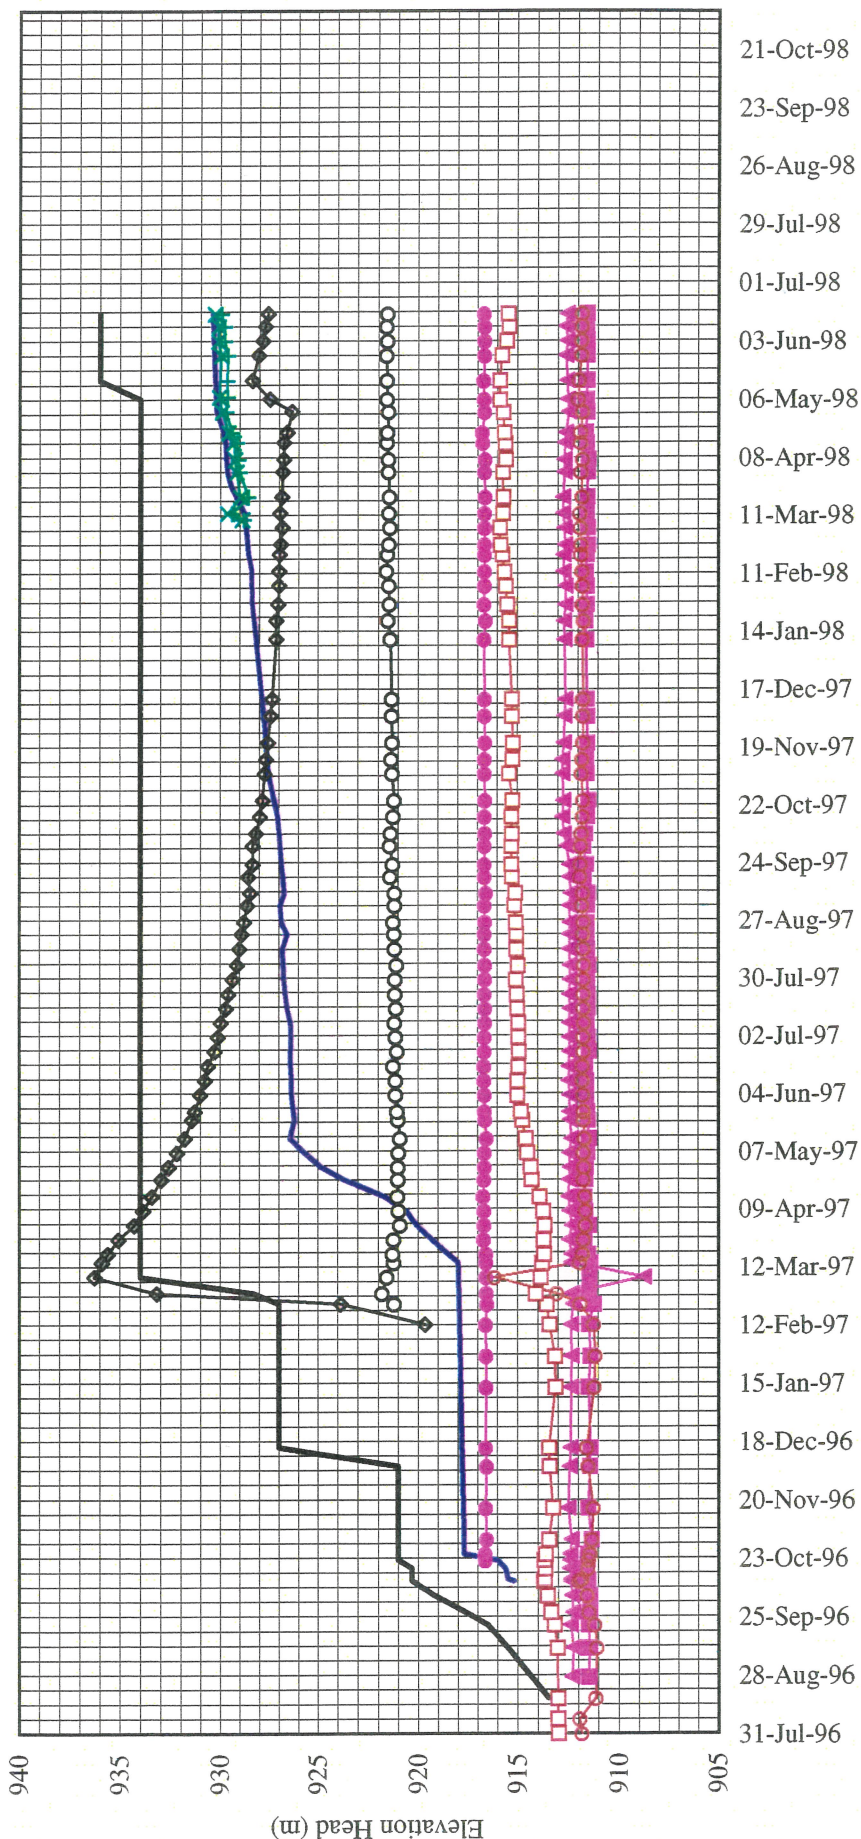
FIGURE 2.1

MOUNT POLLEY MINING CORPORATION
MOUNT POLLEY PROJECT
TAILINGS STORAGE FACILITY
SUMMARY PLOT PIEZOMETER PLANE A

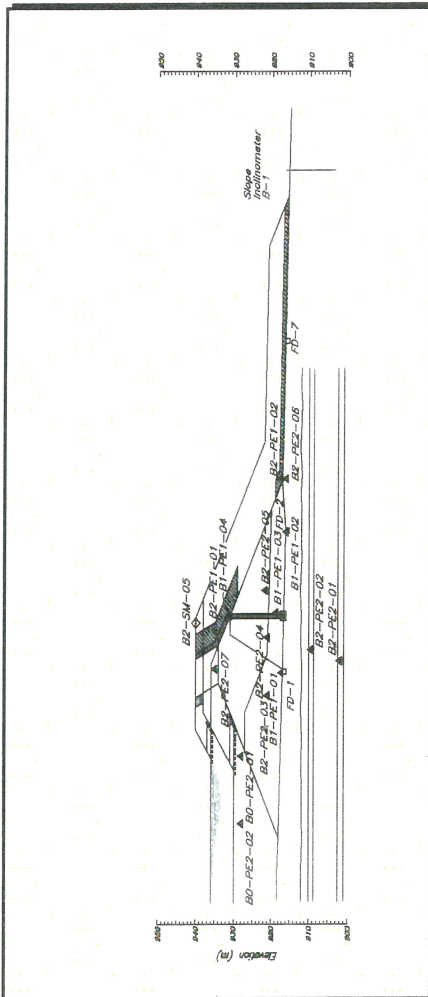
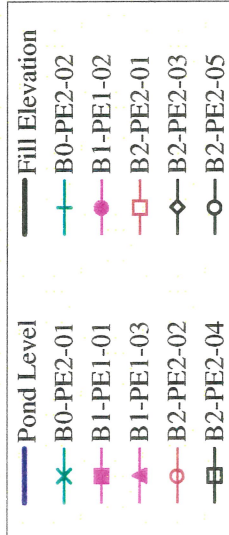
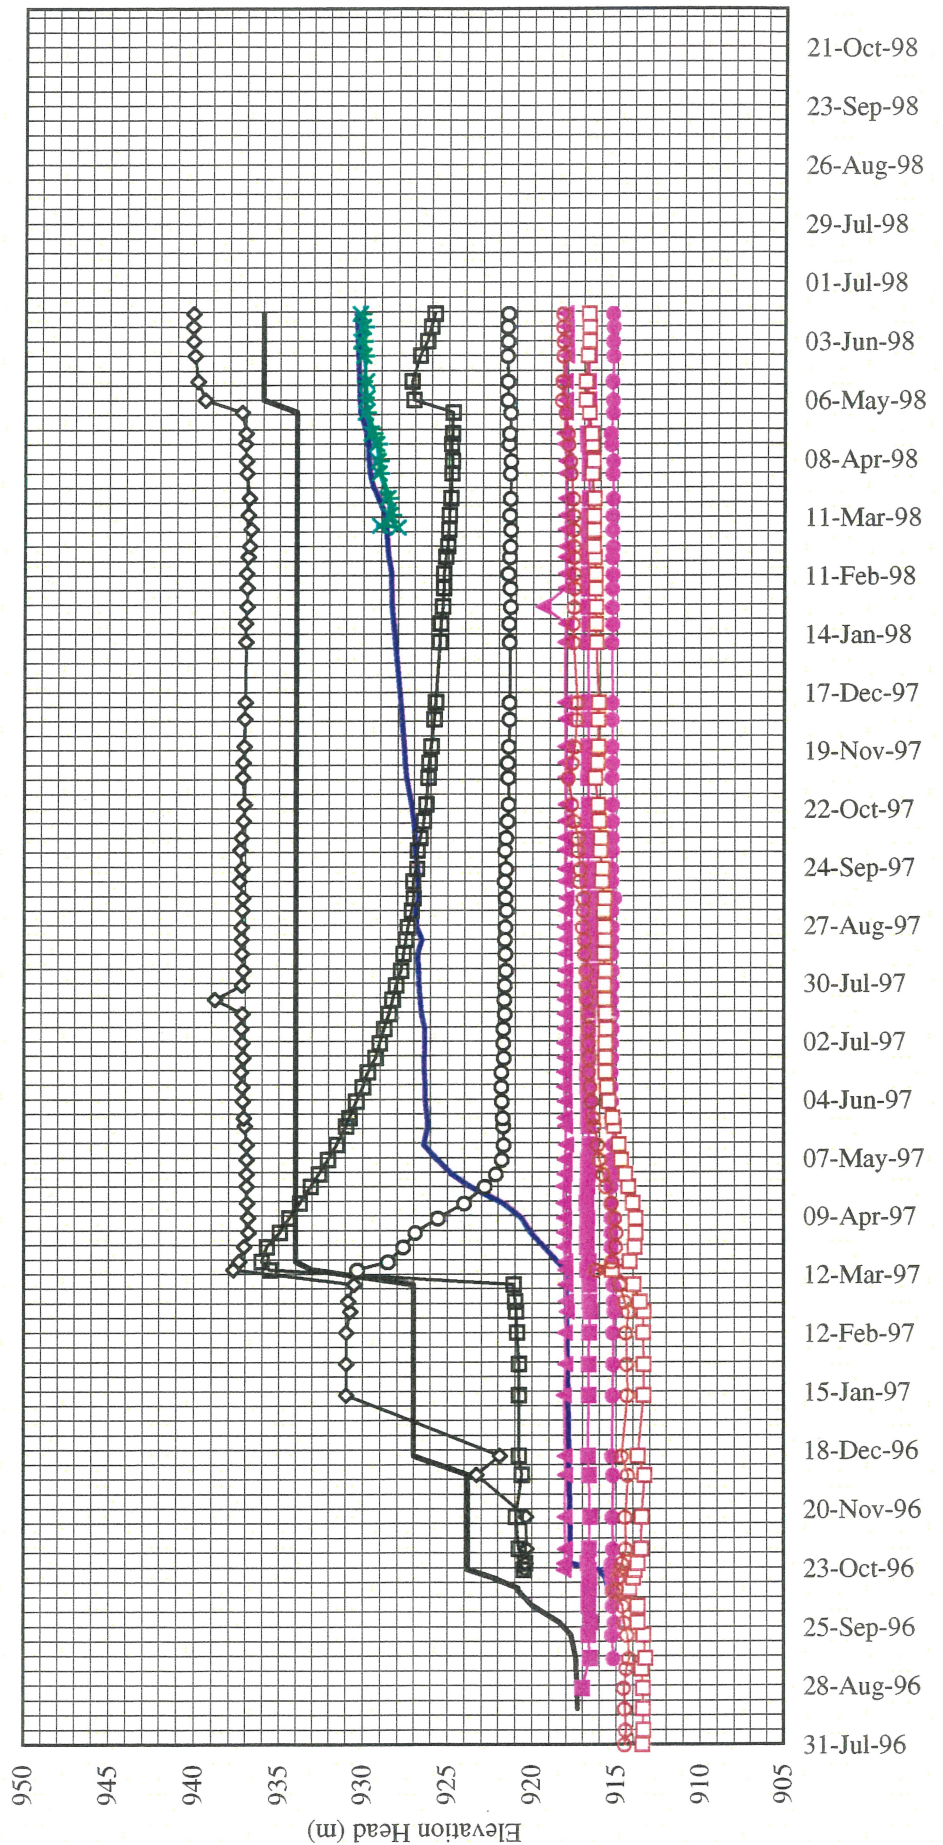
FIGURE 2.2

MOUNT POLLEY MINING CORPORATION
MOUNT POLLEY PROJECT
TAILINGS STORAGE FACILITY
SUMMARY PLOT PIEZOMETER PLANE B

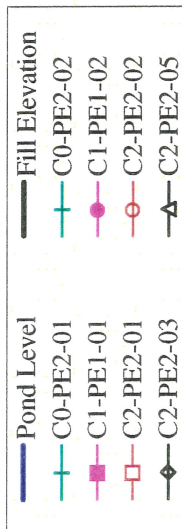
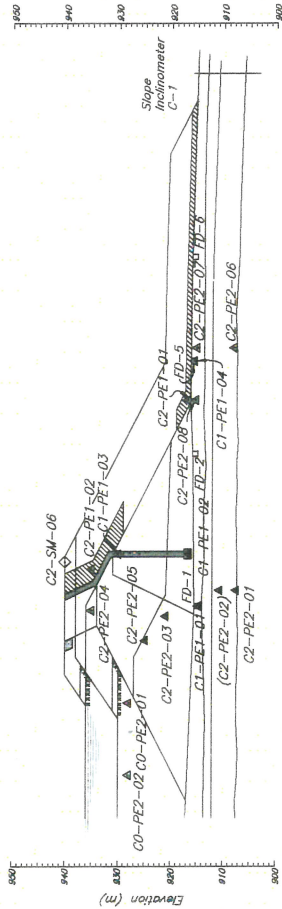
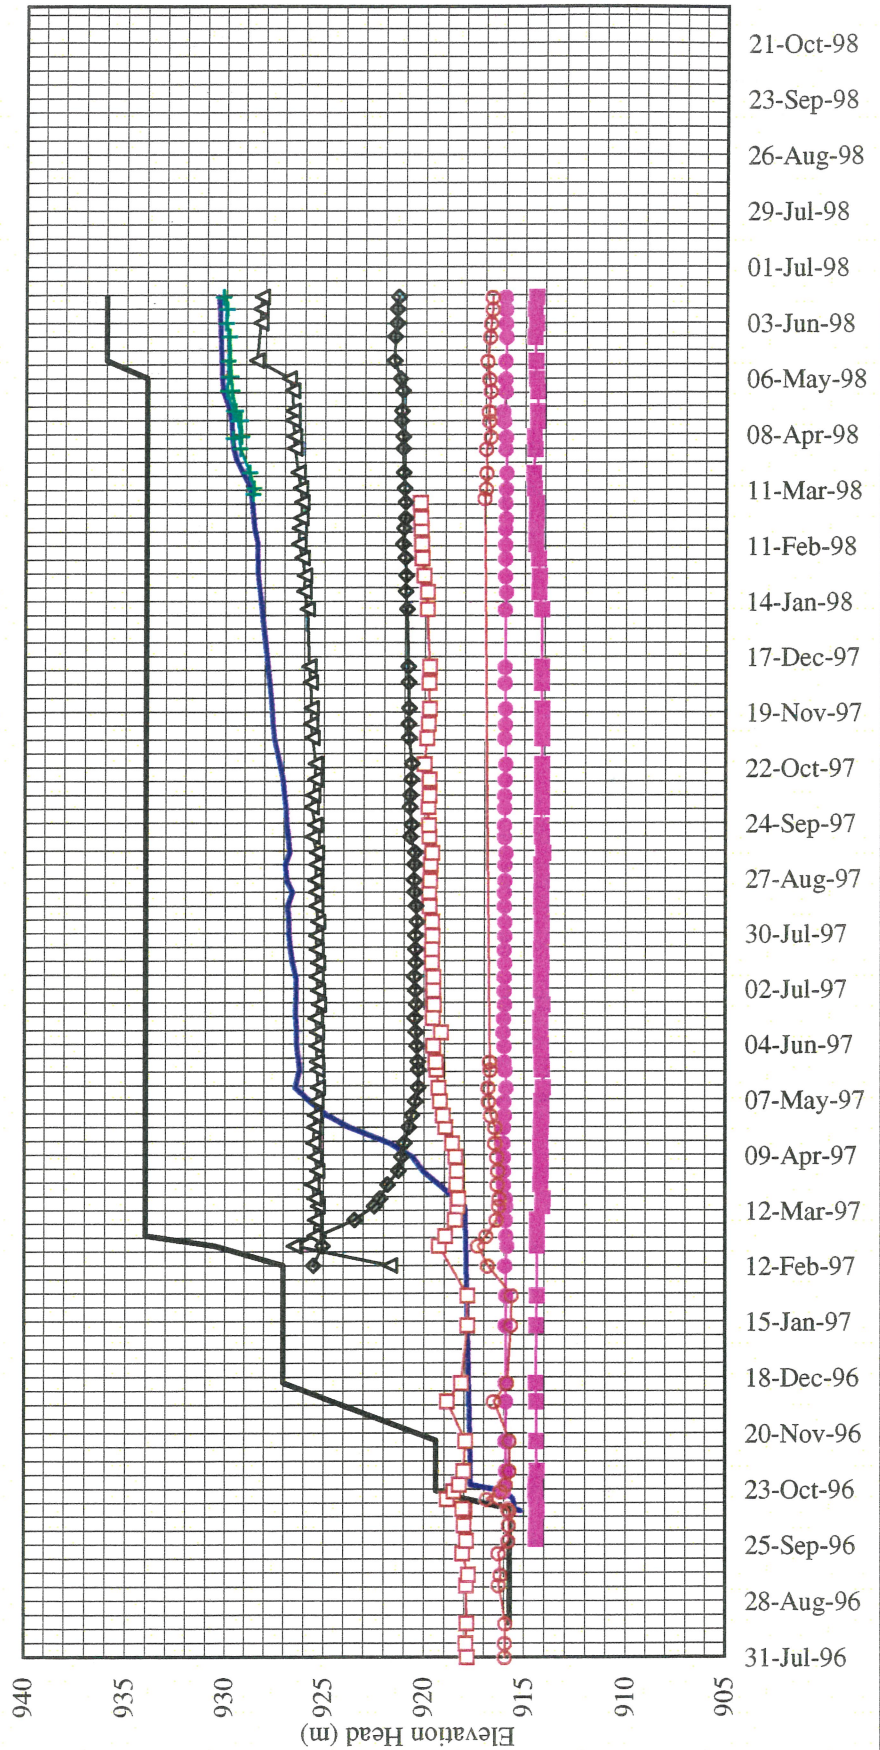
FIGURE 2.3

MOUNT POLLEY MINING CORPORATION
MOUNT POLLEY PROJECT
TAILINGS STORAGE FACILITY
SUMMARY PLOT PIEZOMETER PLANE C

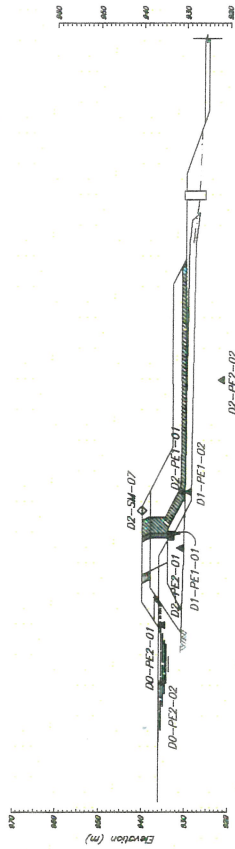
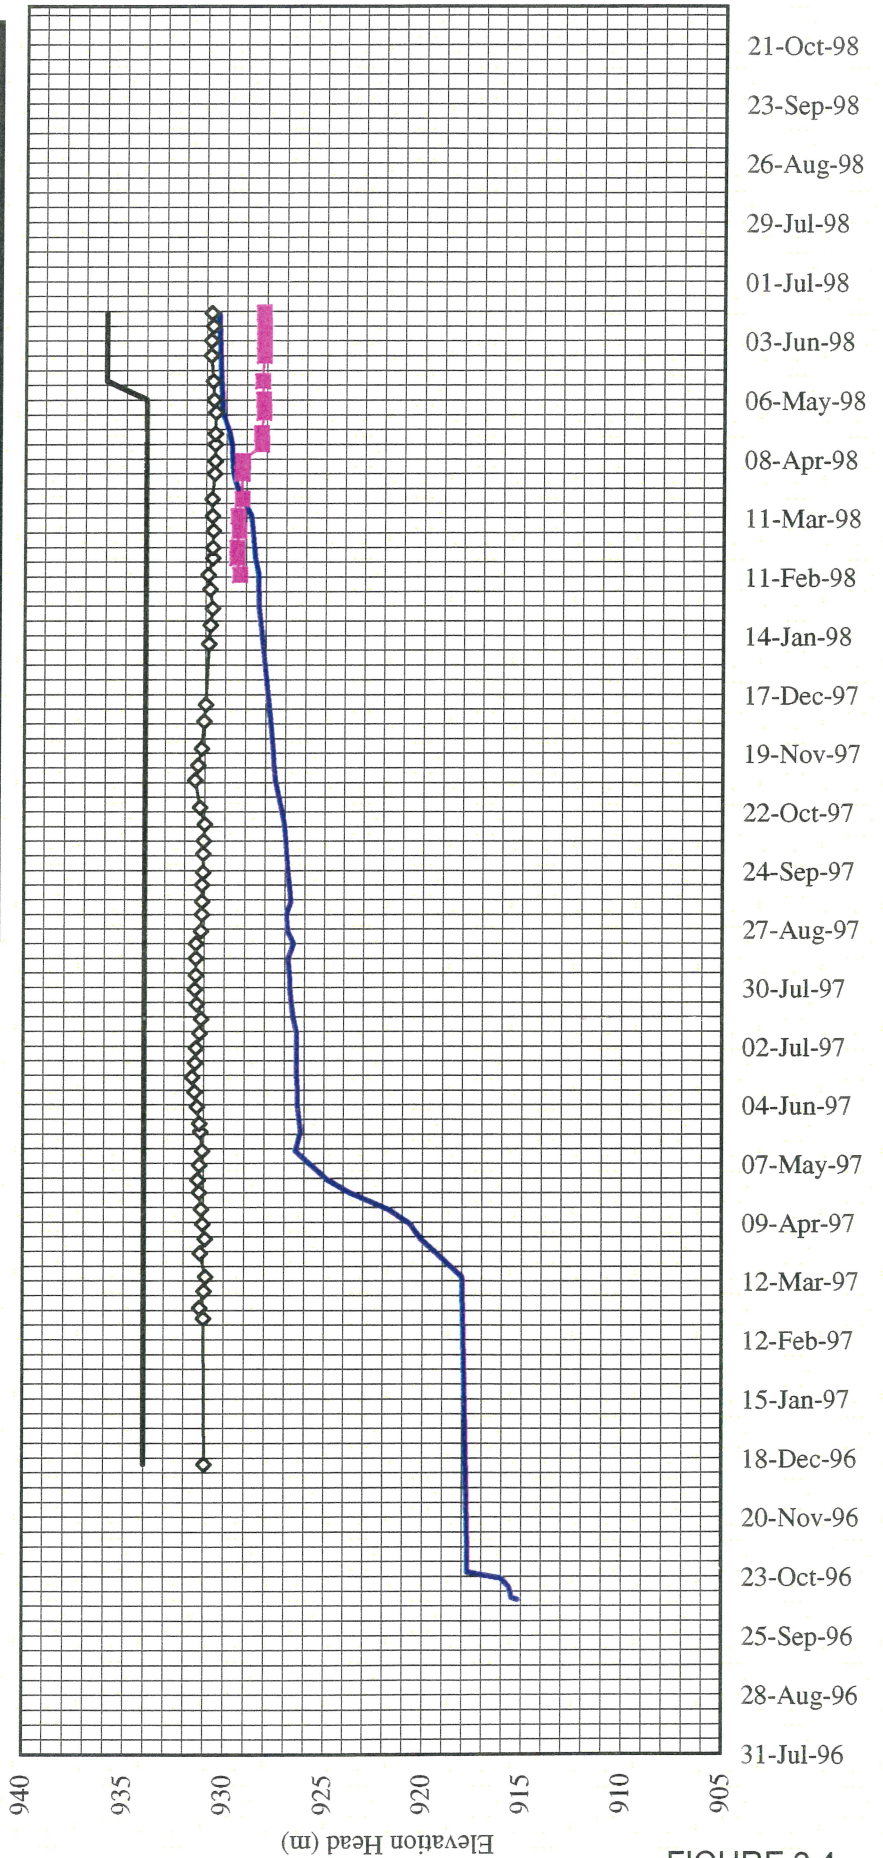
FIGURE 2.4

MOUNT POLLEY MINING CORPORATION
MOUNT POLLEY PROJECT
TAILINGS STORAGE FACILITY
SUMMARY PLOT PIEZOMETER PLANE D

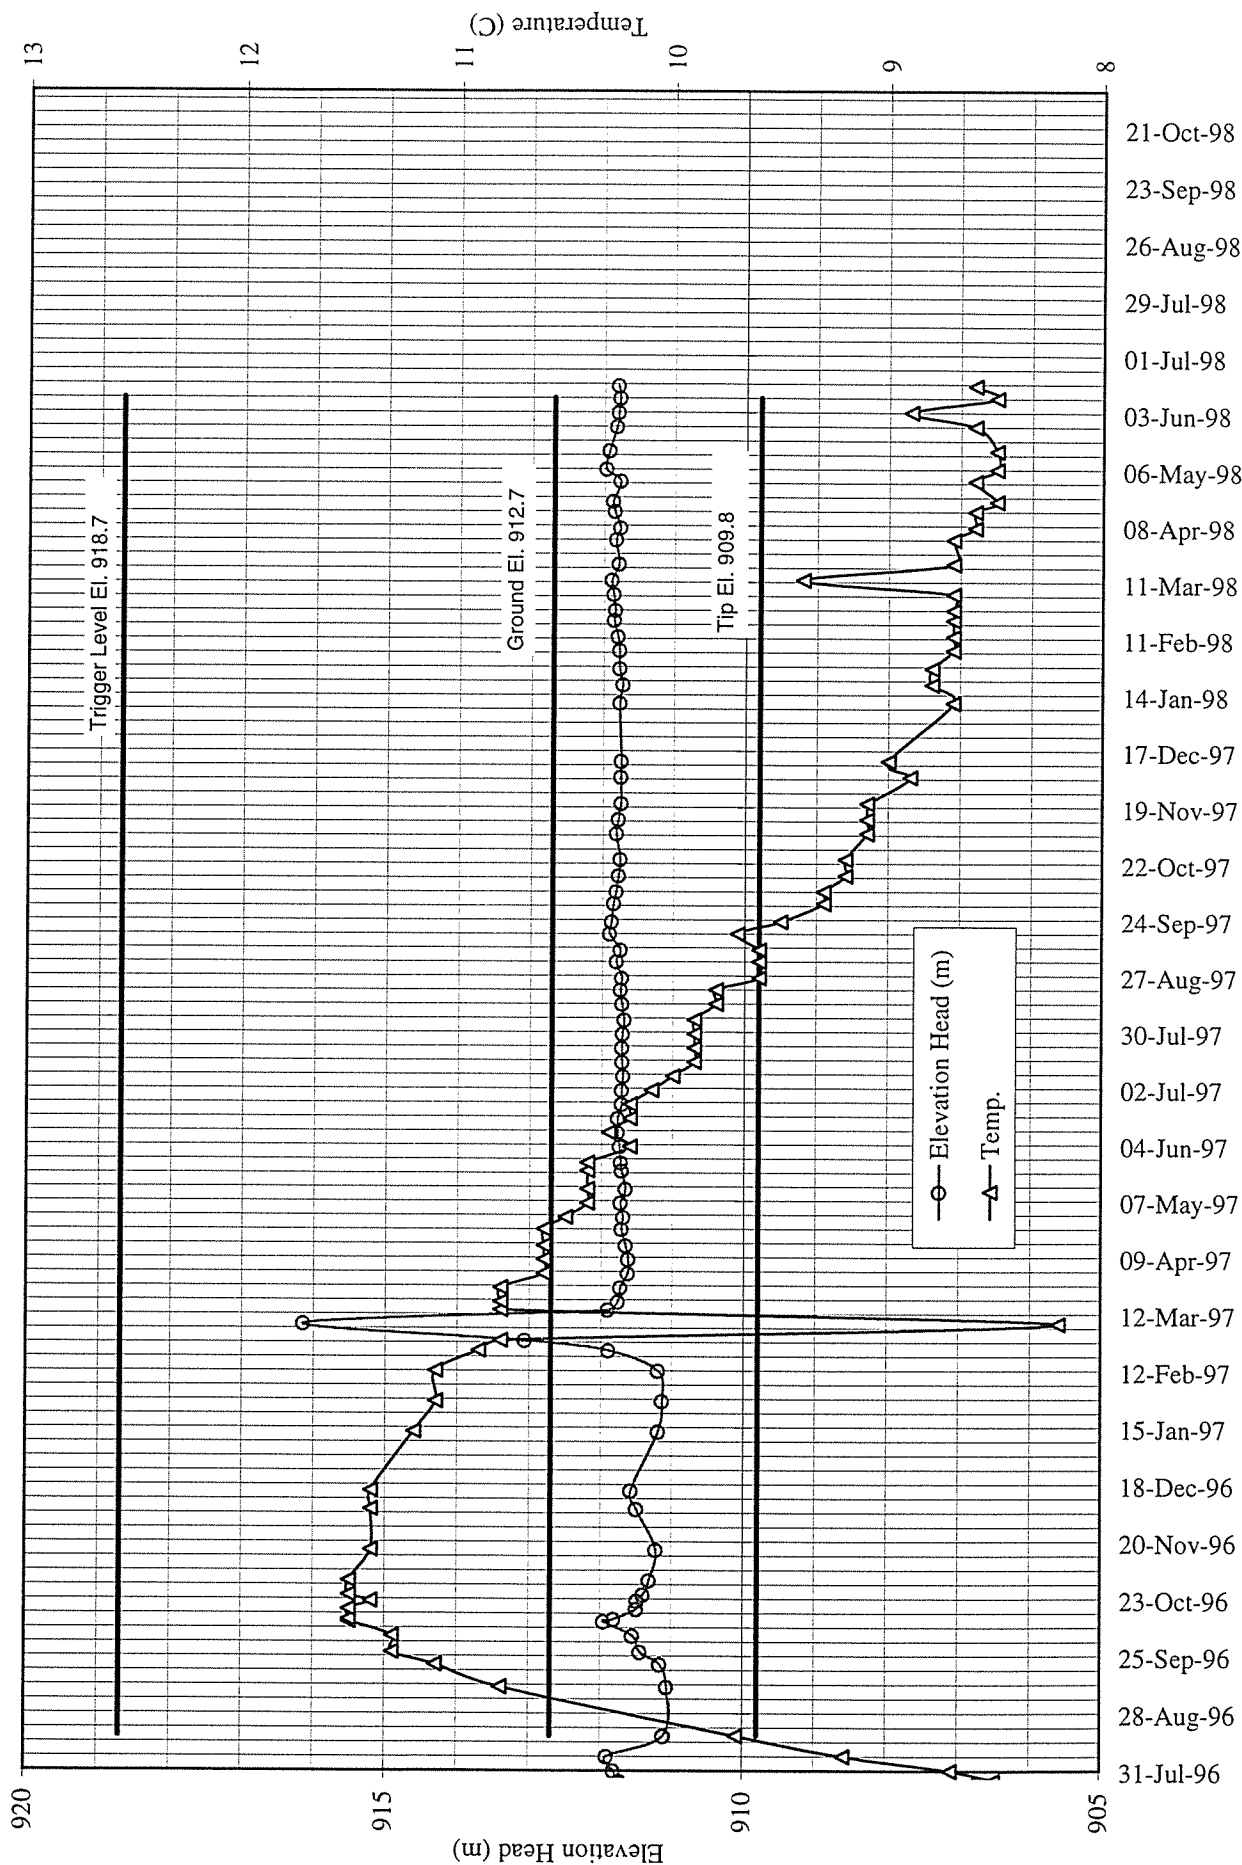
FIGURE 2.6

MOUNT POLLEY MINING CORPORATION.
MOUNT POLLEY PROJECT
TAILINGS STORAGE FACILITY
FOUNDATION PIEZOMETER - A2-PE2-02

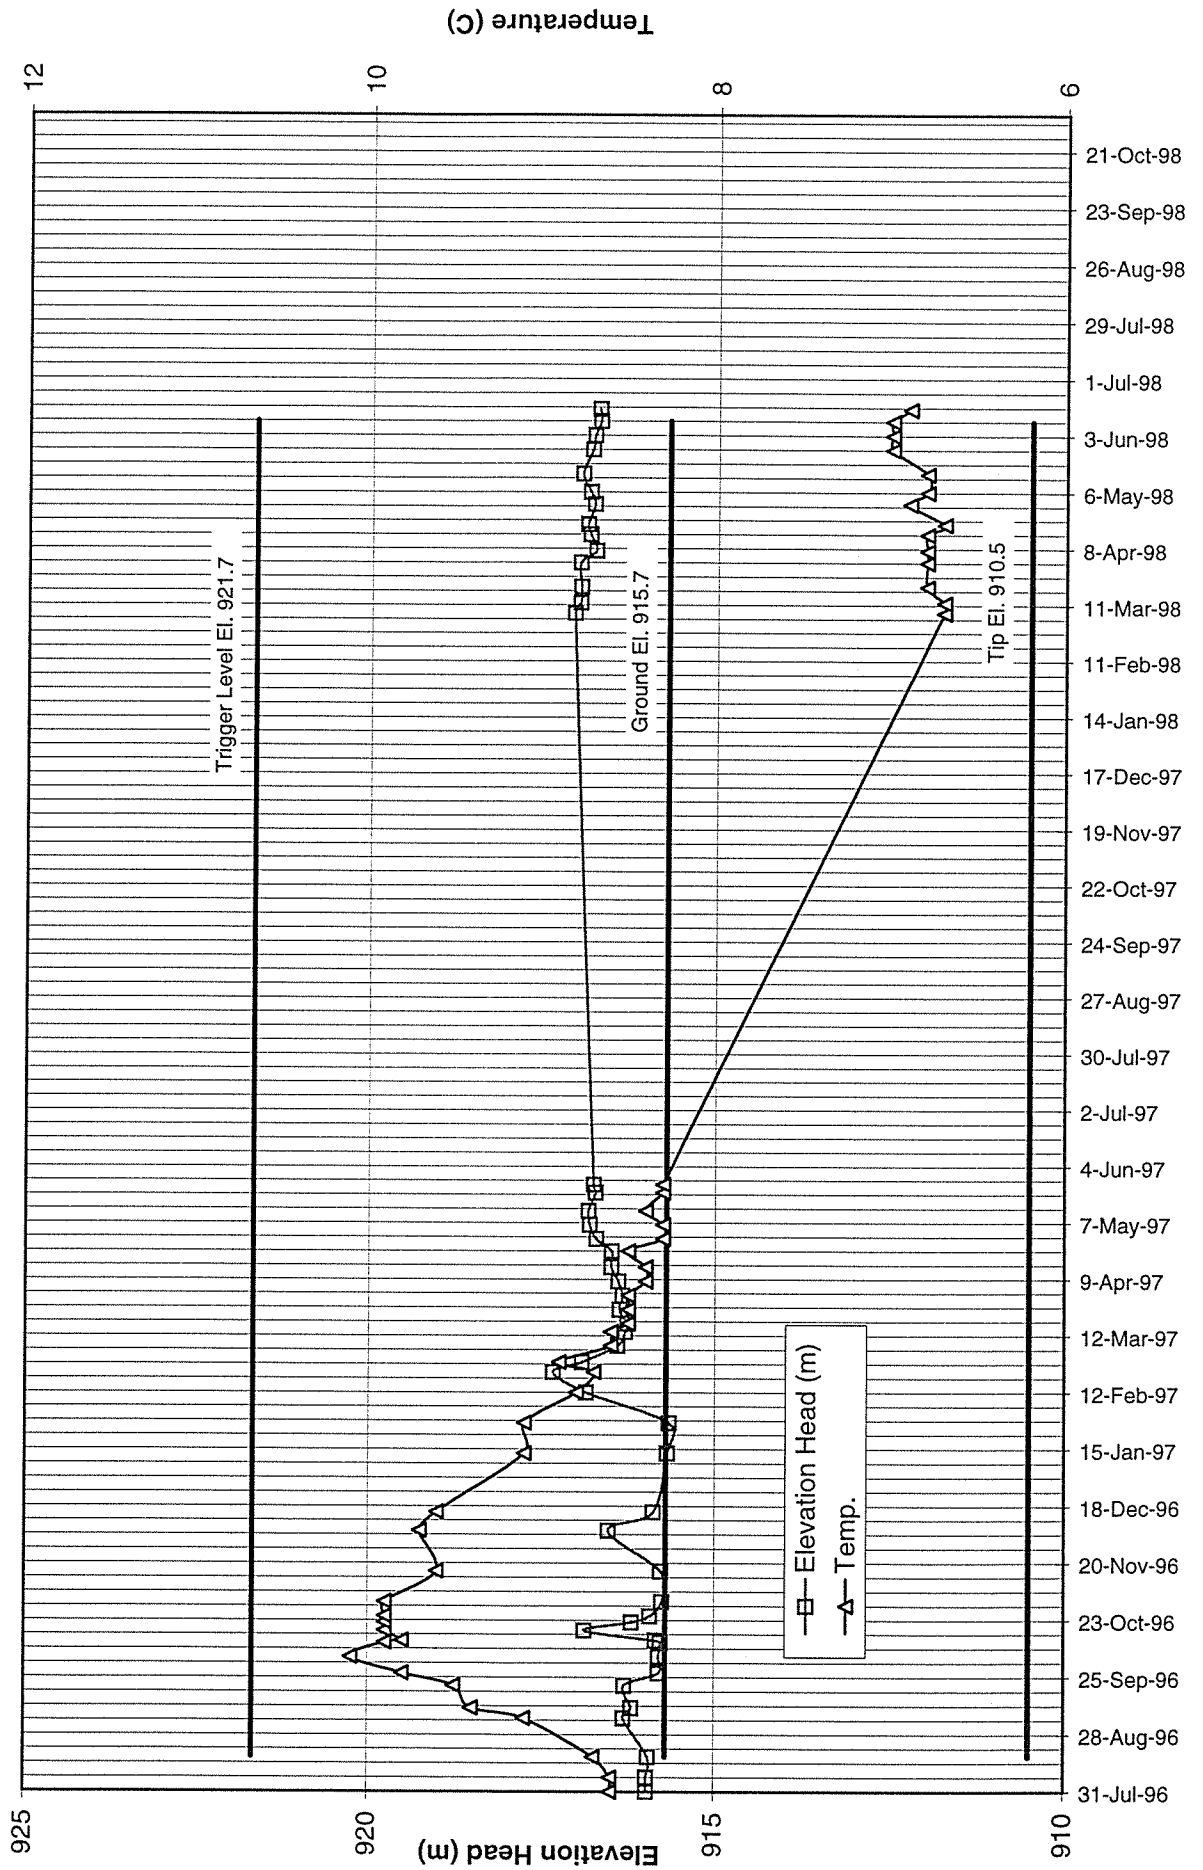
(C2-PE2-01)	---	---	---	---	Foundation Piezometer depth approx. 8.2m (El. 907.48)
C2-PE2-02	6.26	6.18	6.19	0.01	Foundation Piezometer depth approx. 5.2m (El. 910.53)
C2-PE2-03	0.45	0.44	0.38	-0.06	Fill piezometer El. 921.00.
C2-PE2-05	3.48	3.47	3.40	-0.07	Fill piezometer El. 924.80.
D1-PE1-02	-0.59	-0.58	-0.57	0.02	Outlet Drain piezometer, El. 928.76.
D2-PE2-01	-0.22	-0.33	-0.25	0.08	Fill piezometer El. 931.00.

MOUNT POLLEY MINING CORPORATION.
MOUNT POLLEY PROJECT
TAILINGS STORAGE FACILITY
FOUNDATION PIEZOMETER - C2-PE2-02

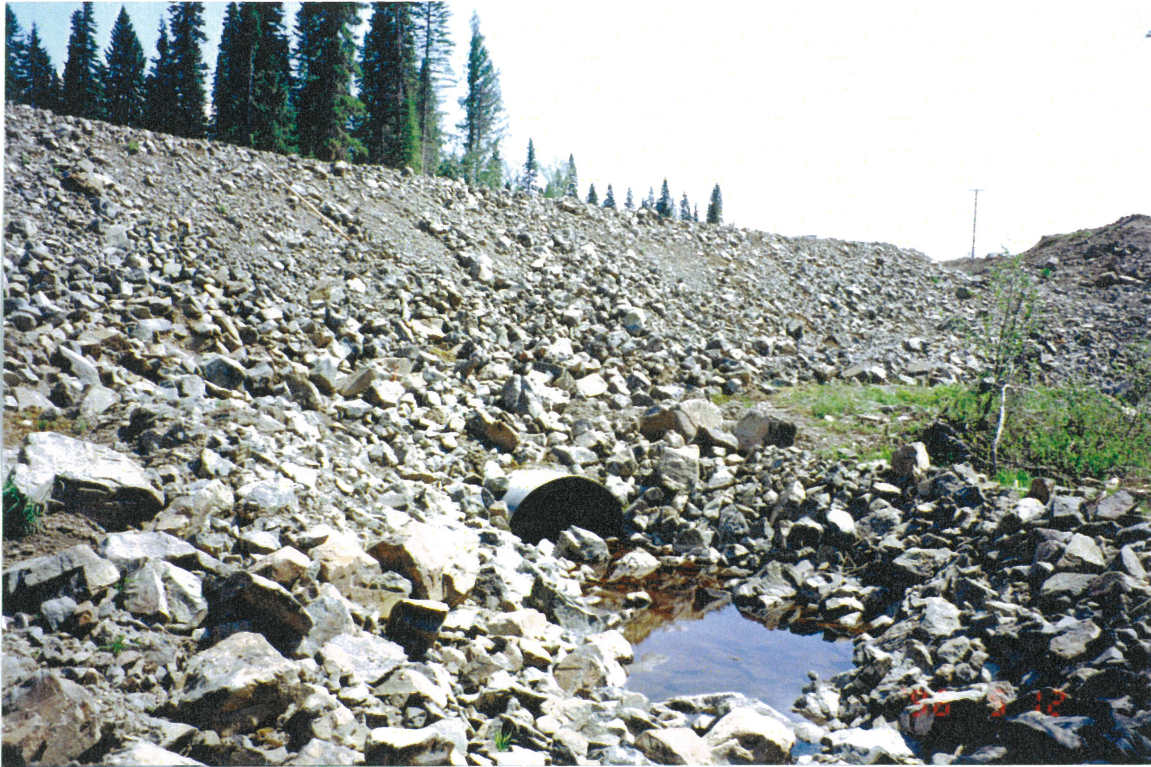
Bootjack Creek Culvert. Upstream side.

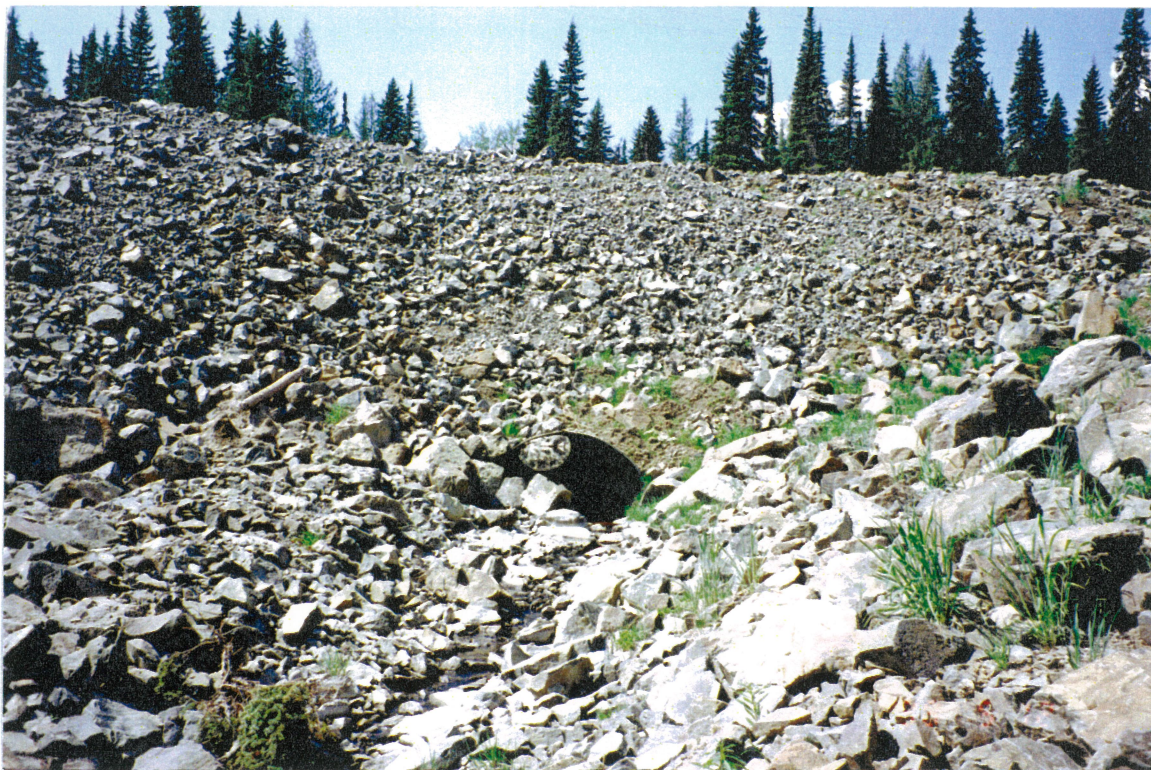
Bootjack Creek Culvert. Downstream side.

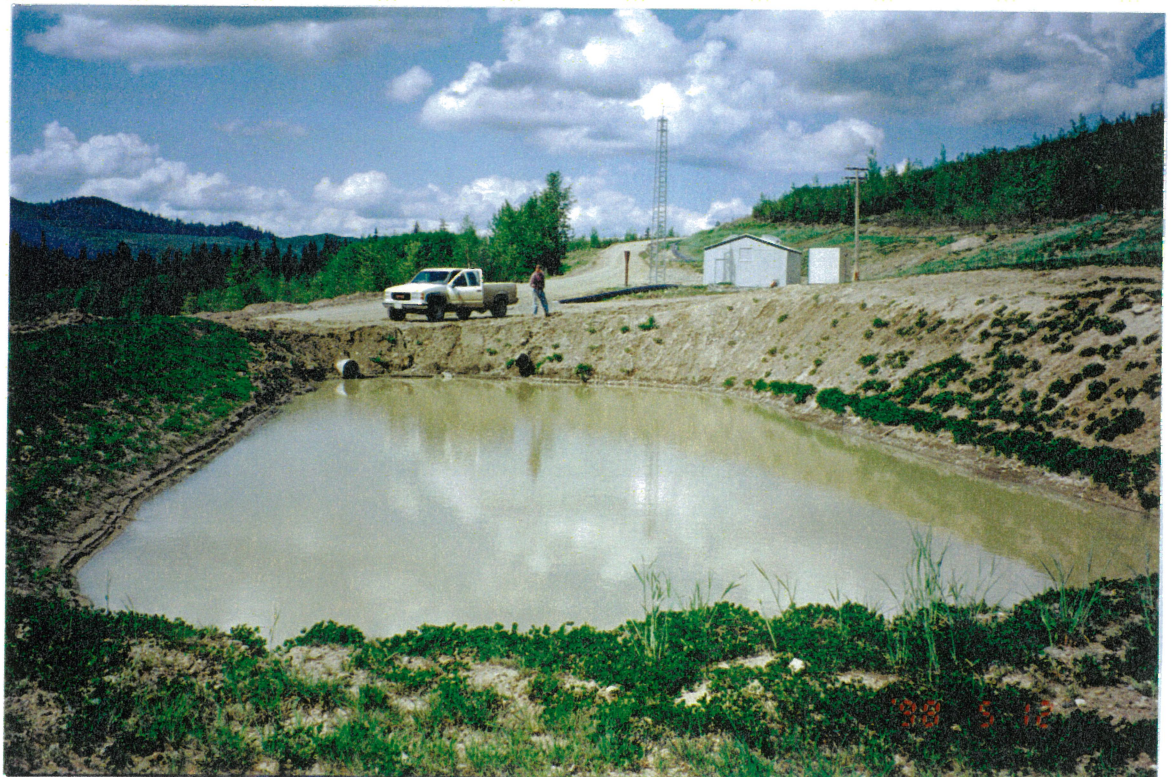
Tailings Pipeline System.
Full T2 Overflow Pond (water).

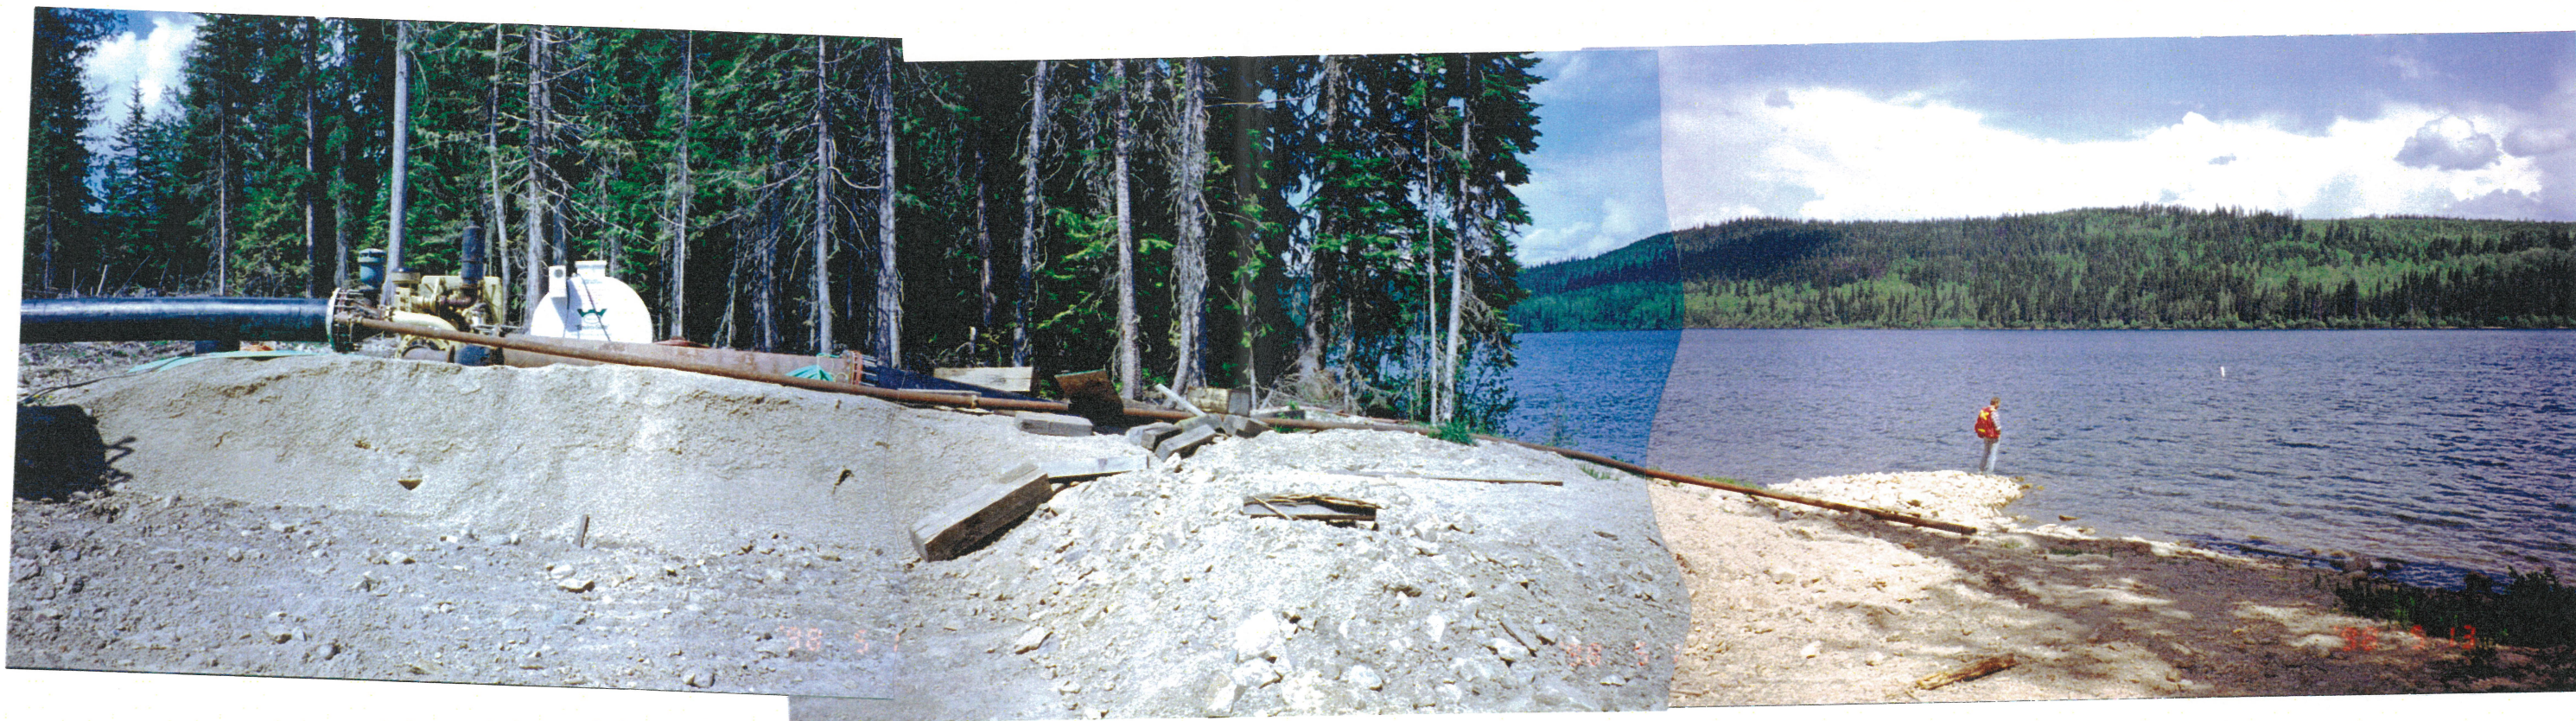
Southeast Sediment Pond. Downstream fill slope looking east. Note dry stable slope and well established re-vegetation.
