**MT. POLLEY MINE**

**N. ROSE GEOTECHNICAL INSPECTION OF OPEN PIT,**

**WASTE DUMPS AND TAILINGS DAMS**

**AUGUST 30, 2006**

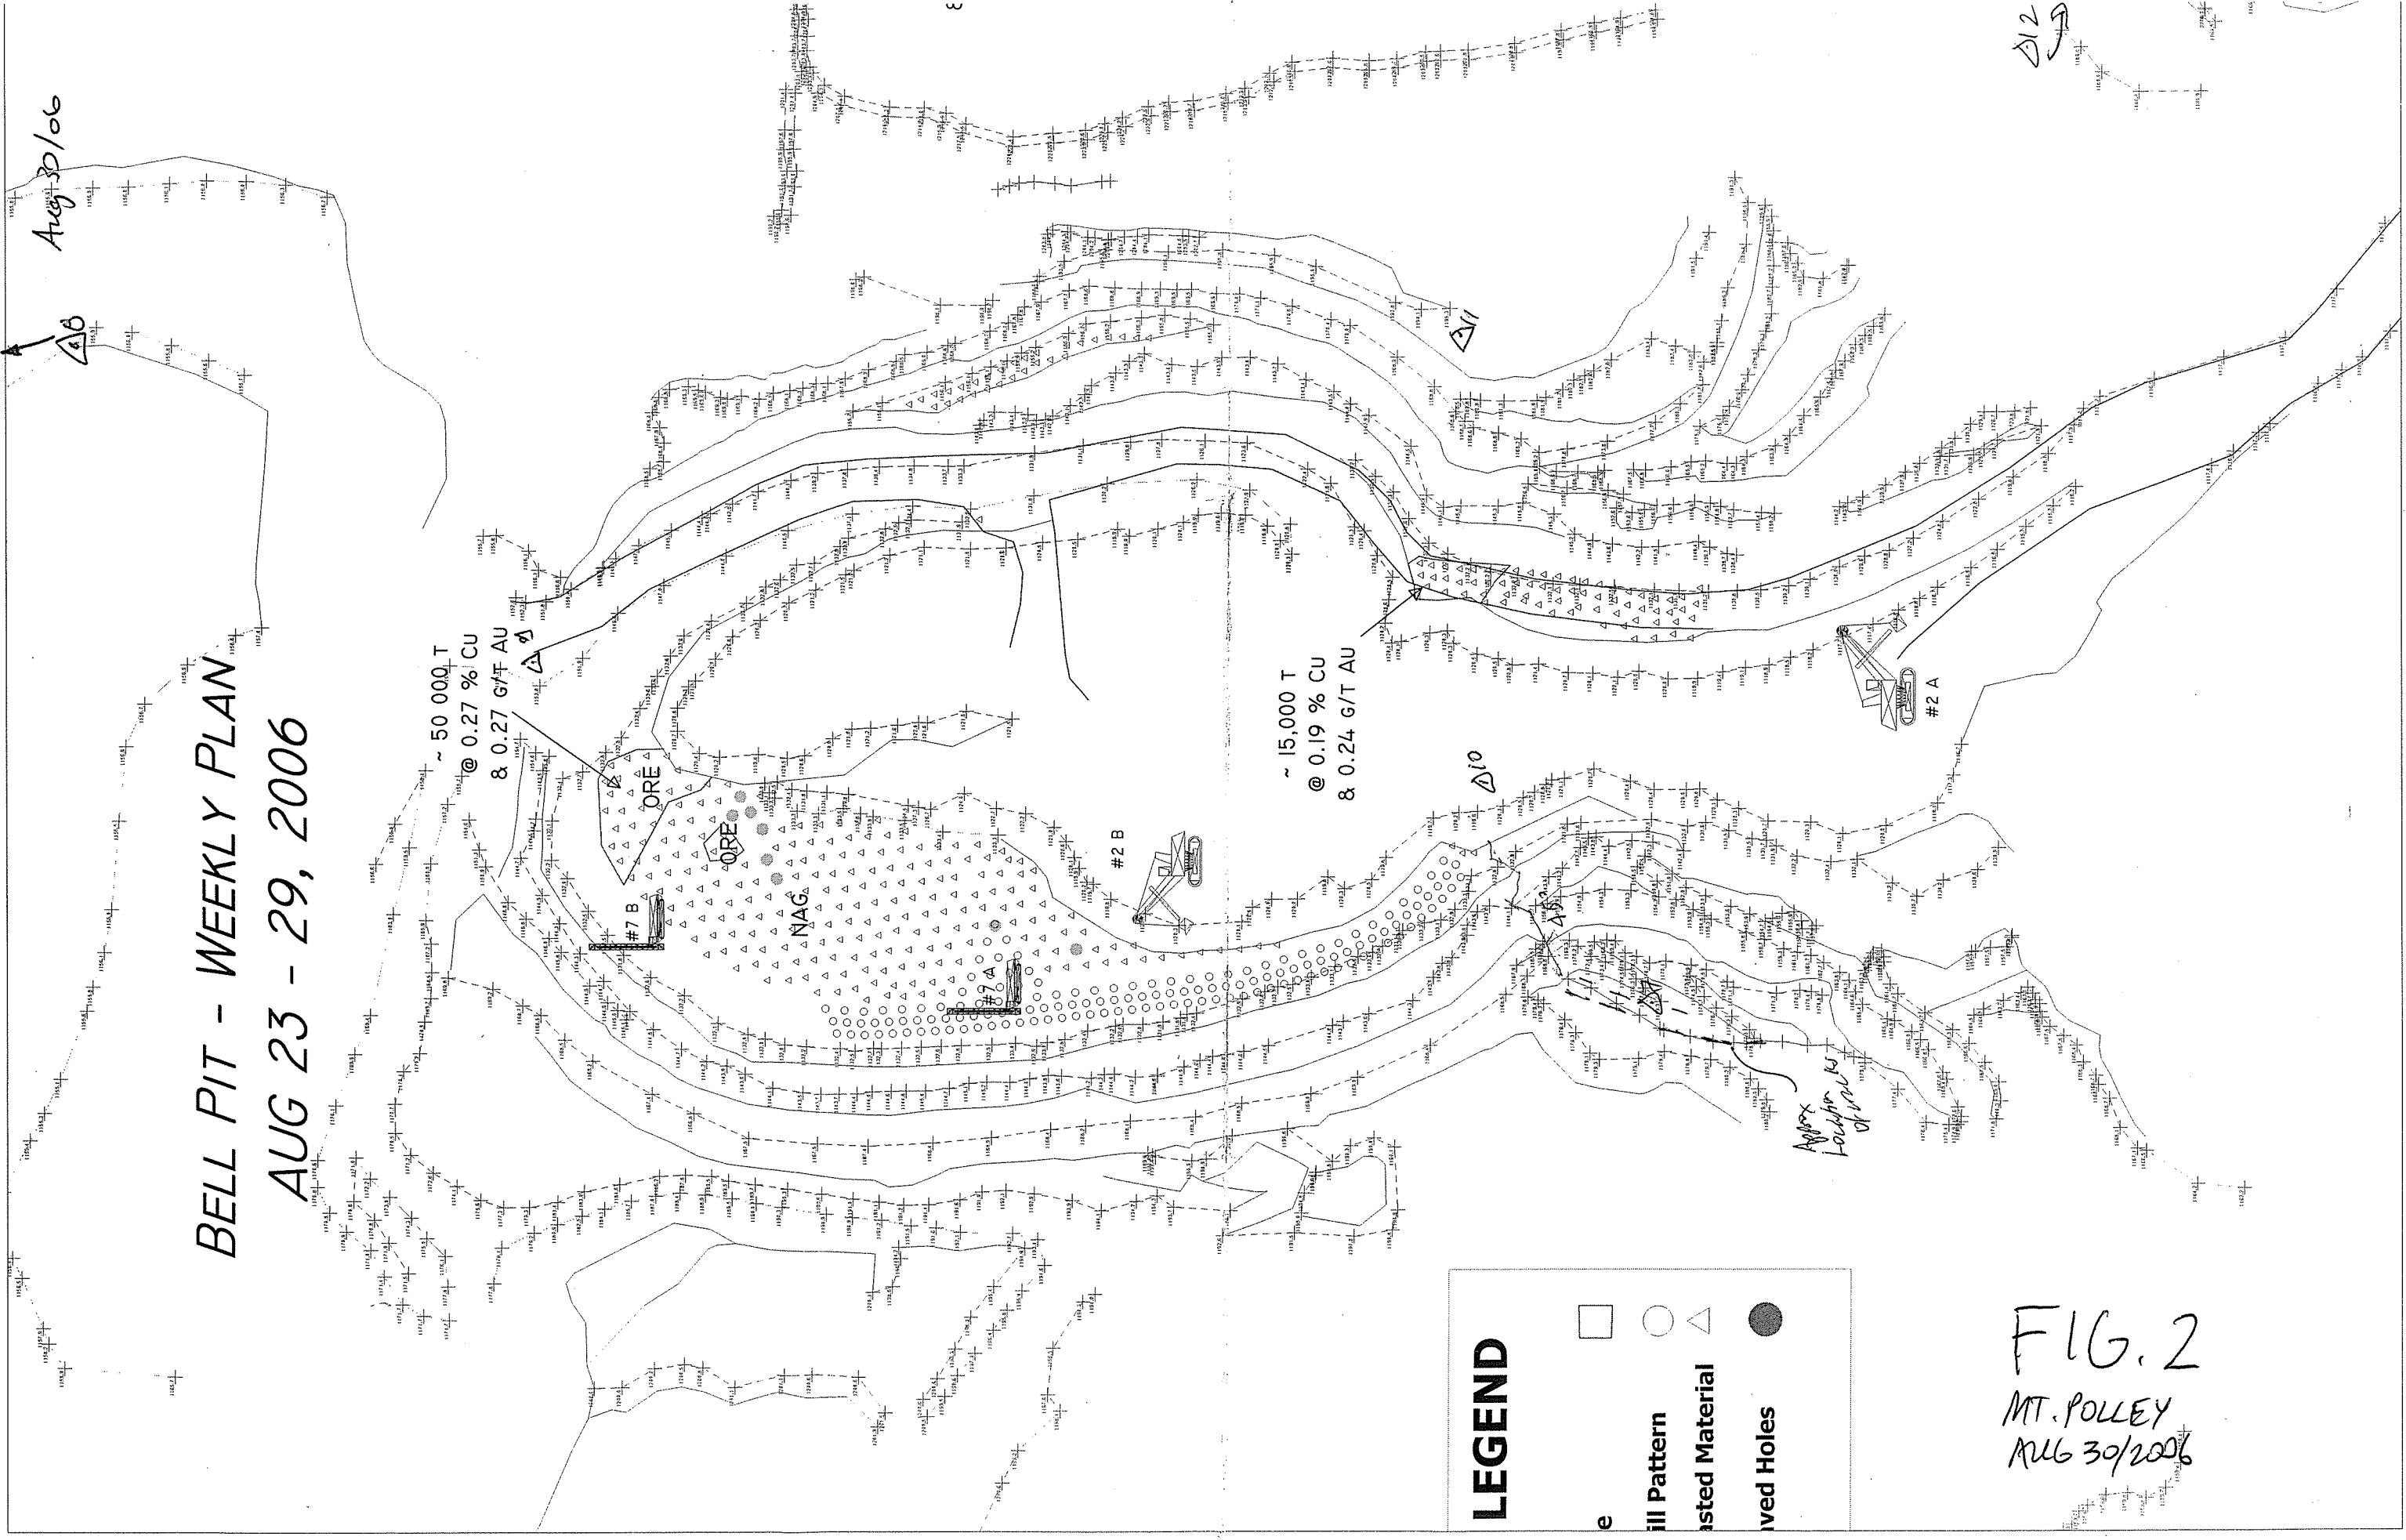
FIG. 2  
MT. POLLEY  
AUG 30/2006

- Station 7:* Tension crack on west wall of Bell Pit. Maximum aperture 15cm, but generally 3 to 4 cm wide (see Fig. 2 plan map for estimated location). Continue to monitor prisms and visually inspect and mark crack locations on regular basis. Operations currently keeping equipment away from toe and inspecting while active in pit.  
View of east side of pit.

- Daily prism monitoring and assessment of monitoring data on west and east wall instability areas in the Bell Pit.
- Manual wireline extensometer and manual crack monitoring devices (e.g., rebar pins) could be used for manual monitoring in addition to prism surveys.
- A suitably sized rockfall impact barrier shall be placed on the north haulroad below the area of active instability if raveling or rockfall hazards develop on the haulroad
- Threshold monitoring movement rate and operational response criteria shall be developed for the west and east walls of the Bell Pit and submitted to the Ministry within 15 days of the receipt of this report.
- The recommendations made by the design consultant for remedial design changes shall be followed.
