**MOUNT POLLEY MINING CORPORATION
MOUNT POLLEY MINE**

**TAILINGS STORAGE FACILITY
REPORT ON 2004 ANNUAL INSPECTION
(REF. NO. VA101-01/7-1)**

Knight Piésold Ltd.

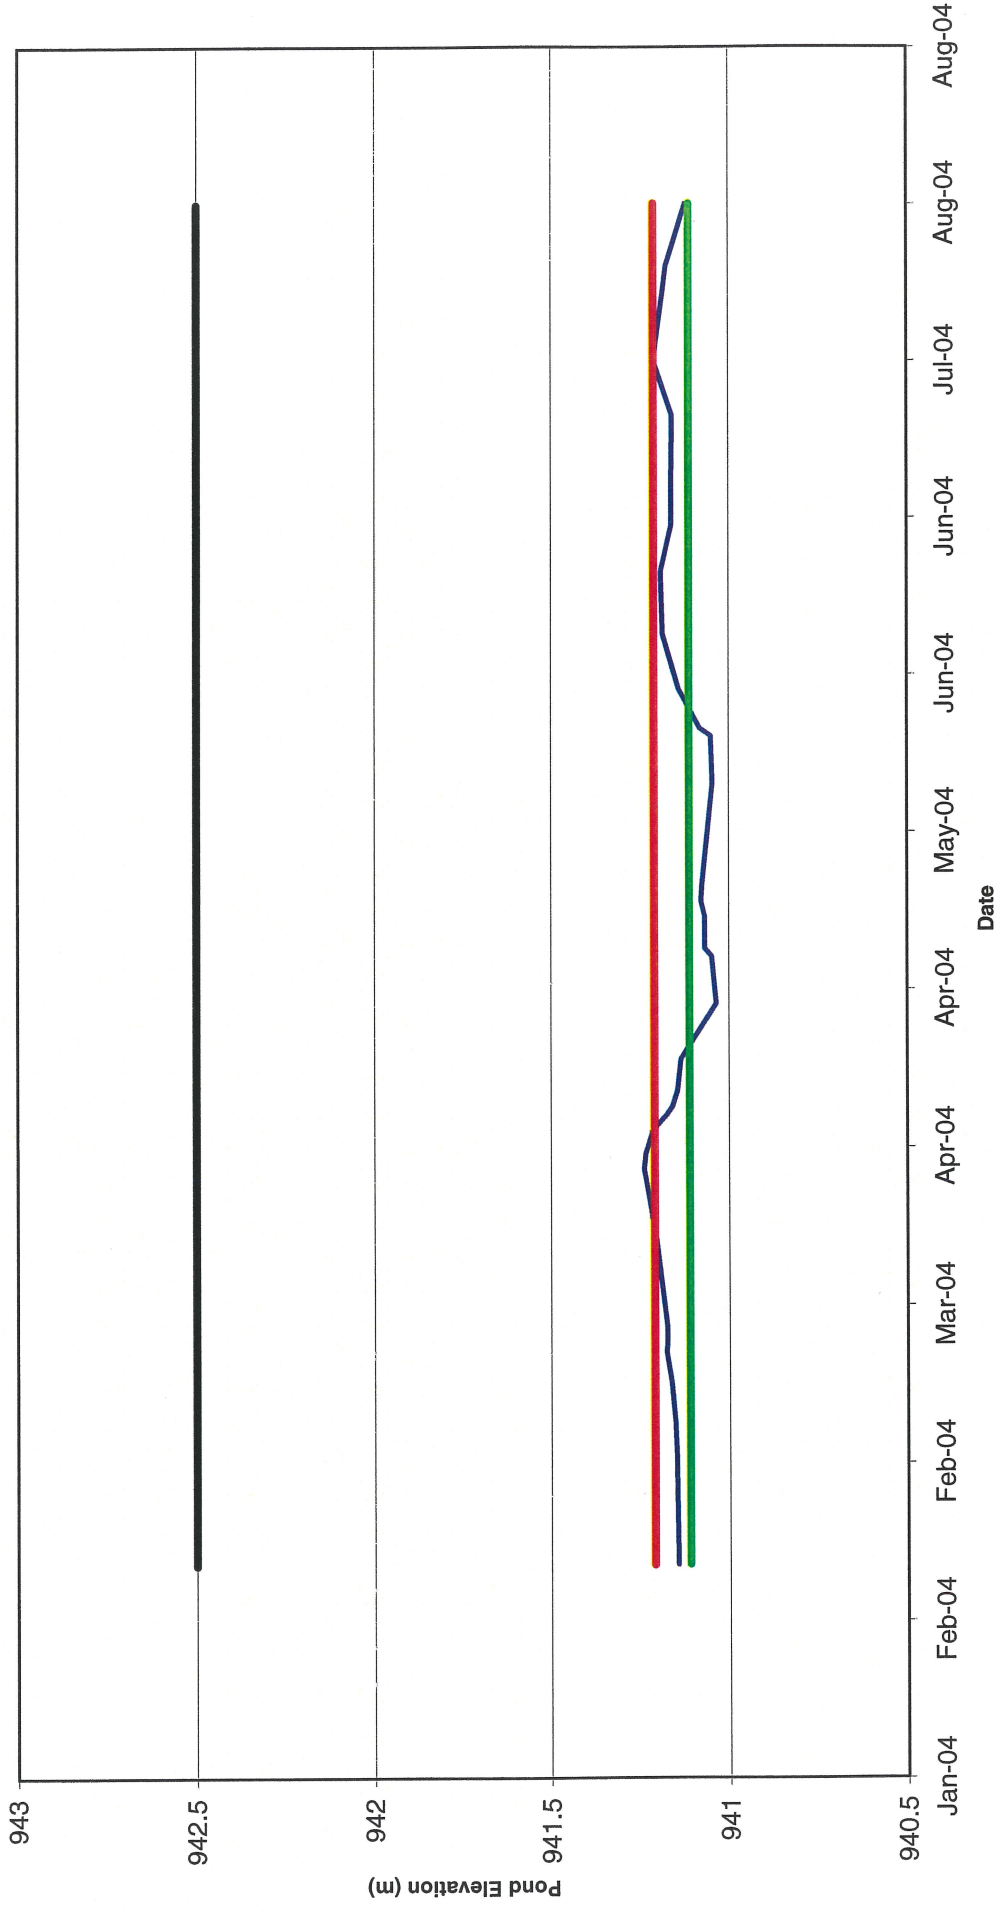
PROJECT / ASSIGNMENT NO.	REF. NO.	REV.
	VA101-177	1	0
FIGURE 3.1

The TSF is required to have sufficient live storage capacity for containment of runoff from the 24-hour PMP volume of 679,000 m³ at all times, which would result in an incremental rise in the tailings pond level of approximately 0.39 m. The 24-hour PMP allowance is in addition to regular inflows from other precipitation runoff, including the spring freshet. The TSF design also incorporates an additional allowance of 1 meter of freeboard for wave run-up. Therefore, the maximum pond level can be determined by subtracting the 1 meter wave run-up requirement and the 0.39 m PMP allowance from the embankment crest elevation of 942.5 m. This results in a maximum pond elevation of 941.11 m. Knight Piésold reviewed the freeboard requirements in a letter to MPMC on April 29, 2003 (included in Appendix D) and concluded that a temporary reduction in the freeboard requirement of 1.0 m to 0.9 m was not considered to be significant based on the geometry of the TSF and the prevailing wind direction (Figure 3.1). This results in a slight increase in the maximum pond elevation to 941.21 m. MPMC generally operated the pond within these tolerances over the past year, and pumped approximately 700,000 m³ to the Caribou Pit during the 2004 freshet to ensure compliance with this requirement.

The water balance information illustrated on Figure 3.1 indicates that the pond elevation will increase above the maximum allowable level during the spring freshet of 2004. Therefore MPMC will be required to discharge water from the tailings impoundment prior to this period. MPMC plans to compile all water quality data during summer 2003 and present it to MWLAP to discuss options for discharging water from the TSF prior to spring 2004. This discharge application will likely be an amendment to MPMC's existing MWLAP permit PE 11678. We understand that a concept MPMC is currently considering is to use a siphon system to allow for controlled discharge of pond water over the Perimeter Embankment and into Hazeltine Creek during high flow periods when adequate dilution is available. Knight Piésold will be pleased to assist in evaluating the viability of this option and in supporting application for a discharge permit.

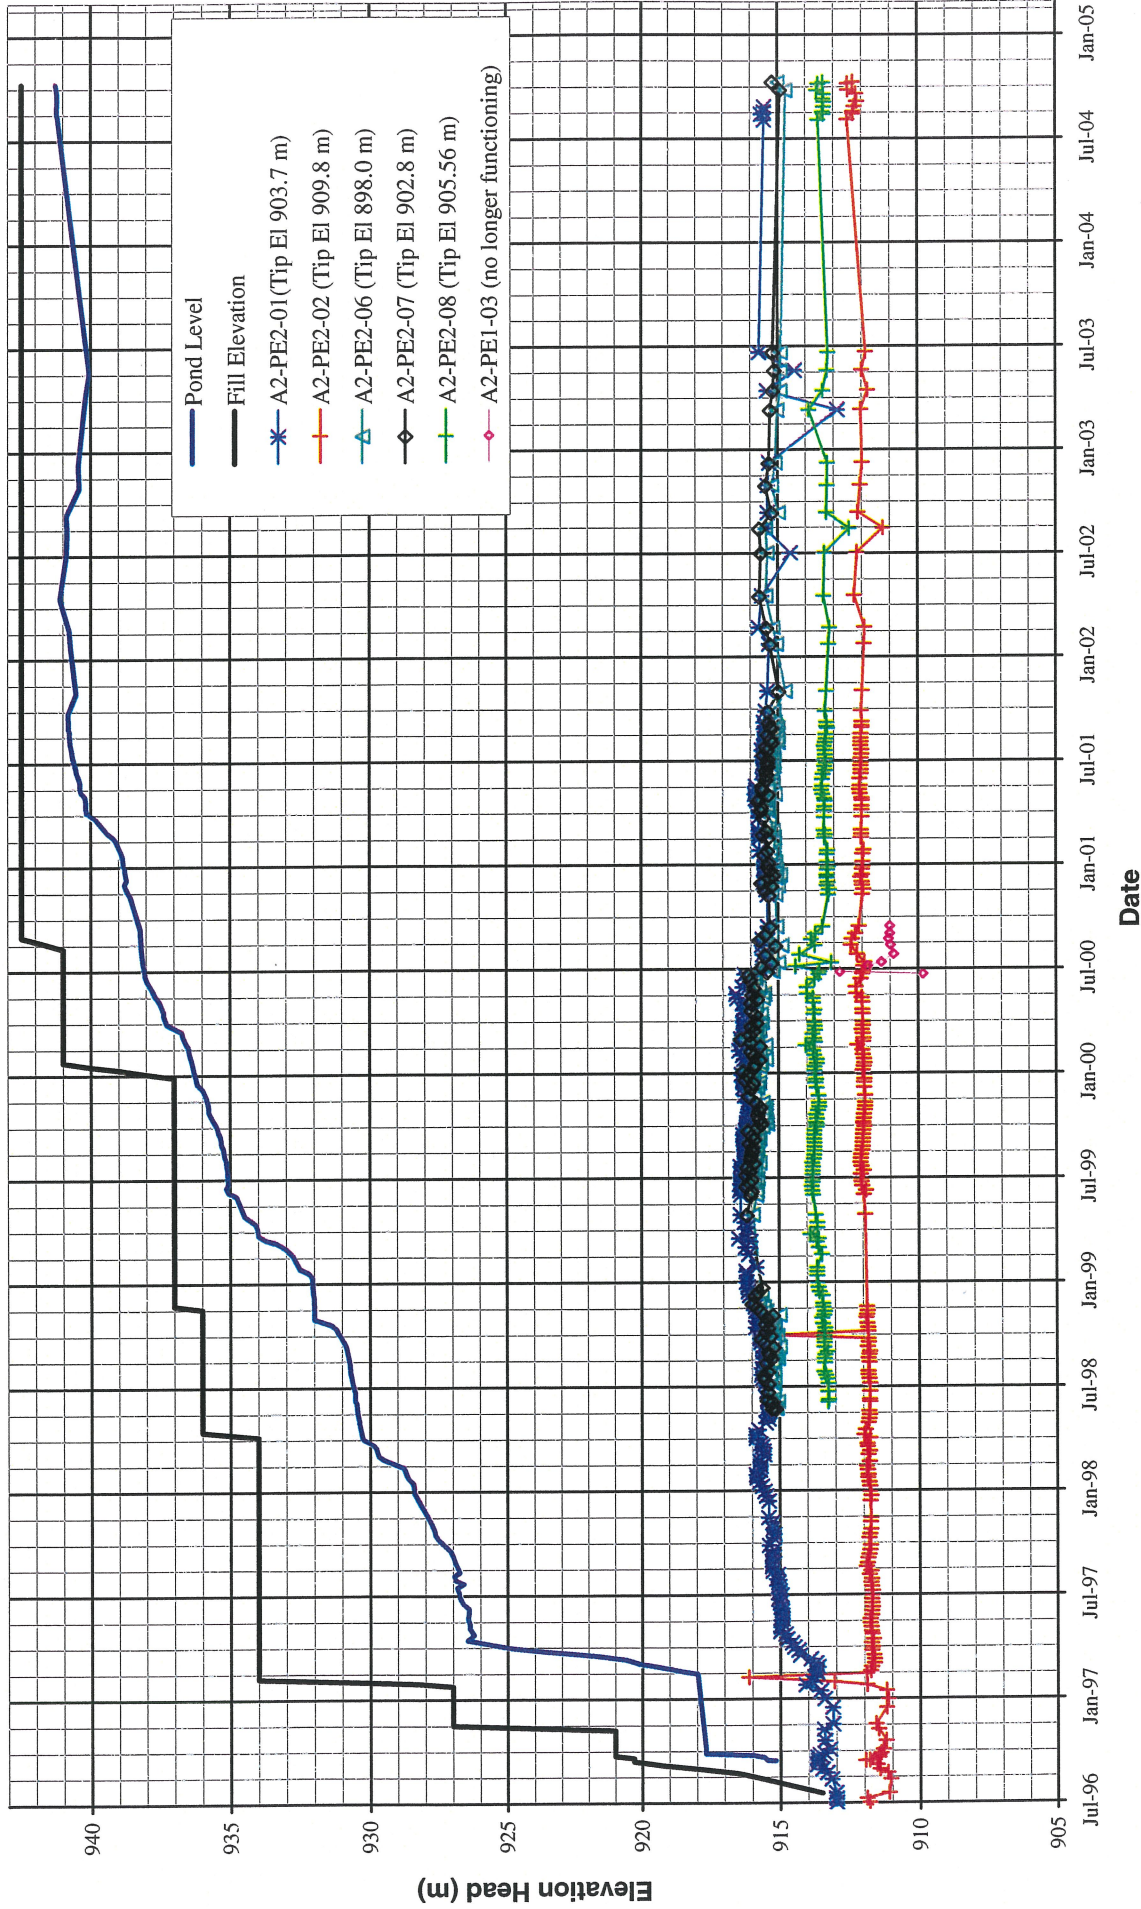
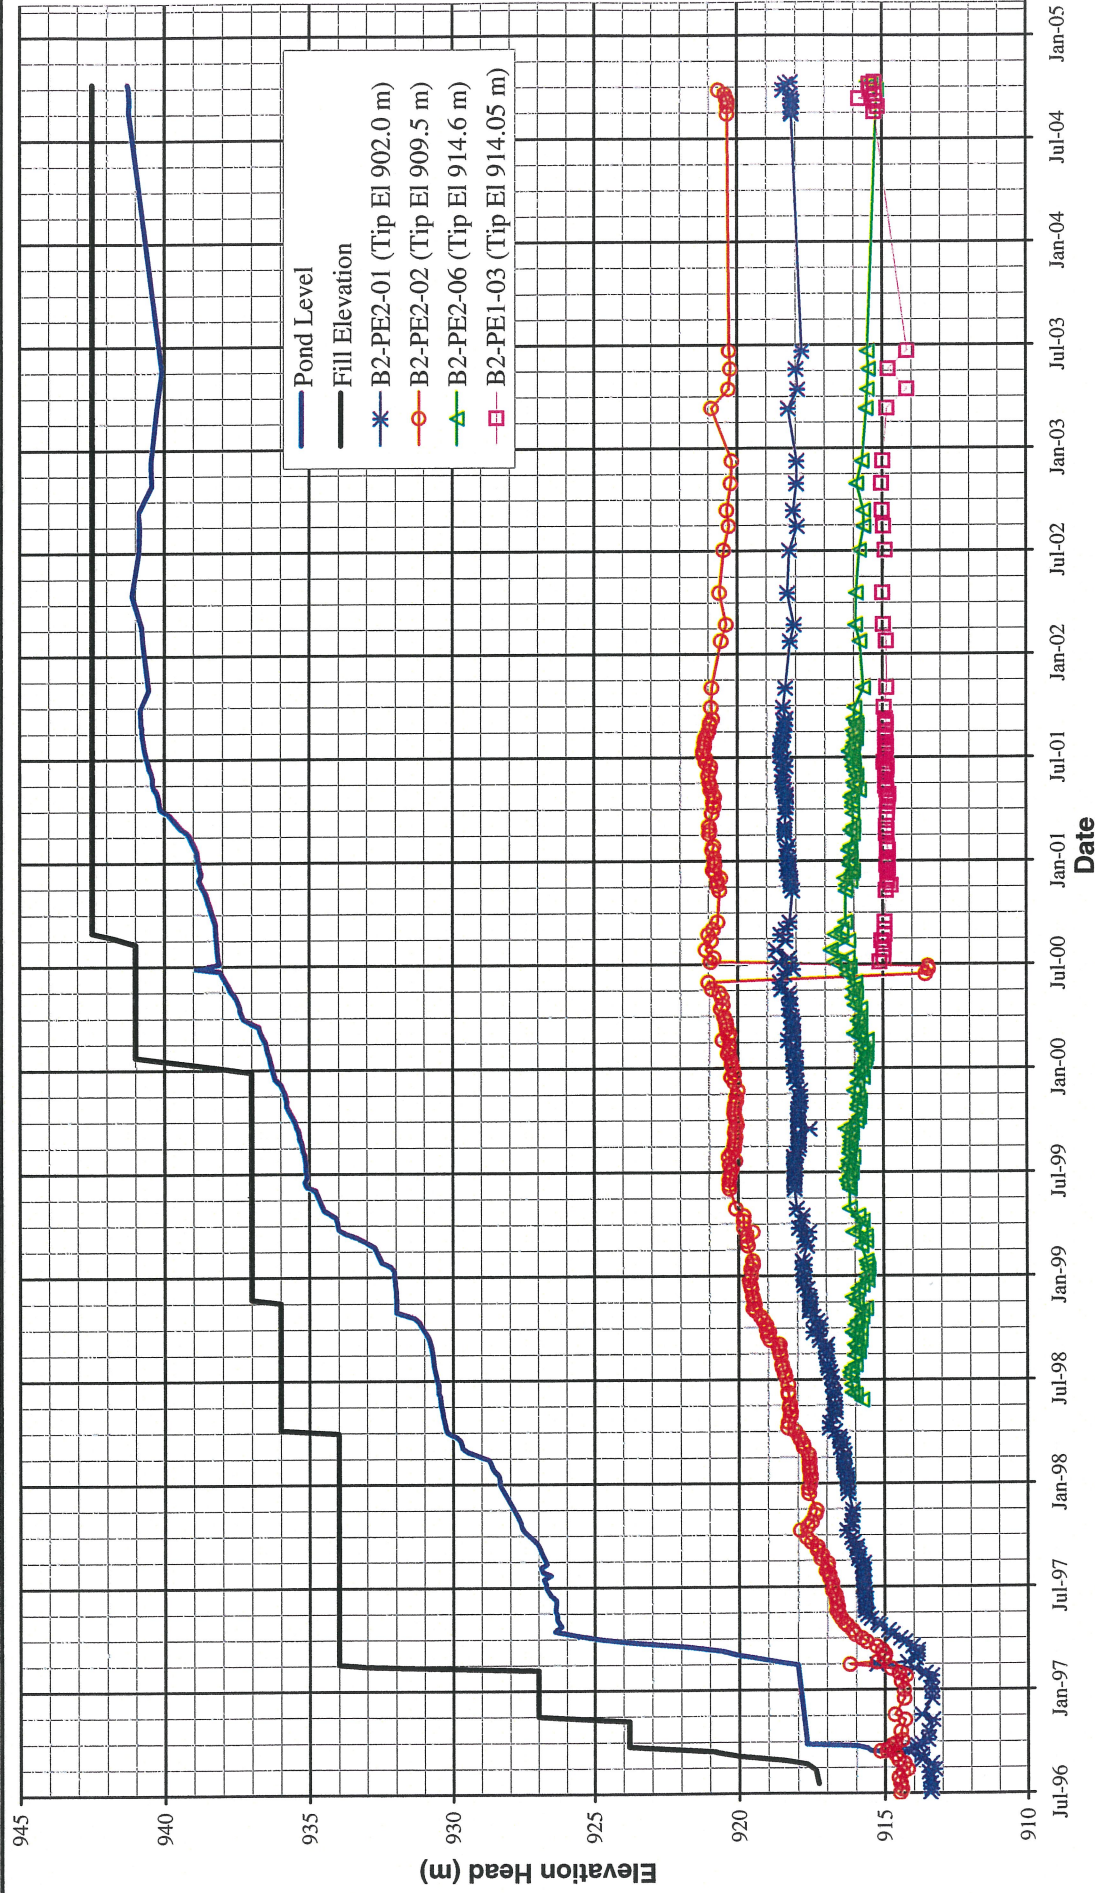
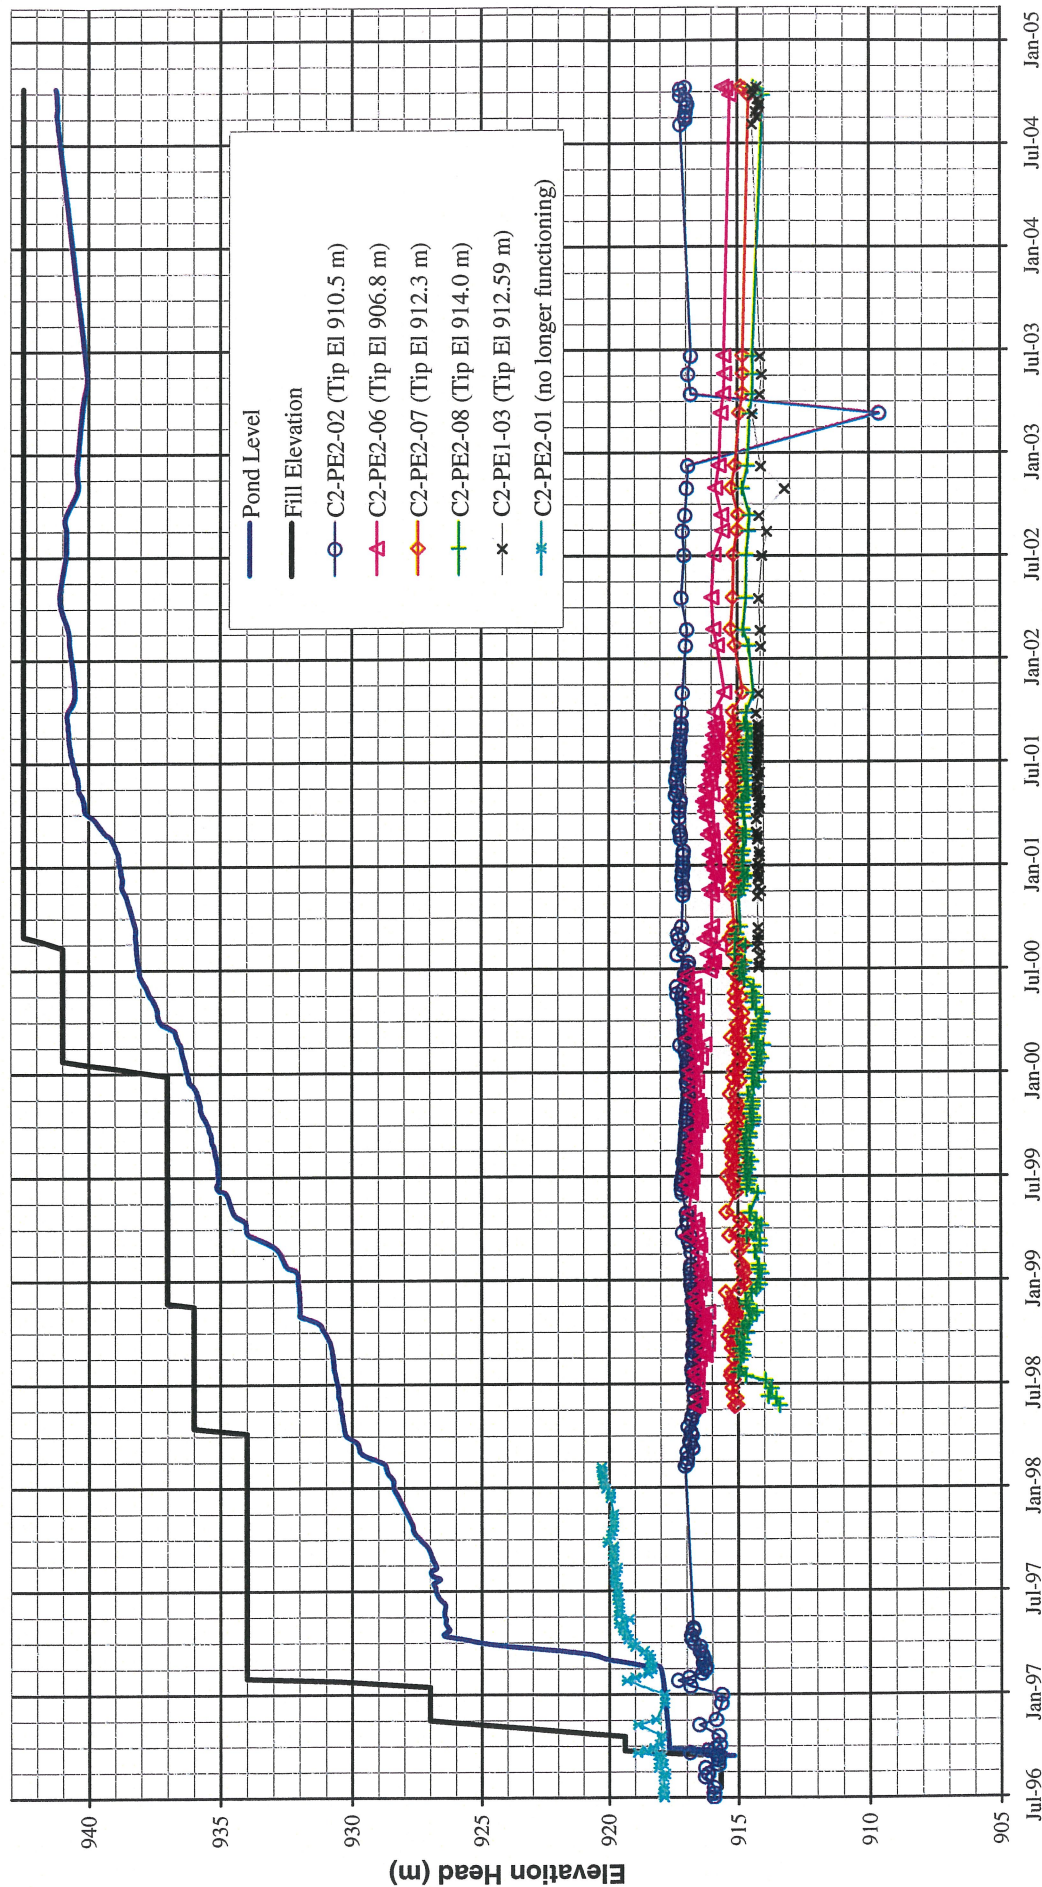
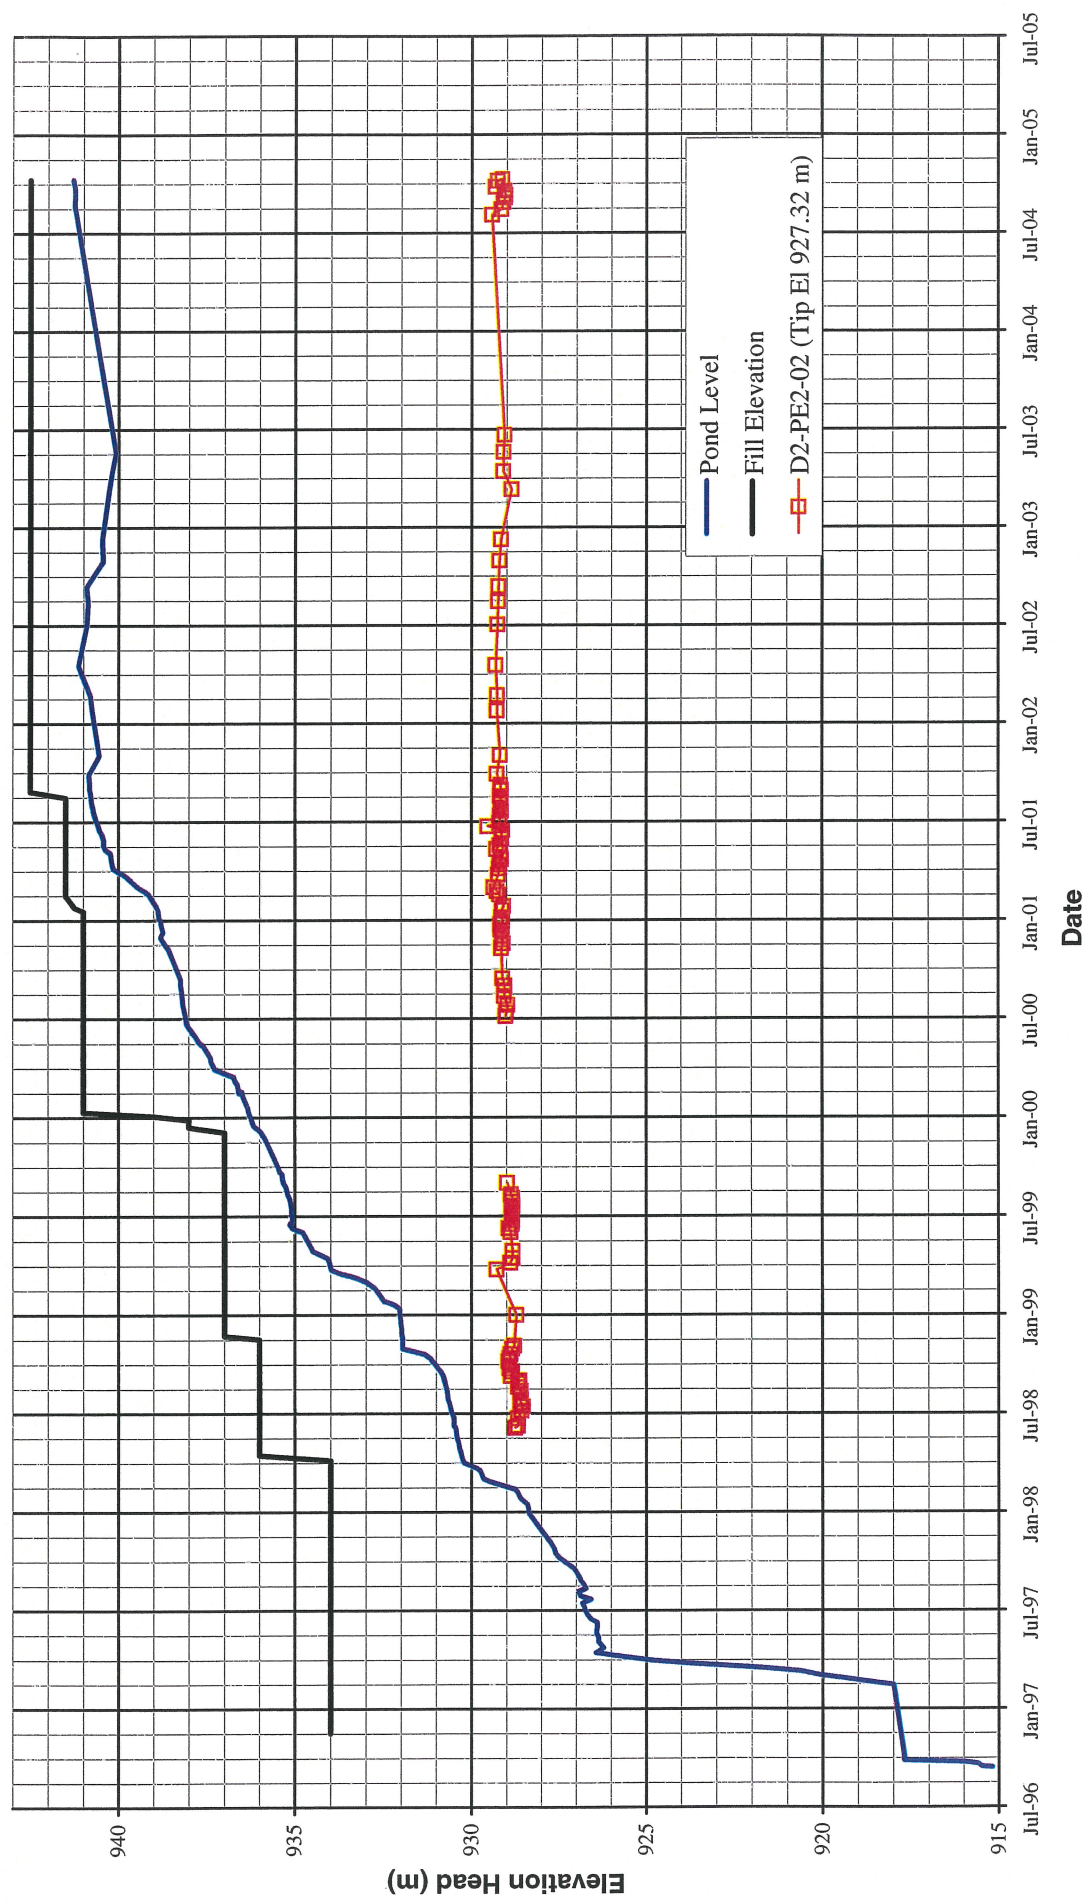
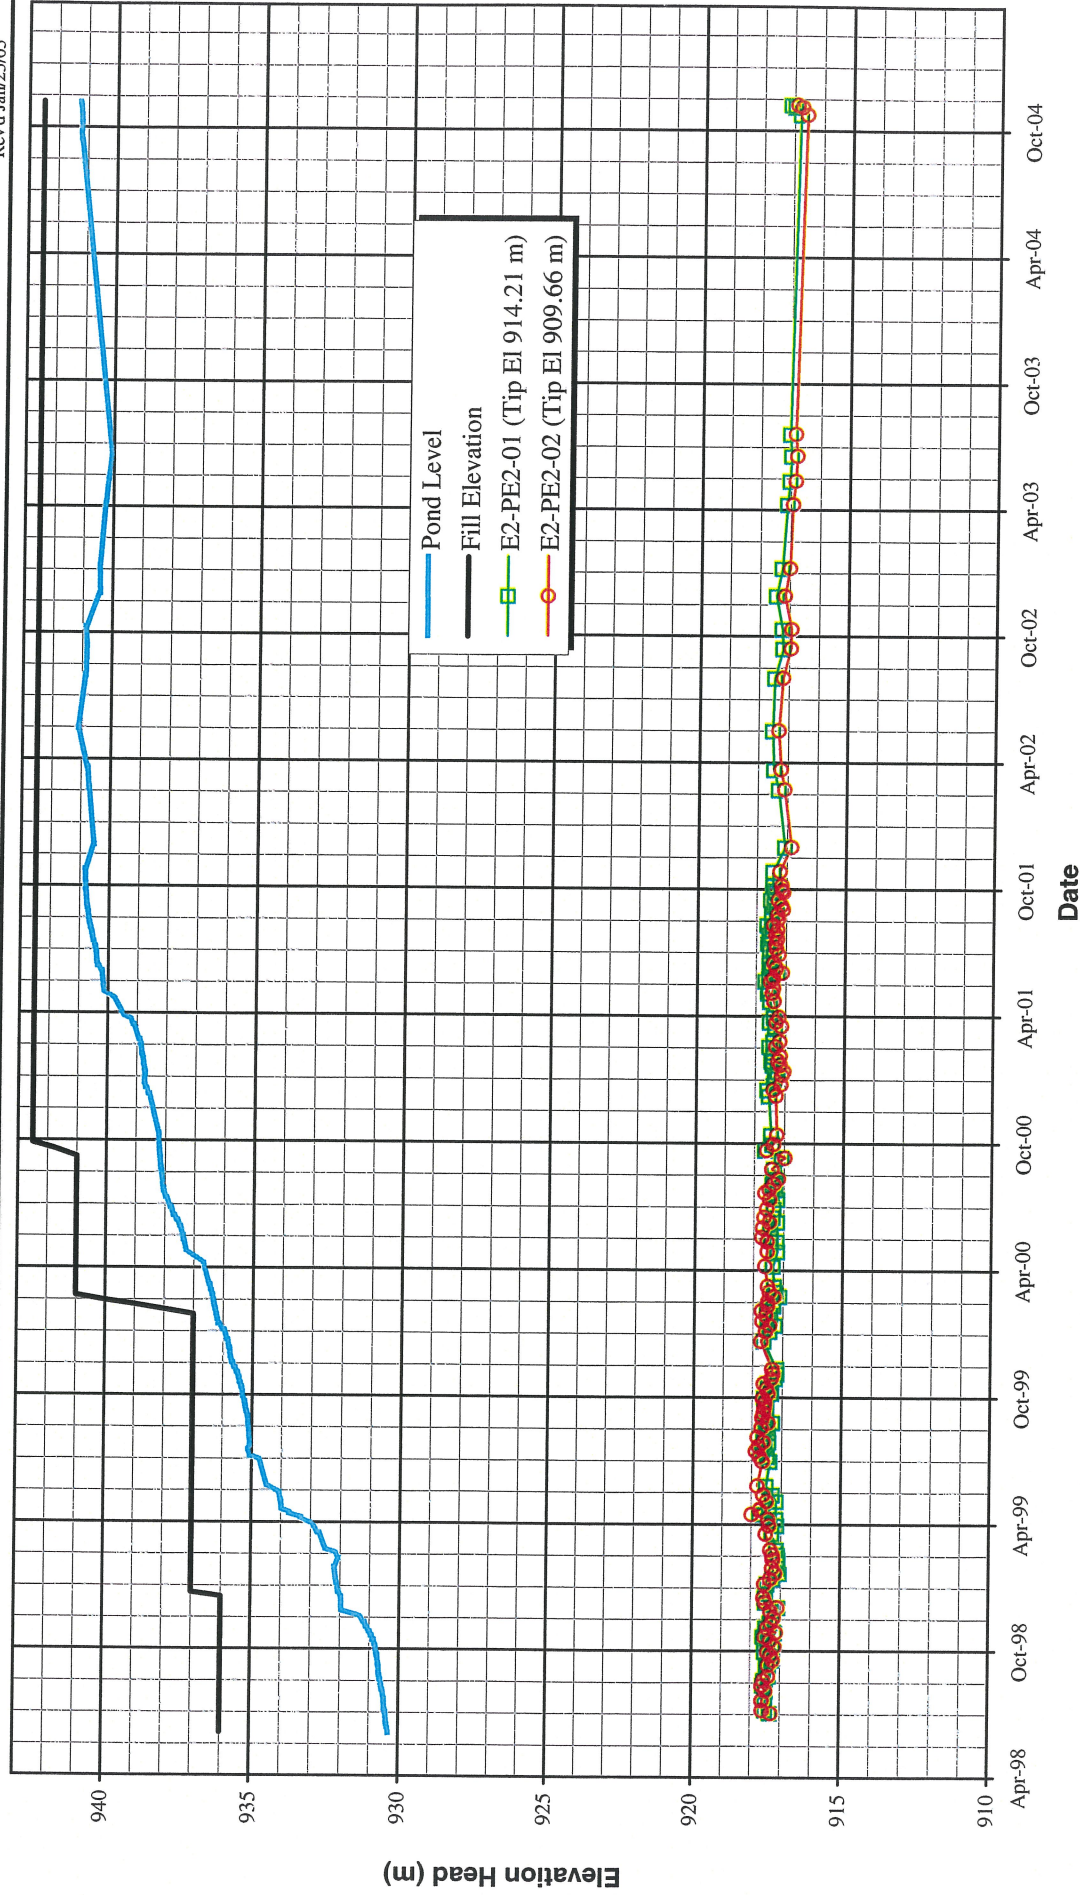
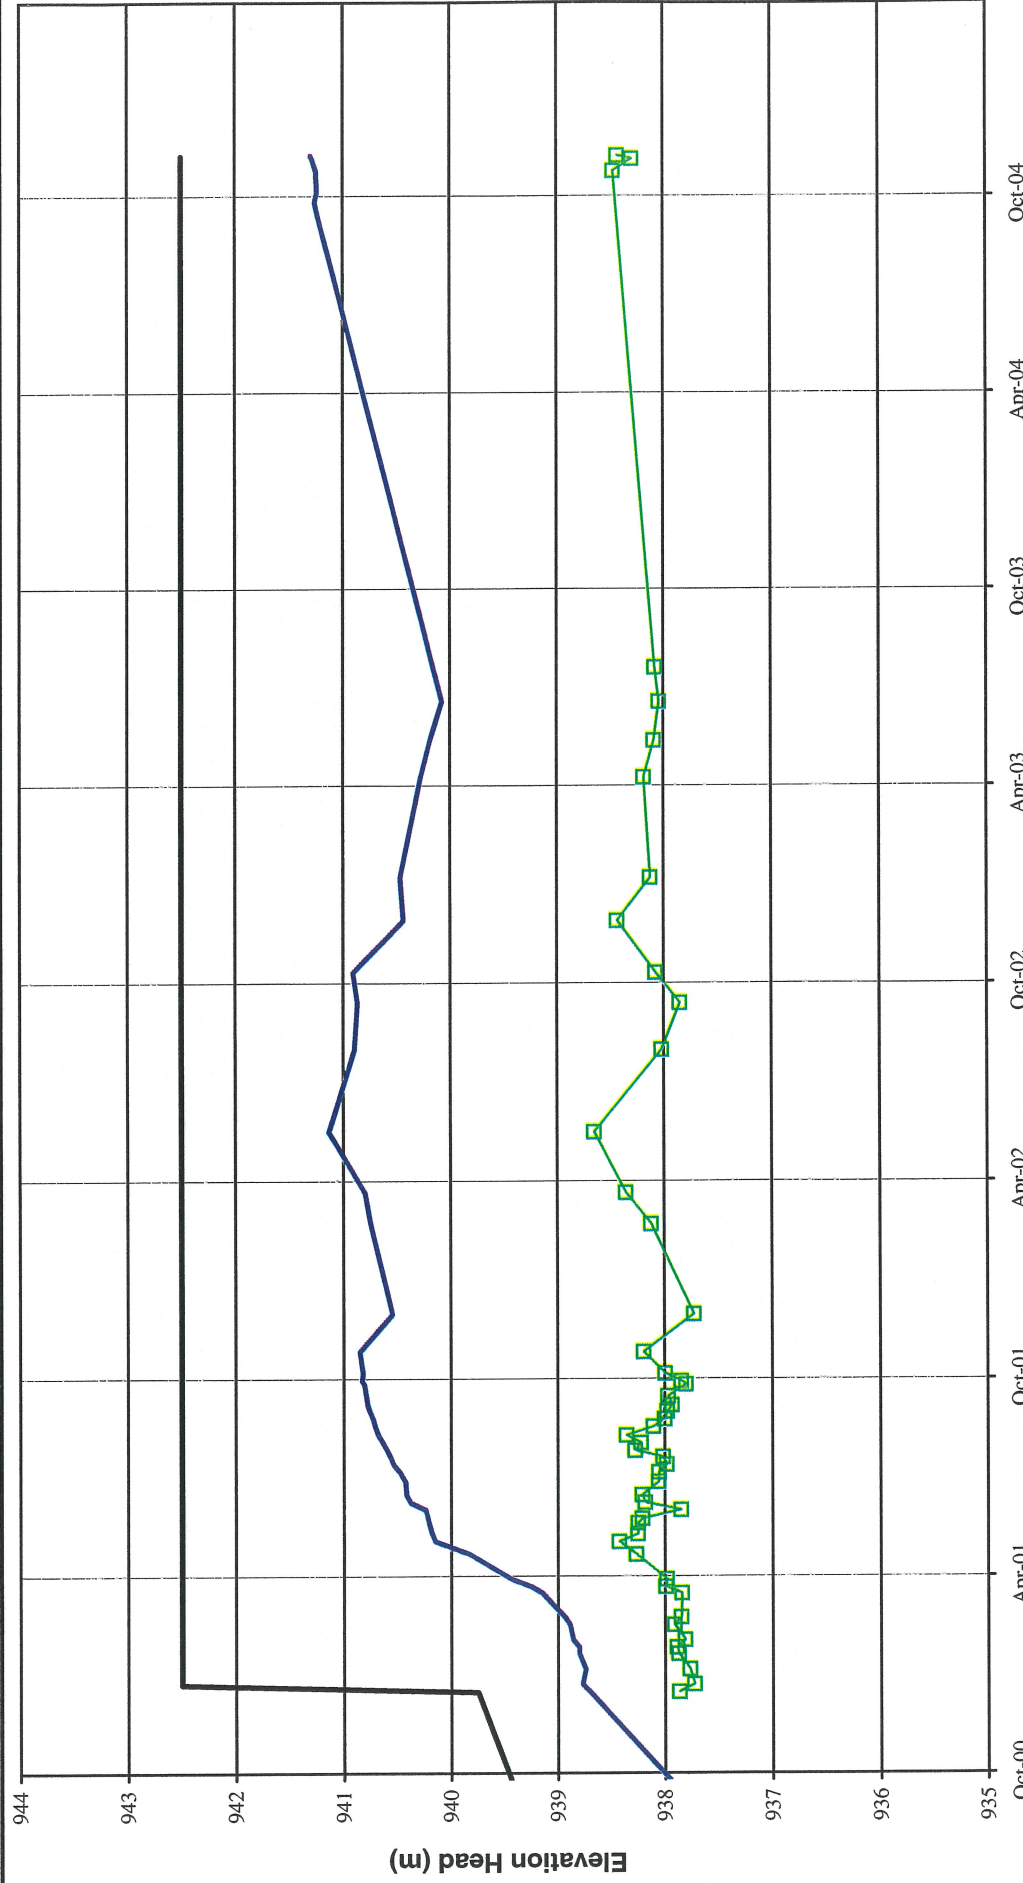
Artesian pressures have remained relatively constant in all the piezometers during the reporting period. No artesian conditions have been encountered at Plane E, where coarser glaciofluvial material is present.

The pore pressures of the foundation piezometers increased slightly over time during previous mine operations. This was likely due to elastic loading of the aquifer and/or seepage recharge from the TSF. However, seepage was minor as evidenced by foundation drain records.

Timeline plots of the embankment foundation piezometers are included in Appendix B2. There are no concerns with the embankment foundation piezometers.
