**MOUNT POLLEY MINING CORPORATION
MOUNT POLLEY MINE**

**TAILINGS STORAGE FACILITY
REPORT ON 2005 ANNUAL INSPECTION
(REF. NO. VA101-01/11-1)**

Rev. No.	Revision	Date	Approved
Rev 0	Issued in Final	May 3, 2006	KJB

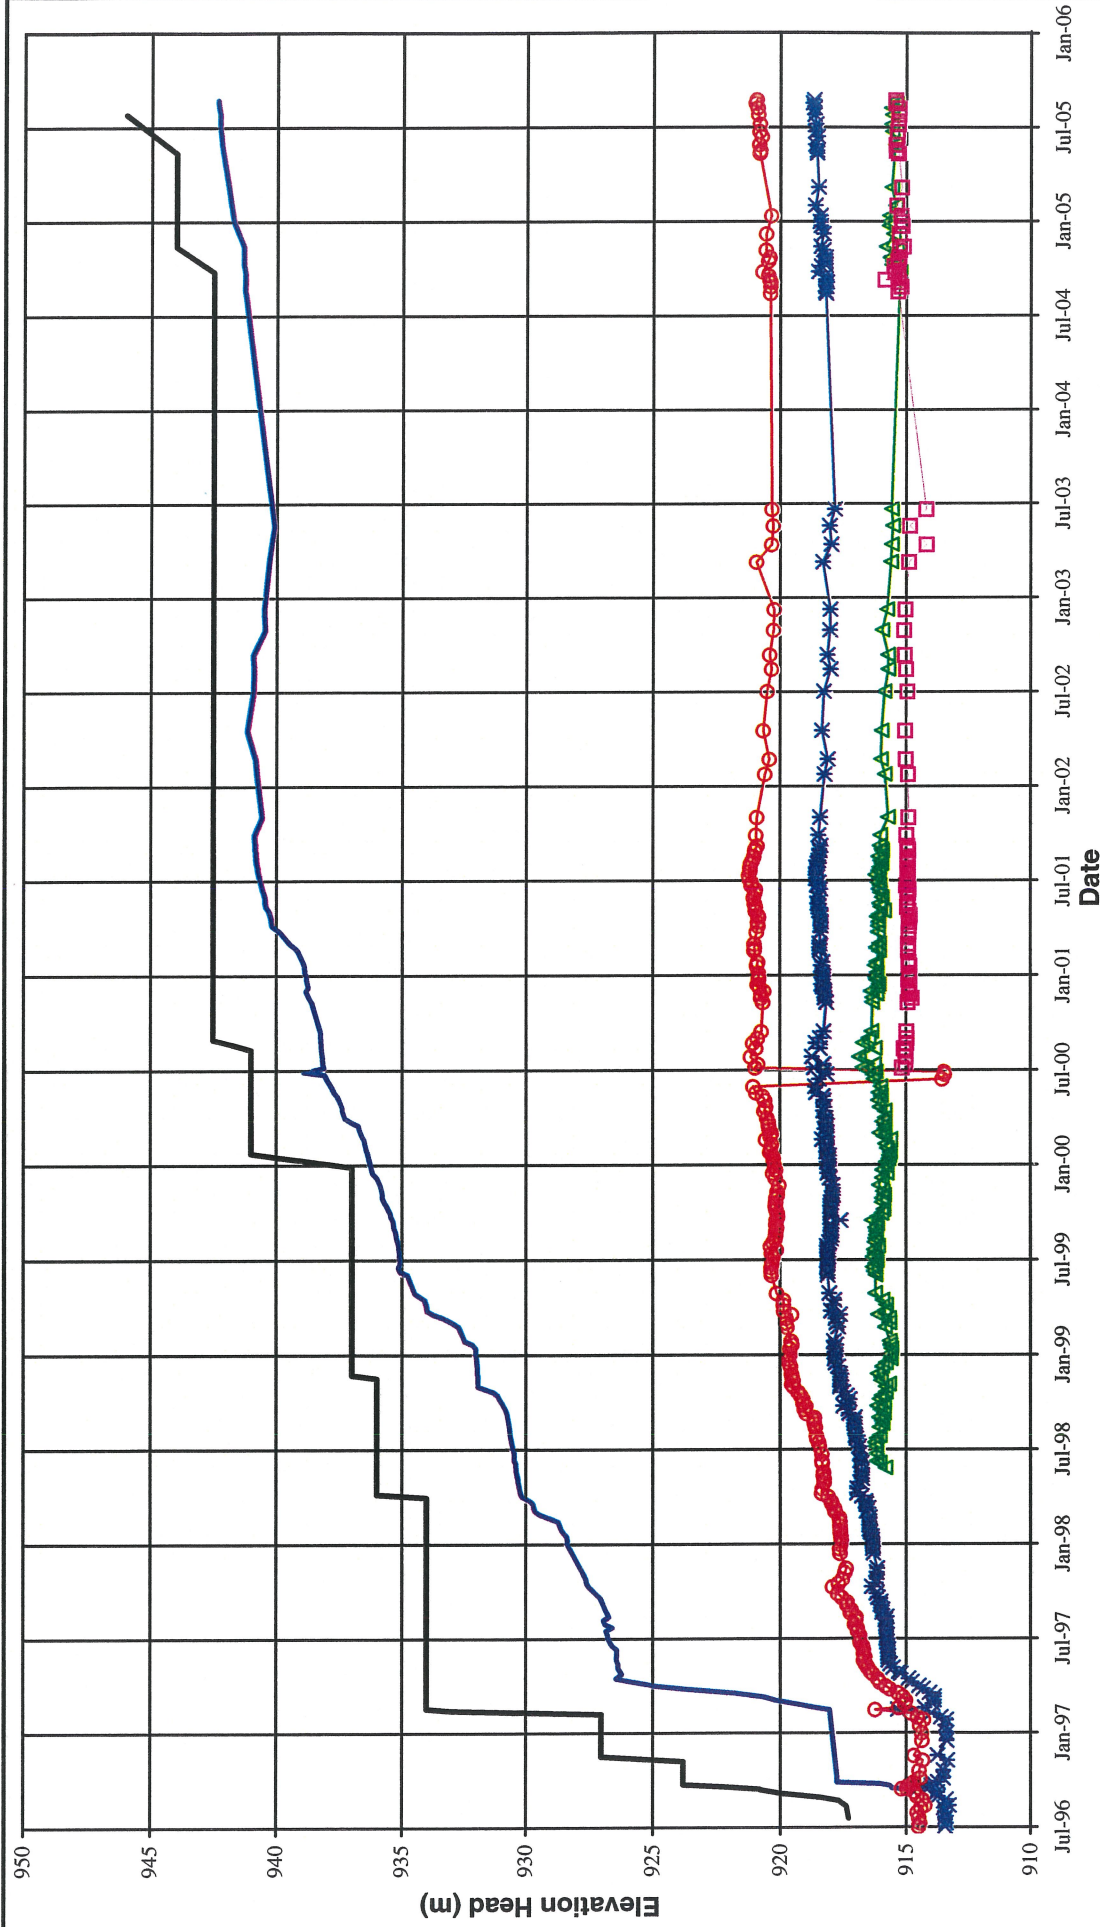
PLANE B FOUNDATION PIEZOMETERS
GRAPH OF ELEVATION HEAD vs. TIME

Artesian pressures have remained relatively constant in all the piezometers during the reporting period. Piezometers B2-PE2-01 and B2-PE2-02 are showing a slight increasing trend but are still well below the 6 metres above ground threshold level. No artesian conditions have been encountered at Plane E, where coarser glaciofluvial material is present.

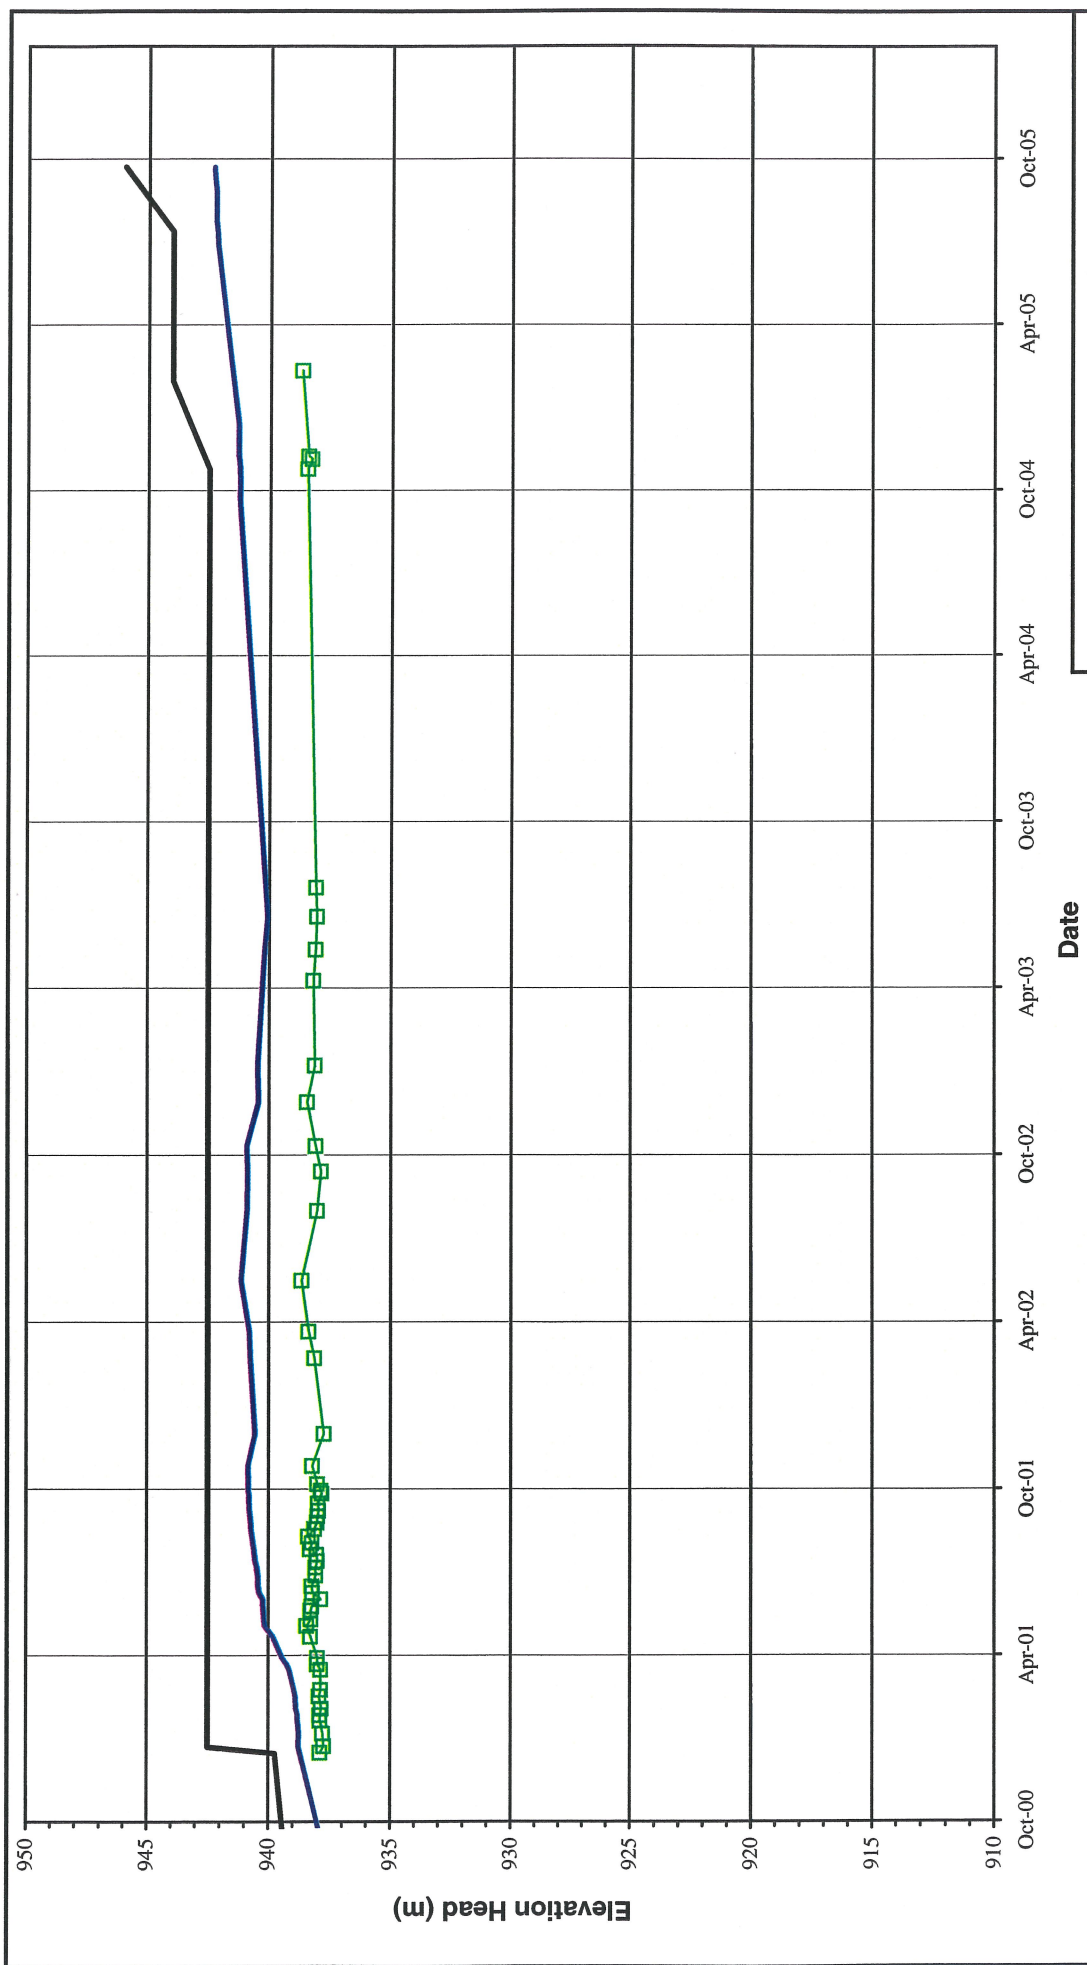
MOUNT POLLEY MINING CORPORATION			
MOUNT POLLEY MINE			
PLANE F FOUNDATION PIEZOMETERS ELEVATION HEAD vs. TIME			
PROJECT NO. VA 101 - 1/11	REF. NO.	REV.	
	1	0	
Knight Piesold CONSULTING			
FIGURE B2-6

— Pond Level — F2-PE2-01

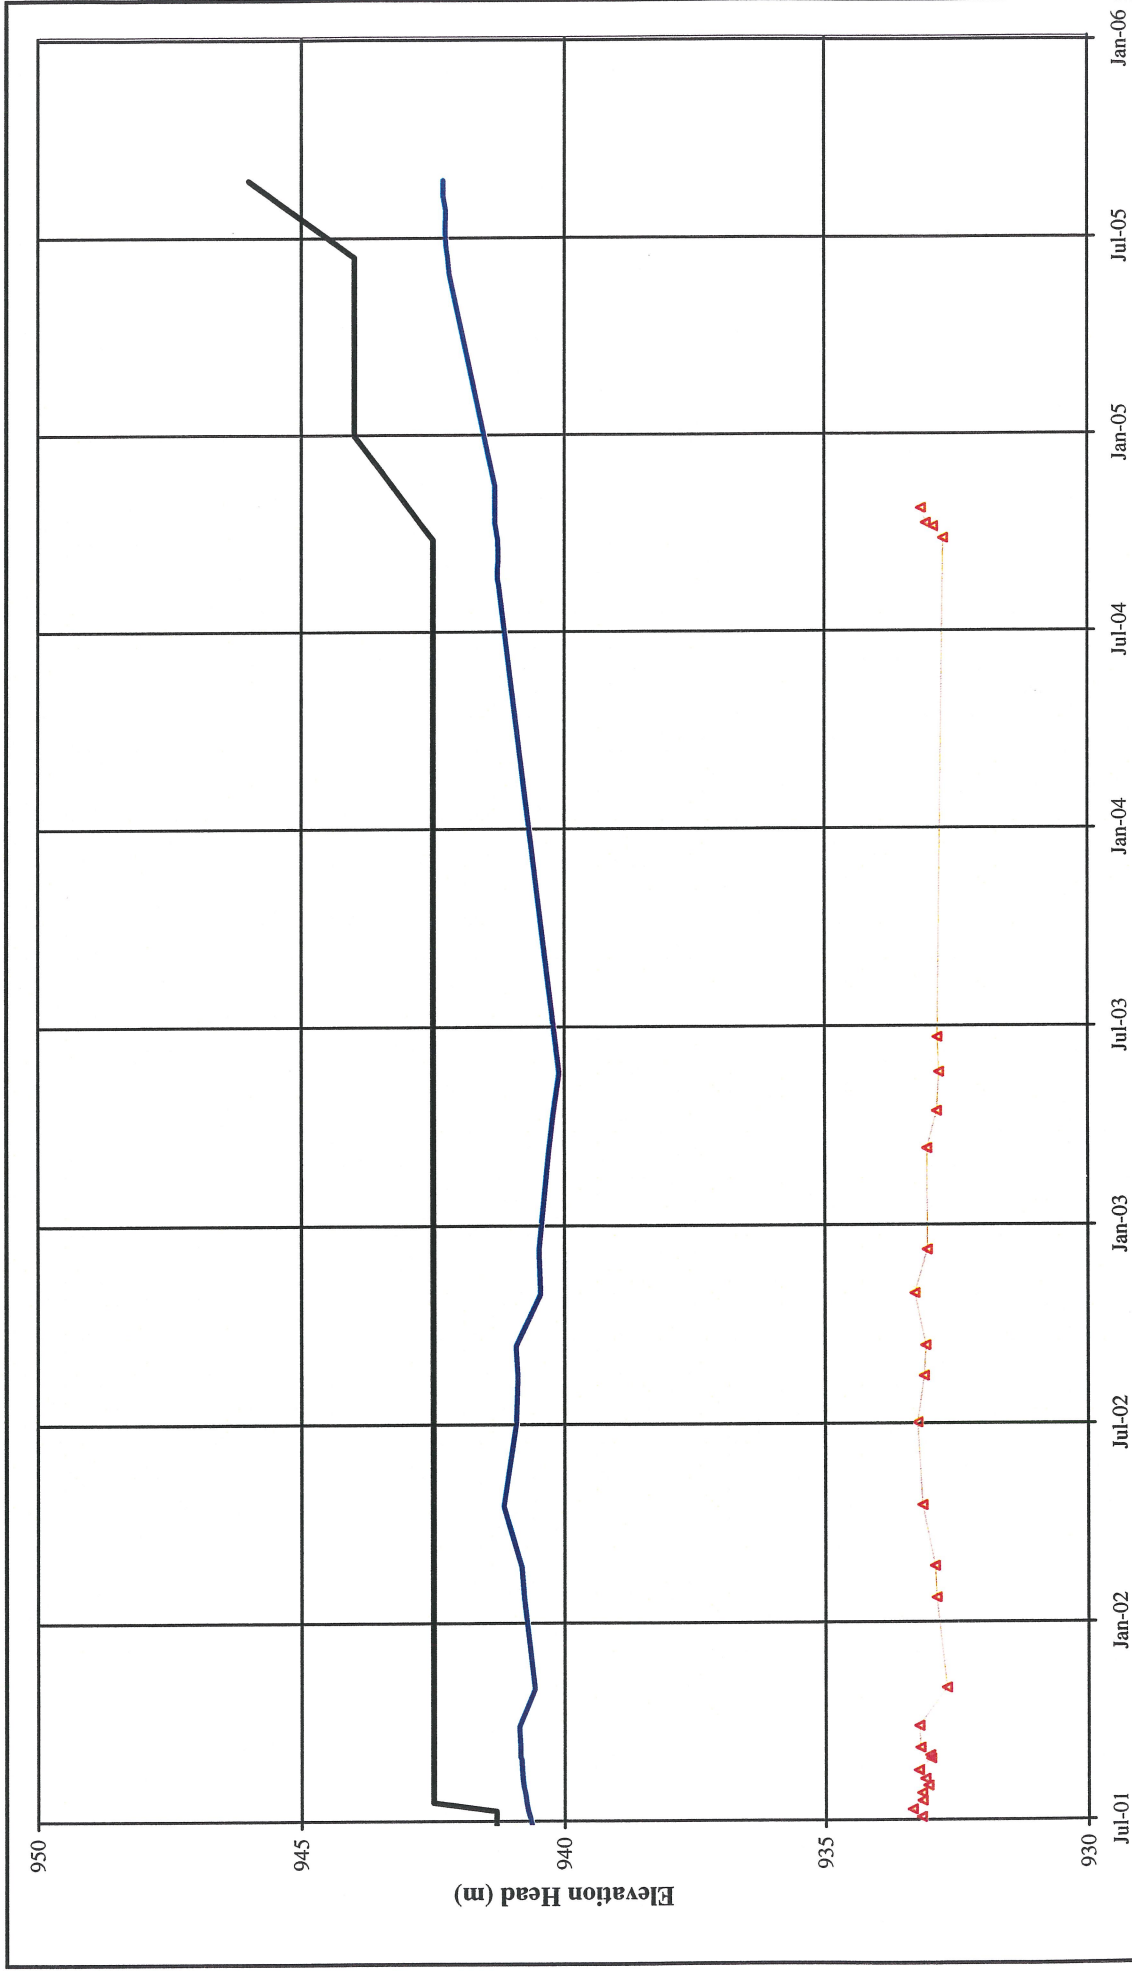
MOUNT POLLEY MINING CORPORATION		
MOUNT POLLEY MINE		
PLANE G DRAIN PIEZOMETERS ELEVATION HEAD vs. TIME		
PROJECT NO.	REF. NO.	REV.
VA 101 - 1/11	1	0
Knight Piésold CONSULTING		
FIGURE B4-5

— Pond Level
 — Fill Elevation
 -▲- H1-PE1-01 (No longer functioning)

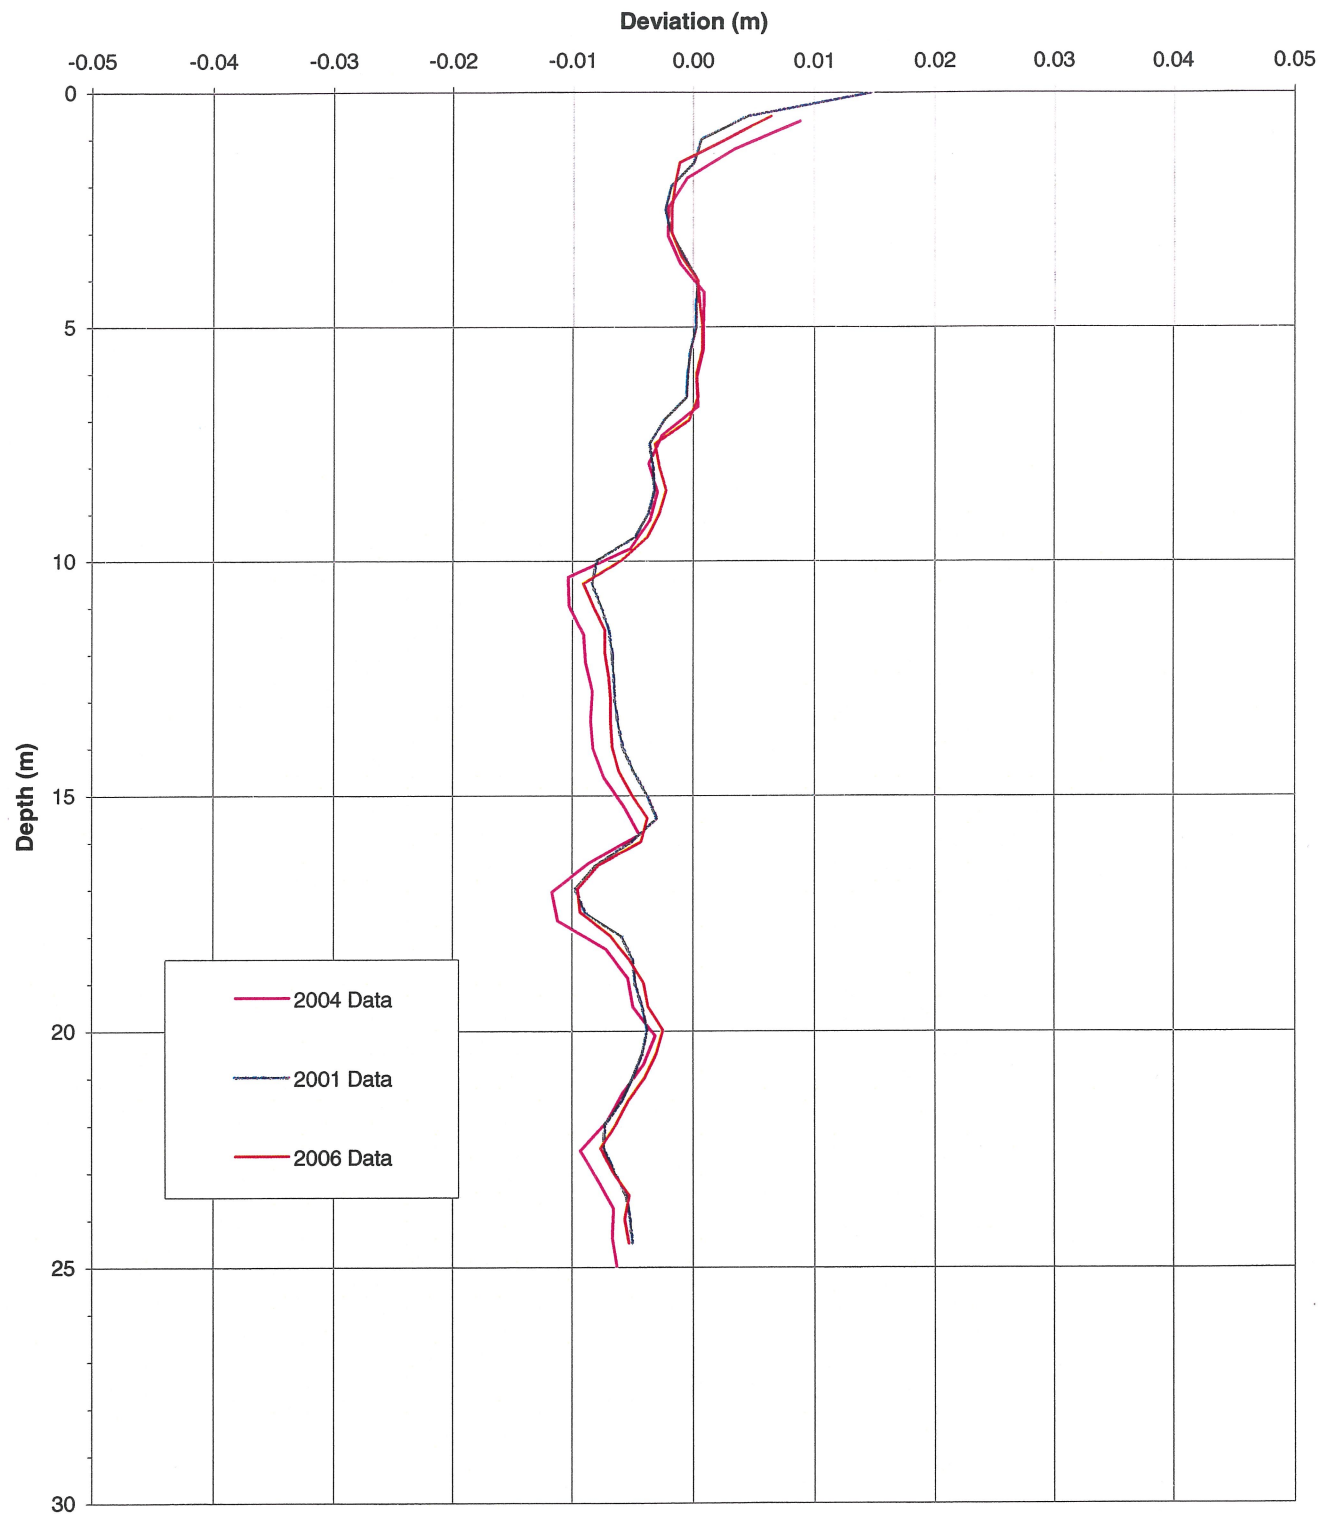
Note:
Hole 1 frozen for 2005 reading.
