**MOUNT POLLEY MINING CORPORATION
MOUNT POLLEY MINE**

**REPORT ON
1999 ANNUAL INSPECTION
(REF. NO. 11162/13-9)**

MOUNT POLLEY MINING CORPORATION

1999 ANNUAL INSPECTION

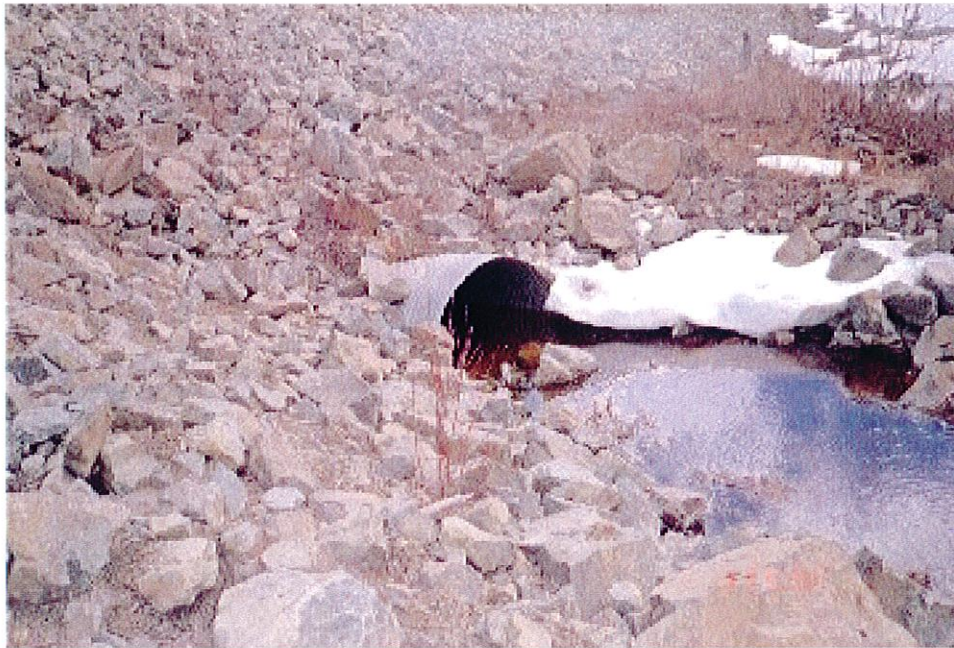
Photo No. 10: Bootjack Creek Culvert, upstream end.

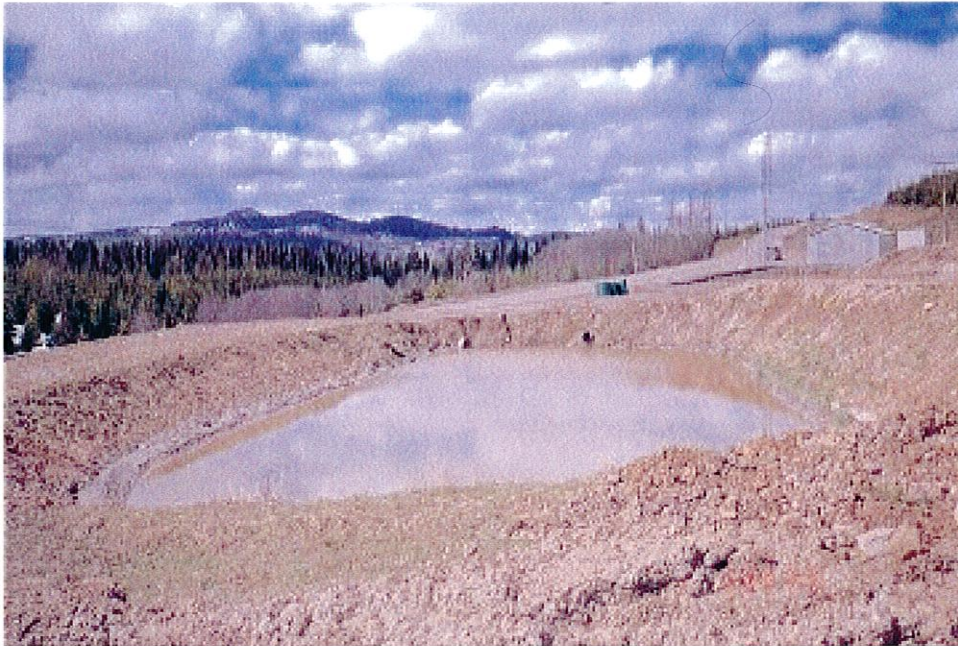
Photo No. 11: T2 Overflow Pond, full of water.

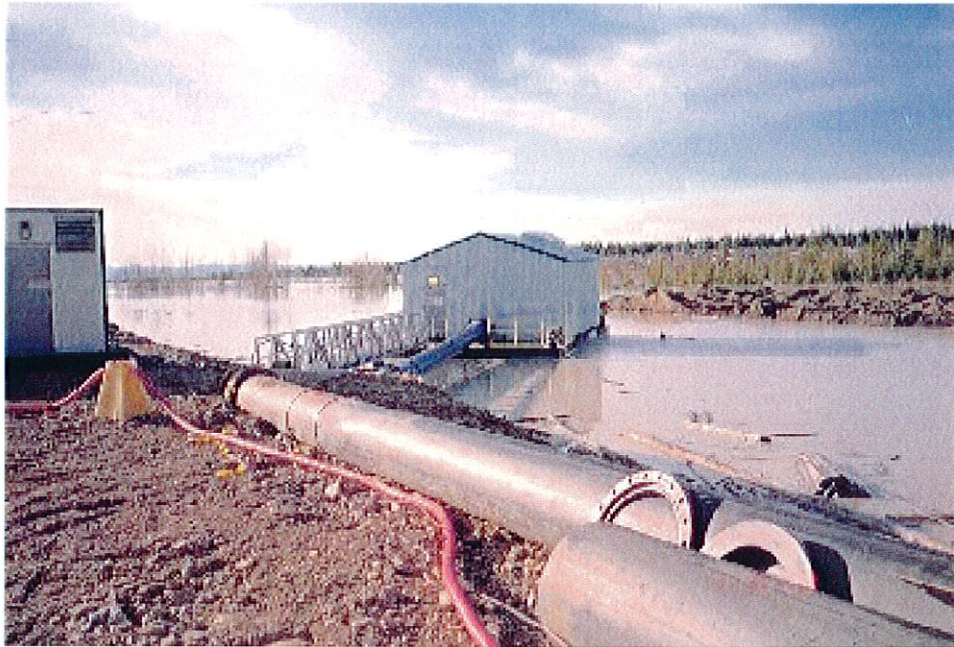
Photo No. 12: Reclaim Barge and Channel.

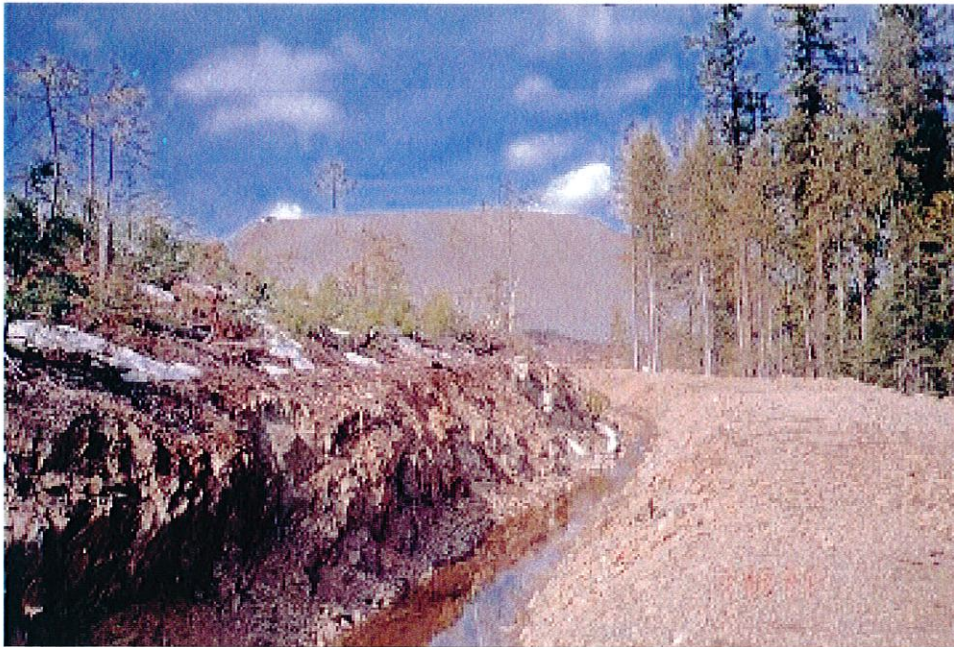
Photo No. 13: Runoff collection ditch leading to the Southeast Sediment Pond. Mine waste dump in background.

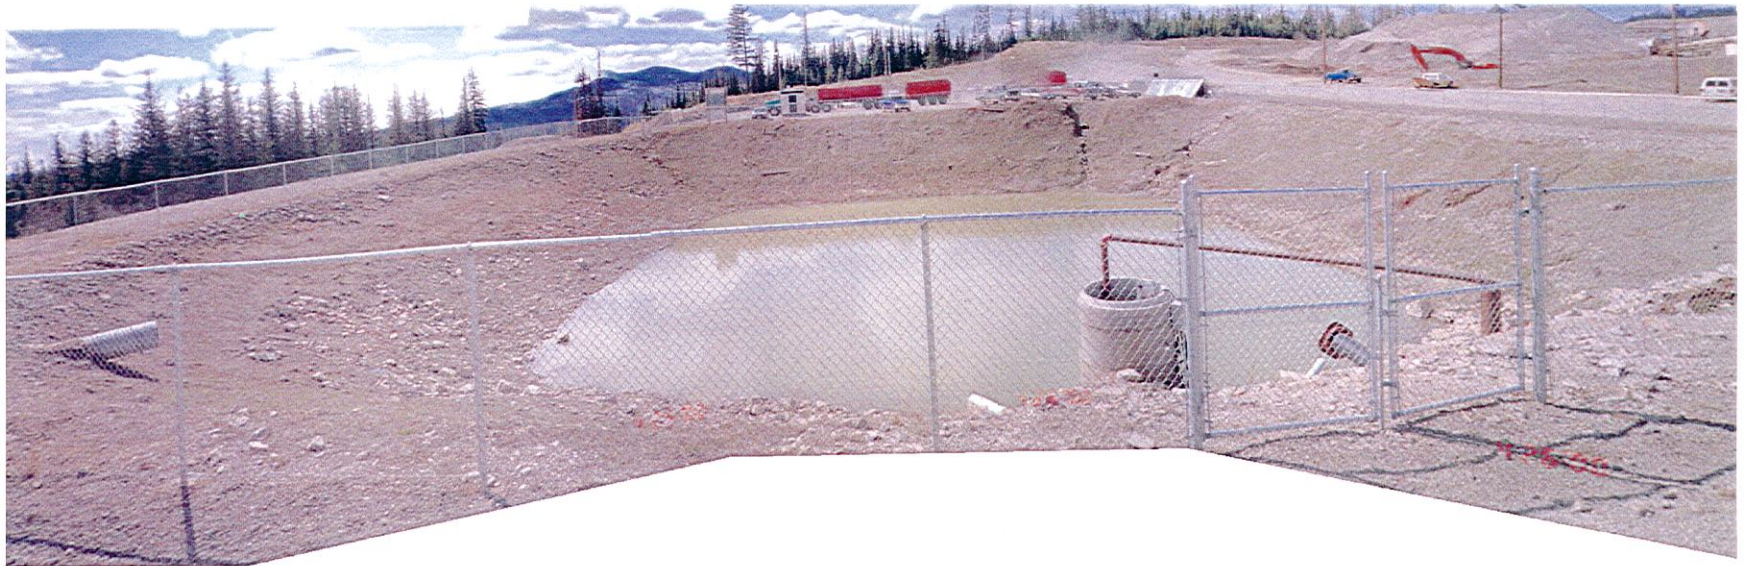
Photo No. 18: Millsite Sump.
