**MOUNT POLLEY MINING CORPORATION
MOUNT POLLEY MINE
TAILINGS STORAGE FACILITY**

**1998 ANNUAL INSPECTION REPORT
(REF. NO. 10162/9-5)**

JUNE 26, 1998

Knight Piésold Ltd.
CONSULTING ENGINEERS

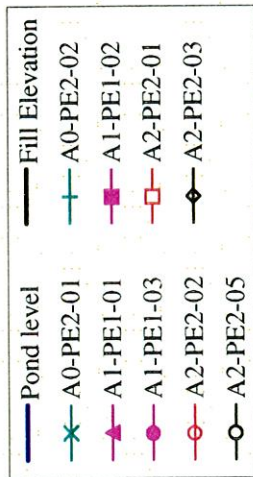
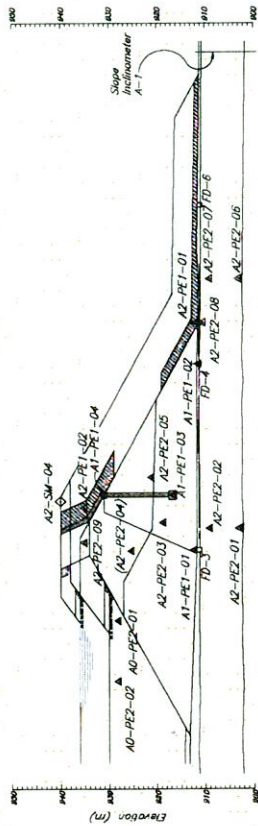
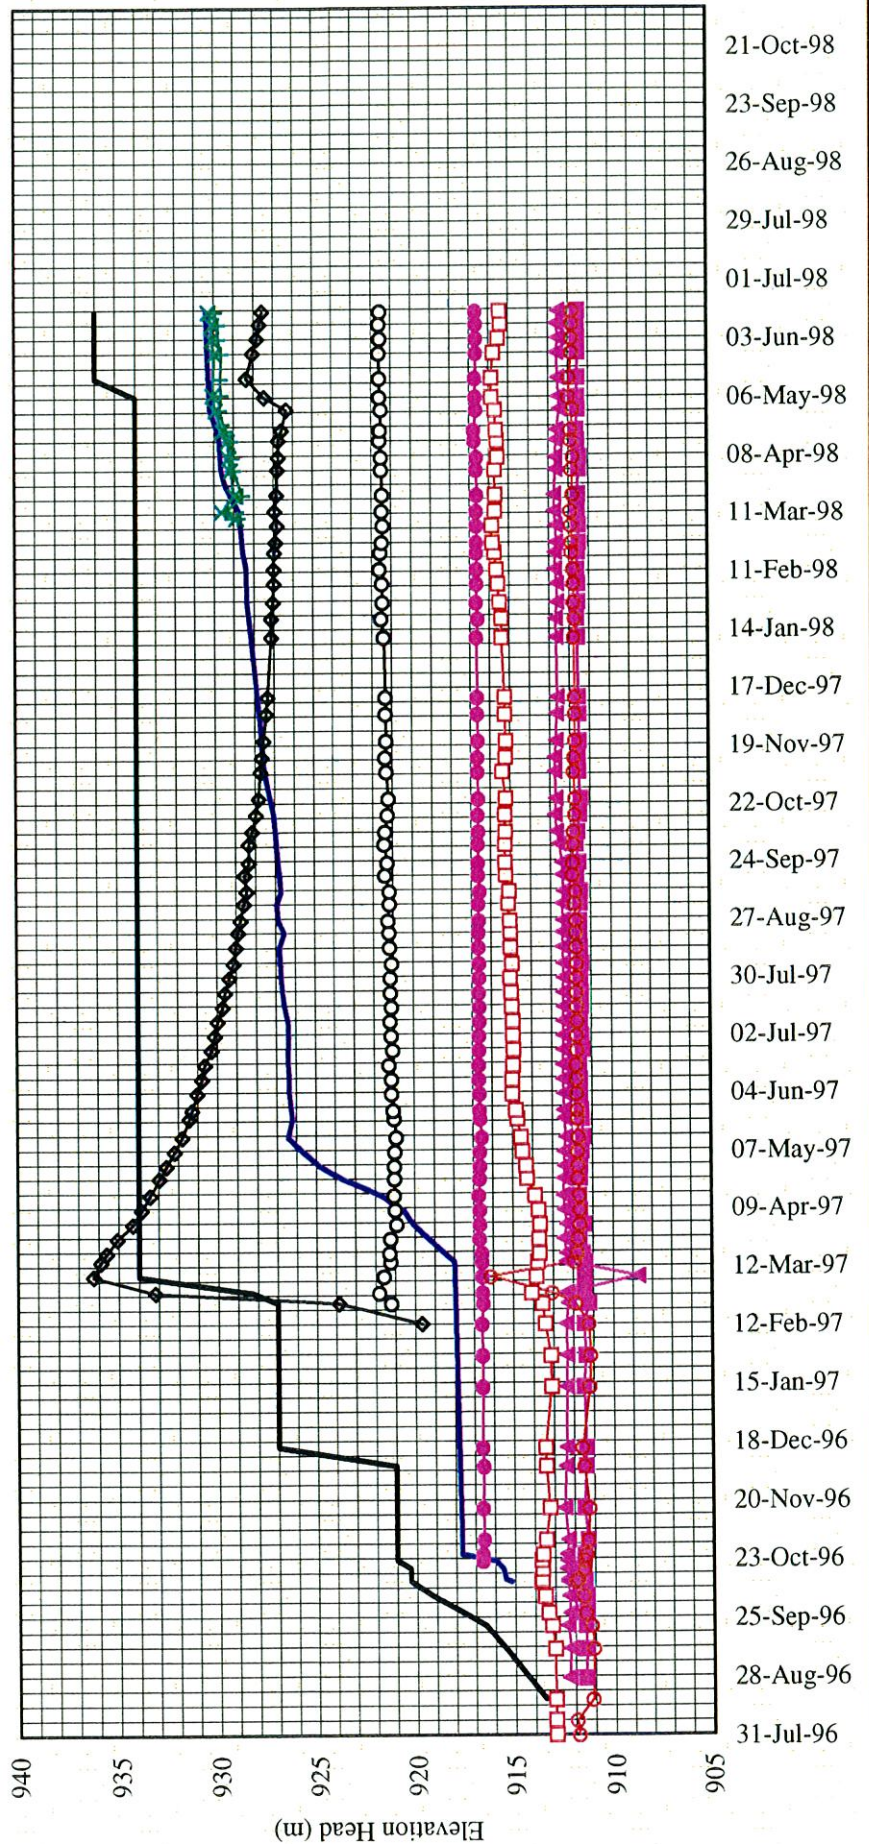
FIGURE 2.1

The most recent weekly piezometer readings, taken June 16, 1998, are summarized on Table 2.2. A comparison of the pre-construction pore pressures to the current pore pressures is presented on Table 2.3. Summary plots for each of instrumentation plane A, B, C and D are shown on Figures 2.1 to 2.4. Individual plots for the foundation piezometers, complete with ground, tip, and trigger levels, are shown on Figures 2.5 to 2.10.

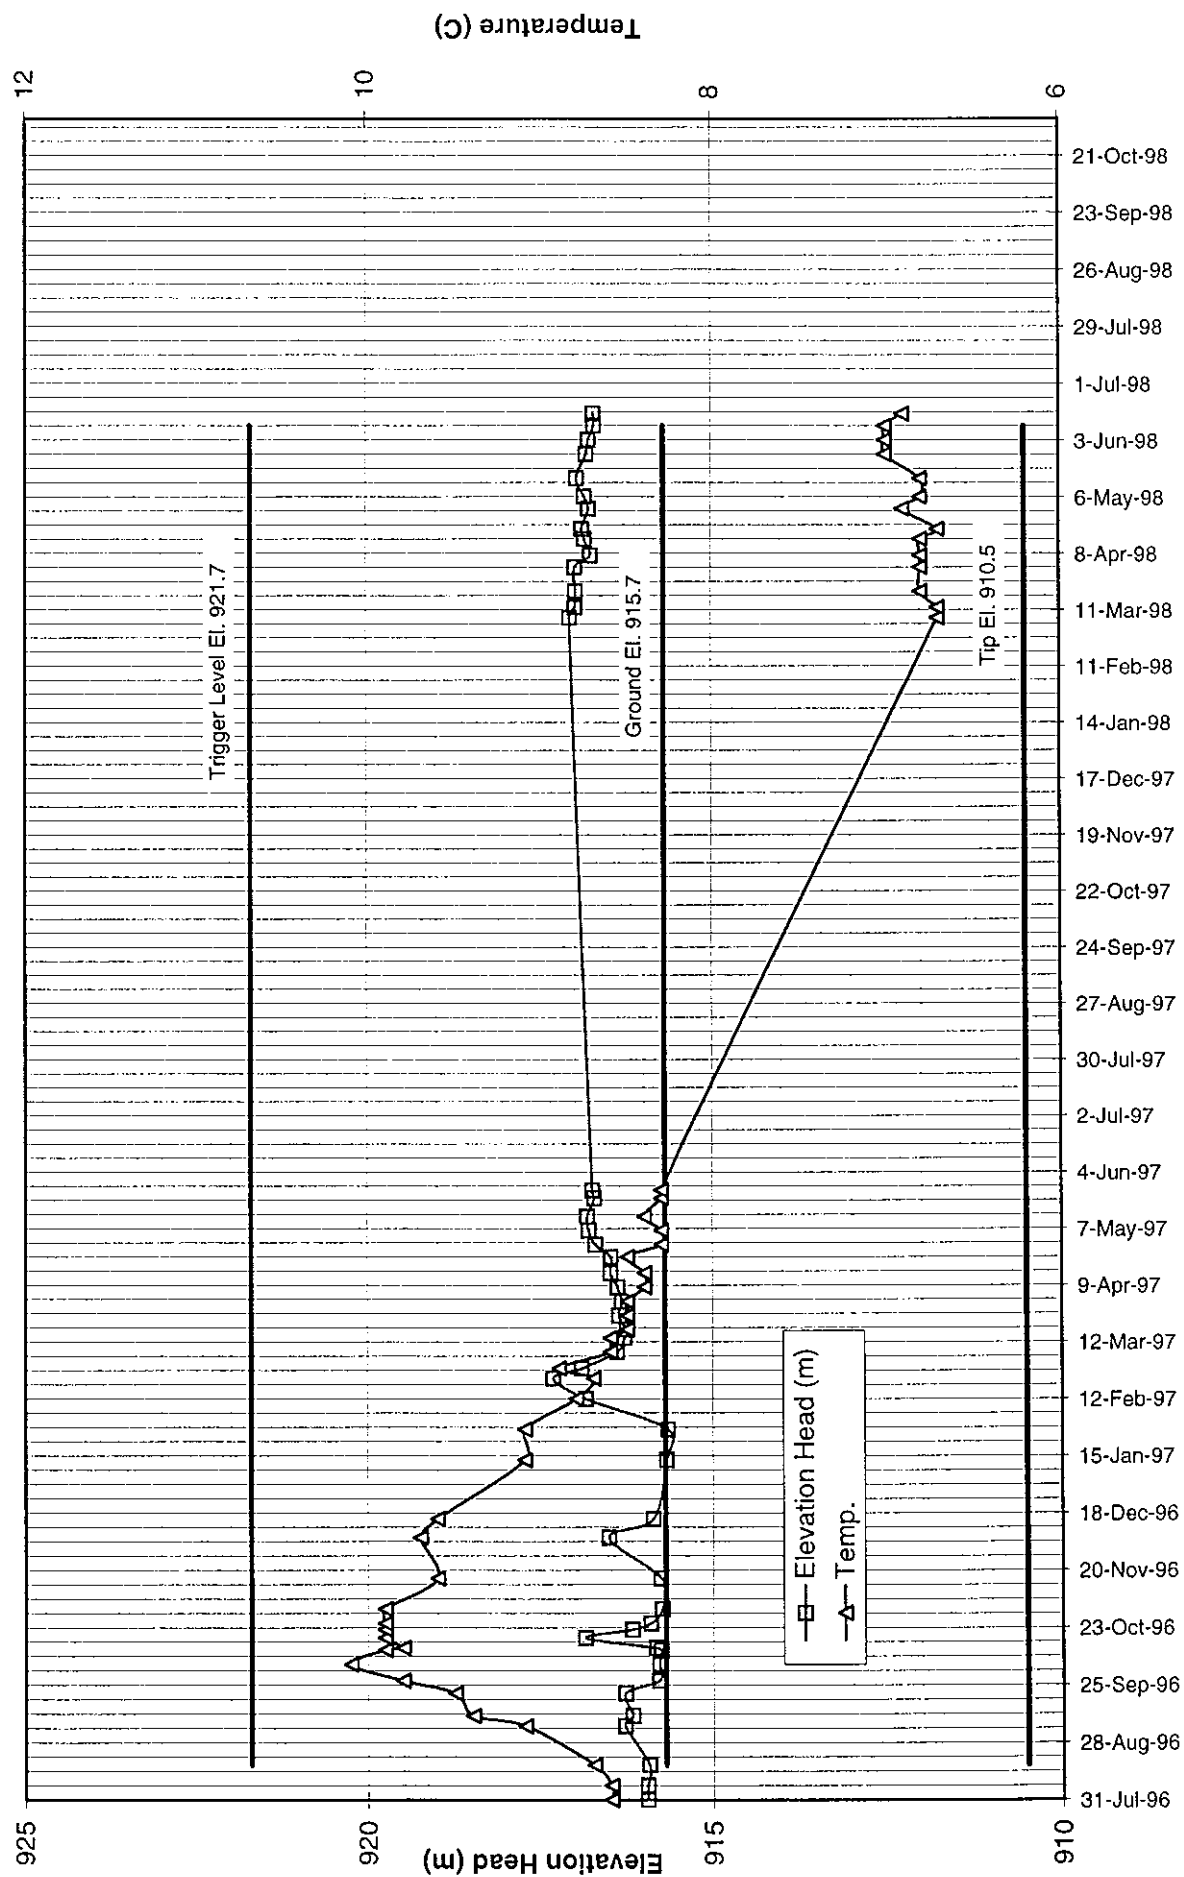
FIGURE 2.10

(C2-PE2-01)	---	---	---	---	Foundation Piezometer depth approx. 8.2m (El. 907.48)
C2-PE2-02	6.26	6.18	6.19	0.01	Foundation Piezometer depth approx. 5.2m (El. 910.53)
C2-PE2-03	0.45	0.44	0.38	-0.06	Fill piezometer El. 921.00.
C2-PE2-05	3.48	3.47	3.40	-0.07	Fill piezometer El. 924.80.
D1-PE1-02	-0.59	-0.58	-0.57	0.02	Outlet Drain piezometer, El. 928.76.
D2-PE2-01	-0.22	-0.33	-0.25	0.08	Fill piezometer El. 931.00.
