**MOUNT POLLEY MINING CORPORATION  
MOUNT POLLEY MINE**

**REPORT ON  
1999 ANNUAL INSPECTION  
(REF. NO. 11162/13-9)**

***Knight Piésold Ltd.***

**TAILINGS STORAGE FACILITY**

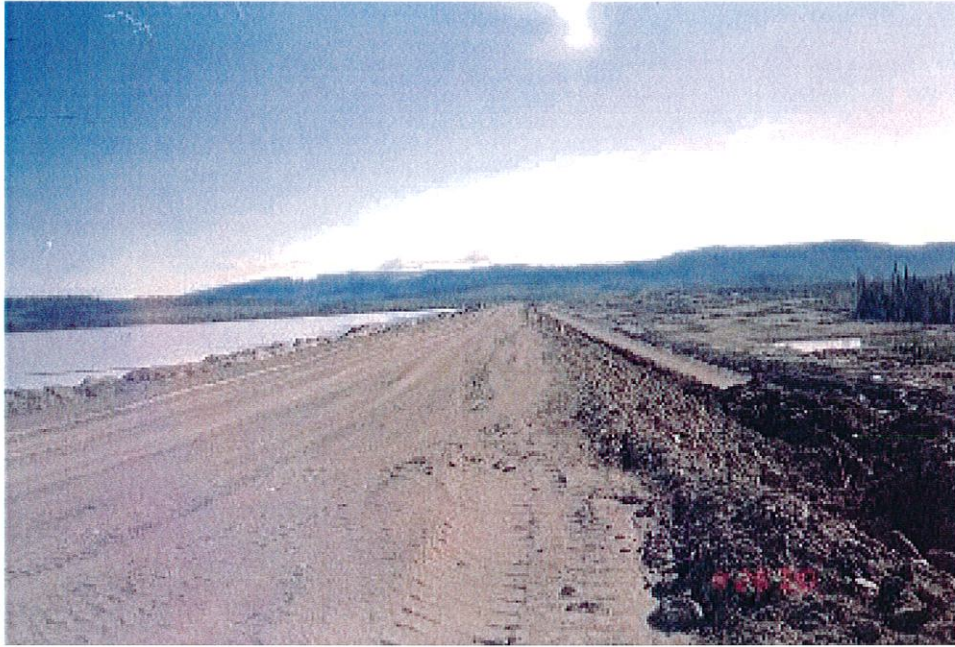
**Photo No. 1:** Main Embankment, view looking east from the right abutment.

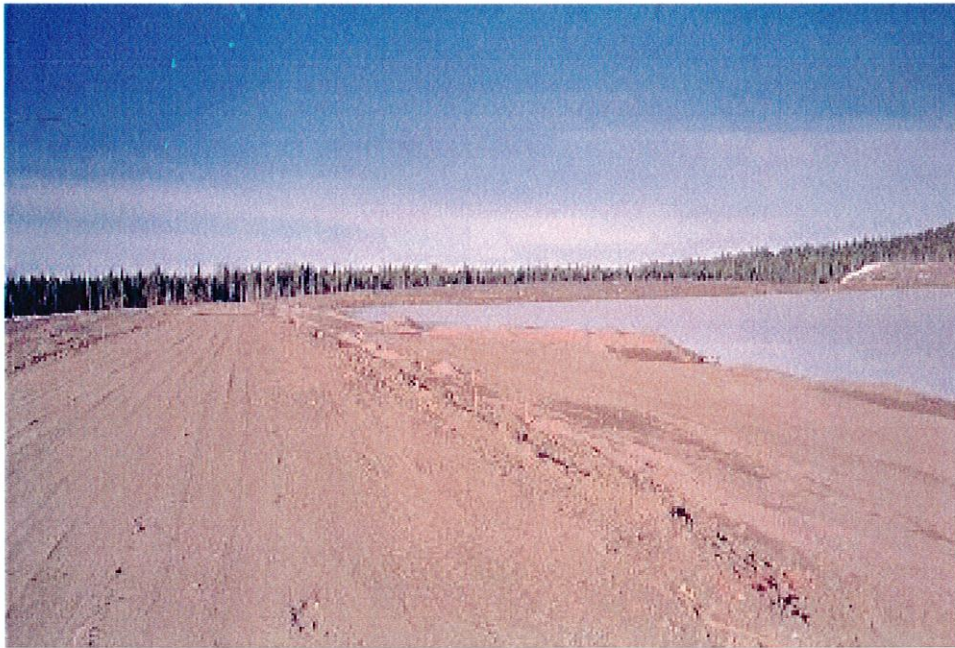
**Photo No. 2:** Main Embankment, view looking west from the left abutment.

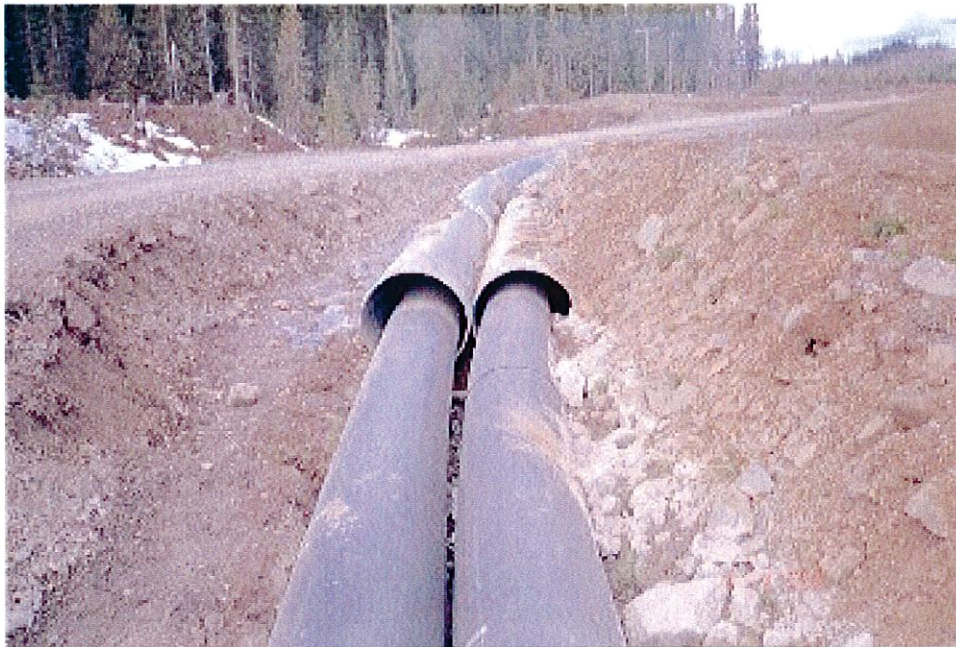
- The pipe containment channel was in good condition and was clear of major obstructions.
- Tailings from the T2 Overflow Pond have previously reached the Bootjack Creek Crossing where it settled out in the culvert sleeves. The area of the Bootjack Creek Crossing must be closely monitored.
- Berms should be constructed along the edges of the road at the Bootjack Creek Crossing to direct flows past Bootjack Creek and towards the Tailings Storage Facility.

**Photo No. 8:** Pipeline Containment Channel. Downstream end of pipeline sleeves at Bootjack Creek Crossing.

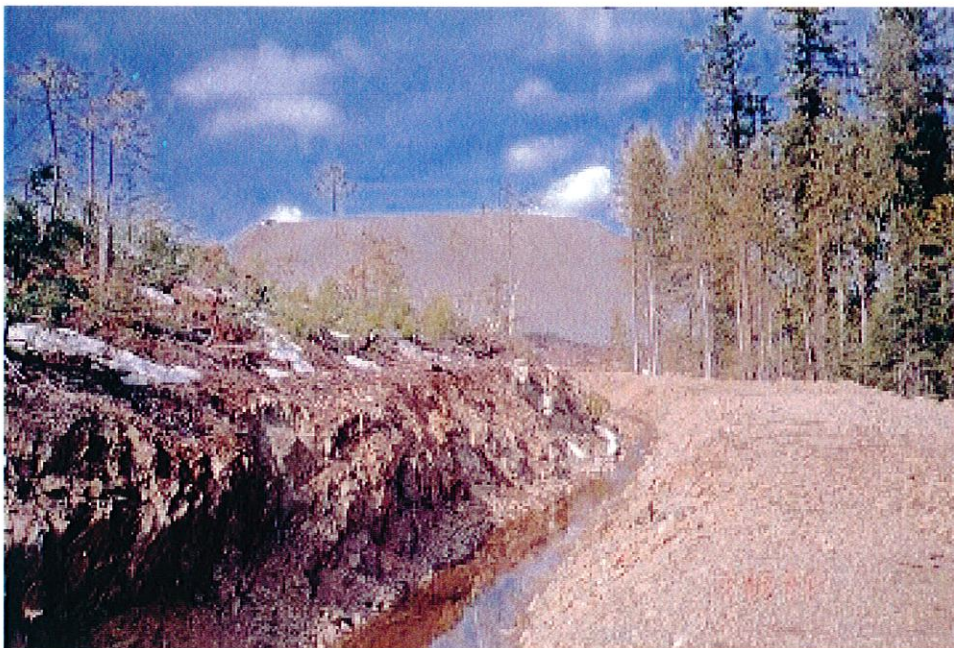
**Photo No. 13:** Runoff collection ditch leading to the Southeast Sediment Pond. Mine waste dump in background.

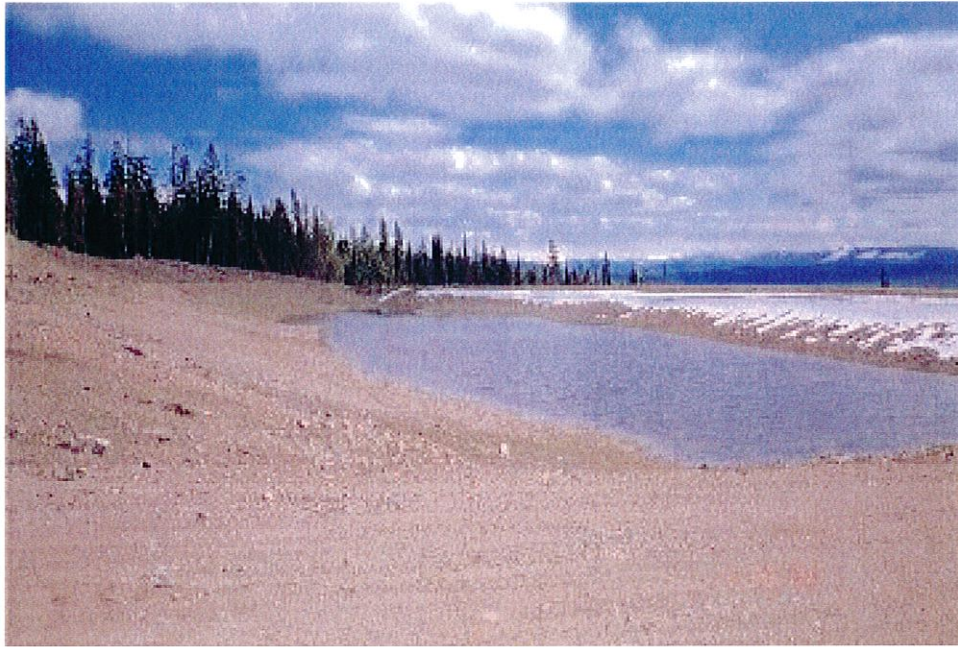
**Photo No. 14:** Southeast Sediment Pond, looking east.

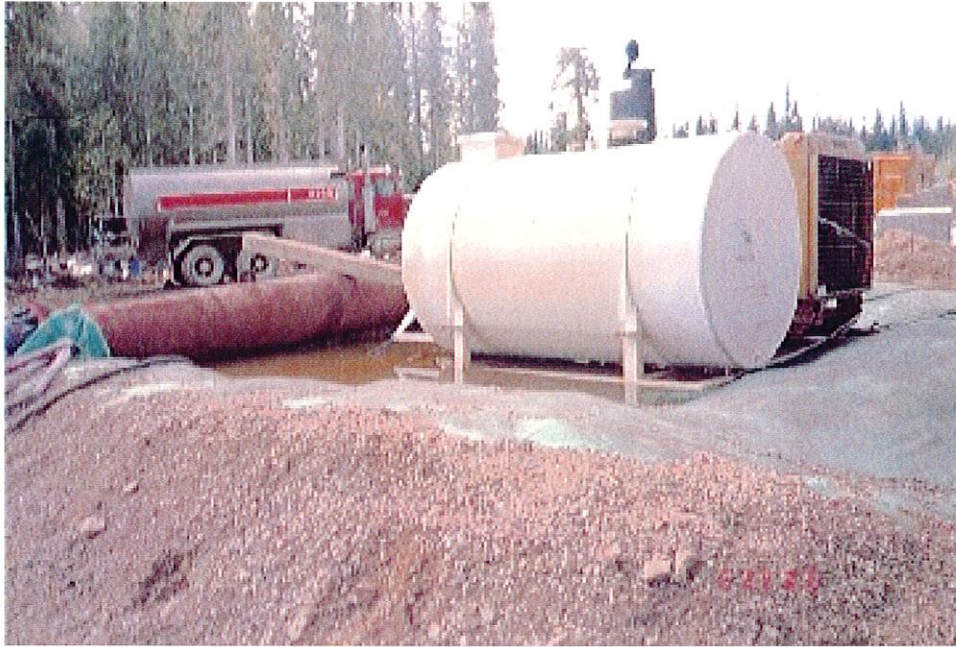
**Photo No. 16:** Polley Lake Pumping System.

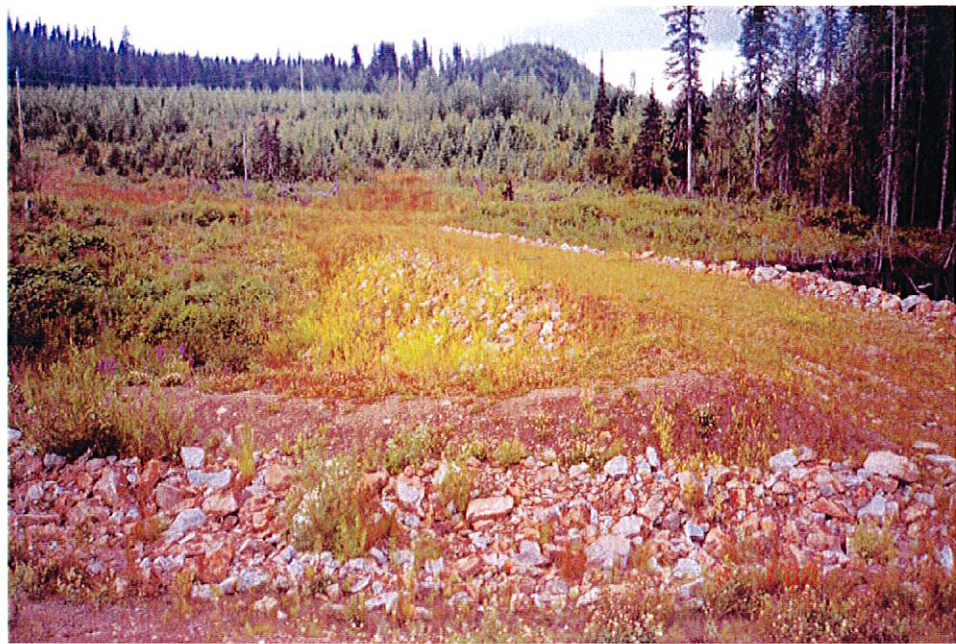
- The water level was low.
- Both upstream and downstream fill slopes were in good condition, with no evidence of seepage or slumping.
- No cracks were observed on the dam crest.
- The spillway contained some vegetation, but was generally unobstructed.

**Photo No. 17:** South Bootjack Dam, downstream slope with spillway in foreground.

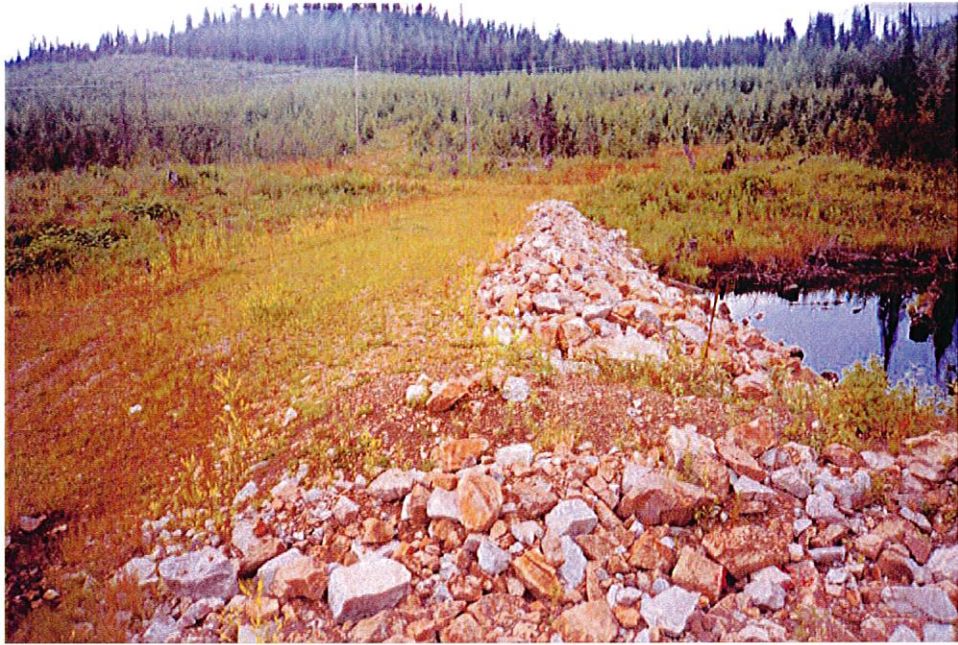
**Photo No. 17:** South Bootjack Dam, upstream slope.

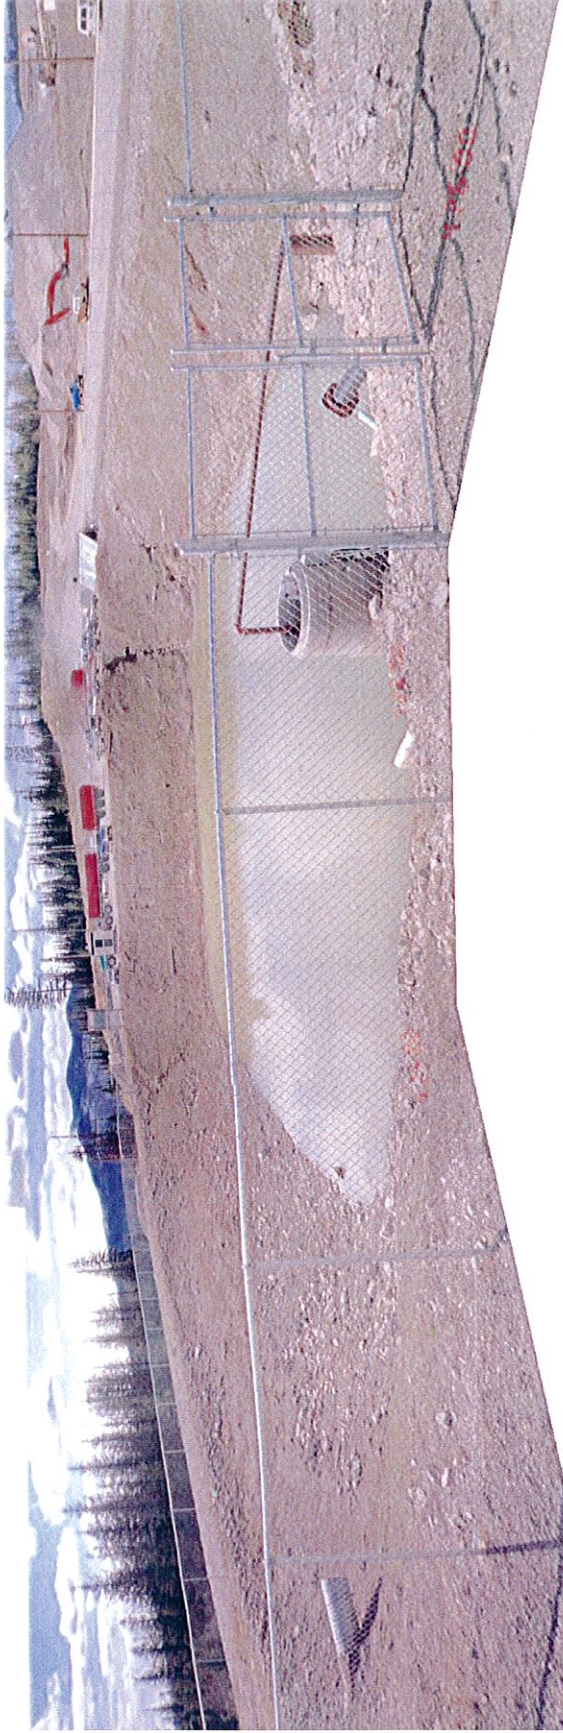
Photo No. 18: Millsite Sump.

- The ditch at the southwest corner of the sump was partially blocked and should be cleaned out. The fence has been damaged, but is still standing.
- No cracks were observed on the crest of the fills.
- No seepage or slumping of the embankment fill slopes was observed.
