MOUNT POLLEY MINING CORPORATION
MOUNT POLLEY MINE

TAILINGS STORAGE FACILITY
REPORT ON 2002 ANNUAL INSPECTION
(REF. NO. VA101-00001/3-1)

EXECUTIVE SUMMARY

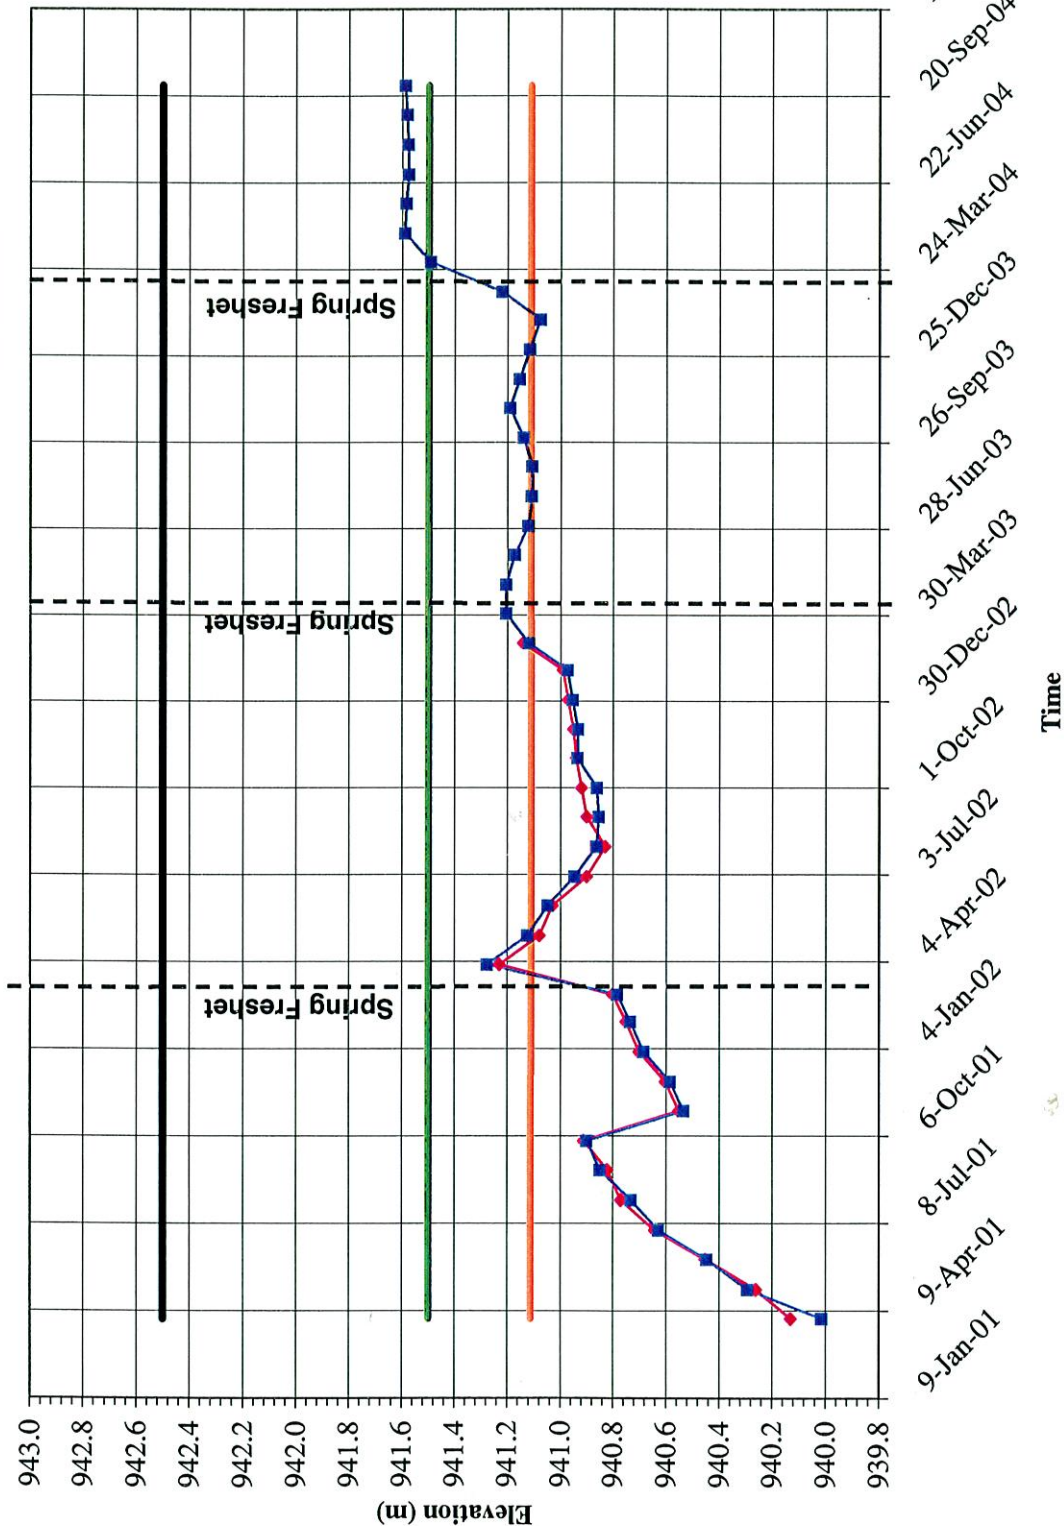
MOUNT POLLEY MINING CORPORATION	
MOUNT POLLEY MINE	
WATER BALANCE	
APRIL 2001 TO OCTOBER 2004	
<i>Knight Piésold</i> CONSULTING	
PROJECT NO. 101-1/3	REV. 1 0
FIGURE 3.1

As indicated on Figure 3.1, water will need to be removed prior to the freshet next year. The projected increase in pond elevation will rise above the maximum allowable level. MPMC plans to compile all water quality data during summer 2003 and present it to MWLAP to discuss discharging water from the TSF prior to spring 2004. This discharge application will likely be an amendment to MPMC's existing MWLAP permit, PE 11678. Using a siphon system to discharge water, the preferred location will be to pump over the Perimeter Embankment and discharge into Hazeltine Creek.

The water balance information illustrated on Figure 3.1 indicates that the pond elevation will increase above the maximum allowable level during the spring freshet of 2004. Therefore MPMC will be required to discharge water from the tailings impoundment prior to this period. MPMC plans to compile all water quality data during summer 2003 and present it to MWLAP to discuss options for discharging water from the TSF prior to spring 2004. This discharge application will likely be an amendment to MPMC's existing MWLAP permit PE 11678. We understand that a concept MPMC is currently considering is to use a siphon system to allow for controlled discharge of pond water over the Perimeter Embankment and into Hazeltine Creek during high flow periods when adequate dilution is available. Knight Piésold will be pleased to assist in evaluating the viability of this option and in supporting application for a discharge permit.
