**MOUNT POLLEY MINING CORPORATION
MOUNT POLLEY MINE**

**TAILINGS STORAGE FACILITY
REPORT ON 2004 ANNUAL INSPECTION
(REF. NO. VA101-01/7-1)**

Les Galbraith, P. Eng., of Knight Piésold Ltd. completed an inspection of the Tailings Storage Facility and associated works on August 30 2004.

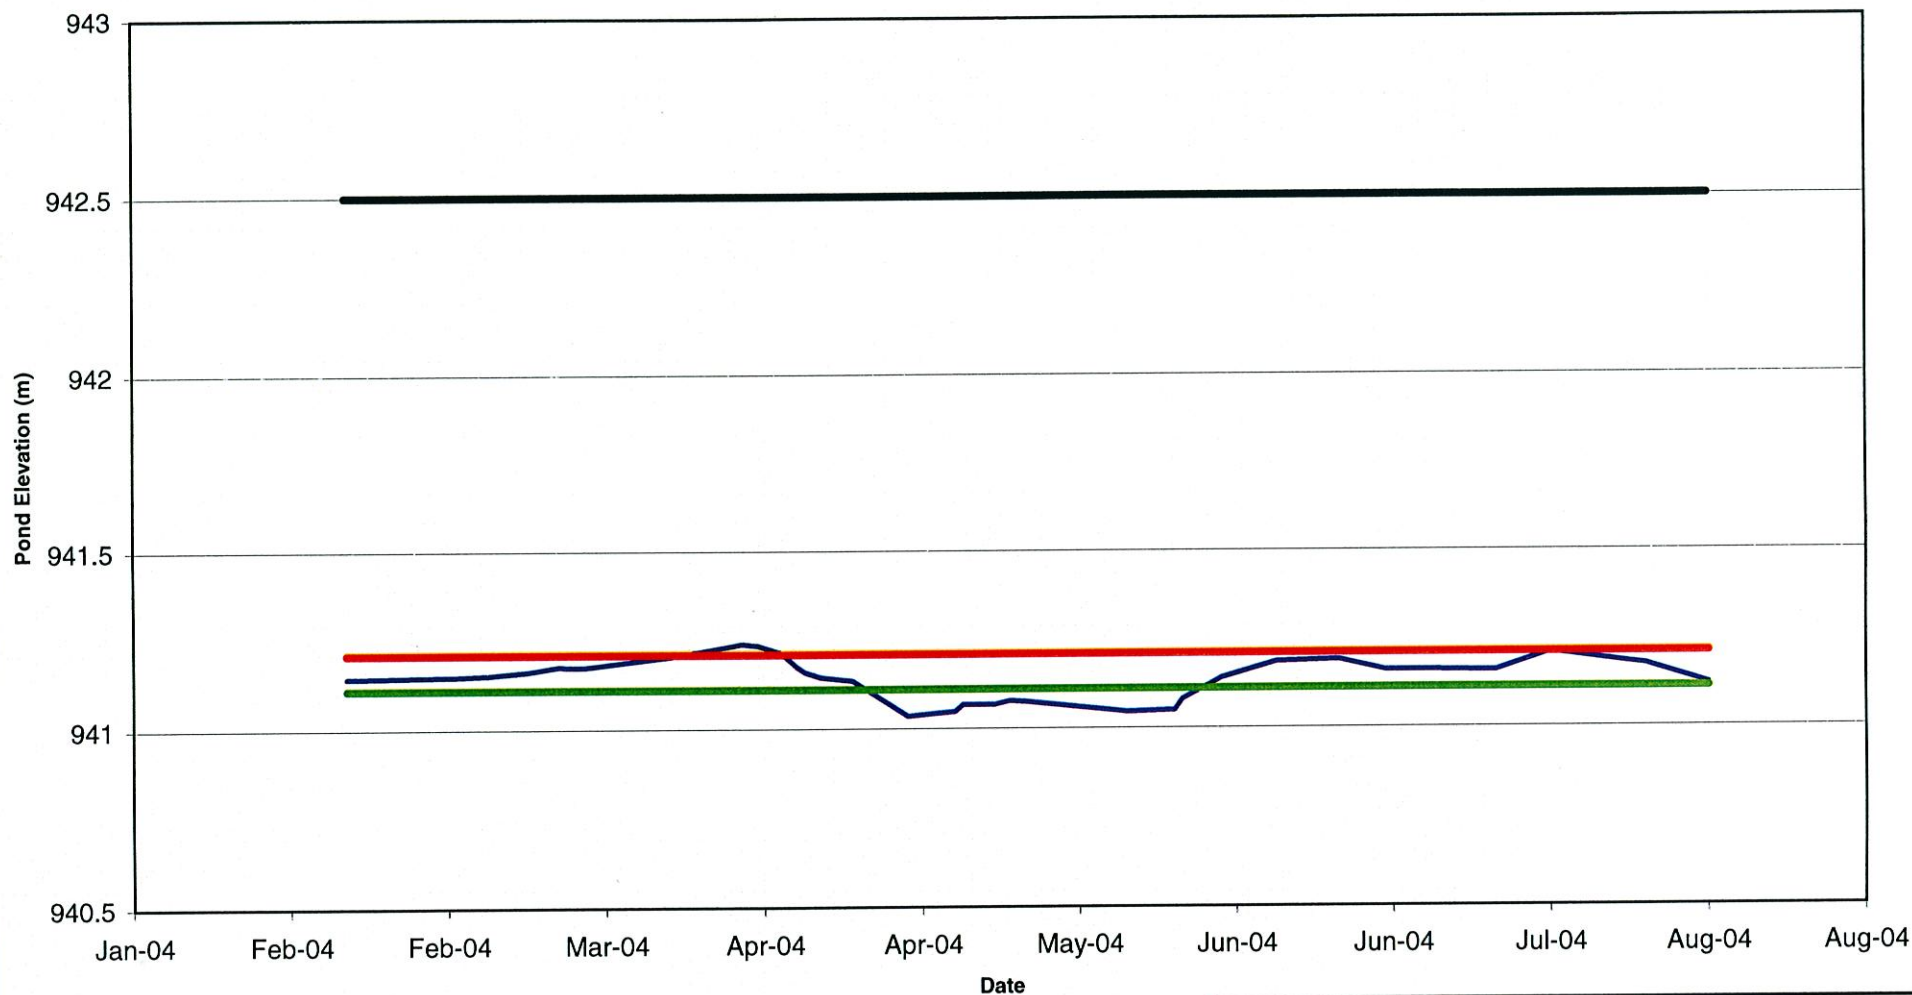
FIGURE 3.1

- Pond Elevation
- 0.9 m-Freeboard and 24-Hour PMP Requirement (El. 941.21 m)
- 1.0 m-Freeboard and 24-Hour PMP Requirement (El. 941.11 m)
- Crest Elevation

The water balance information illustrated on Figure 3.1 indicates that the pond elevation will increase above the maximum allowable level during the spring freshet of 2004. Therefore MPMC will be required to discharge water from the tailings impoundment prior to this period. MPMC plans to compile all water quality data during summer 2003 and present it to MWLAP to discuss options for discharging water from the TSF prior to spring 2004. This discharge application will likely be an amendment to MPMC's existing MWLAP permit PE 11678. We understand that a concept MPMC is currently considering is to use a siphon system to allow for controlled discharge of pond water over the Perimeter Embankment and into Hazeltine Creek during high flow periods when adequate dilution is available. Knight Piésold will be pleased to assist in evaluating the viability of this option and in supporting application for a discharge permit.

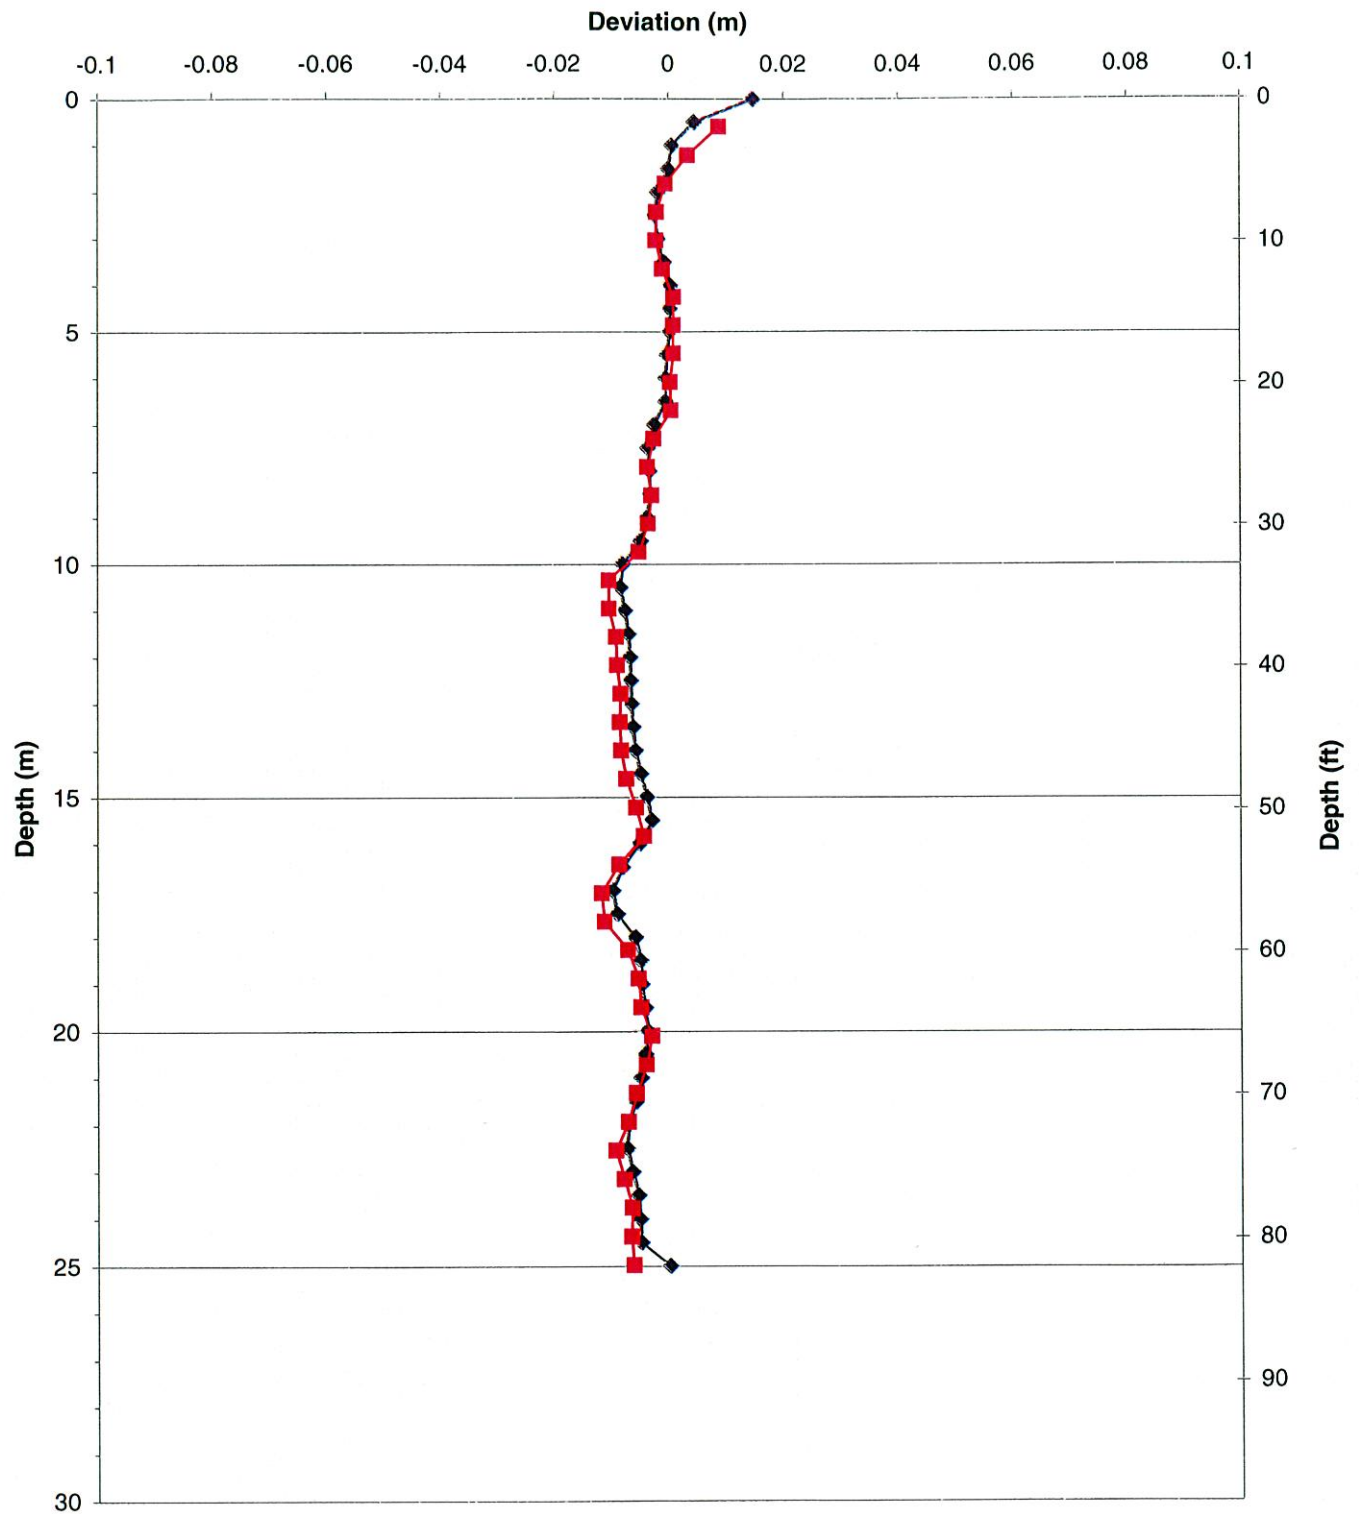
FIGURE C-1

A total of 56 vibrating wire piezometers and two inclinometers have been installed at the TSF. There is thirteen months of data missing, from July 30, 2003 to September 2, 2004; however, the recent piezometer readings indicate that there have been no significant deviations from the piezometric trends seen prior to July 30, 2003. Two slope inclinometers were installed at the toe of the Main Embankment in July 2001 to measure potential deformation of the embankment materials. The inclinometers were read on October 21 2004 and the data was compared to the initial readings taken in 2001. The results show that there has been no significant deviation in the inclinometers since they were installed in 2001.
