**MOUNT POLLEY MINING CORPORATION
MOUNT POLLEY MINE**

**TAILINGS STORAGE FACILITY
REPORT ON 2005 ANNUAL INSPECTION
(REF. NO. VA101-01/11-1)**

Rev. No.	Revision	Date	Approved
Rev 0	Issued in Final	May 3, 2006	K.I.B.

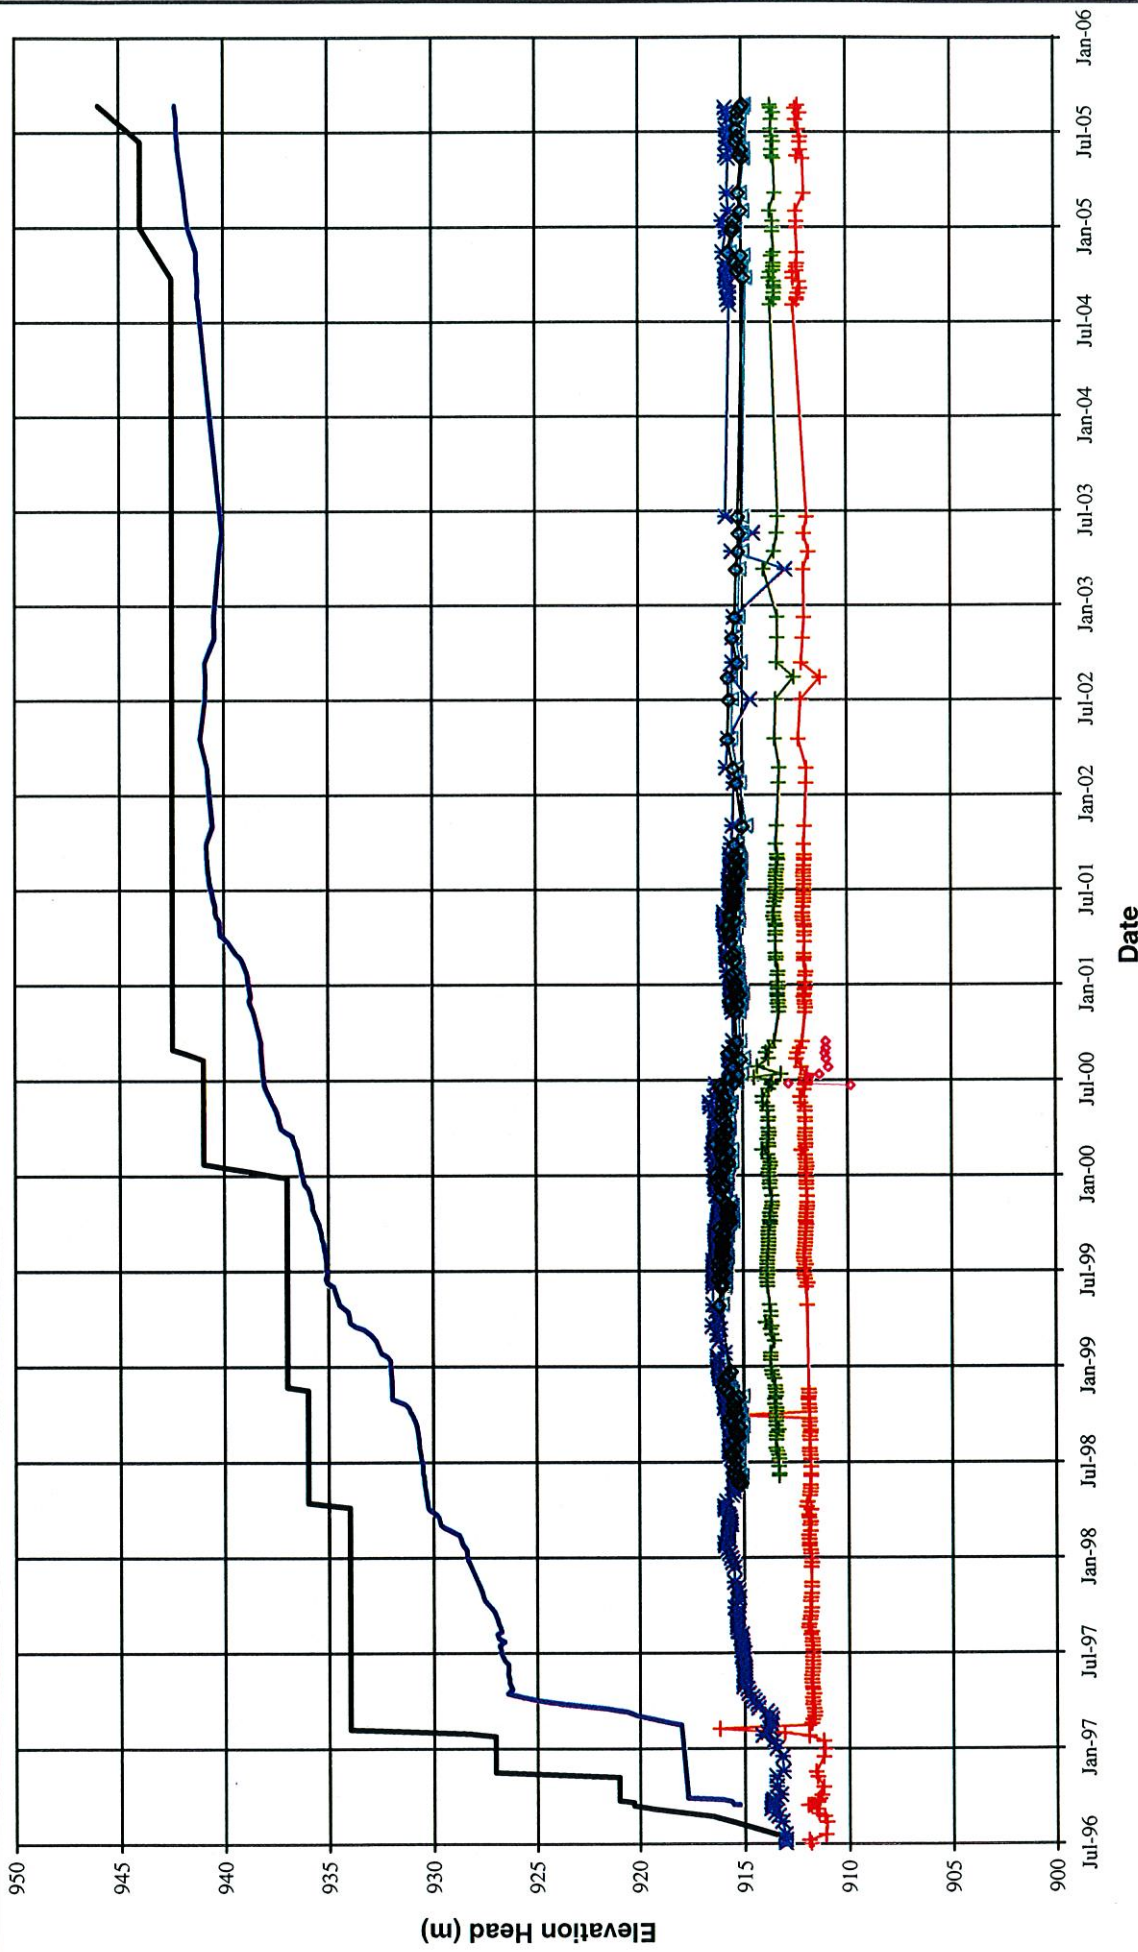
MOUNT POLLEY MINING CORPORATION			
MOUNT POLLEY MINE			
PLANE A FOUNDATION PIEZOMETERS ELEVATION HEAD vs. TIME			
Knight Piésold CONSULTING			
PROJECT NO.	REF. NO.	REV.	
VA101-1/11	1	0	
			FIGURE B2-1

A total of 20 piezometers have been installed in the embankment foundations, 18 of which remain in operation. Artesian conditions are present in the 7 of the 16 foundation piezometers installed under the Main Embankment. The piezometers in this area are used to monitor the pore pressures and to confirm that they remain below the threshold level of 6 metres above ground level (KP Ref. No. 1162/7-2). No unexpected high pore

pressure increases were noted during the reporting period. The artesian head values (above ground surface level) measured in September 2005 are summarized in Table 5.1.

Artesian pressures have remained relatively constant in all the piezometers during the reporting period. Piezometers B2-PE2-01 and B2-PE2-02 are showing a slight increasing trend but are still well below the 6 metres above ground threshold level. No artesian conditions have been encountered at Plane E, where coarser glaciofluvial material is present.

Timeline plots of the embankment foundation piezometers are included in Appendix B2. There are no concerns with the embankment foundation piezometers.

- Repair the damaged piezometers.
- Relocate the piezometer readout boxes downstream of the ultimate toe and extend the existing piezometers to the new readout box location.

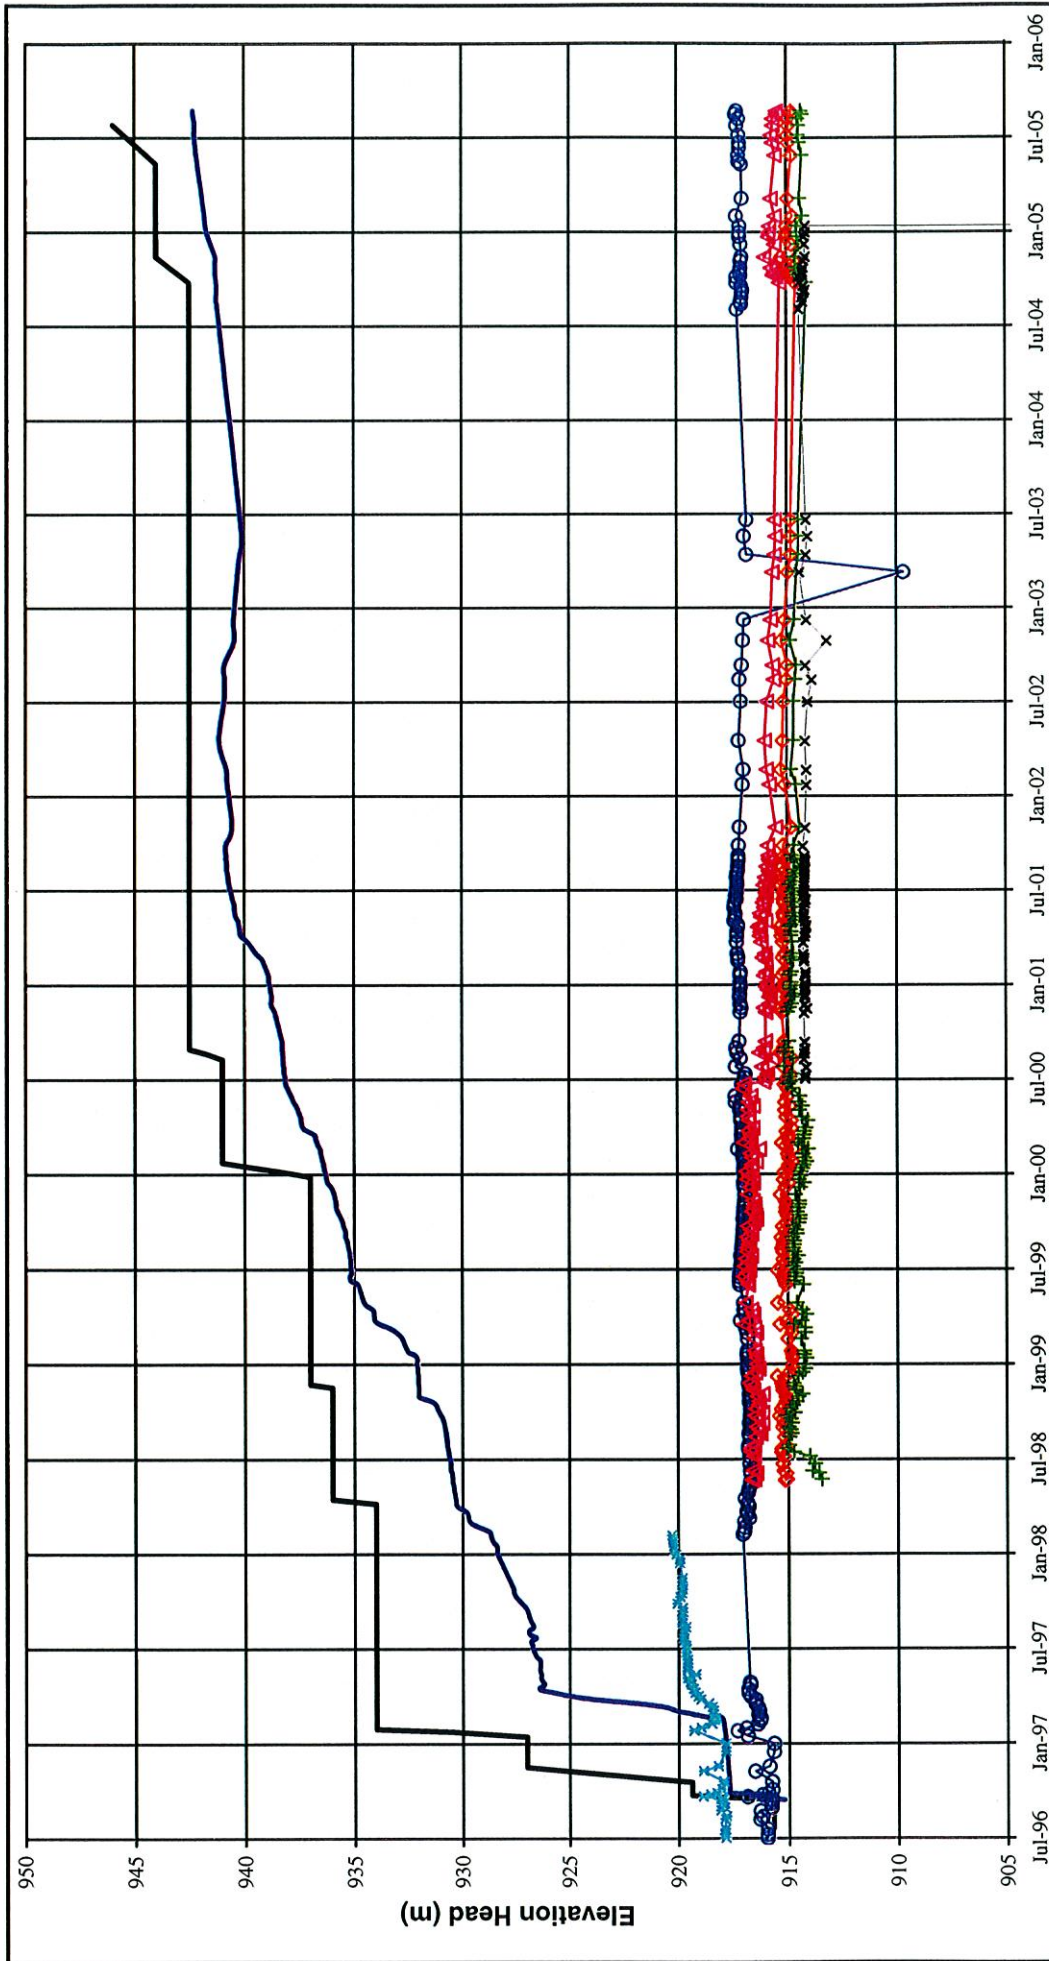
PLANE C FOUNDATION PIEZOMETERS
ELEVATION HEAD vs. TIME

- Pond Level
- C2-PE2-02 (Tip El 910.5 m)
- C2-PE2-07 (Tip El 912.3 m)
- C2-PE1-03 (Tip El 912.59 m)
- Fill Elevation
- C2-PE2-06 (Tip El 906.8 m)
- C2-PE2-08 (Tip El 914.0 m)
- C2-PE2-01 (no longer functioning)

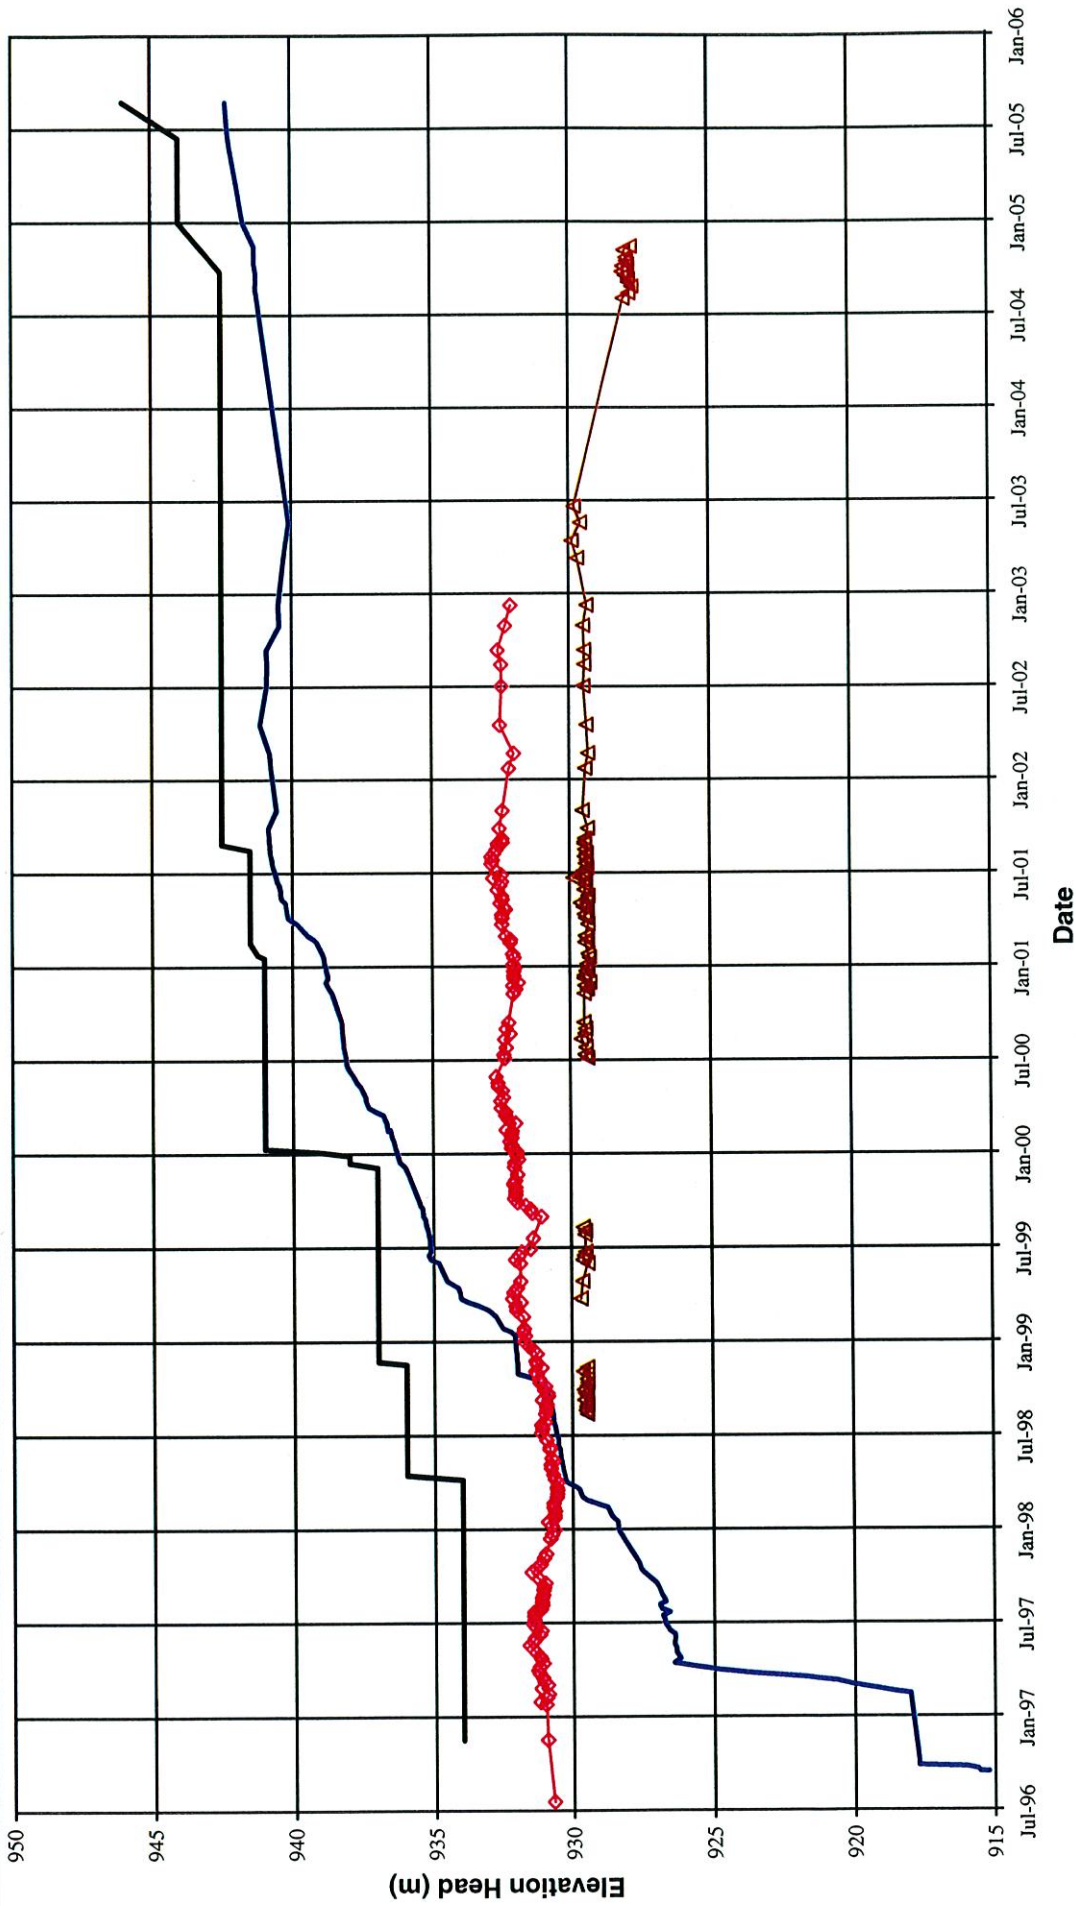
MOUNT POLLEY MINING CORPORATION			
MOUNT POLLEY MINE			
PLANE D FILL PIEZOMETERS ELEVATION HEAD vs. TIME			
PROJECT NO. VA 101-1/11		REF. NO. 1	REV. 0
Knight Piésold CONSULTING		FIGURE B3-4

— Pond Level
 — Fill Elevation
 —△— D2-PE1-01 (Zone T)
 —◇— D2-PE2-01 (Glacial Till) no longer functioning

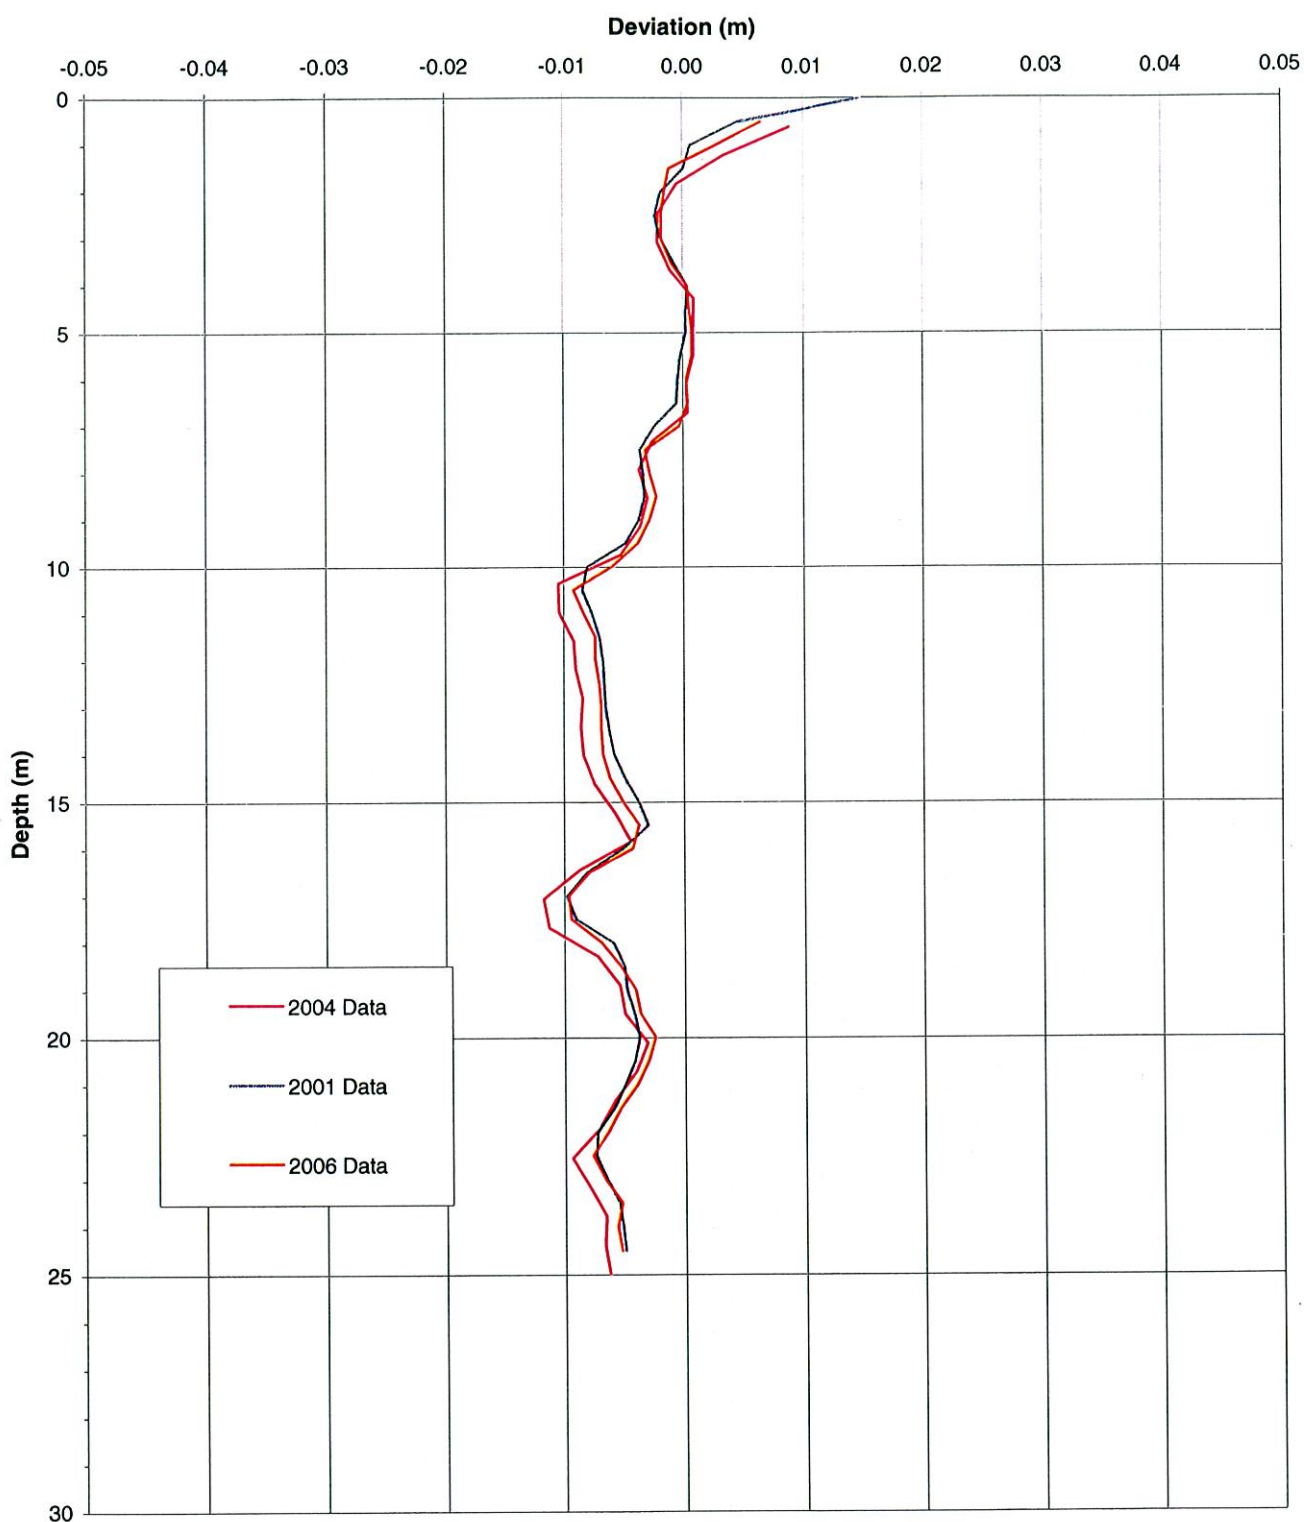
FIGURE C-1

Note:
Hole 1 frozen for 2005 reading.

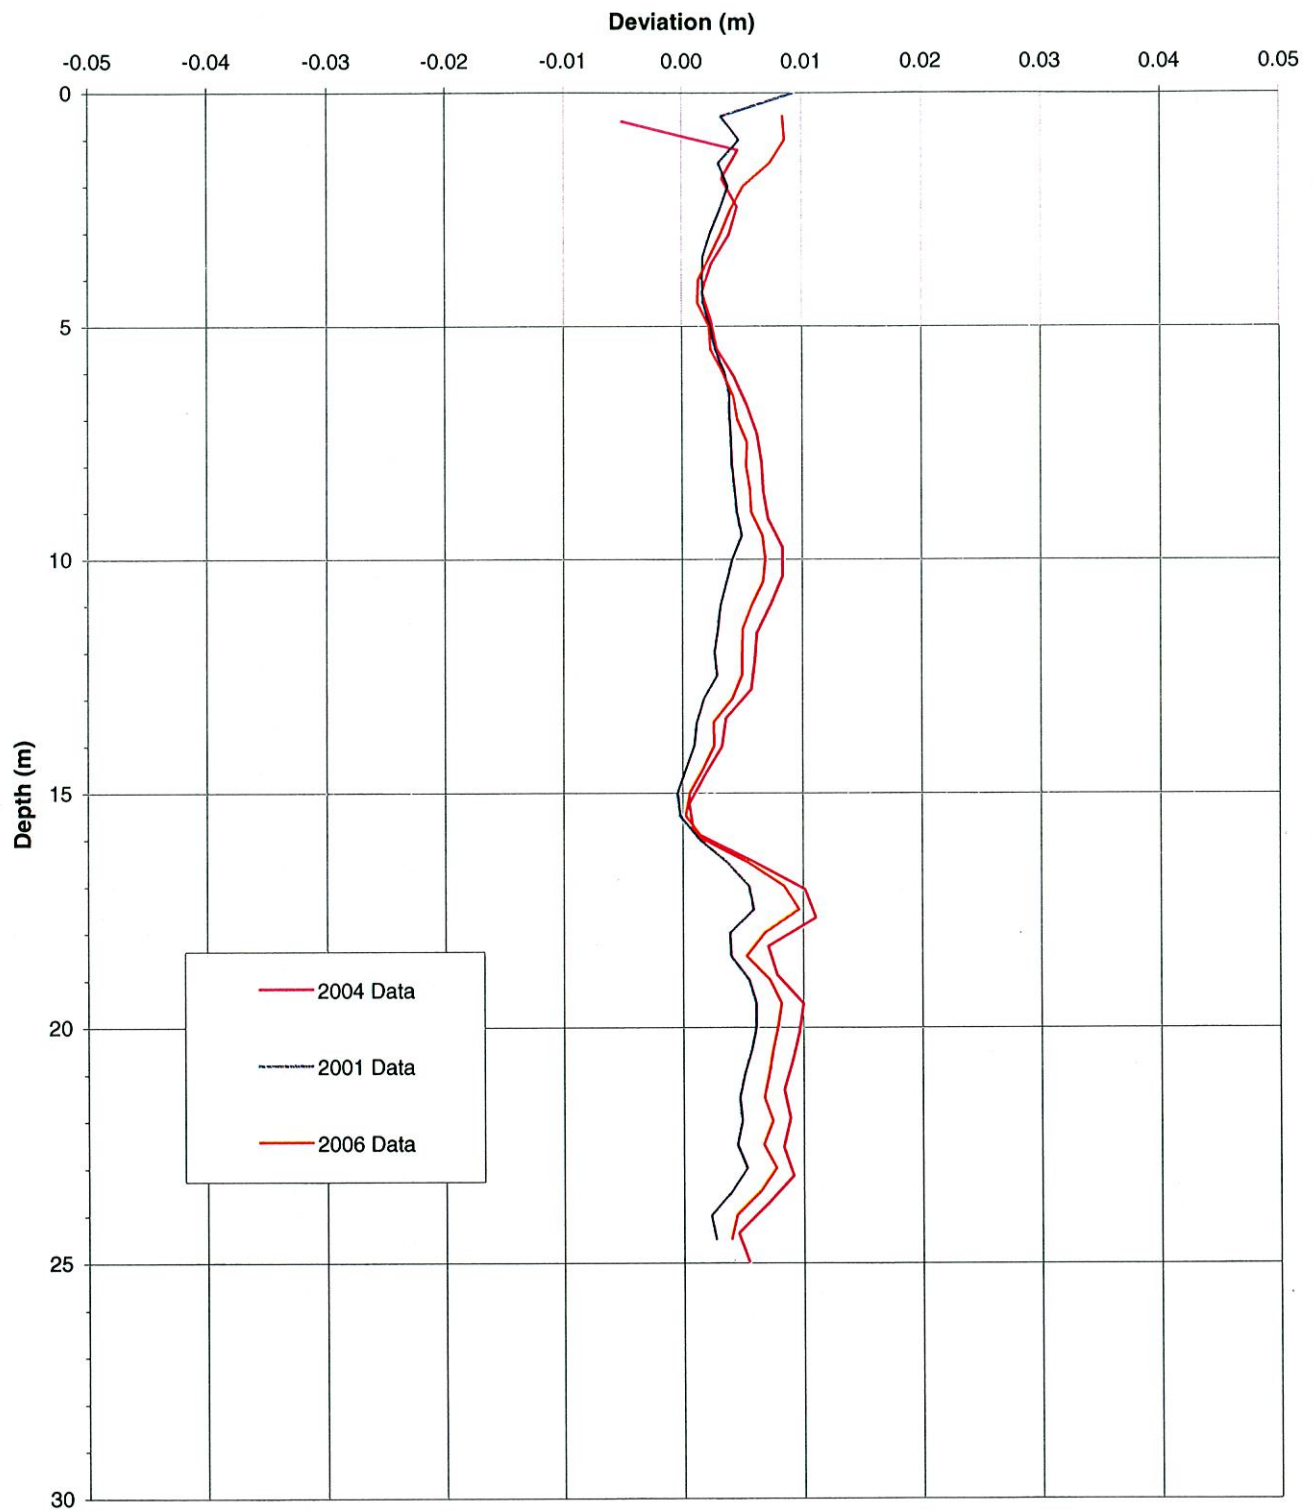
FIGURE C-2

Note:
Hole 1 frozen for 2005 reading.
