**MOUNT POLLEY MINING CORPORATION  
MOUNT POLLEY MINE**

**TAILINGS STORAGE FACILITY  
REPORT ON 2008 ANNUAL INSPECTION  
(REF. NO. VA101-1/24-1)**

**TAILINGS STORAGE FACILITY  
REPORT ON 2008 ANNUAL INSPECTION  
(REF. NO. VA101-01/24-1)**

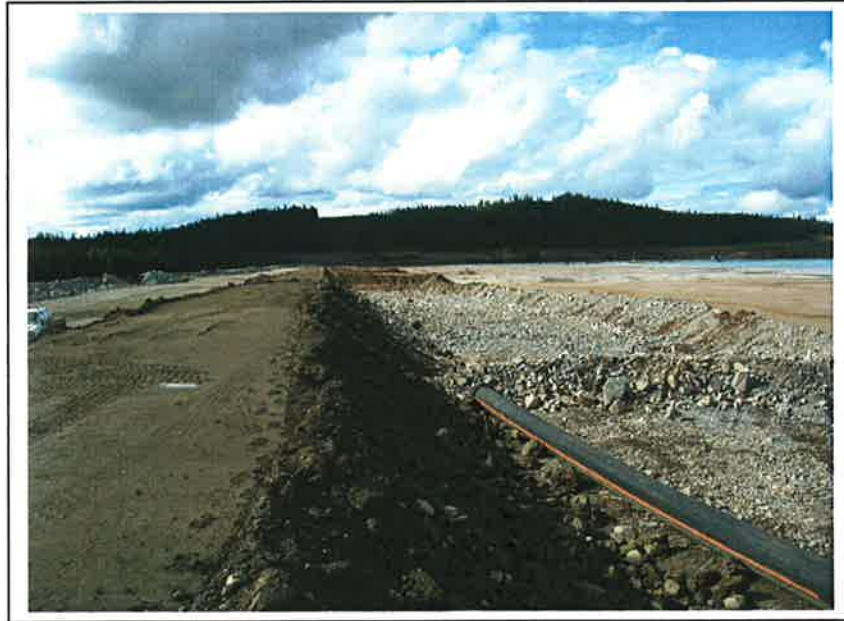
**PHOTO 1** – Components of the TSF, Zone S (left) Zone U (centre) and Tailings Beach (right)

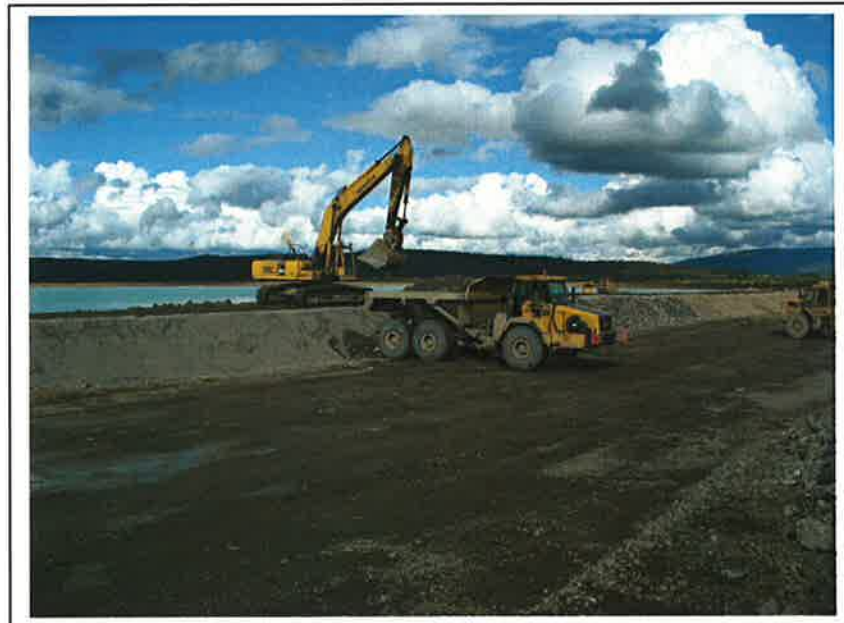
**PHOTO 2** – Downstream components of TSF, Zone C (foreground), Truck is placing Zone T on top of Zone F, Excavator is sitting on Zone S at 954m

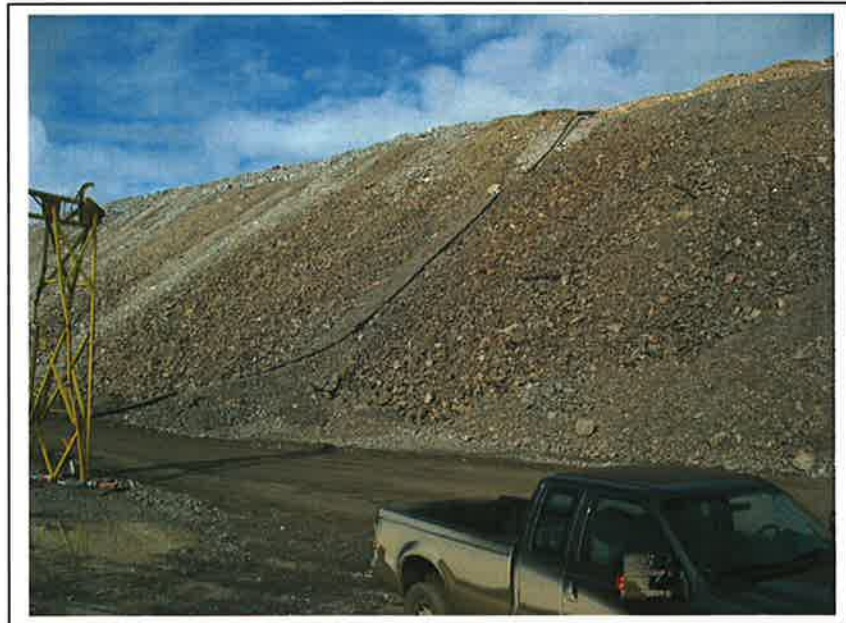
**PHOTO 6** – Main Embankment Seepage Pond Return Pipe

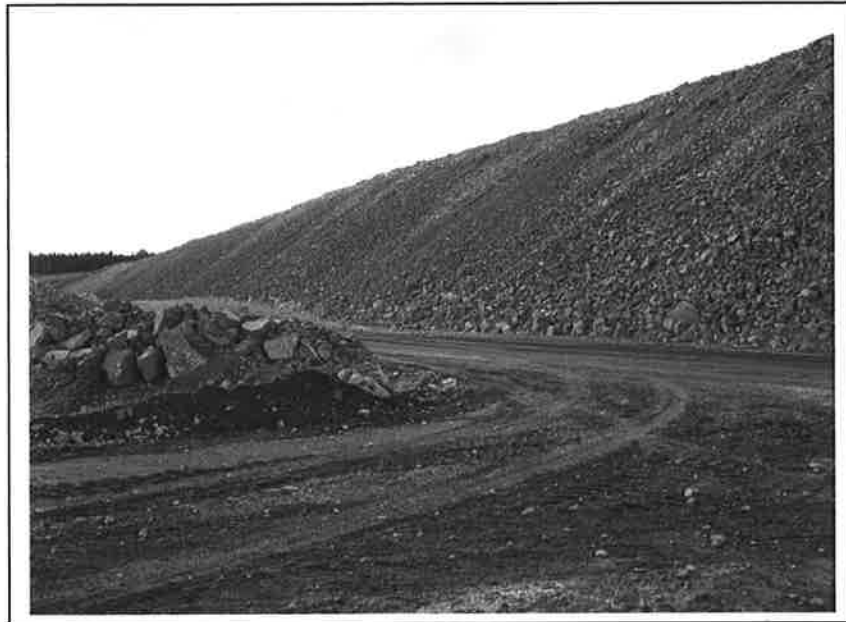
**PHOTO 7** – Main Embankment looking west

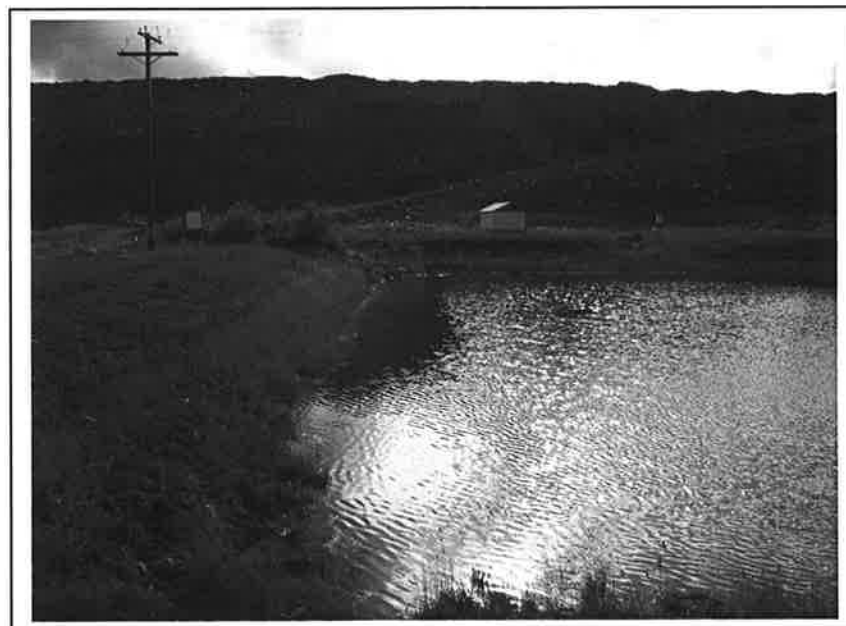
**PHOTO 8** – Perimeter Embankment looking south, showing access ramp to PE seepage pond

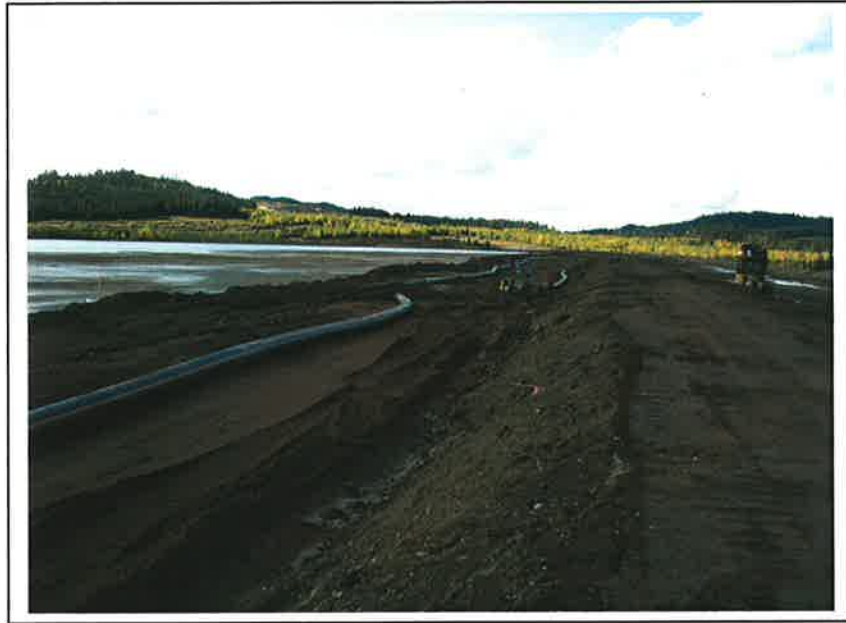
**PHOTO 9** – Perimeter Embankment Zones U and S. The Zone U on the left was constructed using tailings sand cells.

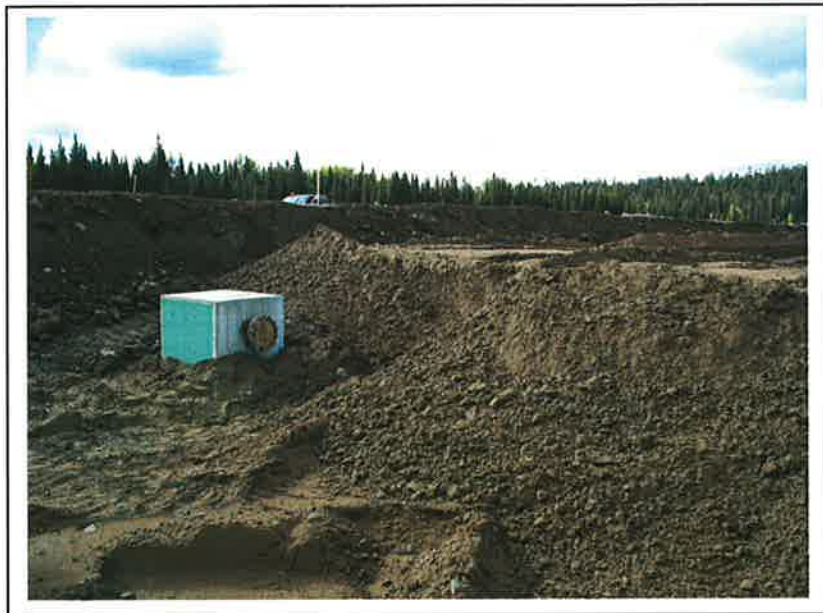
**PHOTO 10** – Upstream toe drain outlet at the South Embankment. To be completed in 2009.

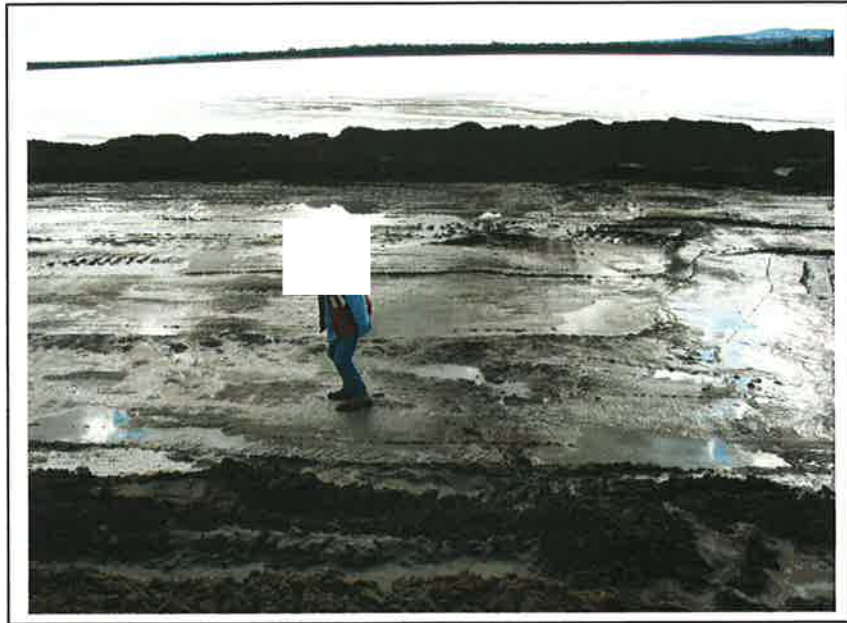
**PHOTO 11** – Recently completed Sand Cell

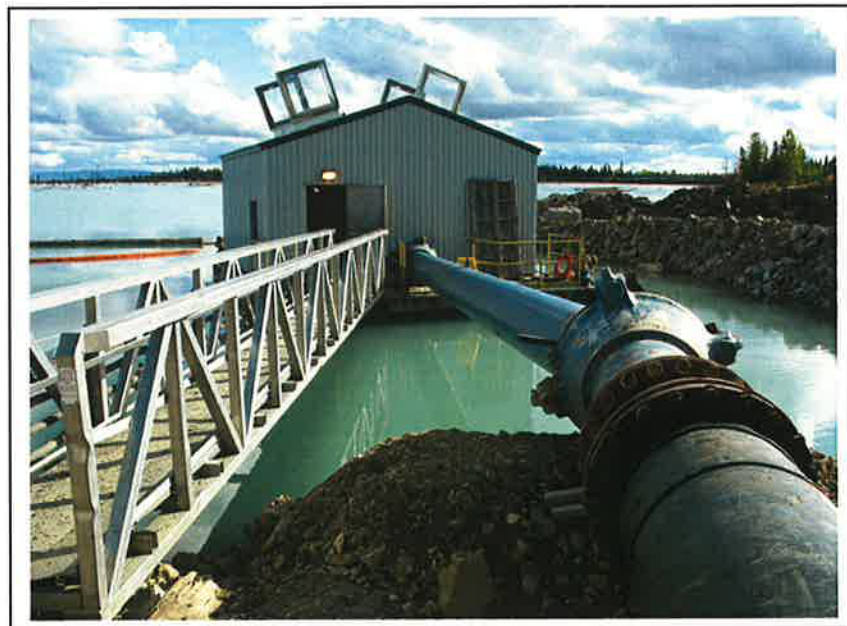
**PHOTO 12** – Pump barge and reclaim pipeline

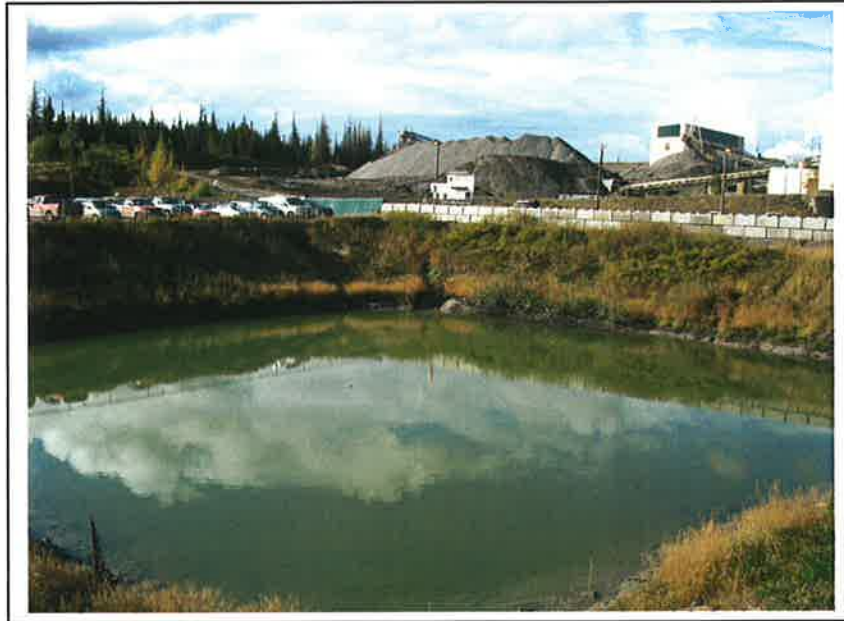
**PHOTO 13 – Mill Site Sump**

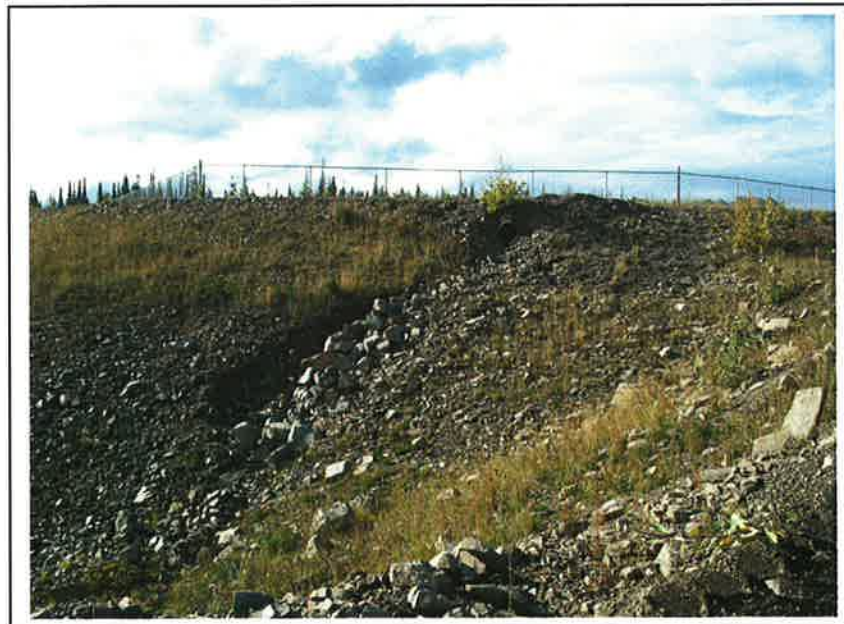
**PHOTO 14 – Mill Site Sump Emergency overflow**

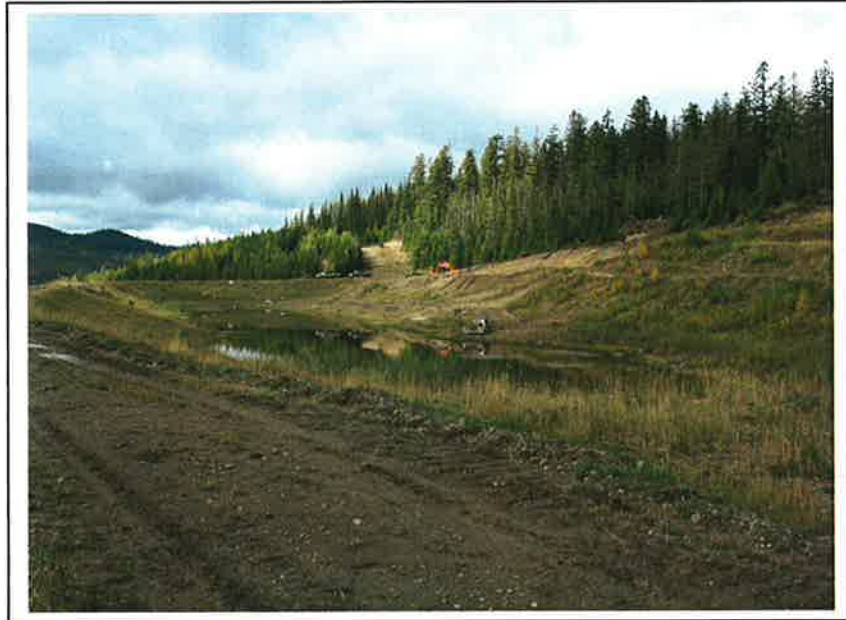
**PHOTO 15** – Southeast Sediment Pond

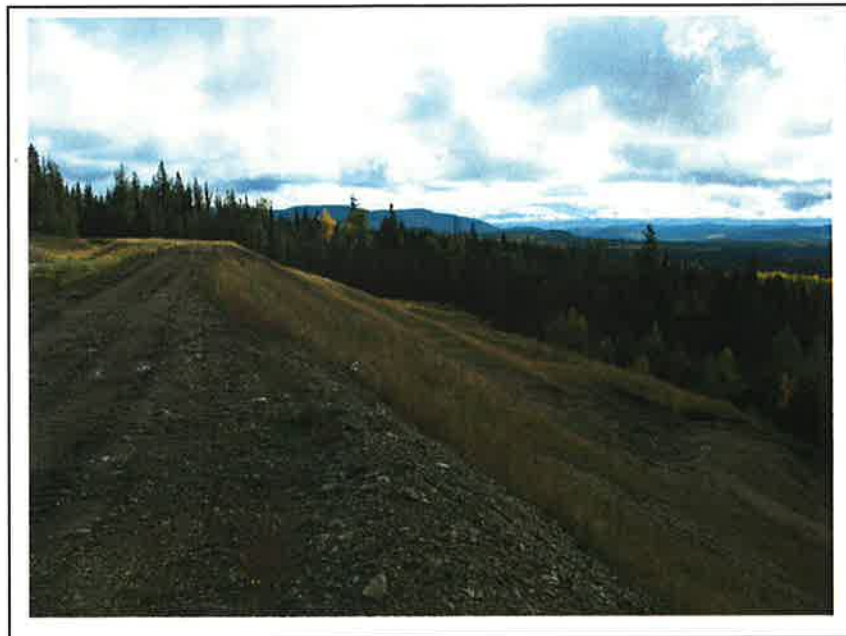
**PHOTO 16** – Southeast Sediment Pond Downstream Slope

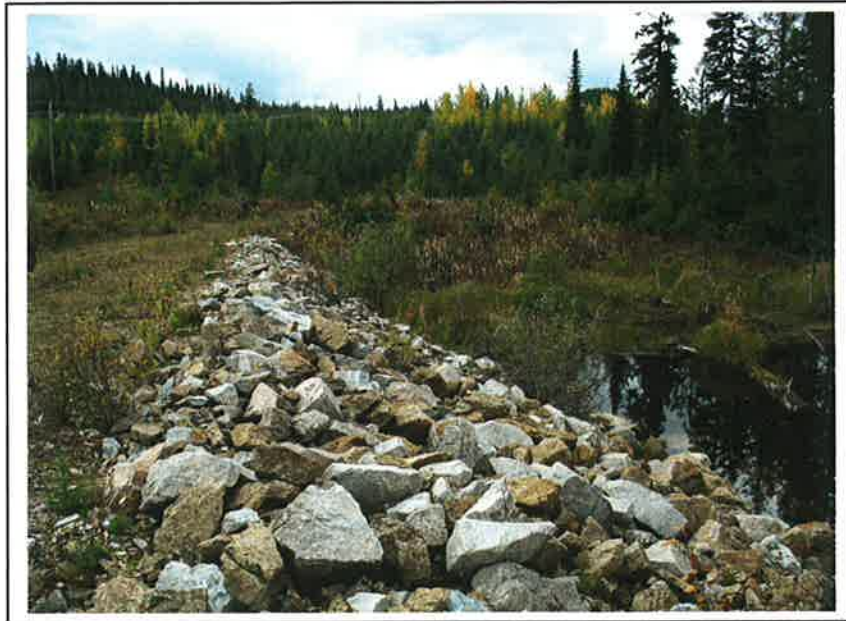
**PHOTO 17** – South Bootjack Dam

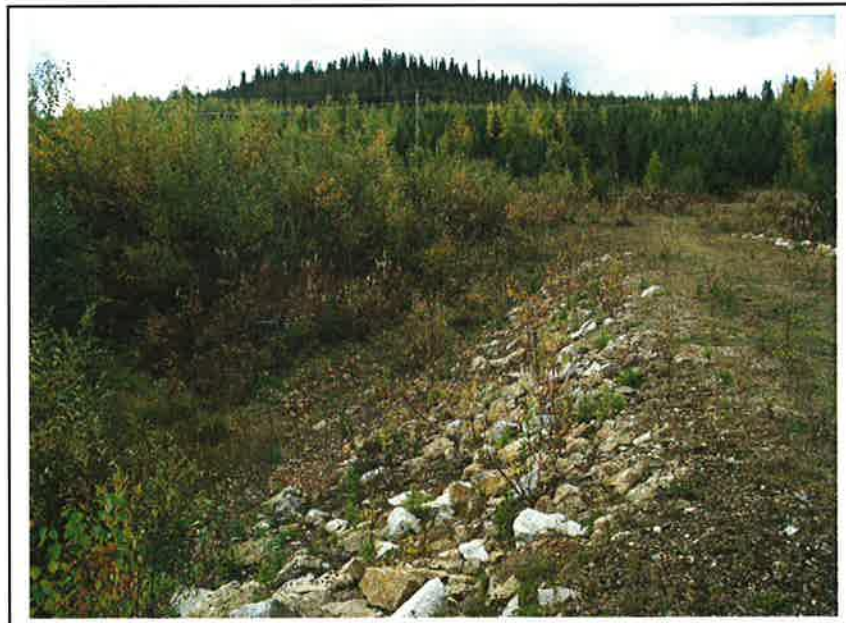
**PHOTO 18** – South Bootjack Dam
