Independent Expert Engineering Investigation and Review Panel

**Report on Mount Polley
Tailings Storage Facility Breach**

Appendix C: Surface Investigations

January 30, 2015

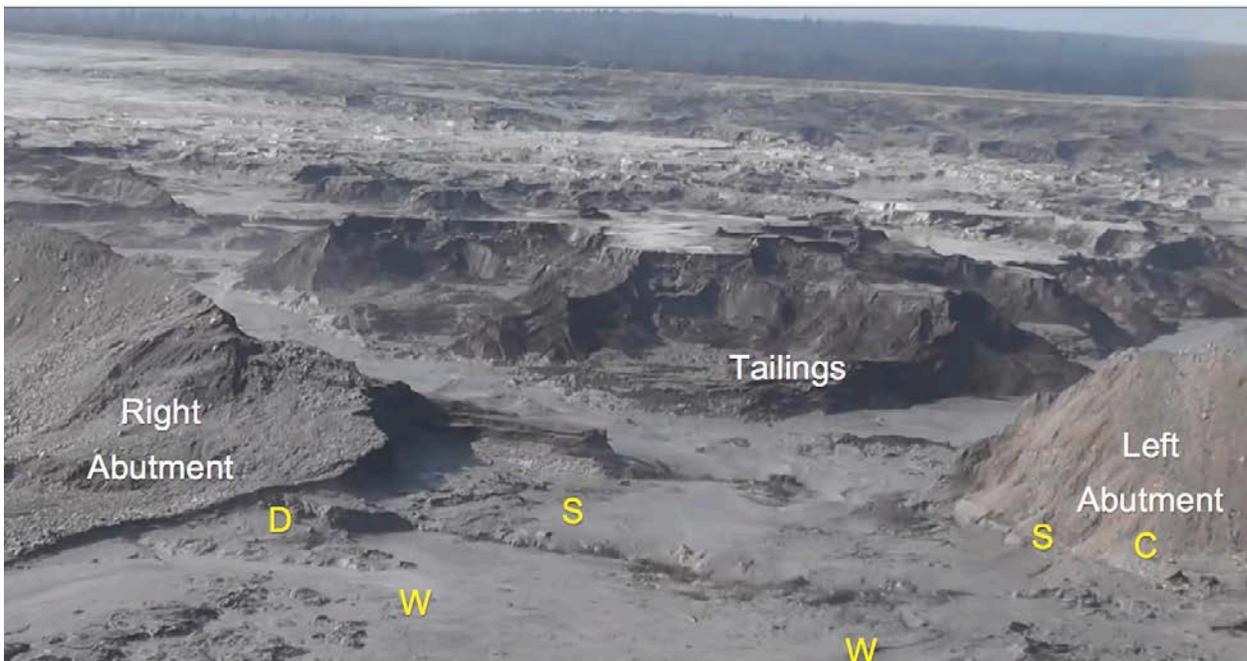
Figure C3.3.1 is a view looking upstream through the breach. It can be seen that the water flowing through the breach originates from both the left and right upstream side of the dam. The right abutment consists of a linear section of remnant till core (S) and a section of displaced downstream shell (D). The left abutment contains a smaller piece of remnant till core (S) behind the downstream rockfill shell (C). The photograph also shows the linear whaleback feature (W) that runs parallel to the dam near the downstream toe. Comprised of highly erosion-resistant native till, the whaleback uplift was subject to continuous overflow and acted as a broad-crested weir during breach discharge.

FIGURE C3.3.1: VIEW LOOKING UPSTREAM INTO TSF THROUGH THE BREACH (CARIBOO VIDEO AT 11:11)

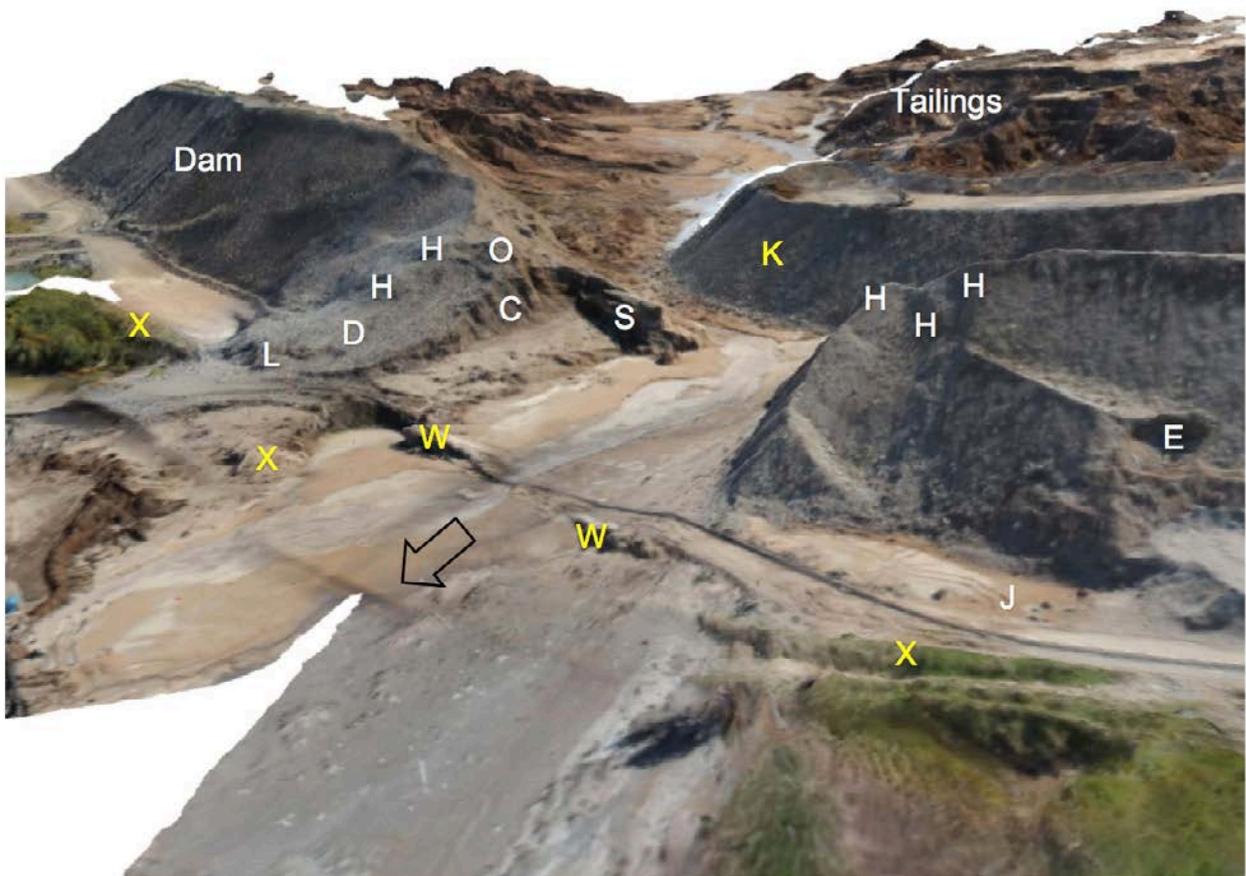
Figure C3.4.1 is a 3-D rendering looking upstream toward the right abutment. It shows the upstream rockfill dike (K) being constructed to retain the remaining tailings, which appears prominently in many of the following September 4, 2014 photos. The figure also shows the linear whaleback (W) and a linear roadside berm consisting of organic till (fill) material (X) that can be traced across the breach area.

FIGURE C3.4.1: VIRTUAL IMAGE LOOKING UPSTREAM THROUGH THE BREACH AREA

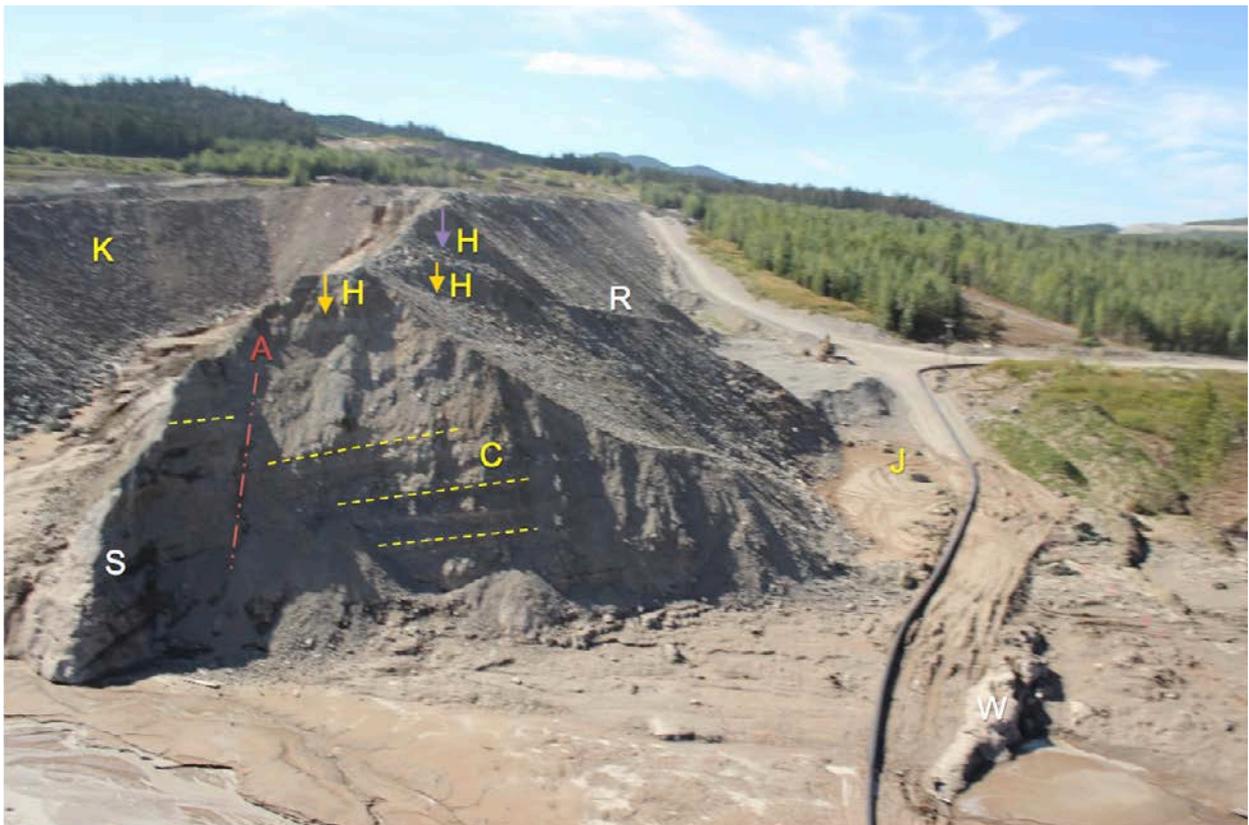
The three en echelon scarps (H) can be seen above the eroded slope face (C). Transported till blocks and pieces of driftwood (J) indicate that the water level during the breach attained this level. The rockfill retaining dike (K) was under construction in the background.

FIGURE C3.5.1:VIEW FROM HELICOPTER LOOKING WEST AT LEFT ABUTMENT (SEPT. 4, 2014 PHOTO)

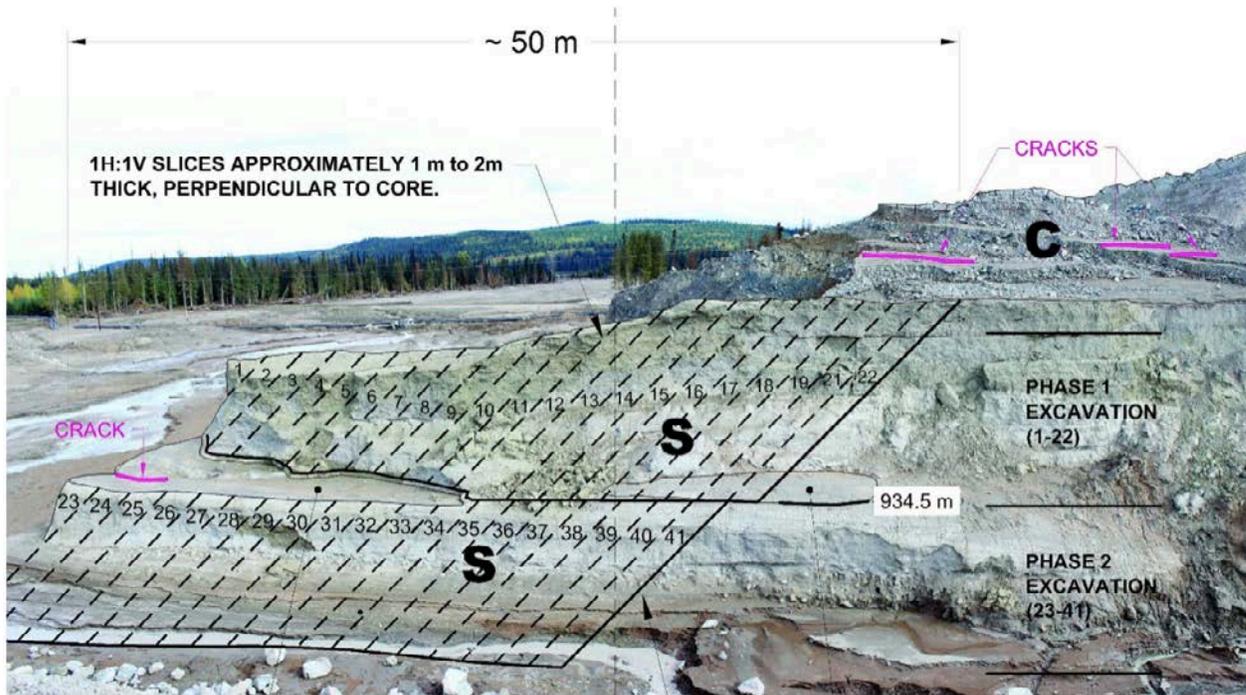
Figure C3.7.2 shows the excavation sequence diagrammatically. The base of the lower phase of the excavation was nominally set at El. 930 m, but some test pits within the excavation extended as deep as El. 925.5 m.

FIGURE C3.7.2: DIAGRAMATIC CROSS-SECTION OF EXCAVATION SLICES THROUGH THE REMNANT TILL CORE

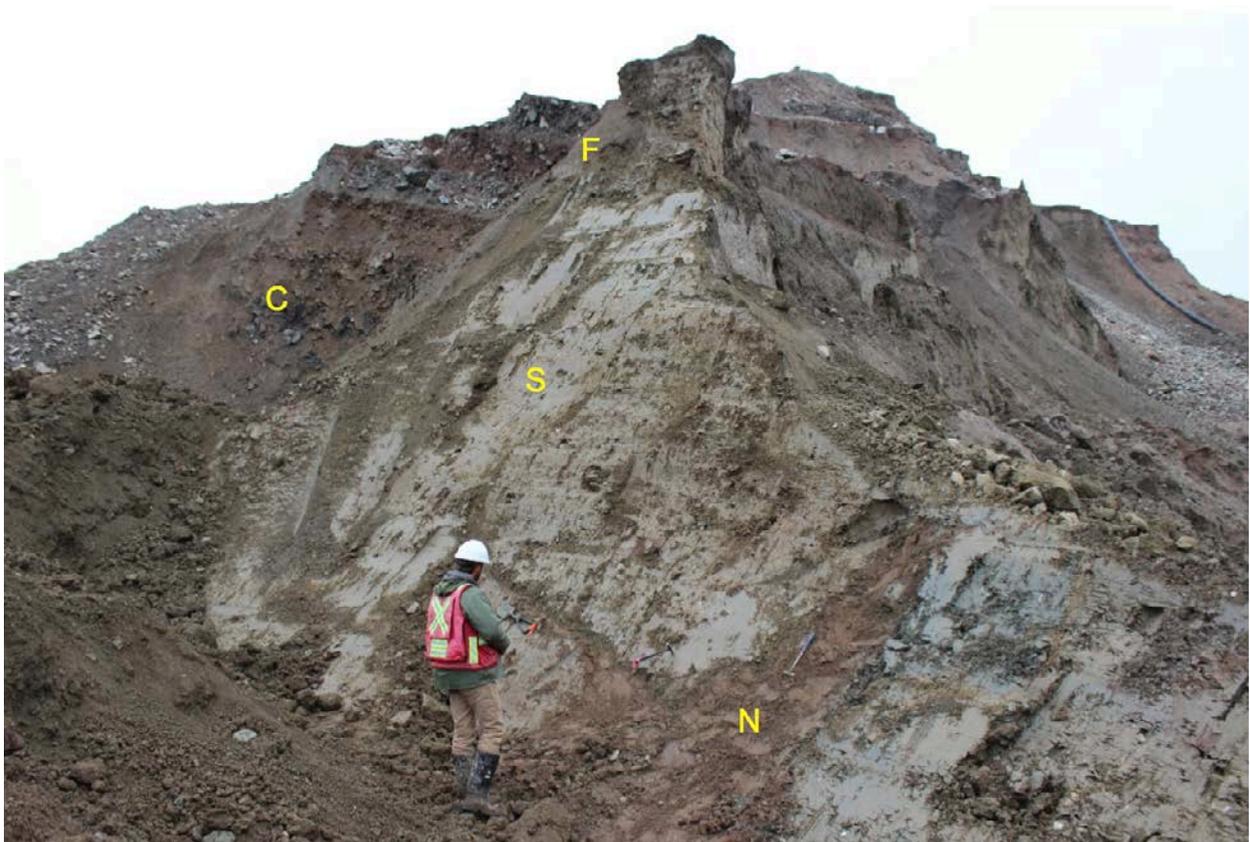
Samples of till core were collected near the Zone S label shown in Figure C3.7.3 in Slices 4, 6, 9, 14 and 20. Samples were collected near the Zone F label in Slices 14, 18 and 20.

FIGURE C3.7.3 TYPICAL FACE IN UPPER PHASE OF SLICE EXCAVATIONS (SLICE 16)

The sand identified as N in the figure has a reddish colour and was observed in slices 5 through 22, except for Slices 10 and 11, in the upper phase of the excavation. In the lower phase, sand-filled cracks were occasionally observed near the top of cut on the downstream side of the shear. Larger sand pockets were observed in Slices 35, 38 and 41 corresponding to the sand zone in the upper slices. In all cases, the sand was present only downstream of the shear surface. Properties of the sand and its possible origin are discussed in Attachment C1.

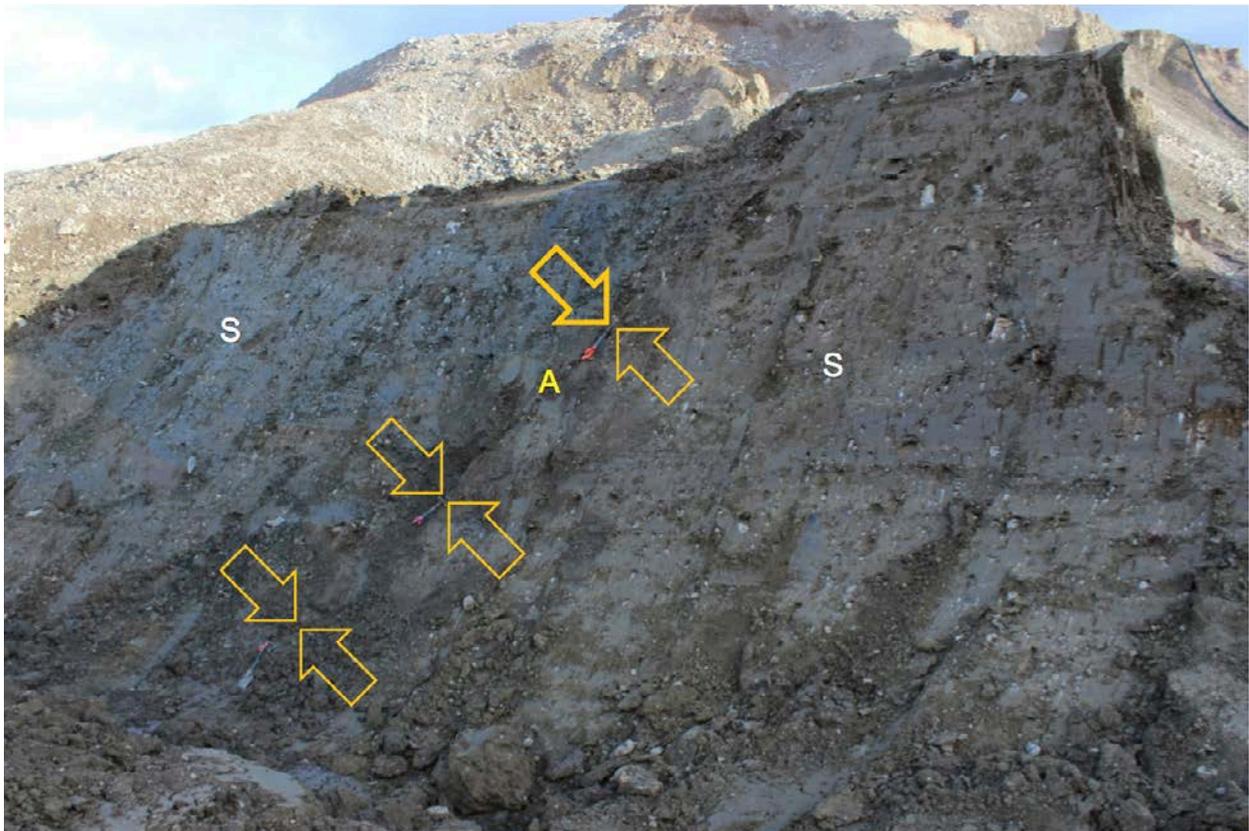
The second phase involved excavating the lower portion of the remnant core from approximate El. 929.5 m to 934 m. **Figure C3.7.4** shows a typical section of the lower phase (Slice 28). A diagonal shear surface was encountered during excavation of the lower phase (A). The surface was delineated by mapping and surveying of each slice during the excavation. Samples of till core were collected near the downstream (left) and also the upstream (right) side of the shear, corresponding approximately to the Zone S labels shown in **Figure C3.7.4** in Slices 27 and 31.

FIGURE C3.7.4: TYPICAL FACE IN UPPER PHASE OF SLICE EXCAVATIONS (SLICE 28)

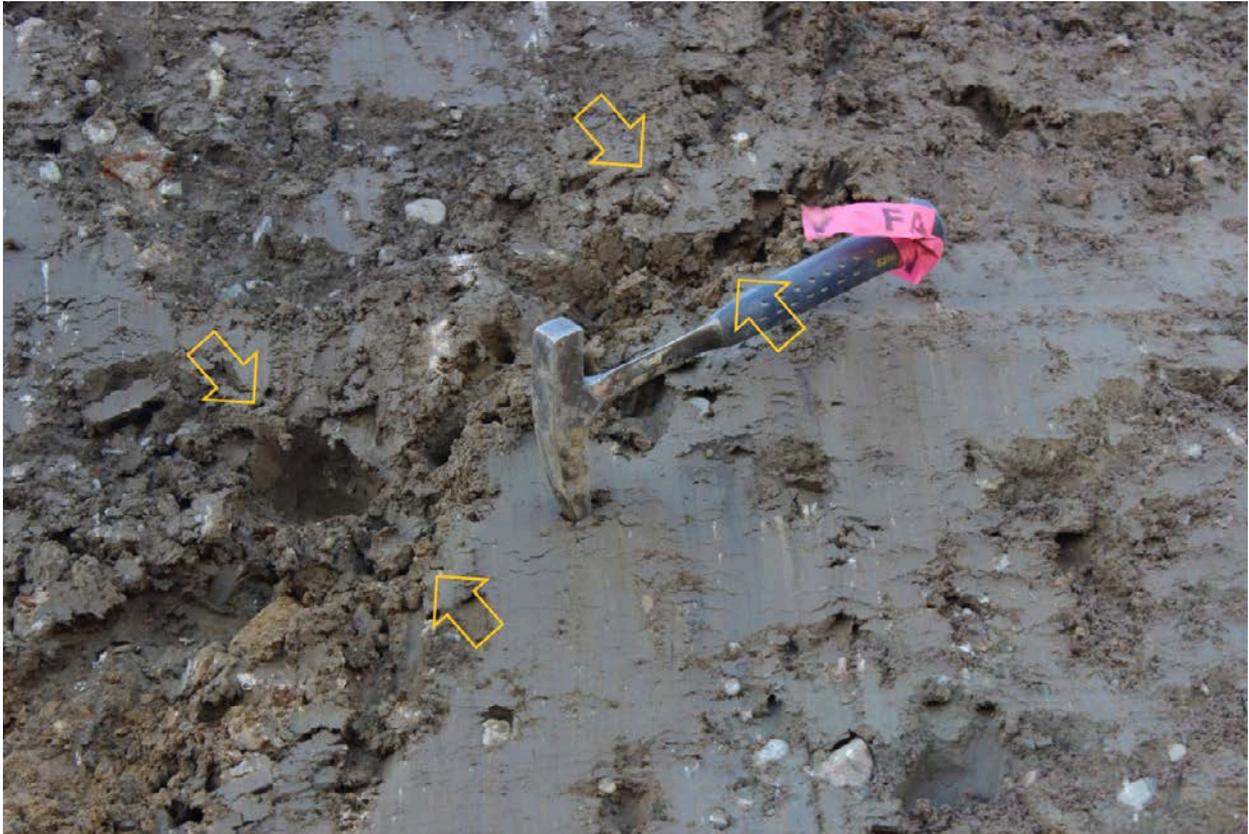
Although its geometry was quite consistent, the nature of the shear varied considerably between the slices. Materials ranged from thin (<10 mm wide) zones of softened till with a colour contact from grey to brown, to wet zones up to 1 m wide containing very soft till, red sand, and light brown angular gravel.

Due to this variability, the appearance, strength, and nature of the shear are difficult to generalize. **Figure C3.7.5** shows a close-up of the shear in Slice 23 with a 330 mm long rock hammer shown for scale. The upper right of the photo shows red sand deposits in the shear and the lower left side shows light brown angular gravel. The shear varies in the photo from about 50 mm to about 150 mm wide (orange arrows).

FIGURE C3.7.5: SHEAR SURFACE IN SLICE 23

In some locations, the base of the shear contained free water. Slices 23 and 24 exhibited approximately 2 litres per minute water flow out of the base of shear. The flowing water also washed fine, red-coloured sand out of the shear and deposited it at the base of the excavation.

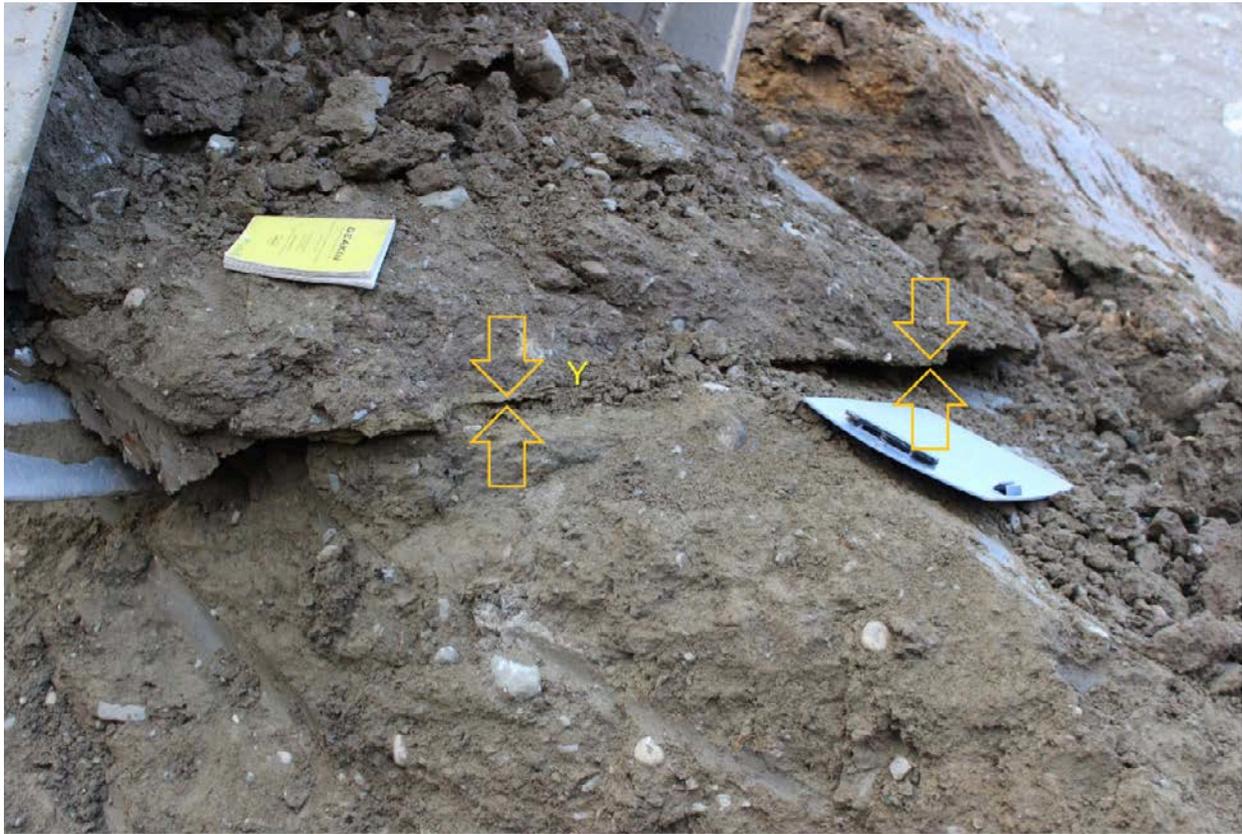
Observations of the construction surface planes (Y) were less prevalent during the lower phase excavation, especially on the upstream side of the shear. One example of a plane on the upstream side of the shear is shown in **Figure C3.7.10**. The plane is horizontal, in contrast to the dipping planes (average 15°) observed on the downstream side of the shear.

FIGURE C3.7.10: HORIZONTAL CONSTRUCTION PLANE EXPOSED DURING EXCAVATION OF SLICE 28

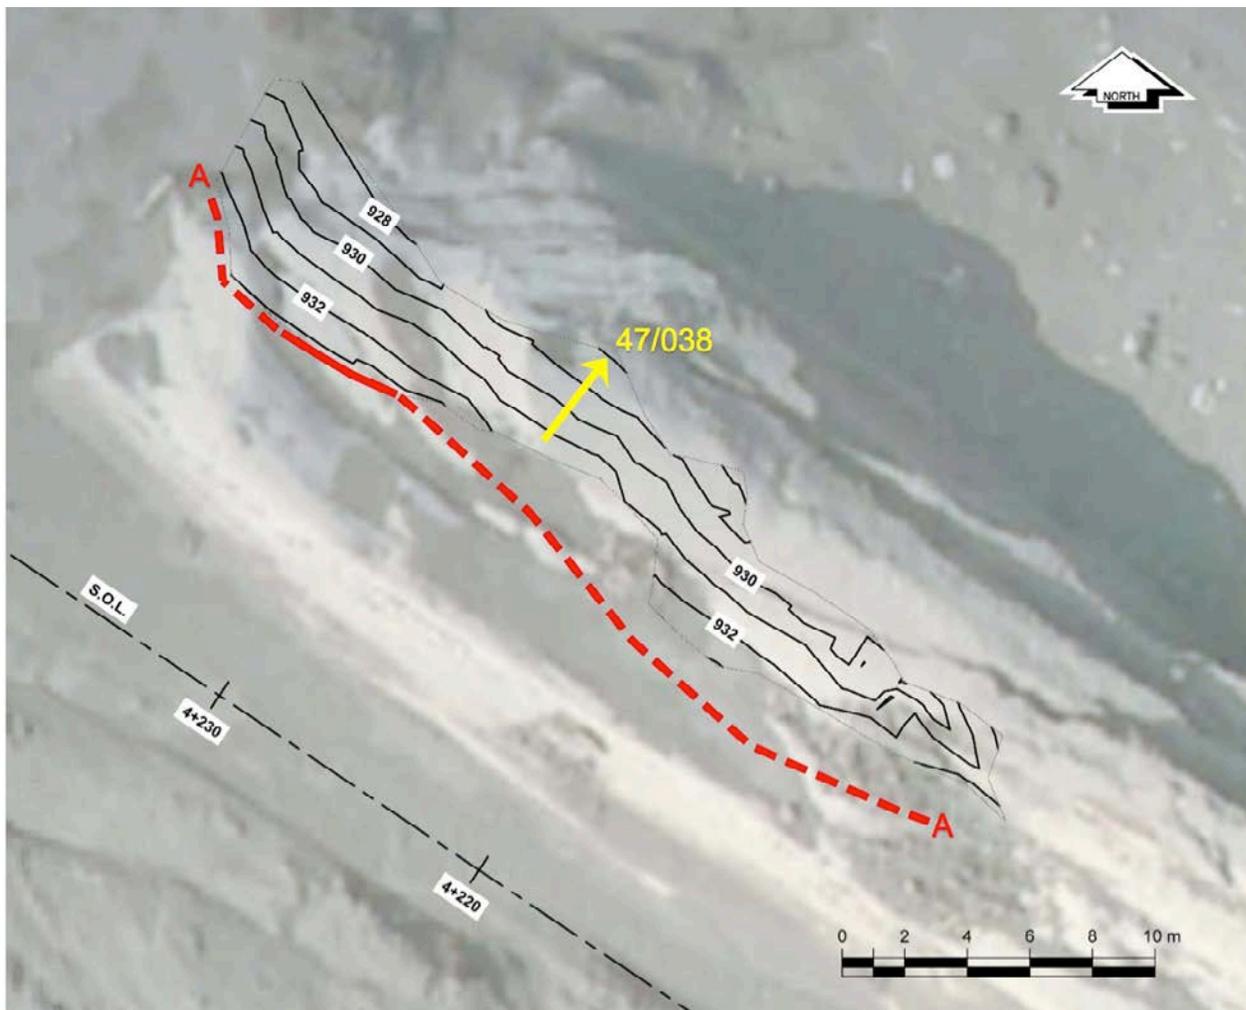
Figure C3.7.13 shows the surveyed trace of the shear surface (A) at the post-breach ground surface in red (dashed where projected). The black contours (1.0 m interval) represent the shear surface itself as measured during excavation. The surveyed points along the plane indicated a relatively constant dip angle of about 47°. The dip direction varied from about 030° to 064° (Mine North) with an average of about 038°. The average orientation of the shear surface (A) is shown in yellow in the figure.

FIGURE C3.7.13: TRACE AND CONTOURS OF SHEAR SURFACE ENCOUNTERED DURING THE EXCAVATION

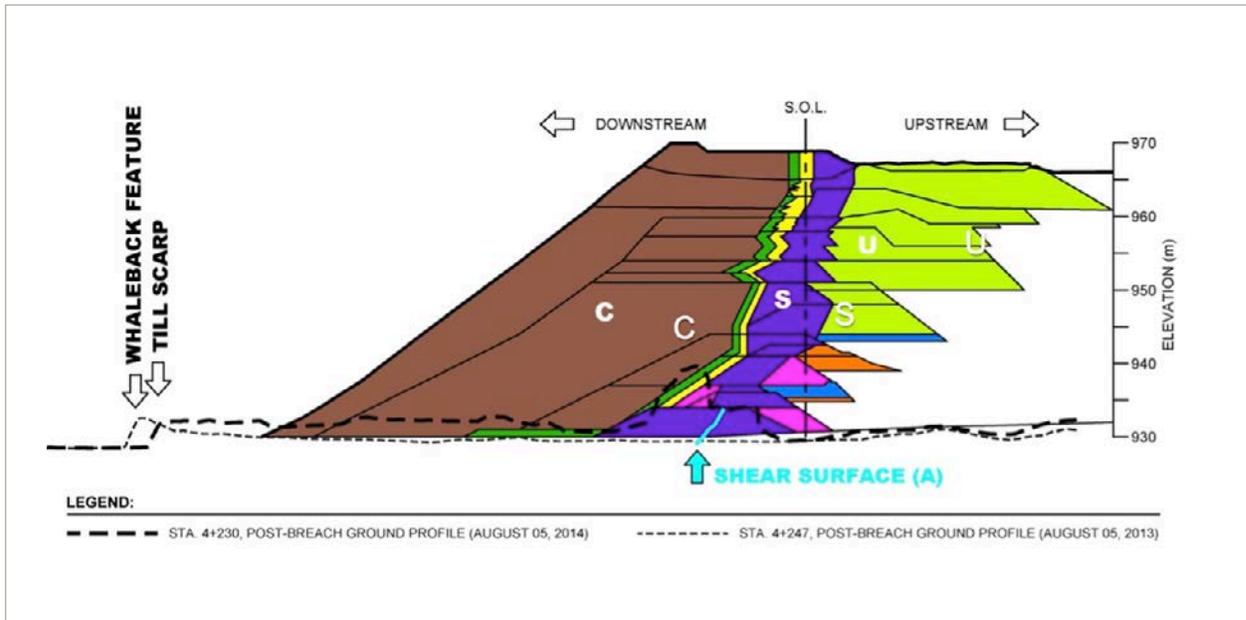
Figure C4.2.2 is a cross-section that shows the location of the mapped shear surface (A) and the whaleback feature in relation to the same composite dam section at the breach location shown previously in Figure C3.1.4. The post-breach ground profiles along Sta. 4+230 and Sta. 4+247 are shown with dashed lines.

FIGURE C4.2.2: CROSS-SECTION SHOWING SHEAR SURFACE LOCATION AND WHALEBACK FEATURE

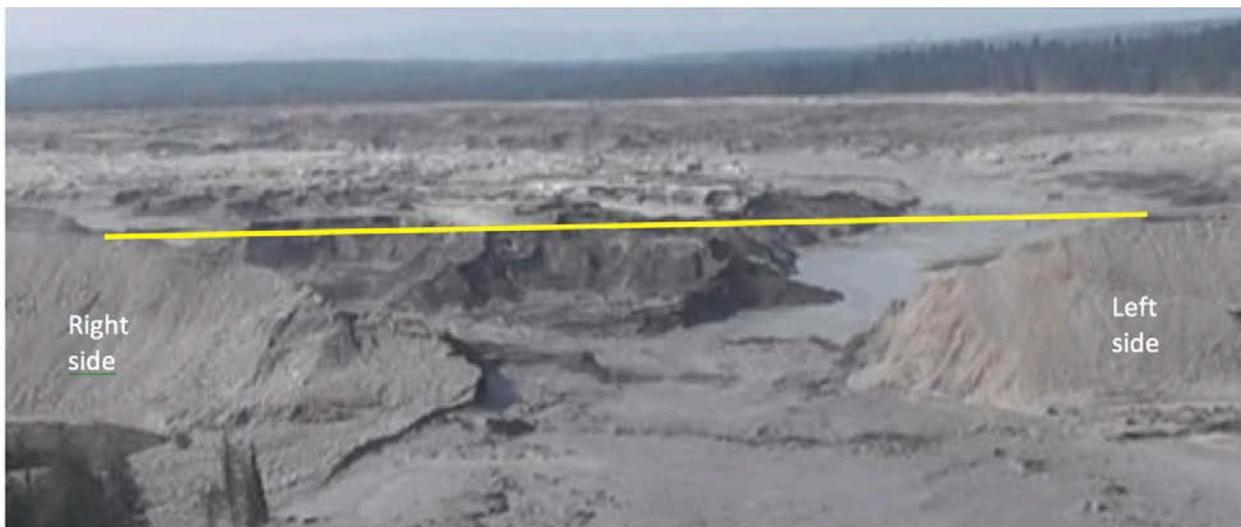
The sequence of breach development provides context for interpreting features observed in the field. The following reconstruction describes in conceptual fashion several key stages in the evolution of post-breach features, starting with the original dam crest in **Figure C4.4.1**.

FIGURE C4.4.1: PRE-BREACH DAM CREST. VIEW LOOKING UPSTREAM (CARIBOO VIDEO AT 11:18)

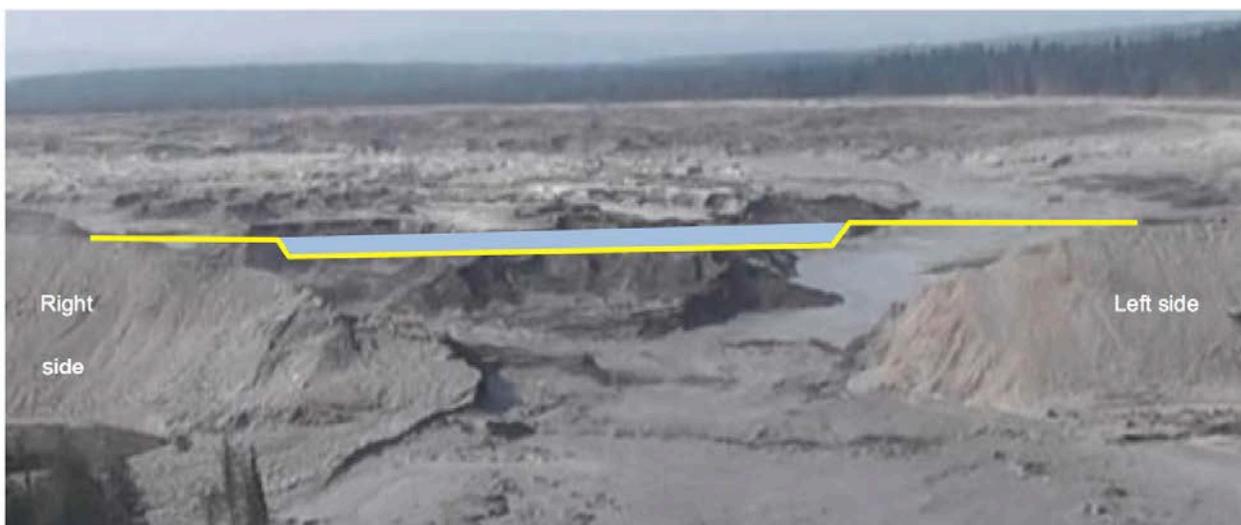
Section 6 of the main report provides the results of deformation analyses using the PLAXIS computer code. They graphically illustrate how the dam crest subsided and the upthrust whaleback formed during the process of foundation sliding. Taking up where this analysis leaves off, crest subsidence initiated breach development by allowing overflow to begin. In **Figure C4.4.2**, the relic erosional surface on the right abutment is indicative of conditions that prevailed over much of the slide area in the early stage of breach development.

FIGURE C4.4.2: BREACH DEVELOPMENT, FIRST STAGE

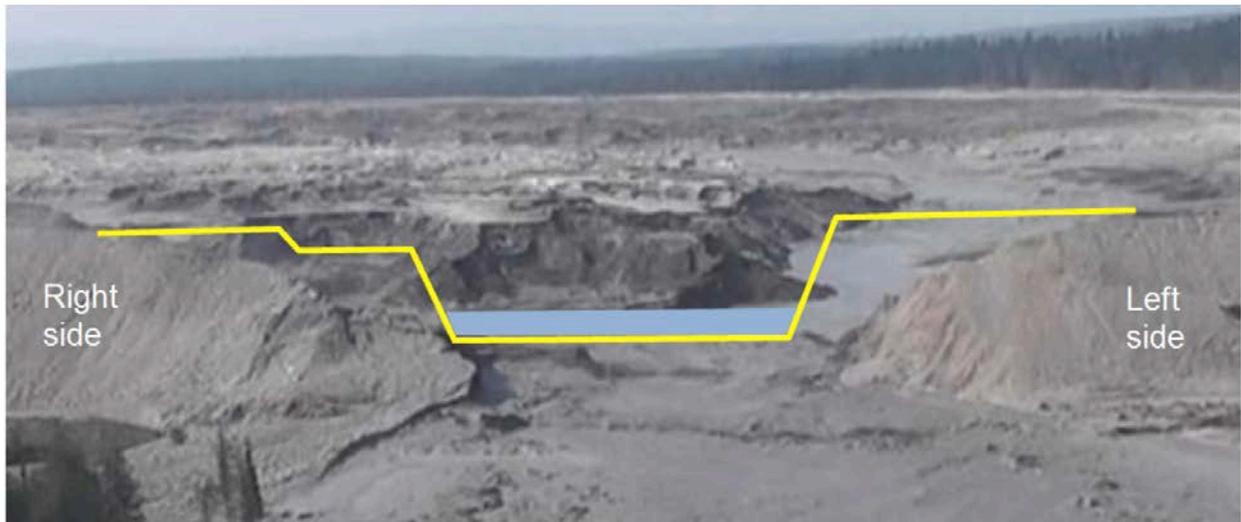
Erosional downcutting deepened in the second stage, shown in **Figure C4.4.3**. The dam core, with its highly erosion-resistant compacted till, acted as the control section. Downcutting progressed preferentially on the left side, terminating sheet flow on the right side as the control section became lower.

FIGURE C4.4.3: BREACH DEVELOPMENT, SECOND STAGE

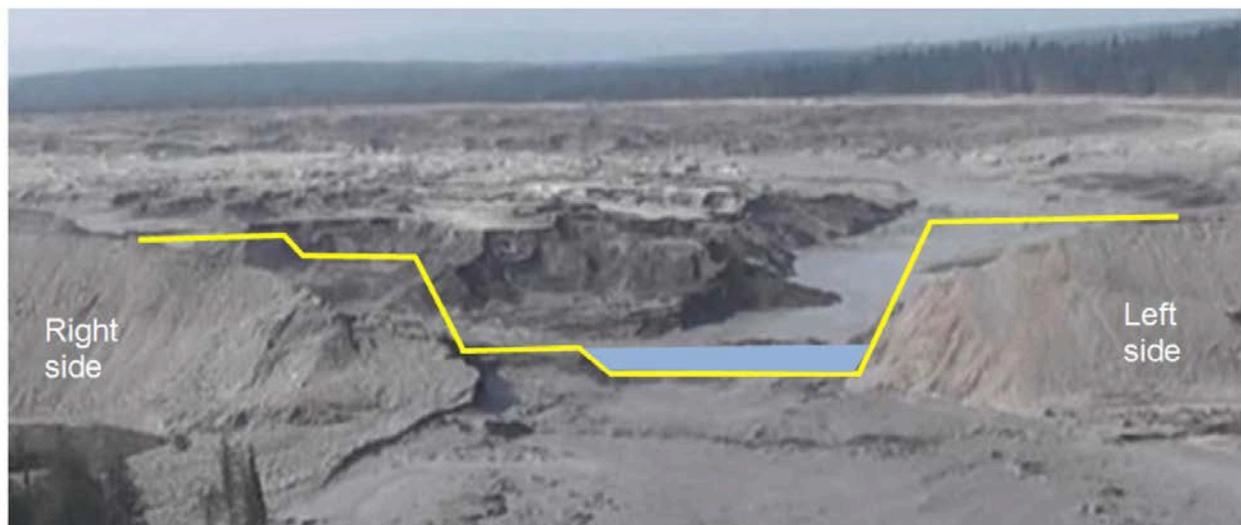
In the third stage, shown in **Figure C4.4.4**, erosion continued to progress on the left side, eventually leaving the projecting core remnant on the right side. This projection acted as a jetty, directing flows still further leftward. On the left abutment, erosional undercutting caused dropdown of the large grabens of dam fill inward toward the breach.

Downstream of the core projection, eddies reduced erosive velocities, preserving much of the remaining rockfill slide mass on the right side. In **Figure C4.4.4**, the linear channel bank extending downstream on the right marks the lateral extent of erosional downcutting in slide debris deposited during initial outflow.

FIGURE C4.4.4 BREACH DEVELOPMENT, THIRD STAGE

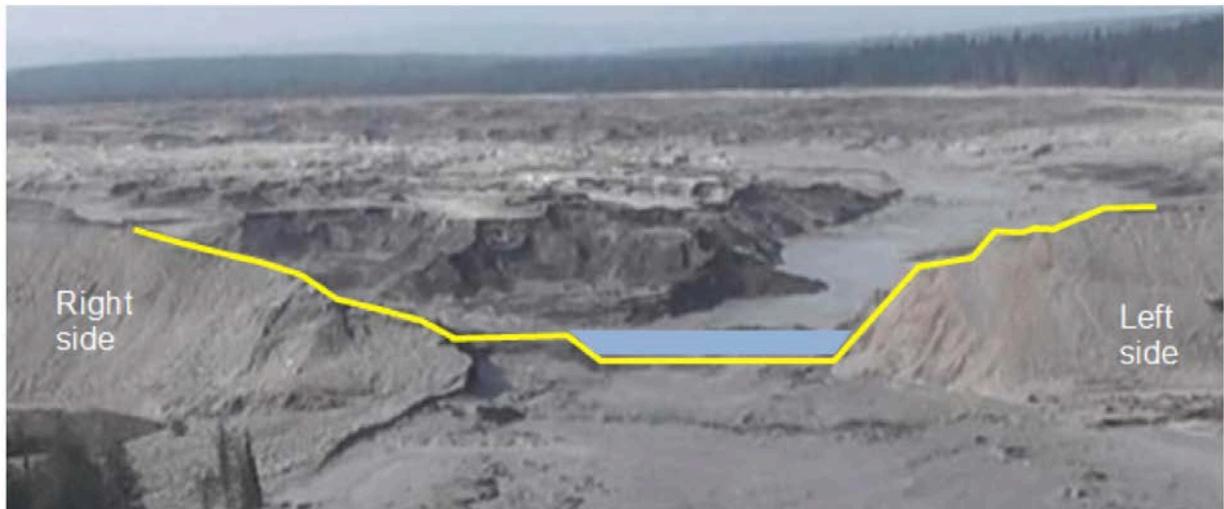
In the fourth and final stage, downcutting flows reached a stable base level at the erosion-resistant foundation till. The downstream whaleback in **Figure C4.4.5** became the new control section, acting as a broad-crested weir by the time the Cariboo video was shot. Meanwhile, erosion and mass movement of tailings had removed support for the back (upstream) side of the dam, causing it to collapse far to either side of the breach itself. The resulting headscarp progressed through the crest and into the downstream slope of the remaining dam sections, producing the ridgeline in the final post-breach profile shown in **Figure C4.4.5**.

FIGURE 4.4.5: BREACH DEVELOPMENT, FINAL STAGE

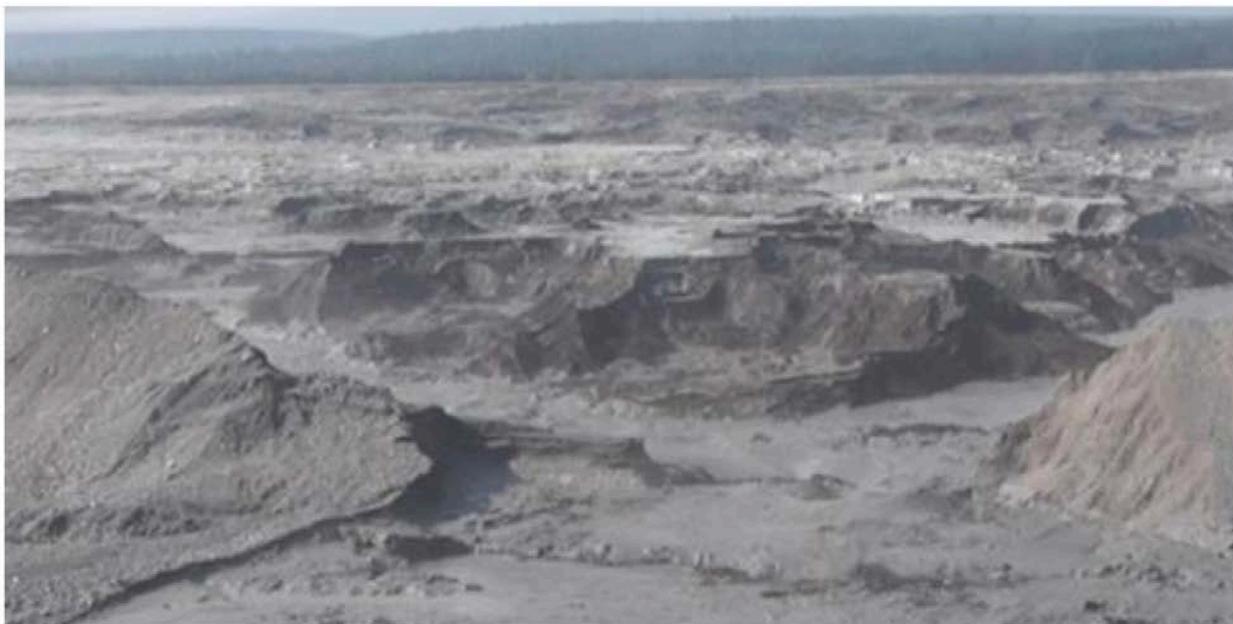
Badland slope formation is dominated by gully erosion that retreats against the direction of flow. A gully knickpoint, or headcut, is an abrupt break in longitudinal profile of a stream caused by the lowering of its base level by erosion. The headward migration of the knickpoint is always toward the maximum water supply, in this case the surface water in the impoundment.¹⁵ In nature, headward migration will continue until reaching a drainage divide, where the reduced catchment area can no longer supply sufficient water. At Mount Polley, the process continued until available surface water stored in the impoundment was exhausted.

FIGURE C4.5.1: BADLANDS TAILINGS TOPOGRAPHY (CARIBOO VIDEO AT 11:23)

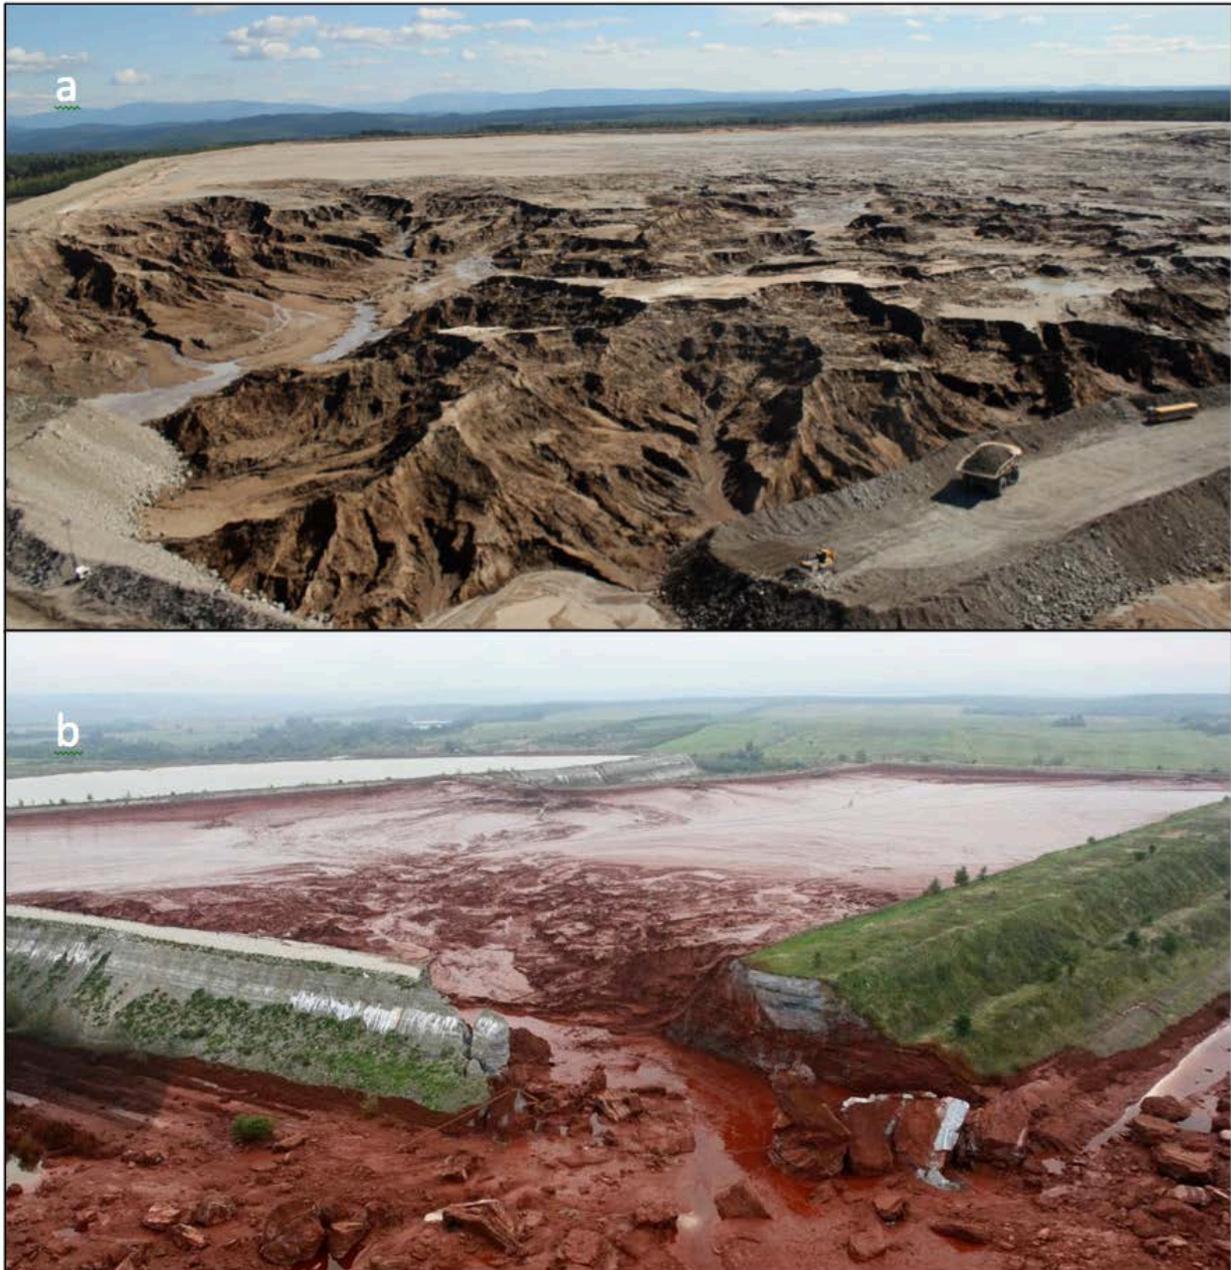
Figure C4.5.2(a), taken one month after the breach, displays other characteristic morphological features in the Mount Polley tailings, such as dendritic drainages that coalesce at the top of narrow divides.^{16,17} Also notable are the cirque-like arcuate headscarps.

FIGURE C4.5.2: COMPARISON OF POST-BREACH TAILINGS MORPHOLOGIES (a) MT. POLLEY, (b) KOLONTAR, HUNGARY

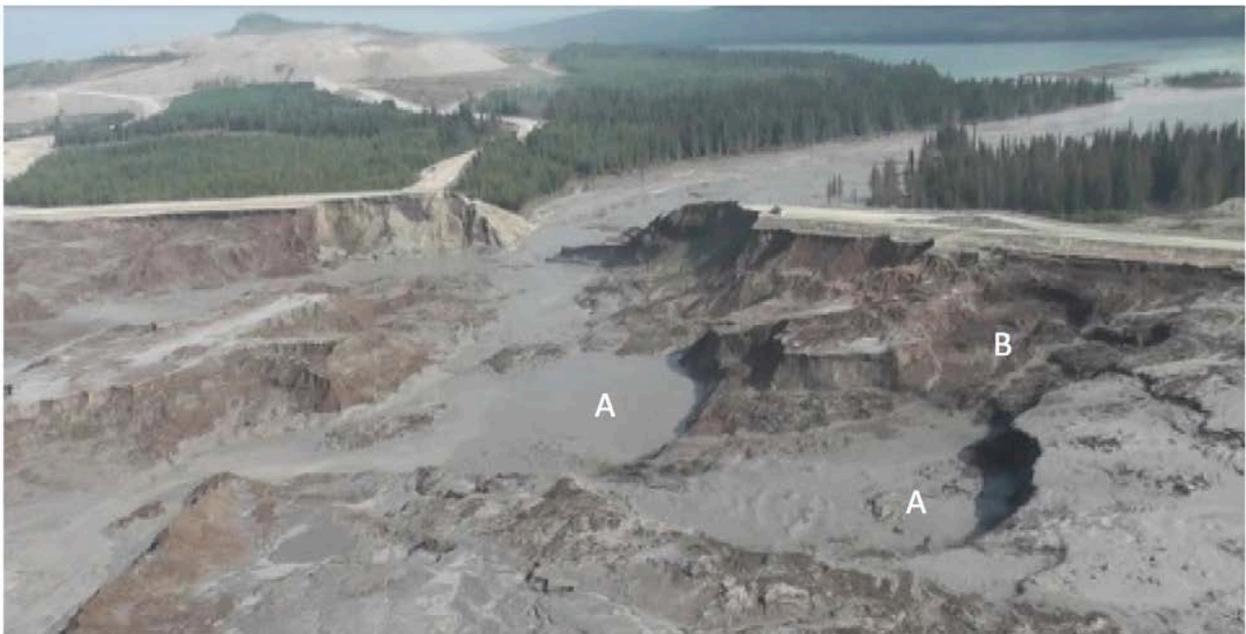
Figure C4.5.3, from the Cariboo video, shows two distinct terrace-like erosional surfaces (A). These are confined by arcuate, vertical headscarps like those previously displayed in **Figure C4.5.2(a)**. These headscarps constitute headward-migrating knickpoints for the well-developed surface flows. Also shown is a developing flowslide in motion and its semicircular headscarp in the process of forming (B).

FIGURE C4.5.3: HEADWARD EROSION AND PROGRESSIVE FLOWSLIDING DURING TAILINGS RELEASE (CARIBOO VIDEO AT 13:55)
