**MOUNT POLLEY MINING CORPORATION
MOUNT POLLEY MINE
TAILINGS STORAGE FACILITY
OPERATION, MAINTENANCE AND SURVEILLANCE
MANUAL**

**MOUNT POLLEY MINING CORPORATION
MOUNT POLLEY MINE
TAILINGS STORAGE FACILITY**

**OPERATION, MAINTENANCE AND SURVEILLANCE MANUAL
(REF. NO. VA101-00001/9-1)**

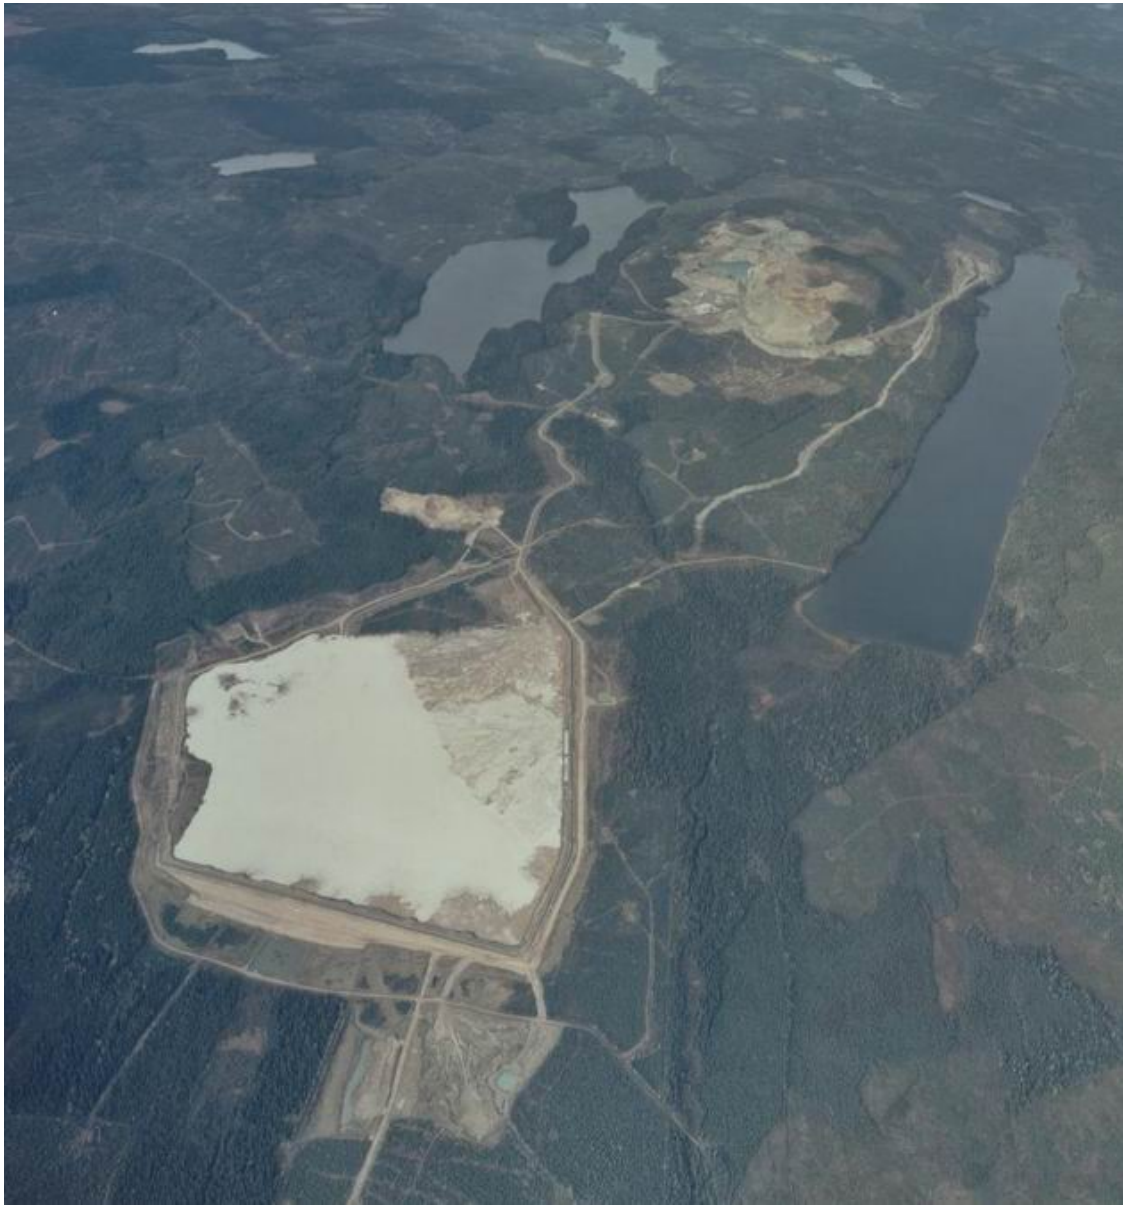
MOUNT POLLEY MINING CORPORATION			
MOUNT POLLEY MINE			
AERIAL PHOTOGRAPH OF MOUNT POLLEY MINE VIEWING NORTH			
<i>Knight Piésold</i> CONSULTING	PROJECT / ASSIGNMENT NO. VA 101-1/18	REF NO. 1	REV. 0
	FIGURE 1.2

Notes:
1) Photograph taken in October 2005

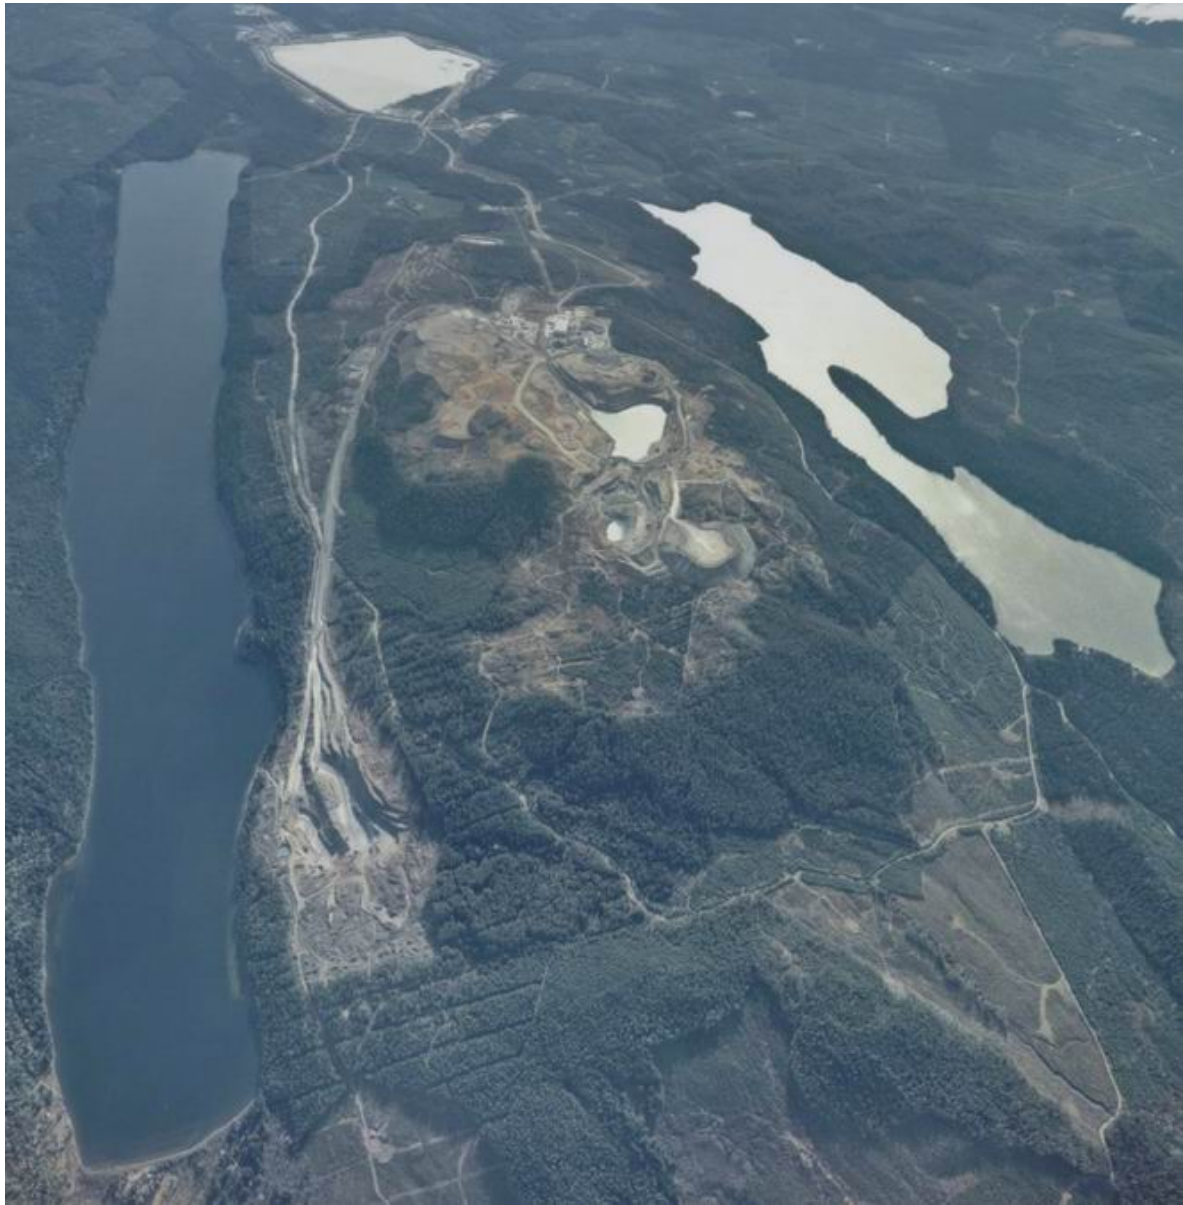
MOUNT POLLEY MINING CORPORATION			
MOUNT POLLEY MINE			
AERIAL PHOTOGRAPH OF MOUNT POLLEY MINE VIEWING SOUTH			
<i>Knight Piésold</i> CONSULTING	PROJECT / ASSIGNMENT NO. VA 101-1/18	REF NO. 1	REV. 0
	FIGURE 1.3

Notes:
1) Photograph taken in October 2005
