**MOUNT POLLEY MINE
Tailings Storage Facility Stage 9
2013 As-Built Report**

Mount Polley Mining Corporation,
Likely, BC

AMEC Environment & Infrastructure,
a division of AMEC Americas Limited
Burnaby, BC

2014

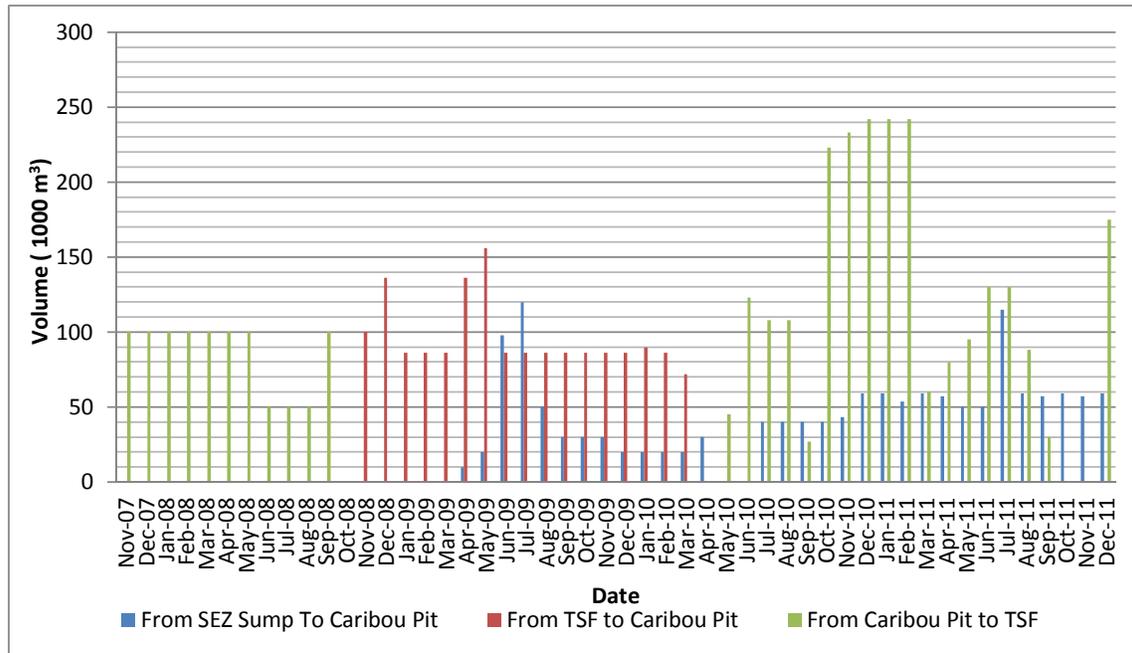
Figure 6.1 Water Volume Transferred

Pit. In addition, to control and maintain required water balance, MPMC transfers water as needed. The volumes transferred are shown in Figure 6.1.
