**MOUNT POLLEY MINE
Tailings Storage Facility Stage 9
2013 As-Built Report**

February 2014
VM00560C

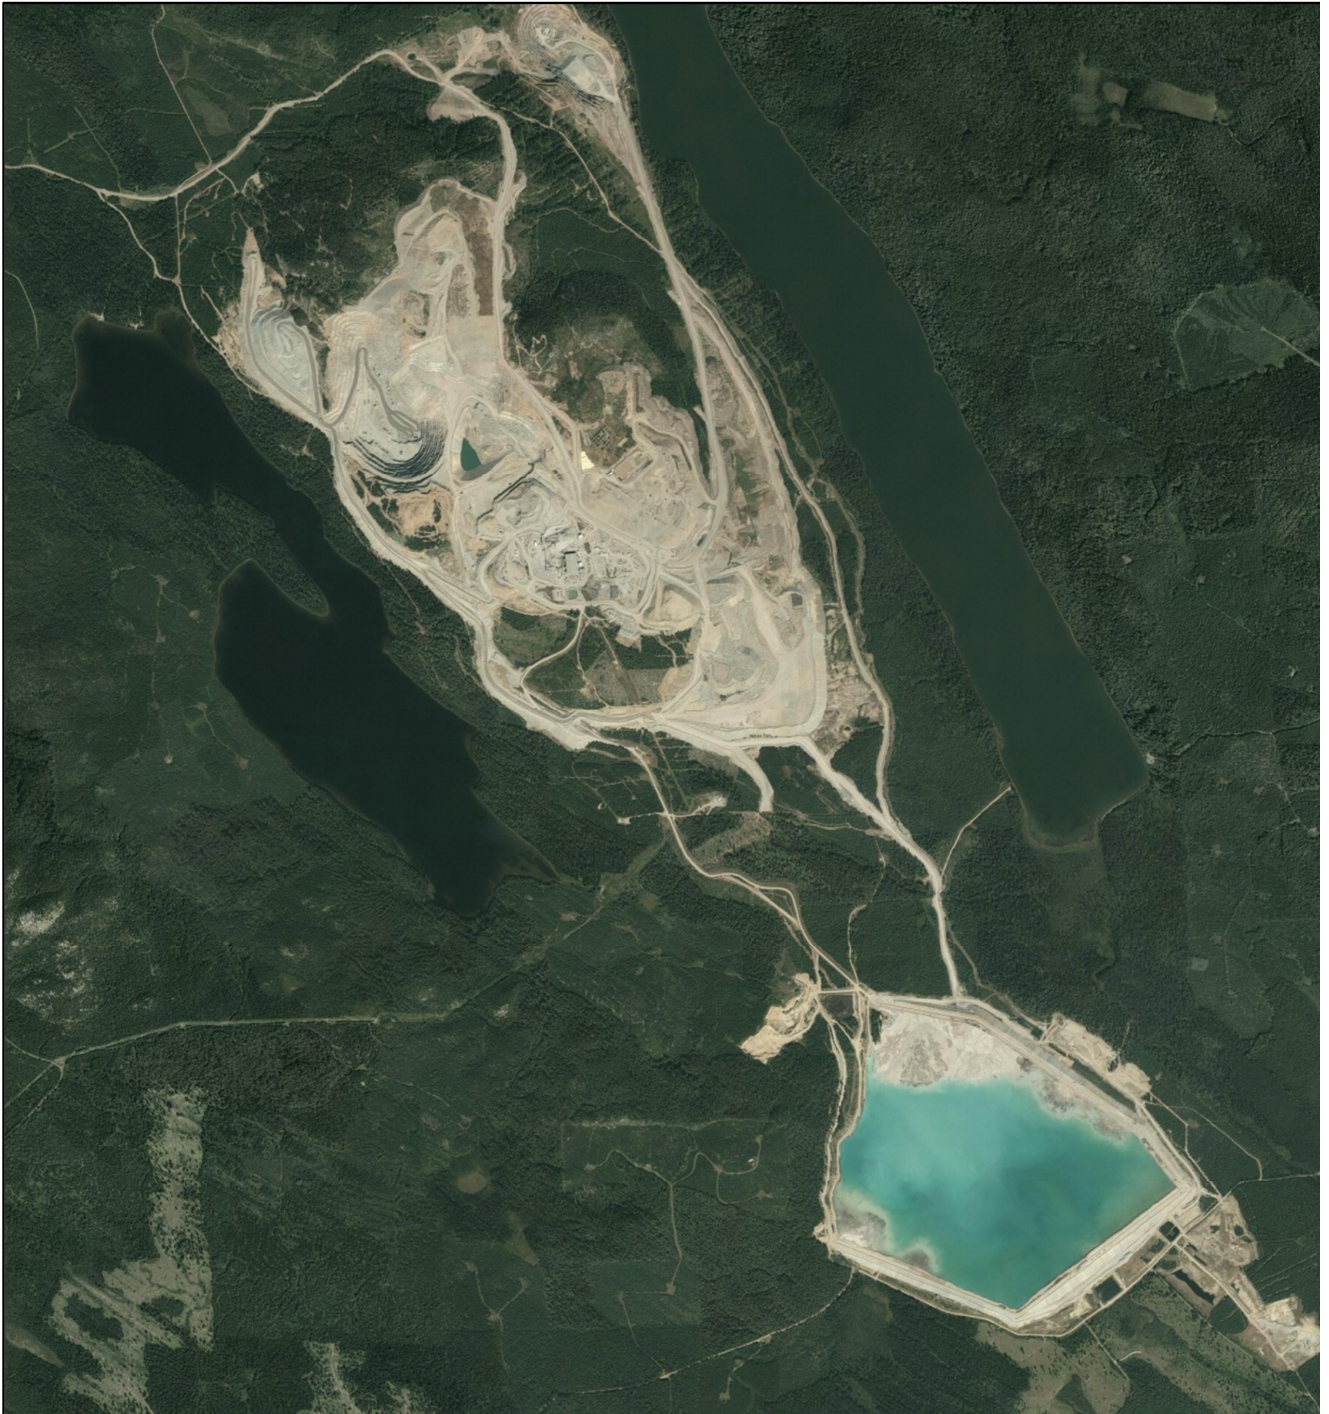
Figure 1.1: Aerial View of Mount Polley Mine Site: October 2013

The Mount Polley Mine is located in central British Columbia, approximately 60 km northeast of Williams Lake. The Mount Polley copper and gold mine commenced production in 1997 and operated until October 2001 when operations were suspended for economic reasons. In March 2005 the mine restarted production and has been in continuous operation since. Ore is crushed and processed by selective flotation to produce a copper-gold concentrate. The mill throughput rate is approximately 20,000 tonnes per day (approx. 7.3 million tonnes per year). Mill tailings are discharged as slurry into the Tailings Storage Facility (TSF) located on the south area of the mine property. Figure 1.1 shows an aerial view of the site from 2013.
