**MOUNT POLLEY MINE  
Tailings Storage Facility Stage 9  
2013 As-Built and Annual Review Report**

**Mount Polley Mining Corporation,**  
Likely, BC

**AMEC Environment & Infrastructure,**  
**a division of AMEC Americas Limited**  
Burnaby, BC

February 2014  
VM00560C

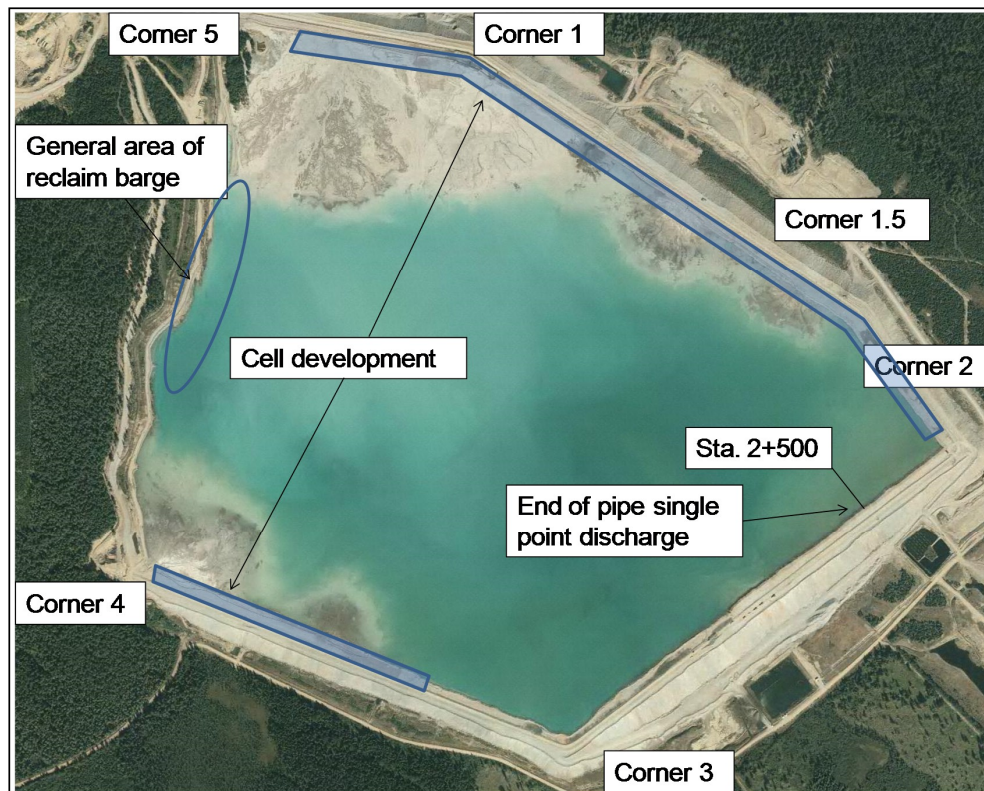
**Figure 2.1: 2013 Cell Development**

Cell construction was carried out from Corner 5 advancing along the Perimeter Embankment to the Main Embankment to about Station 2+500. Near the end of the 2013 construction season, the pipeline route was re-graded near Corner 5 to provide room for embankment expansion at the abutment. Insufficient tailings line pressure prevented cell construction along the central portion of the Main Embankment and single point discharge was employed (approximately Sta. 2+500) to facilitate the beach development in this area. Discharge from Station 2+500 was maintained for about two weeks, after which discharge was relocated to Corner 4. Cellular development began along the South Embankment towards the end of 2013. Figure 2.1 illustrates the cell development locations during 2013.
